ASBESTOS SURVEY REPORT FOR TOWN END ACADEMY, TOWN END FARM, SUNDERLAND, SR5 4NX

Town End Academy, Town End Farm, Sunderland

Date: 12 February 2026

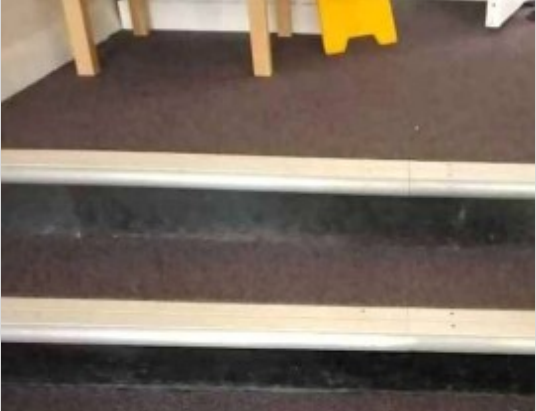
1	AW005974	Floor lining to steps	Lobby and Corridor G/002	No Risk

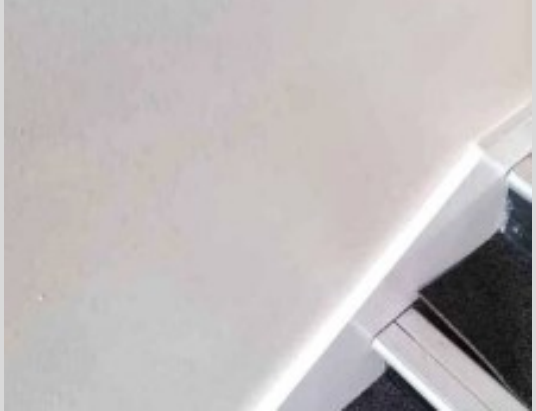
2	AW005975	Floor tile remnants under skirting boards on steps	Lobby and Corridor G/002	No Risk

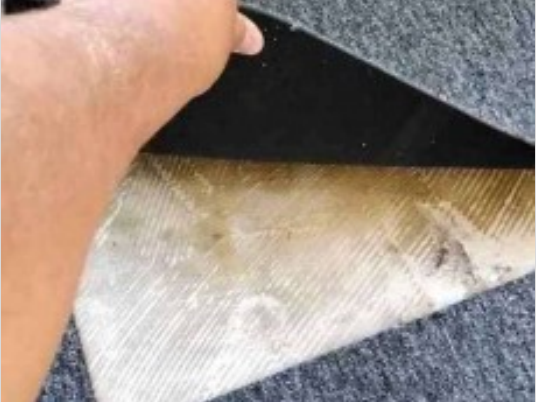
3	AW005976	Floor adhesive below latex screed	Office G/003	No Risk

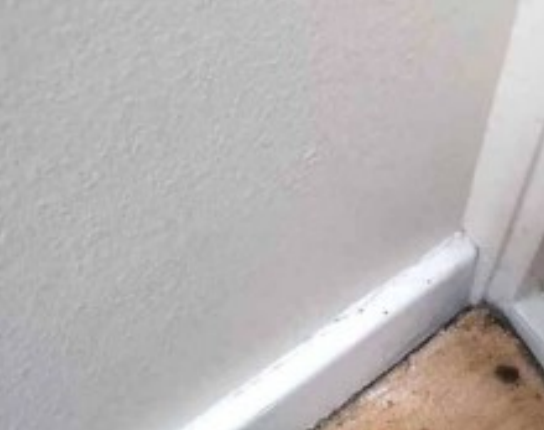
16	As AW006014	Floor covering	Lobby G/067	No Risk

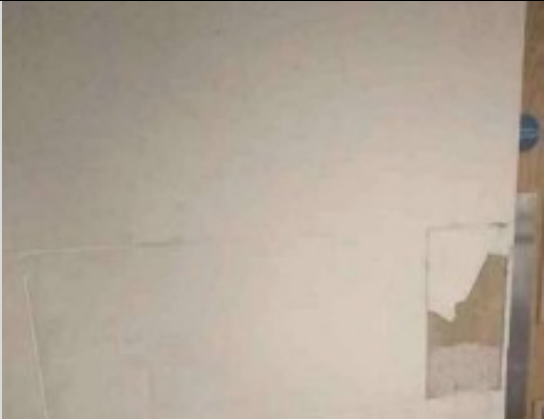
17	AW006015	Wall tile adhesive	Lobby G/067	No Risk

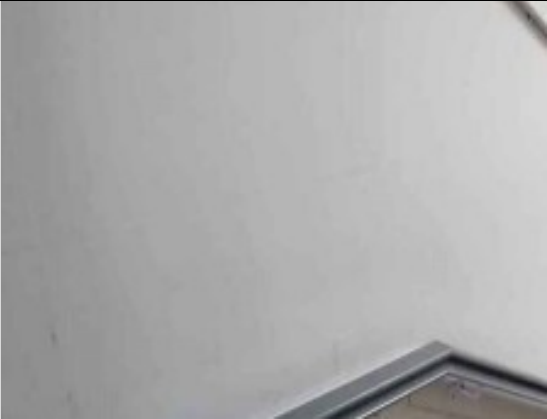
40	As AW006013	Wall tile	Stairwell 1/008	No Risk

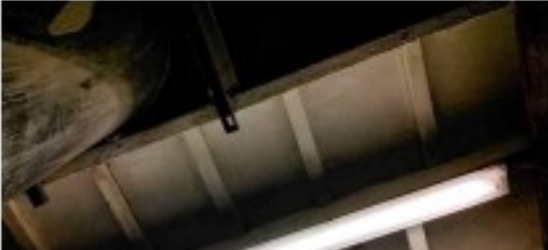
42	AW005977	Ceiling	Tank Room R/001	Very Low Risk – 12 monthly
Photo 1: Wide Angle			Photo 2: Close

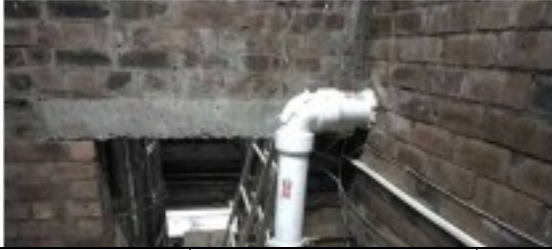
43	AW005978	Flue Pipe	Tank Room R/001	Very Low Risk – 12 monthly
Photo 1: Wide Angle			Photo 2: Close

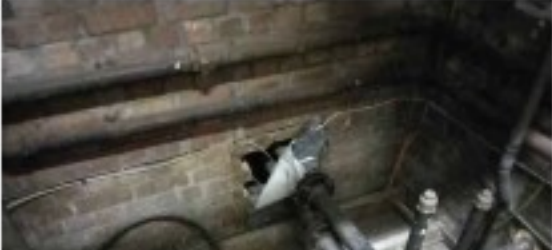
44	AW005979	Pipework Gasket	Tank Room R/001	Very Low Risk – 12 monthly
Photo 1: Wide Angle			Photo 2: Close
