ASBESTOS SURVEY REPORT FOR BEXHILL ACADEMY, TOWN END FARM,
SUNDERLAND, SR5 4PJ

Asbestos Register for

Bexhill Academy, Town End Farm, SR5 4PJ

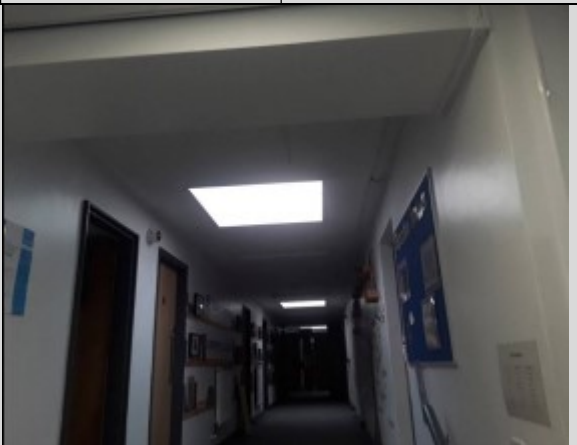
1	NZ001636	Ceiling tile – solid within ceiling void and corridor	Reception/Entrance Hall including corridor G/002	No Risk

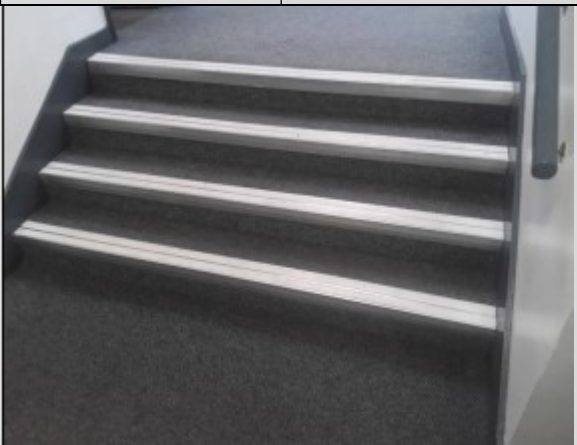
2	NZ001637	Floor nosing to stairs	Reception/Entrance Hall including corridor G/002	No Risk

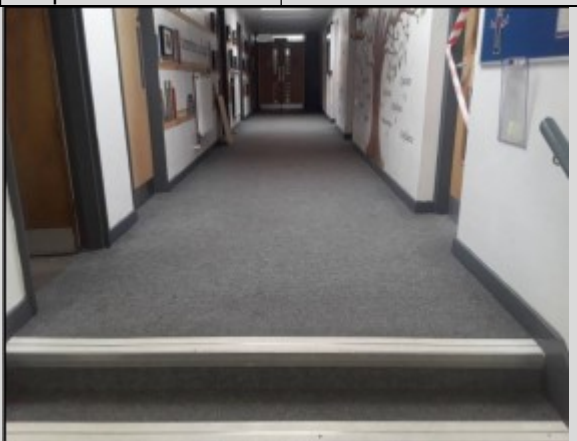
3	NZ001638	Floor tile with adhesive under carpet	Reception/Entrance Hall including corridor G/002	No Risk

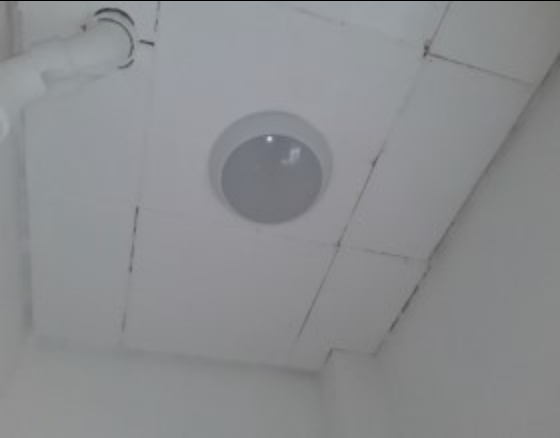
14	As NZ001636	Ceiling tile – solid	Toilets Staff G/008	No Risk

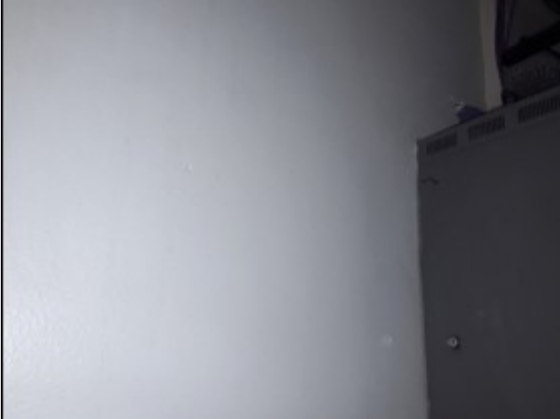
48	As NZ001655	Wall coating to stairwell	Hub/Network room under staircase G/076	No Risk

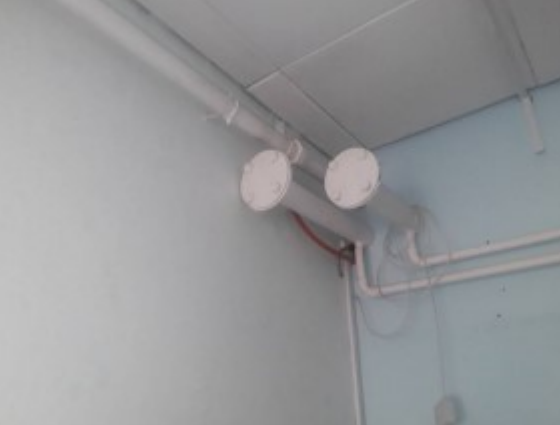
49	NZ001656	Pipework Gaskets	Office G/077	No Risk

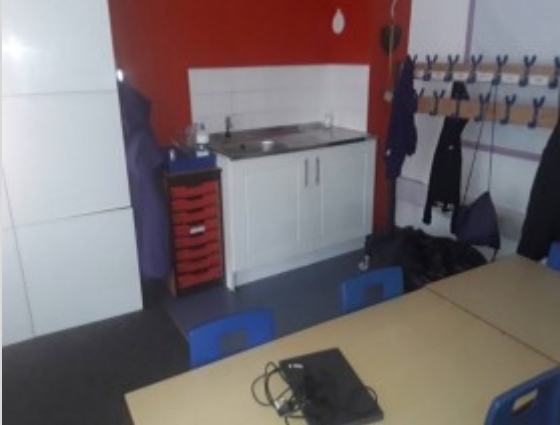
50	As NZ001653	Under sink mat	Classroom G/078	No Risk

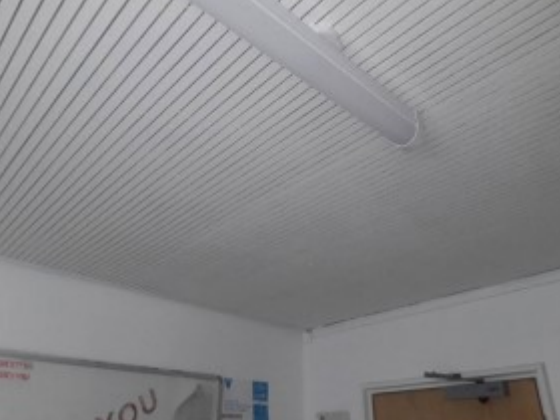
51	NZ001657	Ceiling tile – solid	Office Headteachers G/080	No Risk

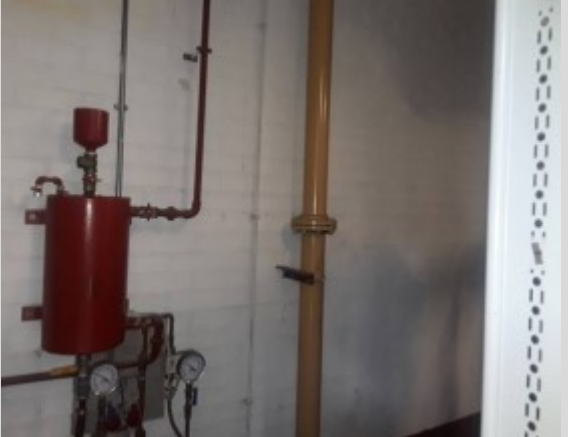
79	NZ001670	Pipework gaskets to gas pipework	Boiler Room E/005	No Risk

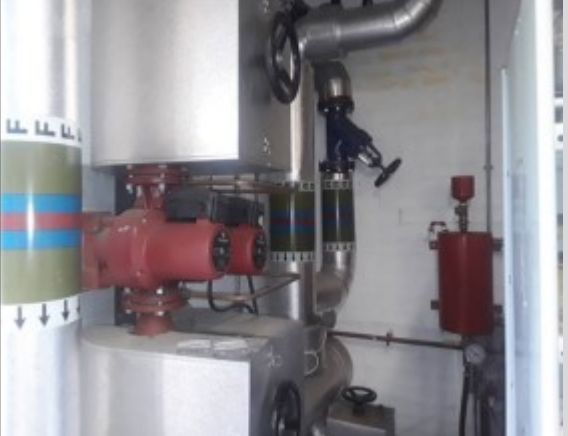
80	NZ001671	Pipework gaskets to pipework	Boiler Room E/005	No Risk

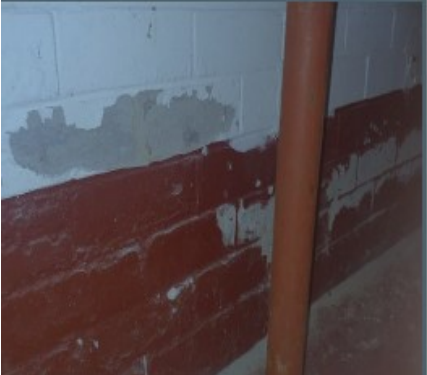
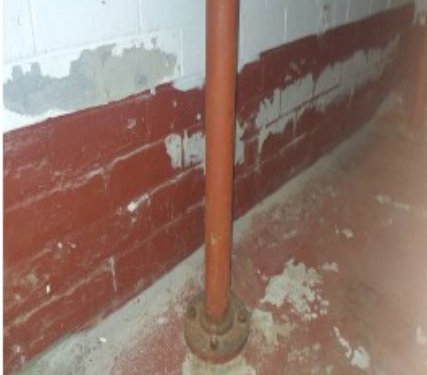
85	IJ007428	Debris/residue to wall	Boiler Store E/01	Very Low Risk
