ASBESTOS SURVEY REPORT FOR CROFTWAY ACADEMY, WILLIAM STREET, BLYTH, NE24 2HP.

Asbestos Register for

Croftway Academy, William Street, Blyth. NE24 2HP

Date: 11 August 2022

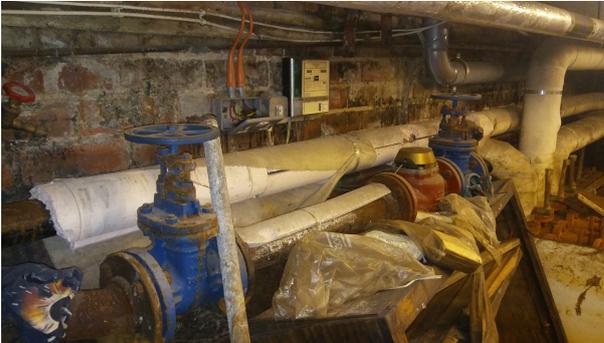
Item 1 Ref: 348056-4

The pipe lagging (Boiler room-access from hatch in 0/027 - Rm -1/01) does not contain asbestos.

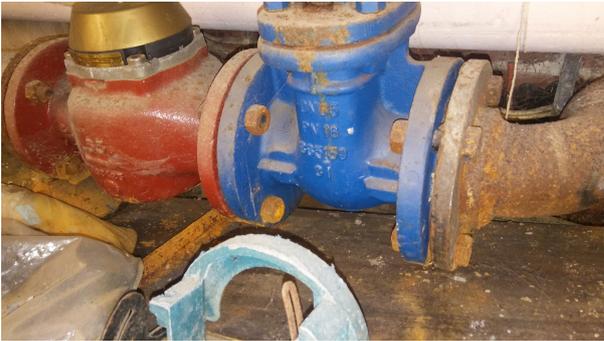
Item 2 Ref: 348056-5

- (Item 1) Ref: 348056-4 – Pipe lagging (Boiler room-access from hatch in 0/027 - Rm -1/01) – No Risk
- (Item 2) Ref: 348056-5 – Pipework flange gasket (Boiler room-access from hatch in 0/027 - Rm -1/01) – Low Risk

The pipework flange gasket (Boiler room-access from hatch in 0/027 - Rm -1/01) contains asbestos.

Picture	Location	Risk	Inspection Frequency	Date of return
<i>Item 1</i>	<i>No asbestos</i>	<i>Is present</i>		
Item 2	Pipework flange gasket (Boiler room-access from hatch in 0/027 - Rm -1/01)	Low Risk	6 monthly	Do not inspect

Any change in appearance should be reported to Property Services.

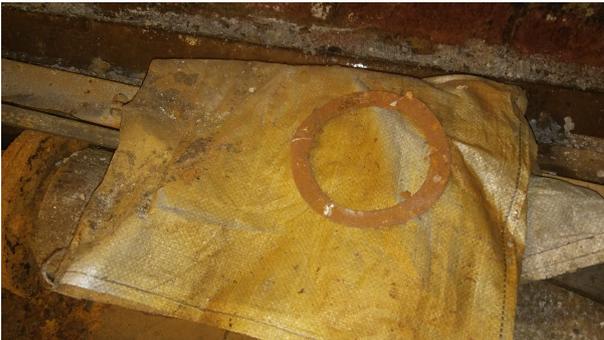
Item 3 Ref: As 348056-5

- (Item 3) As 348056-5 – Loose lying gasket (Boiler room-access from hatch in 0/027 - Rm -1/01) – Low Risk
- (Item 4) Ref: 348056-6 – Break pads - (Boiler room-access from hatch in 0/027 - Rm -1/01) – No Risk

The loose lying gasket (Boiler room-access from hatch in 0/027 - Rm -1/01) contains asbestos.

Item 3	Loose lying gasket (Boiler room-access from hatch in 0/027 - Rm - 1/01)	Low Risk	6 monthly	Do not inspect
<i>Item 4</i>	<i>No asbestos</i>	<i>Is present</i>		
<i>Item 5</i>	<i>No asbestos</i>	<i>Is present</i>		
<i>Item 6</i>	<i>No asbestos</i>	<i>Is present</i>		
<i>Item 7</i>	<i>No asbestos</i>	<i>Is present</i>		
<i>Item 8</i>	<i>No asbestos</i>	<i>Is present</i>		
<i>Item 9</i>	<i>No asbestos</i>	<i>Is present</i>

Any change in appearance should be reported to Property Services.

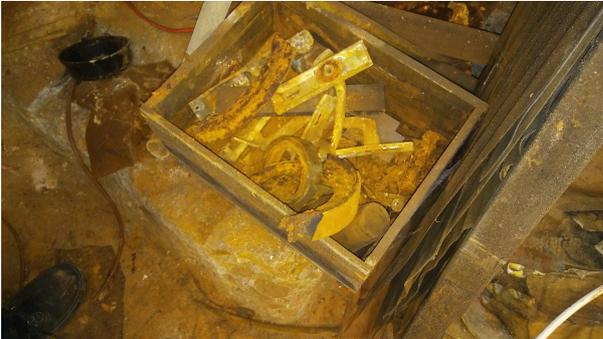
Item 4 Ref: 348056-6

The break pads - (Boiler room-
access from hatch in 0/027 -
Rm -1/01) does not contain
asbestos.

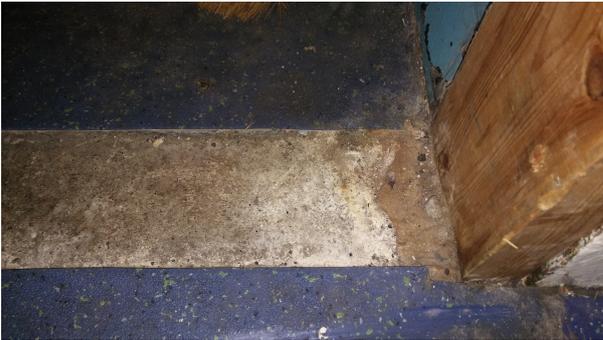
Item 5 Ref: 348056-1

The floor screed (Cleaners
store Rm 0/02) does not
contain asbestos.

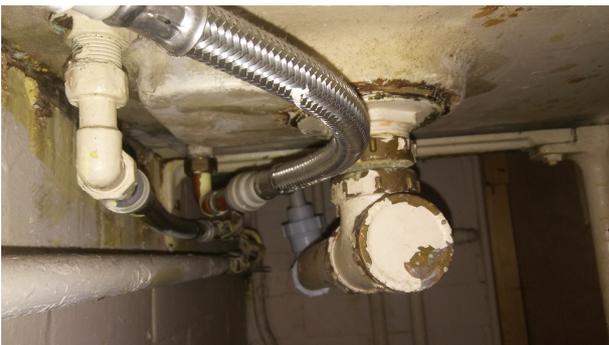
Item 6 Ref: 348056-2

The gasket to underside of
sink (Cloakroom Rm 0/04)
does not contain asbestos.

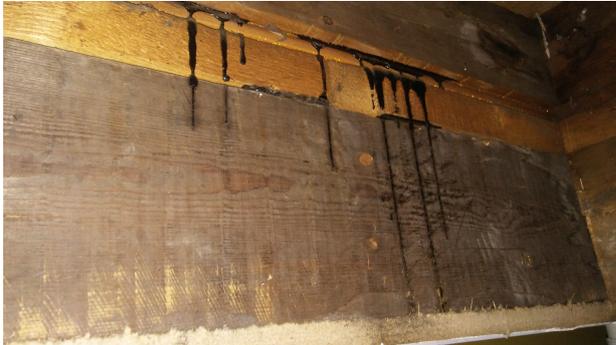
Item 7 Ref: 348056-3

The packers to skylight surrounds (WC-void above Rm 0/05) do not contain asbestos.

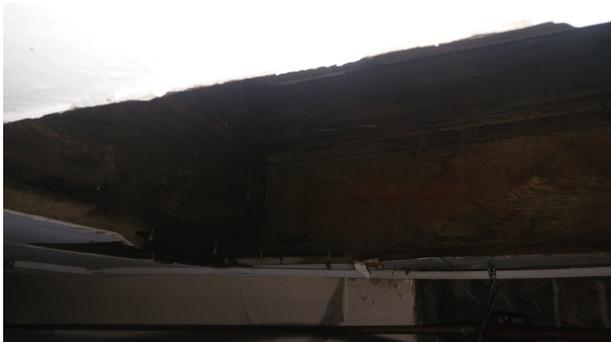
Item 8 Ref: As 348056-3

The packers to skylight surrounds (WC-void above Rm 0/06) do not contain asbestos.

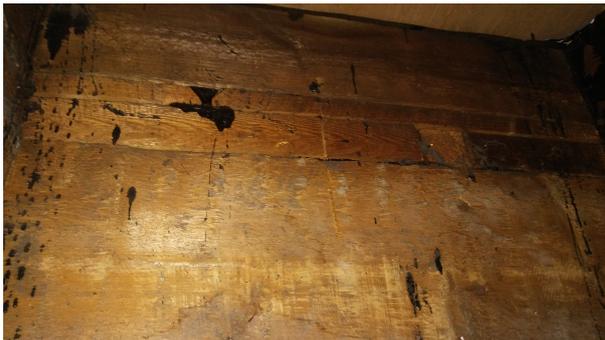
Item 9 Ref: As 348056-3

The packers to skylight surrounds (Boys WC-void above Rm 0/013) do not contain asbestos.

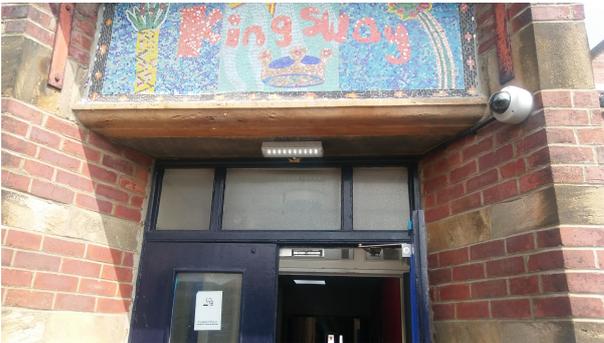
Item 11 Ref: 348056-8

The mastic to windows above fire exit door (externals) does not contain asbestos.

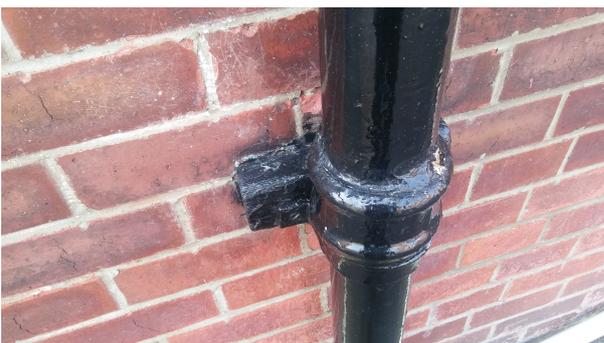
Item 12 Ref: 348056-9

The mastic to down pipe collars (externals) does not contain asbestos.

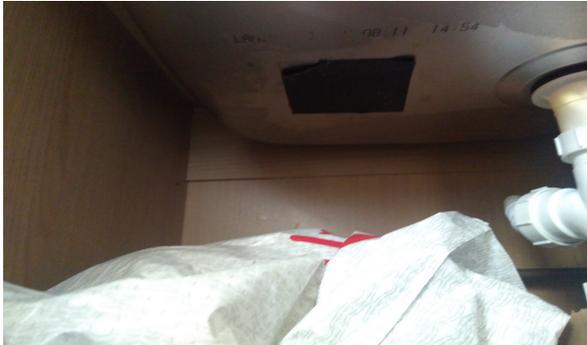
Item 13 Ref: 355899-1

The sink pad in the kitchen in the caretakers house (Room 0/005) does not contain asbestos.

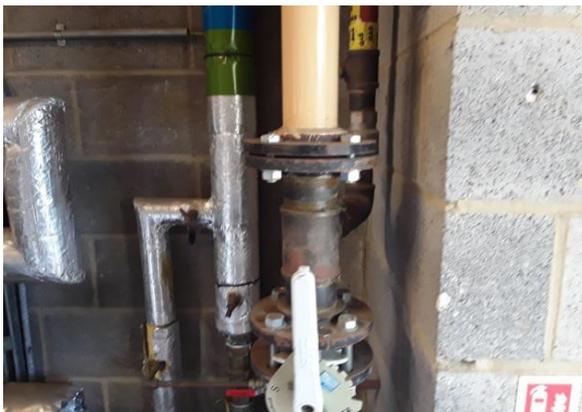
Item 15 Ref: 21-35349-1

The flange to gas pipe (Gaskets) (Room/Area: 2 - Sports hall boiler room) does not contain asbestos.

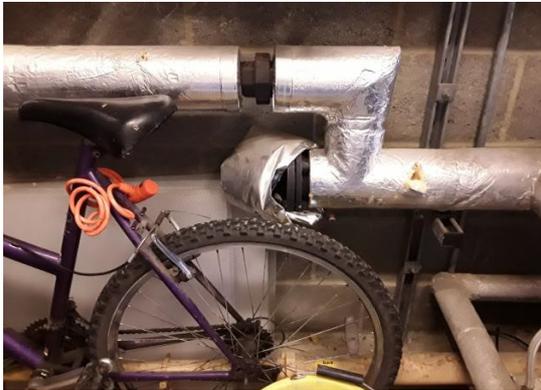
Item 16 Ref: 21-35349-2

The pipe flanges to water heating pipes (Gaskets) (Room/Area: 2 - Sports hall boiler room) do not contain asbestos.

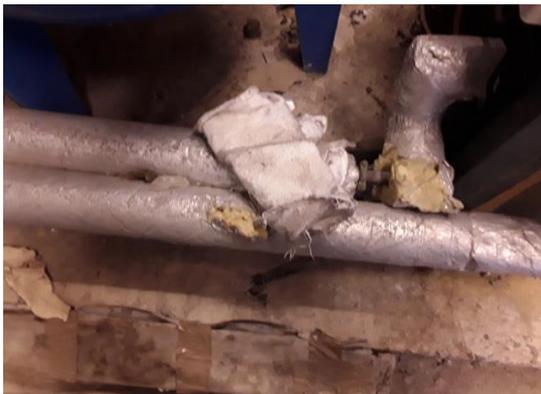
Item 17 Ref: 21-35349-3

The redundant textile pipe wrap to floor (Textile) (Room/Area: 2 - Sports hall boiler room) does not contain asbestos.

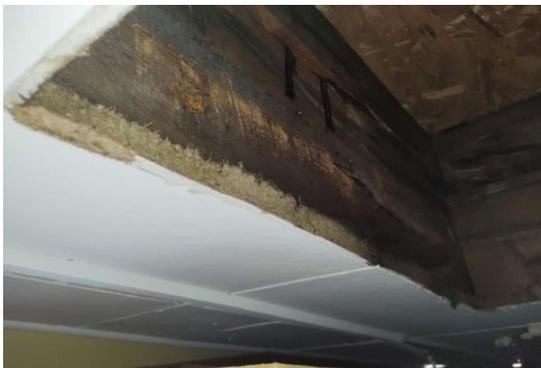
Item 18 Ref: 21-36876-1

The ceiling tiles above suspended ceiling in Girls Toilet (Area 5) does not contain asbestos.

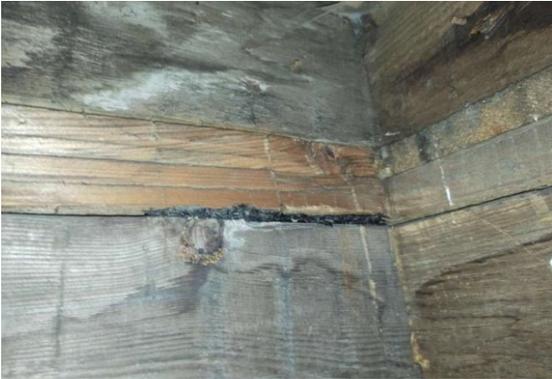
Item 19 Ref: 21-36876-2

The bitumen packers and residue around skylights in Girls Toilet (Area 5) does not contain asbestos.

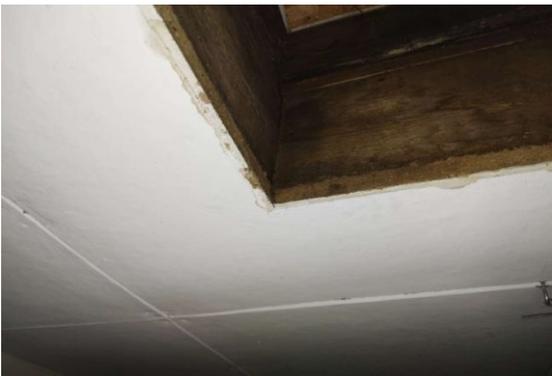
Item 20 Ref: 21-36876-1

The ceiling tiles above suspended ceiling in WC (Area 6) does not contain asbestos.

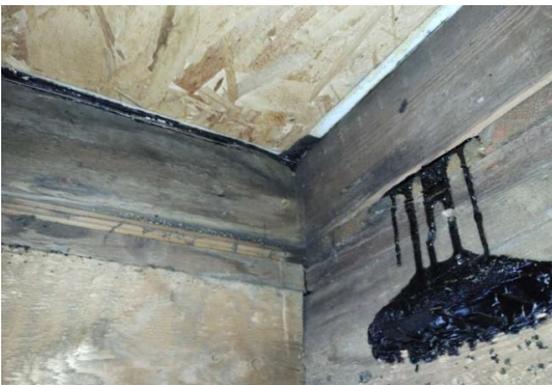
Item 21 Ref: 21-36876-2

The bitumen packers and residue around skylights in WC (Area 6) does not contain asbestos.

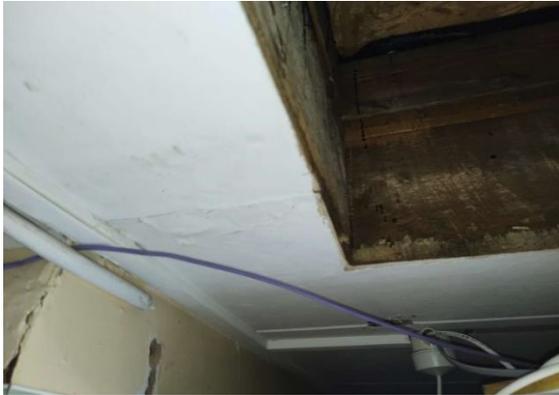
Item 22 Ref: 21-36876-1

The ceiling tiles above suspended ceiling in Boys Toilet (Area 15) does not contain asbestos.

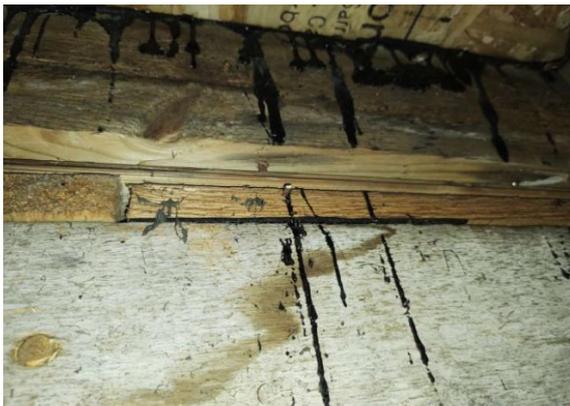
Item 23 Ref: 21-36876-2

The bitumen packers and residue around skylights in Boys Toilet (Area 15) does not contain asbestos.

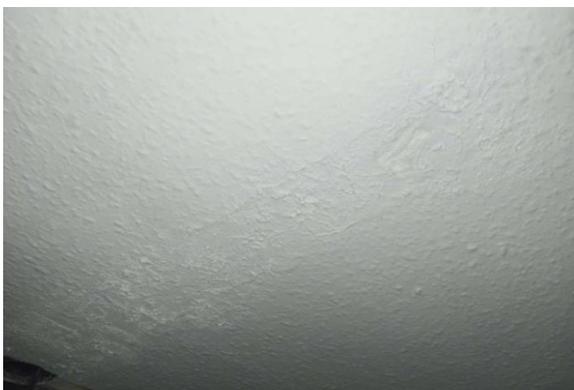
Item 24 Ref: 21-36876-3

The textured coating to repaired patch of ceiling in Learning Space (Area 16) does not contain asbestos.

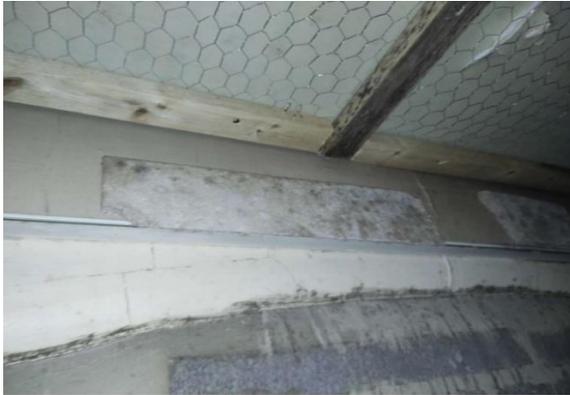
Item 25 Ref: 21-36876-4

The remnants of previous suspended ceiling tiles in Library (Area 26) does not contain asbestos.

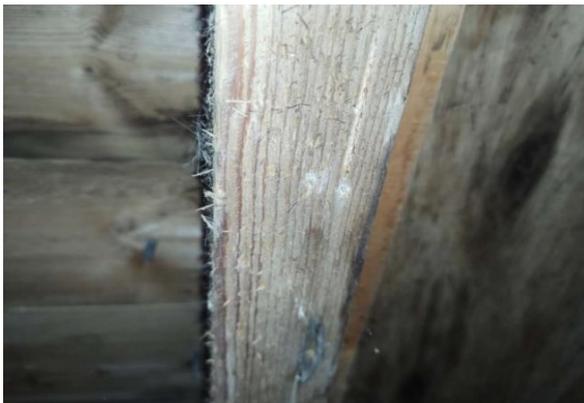
Item 26 Ref: 21-36876-5

The insulating board residue to joists in Nursery Boys Toilet (Area 43) does contain asbestos.

Item 26	Insulating	Low Risk	6 monthly	Do not

Any change in appearance should be reported to Property Services.

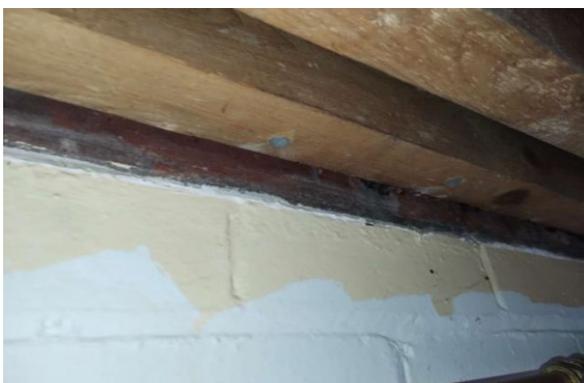
Item 27 Ref: 21-36876-5

The insulating board residue to joists in Nursery Boys Toilet (Area 43) does contain asbestos.

residue to ceiling joists (Area 43/Nursery Boys Toilet)			inspect
Item 27	Insulating residue to walls (Area 43/Nursery Boys Toilet)	Low Risk	6 monthly	Do not inspect
<i>Item 28</i>	<i>No asbestos</i>	<i>Is present</i>		
<i>Item 29</i>	<i>No asbestos</i>	<i>Is present</i>

Any change in appearance should be reported to Property Services.

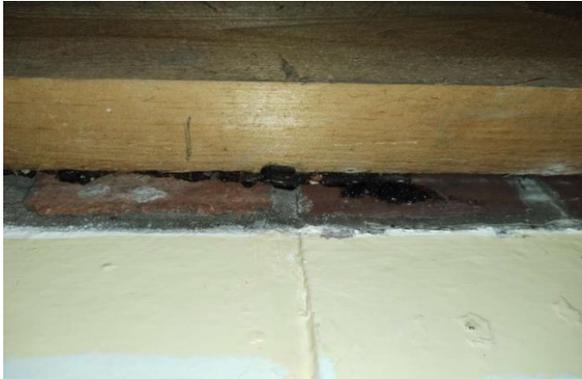
Item 28 Ref: 21-36876-6

The bitumen residue from roof in Nursery Boys Toilet (Area 43) does not contain asbestos.

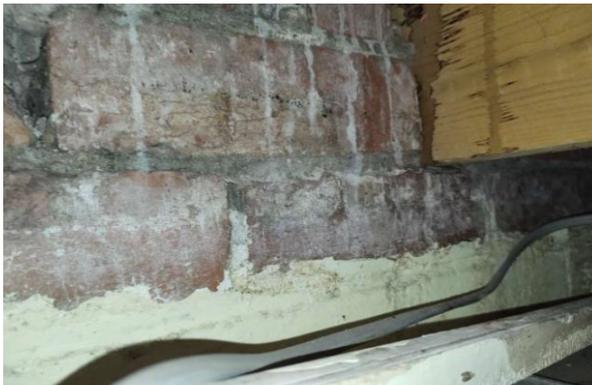
Item 29 Ref: 21-36876-7

The insulating board residue in Nursery Girls Toilet (Area 47) does not contain asbestos.
