ASBESTOS SURVEY REPORT FOR CROFTWAY ACADEMY, WILLIAM STREET, BLYTH, NE24 2HP.

## **Asbestos Register for Croftway Academy, William Street, Blyth. NE24 2HP**

**Date: 06 March 2026**

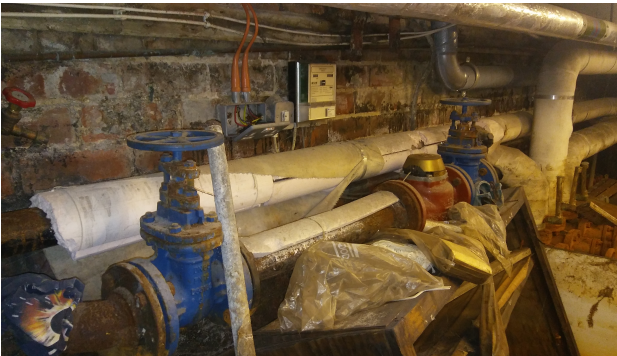
### **Item 1 Ref: 348056-4**

The pipe lagging (Boiler room-access from hatch in 0/027 - Rm -1/01) does not contain asbestos.

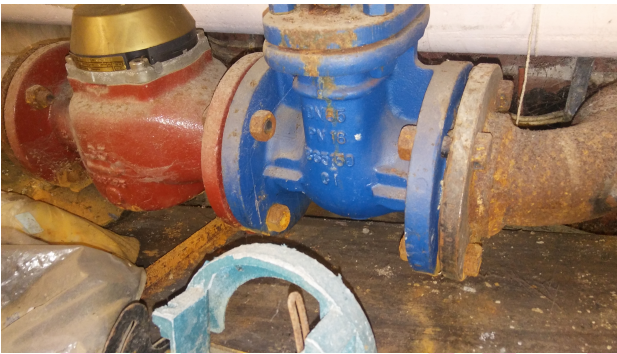
### **Item 2 Ref: 348056-5**

The pipework flange gasket (Boiler room-access from hatch in 0/027 - Rm -1/01) contains asbestos.

Any change in appearance should be reported to Property Services.

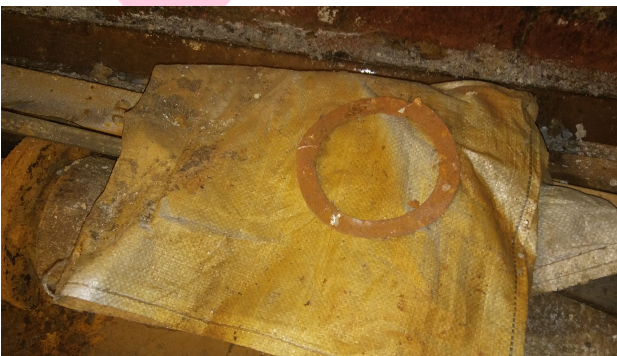
### **Item 3 Ref: As 348056-5**

The loose lying gasket (Boiler room-access from hatch in 0/027 - Rm -1/01) contains asbestos.

Any change in appearance should be reported to Property Services.

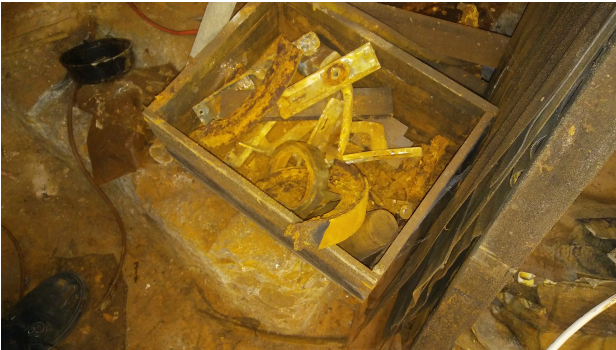
### **Item 4 Ref: 348056-6**

The break pads - (Boiler room - access from hatch in 0/027 - Rm -1/01) does not contain asbestos.

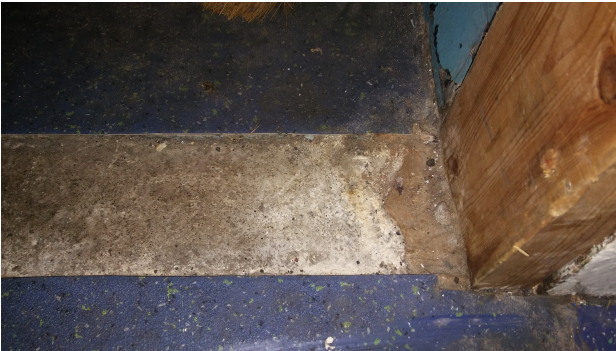
### **Item 5 Ref: 348056-1**

The floor screed (Cleaners store Rm 0/02) does not contain asbestos.

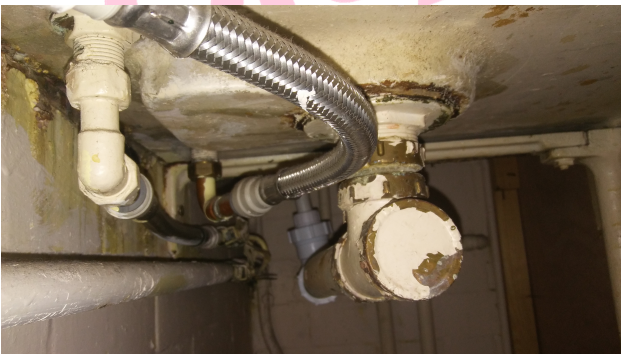
### **Item 6 Ref: 348056-2**

The gasket to underside of sink (Cloakroom Rm 0/04) does not contain asbestos.

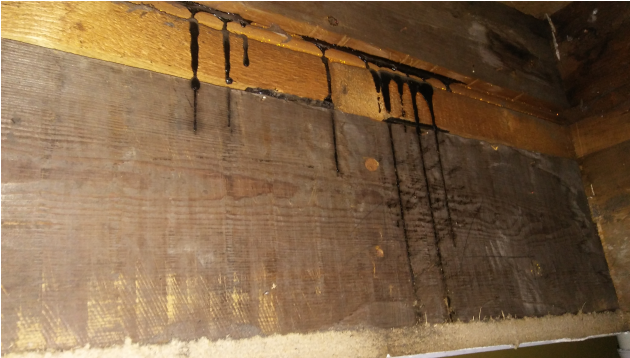
**Item 7 Ref: 348056-3**

The packers to skylight surrounds (WC-void above Rm 0/05) do not contain asbestos.

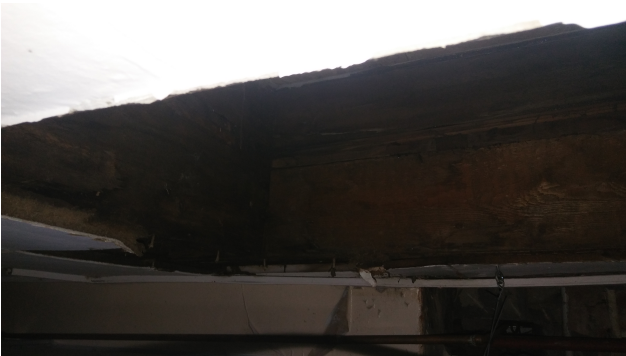
**Item 8 Ref: As 348056-3**

The packers to skylight surrounds (WC-void above Rm 0/06) do not contain asbestos.

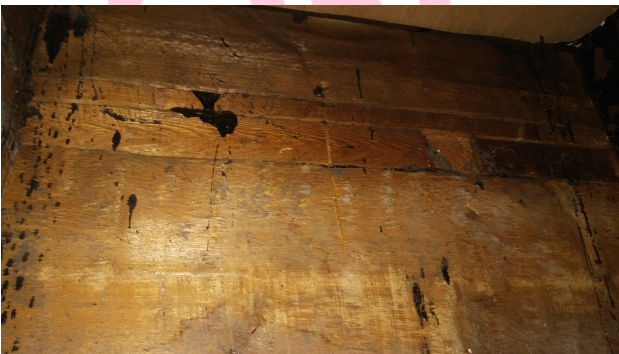
**Item 9 Ref: As 348056-3**

The packers to skylight surrounds (Boys WC-void above Rm 0/013) do not contain asbestos.

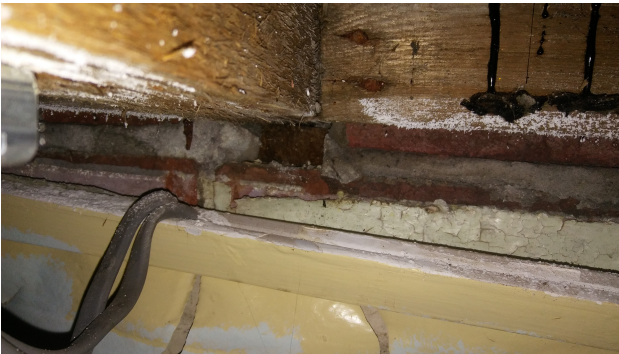
### **Item 10 Ref: 348056-7**

- (Item 9) Ref: As 348056-3 – Packers to skylight surrounds (Boys WC-void above Rm 0/013) – No Risk
- (Item 10) Ref: 348056-7 – Debris to walls (WC-void above Rm 0/045) – Medium Risk

The Debris to walls (WC-void above Rm 0/045) contains asbestos.

Any change in appearance should be reported to Property Services.

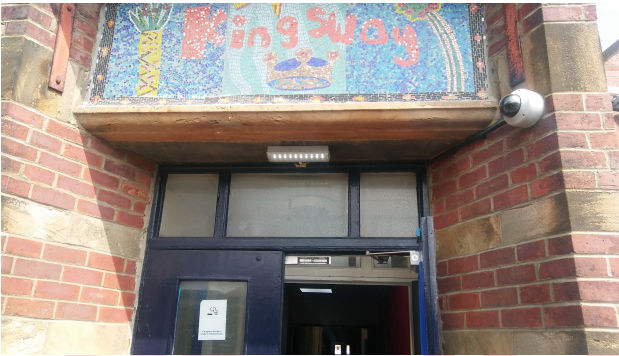
### **Item 11 Ref: 348056-8**

The mastic to windows above fire exit door (externals) does not contain asbestos.

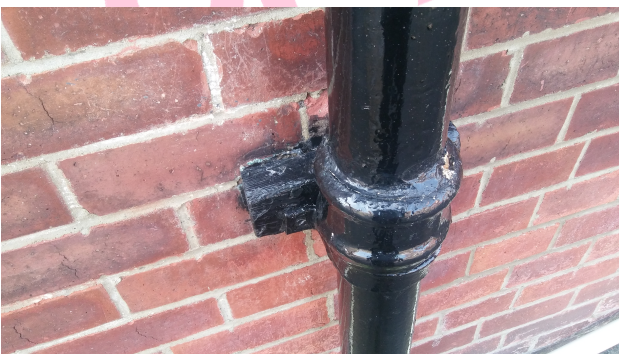
### **Item 12 Ref: 348056-9**

The mastic to down pipe collars (externals) does not contain asbestos.

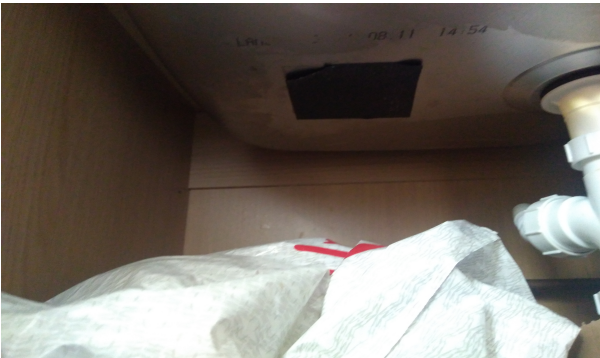
**Item 13 Ref: 355899-1**

The sink pad in the kitchen in the caretakers house (Room 0/005) does not contain asbestos.

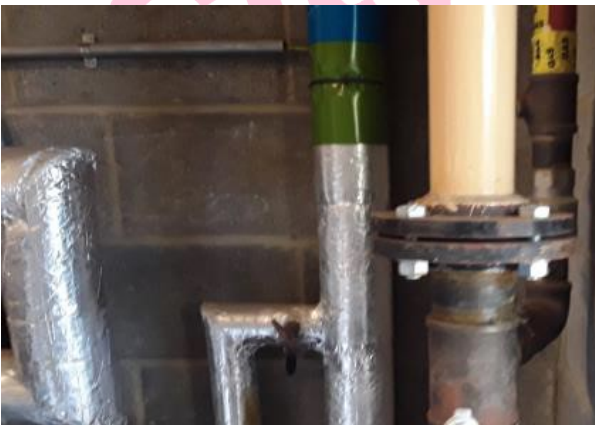
**Item 15 Ref: 21-35349-1**

The flange to gas pipe (Gaskets) (Room/Area: 2 - Sports hall boiler room) does not contain asbestos.

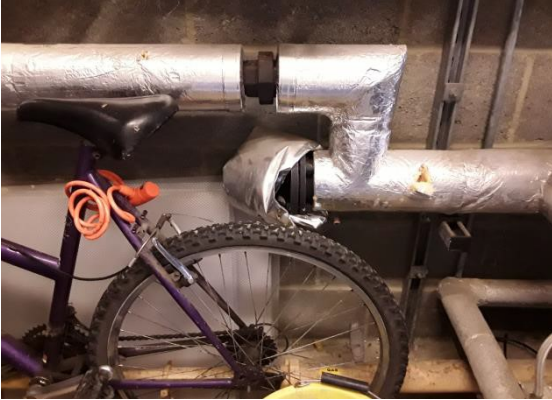
### **Item 16 Ref: 21-35349-2**

The pipe flanges to water heating pipes (Gaskets) (Room/Area: 2 - Sports hall boiler room) do not contain asbestos.

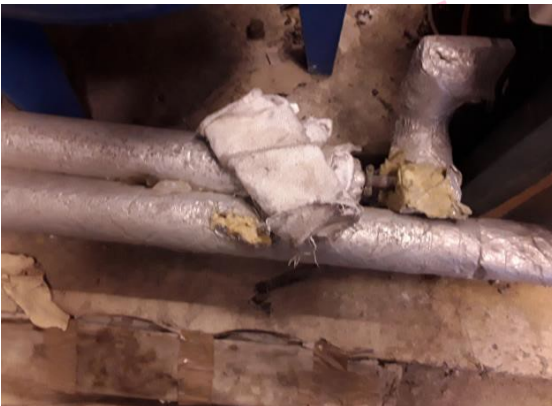
### **Item 17 Ref: 21-35349-3**

The redundant textile pipe wrap to floor (Textile) (Room/Area: 2 - Sports hall boiler room) does not contain asbestos.

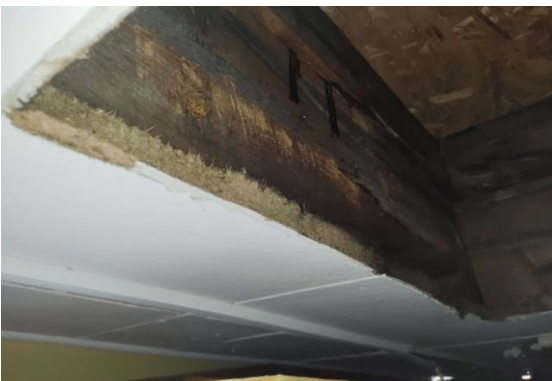
### **Item 18 Ref: 21-36876-1**

The ceiling tiles above suspended ceiling in Girls Toilet (Area 5) does not contain asbestos.

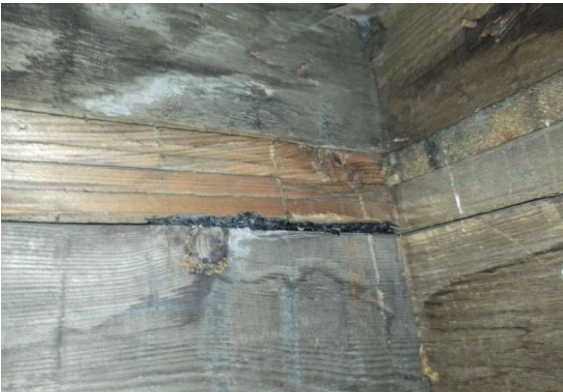
**Item 19 Ref: 21-36876-2**

The bitumen packers and residue around skylights in Girls Toilet (Area 5) does not contain asbestos.

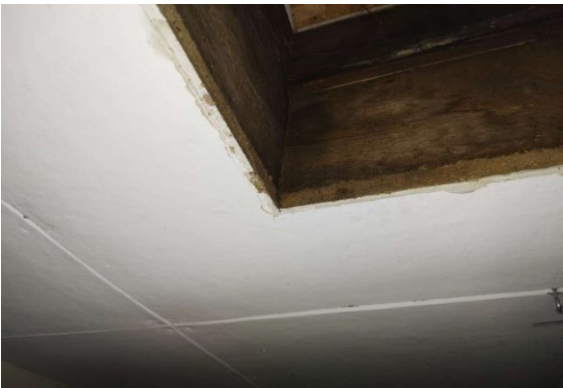
**Item 20 Ref: 21-36876-1**

The ceiling tiles above suspended ceiling in WC (Area 6) does not contain asbestos.

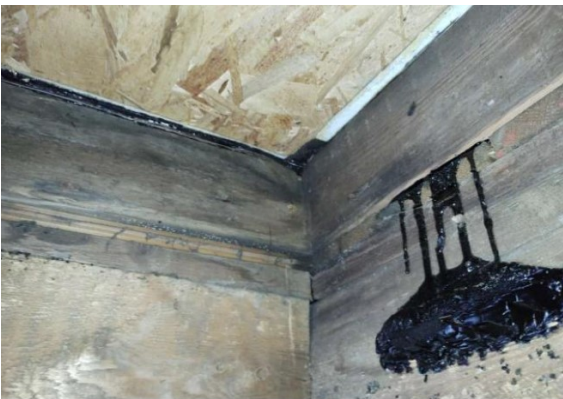
**Item 21 Ref: 21-36876-2**

The bitumen packers and residue around skylights in WC (Area 6) does not contain asbestos.

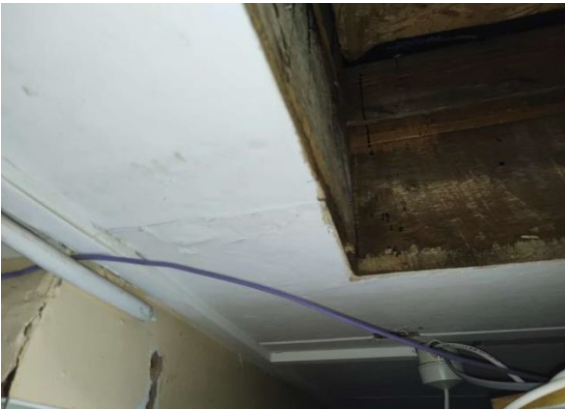
### **Item 22 Ref: 21-36876-1**

The ceiling tiles above suspended ceiling in Boys Toilet (Area 15) does not contain asbestos.

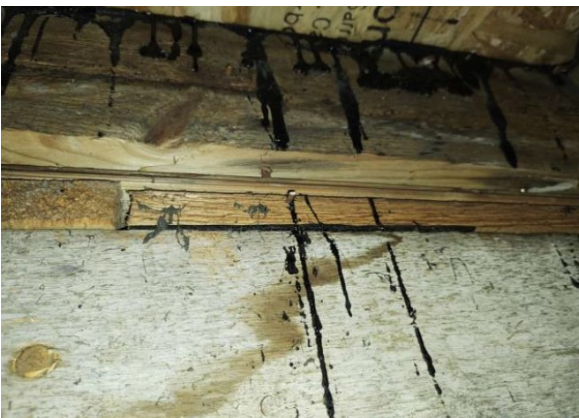
### **Item 23 Ref: 21-36876-2**

The bitumen packers and residue around skylights in Boys Toilet (Area 15) does not contain asbestos.

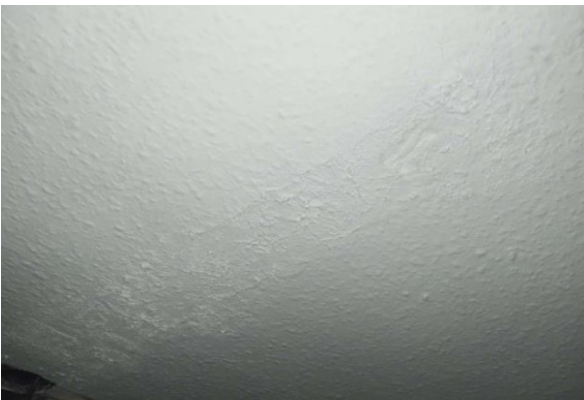
### **Item 24 Ref: 21-36876-3**

The textured coating to repaired patch of ceiling in Learning Space (Area 16) does not contain asbestos.

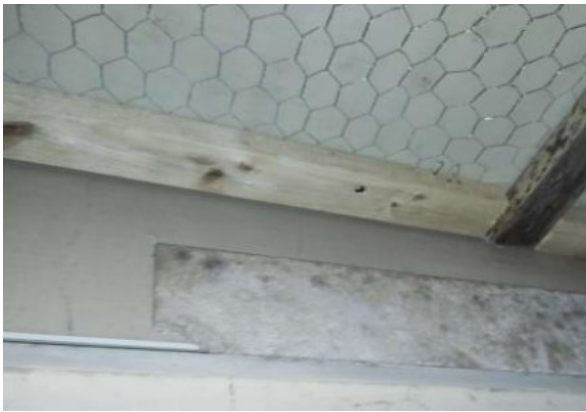
### **Item 25 Ref: 21-36876-4**

The remnants of previous suspended ceiling tiles in Library (Area 26) does not contain asbestos.

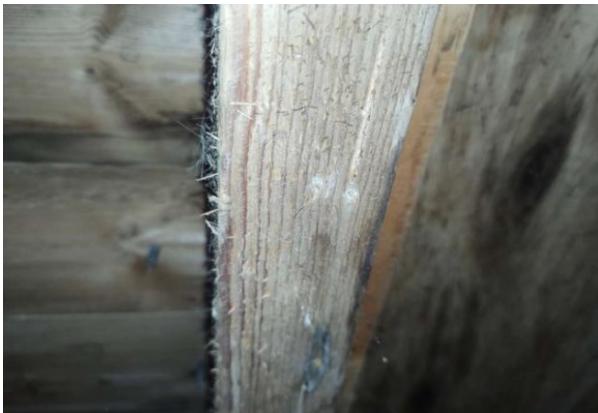
### **Item 26 Ref: 21-36876-5**

The insulating board residue to joists in Nursery Boys Toilet (Area 43) does contain asbestos.

Any change in appearance should be reported to Property Services.

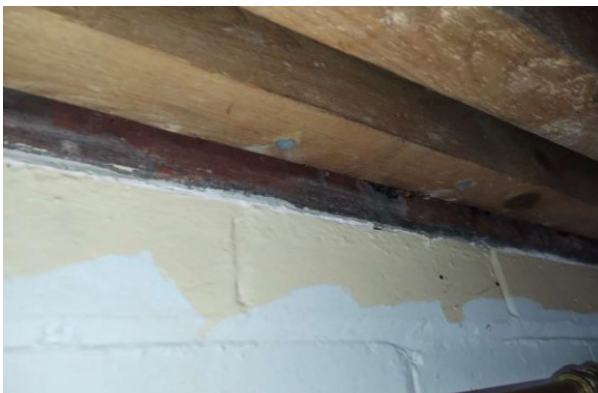
### **Item 27 Ref: 21-36876-5**

The insulating board residue to joists in Nursery Boys Toilet (Area 43) does contain asbestos.

Any change in appearance should be reported to Property Services.

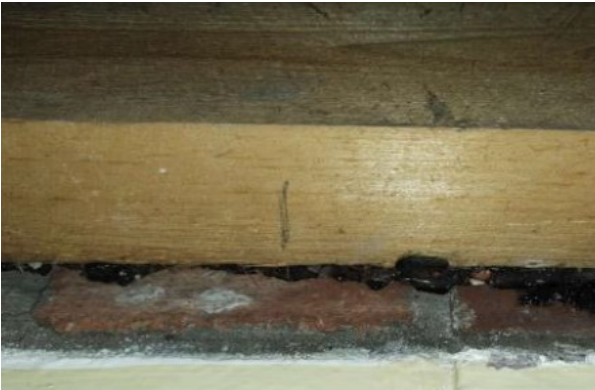
**Item 28 Ref: 21-36876-6**

The bitumen residue from roof in Nursery Boys Toilet (Area 43) does not contain asbestos.

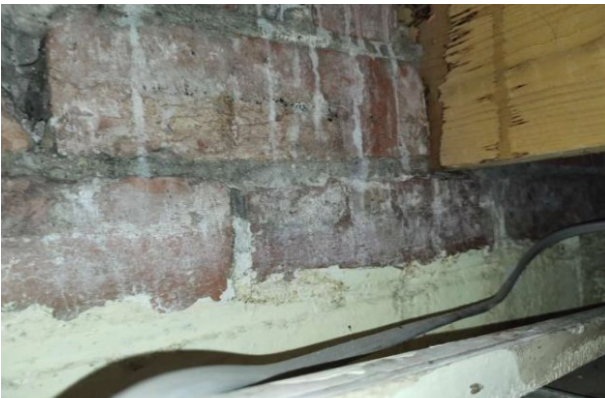
**Item 29 Ref: 21-36876-7**

The insulating board residue in Nursery Girls Toilet (Area 47) does not contain asbestos.

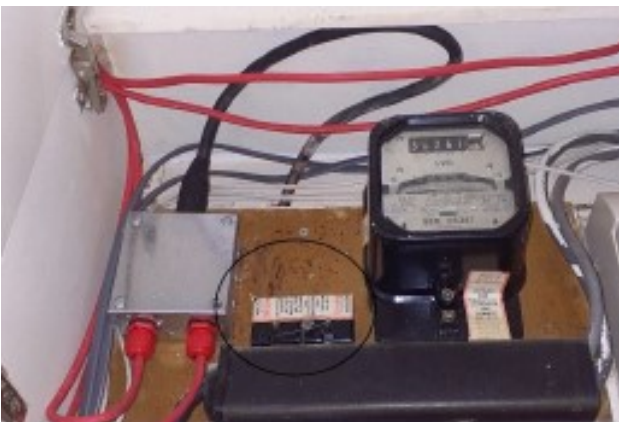
**Item 30 Ref: Presumed**

The textiles in the electric meter (Entrance Lobby G/01) are presumed to contain asbestos.

Any change in appearance should be reported to Property Services.

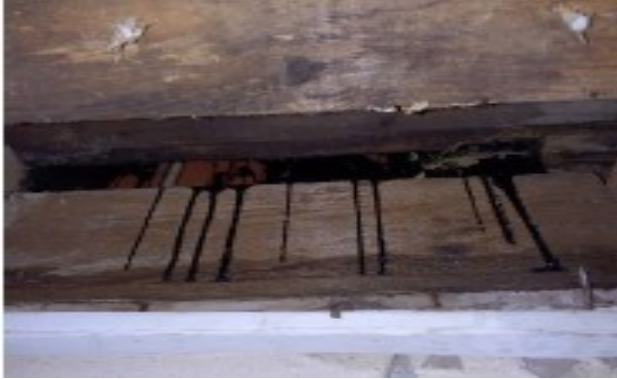
**Item 31 Ref: HD000490**

The bitumen overspill to timber beams in the ceiling void (Toilets G/06) does not contain asbestos.

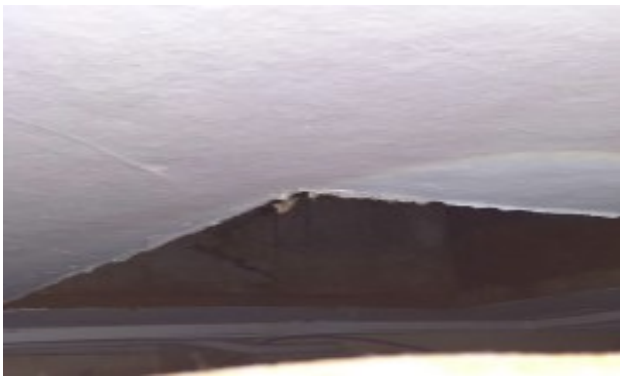
**Item 32 Ref: As HD000490**

The bitumen overspill to timber beams above fibroboard ceiling in the ceiling void (Toilets G/13) does not contain asbestos.

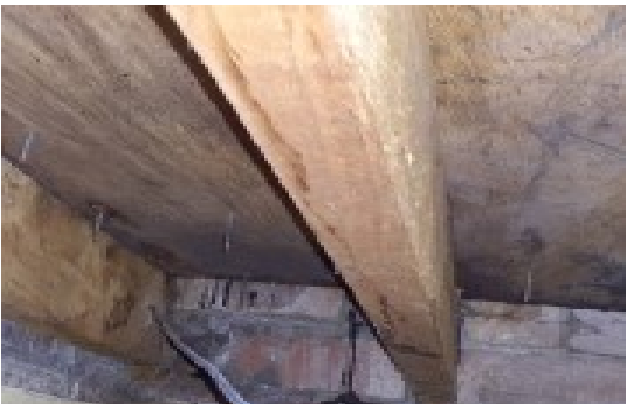
**Item 33 Ref: As HD000490**

The bitumen overspill to walls in the ceiling void (Toilets G/45) does not contain asbestos.

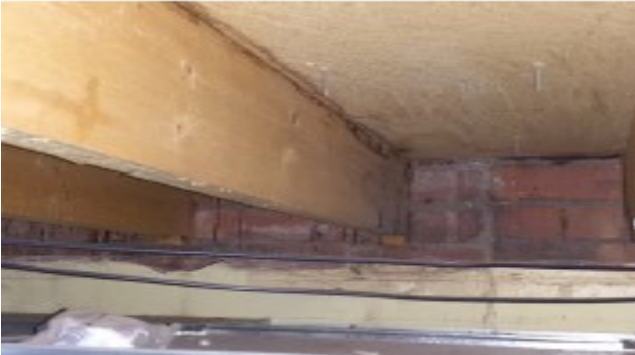
**Item 34 Ref: As HD000490**

The bitumen overspill to walls in the ceiling void (Toilets G/52) does not contain asbestos.
