ASBESTOS SURVEY REPORT FOR HALTWHISTLE PRIMARY ACADEMY,
PARK AVENUE, HALTWHISTLE, NORTHUMBERLAND, NE49 9BA

Asbestos Register for

**Haltwhistle Primary Academy, Park Avenue, Haltwhistle,
Northumberland, NE49 9BA**

Date: 23 March 2026

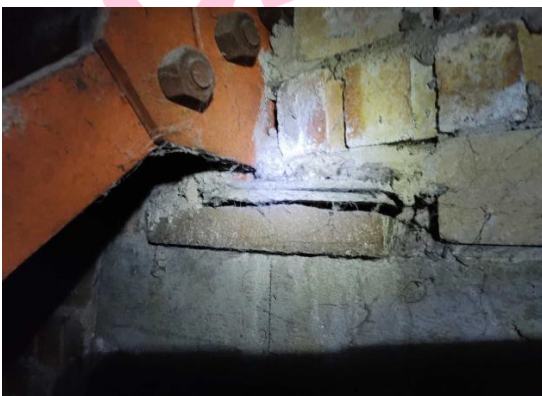
Item 3 Ref: 21-39567-2

The packers below steel joists within brick wall (Area 7/Loft Space 7) contain asbestos.

Any change in its appearance should be recorded and passed to Property Services.

Encapsulated May 2022 – continue to monitor

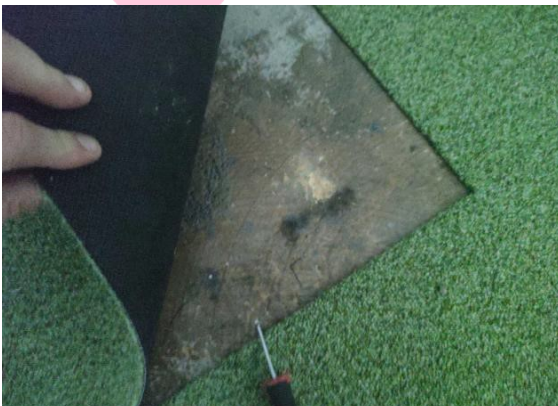
Item 6 Ref: 21-39567-4

The floor screed (Area 15/Library and Cupboard) does not contain asbestos.

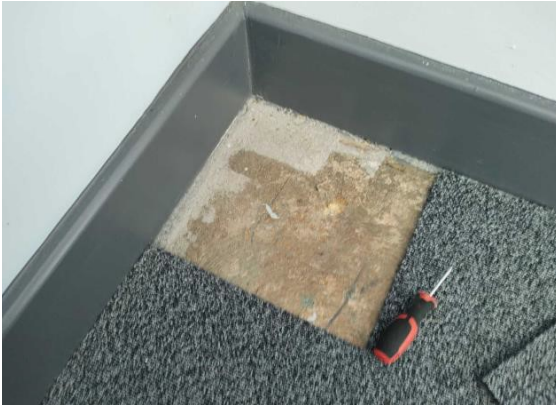
Item 7 Ref: 21-39567-5

The floor screed (Area 16/Classroom 3 and Cupboard) does not contain asbestos.

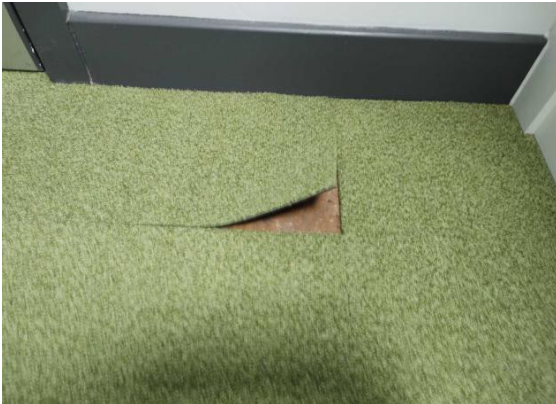
Item 8 Ref: 21-39567-5

The floor screed (Area 16/Classroom 3 and Cupboard) does not contain asbestos.

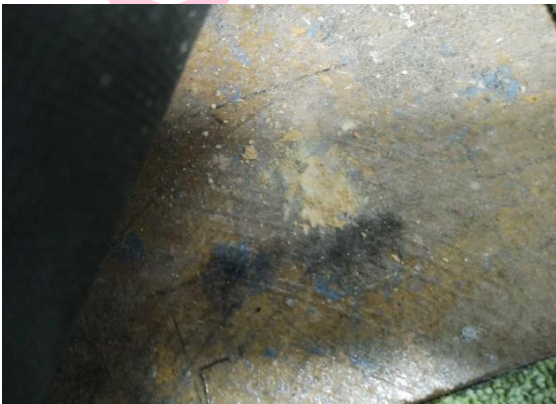
Item 9 Ref: 21-39567-5

The floor screed (Area 17/Classroom 4 and Cupboard) does not contain asbestos.

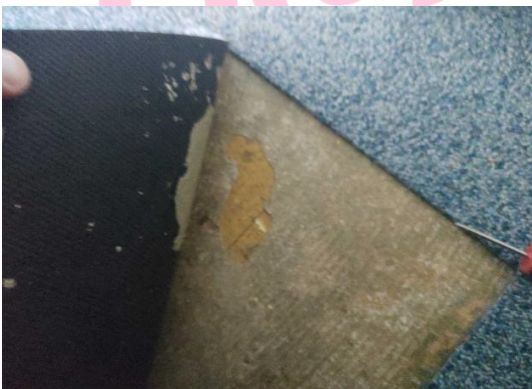
Item 12 Ref: 21-39567-6

The floor screed (Area 34/Library 2 and Cupboard) does not contain asbestos.

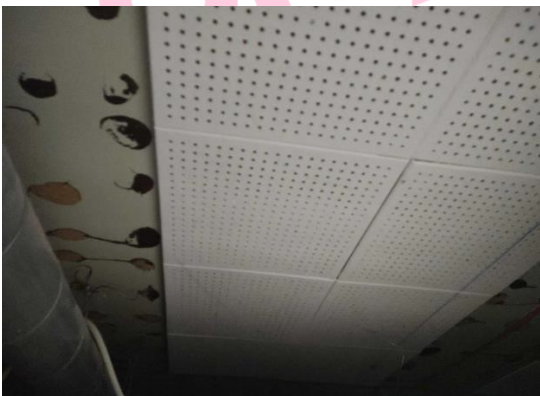
Item 15 Ref: 21-39567-9

The ceiling (Area 62/Pastoral Office) does not contain asbestos.

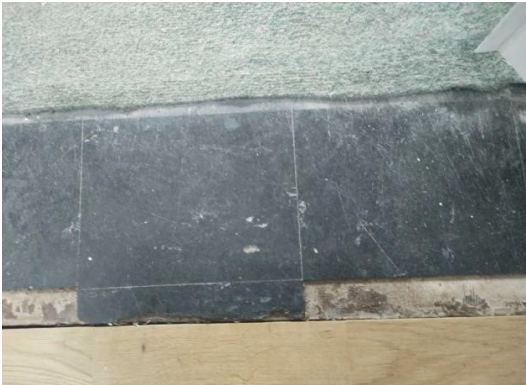
Item 17 Ref: 21-39567-11

The floor tiles and adhesive (Area 82/Medical Room) contain asbestos.

Any change in its appearance should be recorded and passed to Property Services.

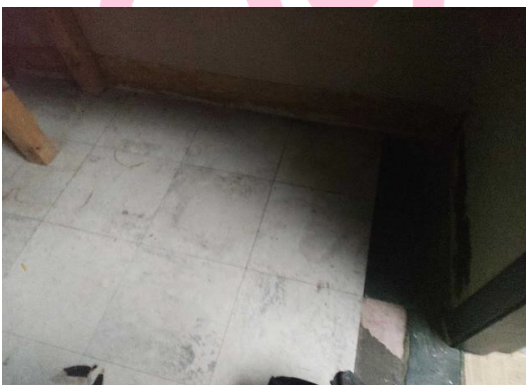
Item 18 Ref: 21-39567-12

The floor tiles and adhesive (Area 84/Store) contain asbestos.

Any change in its appearance should be recorded and passed to Property Services.

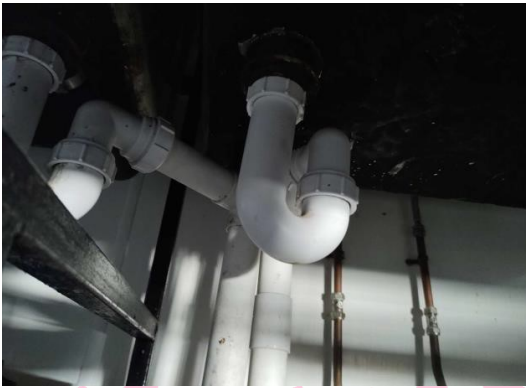
Item 20 Ref: 21-39567-14

The sink pad (Area 87/Kitchen) does not contain asbestos.

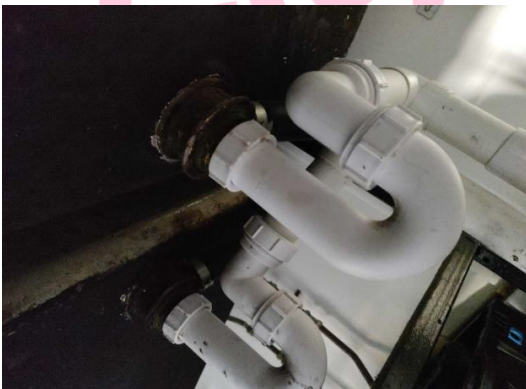
Item 21 Ref: 21-39567-15

- (Item 19) Ref: 21-39567-13 – Textured coated ceiling (Area 87/Kitchen) – Low Risk
- (Item 20) Ref: 21-39567-14 – Sink pad (Area 87/Kitchen) – No Risk
- (Item 21) Ref: 21-39567-15 – Gaskets to underside of Portland sinks (Area 87/Kitchen) – Medium Risk

The gaskets to underside of Portland sinks (Area 87/Kitchen) contain asbestos.

Any change in its appearance should be recorded and passed to Property Services.

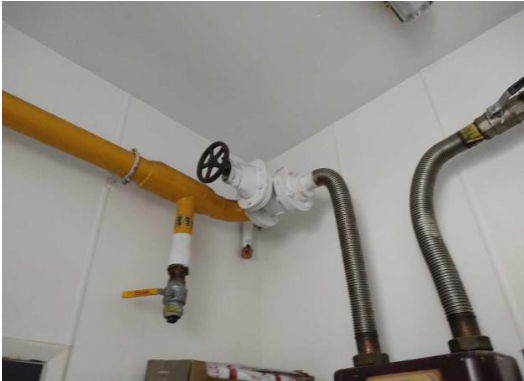
Item 22 Ref: 21-39567-16

The composite gasket to gas main flange (Area 90/Kitchen Store) contains asbestos.

Any change in its appearance should be recorded and passed to Property Services.

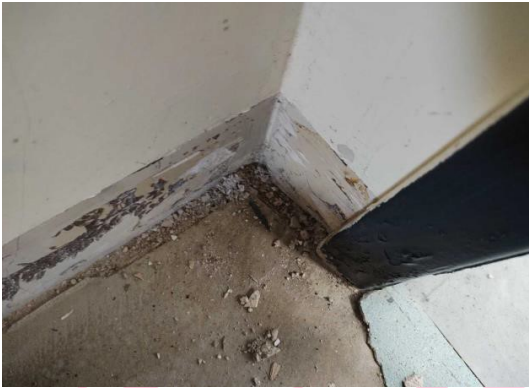
Item 23 Ref: 21-39567-17

The floor tiles and adhesive (Area 96/Drying Store) does not contain asbestos.

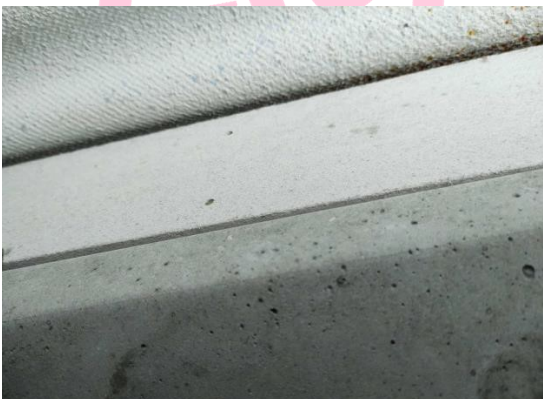
Item 24 Ref: 21-39567-18

The infill panels to top of wall (Area 104/Garage 1) do not contain asbestos.

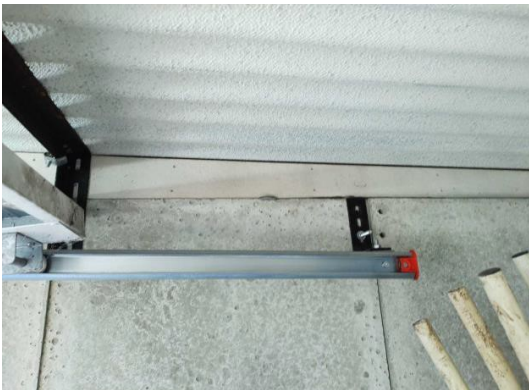
Item 26 Ref: 21-39567-18

The infill panels to top of wall (Area 106/Garage 3) do not contain asbestos.

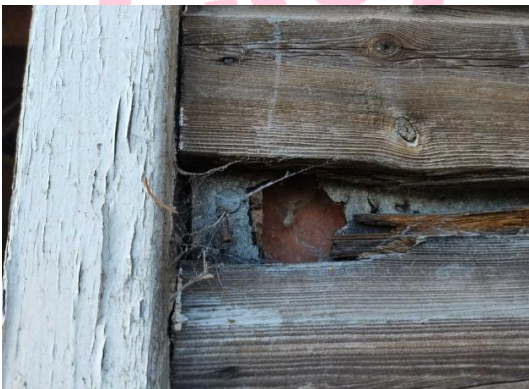
Item 27 Ref: 21-39567-19

The damp proof sheeting behind wood cladding to walls (Area 107/External Store) does not contain asbestos.

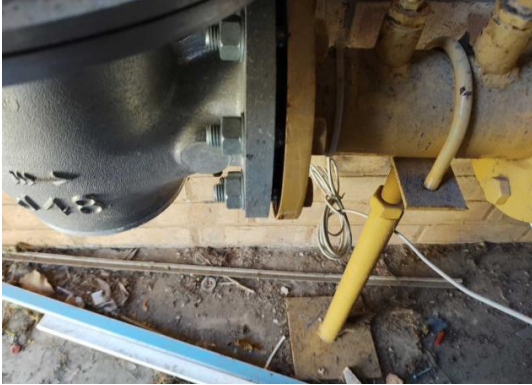
Item 28 Ref: 21-39567-20

The gasket to gas main flanges (Area 108/Gas inlet cupboard) does not contain asbestos.

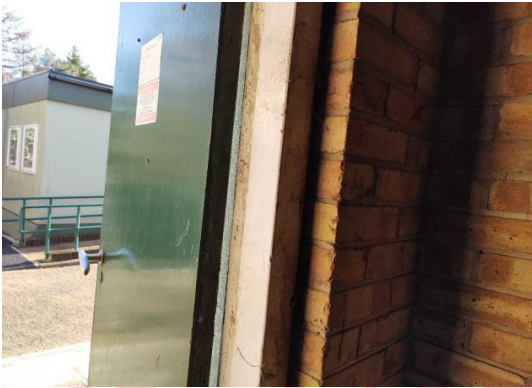
Item 29 Ref: 21-39567-27

The door frame sealant (Area 108/Gas inlet cupboard) contains asbestos.

Any change in its appearance should be recorded and passed to Property Services.

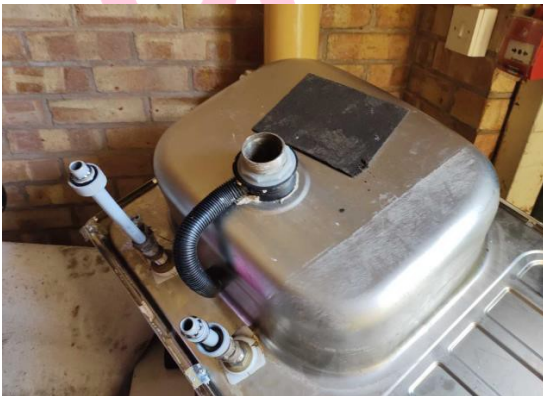
Item 30 Ref: 21-39567-28

The sink pad to redundant sink (Area 108/Gas inlet cupboard) does not contain asbestos.

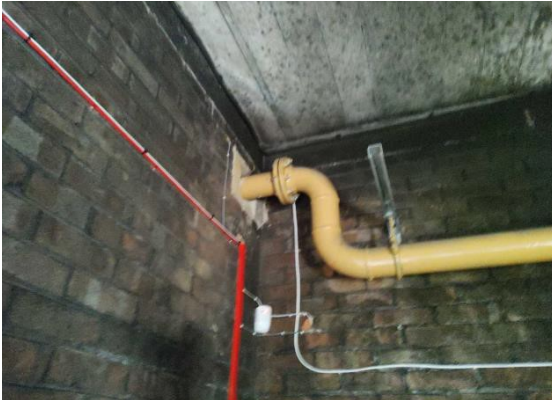
Item 31 Ref: 21-39567-20

The gasket to gas main pipe (Area 109/Vehicle store) does not contain asbestos.

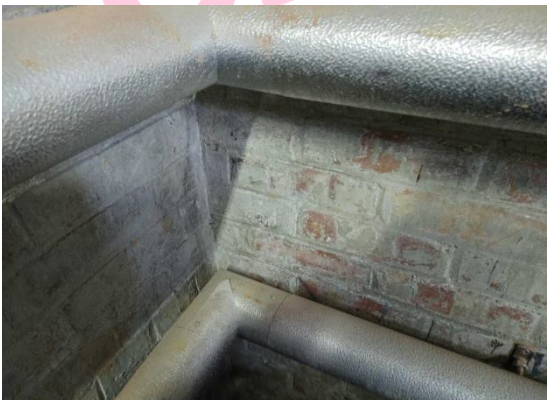
Item 33 Ref: 21-39567-21

The residue to wall 2 (Area 110/Boiler Room) does not contain asbestos.

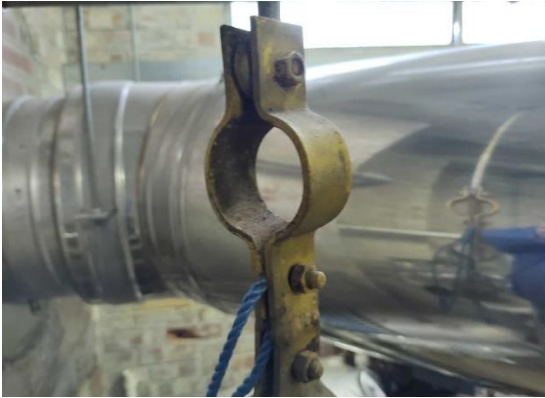
Item 37 Ref: 21-39567-25

The residue to yellow hanging pipe hanger (Area 110/Boiler Room) contains asbestos.

Removed May 2022

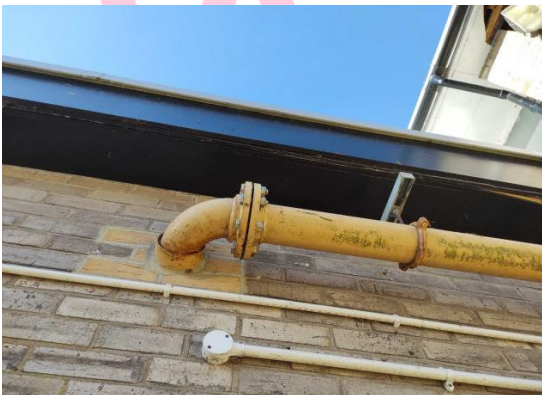
Item 39 Ref: 21-39567-20

The gasket to flange of gas mains pipe (Area 129/ External) does not contain asbestos.

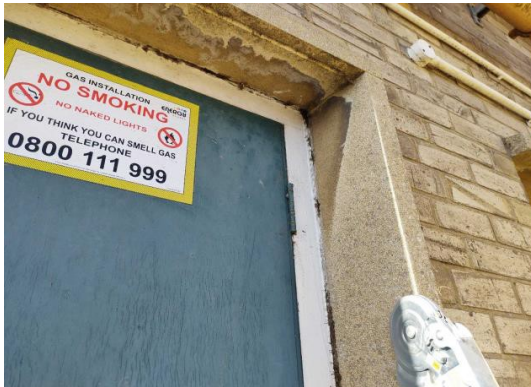
Item 40 Ref: 21-39567-27

The mastic to outside door of gas inlet cupboard (Area 129/External) contains asbestos.

Any change in its appearance should be recorded and passed to Property Services.

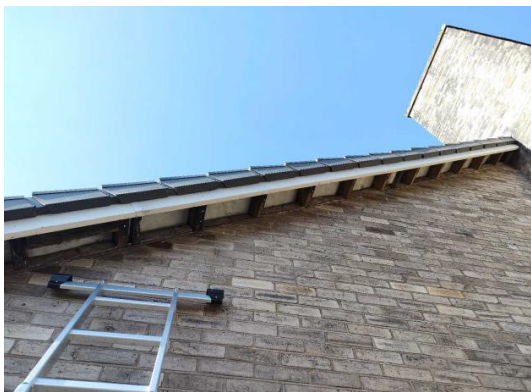
Item 41 Ref: 21-39567-29

The residue to nails to former gable end soffits of Children's centre (Area 129/External) does not contain asbestos.

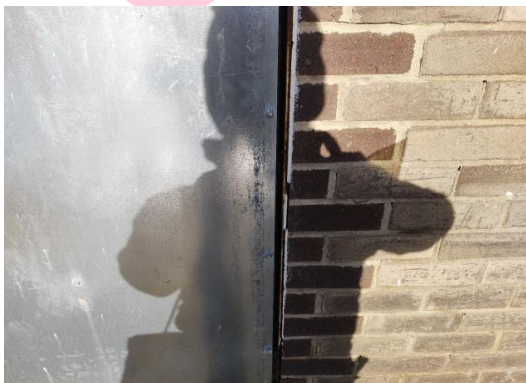
Item 42 Ref: 21-39567-30

The mastic to quad bike store doors (Area 129/External) does not contain asbestos.

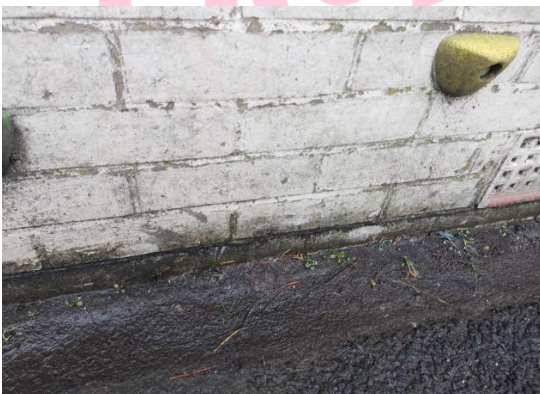
Item 45 Ref: 21-39567-33

The damp proof course to walls (Area 129/External) does not contain asbestos.

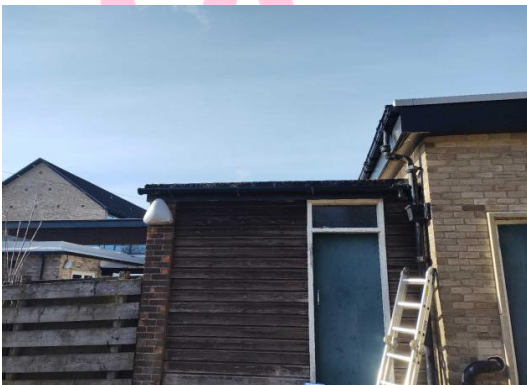
Item 48 Ref: 21-39567-32

The roof felt (bitumen) (Area 107/External Store) does not contain asbestos.
