ASBESTOS SURVEY REPORT FOR HASTINGS HILL ACADEMY, THORNEY CLOSE, SUNDERLAND, SR3 4LY.

Asbestos Register for Hastings Hill Academy

Date: 10th November 2025

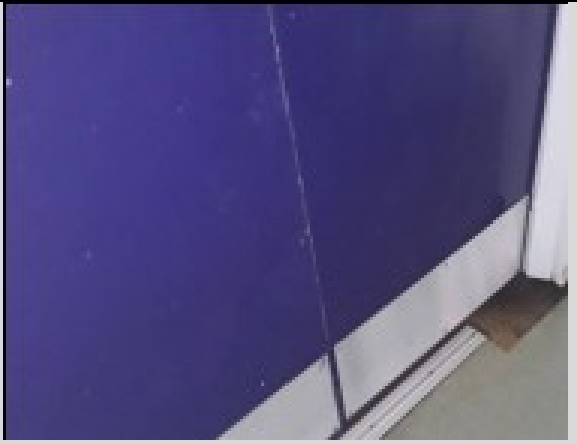
7	NZ001682	Wall skirting adhesive from removed skirting under modern skirting	Dining Room G/003	No Risk

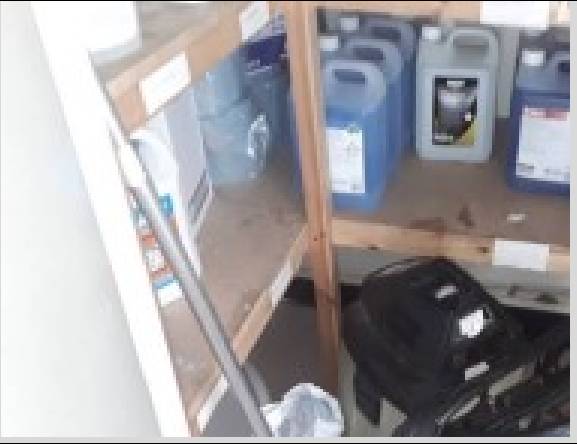
8	NZ001683	Pipework insulation wrap to pipework	Kitchen Cleaners Cupboard G/004	No Risk

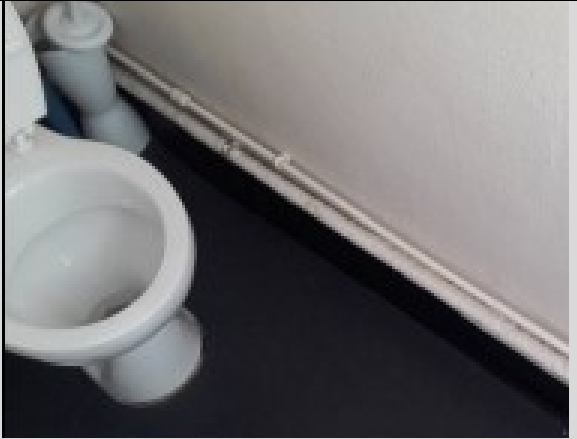
9	As NZ001683	Pipework insulation wrap to pipework	Kitchen Toilets G/005	No Risk

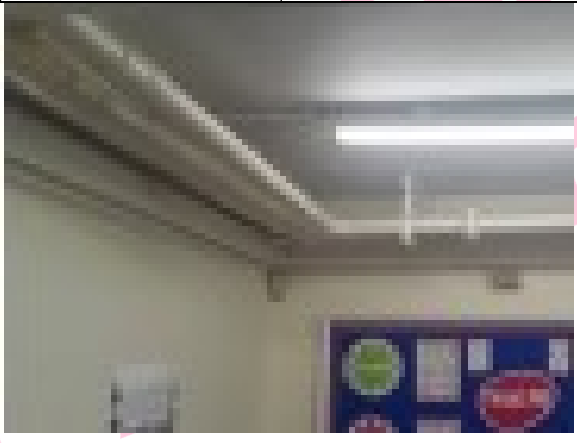
23	NZ001689	Pipework Gasket	Corridor G/019	Very Low Risk – 12 monthly

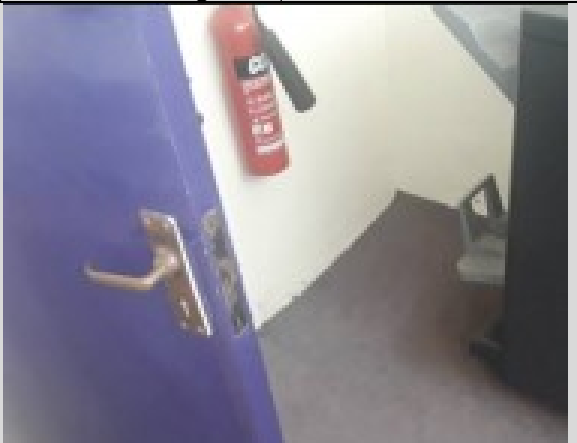
24	As NZ001682	Wall skirting adhesive from removed skirting	Store Room Music G/020	No Risk

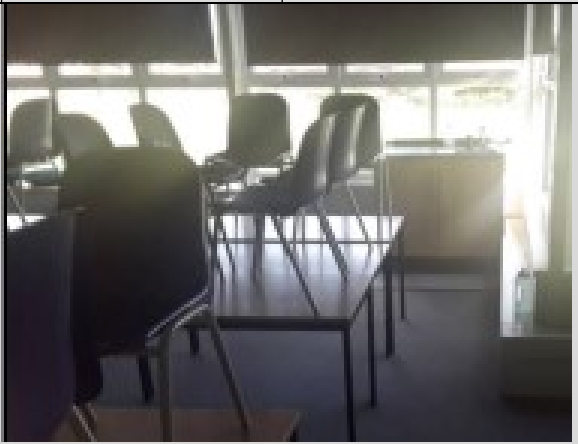
41	As NZ001694	Under sink mat	Classroom G/035	No Risk

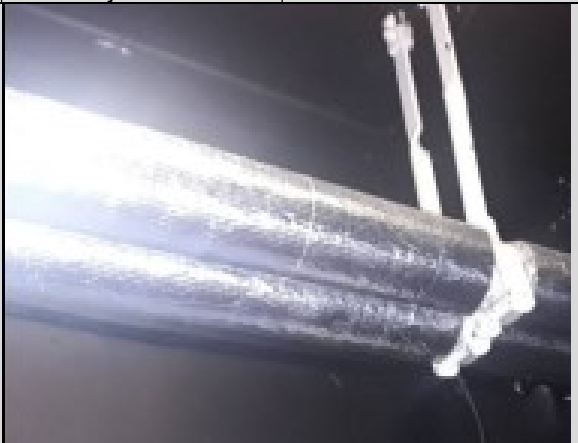
42	NZ001695	Pipework insulation remnants to pipework under modern insulation samples taken from several joints	Store Room G/036	No Risk

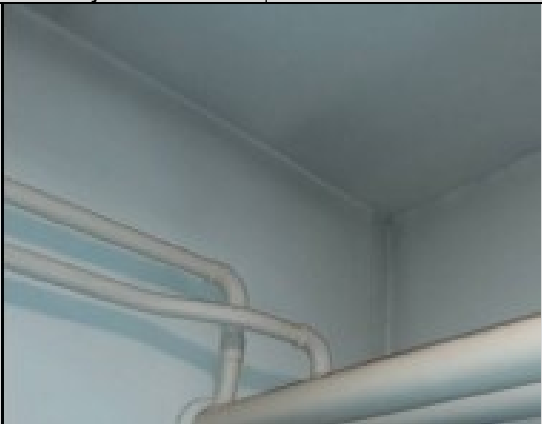
65	NZ001705	Pipework insulation remnants to pipework under modern insulation samples taken from several joints	Store Room G/047	No Risk

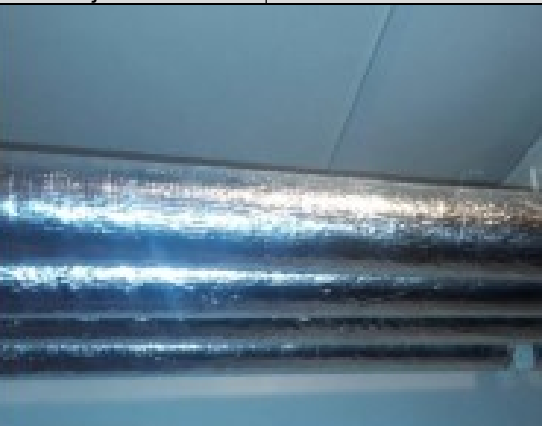
66	As NZ001705	Pipework insulation remnants to pipework under modern insulation samples taken from several joints	Hub/Network Room G/049	No Risk

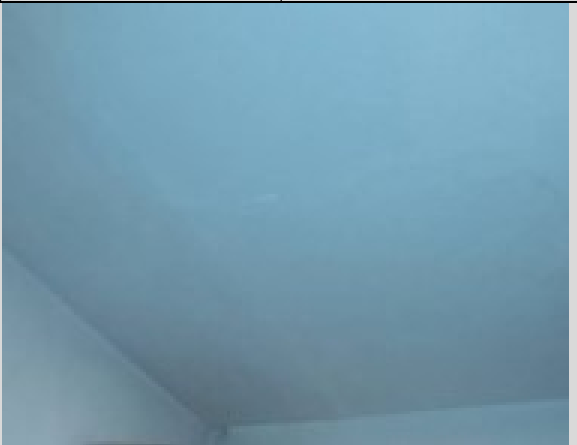
67	As NZ001690	Ceiling Coating	Hub/Network Room G/049	No Risk

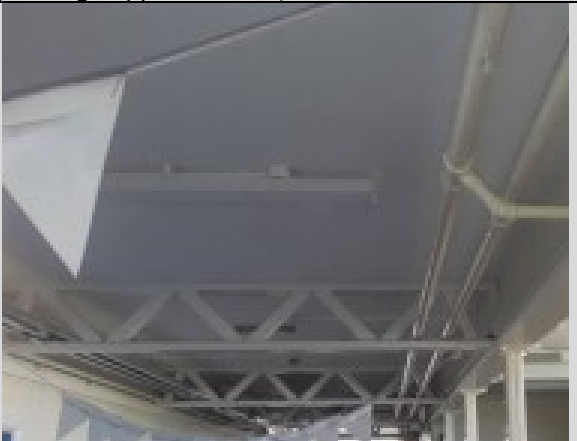
69	NZ001707	Pipework insulation remnants to pipework and metal ceiling supports	Corridor including cloakrooms G/050	No Risk

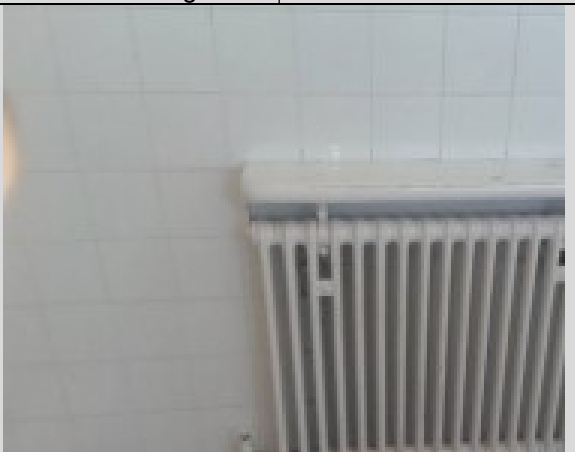
70	As NZ001678	Shelving rear panel above radiator behind shelving	Toilets Female G/053	No Risk

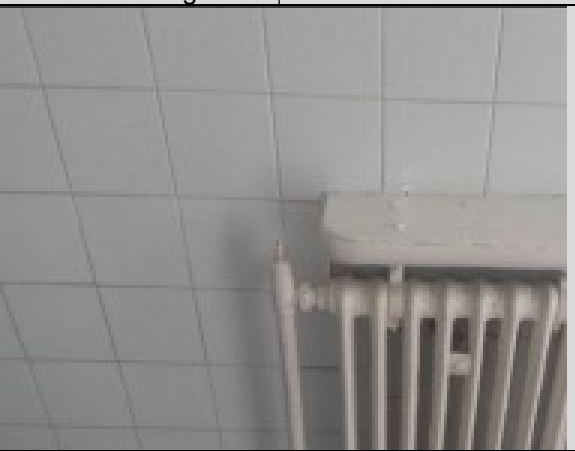
71	As NZ001678	Shelving rear panel above radiator behind shelving	Toilets Male G/054	No Risk

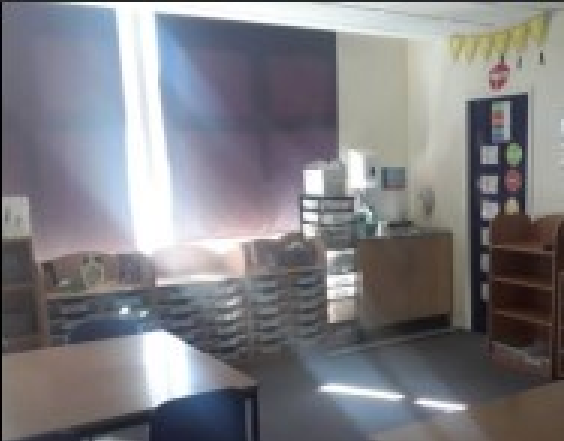
77	As NZ001700	Under sink mat	Classroom G/057	No Risk

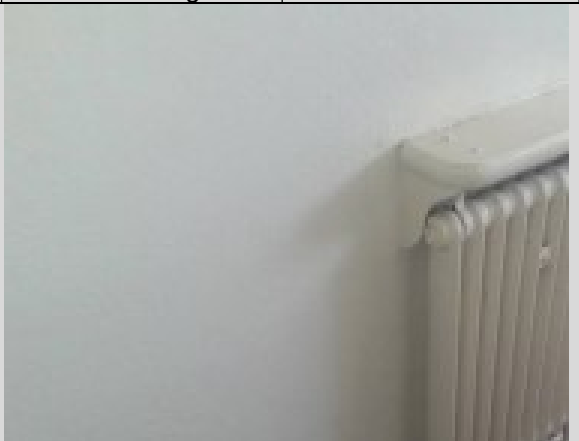
81	NZ001708	Shelving rear panel above radiator behind shelving	Toilets Male G/060	No Risk

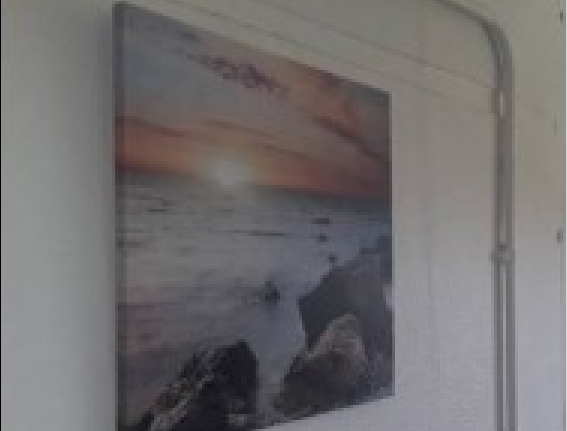
82	NZ001709	Wall coating	Toilets Male G/060	No Risk

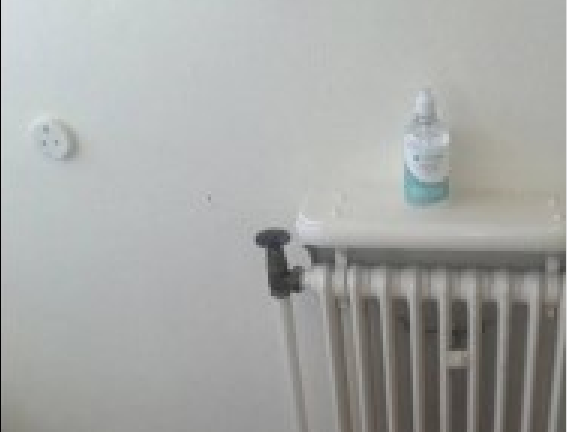
83	As NZ001708	Shelving rear panel above radiator behind shelving	Toilets Female G/063	No Risk

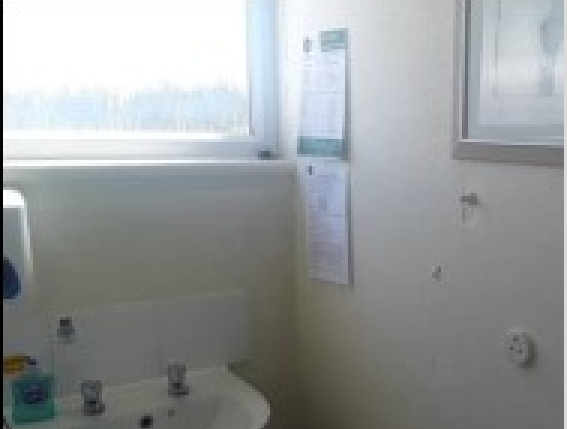
84	As NZ001709	Wall coating	Toilets Female G/063	No Risk

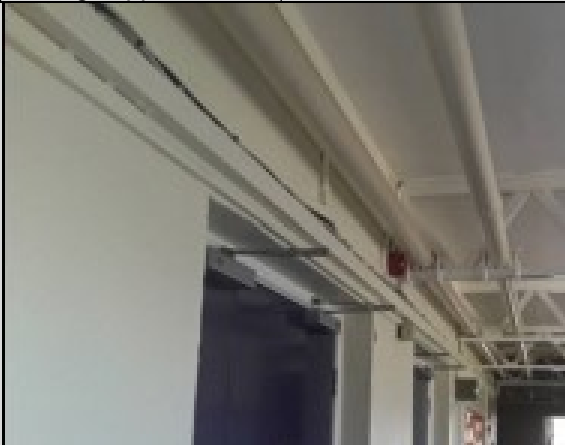
92	NZ001712	Pipework insulation remnants to pipework and metal ceiling supports	Corridor G/066	No Risk

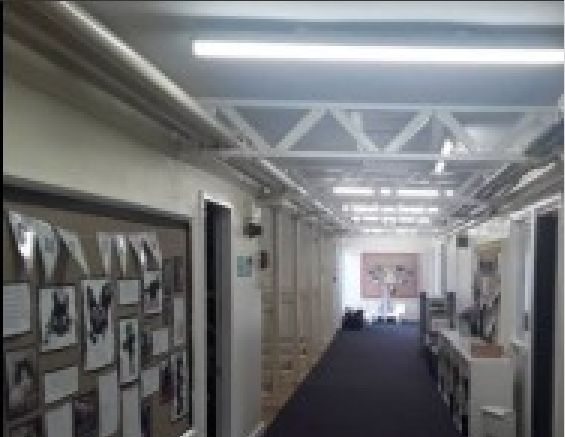
100	As NZ001714	Wall coating	Corridor including cloakrooms G/078	No Risk

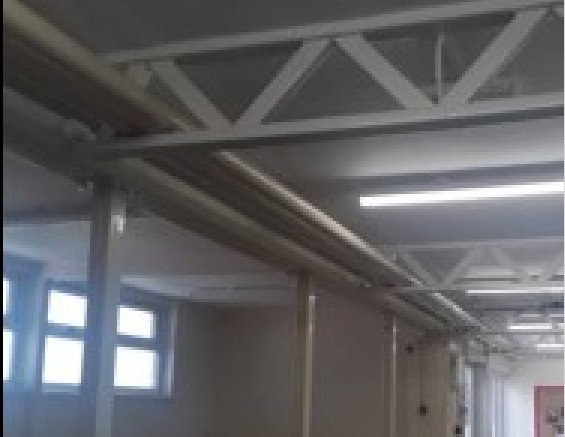
101	NZ001715	Pipework insulation remnants to pipework and metal ceiling supports	Corridor including cloakrooms G/078	No Risk

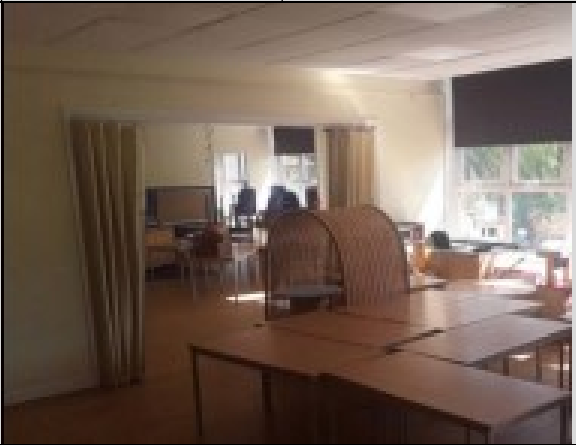
115	As NZ001722	Under sink mat	Classroom G/091	No Risk

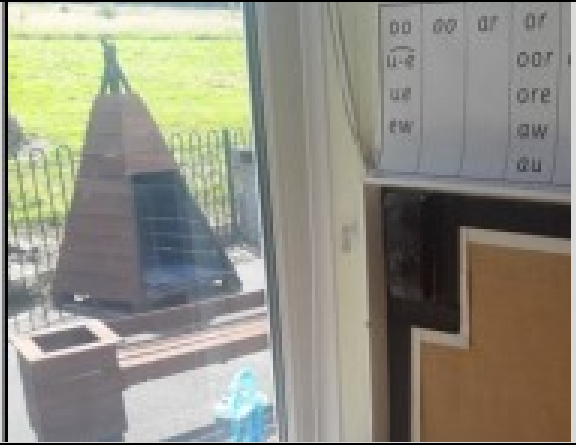
116	As NZ001687	Electrical Services Heater Switch	Classroom G/091	No Risk

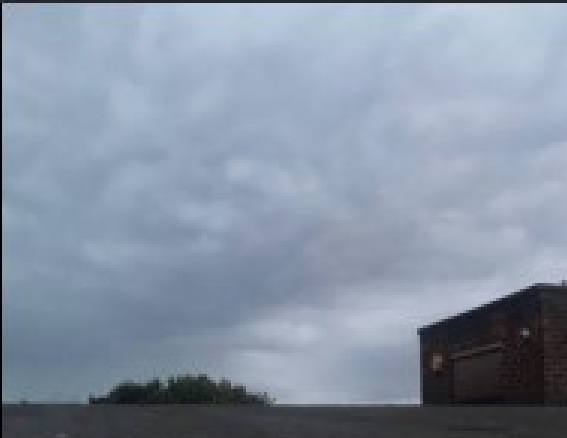
139	NZ001727	Window putty seal to tank room windows metal frames	External E/001	No Risk

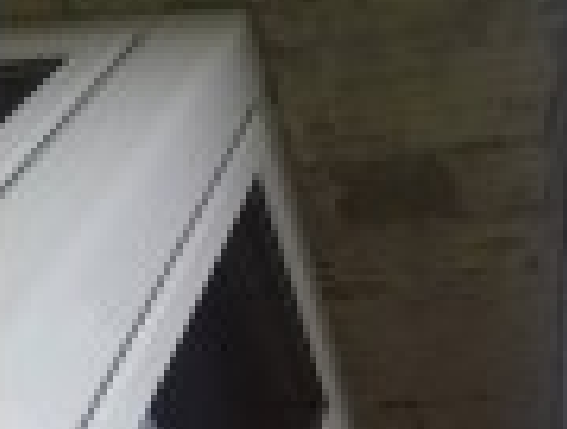
140	NZ001728	Soffits to lower and upper roof areas	External E/001	Very Low Risk – 12 monthly

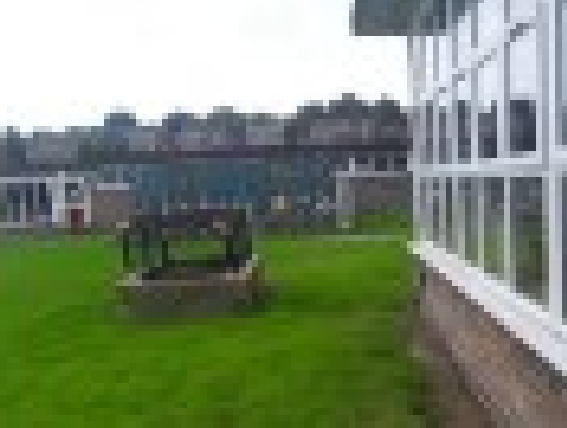
141	NZ001729	Debris/Residue imbedded in ground presumed to be from removed damaged soffits	External E/001	Low Risk – 6 monthly

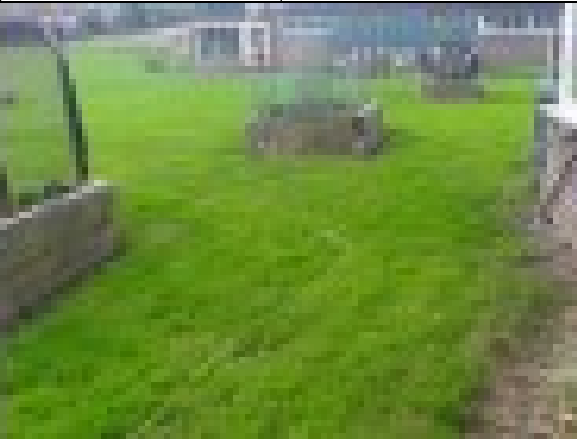
142	NZ001730	Debris/residue imbedded in ground around classroom area	External E/001	Very Low Risk – 12 monthly

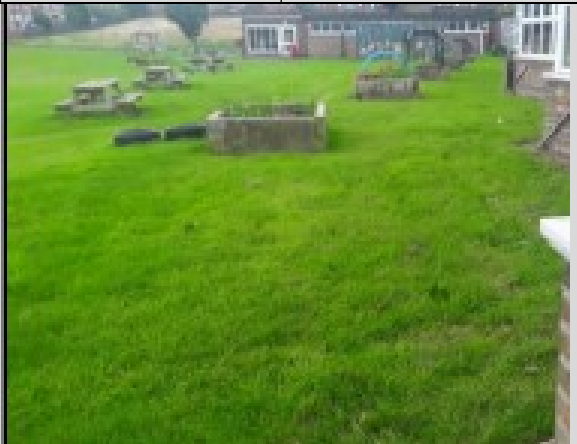
143	NZ001731	Debris/Residue embedded in ground presumed to be from removed windows	External E/001	No Risk

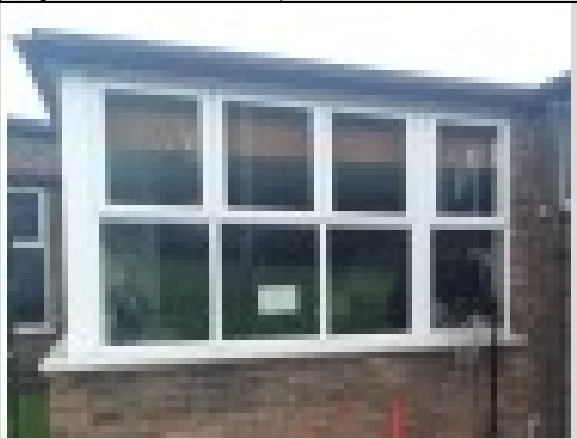
144	NZ001745	Rainwater goods bottom section adjacent kitchen	External E/001	Removed February 2025

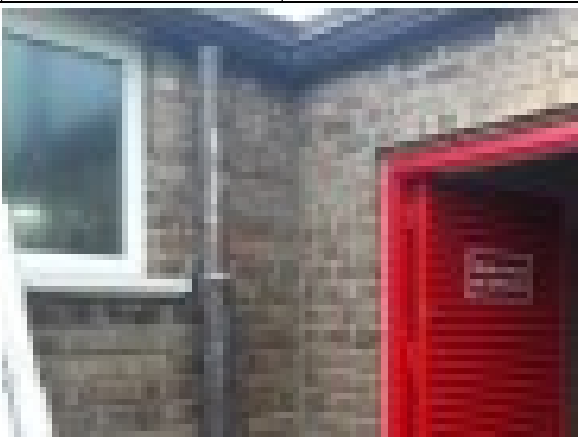
160	As NZ001738	Damp proof course around door frame	Boiler Room 2 E/003	Very Low Risk – 12 monthly

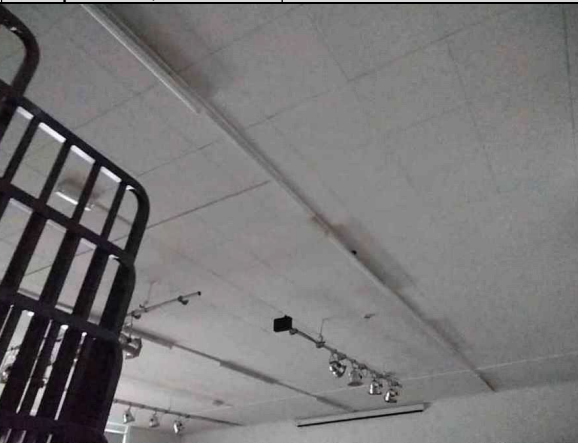
161	DC005125	Ceiling Tile - Suspended, Solid	Main Hall Room G/016	No Risk

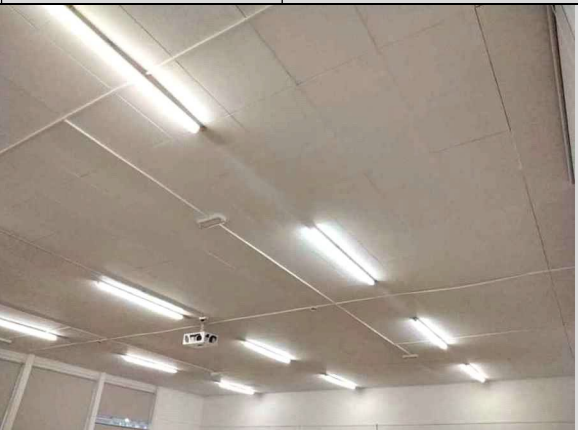
162	As DC005125	Ceiling Tile - Suspended, Solid presumed same due to height restrictions	Main Hall Room G/076	No Risk
