ASBESTOS SURVEY REPORT FOR WELBECK ACADEMY, FLODDEN STREET, WALKER, NEWCASTLE, NE6 2QP

Asbestos Register for Welbeck Academy

Date: 09 May 2025

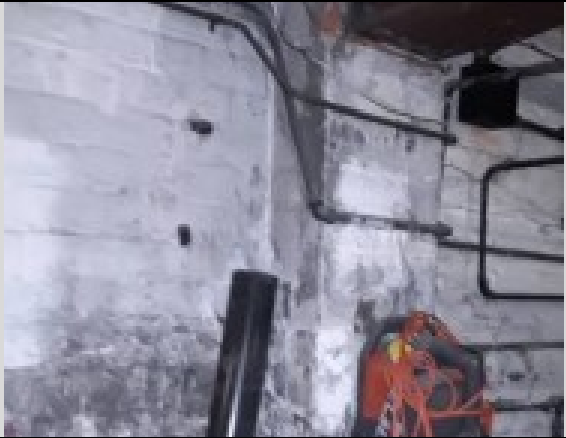
2	NZ001808	Debris to left hand wall	Boiler room north Z1/001	No Risk

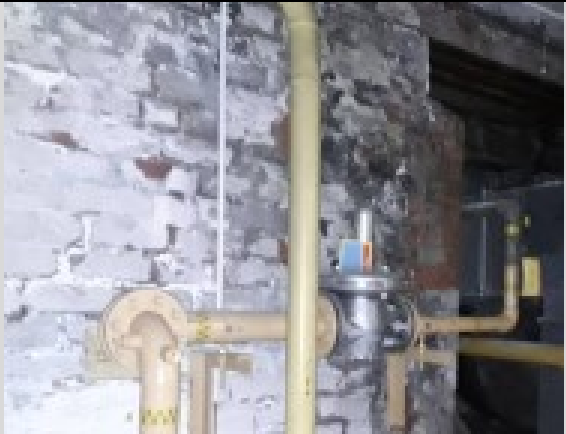
3	NZ001809	Debris to rear wall	Boiler room north Z1/001	No Risk

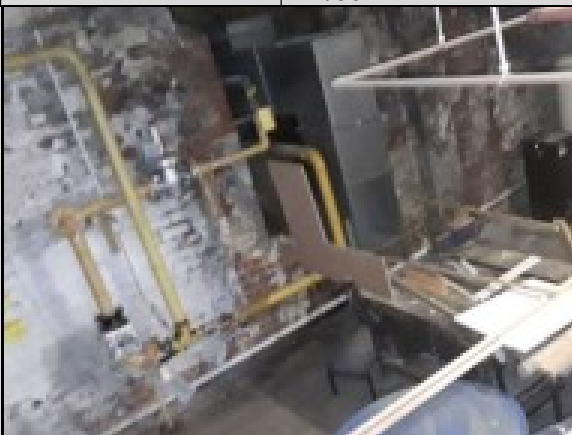
6	NZ001812	Debris to floor	Boiler room north Z1/001	No Risk

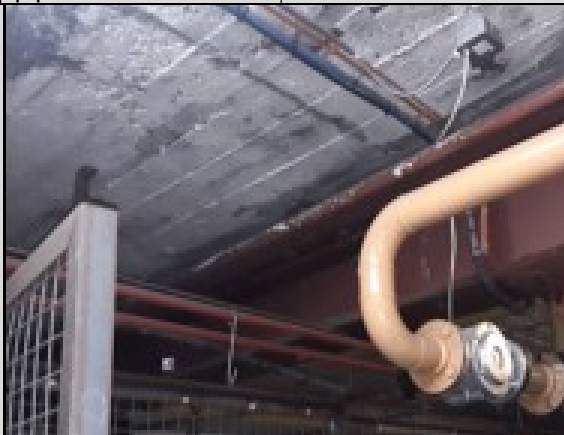
7	NZ001813	Pipework gaskets to new boilers and gas pipes	Boiler room north Z1/001	No Risk

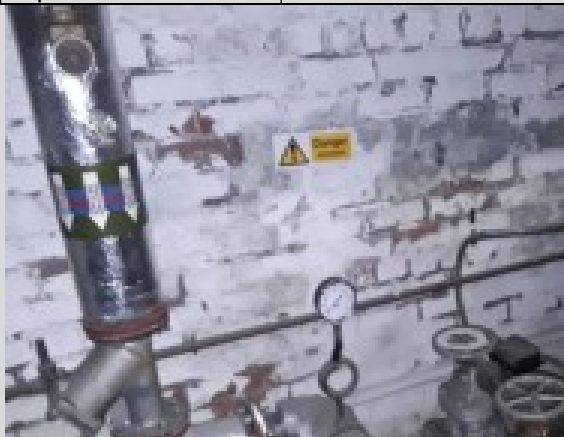
9	NZ001815	Pipework gaskets redundant gasket on top of old valves	Boiler room north Z1/001	No Risk

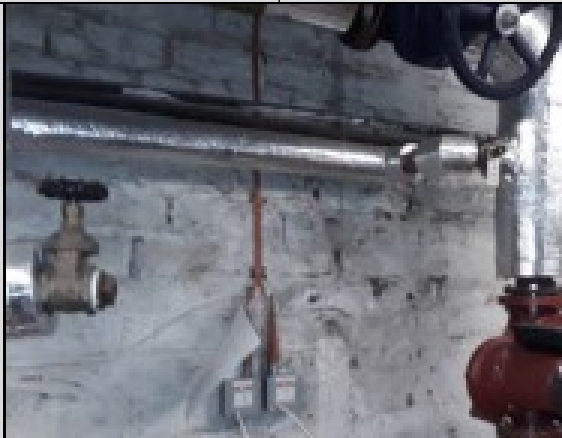
11	NZ001816	Debris to entrance wall	Boiler room South Z1/003	No Risk

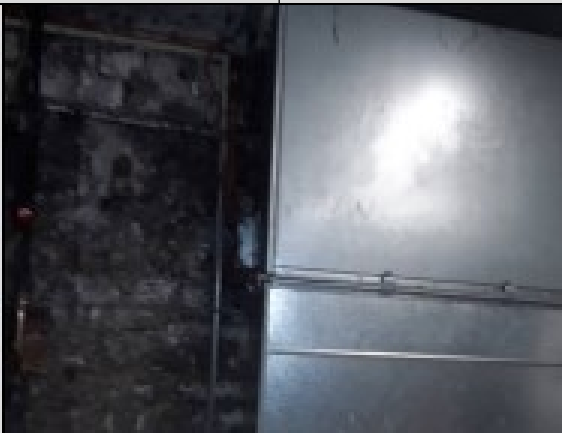
12	NZ001817	Debris to left hand wall	Boiler room South Z1/003	No Risk

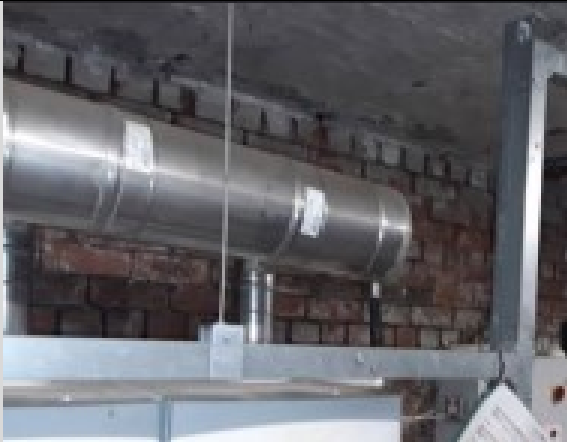
13	NZ001818	Debris to rear wall	Boiler room South Z1/003	No Risk

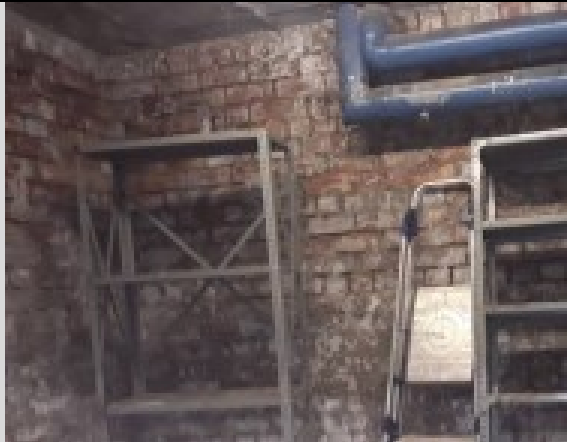
14	NZ001819	Debris to right wall	Boiler room South Z1/003	No Risk

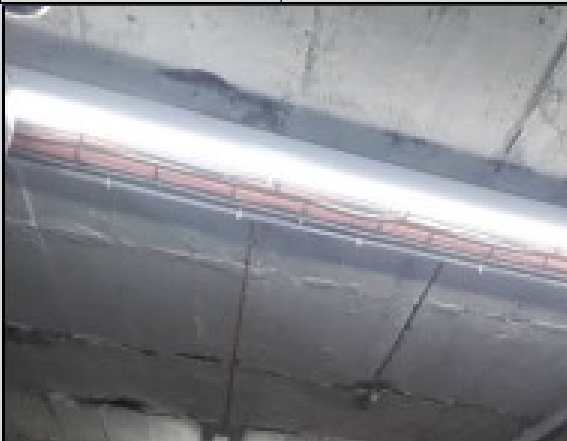
15	NZ001820	Debris to ceiling	Boiler room South Z1/003	No Risk

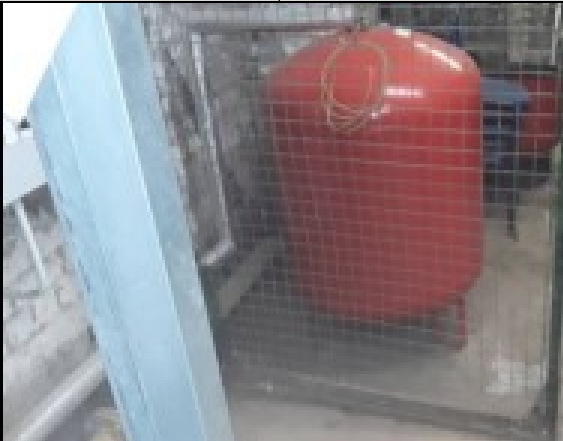
16	NZ001821	Debris to floor	Boiler room South Z1/003	No Risk

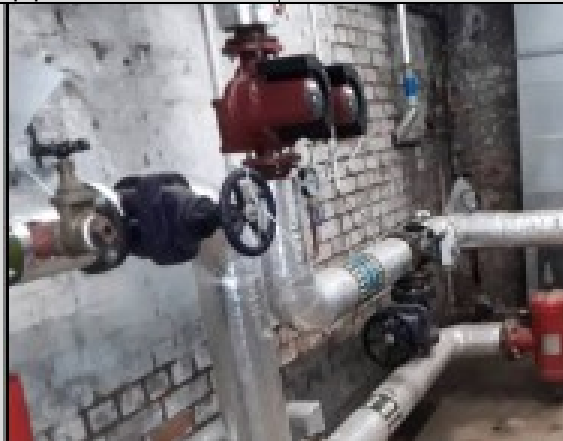
17	NZ001822	Pipework gaskets to new boilers and gas pipes	Boiler room South Z1/003	No Risk

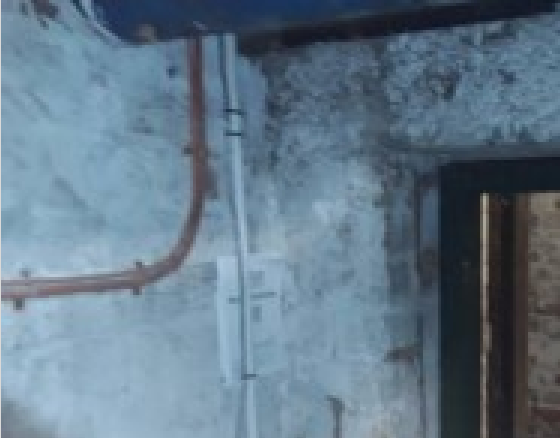
19	NZ001823	Door seal gasket remnants from removed door frame	Boiler room South Z1/003	No Risk

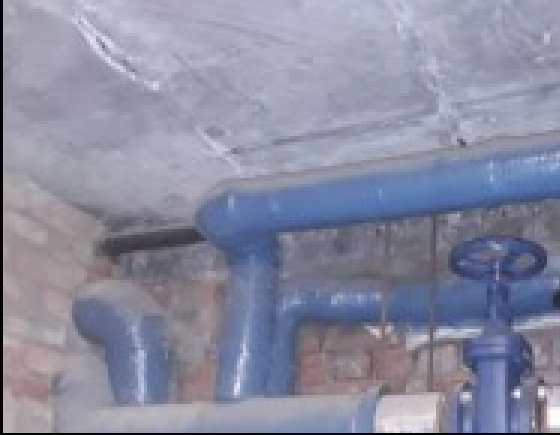
20	NZ001824	Pipework Gaskets	Gas inlet room Z1/004	No Risk

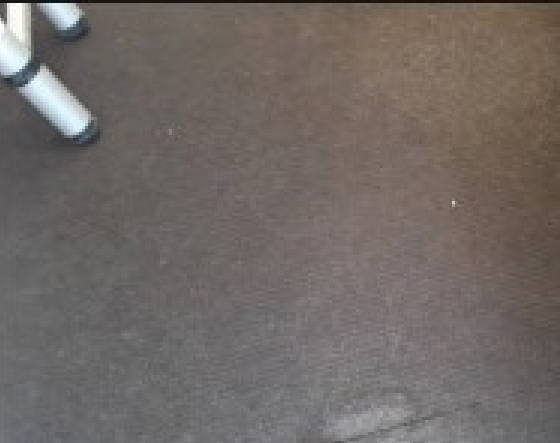
21	NZ001784	Floor adhesive under modern screed	Entrance Hall/Foyer/Lobby G/001	No Risk

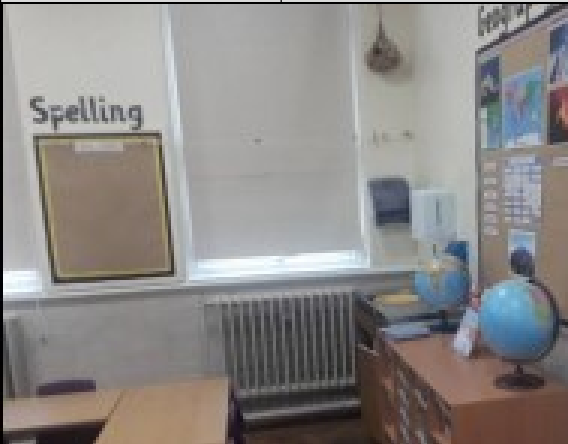
37	NZ001789	Under Sink Mat	Classroom G/033	No Risk

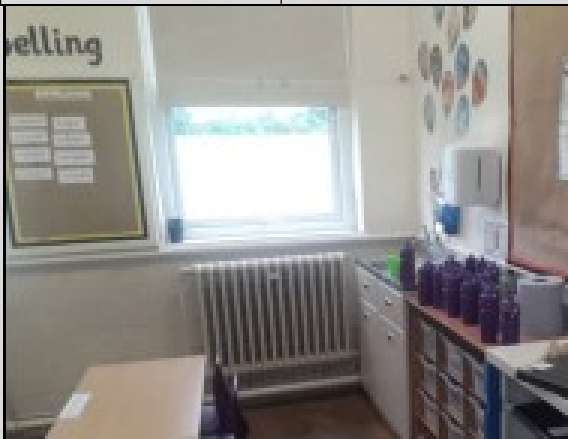
39	As NZ001789	Under Sink Mat	Classroom G/034	No Risk

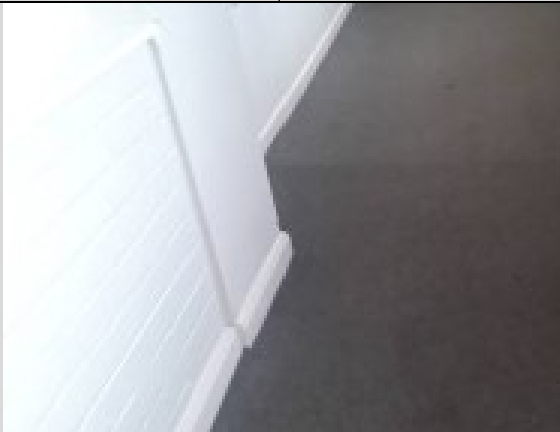
</div>				
42	NZ001790	Floor adhesive under carpet and modern screed	Corridor G/037	No Risk

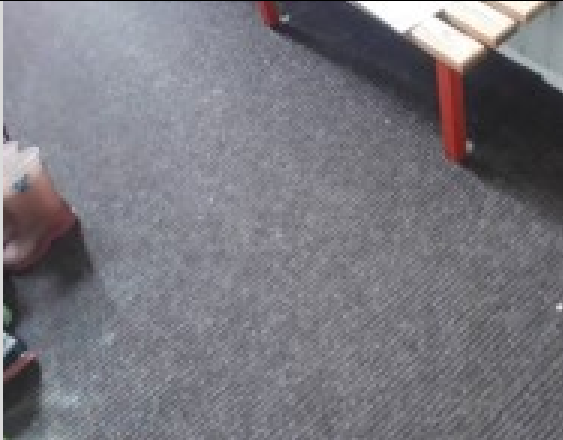
56	As NZ001794	Floor adhesive under carpet and modern screed	Corridor G/068	No Risk

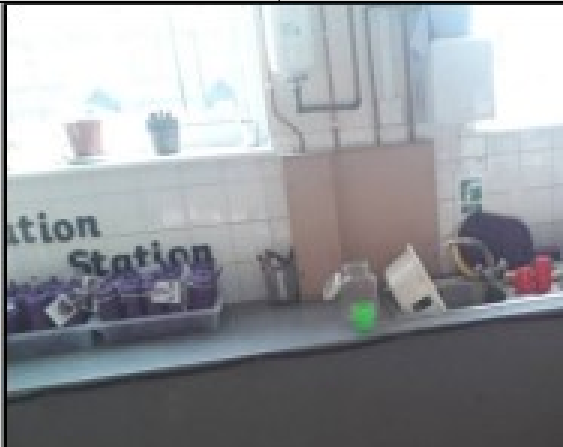
57	As NZ001793	Under sink mat	Classroom G/070	No Risk

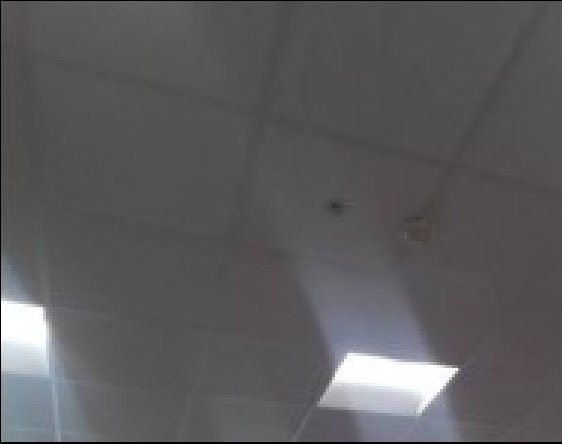
67	As NZ001797	Ceiling void - Ceiling above	Classroom 1/024	No Risk

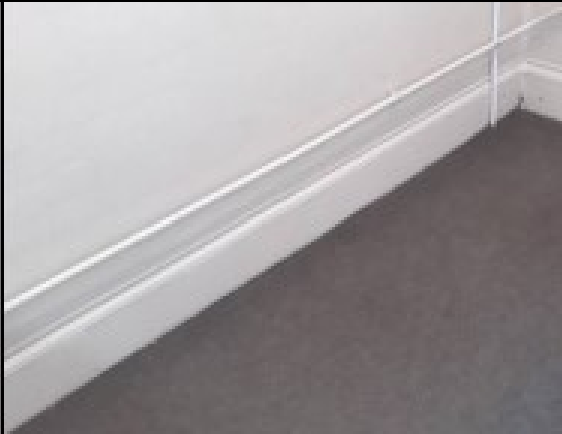
69	NZ001803	Floor tile with adhesive	Landing 1/025	No Risk

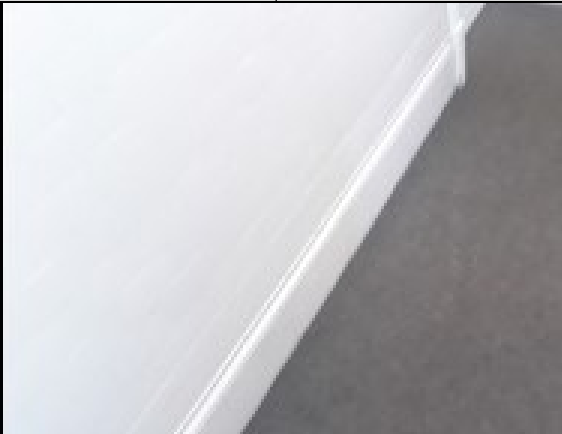
</div>				
72	As NZ001803	Floor tile with adhesive	Landing 1/035	No Risk

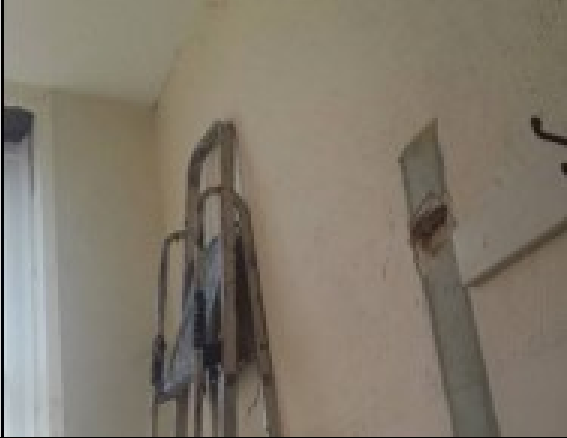
73	NZ001805	Wall coating	Store Room 1/040	No Risk

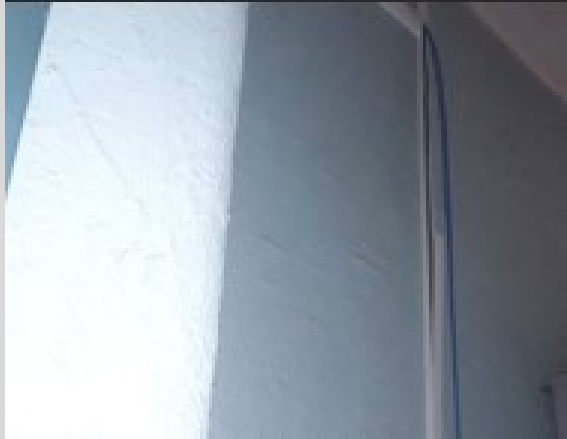
74	As NZ001805	Wall coating	Store Room restricted due to stored items 1/041	No Risk

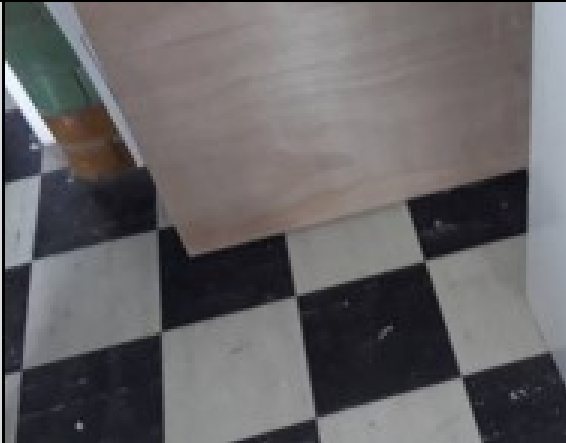
</div>				
77	NZ001799	Floor – tile with adhesive under	Hallway MZ/002	No Risk

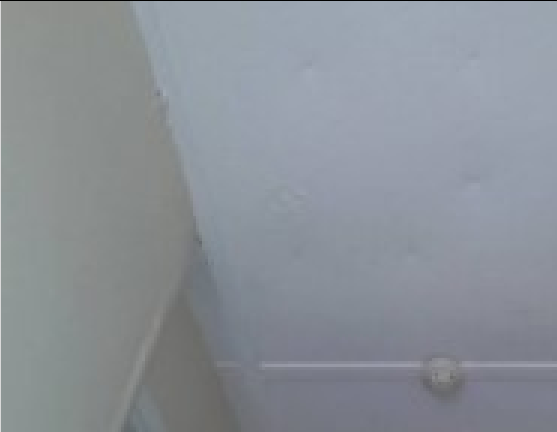
</div> <div> <div>Photo 2: Close Up</div>   </div>				
84	As NZ001797	Ceiling	Landing MZ/010	No Risk

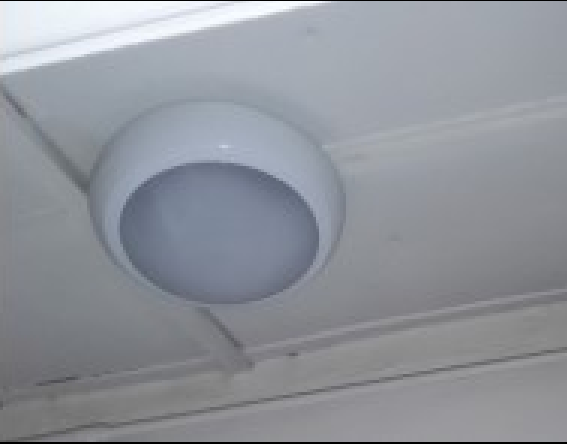
91	As NZ001797	Ceiling	Store Room MZ/014	No Risk

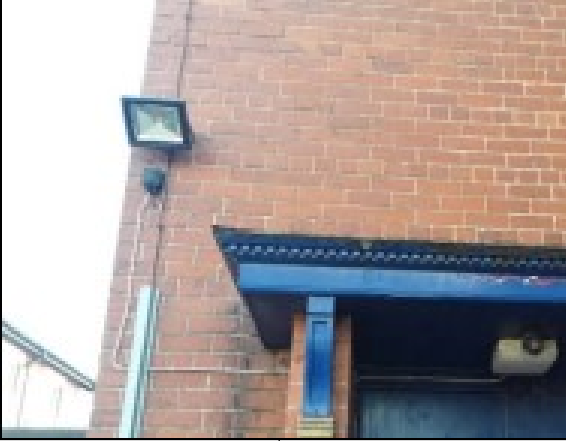
</div>				
95	NZ001826	Roof felt to canopy x 2	External E/001	No Risk

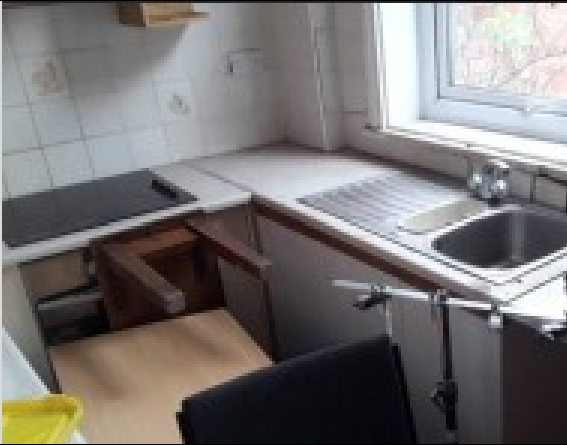
103	NZ001832	Under sink mat	Caretakers House Kitchen G/005	No Risk

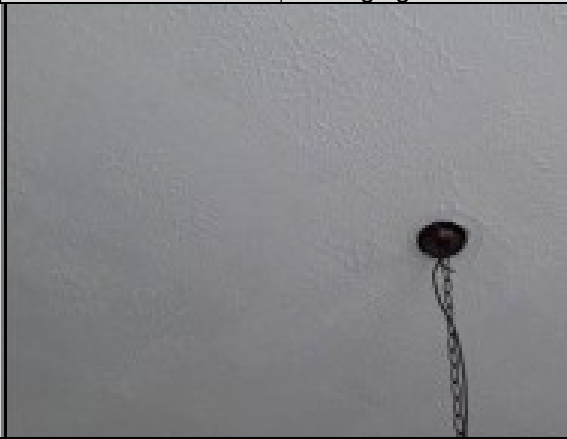
104	NZ001833	Ceiling coating	Caretakers House Living room/lounge limited inspection within due to tenants belongings G/007	No Risk
