ASBESTOS SURVEY REPORT FOR WELBECK ACADEMY, FLODDEN STREET, WALKER, NEWCASTLE, NE6 2QP

Asbestos Register for Welbeck Academy

Date: 04 March 2026

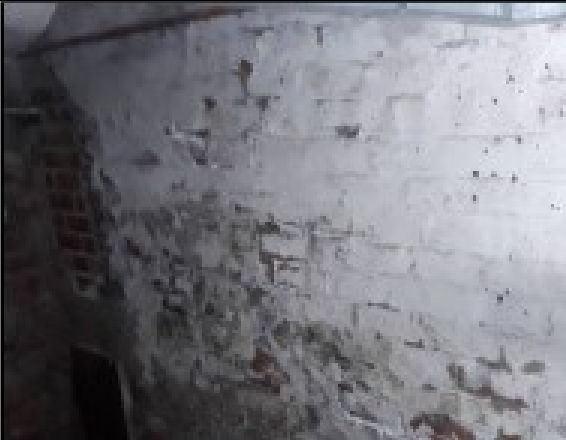
| 1 | NZ001807 | Debris to entrance wall | Boiler room north Z1/001 | No Risk |

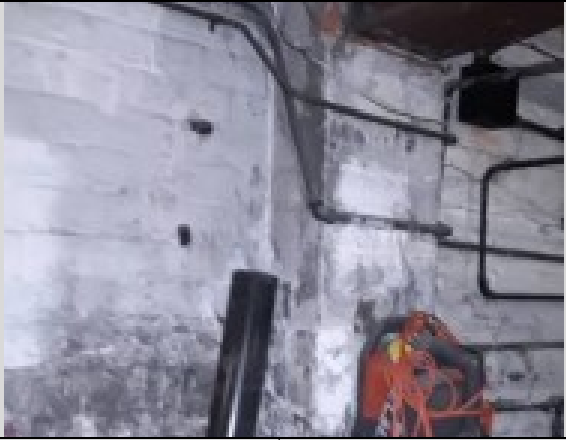
| 2 | NZ001808 | Debris to left hand wall | Boiler room north Z1/001 | No Risk |

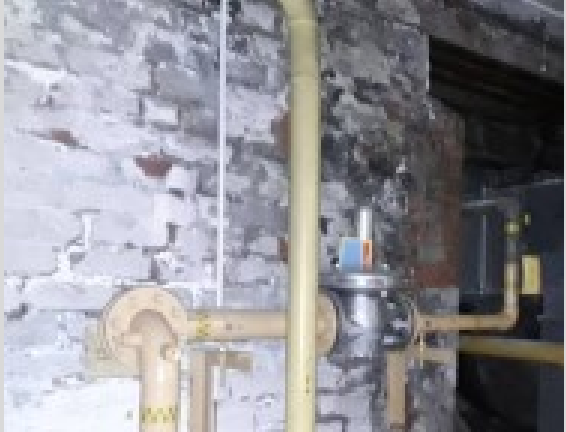
| 3 | NZ001809 | Debris to rear wall | Boiler room north Z1/001 | No Risk |

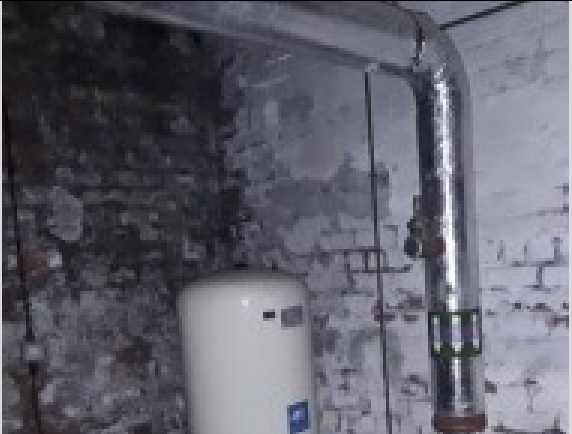
| 4 | NZ001810 | Debris to right wall | Boiler room north Z1/001 | No Risk |

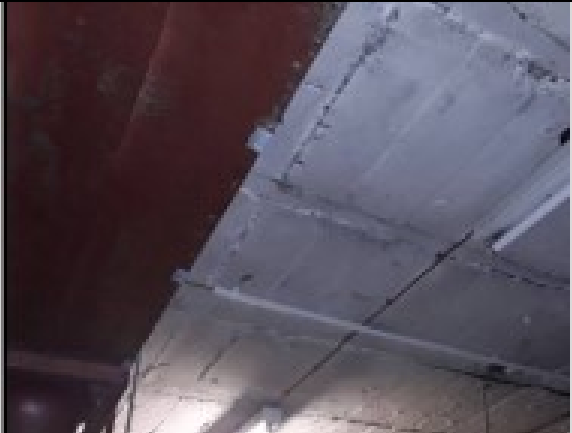
| 5 | NZ001811 | Debris to ceiling | Boiler room north Z1/001 | No Risk |

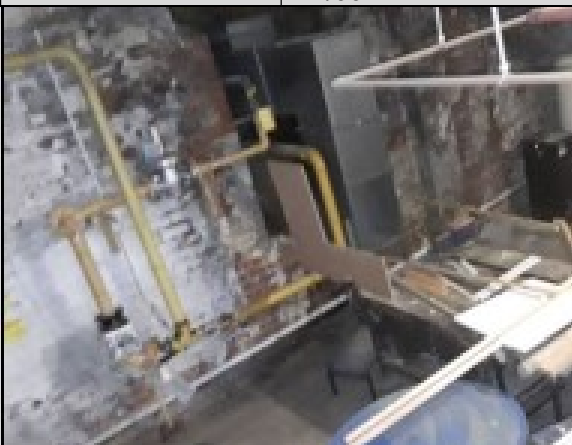
| 6 | NZ001812 | Debris to floor | Boiler room north Z1/001 | No Risk |

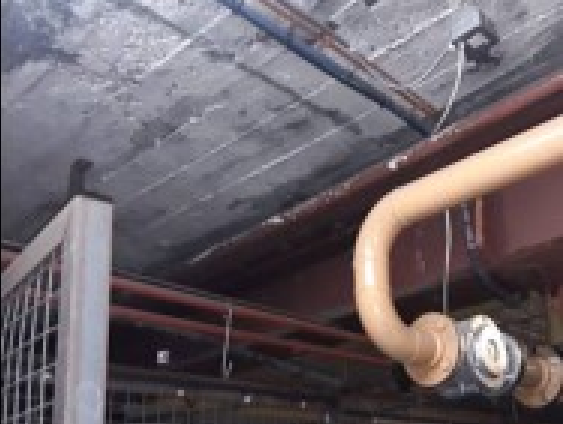
| 7 | NZ001813 | Pipework gaskets to new boilers and gas pipes | Boiler room north Z1/001 | No Risk |

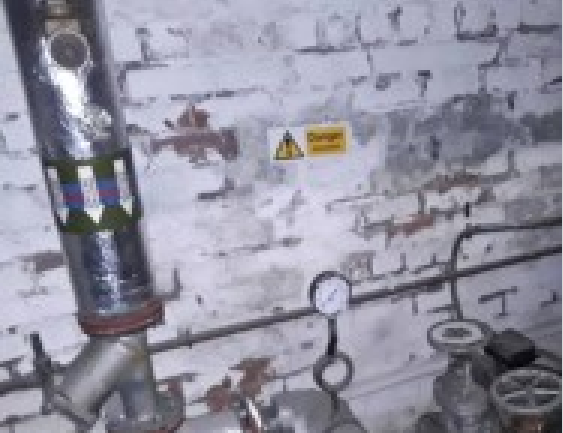
| 9 | NZ001815 | Pipework gaskets redundant gasket on top of old valves | Boiler room north Z1/001 | No Risk |

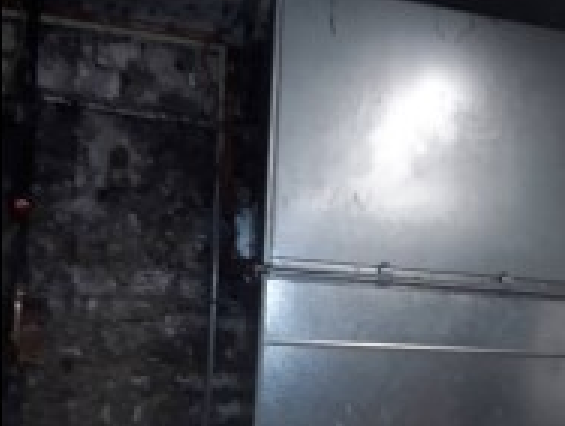
| | | | | | |
| 12 | NZ001817 | Debris to left hand wall | Boiler room South Z1/003 | No Risk | | | | |
| | |

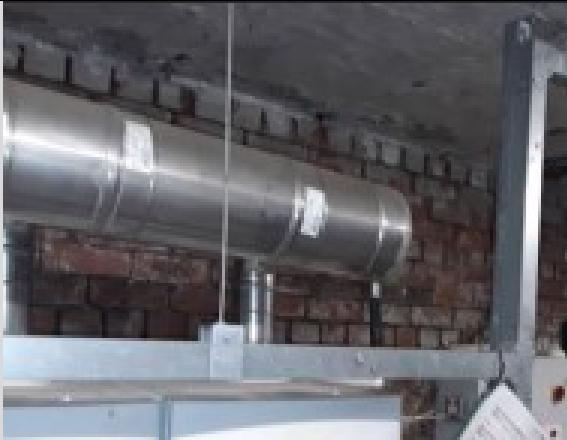
| 13 | NZ001818 | Debris to rear wall | Boiler room South Z1/003 | No Risk |

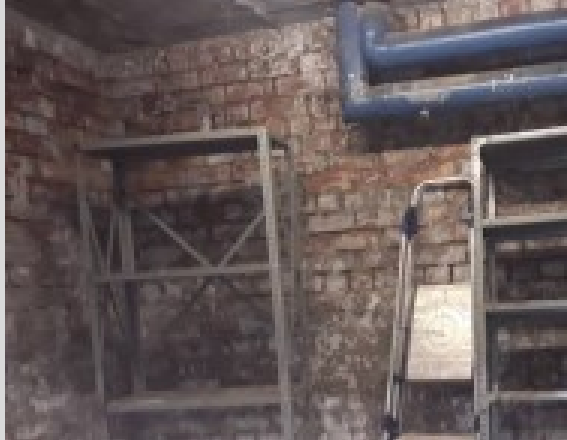
| 14 | NZ001819 | Debris to right wall | Boiler room South Z1/003 | No Risk |

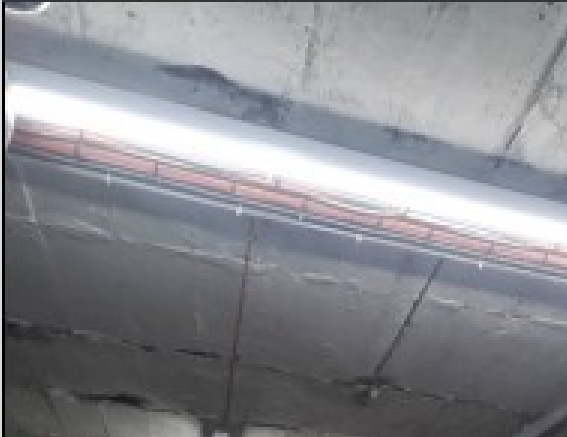
| 15 | NZ001820 | Debris to ceiling | Boiler room South Z1/003 | No Risk |

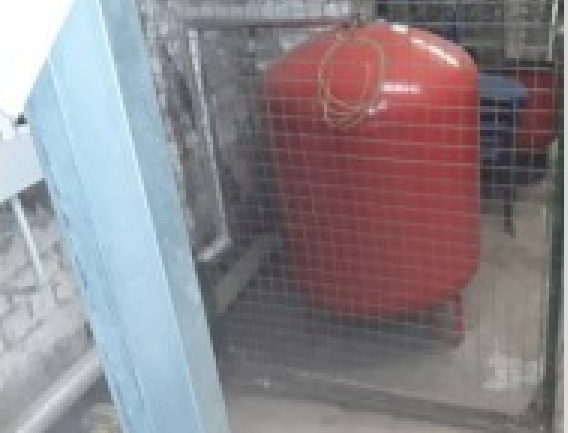
| | | | | | | |
|---|--|---|---|---|---|--|
| 16 | NZ001821 | Debris to floor | Boiler room South Z1/003 | No Risk | | |
| | |

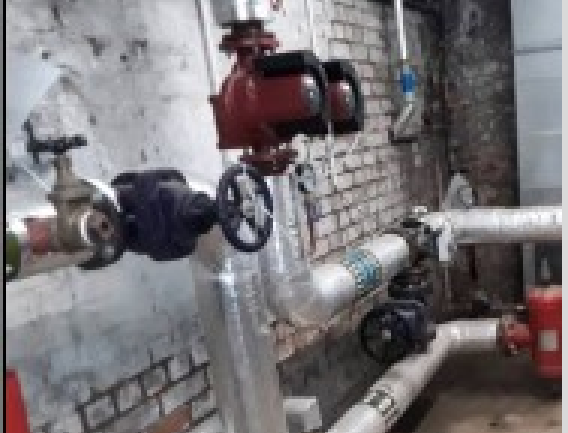
| | | | |
| 17 | NZ001822 | Pipework gaskets to new boilers and gas pipes | Boiler room South Z1/003 | No Risk | | |
| | |

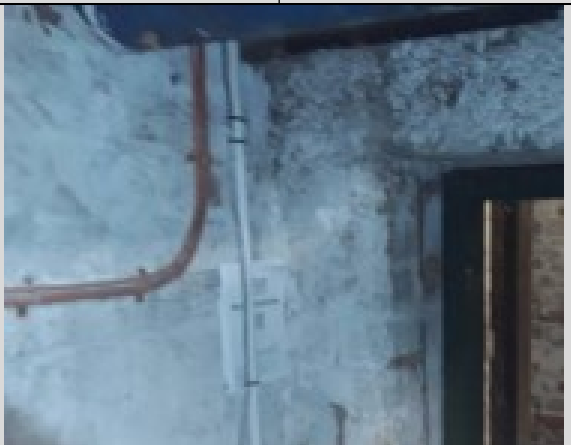
| 19 | NZ001823 | Door seal gasket remnants from removed door frame | Boiler room South Z1/003 | No Risk |

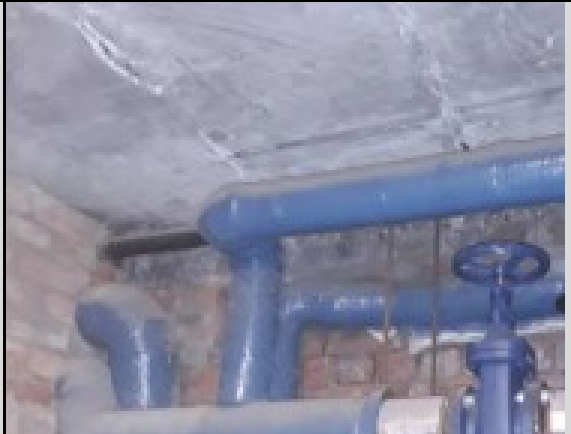
| 20 | NZ001824 | Pipework Gaskets | Gas inlet room Z1/004 | No Risk |

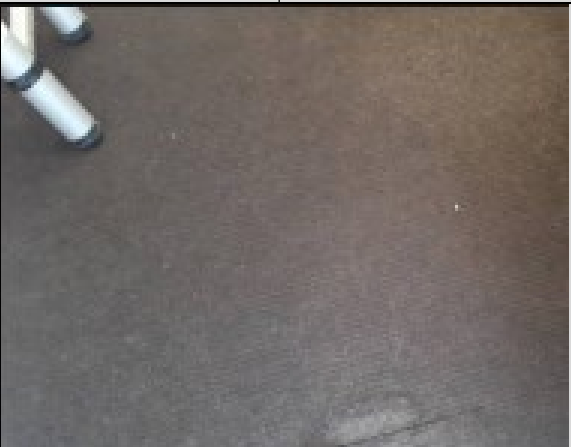
| 21 | NZ001784 | Floor adhesive under modern screed | Entrance Hall/Foyer/Lobby G/001 | No Risk |

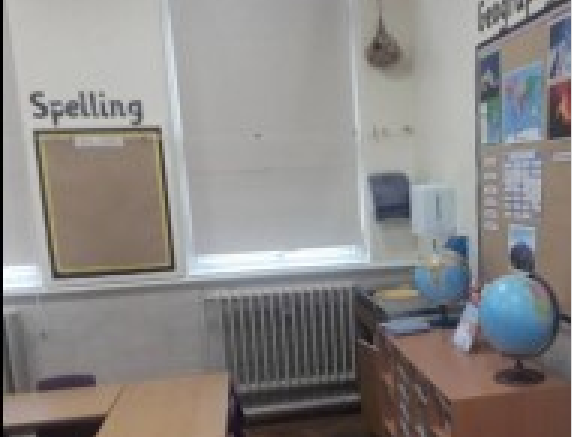
| | | | | | | | | |
|--|---|---|---|---|---|---|--|---|
| 37 | NZ001789 | Under Sink Mat | Classroom G/033 | No Risk | | | | |
| | |

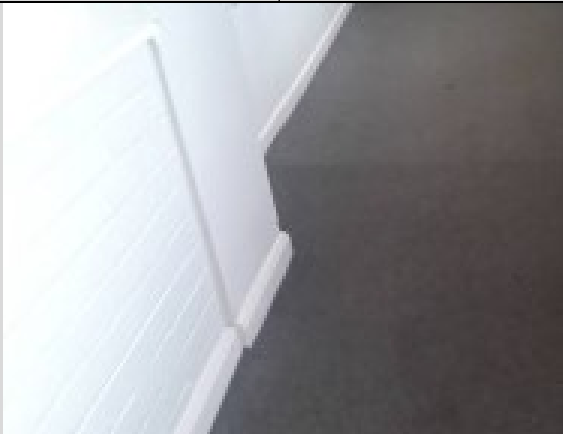
| 42 | NZ001790 | Floor adhesive under carpet and modern screed | Corridor G/037 | No Risk |

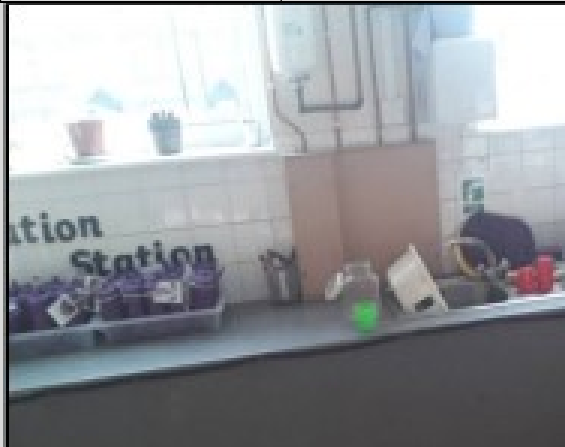
| | | | | | | | |
| 57 | As NZ001793 | Under sink mat | Classroom G/070 | No Risk | | | | |
|

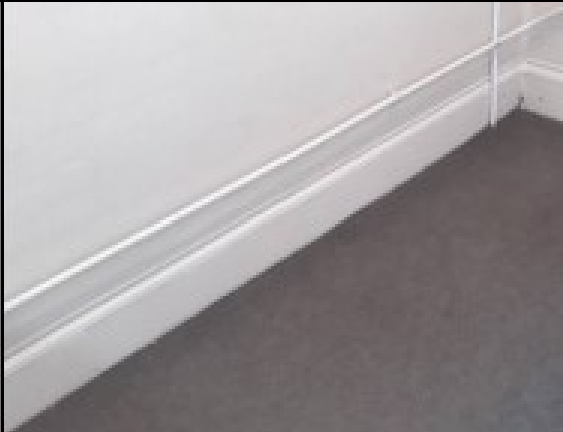
| 69 | NZ001803 | Floor tile with adhesive | Landing 1/025 | No Risk |

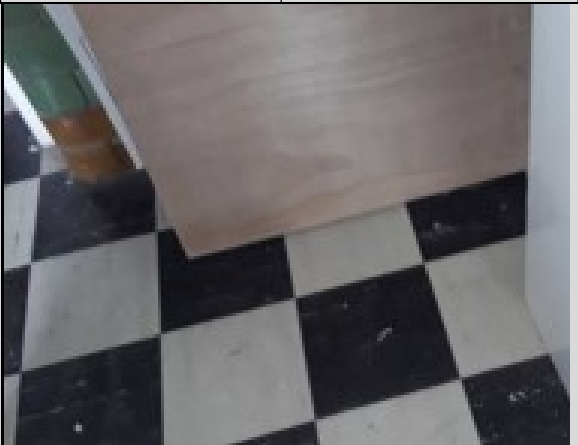
| 77 | NZ001799 | Floor – tile with adhesive under | Hallway MZ/002 | No Risk |

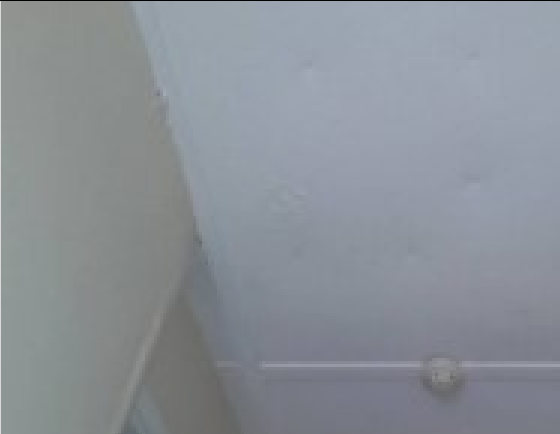
| 84 | As NZ001797 | Ceiling | Landing MZ/010 | No Risk | | | | |

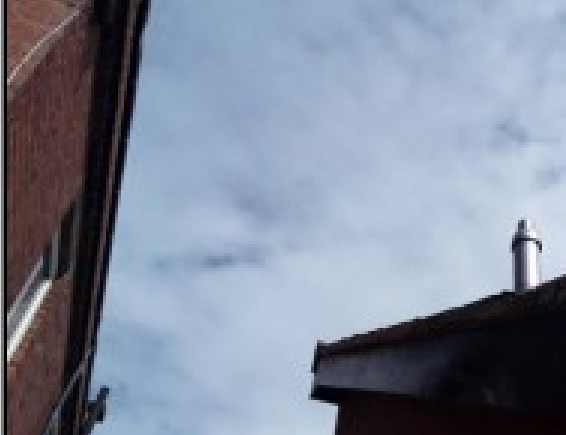
| | | | | | |
| 96 | NZ001827 | Undercloak to newly built dining block and kitchen | External E/001 | No Risk | | | | |
| | |

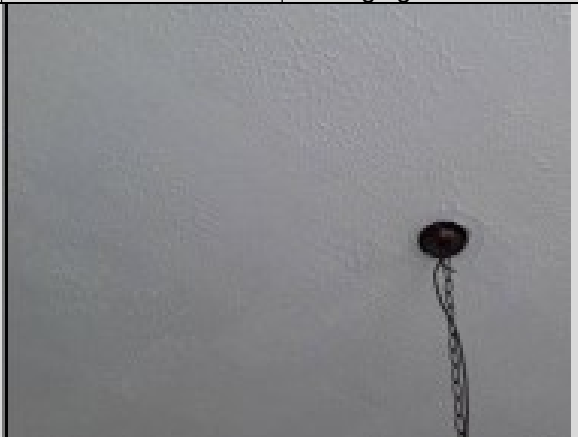
| | | | |
| 104 | NZ001833 | Ceiling coating | Caretakers House Living room/lounge limited inspection within due to tenants belongings G/007 | No Risk | | |
| | |
