ASBESTOS SURVEY REPORT FOR PLAINS FARM ACADEMY, SUNDERLAND

Asbestos Register for PLAINS FARM ACADEMY

Premises Manager / Samo: - Tenant Date: 27 January 2022

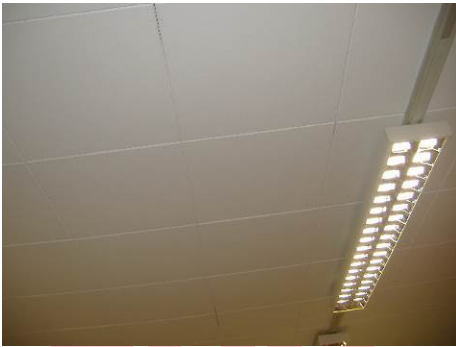
Item 2 - Ref: AW0426/08

The ceiling tiles to the year 6 classroom (Rm 0/02) contain asbestos.

Any change in its appearance should be recorded, and passed to Property Services.

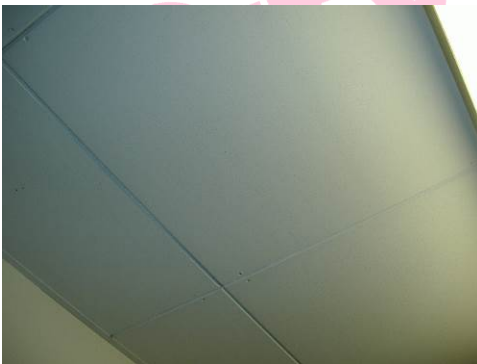
Item 3 - Ref: Presumed

The ceiling tiles to the store room (Rm 0/03) are presumed to contain asbestos.

Any change in its appearance should be recorded, and passed to Property Services.

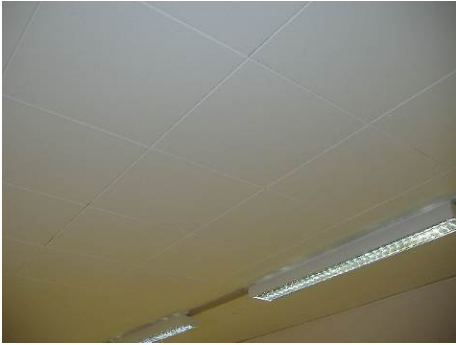
Item 7 Ref: Presumed

The ceiling tiles to the staff room (Rm 0/06) are presumed to contain asbestos.

Any change in its appearance should be recorded, and passed to Property Services.

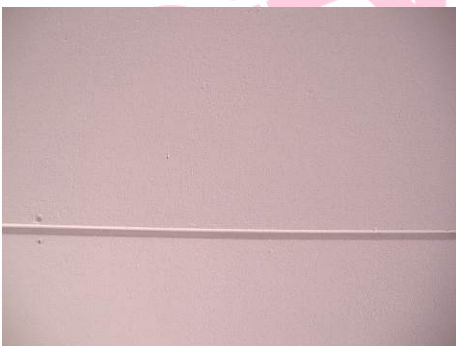
Item 16 - Ref: Presumed

The ceiling tiles to the cleaners cupboard (Rm 0/13) are presumed to contain asbestos.

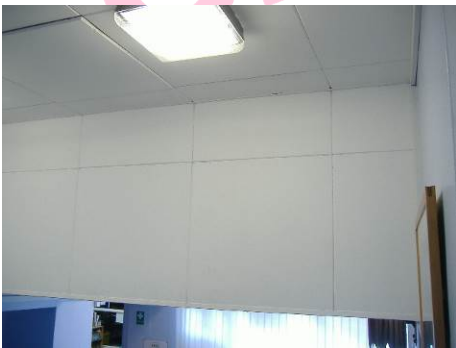
Item 25 - Ref: Presumed

The ceiling tiles to the lobby (Rm 0/24) are presumed to contain asbestos.

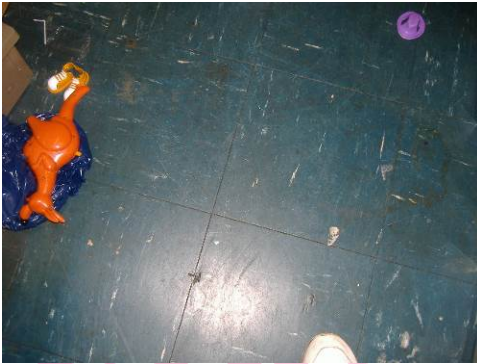
Item 33 Ref: AW0429/08

The blue floor tiles to the store room (Rm 0/31) do not contain asbestos.

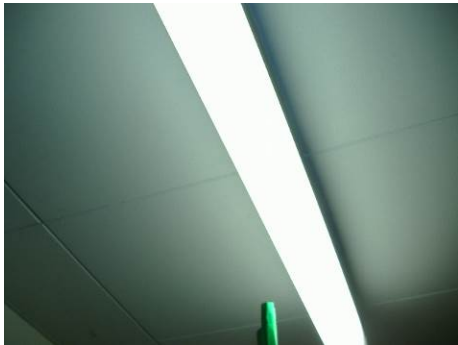
Item 35 - Ref: Presumed

The ceiling tiles to the store room (Rm 0/33) are presumed to contain asbestos.

Any change in its appearance should be recorded, and passed to Property Services.

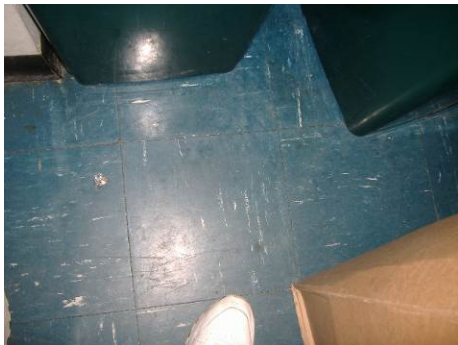
Various Ref: AW0431/08

The blue floor tiles to the store room (Rm 0/33) contain asbestos (Item 36).

Similar flooring is located in room 0/41.

Any change in its appearance should be recorded, and passed to Property Services.

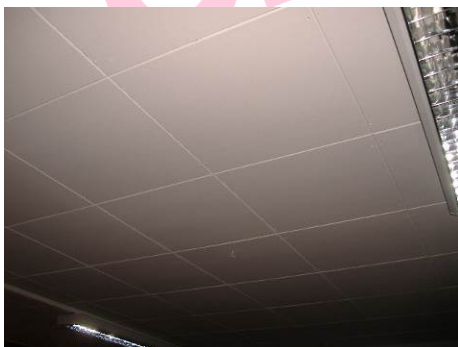
Item 37 - Ref: Presumed

The ceiling tiles to the classroom (Rm 0/34) are presumed to contain asbestos.

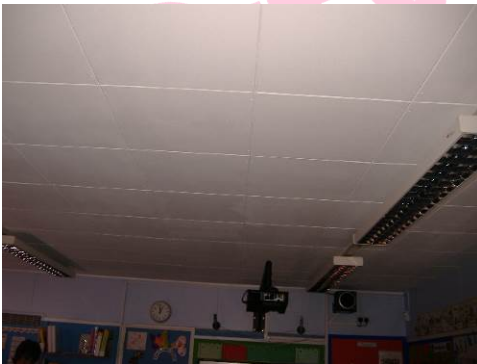
Item 44 - Ref: Presumed

The ceiling tiles to the classroom (Rm 0/40) were presumed to contain asbestos.

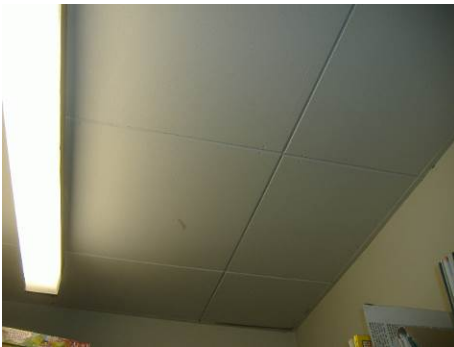
Item 46 Ref: Presumed

The ceiling tiles to the store room (Rm 0/42) are presumed to contain asbestos.

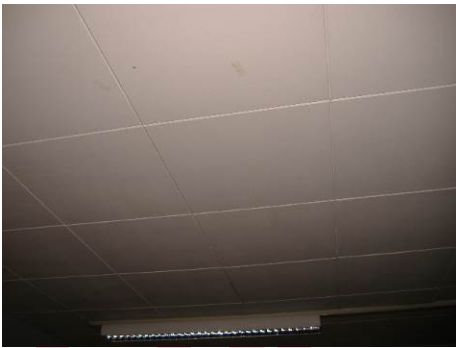
Item 49 - Ref: Presumed

The ceiling tiles to the store room (Rm 0/46) are presumed to contain asbestos.

These were removed in August 2015.

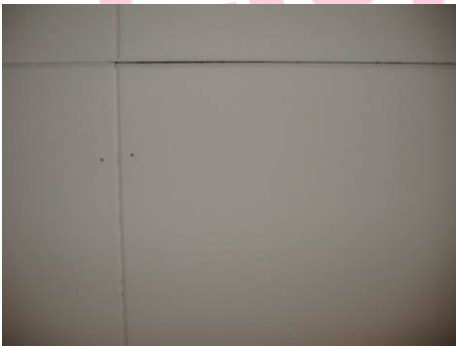
Item 50 - Ref: Presumed

The ceiling tiles to the library/music (Rm 0/45) were presumed to contain asbestos.

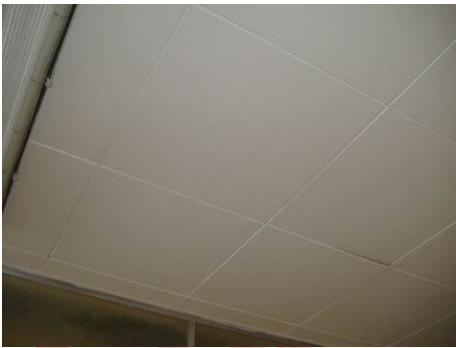
Item 55 - Ref: 247623-1

The ceiling tiles to the kitchen (Rm 0/66) contain asbestos.

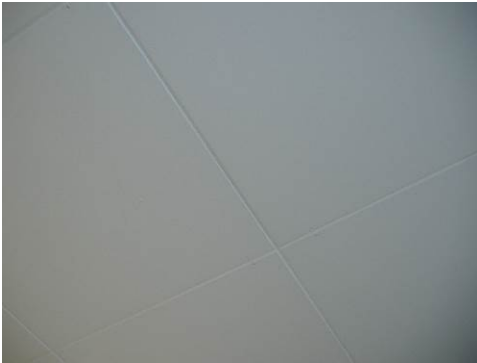
Item 60 - Ref: Presumed

The ceiling tiles to the store room (Rm 0/71) are presumed to contain asbestos.

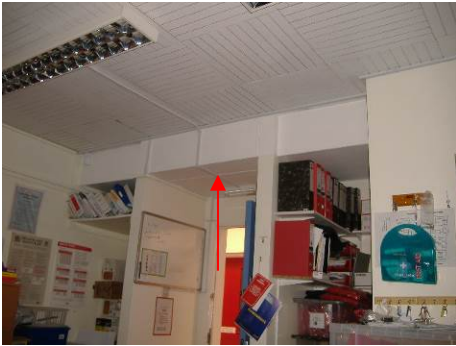
Item 63 - Ref: Presumed

The ceiling tile above the doorway and within recess in the office (Rm 0/75) is presumed to contain asbestos.

Any change in its appearance should be recorded, and passed to Property Services.

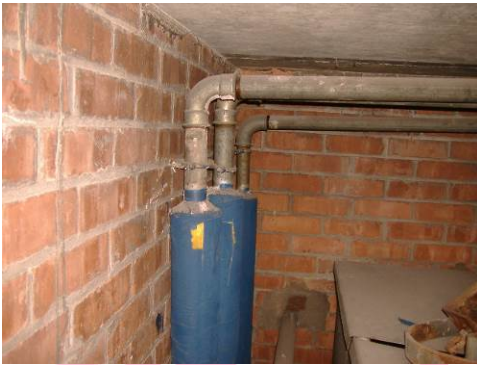
Item 64 - Ref: AW0445/08

The pipework insulation to the tank room (Rm M274) does not contain asbestos.

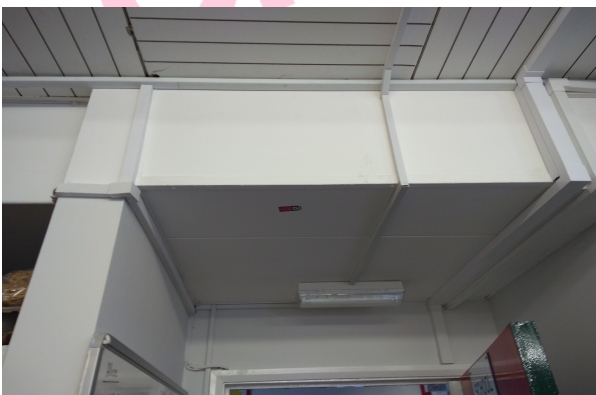
Item 95-Ref: 293720-1

The Ceiling/boxing above entrance doors (& cupboards) in the main office contain asbestos.

This item was removed November 2018.

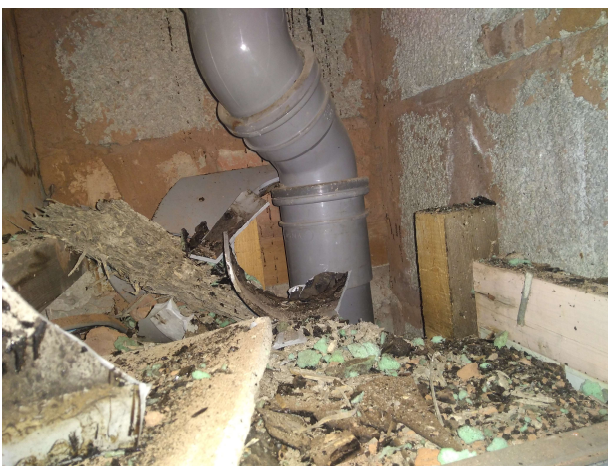
Item 98-Ref: 293720-3

The bitumen roof covering debris in the main office (void above) contains asbestos.

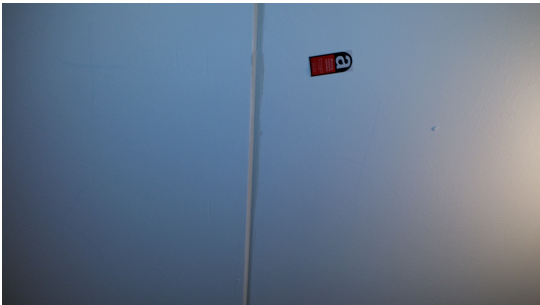
Item 107 Ref: As 247623-1

The ceiling in Rm 003/Kitchen Toilet contains asbestos.

Any change in its appearance should be recorded and passed to Property Services.

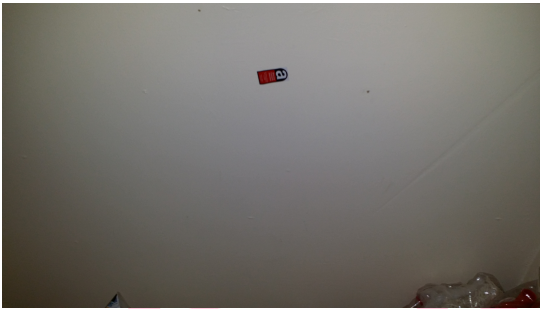
Item 109 Ref: Presumed

The panels above wooden ceiling in Rm 005/Kitchen Store are presumed to contain asbestos.

Any change in its appearance should be recorded and passed to Property Services.

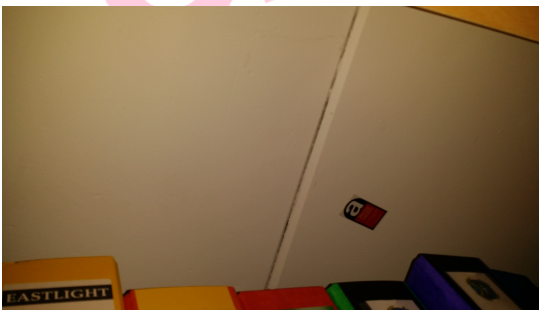
Item 113 Ref: 247623-3

The ceiling in Rm 007/ Headteachers office cupboard contains asbestos.

Any change in its appearance should be recorded and passed to Property Services.
