ASBESTOS SURVEY REPORT FOR BURNSIDE ACADEMY, BURNSIDE ESTATE, HOUGHTON LE SPRING

Asbestos Register for

**BURNSIDE ACADEMY, BURNSIDE ESTATE, HOUGHTON LE
SPRING**

Burnside Academy - Last updated 22/12/2025 – Version 2

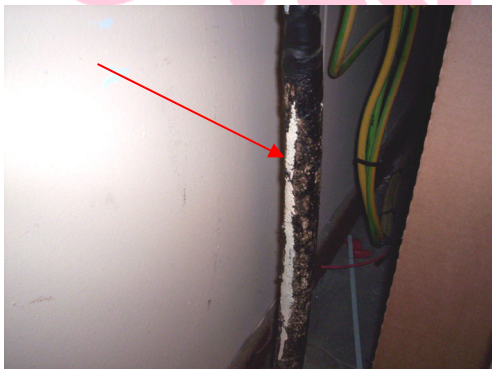
Item 5 - Ref: Presumed

The main cable sheath was inaccessible as it was live during the survey therefore it has to be presumed that there could be asbestos within.

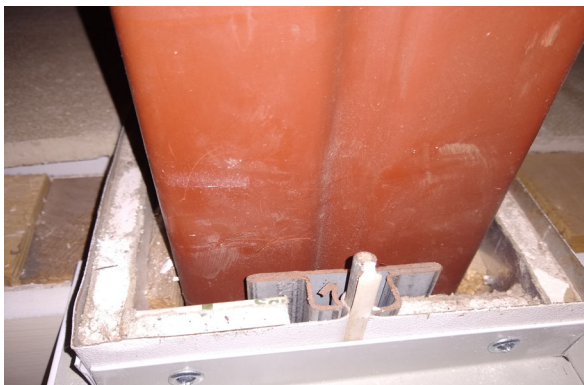
Item 50 – Ref: As 366050-2

The cladding to the beams in the corridor (Room 021 void above suspended ceiling) does not contain asbestos.

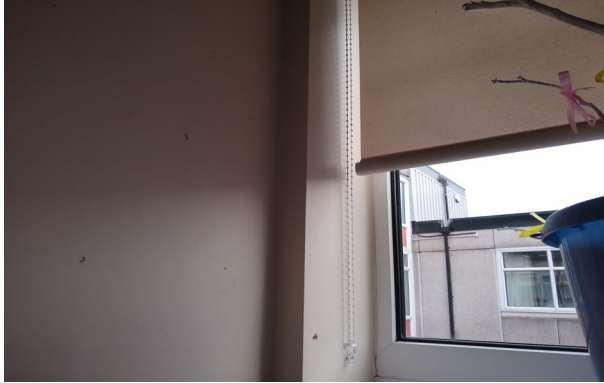
Item 51 – Ref: As 366050-3

The cladding to the beams in the classroom (Room 028) localised to wall does not contain asbestos.

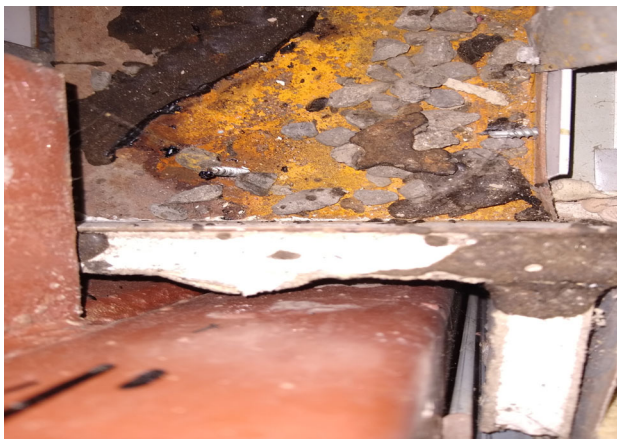
Item 52 – Ref: As 366050-3

The cladding to the beams in the classroom (Room 029) void above suspended ceiling does not contain asbestos.

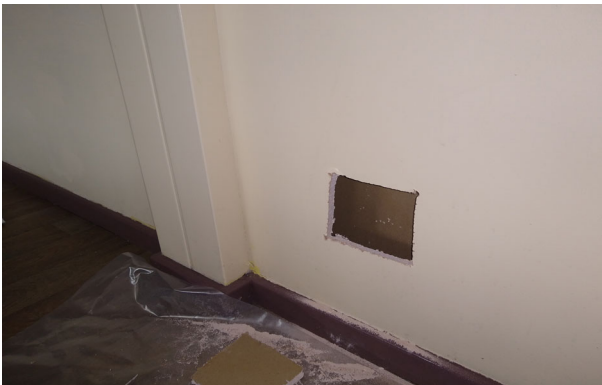
Item 55 – Ref: As 366050-2

The cladding to the columns in the corridor (Room 021) localised to wall does not contain asbestos.

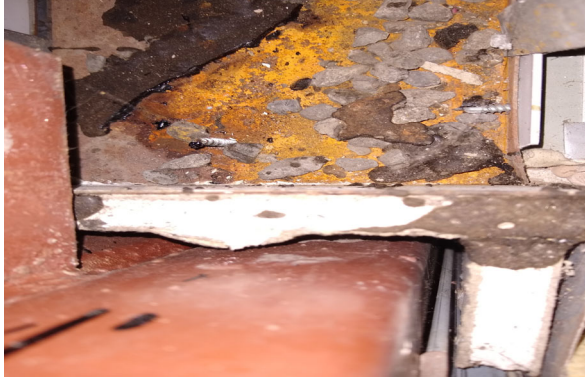
Item 57 – Ref: 345636-2

The remnant adhesive to the floor in classroom (room 028) does contain asbestos.

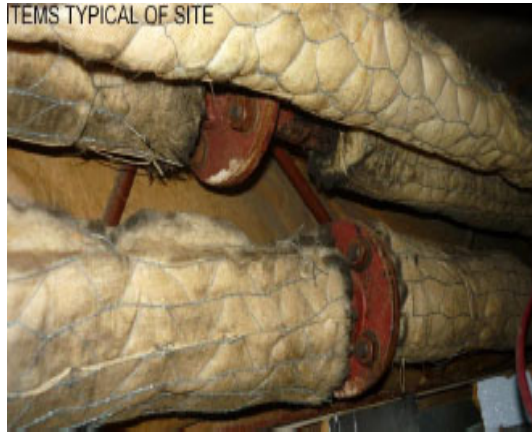
Item 120 – Ref: Presumed

The pipework flange gasket in the ceiling void in the staff room (Rm 008) is presumed to contain asbestos.

Further investigation is required before works should be carried out in this area.

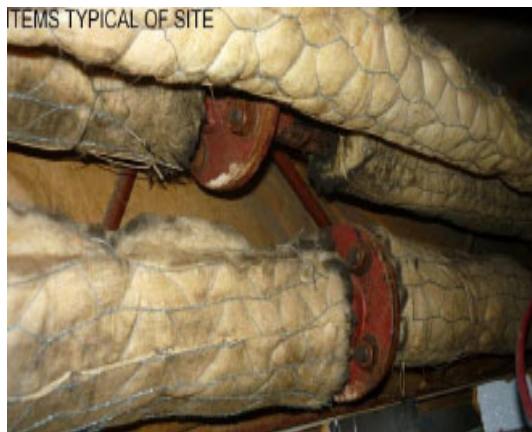
Item 121 – Ref: Presumed

The pipework flange gasket in the ceiling void in the office (Rm 011) is presumed to contain asbestos.

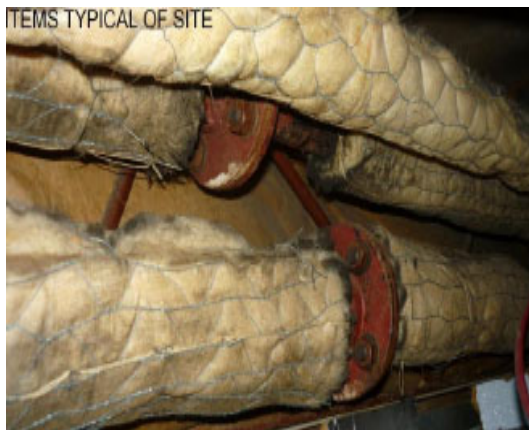
Item 125 – Ref: Presumed

The gasket in the ceiling void in the corridor/cloakroom (Rm 041) is presumed to contain asbestos.

Further investigation is required before works should be carried out in this area.

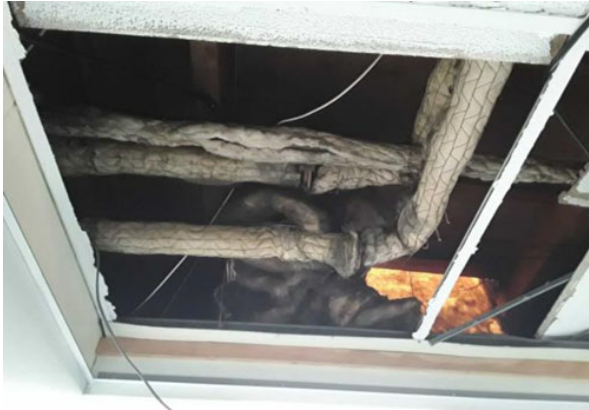
Item 129 – Ref: 22-50659-3

The string wrap to mmmf lagged pipes in the fire exit hallway (Area 5) does not contain asbestos.

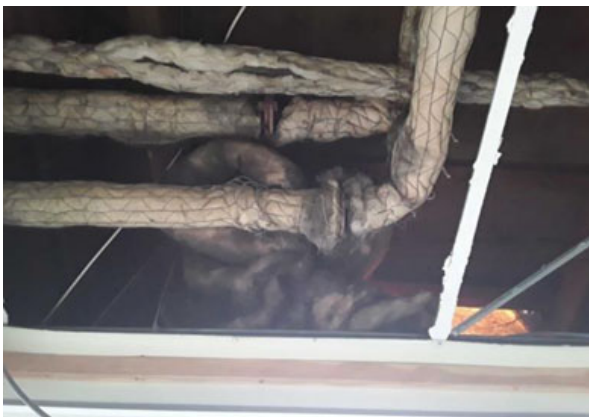
Item 130 – Ref: Presumed

The pipe flanges (gaskets) in the fire exit hallway (Area 5) is presumed to contain asbestos.

Any change in appearance should be reported to Property Services.

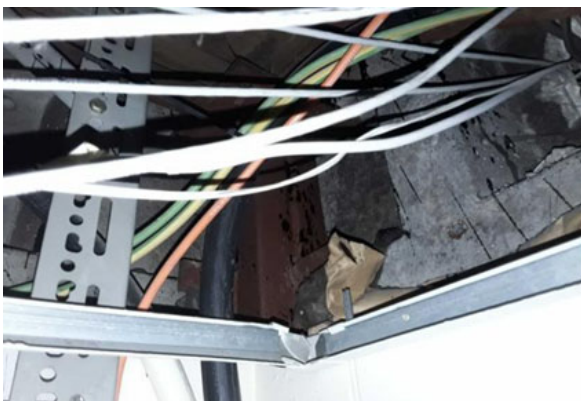
Item 131 – Ref: Presumed

The lining inside clasp columns in the electric meter cupboard (Area 6) is presumed to contain asbestos.

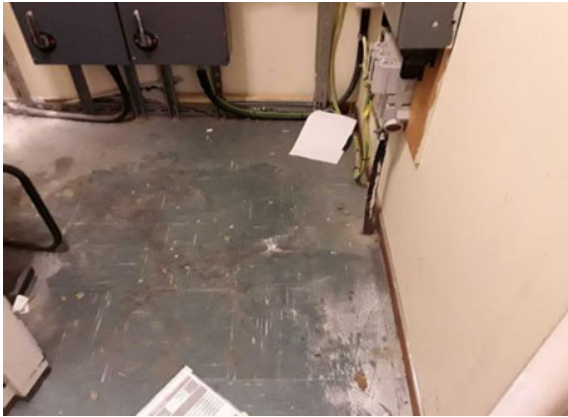
Item 132 – Ref: 22-50659-5

The floor tiles and adhesive in the electric meter cupboard (Area 6) does contain asbestos.

(Screeded over Oct 22 – But residual still in place)

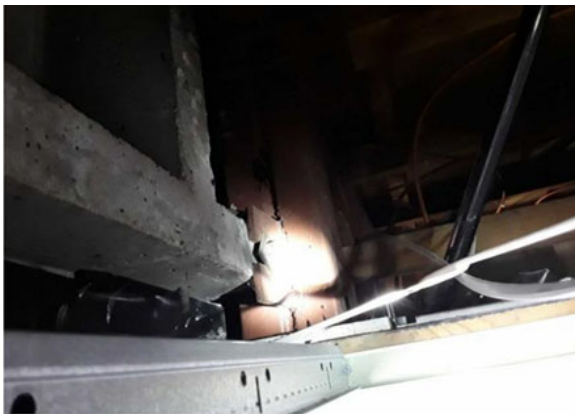
Item 133 – Ref: Presumed

The lining inside clasp columns in the staff room (Area 7) is presumed to contain asbestos.

Any change in appearance should be reported to Property Services.

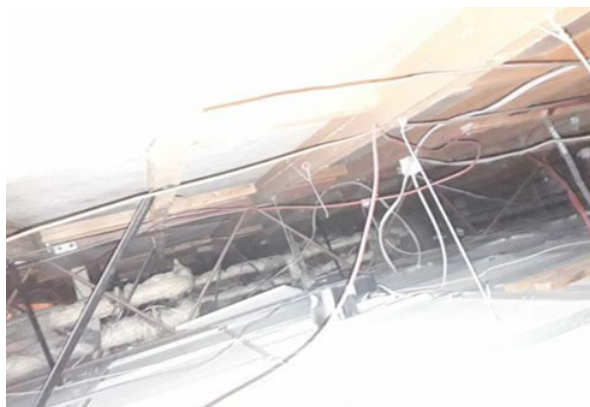
Item 134 – Ref: 22-50659-3

The string wrap to mmmf lagged pipes in the staff room (Area 7) does not contain asbestos.

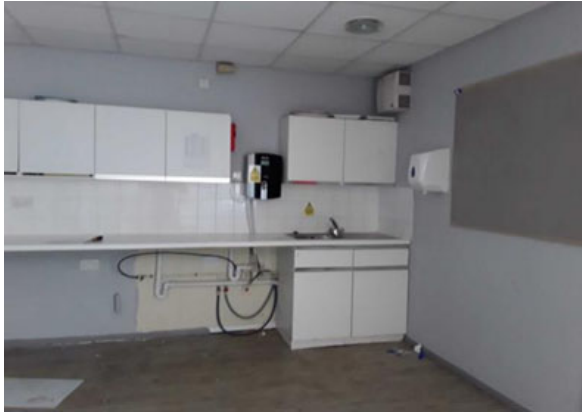
Item 135 – Ref: 22-50659-6

The ceramic tile adhesive to the walls in the staff room (Area 7) does not contain asbestos.

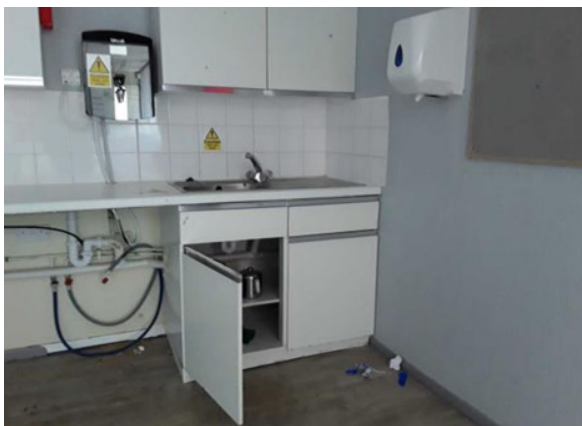
Item 136 – Ref: 22-50659-7

The sink pad in the staff room (Area 7) does not contain asbestos.

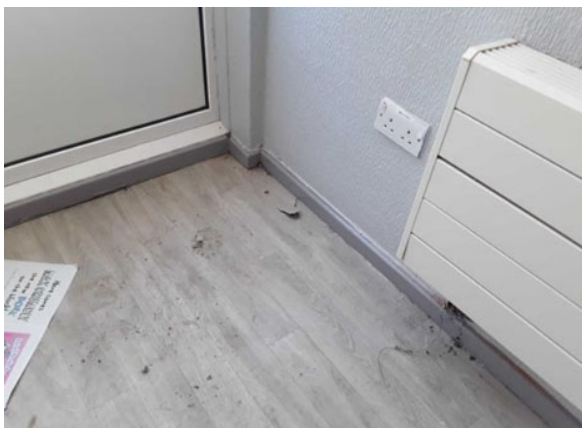
Item 137 – Ref: 22-50659-8

The adhesive beneath screed on the floor in the staff room (Area 7) does contain asbestos.

Any change in appearance should be reported to Property Services.

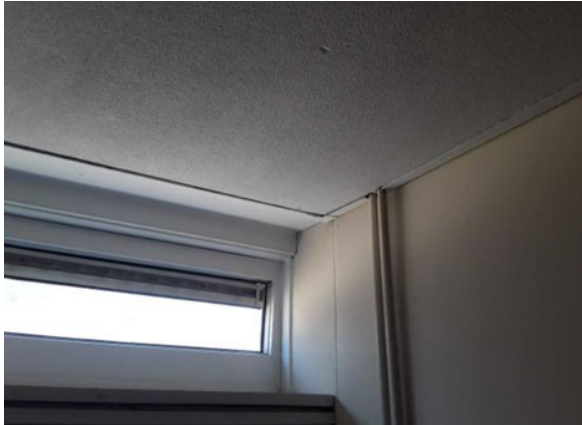
Item 138 – Ref: Presumed

The lining inside clasp columns in gents toilets (Area 8) is presumed to contain asbestos.

Any change in appearance should be reported to Property Services.

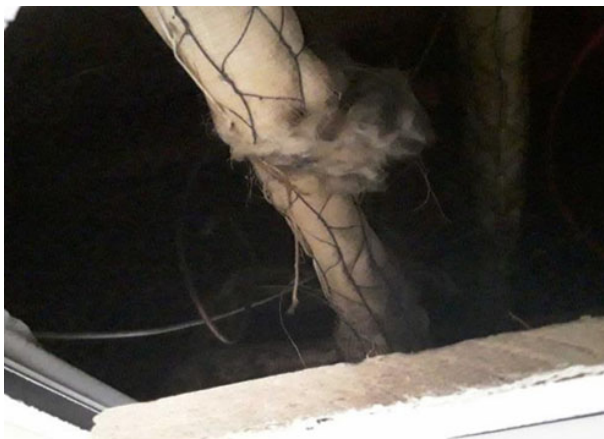
Item 139 – Ref: Presumed

The string wrap to mmmf lagged pipes in the gents toilet (Area 8) does not contain asbestos.

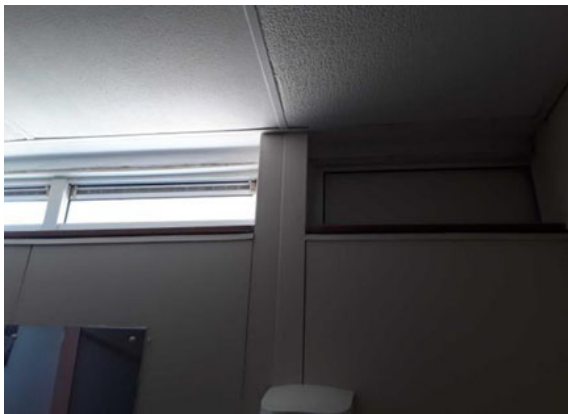
Item 140 – Ref: Presumed

The lining inside clasp columns in ladies toilet (Area 9) is presumed to contain asbestos.

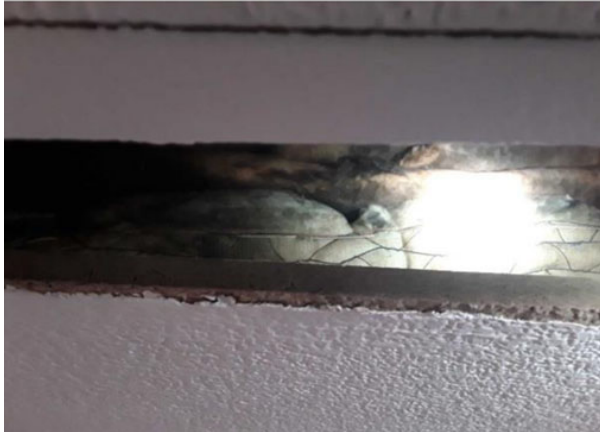
Item 141 – Ref: 22-50659-3

The string wrap to mmmf lagged pipes in the ladies toilet (Area 9) does not contain asbestos.

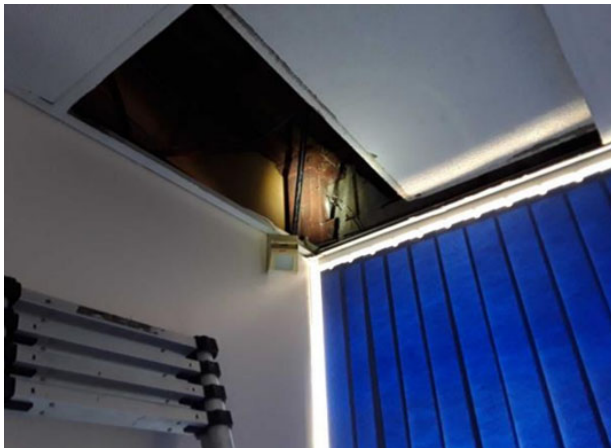
Item 142 – Ref: Presumed

The lining inside clasp columns in the meeting room (Area 10) is presumed to contain asbestos.

Any change in appearance should be reported to Property Services.

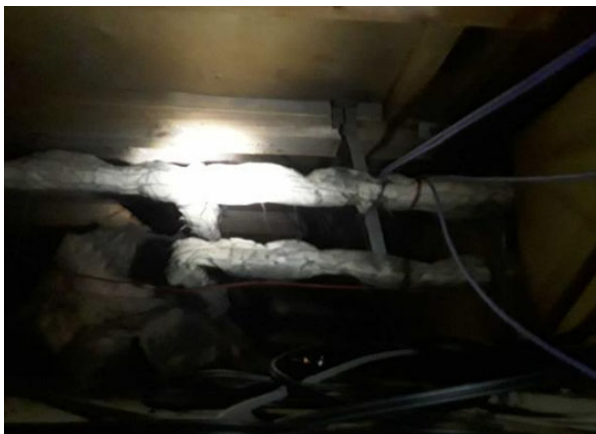
Item 143 – Ref: 22-50659-3

The string wrap to mmmf lagged pipes in the meeting room (Area 10) does not contain asbestos.

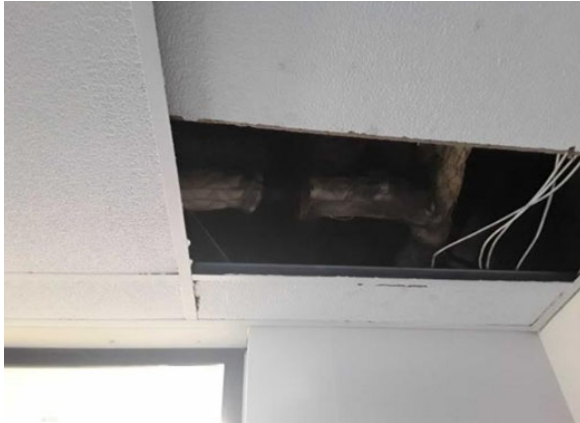
Item 144 – Ref: Presumed

The pipe flanges (gaskets) in the meeting room (Area 10) is presumed to contain asbestos.

Any change in appearance should be reported to Property Services.

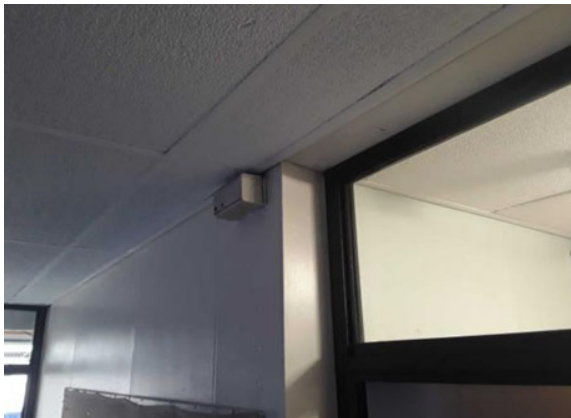
Item 145 – Ref: Presumed

The lining inside clasp columns in the store cupboard (Area 11) is presumed to contain asbestos.

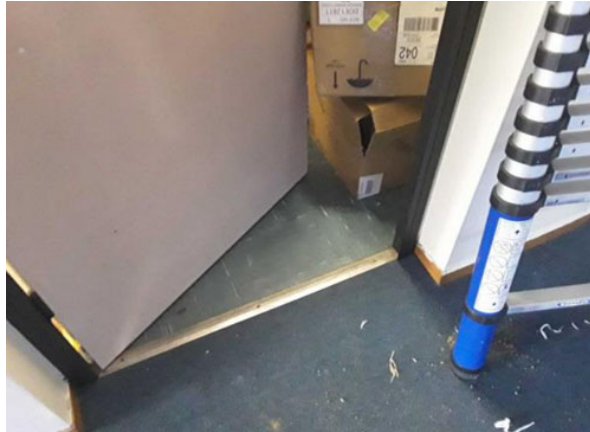
Item 147 – Ref: 22-50659-9

The floor tiles and adhesive in the store cupboard (Area 11) does contain asbestos.

(Screeded over Oct 22 – But residual still in place)

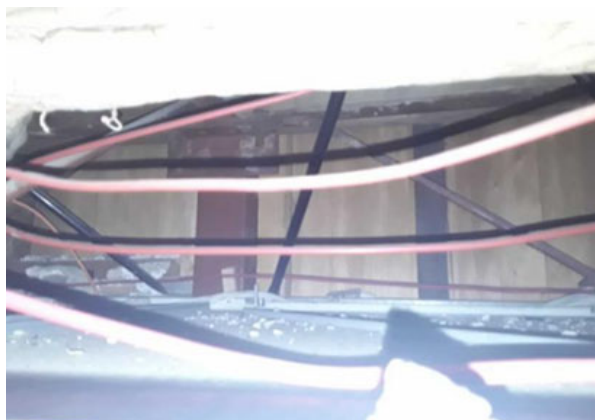
Item 148 – Ref: Presumed

The lining inside clasp columns in the store cupboard (Area 11) is presumed to contain asbestos.

Any change in appearance should be reported to Property Services.

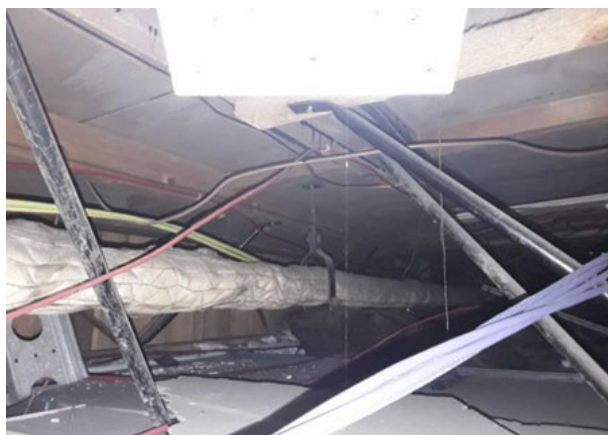
Item 149 – Ref: 22-50659-3

The string wrap to mmmf lagged pipes in the store cupboard (Area 12) does not contain asbestos.

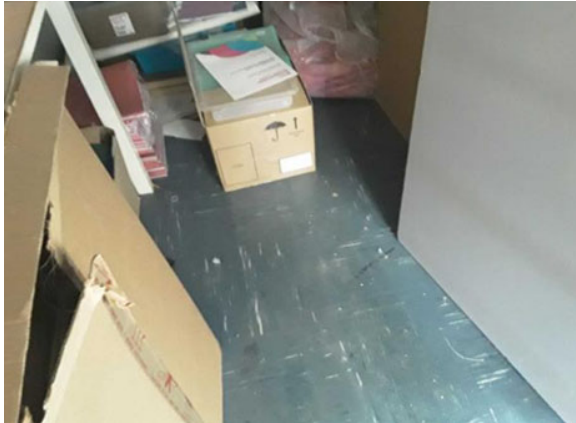
Item 150 – Ref: 22-50659-9

The floor tiles and adhesive in the store cupboard (Area 12) does contain asbestos.

Any change in appearance should be reported to Property Services.

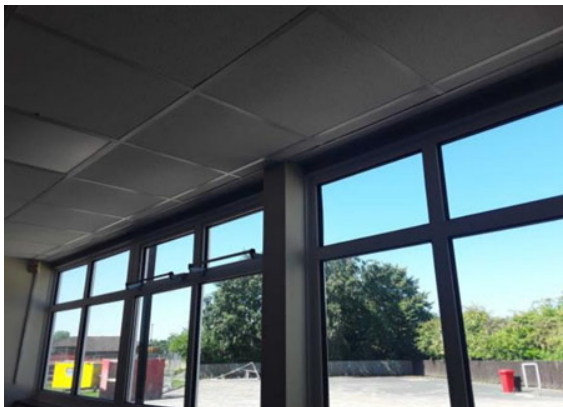
Item 151 – Ref: Presumed

The lining inside clasp columns in the corridor (Area 13) is presumed to contain asbestos.

Any change in appearance should be reported to Property Services.

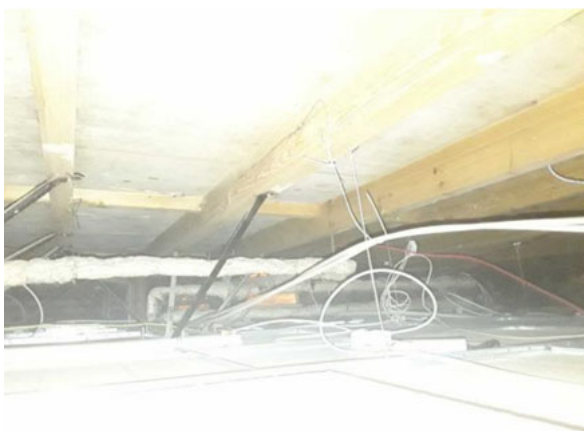
Item 152 – Ref: 22-50659-3

The string wrap to mmmf lagged pipes in the corridor (Area 13) does not contain asbestos.

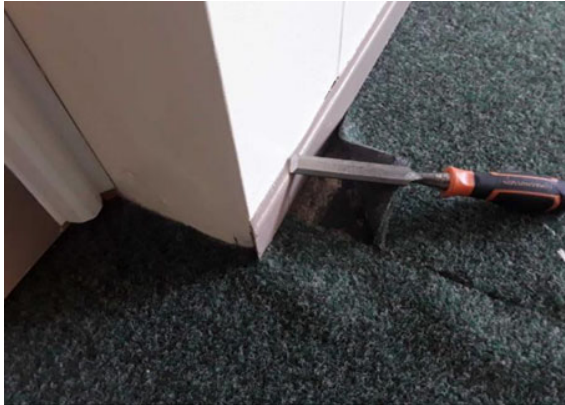
Item 153 – Ref: 22-50659-10

The residual adhesive beneath the screed in the head teachers office (Area 14) does contain asbestos.

Any change in appearance should be reported to Property Services.

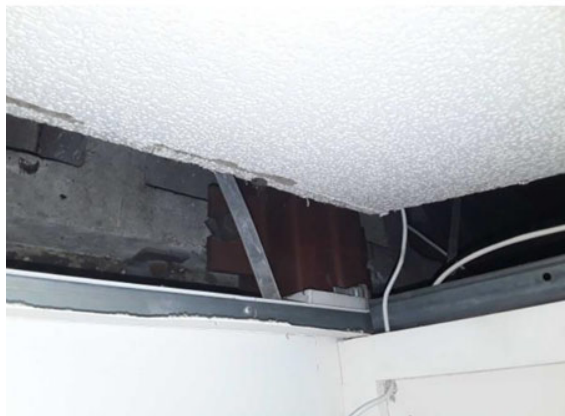
Item 154 – Ref: Presumed

The lining inside clasp columns in the headteachers office (Area 14) is presumed to contain asbestos.

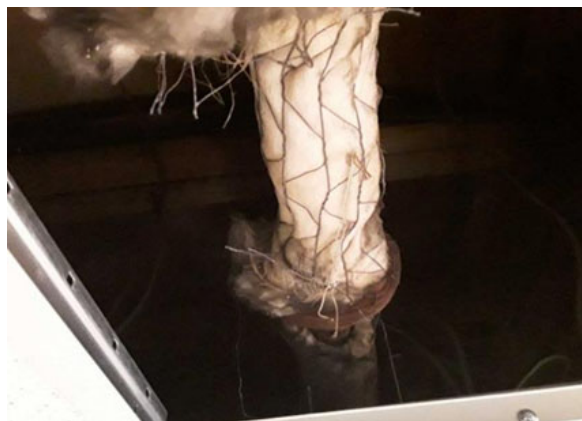
Item 158 – Ref: 22-50659-3

The string wrap to mmmf lagged pipes in the corridor (Area 13) does not contain asbestos.

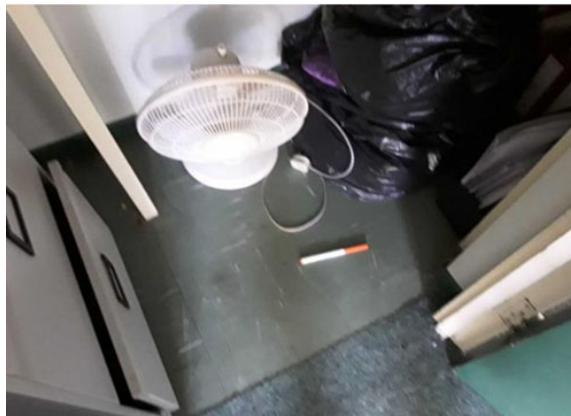
Item 160 – Ref: 22-50659-9

The floor tiles and adhesive in the headteachers store (Area 15) does contain asbestos.

(Screeded over Oct 22 – But residual still in place)

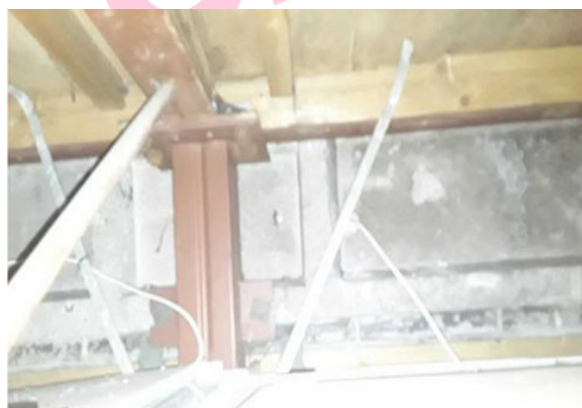
Item 161 – Ref: Presumed

The lining inside clasp columns in the deputy headteachers office and cupboard (Area 16) is presumed to contain asbestos.

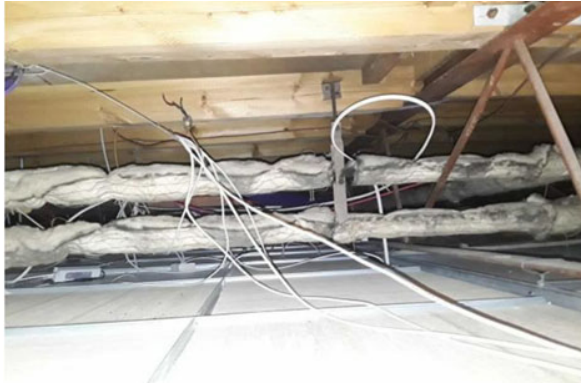
Item 162 – Ref: 22-50659-3

The string wrap to mmmf lagged pipes in the deputy headteachers office and cupboard (Area 16) does not contain asbestos.

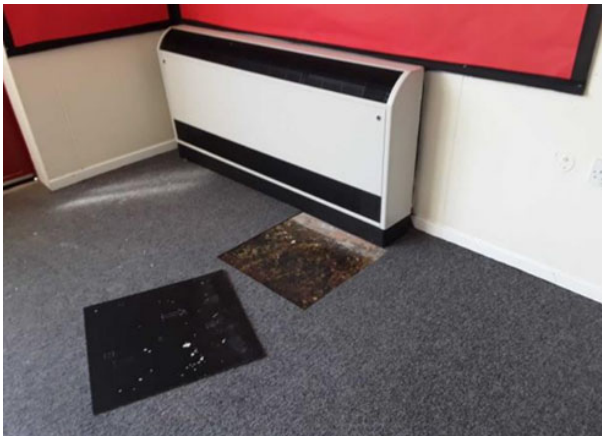
Item 163 – Ref: 22-50659-11

The floor residue to the ICT room and cupboards (Area 17) does to contain asbestos.

Any change in appearance should be reported to Property Services.

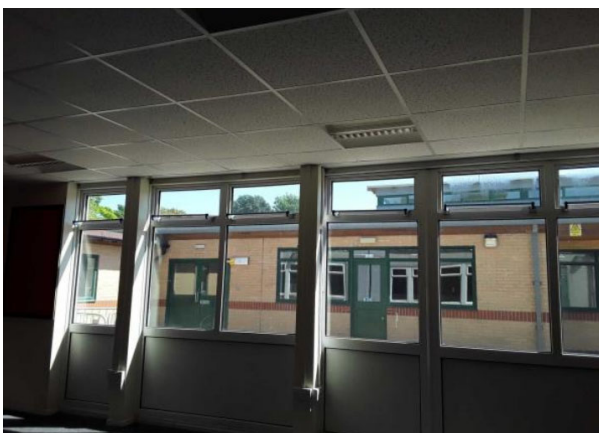
Item 164 – Ref: Presumed

The lining inside clasp columns in the ICT room and cupboards (Area 17) is presumed to contain asbestos.

Any change in appearance should be reported to Property Services.

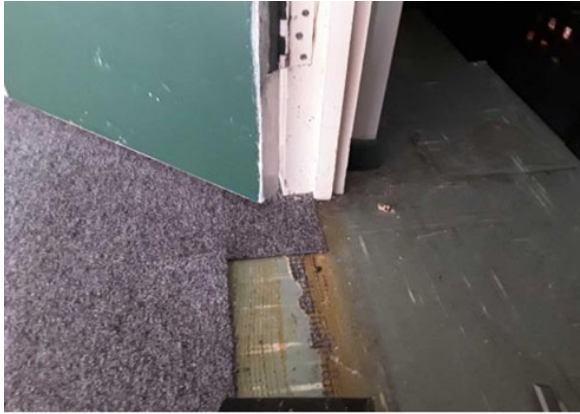
Item 165 – Ref: 22-50659-9

The floor tiles and adhesive in the ICT room and cupboards (Area 17) does contain asbestos.

Any change in appearance should be reported to Property Services.

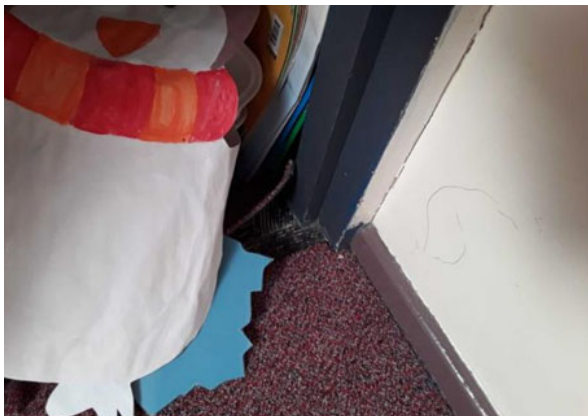
Item 166 – Ref: 22-50659-12

The floor residue to the Year 2 classroom and cupboards (Area 18) does to contain asbestos.

Any change in appearance should be reported to Property Services.

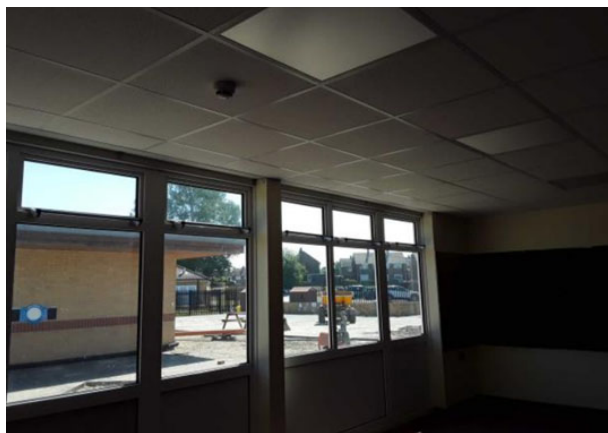
Item 167 – Ref: Presumed

The lining inside clasp columns in the Year 2 Classroom and cupboards (Area 18) is presumed to contain asbestos.

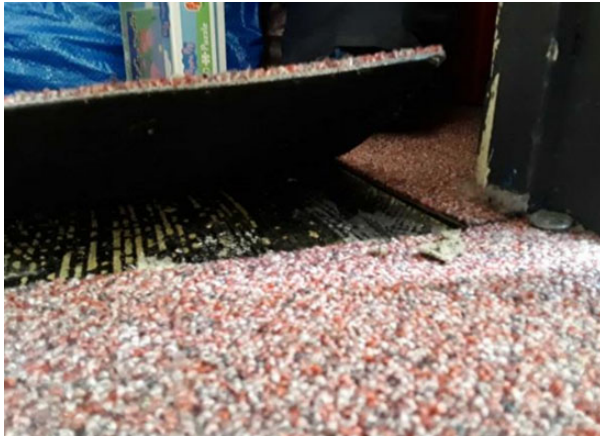
Item 169 – Ref: 22-50659-13

The floor adhesive to the Year 1 classroom and cupboards (Area 19) does to contain asbestos.

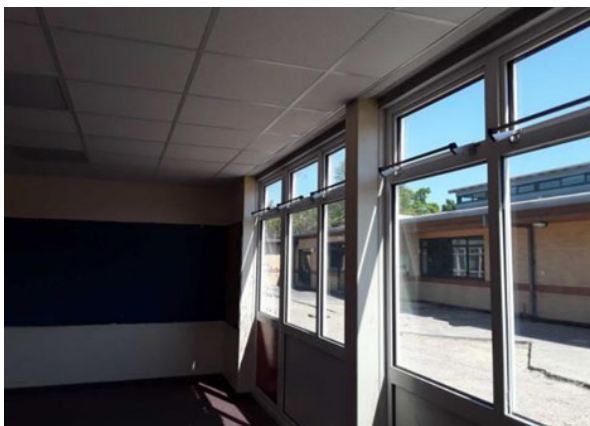
Item 170 – Ref: Presumed

The lining inside clasp columns in the Year 1 Classroom and cupboards (Area 19) is presumed to contain asbestos.

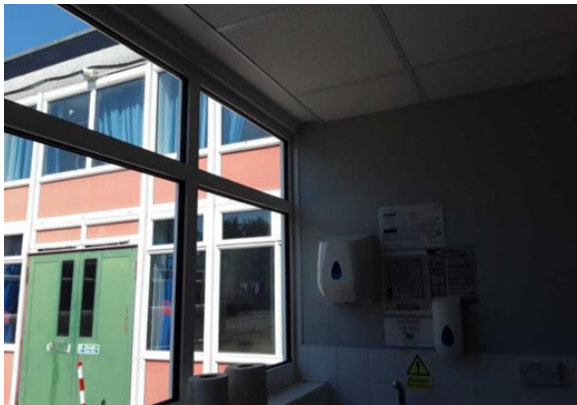
Item 172 – Ref: Presumed

The lining inside clasp columns in the utility room (Area 20) is presumed to contain asbestos.

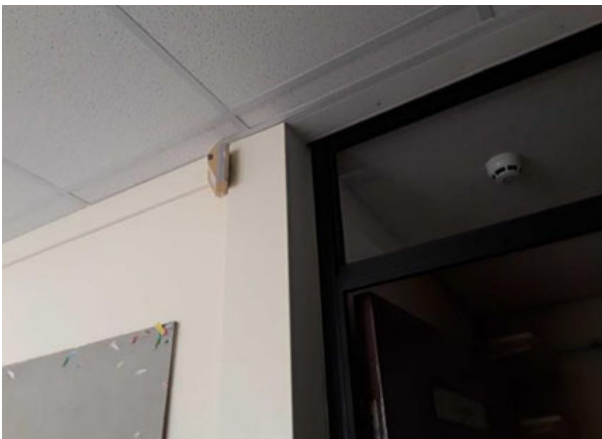
Item 173 – Ref: Presumed

The lining inside clasp columns in the cleaners cupboard (Area 21) is presumed to contain asbestos.

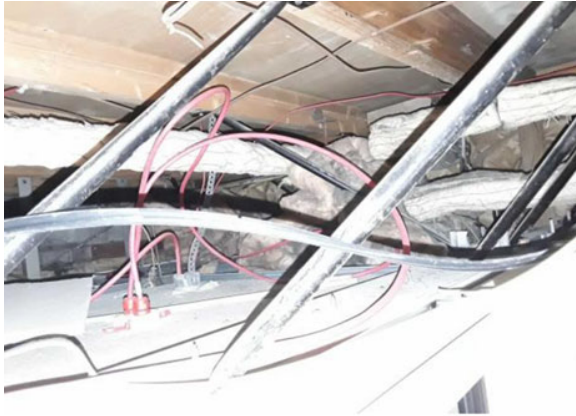
Item 174 – Ref: 22-50659-3

The string wrap to mmmf lagged pipes in the Year 2 Classroom and cupboards (Area 18) does not contain asbestos.

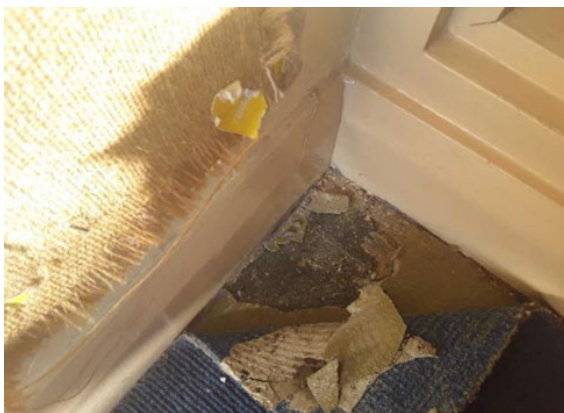
Item 176 – Ref: 22-50659-15

The residual adhesive beneath floor screed in the foundation office 1 (Area 23) contains asbestos.

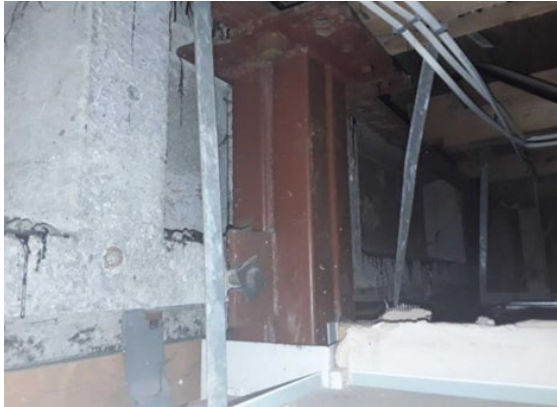
Item 177 – Ref: Presumed

The lining inside clasp columns in the foundation office 1 (Area 23) is presumed to contain asbestos.

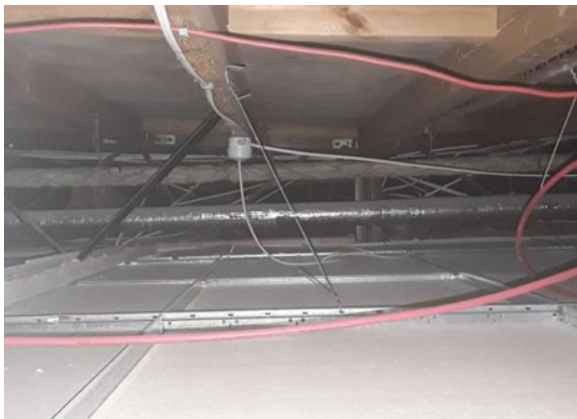
Item 178 – Ref: 22-50659-3

The string wrap to mmmf lagged pipes in the foundation office 1 (Area 23) does not contain asbestos.

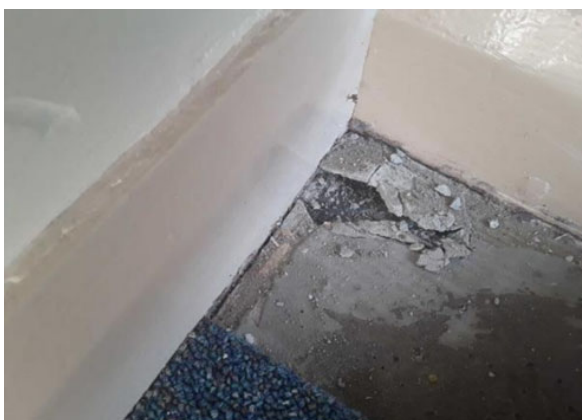
Item 179 – Ref: 22-50659-15

The residual adhesive beneath floor screed in the foundation office 2 (Area 24) contains asbestos.

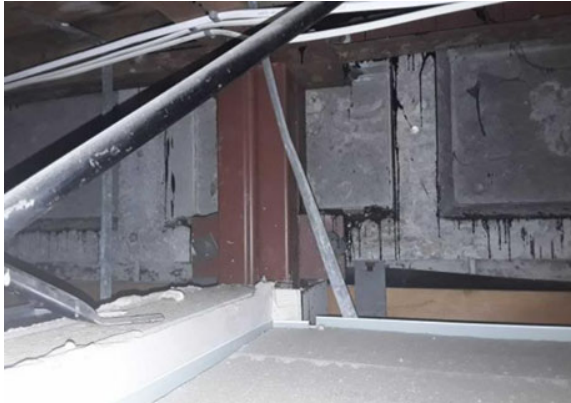
Item 180 – Ref: Presumed

The lining inside clasp columns in the foundation office 2 (Area 24) is presumed to contain asbestos.

Any change in appearance should be reported to Property Services.

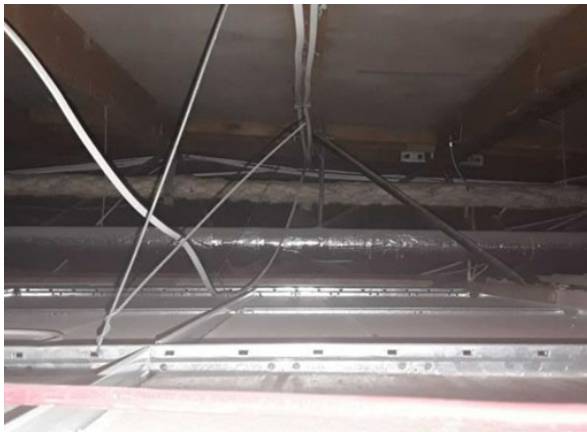
Item 181 – Ref: 22-50659-3

The string wrap to mmmf lagged pipes in the foundation office 2 (Area 22) does not contain asbestos.

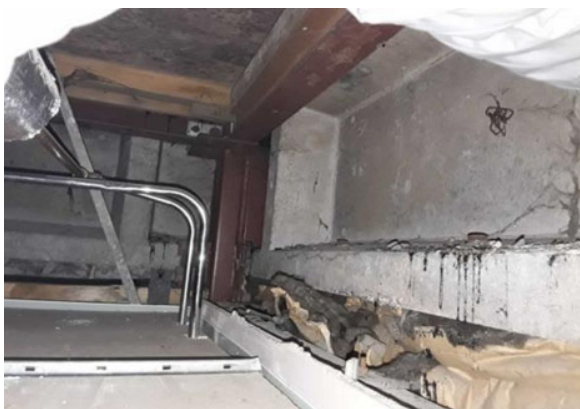
Item 182 – Ref: Presumed

The lining inside clasp columns in the foundation bathroom (Area 25) is presumed to contain asbestos.

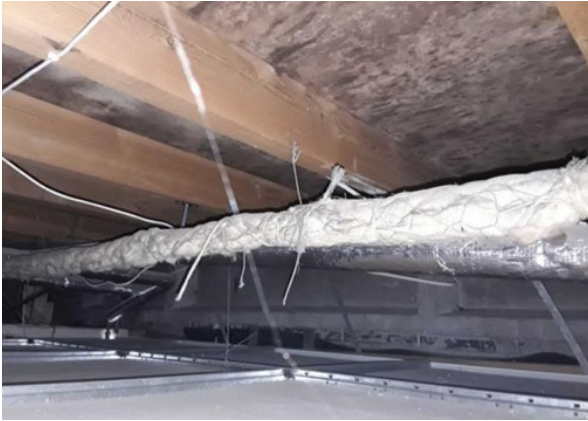
Item 183 – Ref: 22-50659-3

The string wrap to mmmf lagged pipes in the foundation bathroom (Area 25) does not contain asbestos.

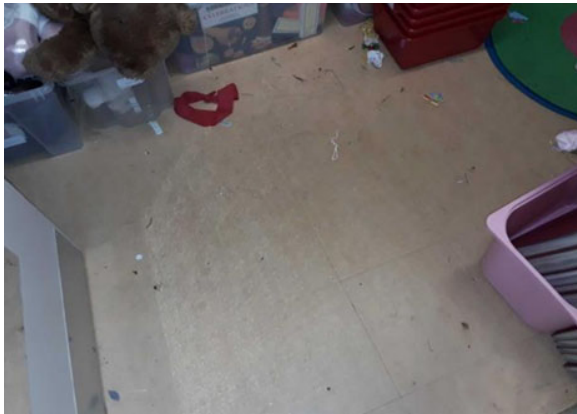
Item 184 – Ref: 22-50659-14

The floor adhesive to the foundation store room (Area 26) does to contain asbestos.

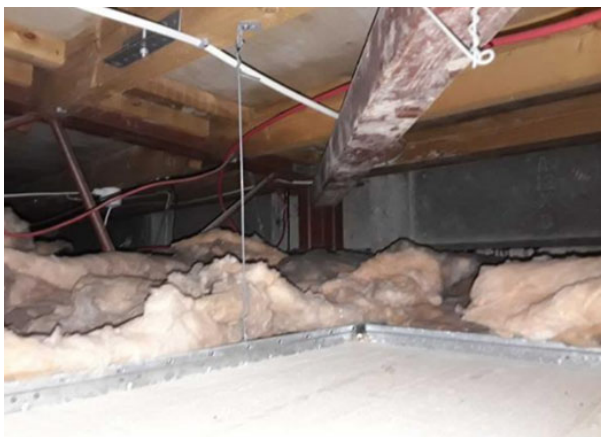
Item 185 – Ref: Presumed

The lining inside clasp columns in the foundation store room (Area 26) is presumed to contain asbestos.

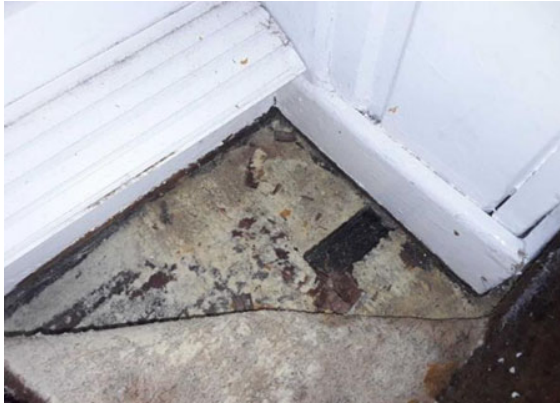
Item 186 – Ref: 22-50659-16

The residual adhesive below parquet flooring and carpet in the Hall (Area 27) does not contain asbestos.

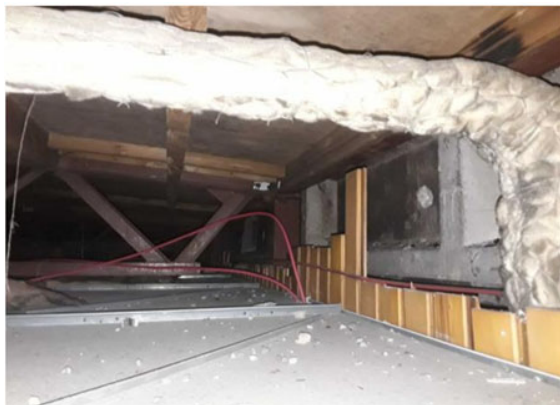
Item 187 – Ref: Presumed

The lining inside clasp columns in the hall (Area 27) is presumed to contain asbestos.

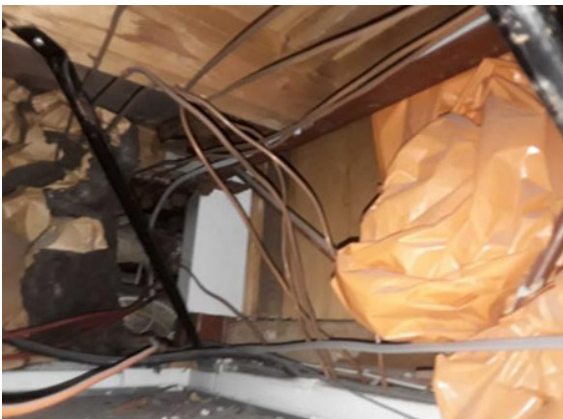
Item 191 – Ref: Presumed

The lining inside clasp columns in the hall store 2 (Area 29) is presumed to contain asbestos.

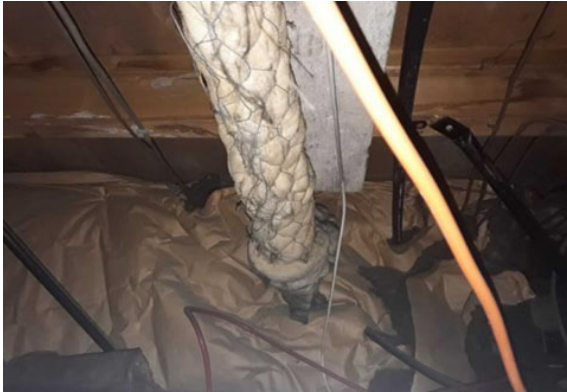
Item 192 – Ref: 22-50659-3

The string wrap to mmmf lagged pipes in the hall store 2 (Area 29) does not contain asbestos.

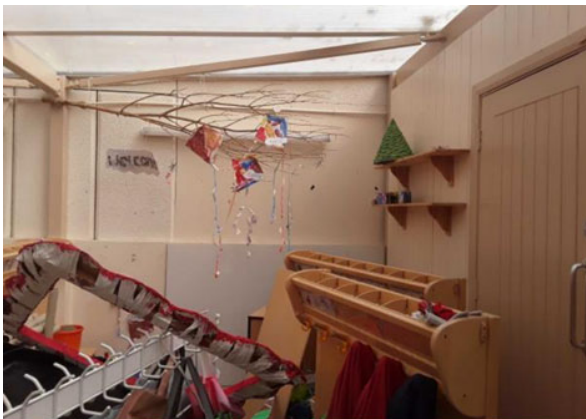
Item 193 – Ref: 22-50659-17

The boards to walls in the conservatory and store cupboard (Area 31) do not contain asbestos.

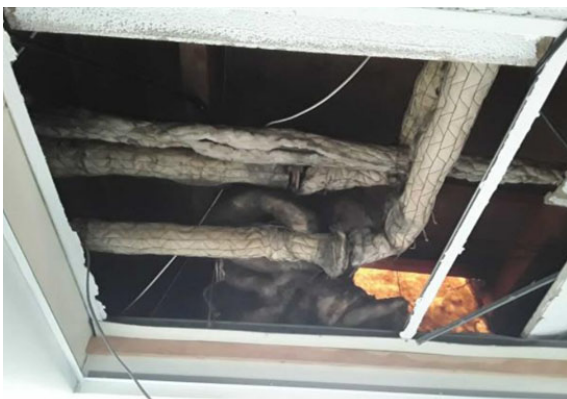
Item 194 – Ref: Presumed

The lining inside clasp columns in the conservatory and store cupboard (Area 31) is presumed to contain asbestos.

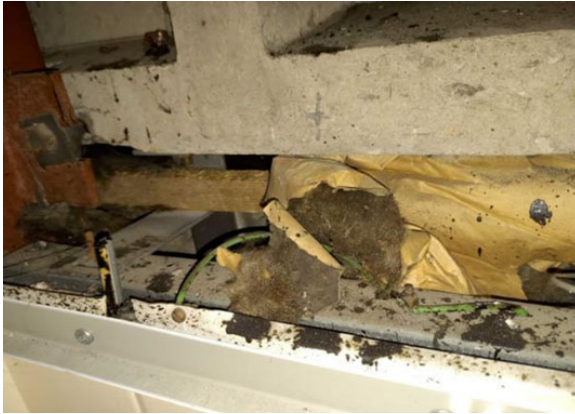
Item 195 – Ref: 22-53465-1

The cavity wall insulation to the internal wall void (Area 2) does not contain asbestos.

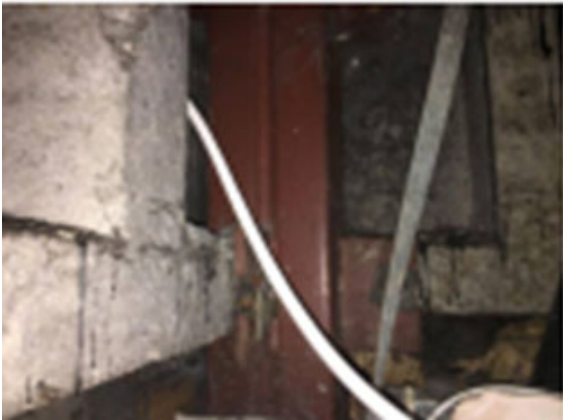
Item 196– Ref: Presumed

The column cladding in Classroom (G/002) is presumed to contain asbestos.
