### **ASBESTOS SURVEY REPORT FOR FARRINGTON ACADEMY SCHOOL, SUNDERLAND**

### **FARRINGTON ACADEMY SCHOOL, SUNDERLAND**

**Date: 05 June 2025**

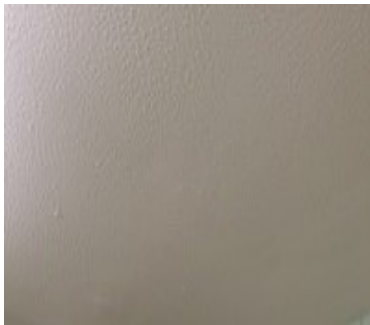
### **Item 11 As: 101894-1**

The textured coating to the ceiling in the time out room in the behaviour unit (Rm 008) contains asbestos.

Any change in its appearance should be recorded and passed to Property Services.

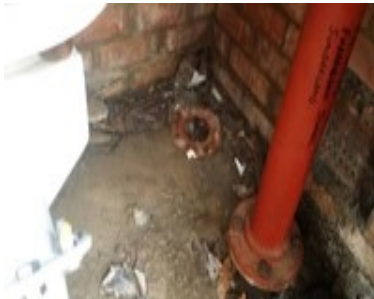
### **Item 17 Ref: 101894-9**

The loose lying gasket to the gas meter house contains asbestos.

Any change in its appearance should be recorded and passed to Property Services.

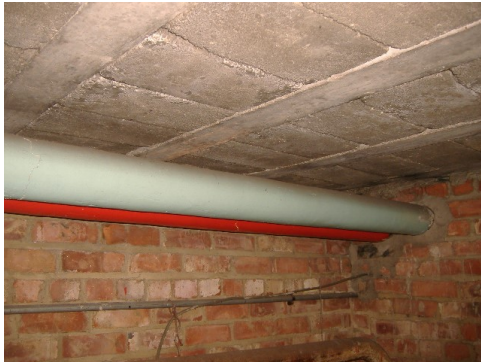
### **Item 39 - Ref: Presumed**

The pipework insulation to the tank room (Rm 0/110) is presumed to contain asbestos.

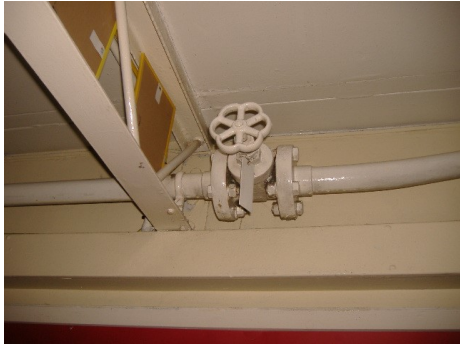
#### **Item 44- Ref: Presumed**

The gaskets to the corridor/first aid area (Rm 0/114) are presumed to contain asbestos.

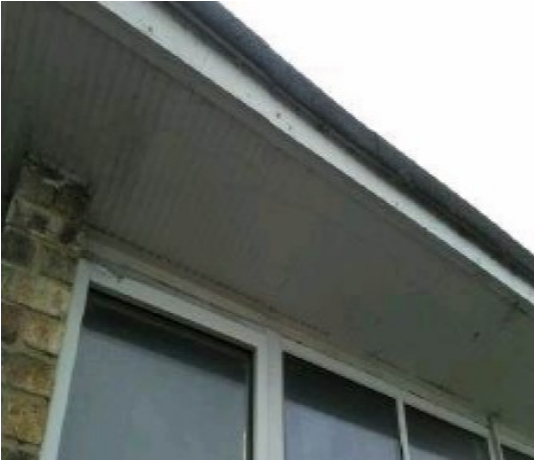
### **Item 47 - Ref: WC0483/08**

The soffits to the exterior of the building contain asbestos.

Any change in its appearance should be recorded and passed to Property Services.

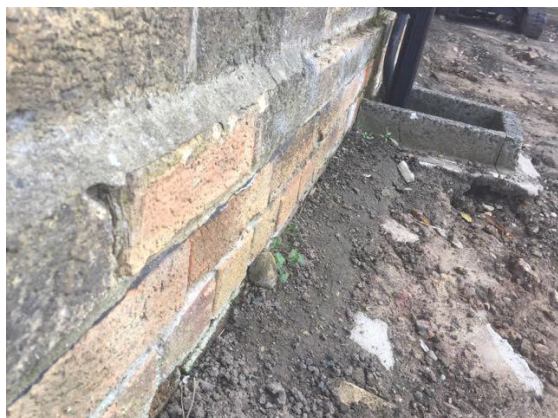
### **Item 53 - Ref: 741271-7**

The damp proof course to the Lower Wall (External) contains asbestos.

Any change in its appearance should be recorded and passed to Property Services.

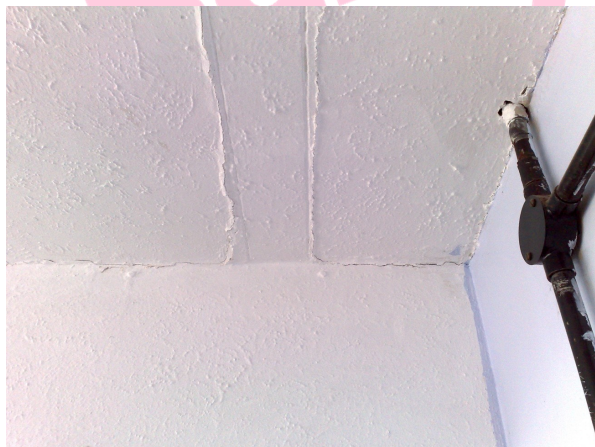
### **Item 56 - Ref: KR09/46**

The textured coating to the ceiling in Store B (Room 0/03) contains asbestos.

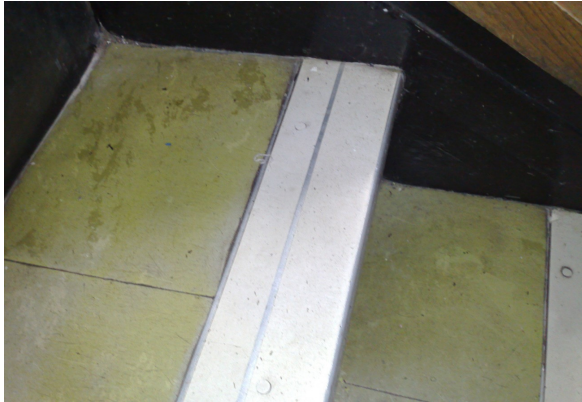
### **Item 85 - Ref: KR09/54**

The stair nosing in the stairwell and landings (Room 0/37) contains asbestos.

Any change in its appearance should be recorded and passed to Property Services.

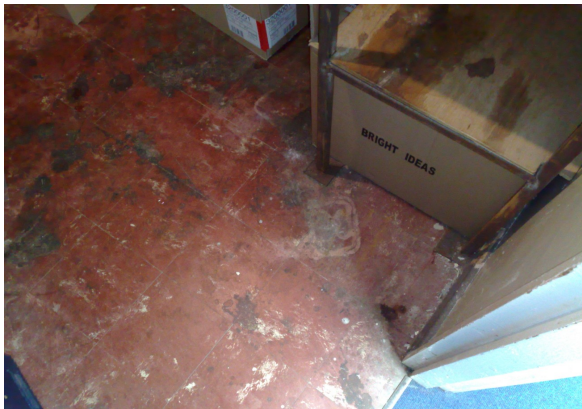
### **Item 93 - Ref: KR09/58**

The floor tiles and adhesive in Store D (Room 0/47) contains asbestos.

Any change in its appearance should be recorded and passed to Property Services.

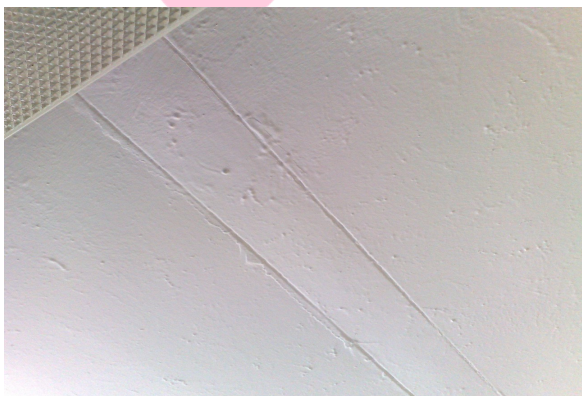
### **Item 94 - Ref: KR09/46**

The textured coating to the ceiling in the craft area (Room 0/48) contains asbestos.

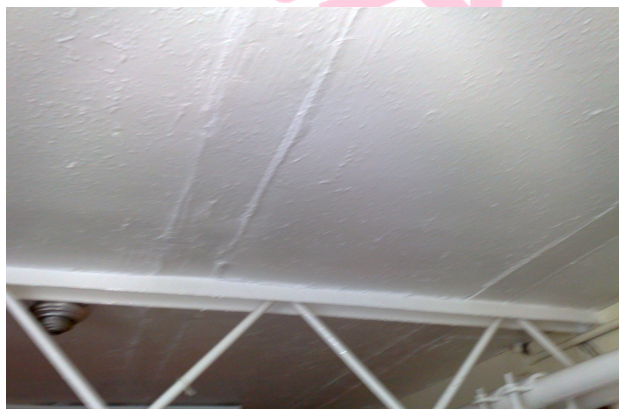
### **Item 109 - Ref: KR09/60**

The textured coating to the ceiling Kitchen area corridor (Room 0/69) contains asbestos.

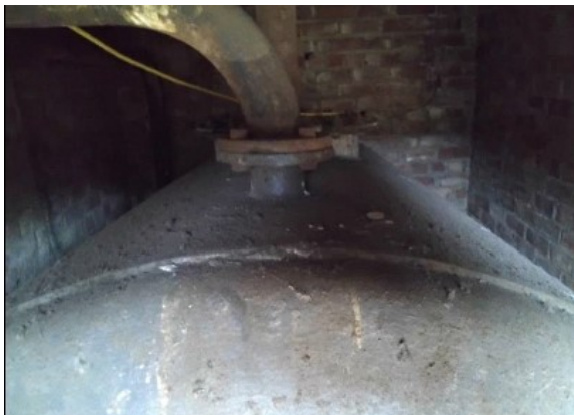
### **Item 184 - Ref: SC005251**

The debris/residue to tank in the Boiler Room (External) does contain asbestos.

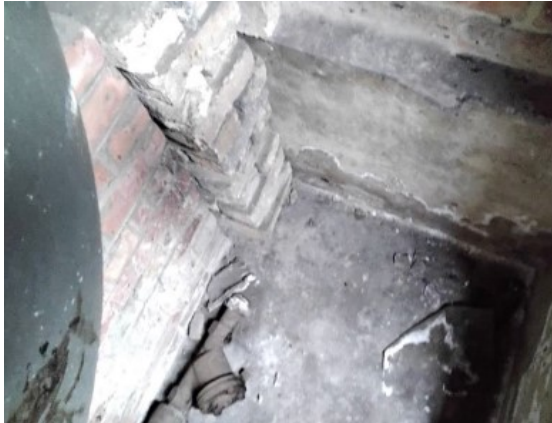
### **Item 185 - Ref: SC005252**

The debris/residue to the floor in the Boiler Room (External) does contain asbestos.

This should be removed asap.

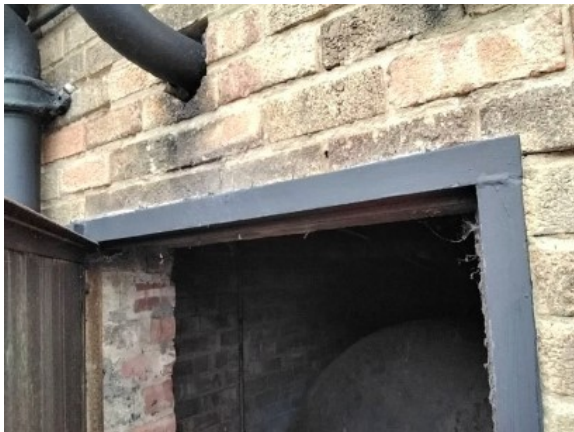
### **Item 186 - Ref: SC005254**

The door seal gasket in the Boiler Room (External) does contain asbestos.

Any change in appearance should be reported to Property Services.

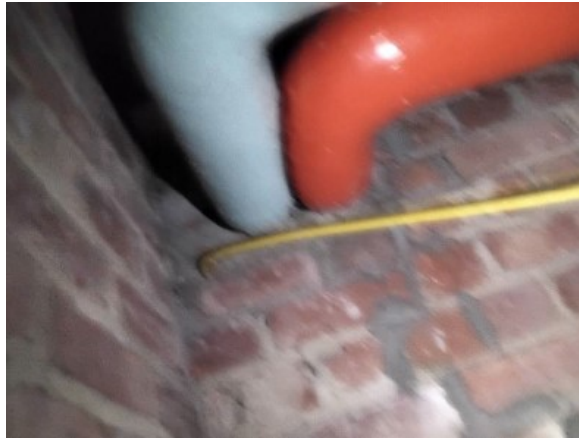
### **Item 188 - Ref: SC005250**

The pipework insulation in the Boiler Room (External) does contain asbestos.

Any change in appearance should be reported to Property Services.

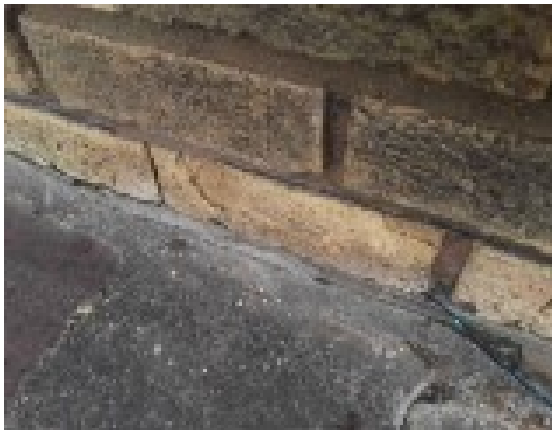
### **Item 216 - Ref: NZ001564**

The Damp proof course (External area 3 pointing area 2 roof E/001).

Any change in appearance should be reported to Property Services

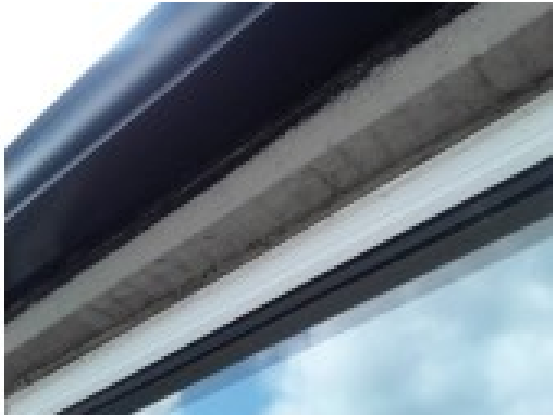
### **Item 218 - Ref: NZ001566**

The Soffits (External area 2 pointing E/002).

Any change in appearance should be reported to Property Services.

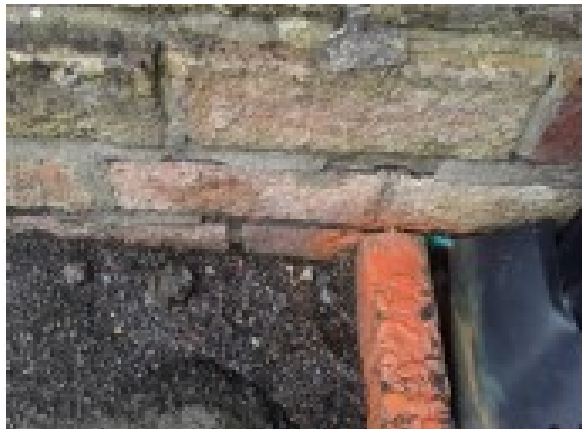
### **Item 219 - Ref: NZ001567**

The Damp proof course (External area 1 pointing E/003).

Any change in appearance should be reported to Property Services.

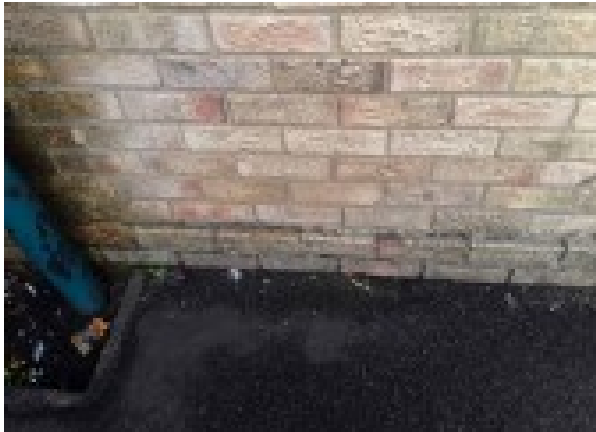
### **Item 221 - Ref: AS NZ001567**

The Damp proof course  
(External area 3 Roof E/004).

Any change in appearance  
should be reported to Property  
Services.

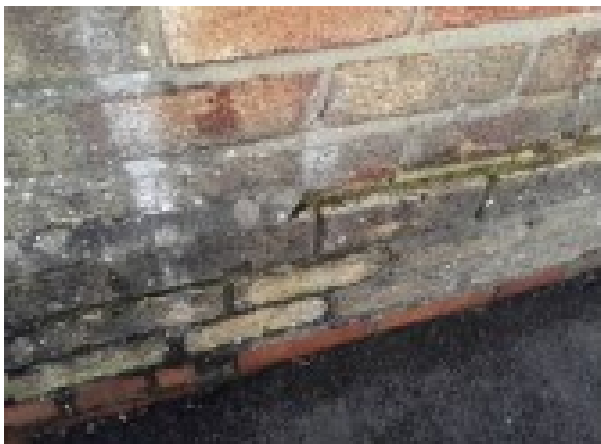
### **Item 223 - Ref: As NZ001565**

The Damp proof course  
(External area 4 Roof E/005).

Any change in appearance  
should be reported to Property  
Services.

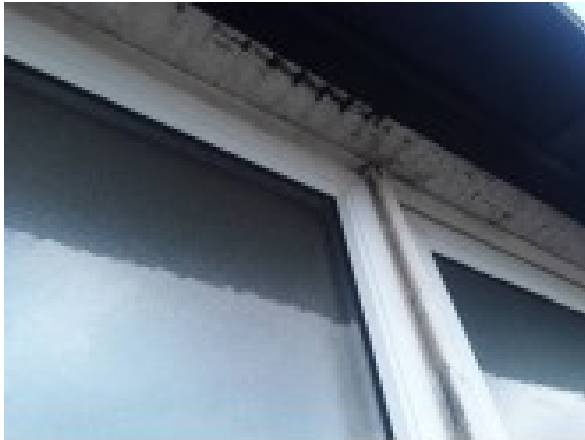
#### **Item 224 - Ref: NZ001568**

The Soffits (External area 4  
Roof E/005)

Any change in appearance  
should be reported to Property  
Services.
