ASBESTOS SURVEY REPORT FOR FARRINGDON ACADEMY SCHOOL, SUNDERLAND

**FARRINGTON ACADEMY SCHOOL,
SUNDERLAND**

Date: 26 March 2026

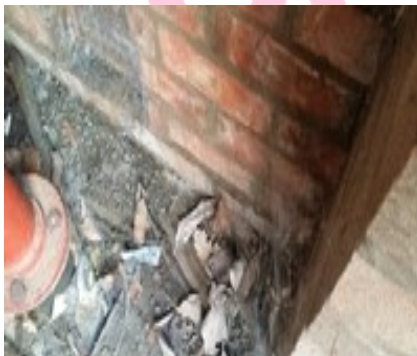
Item 18 Ref: 101894-10

The damp proof course to the gas meter house does not contain asbestos.

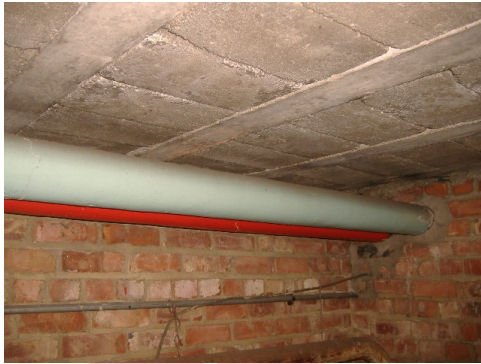
Item 39 - Ref: Presumed

The pipework insulation to the tank room (Rm 0/110) is presumed to contain asbestos.

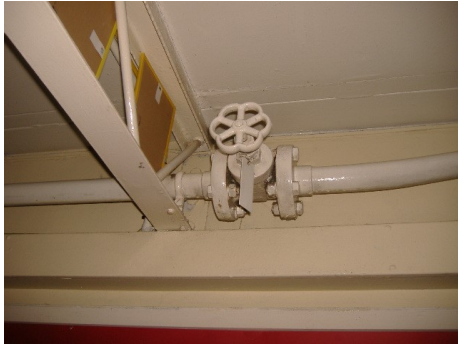
Item 44- Ref: Presumed

The gaskets to the corridor/first aid area (Rm 0/114) are presumed to contain asbestos.

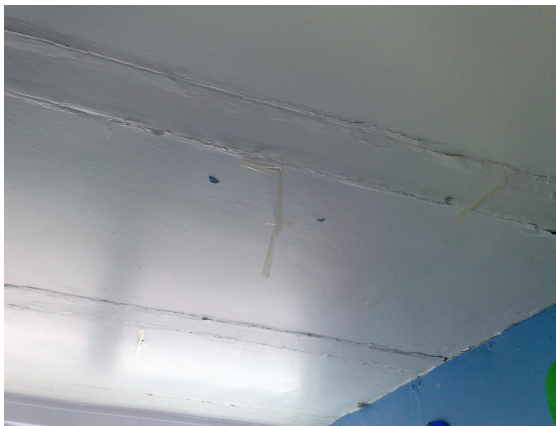
Item 54 - Ref: KR09/47

The ceiling in cloakroom 1 (Room 0/01) does not contain asbestos.

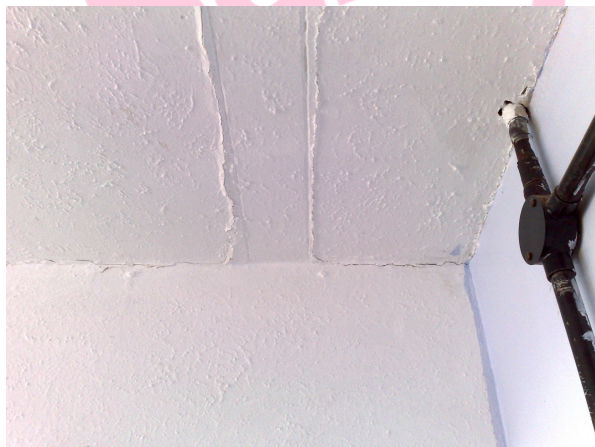
Item 56 - Ref: KR09/46

The textured coating to the ceiling in Store B (Room 0/03) contains asbestos.

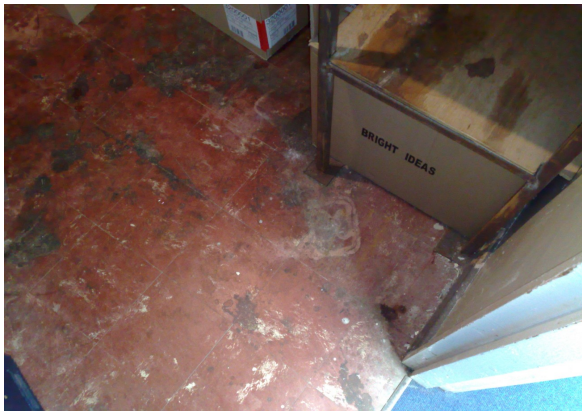
Item 93 - Ref: KR09/58

The floor tiles and adhesive in Store D (Room 0/47) contains asbestos.

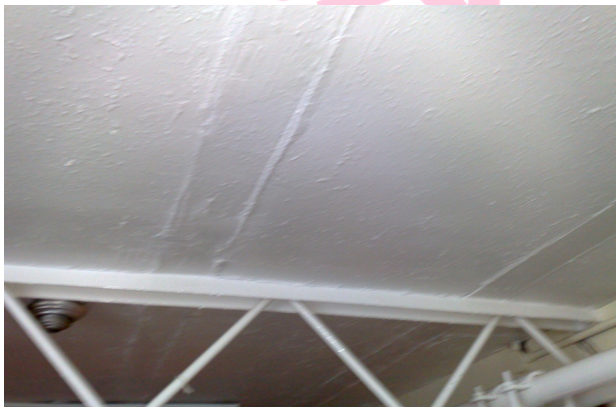
Item 109 - Ref: KR09/60

The textured coating to the ceiling Kitchen area corridor (Room 0/69) contains asbestos.

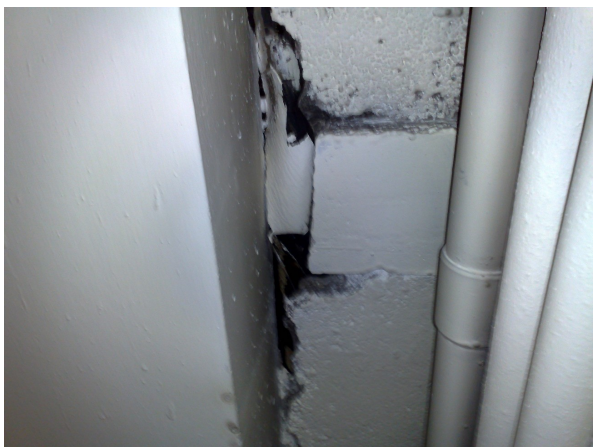
Item 134 - Ref: KR09/66

The bitumen material to ceiling above door in under stairs store (Room 0/83) does not contain asbestos.

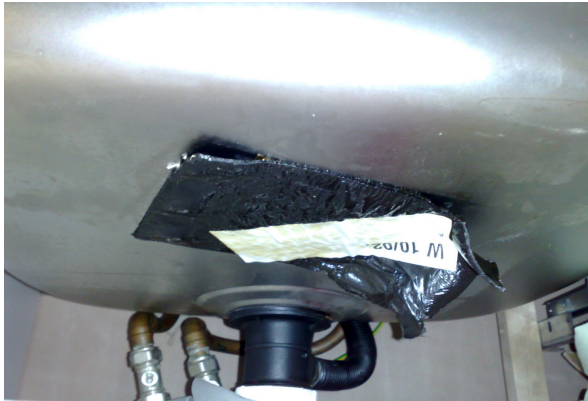
Item 143 - Ref: KR09/51

The sink pad in the kitchen (Room 0/021) does not contain asbestos.

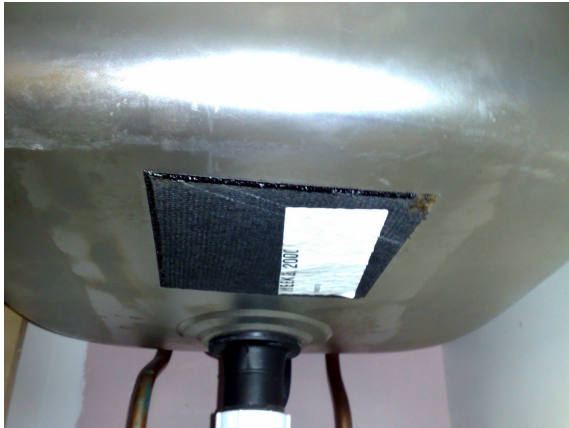
Item 145 - Ref: KR09/57

The sink pad in the Staff Room (Room 0/062) does not contain asbestos.

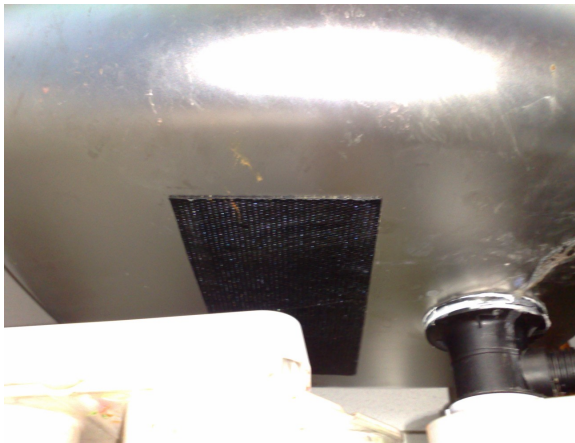
Item 146 - Ref: KR09/50

The sink pad in the Art Room (Room 0/016) does not contain asbestos.

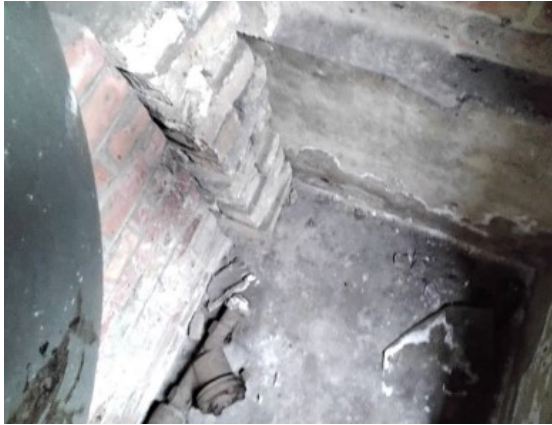
Item 185 - Ref: SC005252

The debris/residue to the floor in the Boiler Room (External) does contain asbestos.

This should be removed asap.

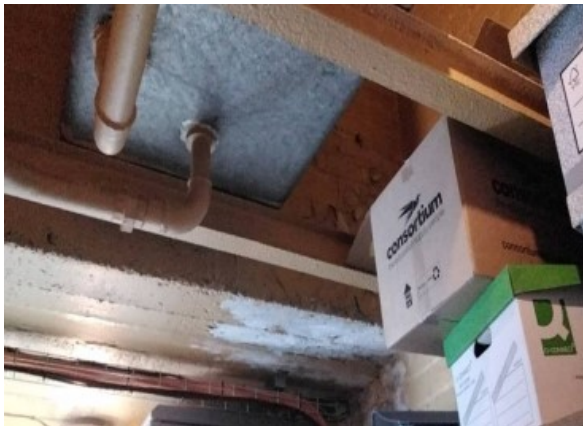
Item 189 - Ref: NO000640

The wall coating in the Store Room (Rm 1/001) does not contain asbestos.

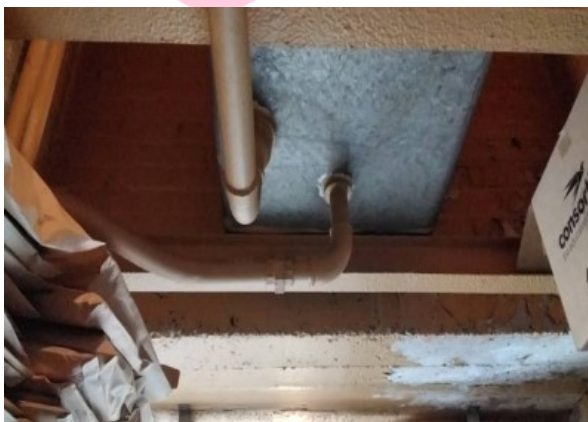
Item 190 - Ref: NO000641

The wall coating to tank support girders in the Store Room (Rm 1/001) does not contain asbestos.

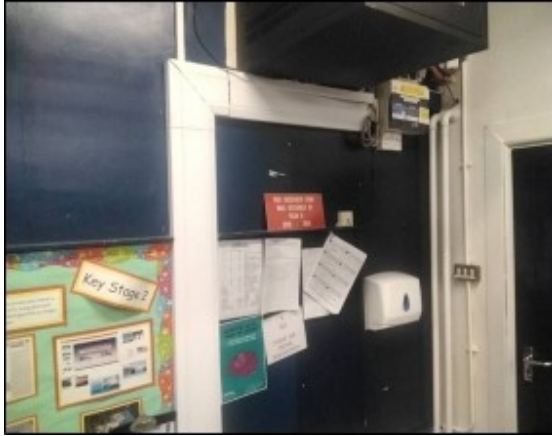
Item 191 - Ref: NG002283

The wall coating in the ITC Room (Rm G/001) does not contain asbestos.

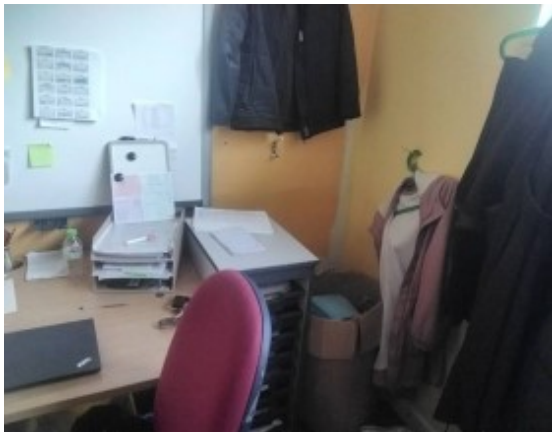
Item 192 - Ref: NG002302

The wall coating in the Canteen Office (Rm G/002) does not contain asbestos.

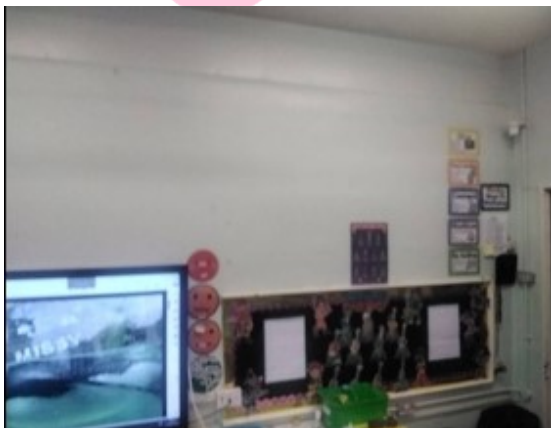
Item 196 - Ref: NG002288

The wall coating in the Year 3 Classroom (Rm G/006) does not contain asbestos.

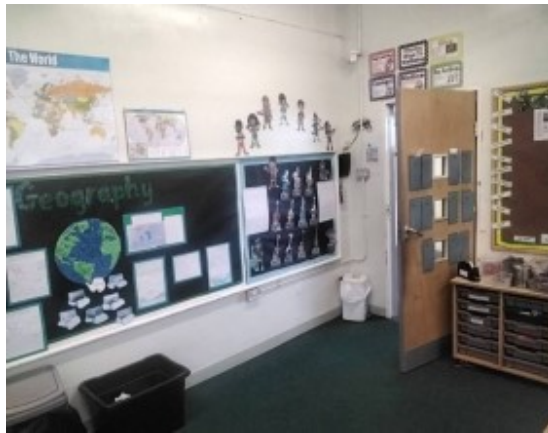
Item 197 - Ref: NG002289

The wall coating in the Year 3B Classroom (Rm G/007) does not contain asbestos.

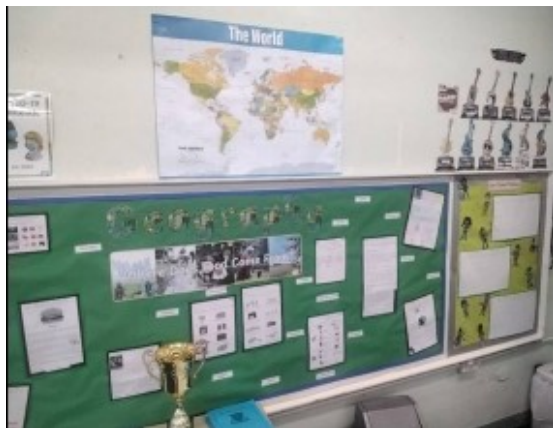
Item 198 - Ref: NG0023290

The wall coating in the 4A Classroom (Rm G/008) does not contain asbestos.

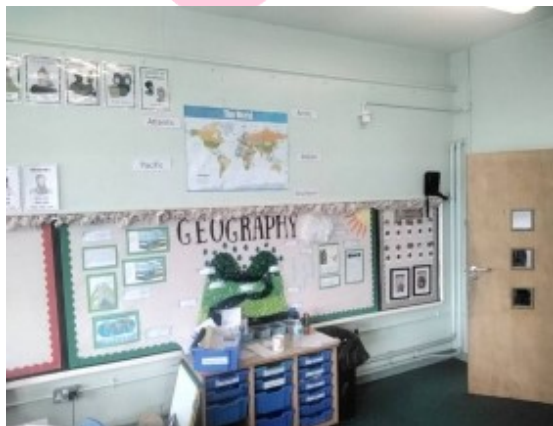
Item 199 - Ref: NG002291

The wall coating in the 5A Classroom (Rm G/009) does not contain asbestos.

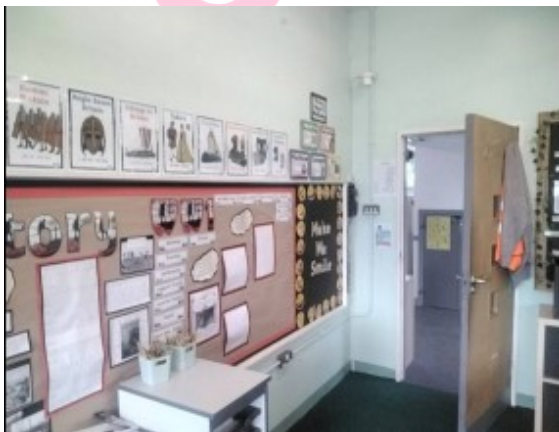
Item 202 - Ref: NG002294

The wall coating in the 6B Classroom (Rm G/012) does not contain asbestos.

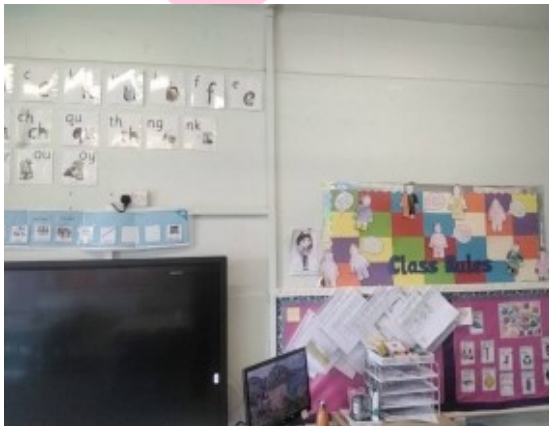
Item 205 - Ref: NG002298

The wall coating in the 1B Classroom (Rm G/015) does not contain asbestos.

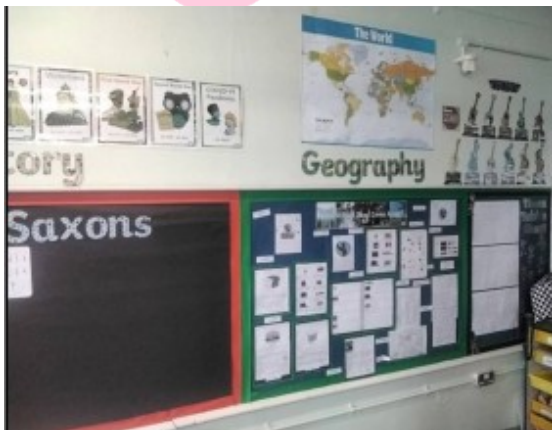
Item 208 - Ref: NG002304

The wall coating in the 4B Classroom (Rm G/018) does not contain asbestos.

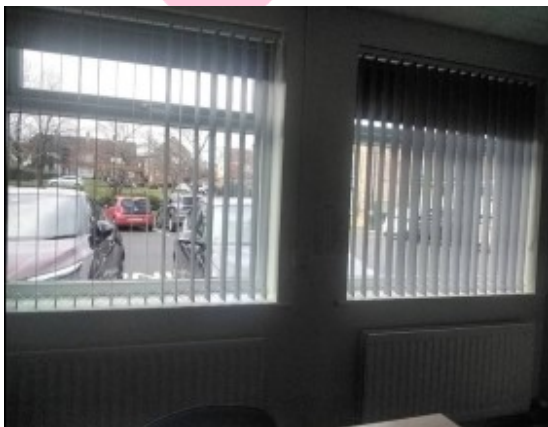
Item 211 - Ref: NG002307

The wall coating in the TLR Room (Rm G/021) does not contain asbestos.

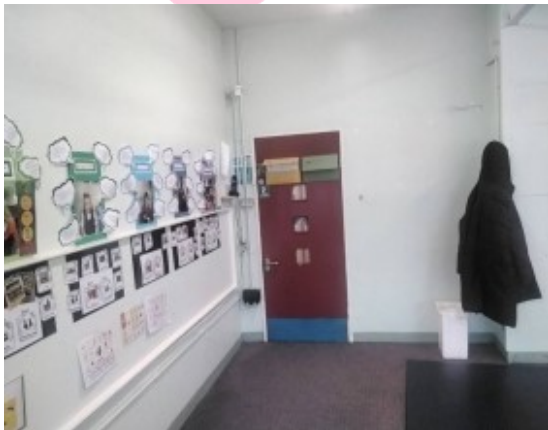
Item 214 - Ref: NG002285

The wall coating in the Soft Play (Rm G/024) does not contain asbestos.

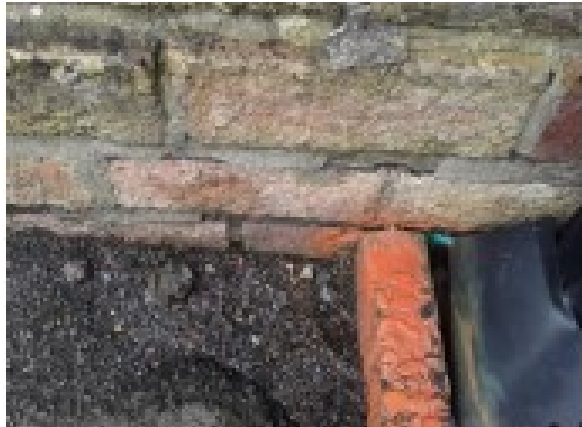
Item 219 - Ref: NZ001567

The Damp proof course (External area 1 pointing E/003).

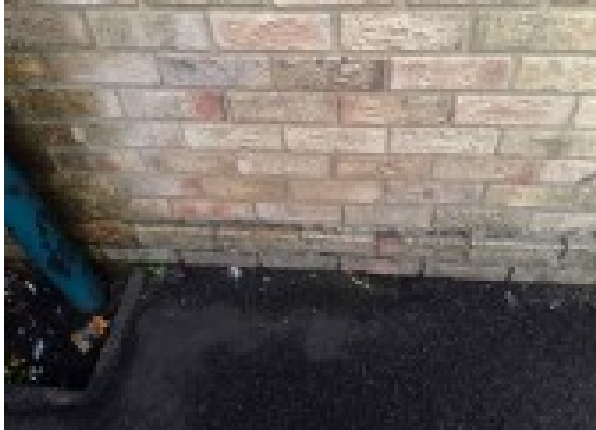
Item 221 - Ref: AS NZ001567

The Damp proof course
(External area 3 Roof E/004).

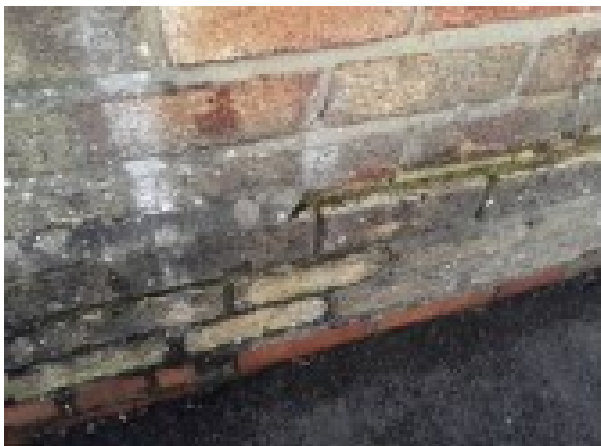
Item 223 - Ref: As NZ001565

The Damp proof course
(External area 4 Roof E/005).

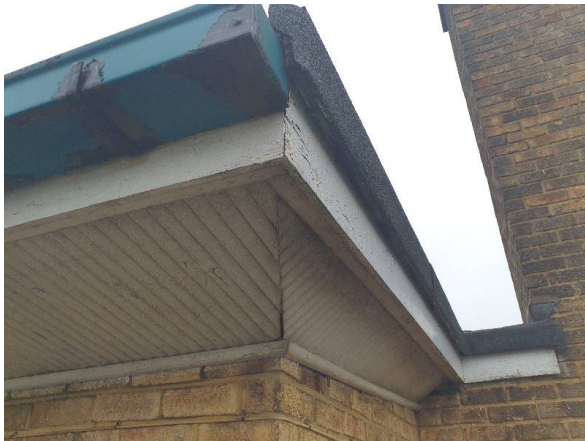
Item 225 - Ref: OU003187

The Cement Soffits (External E/001) contain asbestos.

Any change in appearance should be reported to Property Services.

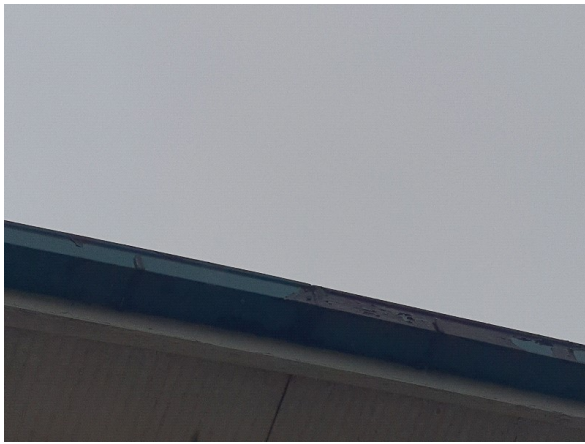
Item 226 - Ref: OU003187

The joint capping – rainwater goods (External E/001) contain asbestos.

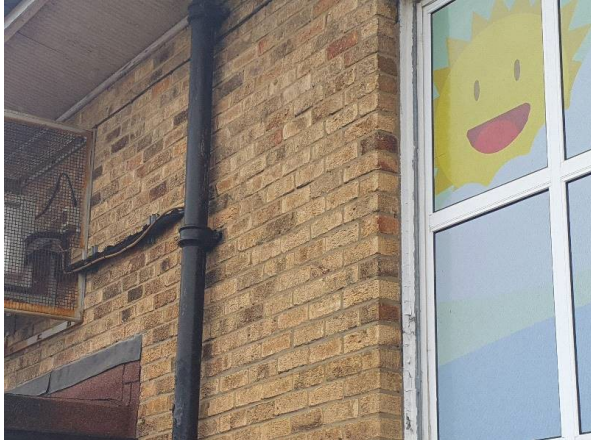
Item 227 - Ref: OU003187

The joint capping – downpipes (External E/001) contain asbestos.

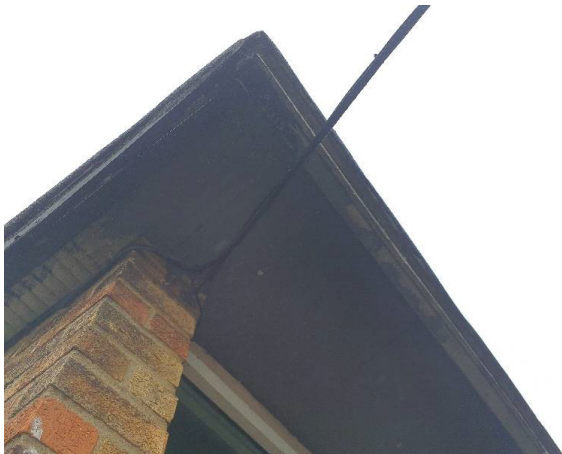
Item 229 - Ref: OU003192

The Cement Soffits (External E/001) contains asbestos.

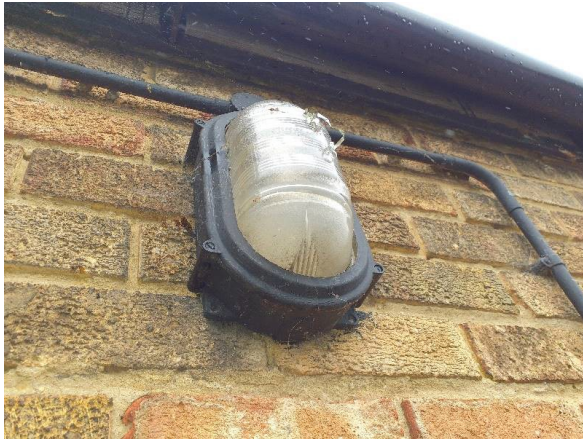
Item 230 - Ref: OU003194

The sealant around oval spot light (External E/001) contain asbestos.

Any change in appearance should be reported to Property Services.

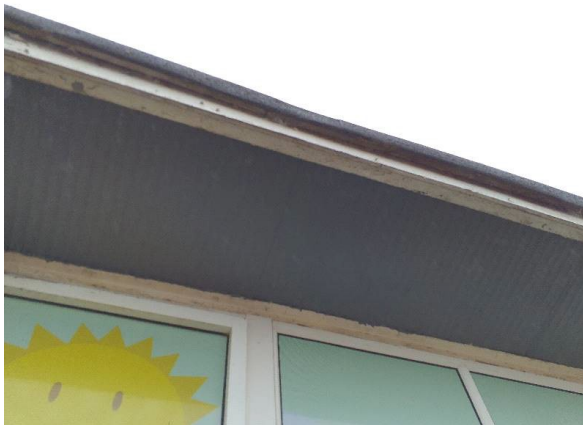
Item 231 - Ref: OU003195

The Cement Soffits (External E/001) contain asbestos.

Any change in appearance should be reported to Property Services.

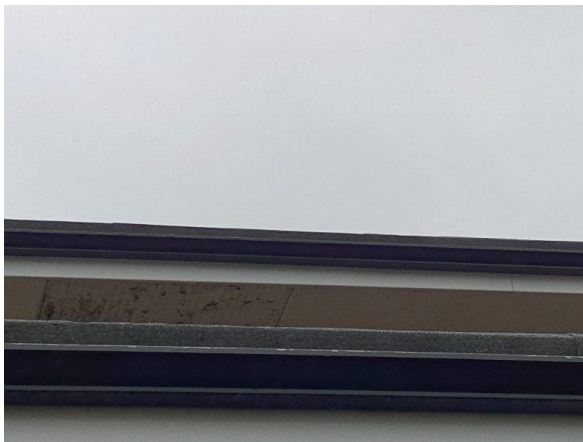
Item 232 - Ref: OU003197

The Cement Soffits (External E/001) contains asbestos.

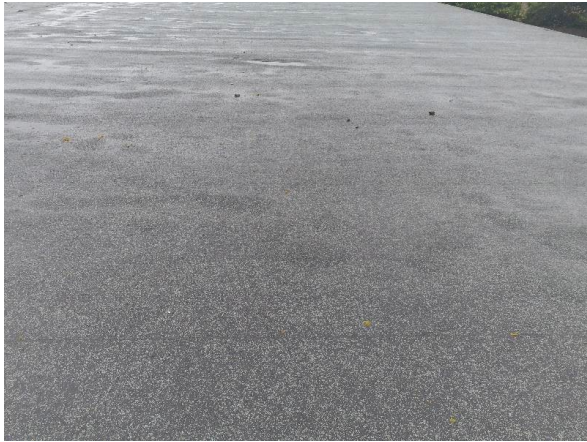
Item 233 - Ref: OU003177

The bitumen lining roof (External E/001) does not contain asbestos.

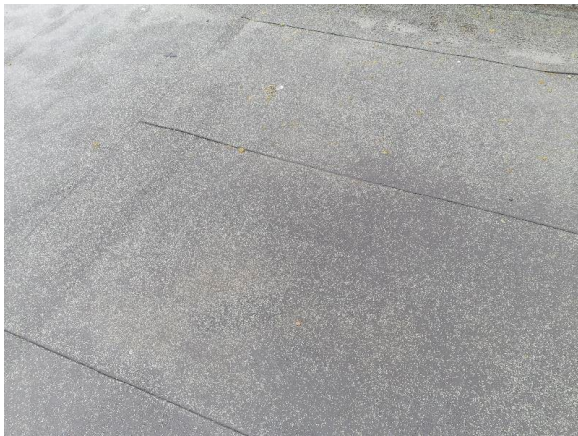
Item 234 - Ref: OU003178

The bitumen lining roof (External E/001) does not contain asbestos.

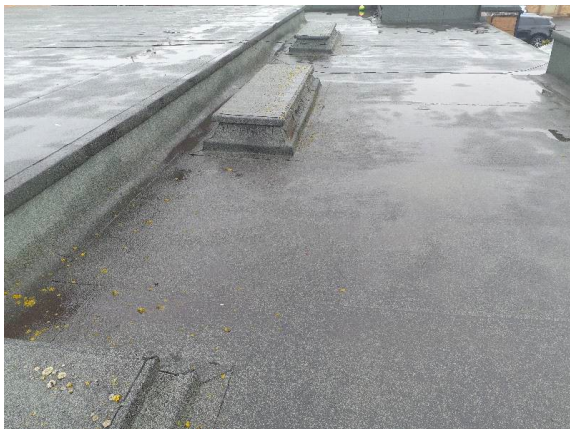
Item 235 - Ref: OU003179

The bitumen sealant around covered skylights (External E/001) does not contain asbestos.

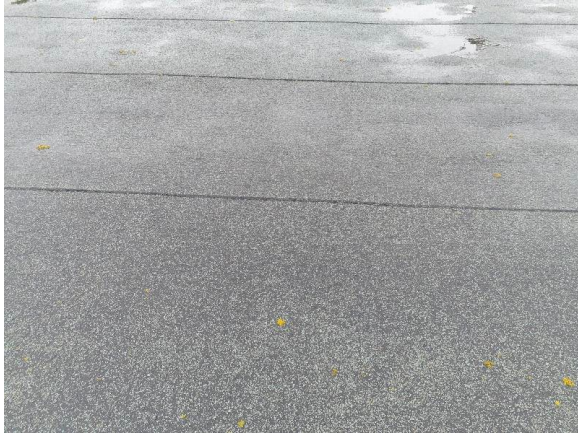
Item 236 - Ref: OU003180

The bitumen lining roof (External E/001) does not contain asbestos.

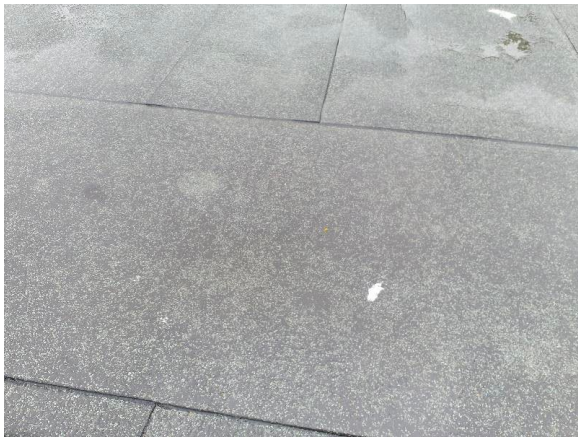
Item 237 - Ref: OU003181

The bitumen lining roof (External E/001) does not contain asbestos.

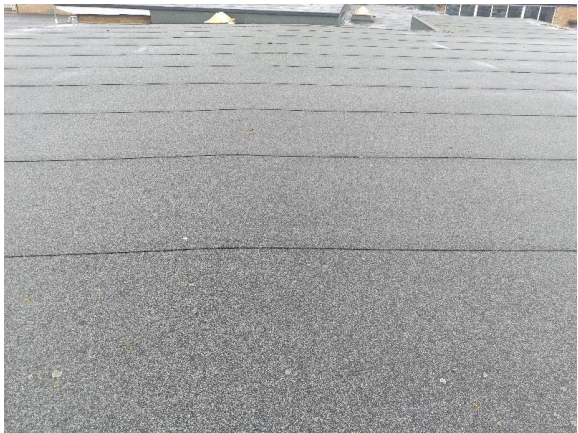
Item 238 - Ref: OU003182

The bitumen lining roof (External E/001) does not contain asbestos.

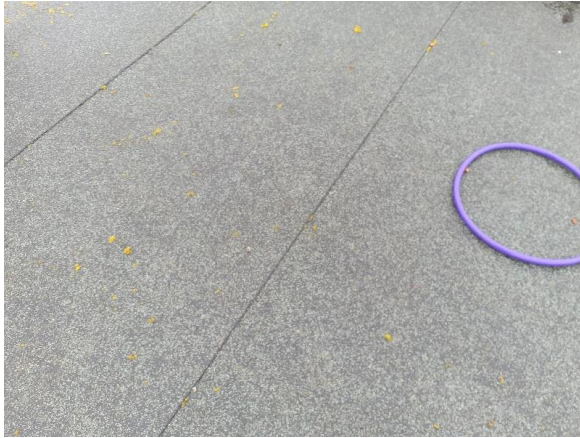
Item 239 - Ref: OU003183

The bitumen lining roof (External E/001) does not contain asbestos.

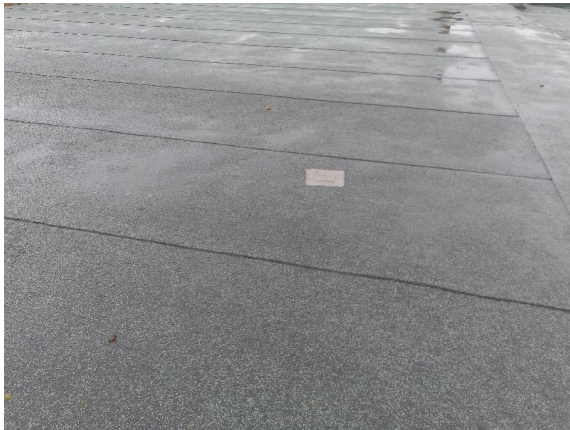
Item 240 - Ref: OU003184

The bitumen lining roof (External E/001) does not contain asbestos.

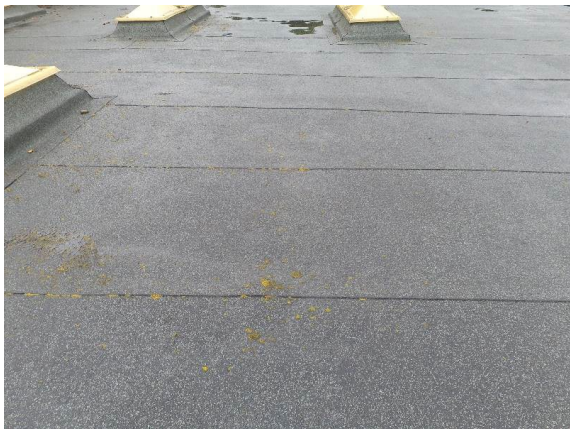
Item 241 - Ref: OU003185

The bitumen lining roof (External E/001) does not contain asbestos.

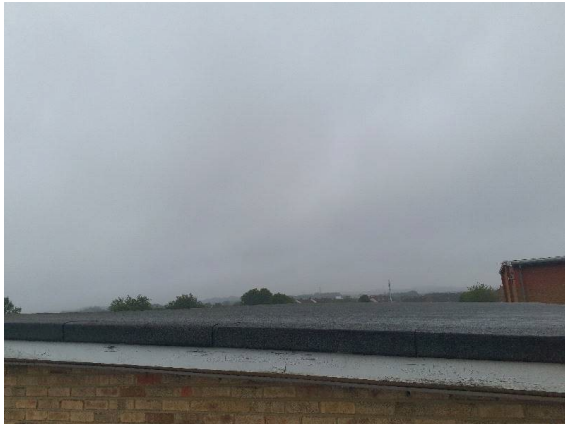
Item 242 - Ref: OU003186

The bitumen lining roof (External E/001) does not contain asbestos.
