### **ASBESTOS SURVEY REPORT FOR NEW PENSHAW ACADEMY, NEW PENSHAW, SUNDERLAND, DH4 7HY**

## **Asbestos Register for New Penshaw Academy**

**Date: 08 August 2025**

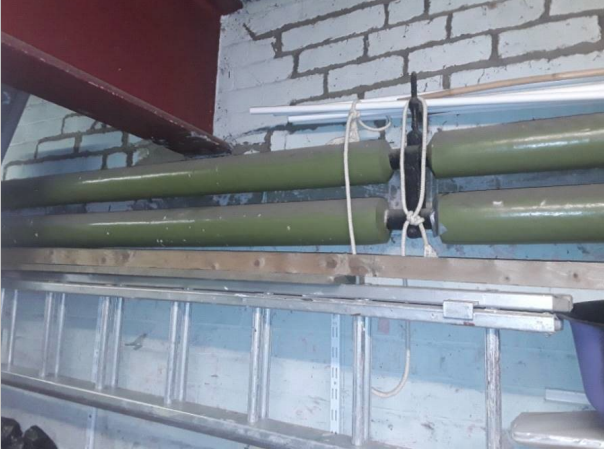
1	NZ000608	Pipework insulation top pipe painted green	Boiler Room Entrance Z1/001	No Risk

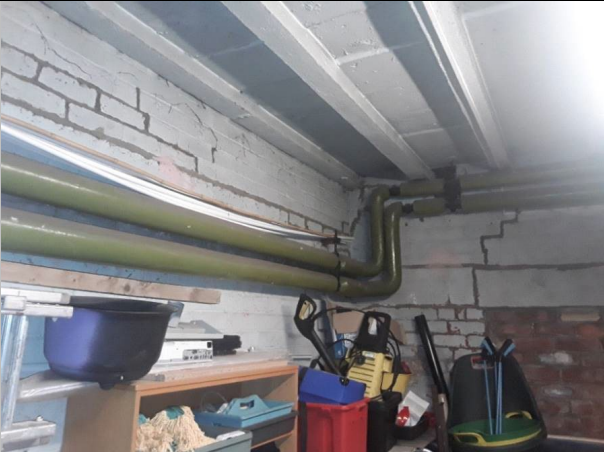
2	NZ000609	Pipework insulation bottom pipe painted green	Boiler Room Entrance Z1/001	No Risk

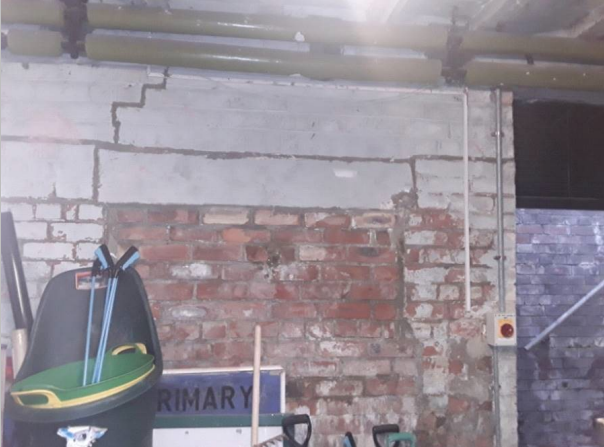
3	NZ000610	Debris/Residue to entrance wall	Boiler Room Entrance Z1/001	No Risk

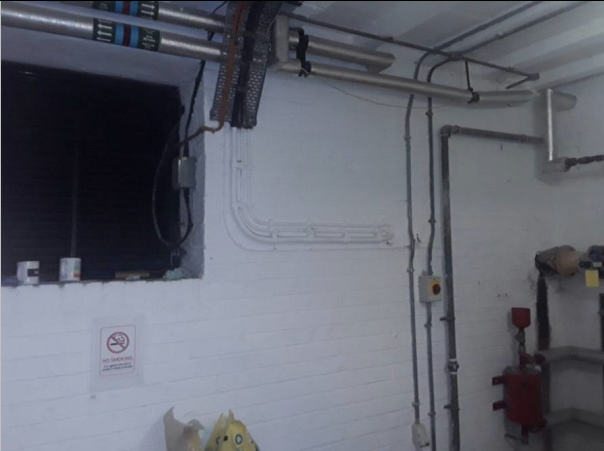
10	NZ000616	Debris/residue to entrance wall	Boiler Room Z1/002	No Risk

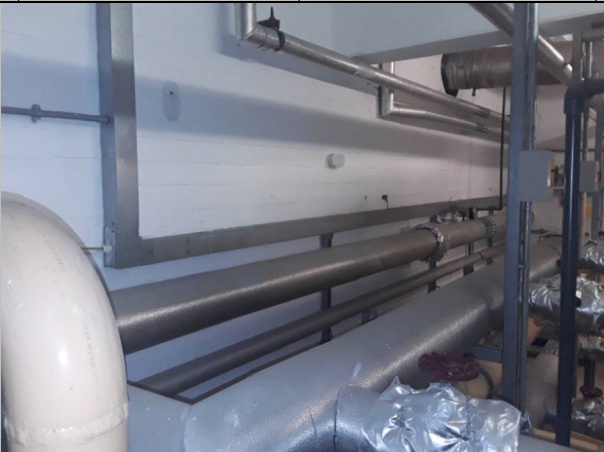
11	NZ000617	Debris/residue to left hand wall rear of boilers and on cable conduit	Boiler Room Z1/002	No Risk

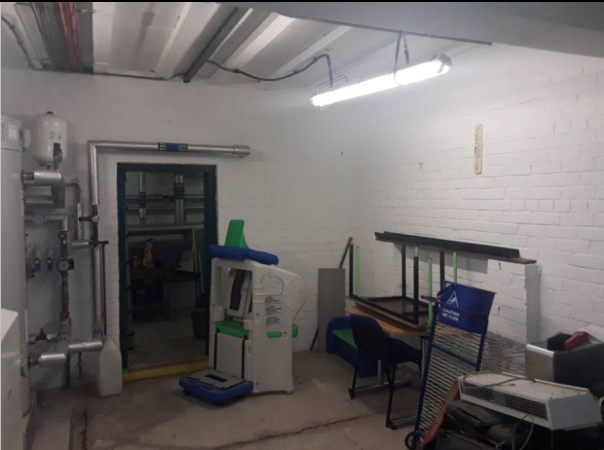
12	NZ000618	Debris/residue to boiler room rear and right-hand wall	Boiler Room Z1/002	No Risk

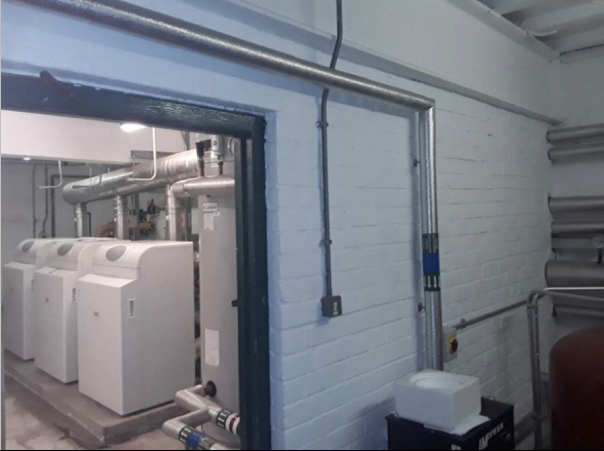
16	NZ000622	Debris/residue to entrance and left-hand wall	Boiler Room Rear Z1/003	No Risk

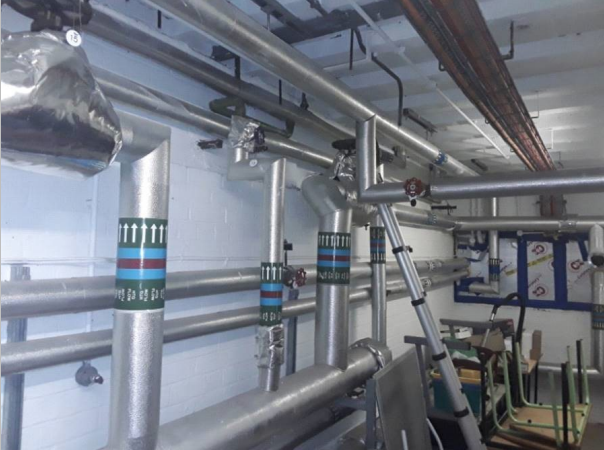
17	NZ000623	Debris/residue to rear and right-hand wall including pipework brackets	Boiler Room Rear Z1/003	No Risk

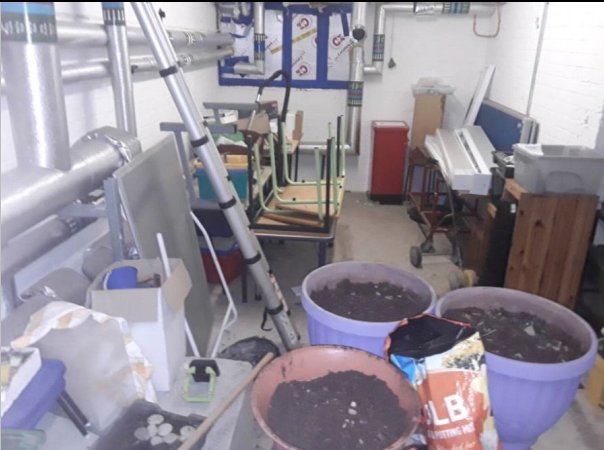
18	NZ000624	Debris/residue to floor	Boiler Room Rear Z1/003	No Risk

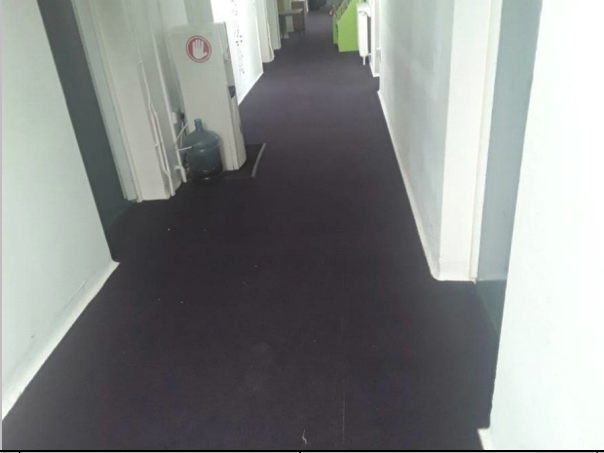
25	NZ000599	Floor tile with adhesive remnants under carpet	Corridor G/021	No Risk

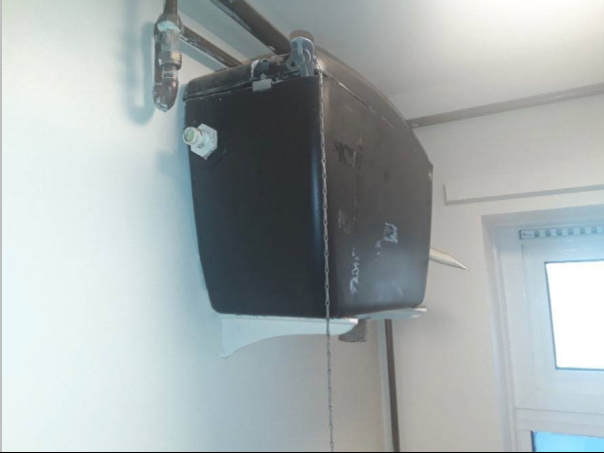
26	NZ000600	Toilet cisterns redundant	Toilets G/024	No Risk

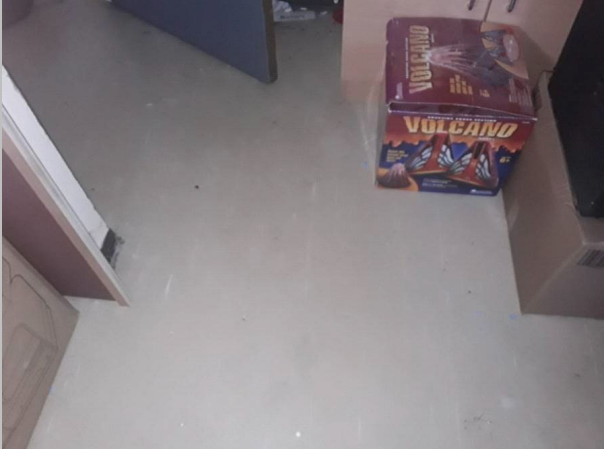
27	NZ000601	Floor covering	Store Room G/030	No Risk

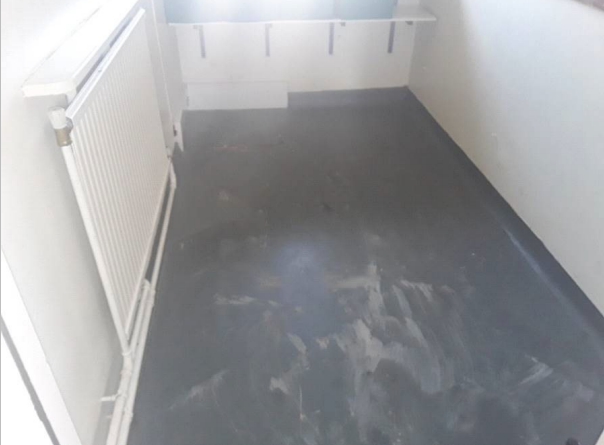
28	NZ000602	Floor covering	Cloak Room G/031	No Risk

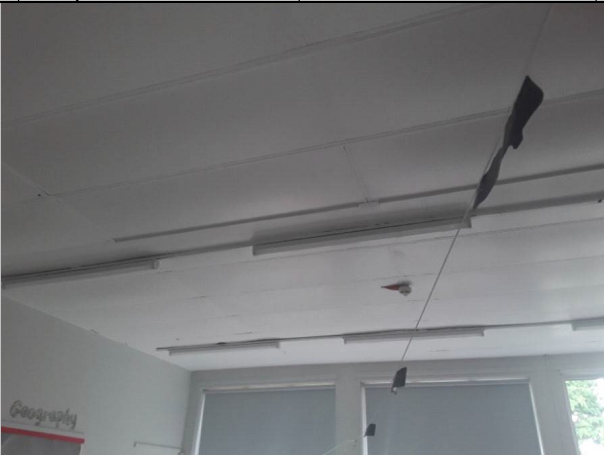
29	NZ000603	Ceiling Tile suspended solid	Classroom 7 G/034	No Risk

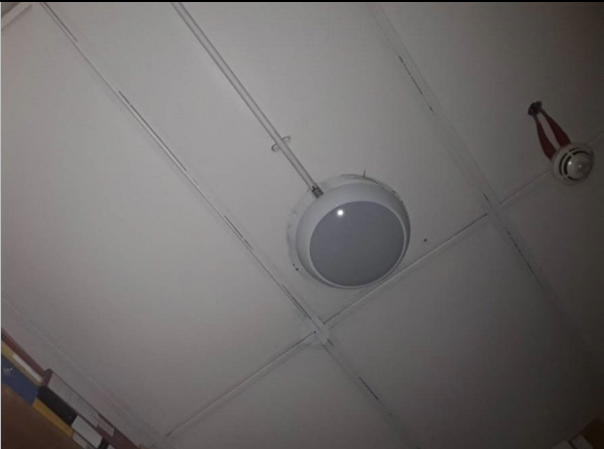
30	As NZ000603	Ceiling Tile suspended solid	Store room right hand within Classroom 7 G/035	No Risk

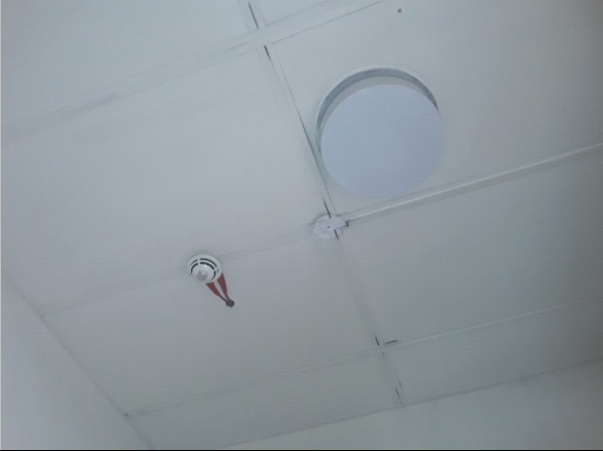
31	As NZ000603	Ceiling Tile suspended solid	Store room left hand within Classroom 7 G/036	No Risk

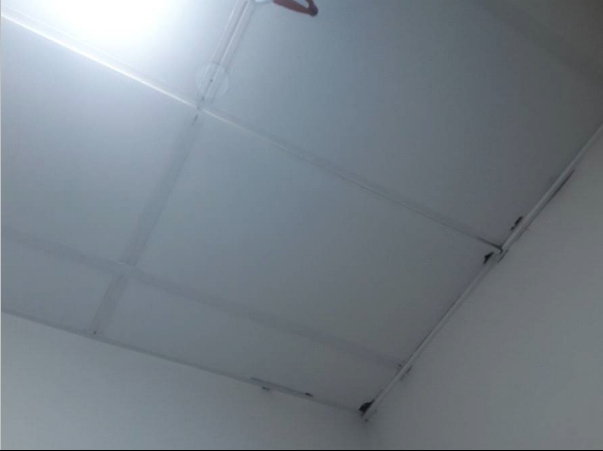
32	As NZ000603	Ceiling Tile suspended solid	Store room within Classroom 6 G/037	No Risk

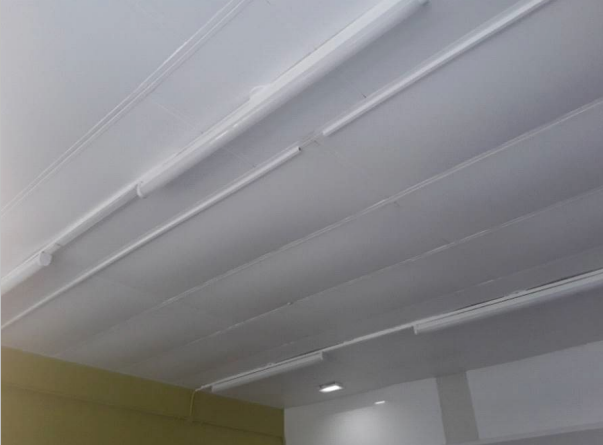
33	As NZ000603	Ceiling Tile suspended solid	Classroom 6 G/038	No Risk

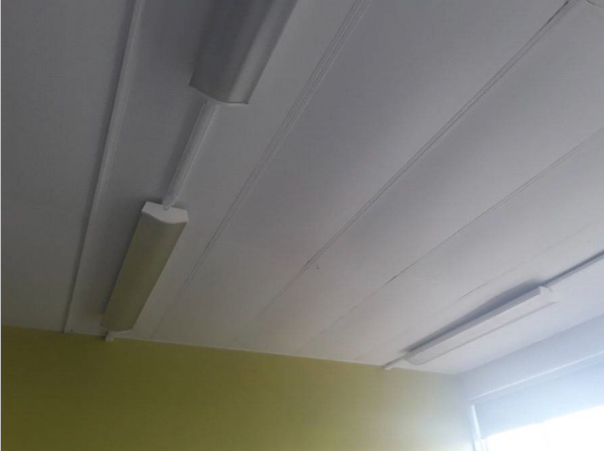
43	As NZ000606	Ceiling tile suspended solid	Classroom 2 G/083	No Risk

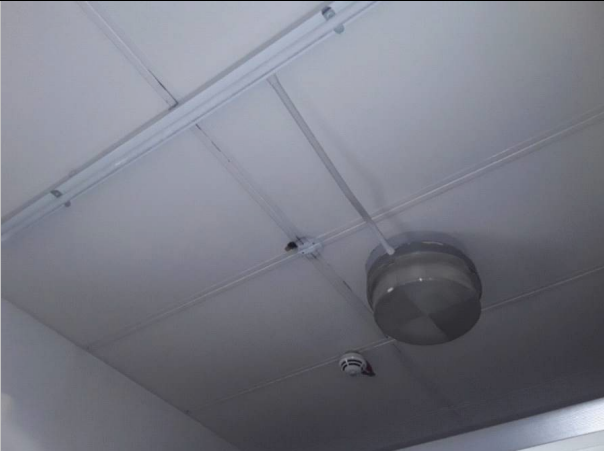
44	As NZ000606	Ceiling tile suspended solid	Store room right hand within Classroom 2 G/084	No Risk

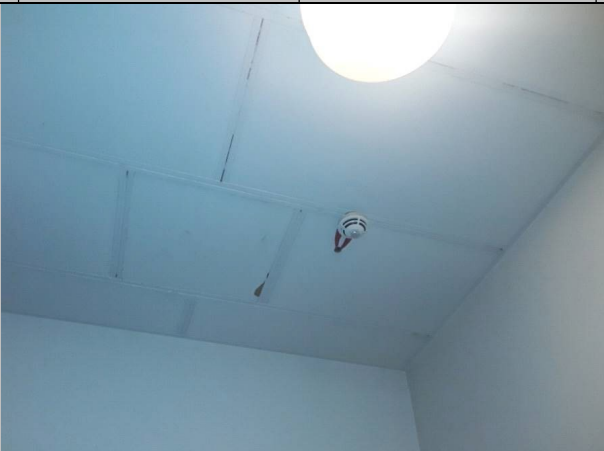
45	As NZ000606	Ceiling tile suspended solid	Store room left hand within Classroom 2 G/085	No Risk

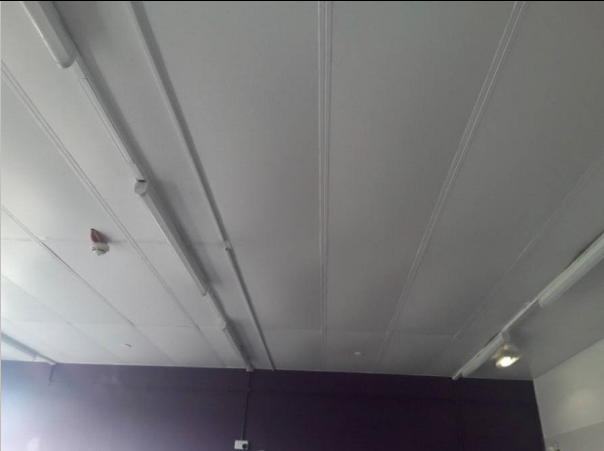
46	As NZ000606	Ceiling tile suspended solid	Classroom 3 G/086	No Risk

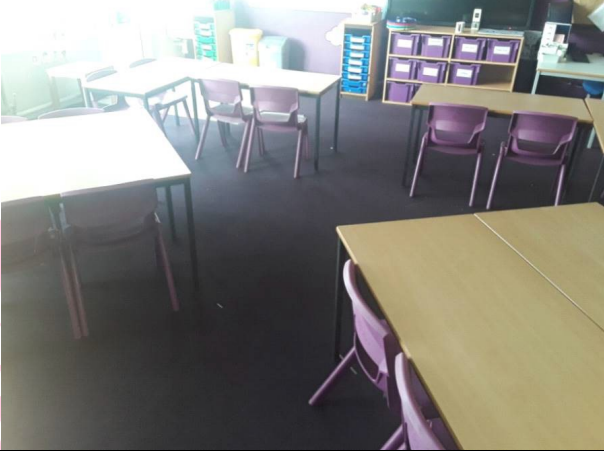
47	NZ000607	Floor covering under carpet	Classroom 3 G/086	Very Low Risk – inspect 12 monthly

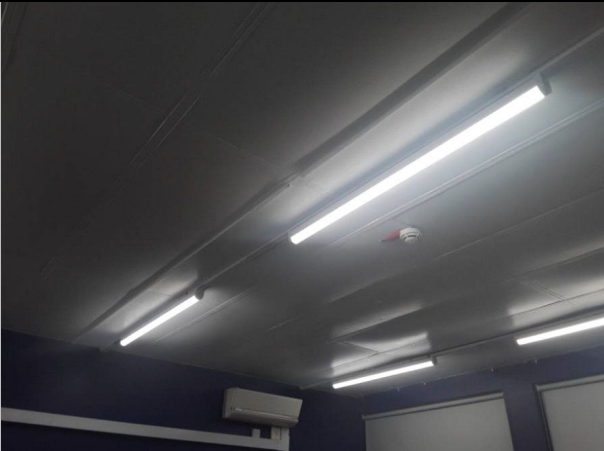
48	As NZ000606	Ceiling tile suspended solid	Classroom 4 G/087	No Risk

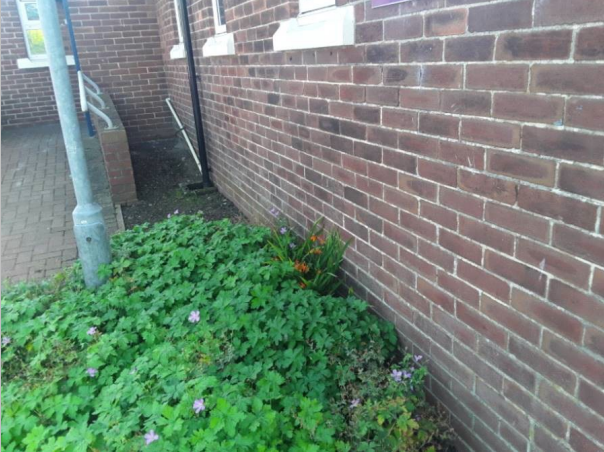
49	NZ000628	Damp proof course	External E/001	No Risk

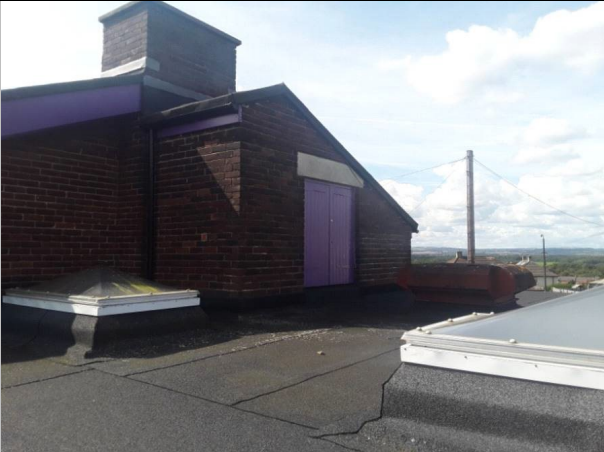
50	NZ000629	Roof flashing to roof top plant room	External E/001	No Risk

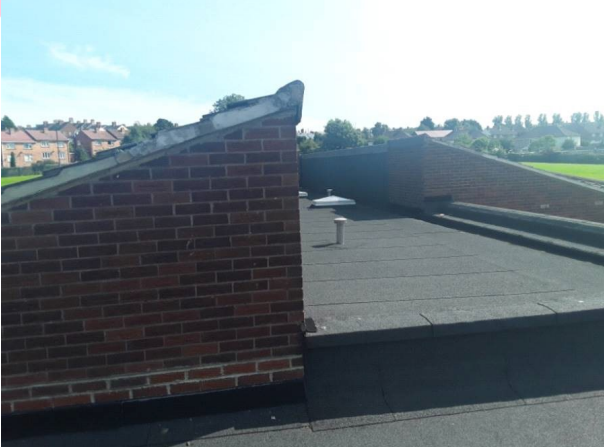
51	NZ000630	Undercloak to nursery block	External E/001	Very Low Risk – inspect 12 monthly
