ASBESTOS SURVEY REPORT FOR NEW PENSHAW ACADEMY, NEW PENSHAW, SUNDERLAND, DH4 7HY

Asbestos Register for New Penshaw Academy

Date: 23 June 2025

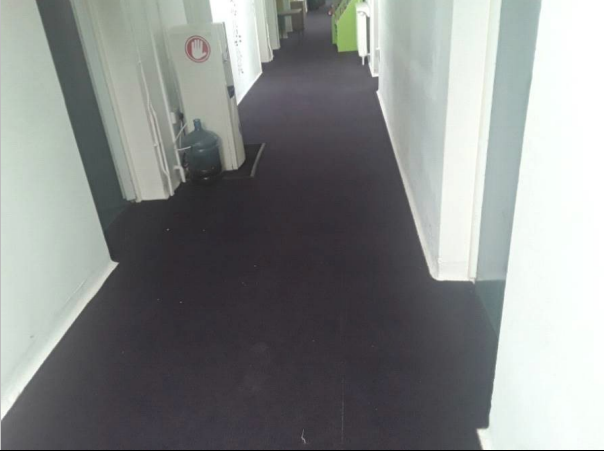
25	NZ000599	Floor tile with adhesive remnants under carpet	Corridor G/021	No Risk

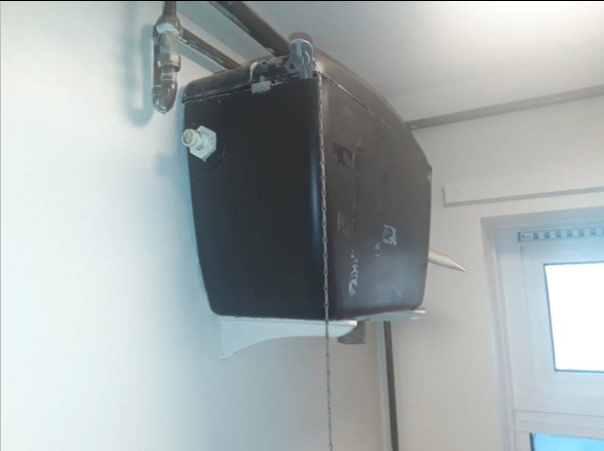
26	NZ000600	Toilet cisterns redundant	Toilets G/024	No Risk

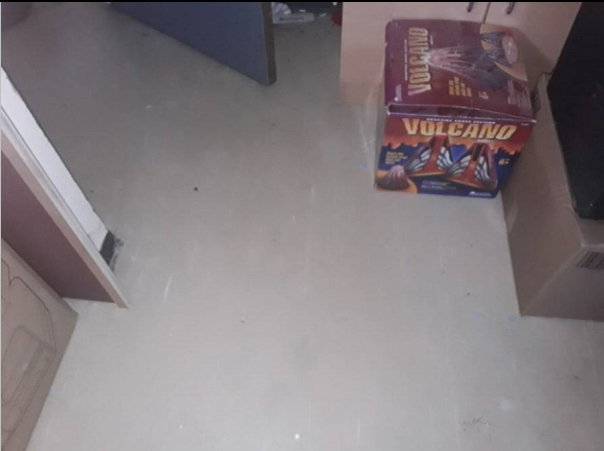
27	NZ000601	Floor covering	Store Room G/030	No Risk

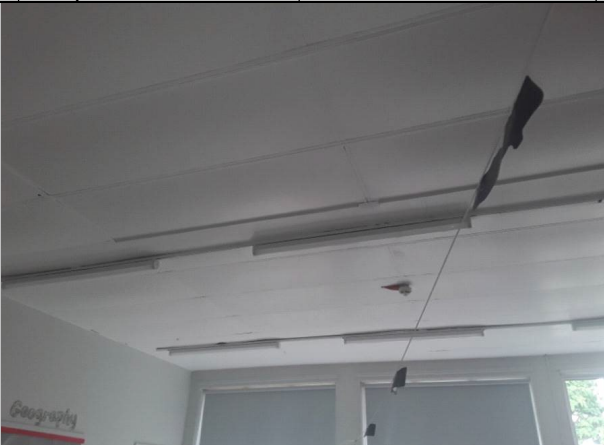
29	NZ000603	Ceiling Tile suspended solid	Classroom 7 G/034	No Risk

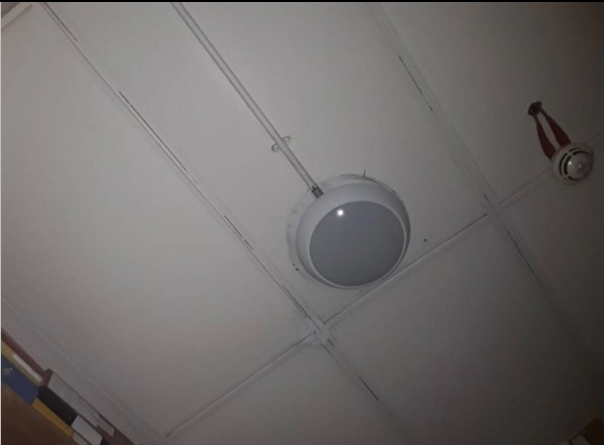
30	As NZ000603	Ceiling Tile suspended solid	Store room right hand within Classroom 7 G/035	No Risk

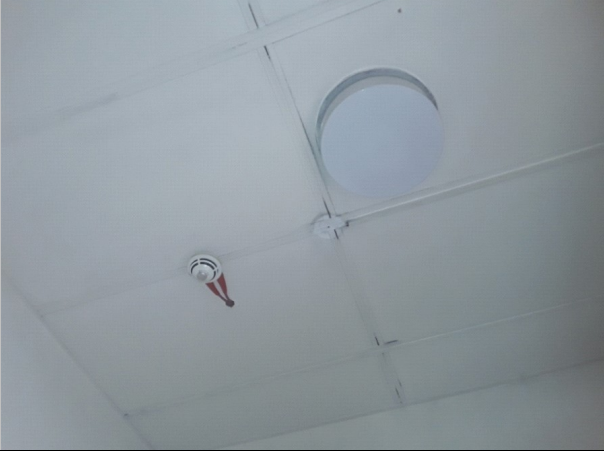
31	As NZ000603	Ceiling Tile suspended solid	Store room left hand within Classroom 7 G/036	No Risk

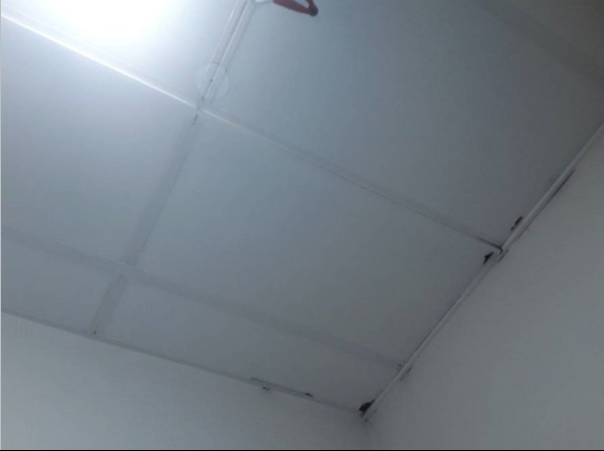
32	As NZ000603	Ceiling Tile suspended solid	Store room within Classroom 6 G/037	No Risk

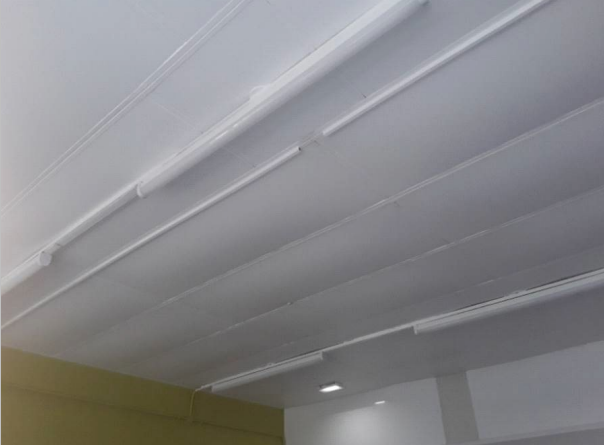
33	As NZ000603	Ceiling Tile suspended solid	Classroom 6 G/038	No Risk

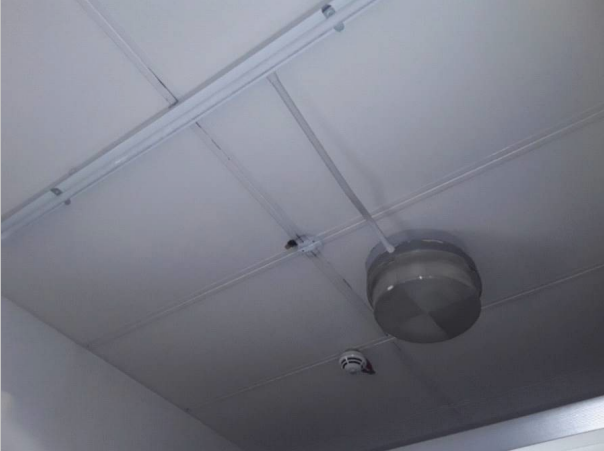
44	As NZ000606	Ceiling tile suspended solid	Store room right hand within Classroom 2 G/084	No Risk

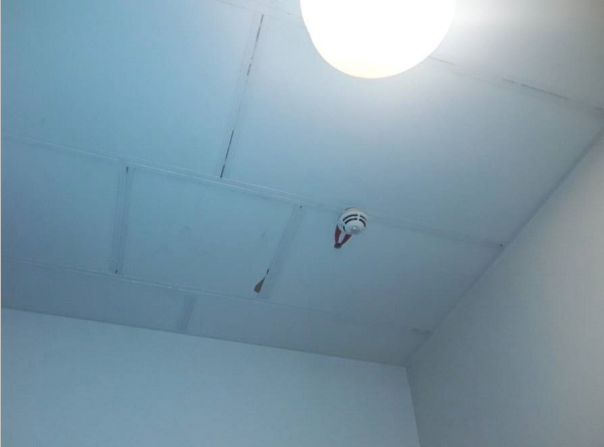
45	As NZ000606	Ceiling tile suspended solid	Store room left hand within Classroom 2 G/085	No Risk

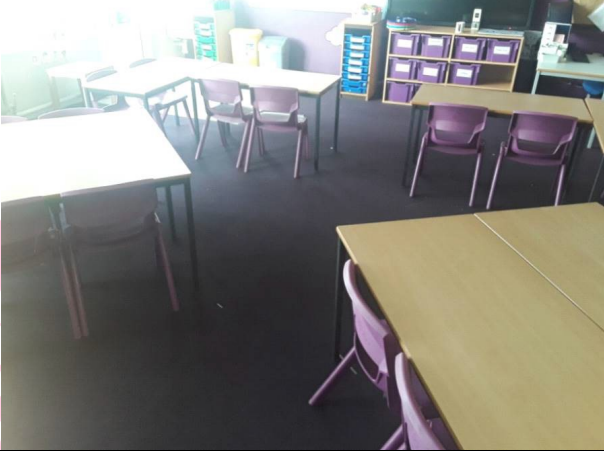
47	NZ000607	Floor covering under carpet	Classroom 3 G/086	Very Low Risk – inspect 12 monthly

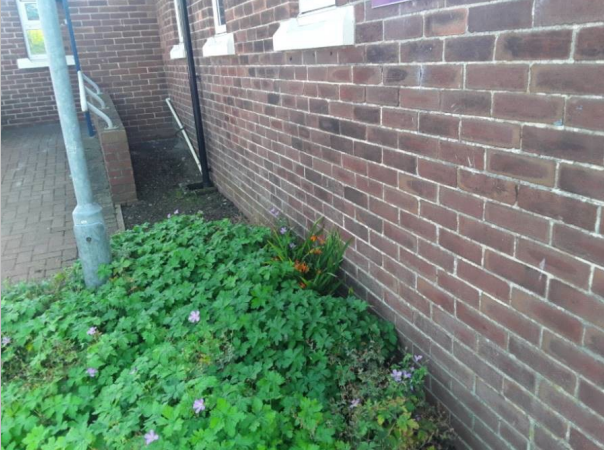
49	NZ000628	Damp proof course	External E/001	No Risk

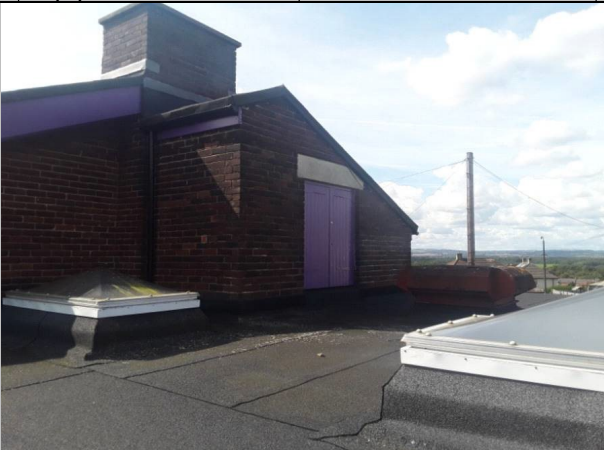
50	NZ000629	Roof flashing to roof top plant room	External E/001	No Risk

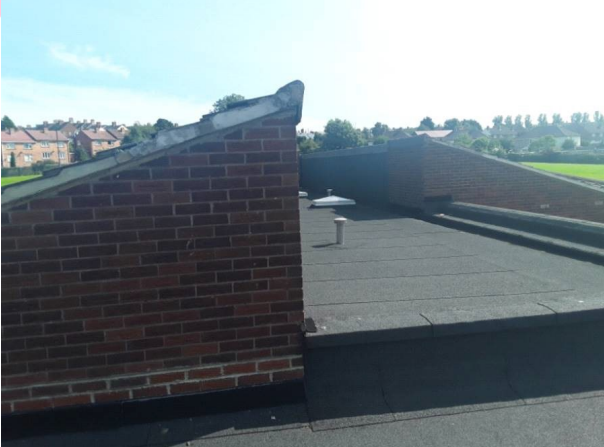
51	NZ000630	Undercloak to nursery block	External E/001	Very Low Risk – inspect 12 monthly

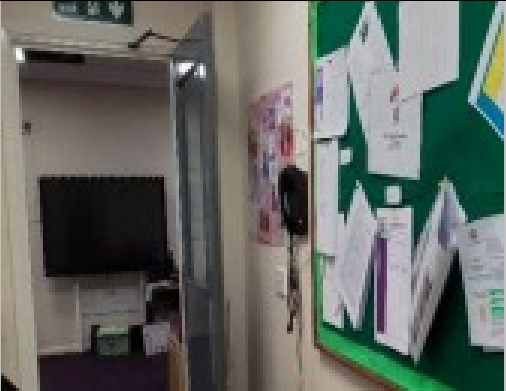
55	OQ000245	Wall	Corridor G/003	No Risk
