ASBESTOS SURVEY REPORT FOR NEW PENSHAW ACADEMY, NEW PENSHAW, SUNDERLAND, DH4 7HY

Asbestos Register for New Penshaw Academy

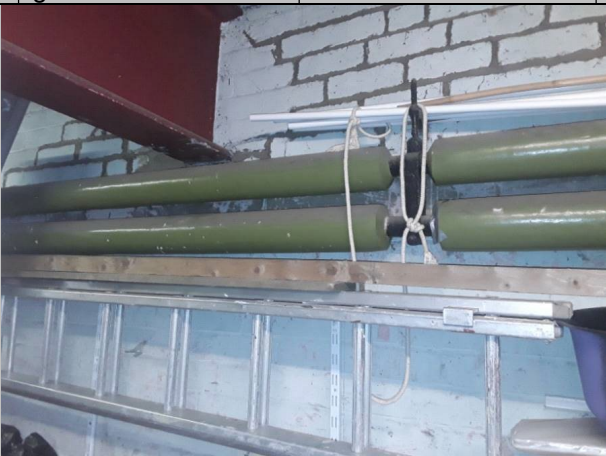
1	NZ000608	Pipework insulation top pipe painted green	Boiler Room Entrance Z1/001	No Risk

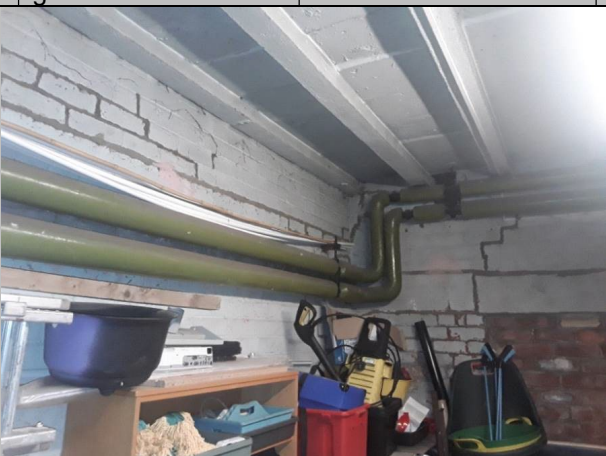
2	NZ000609	Pipework insulation bottom pipe painted green	Boiler Room Entrance Z1/001	No Risk

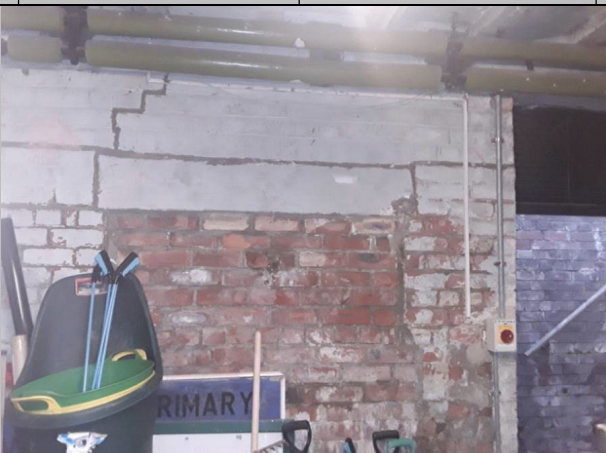
3	NZ000610	Debris/Residue to entrance wall	Boiler Room Entrance Z1/001	No Risk

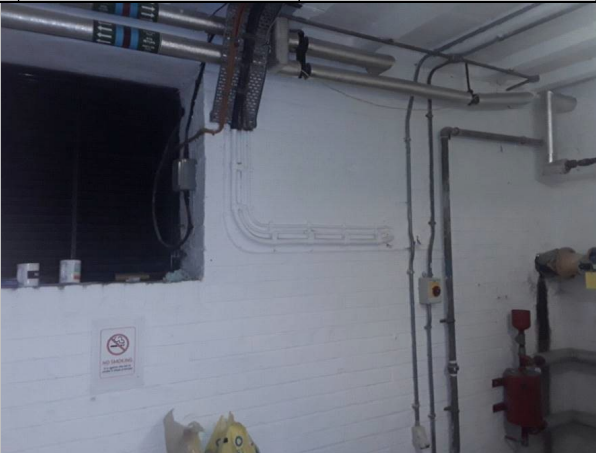
10	NZ000616	Debris/residue to entrance wall	Boiler Room Z1/002	No Risk

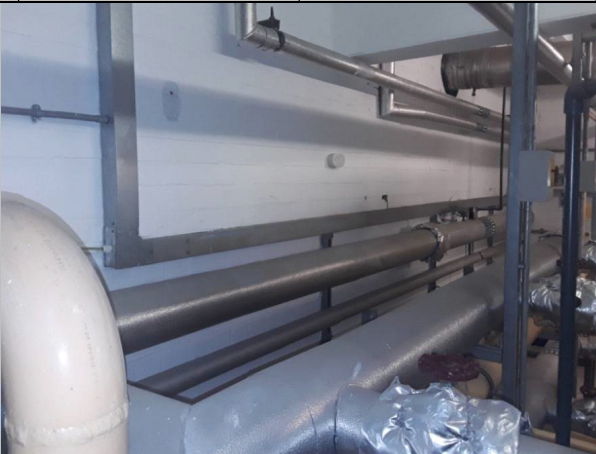
11	NZ000617	Debris/residue to left hand wall rear of boilers and on cable conduit	Boiler Room Z1/002	No Risk

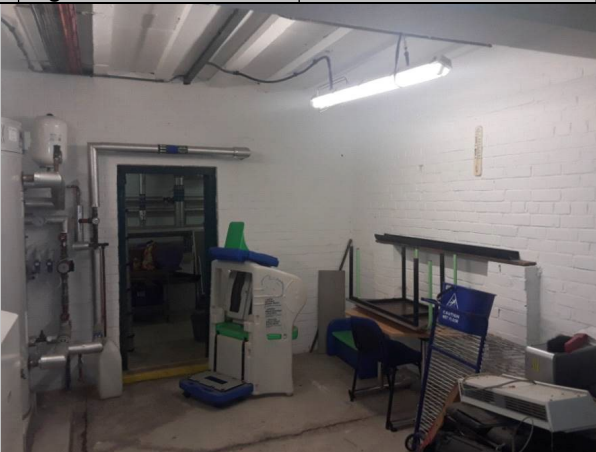
12	NZ000618	Debris/residue to boiler room rear and right-hand wall	Boiler Room Z1/002	No Risk

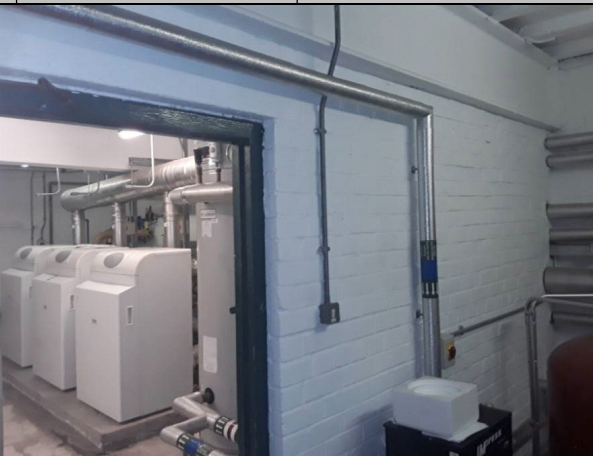
16	NZ000622	Debris/residue to entrance and left-hand wall	Boiler Room Rear Z1/003	No Risk

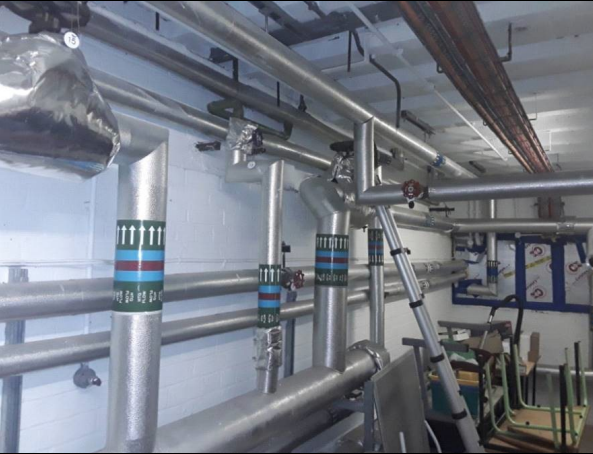
17	NZ000623	Debris/residue to rear and right-hand wall including pipework brackets	Boiler Room Rear Z1/003	No Risk

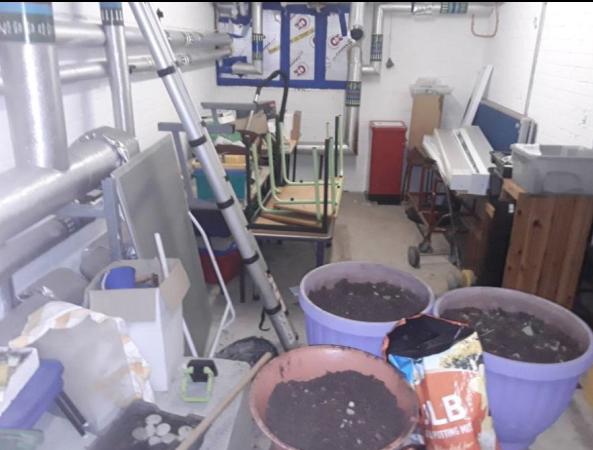
18	NZ000624	Debris/residue to floor	Boiler Room Rear Z1/003	No Risk

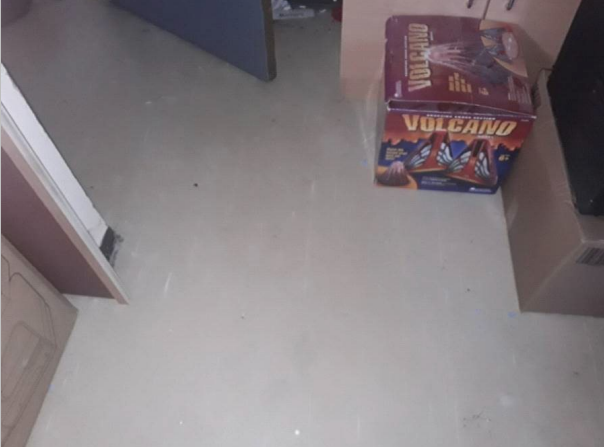
27	NZ000601	Floor covering	Store Room G/030	No Risk

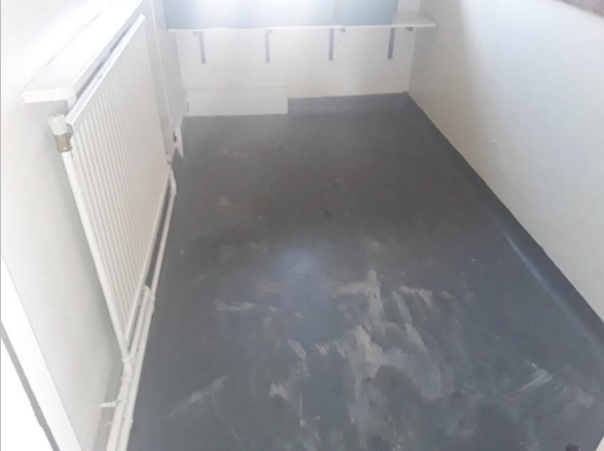
28	NZ000602	Floor covering	Cloak Room G/031	No Risk

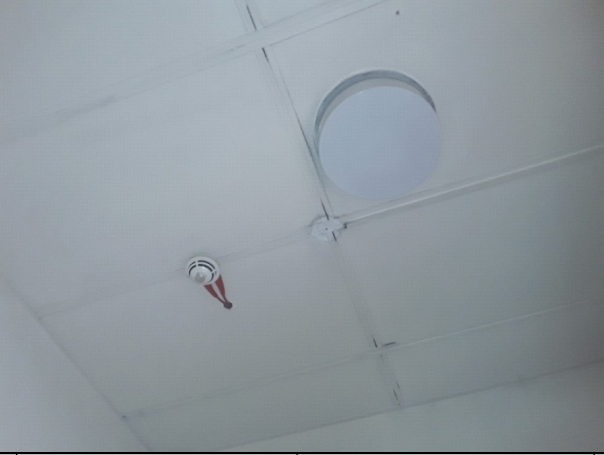
31	As NZ000603	Ceiling Tile suspended solid	Store room left hand within Classroom 7 G/036	No Risk

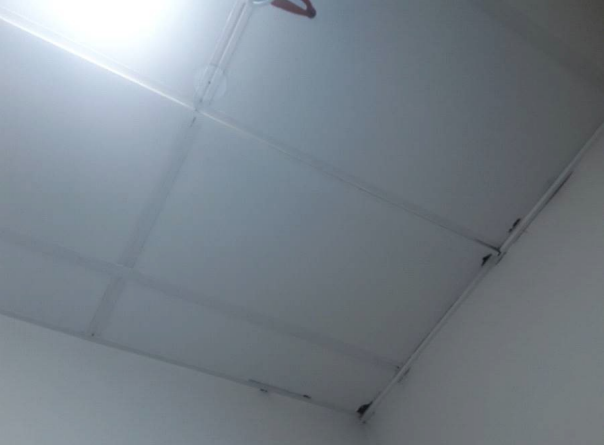
32	As NZ000603	Ceiling Tile suspended solid	Store room within Classroom 6 G/037	No Risk

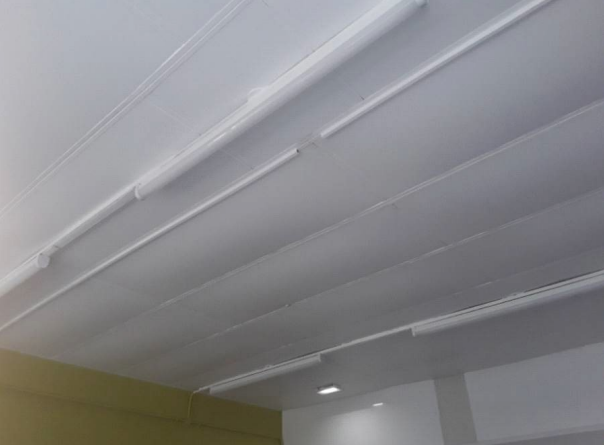
33	As NZ000603	Ceiling Tile suspended solid	Classroom 6 G/038	No Risk

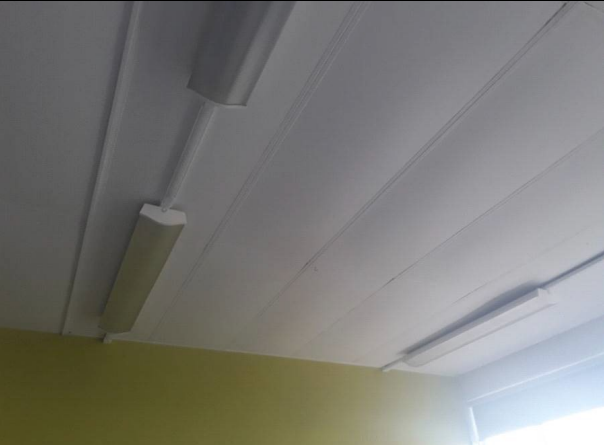
43	As NZ000606	Ceiling tile suspended solid	Classroom 2 G/083	No Risk

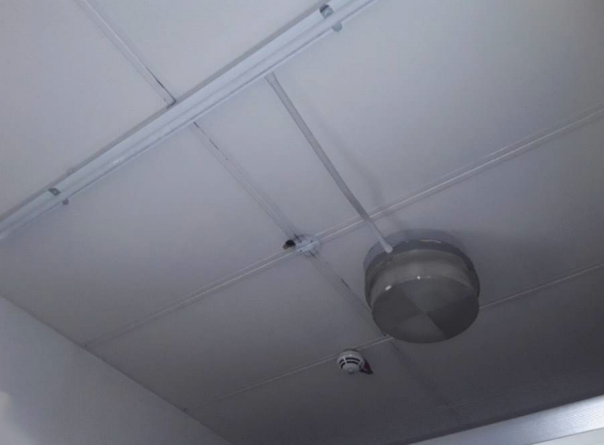
44	As NZ000606	Ceiling tile suspended solid	Store room right hand within Classroom 2 G/084	No Risk

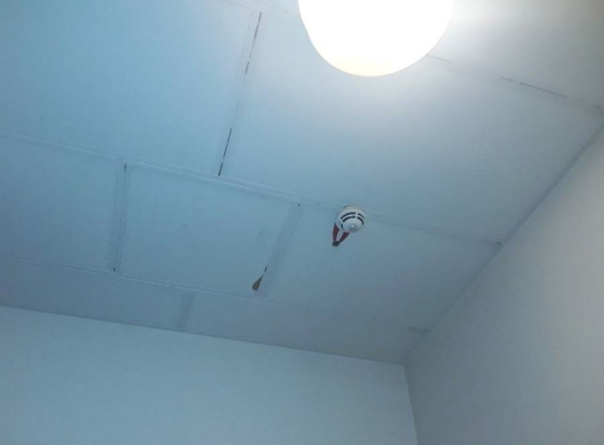
45	As NZ000606	Ceiling tile suspended solid	Store room left hand within Classroom 2 G/085	No Risk

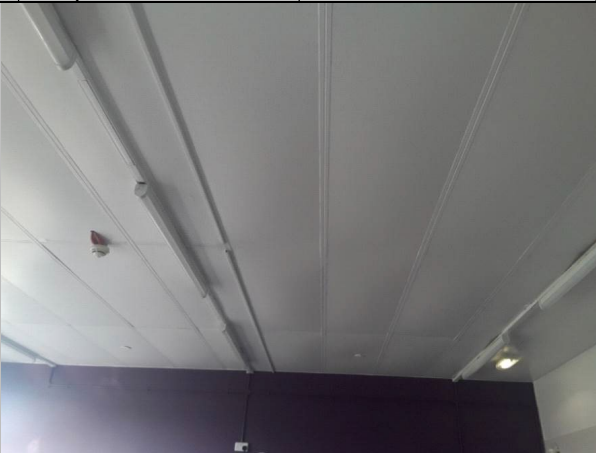
46	As NZ000606	Ceiling tile suspended solid	Classroom 3 G/086	No Risk

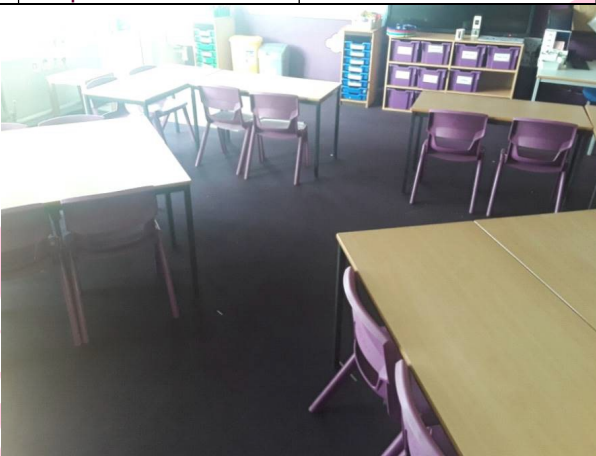
47	NZ000607	Floor covering under carpet	Classroom 3 G/086	Very Low Risk – inspect 12 monthly

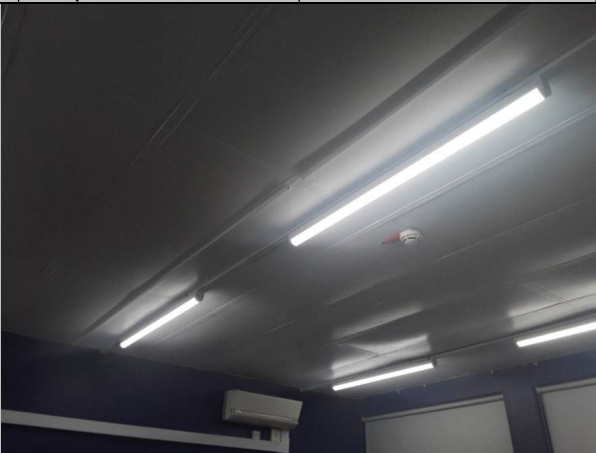
48	As NZ000606	Ceiling tile suspended solid	Classroom 4 G/087	No Risk

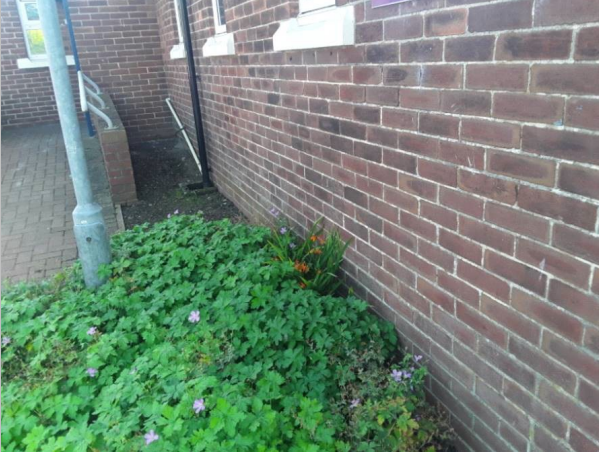
49	NZ000628	Damp proof course	External E/001	No Risk

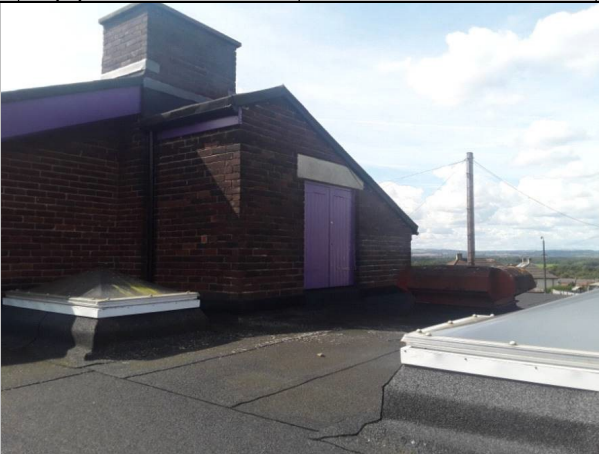
50	NZ000629	Roof flashing to roof top plant room	External E/001	No Risk

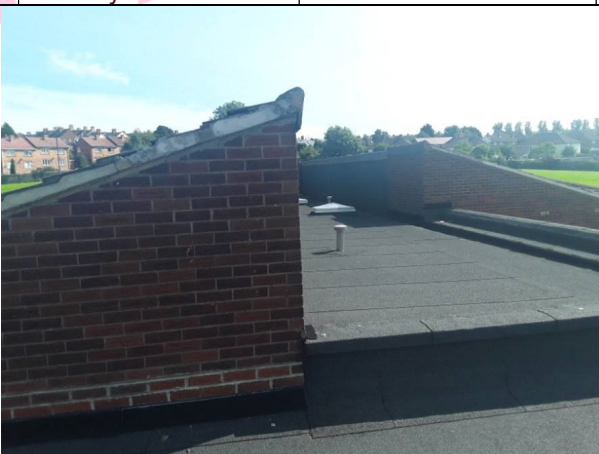
51	NZ000630	Undercloak to nursery block	External E/001	Very Low Risk – inspect 12 monthly
