ASBESTOS SURVEY REPORT FOR ALBANY PRIMARY SCHOOL, CROSSGILL, WASHINGTON, NE37 1UA.

Asbestos Register for Albany Primary School, Crossgill, Washington

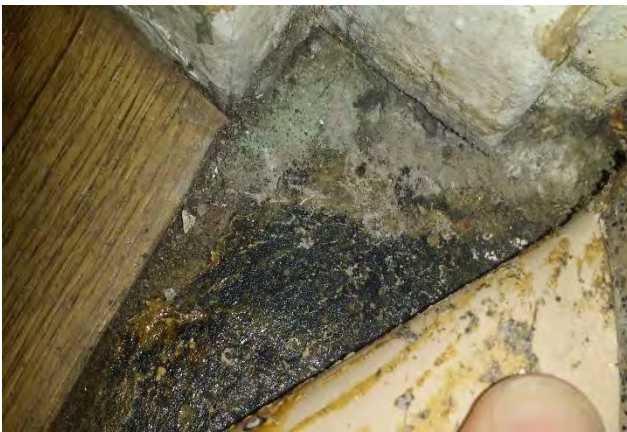
Item 32 Ref: As 369386-30

The remnant adhesive backing to floor in Rm 020/Cleaners Store contains asbestos.

Any change in its appearance should be recorded and passed to Property Services.

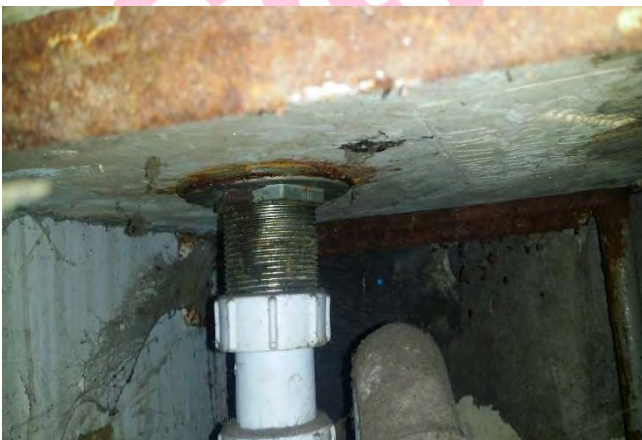
Item 33 Ref: 369386-43

The mastic to soil pipe at basin in Rm 020/Cleaners Store does not contain asbestos.

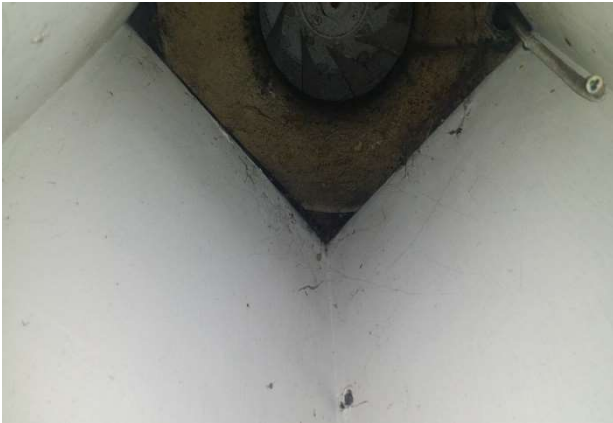
Item 35 Ref: 369386-48

The packing to skylight top in Rm 021/Hall Store does not contain asbestos.

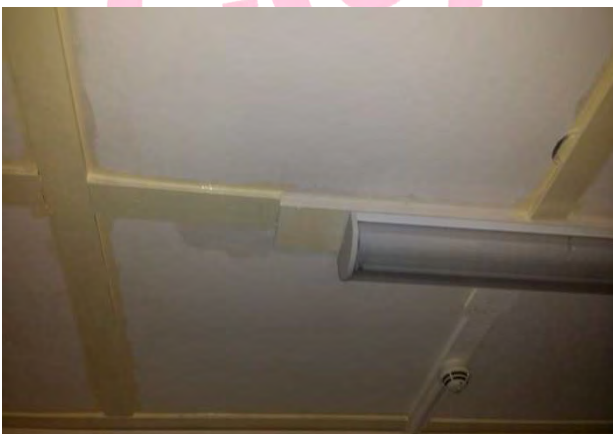
Item 36 Ref: 369386-49

The ceiling in Rm 022/Hall Store contains asbestos.

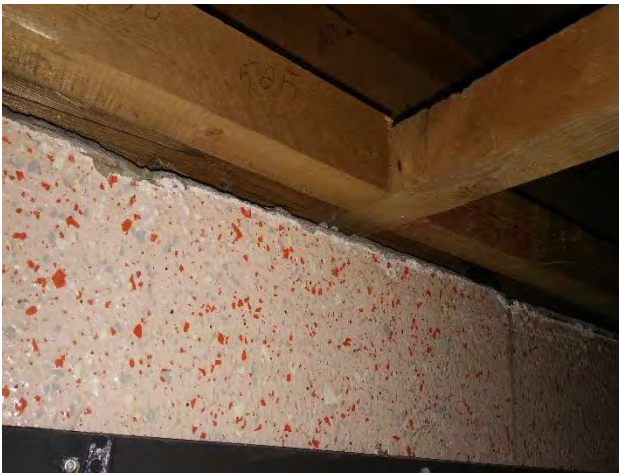
Item 38 Ref: 369386-89

The debris to perimeter wall in Rm 023A/Girls WC – void above contains asbestos.

Any change in its appearance should be recorded and passed to Property Services.

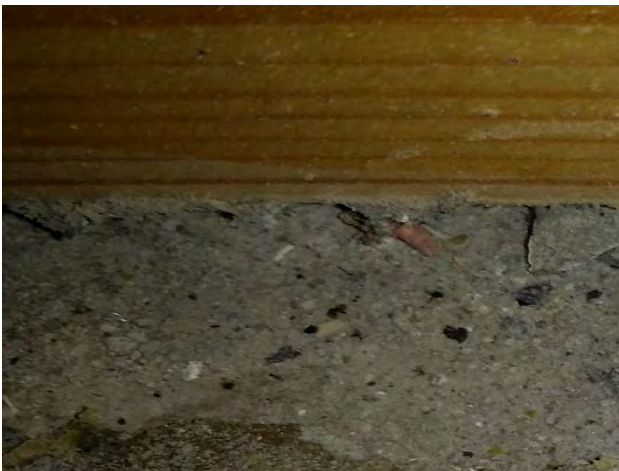
Item 39 Ref: 369386-90

The adhesive backing to floor in Rm 024/Classroom contains asbestos.

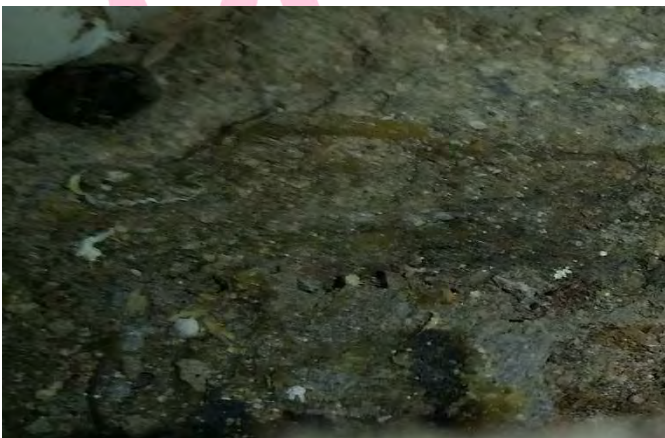
Item 42 Ref: As 369386-90

The remnant adhesive backing to floor in Rm 024a/Lobby contains asbestos.

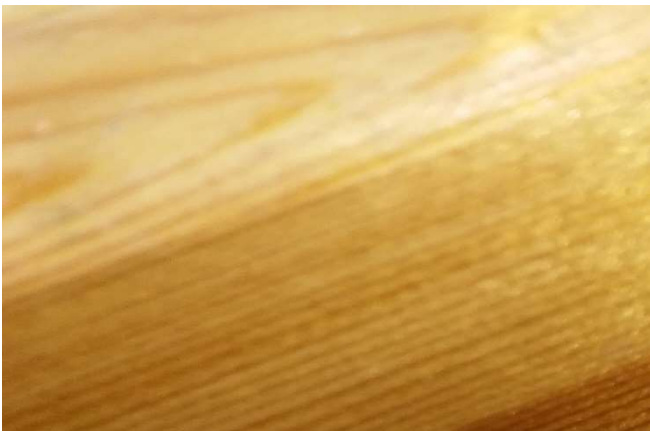
Item 45 Ref: As 369386-90

The remnant adhesive to floor under carpet in Rm 026b/Classroom contains asbestos.

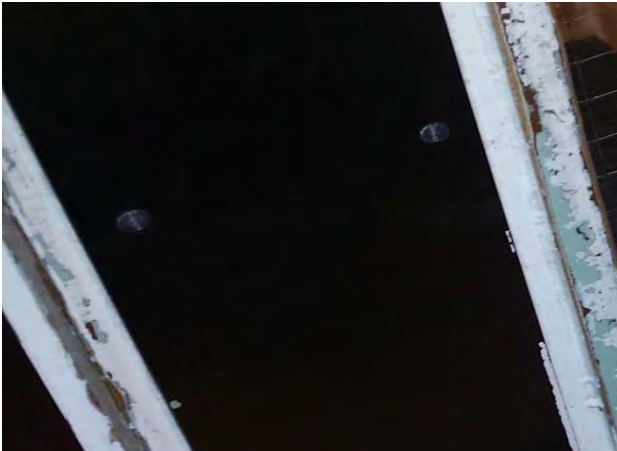
Item 47 Ref: As 369386-5

The mastic to fire doors in Rm 030/Cloakroom contains asbestos.

Any change in its appearance should be recorded and passed to Property Services.

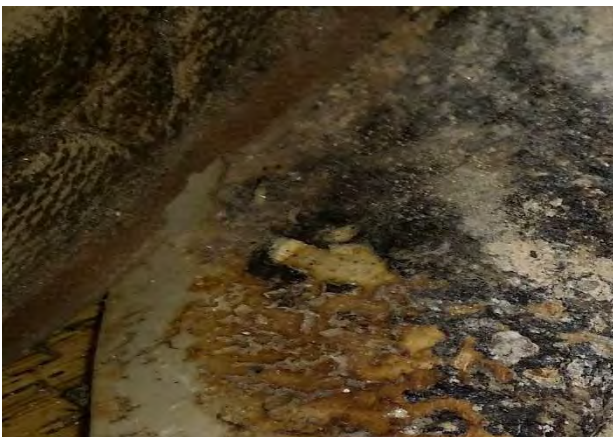
Item 48 Ref: 369386-25

The remnant adhesive backing to floor in Rm 030/Cloakroom contains asbestos.

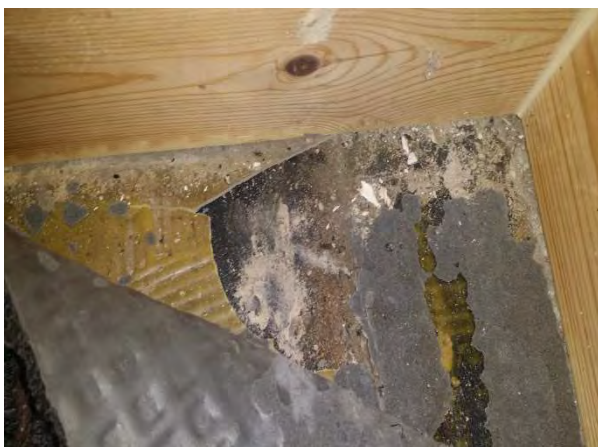
Item 51 Ref: 369386-17

The subfloor in Rm 030a/Corridor lobby contains asbestos.

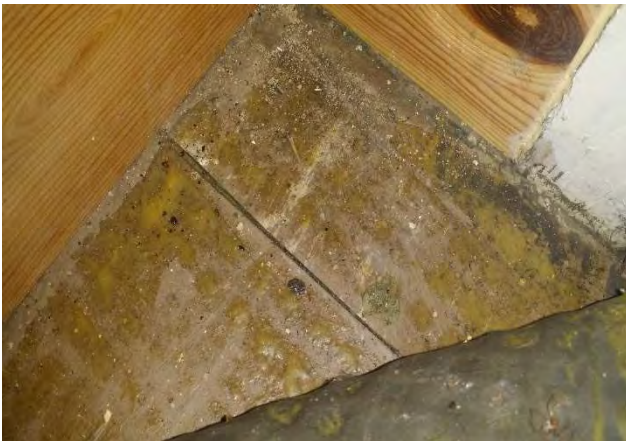
Item 54 Ref: As 369386-17

The subfloor in Rm 030b/Corridor lobby contains asbestos.

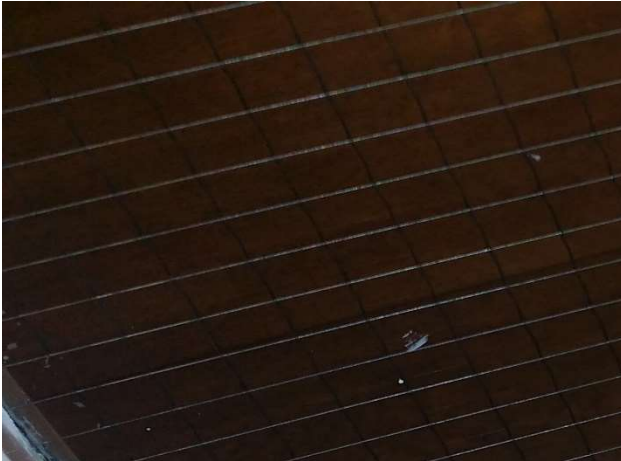
Item 55 Ref: As 369386-16

The mastic to fire doors in Rm 030b/Corridor lobby does not contain asbestos

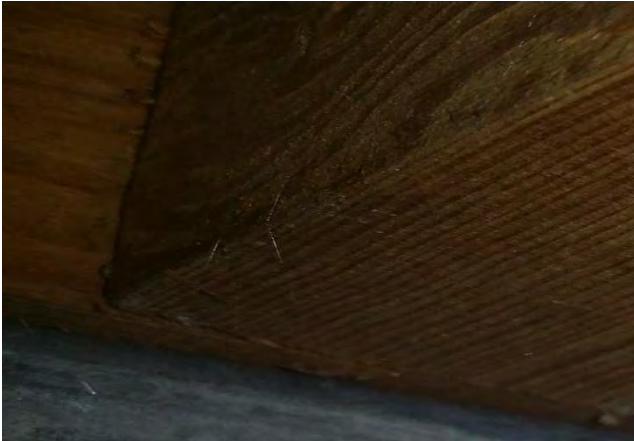
Item 58 Ref: 369386-21

The residue to skylight surround in Rm 031/Boys toilet – void above contains asbestos.

Any change in its appearance should be recorded and passed to Property Services.

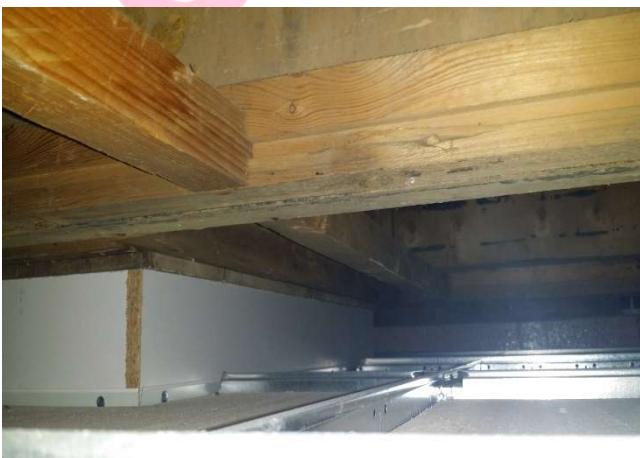
Item 60 Ref: 369386-23

The residue to beams including nail holes in Rm 032/Girls toilet – void above contains asbestos.

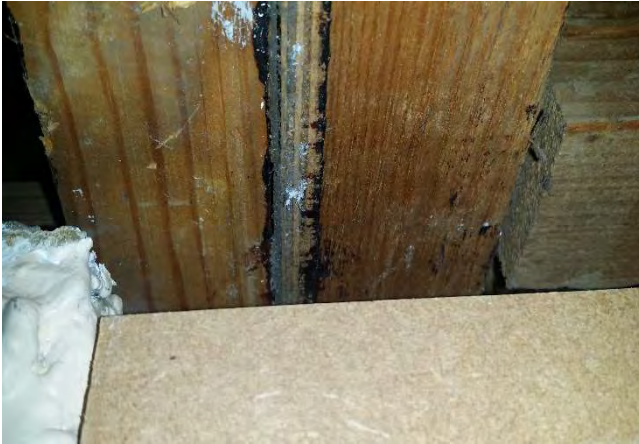
Item 61 Ref: As 369386-12

The residue to beams in Rm 033/Classroom – void above contains asbestos.

Any change in its appearance should be recorded and passed to Property Services.

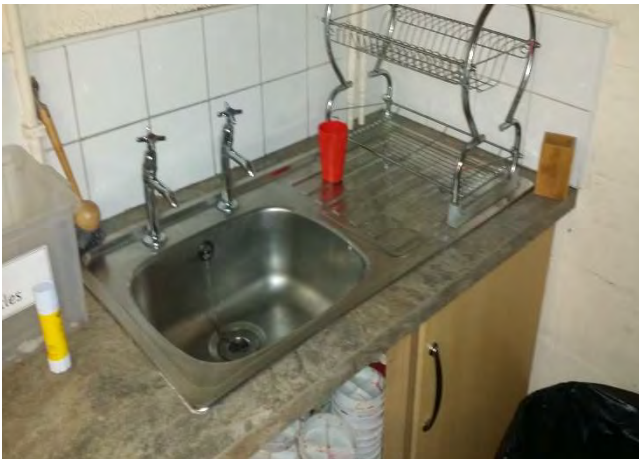
Item 62 Ref: 369386-7

The sink pad in Rm 034/Classroom does not contain asbestos.

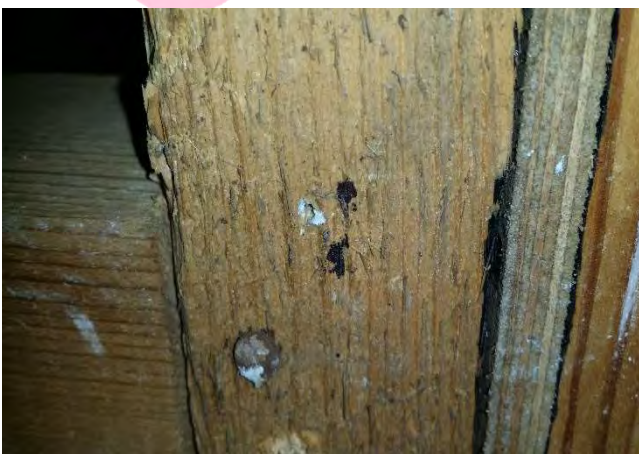
Item 63 Ref: 369386-8

The residue to beams and nail holes in Rm 034/Classroom – void above contains asbestos.

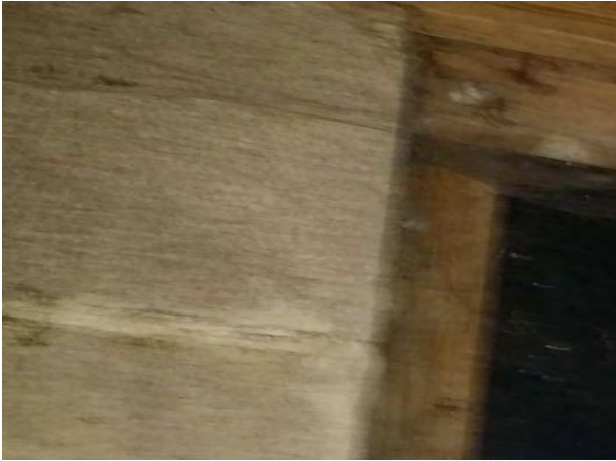
Item 64 Ref: As 369386-9

The membrane above window in Rm 034/Classroom – void above does not contain asbestos.

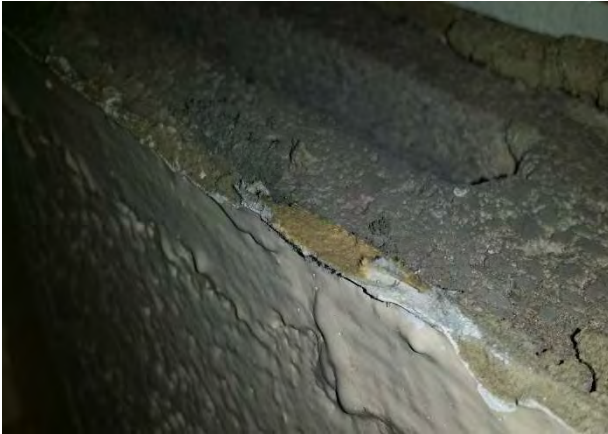
Item 65 Ref: 369386-10

The remnant fireboard to cupboard wall top at rear LHS in Rm 034/Classroom – void above contains asbestos.

Any change in its appearance should be recorded and passed to Property Services.

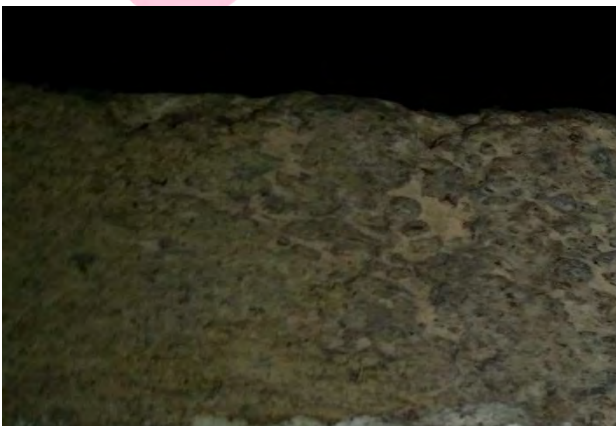
Item 66 Ref: 369386-11

The remnant fireboard to perimeter walls in Rm 034/Classroom – void above contains asbestos.

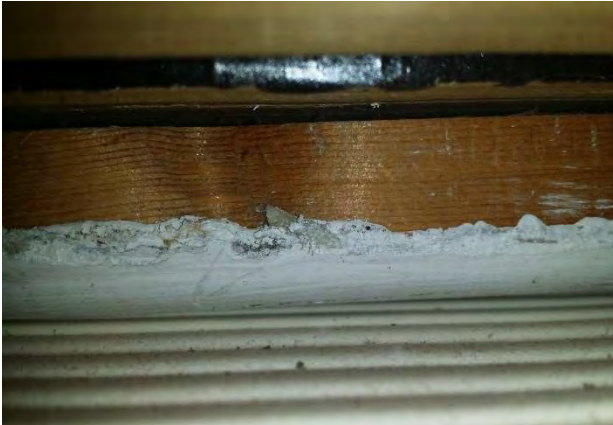
Item 67 Ref: 369386-12

The residue above windows in Rm 034/Classroom – void above contains asbestos.

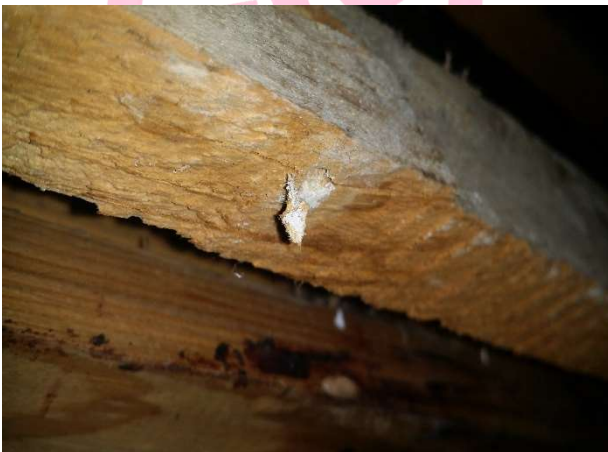
Item 69 Ref: As 369386-8

The residue to beams and nail holes in Rm 035/Classroom – void above contains asbestos.

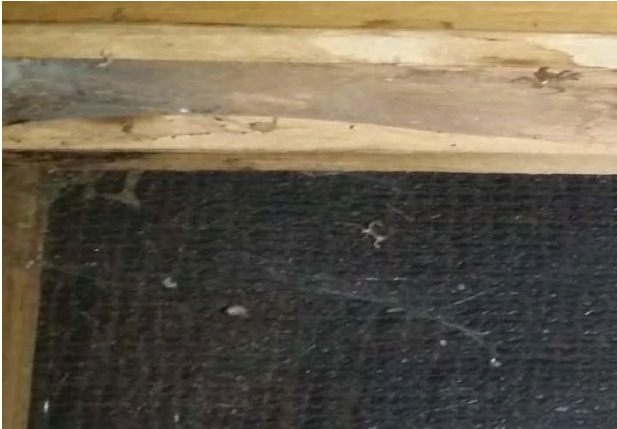
Item 70 Ref: As 369386-9

The membrane above window in Rm 035/Classroom – void above does not contain asbestos.

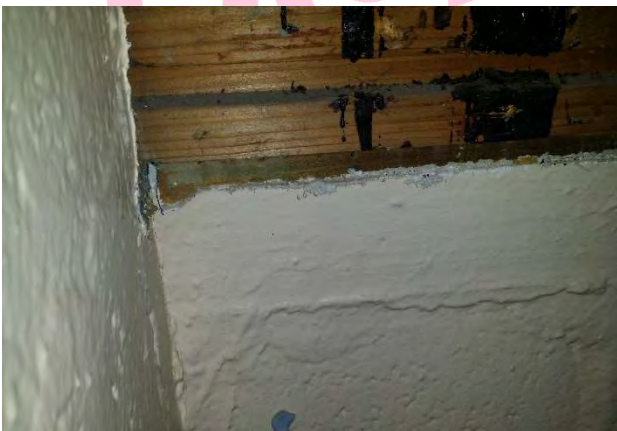
Item 72 Ref: 369386-14

The remnant fibreboard ceiling above heater adj entrance door in Rm 036/Classroom – void above contains asbestos.

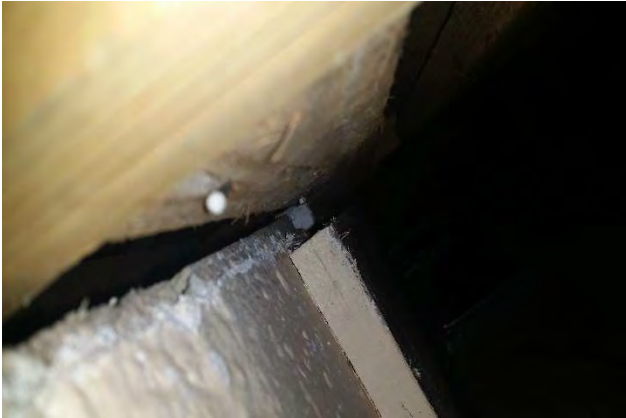
Item 73 Ref: 369386-13

The remnant fibreboard to cupboard wall tops in Rm 036/Classroom – void above contains asbestos.

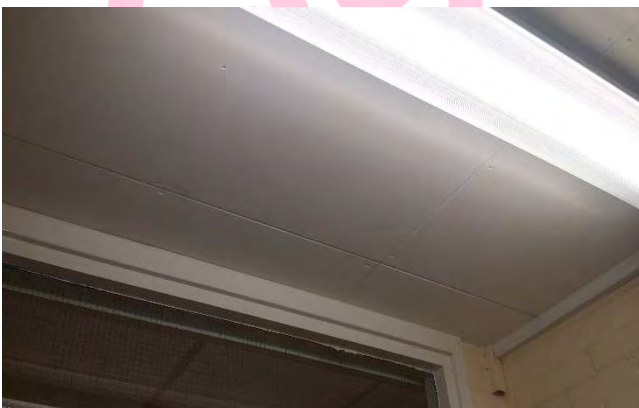
Item 75 Ref: As 369386-2

The ceiling in Rm 037a/Corridor contains asbestos.

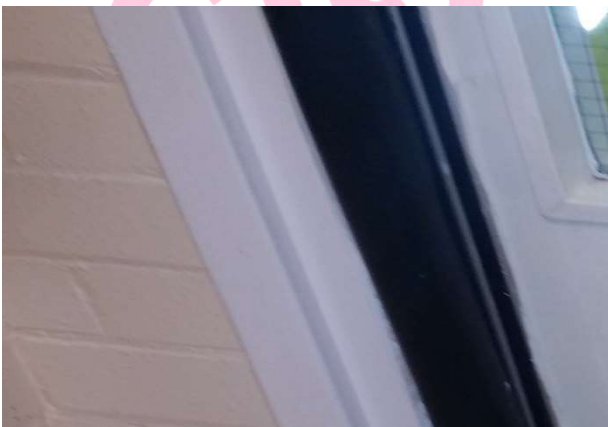
Item 78 Ref: As 369386-5

The mastic to fire doors in Rm 038/Cloakroom contains asbestos.

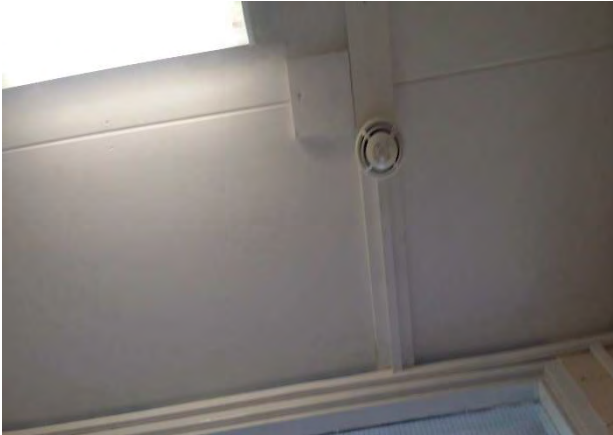
Item 79 Ref: 369386-2

The ceiling in Rm 038a/Corridor lobby contains asbestos.

Any change in its appearance should be recorded and passed to Property Services.

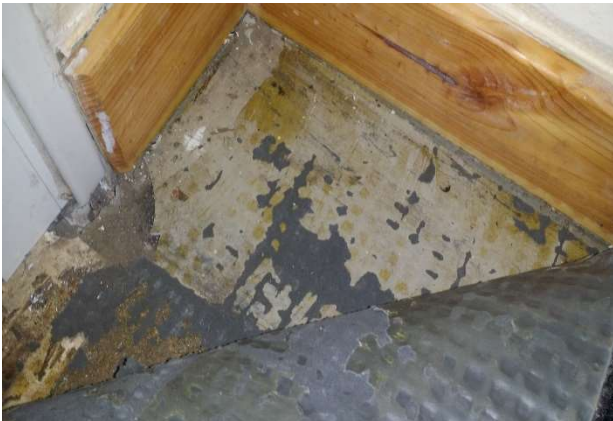
Item 80 Ref: 369386-3

The subfloor in Rm 038a/Corridor lobby contains asbestos.

Any change in its appearance should be recorded and passed to Property Services.

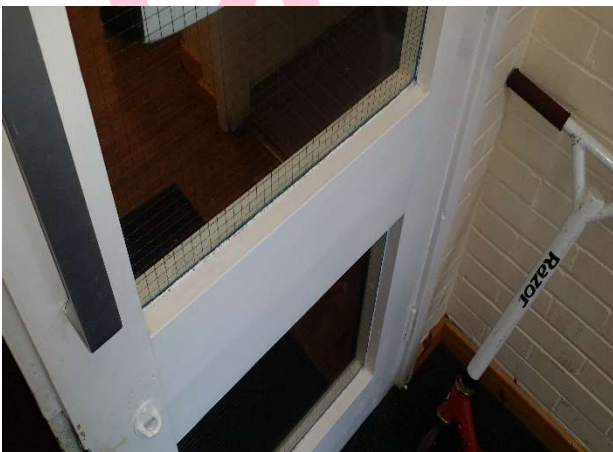
Item 81 Ref: As 369386-5

The mastic to fire doors in Rm 038a/Corridor lobby contains asbestos.

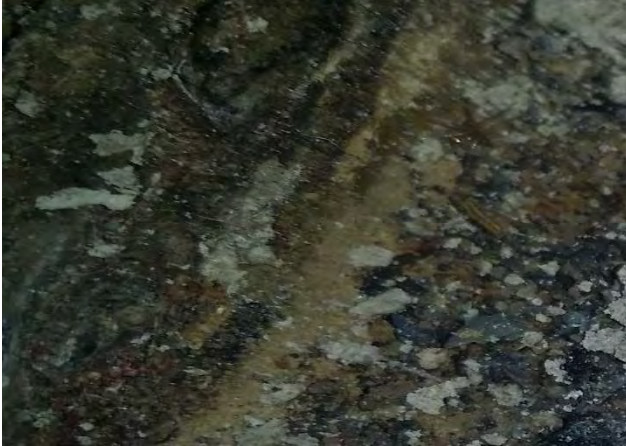
Item 82 Ref: 369386-59

The remnant adhesive backing to floor in Rm 039/Classroom contains asbestos.

Any change in its appearance should be recorded and passed to Property Services.

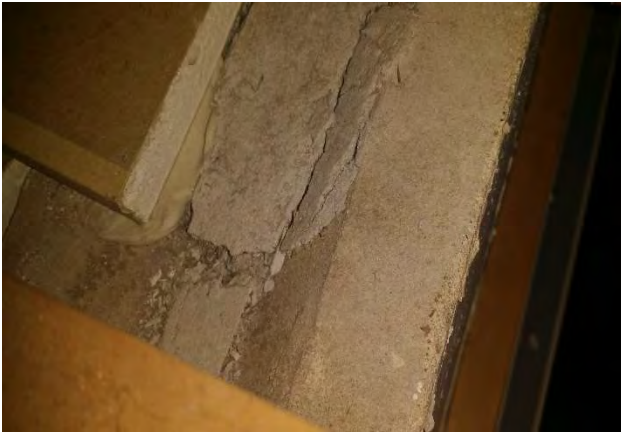
Item 83 Ref: 369386-60

The debris to wall top around cupboard in Rm 039/Classroom – void above contains asbestos.

Removed August 2023

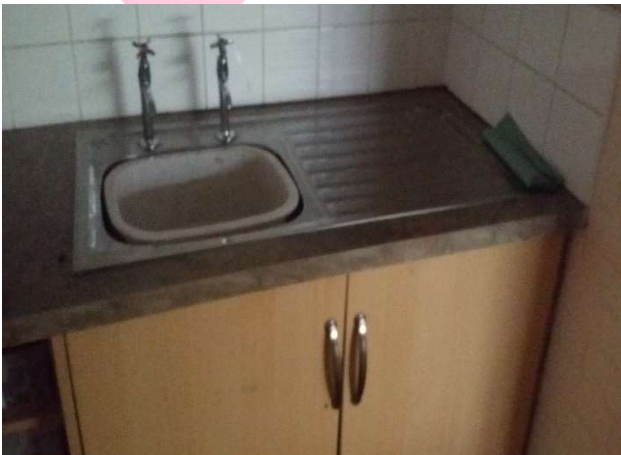
Item 84 Ref: 369386-1

The sink pad in Rm 040/Classroom does not contain asbestos.

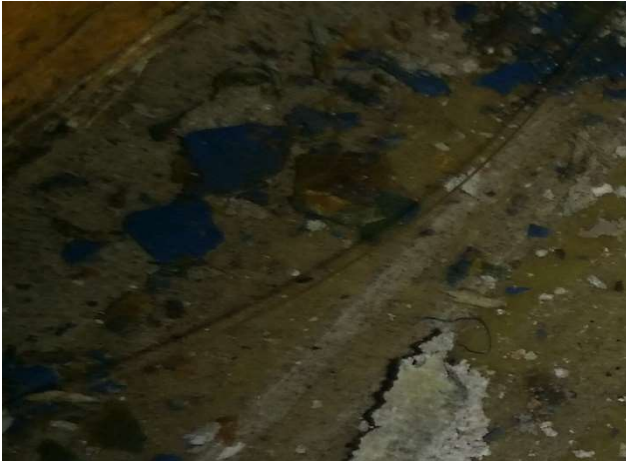
Item 85 Ref: As 369386-59

The remnant adhesive backing to floor in Rm 040/Classroom contains asbestos.

Any change in its appearance should be recorded and passed to Property Services.

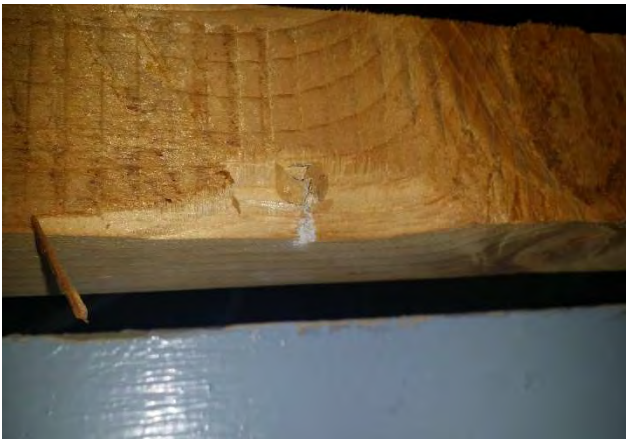
Item 86 Ref: 369386-81

The residue to beams and joists in Rm 040/Classroom – void above contains asbestos.

Removed August 2023

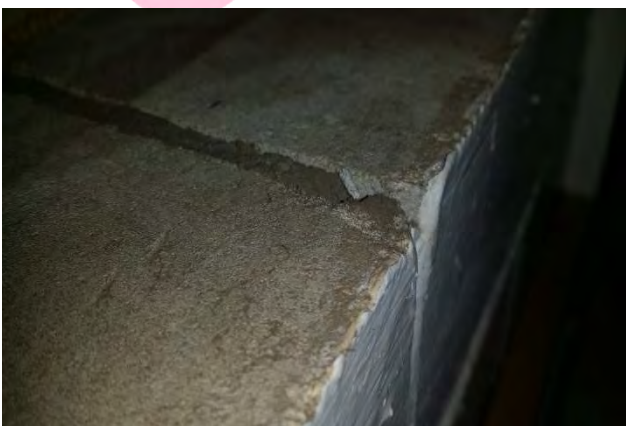
Item 87 Ref: As 369386-83

The debris to cupboard wall top in Rm 040/Classroom – void above contains asbestos.

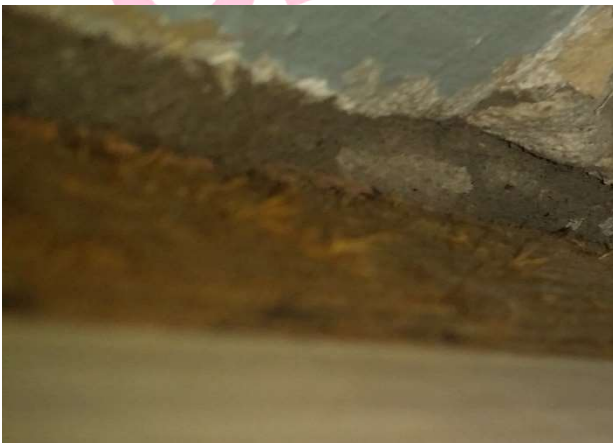
Item 90 Ref: As 369386-83

The debris to wall top above reading area in Rm 041/Classroom – void above contains asbestos.

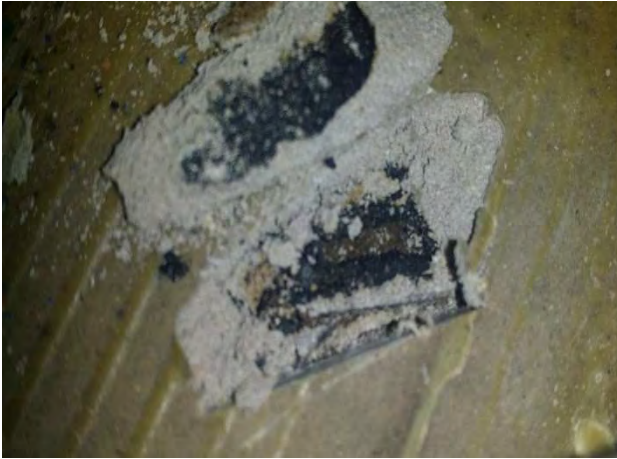
Item 91 Ref: As 369386-59

The remnant adhesive backing to floor in Rm 042/Classroom contains asbestos.

Any change in its appearance should be recorded and passed to Property Services.

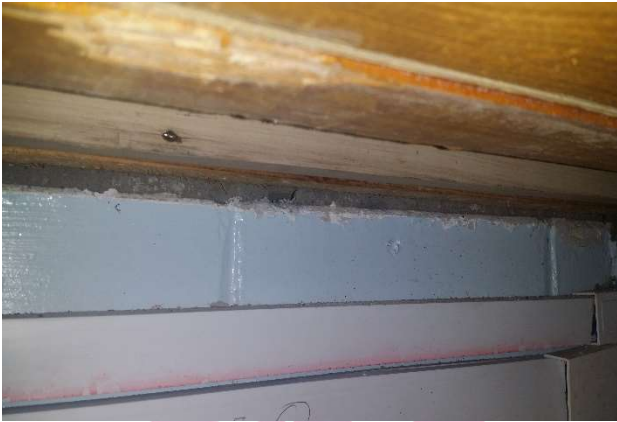
Item 92 Ref: 369386-82

The debris to perimeter wall in Rm 042/Classroom – void above contains asbestos.

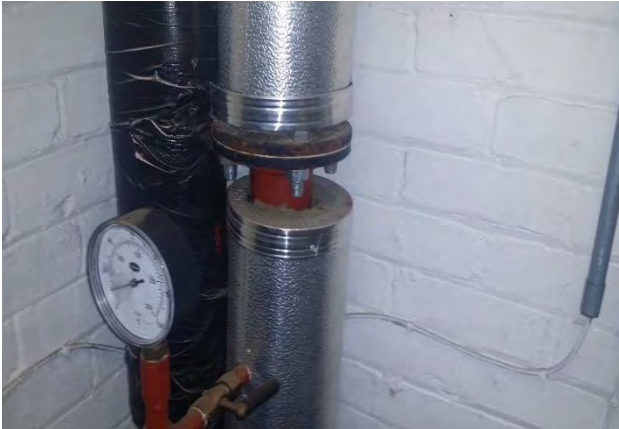
Item 94 Ref: 369386-53

The gaskets to pipework in Rm 043/Boiler Room does not contain asbestos.

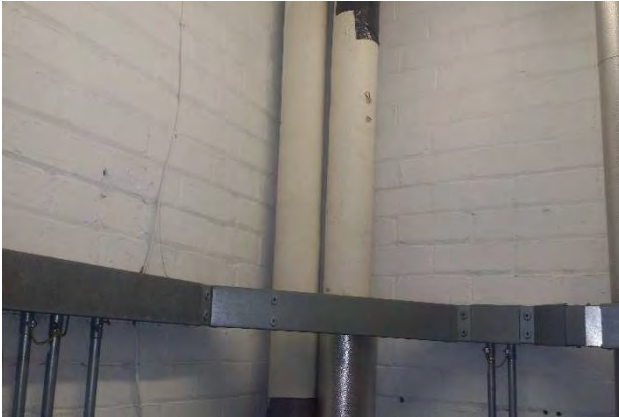
Item 95 Ref: 369386-54

The pipe lagging in Rm 043/Boiler Room does not contain asbestos.

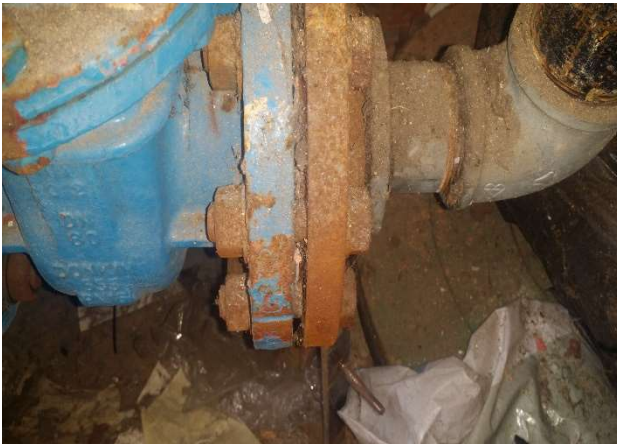
Item 98 Ref: 369386-52

The gasket to pipework in Rm 043a/Gas Meter Room does not contain asbestos.

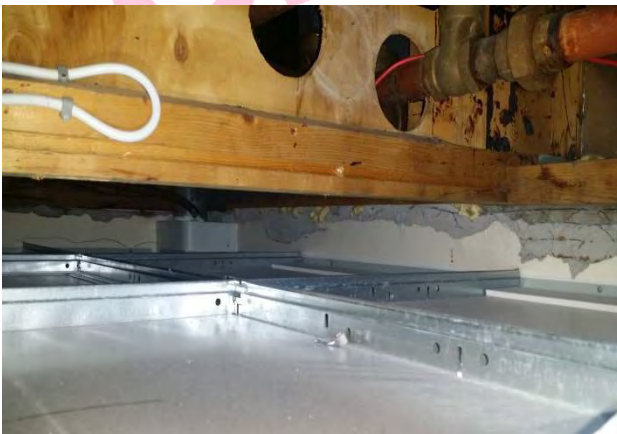
Item 99 Ref: Presumed

The debris to wall gap in Rm 044/Boys Toilet – void above contains asbestos.

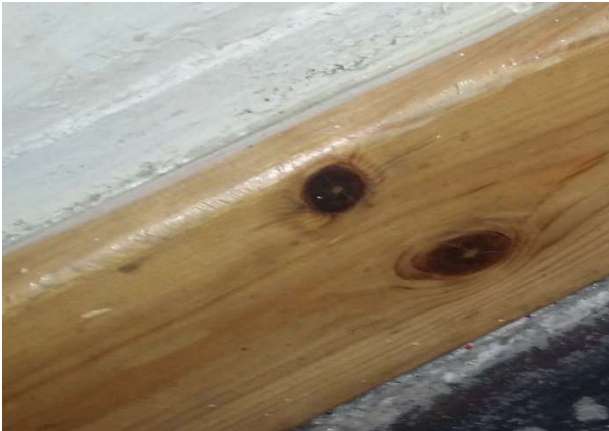
Item 101 Ref: 369386-85

The remnant adhesive backing to floor in Rm 047/Hall contains asbestos.

Any change in its appearance should be recorded and passed to Property Services.

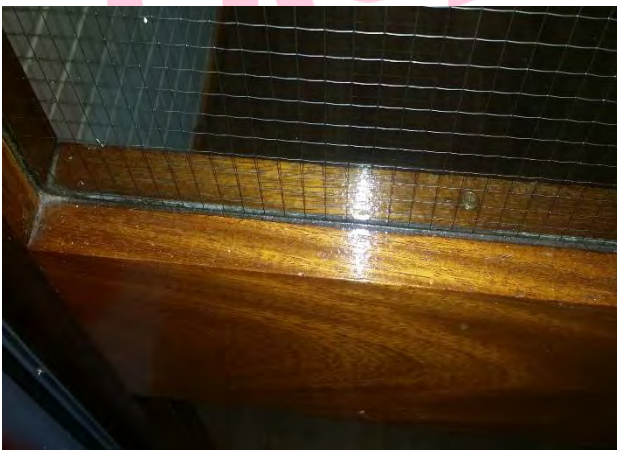
Item 102 Ref: 369386-84

The mastic to glazing at doors in Rm 047/Hall does not contain asbestos.

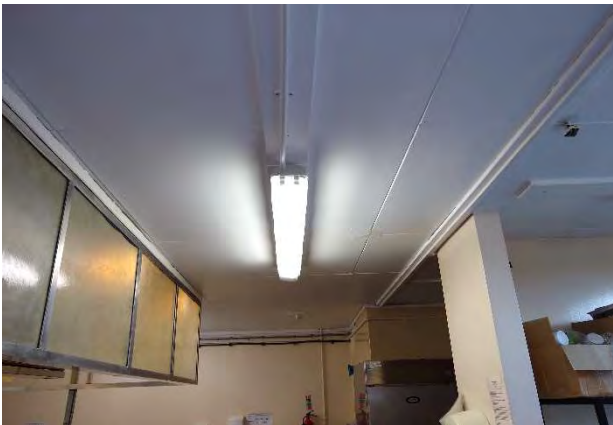
Item 104 Ref: 369386-74

The fixed ceiling tiles in Rm 048/Kitchen contains asbestos.

Any change in its appearance should be recorded and passed to Property Services.

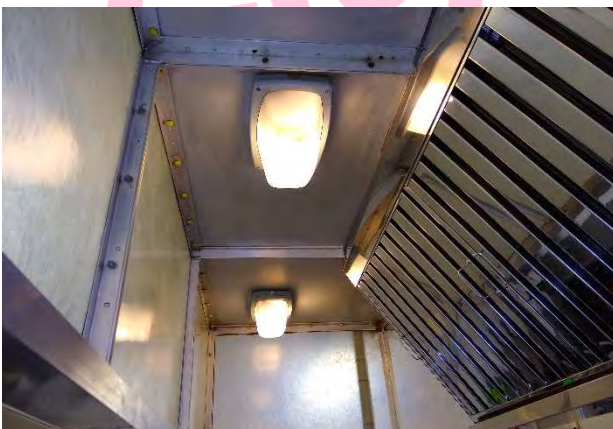
Item 105 Ref: 369386-73

The sealant to lights within extraction bulkhead in Rm 048/Kitchen contains asbestos.

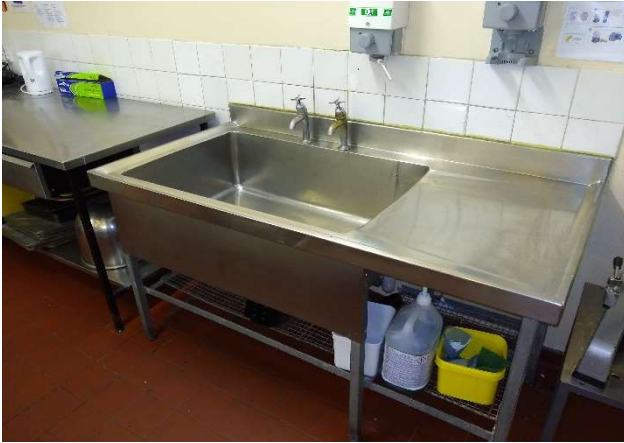
Item 106 Ref: 369386-72

The acoustic seal to sink base in Rm 048/Kitchen does not contain asbestos.

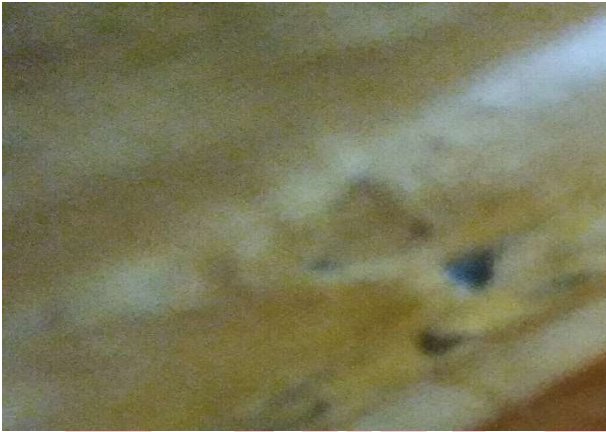
Item 113 Ref: As 369386-76

The floor in Rm 051/Corridor contains asbestos.

Any change in its appearance should be recorded and passed to Property Services.
