### ASBESTOS SURVEY REPORT FOR BARMSTON VILLAGE PRIMARY SCHOOL, WASHINGTON

*Control of Asbestos  
Regulations 2012*

**BARMSTON VILLAGE PRIMARY SCHOOL**

**Date: 24 April 2026**

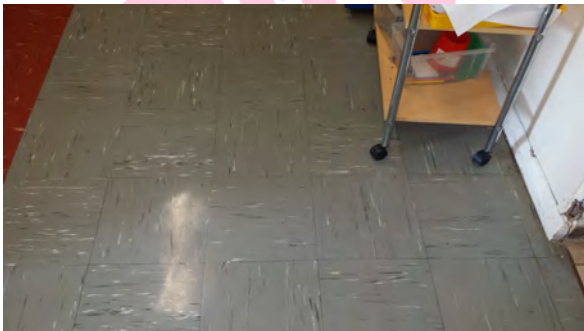
### **Item 36 Ref: 369922-15**

The floor covering (035/corridor) contains asbestos.

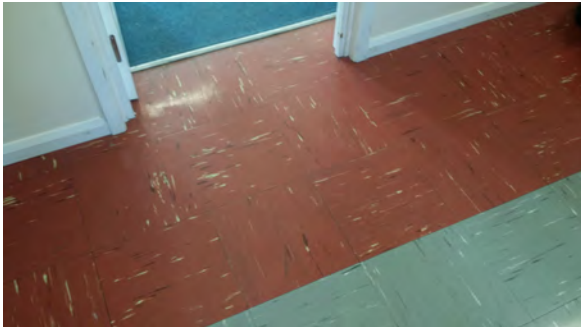
### **Item 37 Ref: 369922-16**

The floor covering (035/corridor) contains asbestos.

Any change in its appearance should be documented and passed to Property Services.

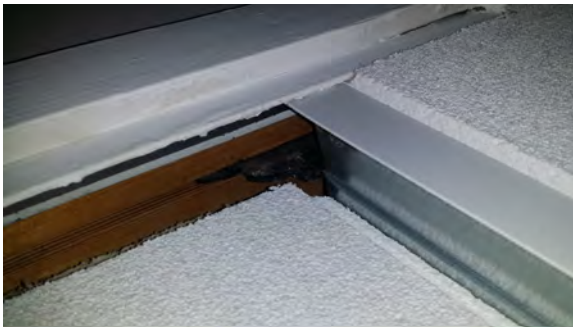
### **Item 38 Ref: As 193462-5**

The packers to skylight upstand at suspended ceiling height (035/Corridor void above) contain asbestos.

Any change in its appearance should be documented and passed to Property Services.

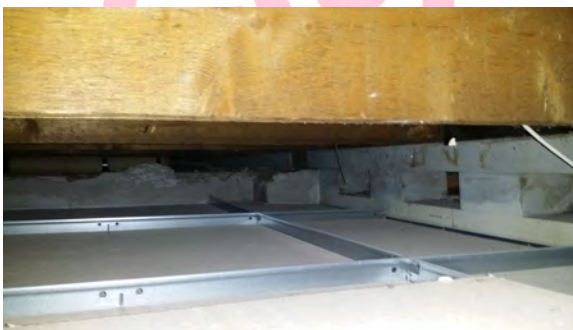
### **Item 39 Ref: 369922-13**

The felt to external wall (035/corridor void above) does not contain asbestos.

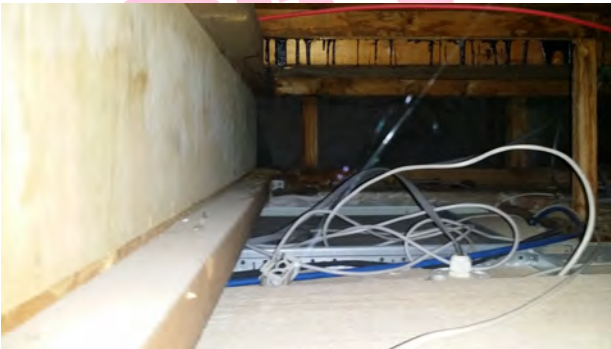
### **Item 42 Ref: 369922-32**

The felt to external wall (035a/meeting room) does not contain asbestos.

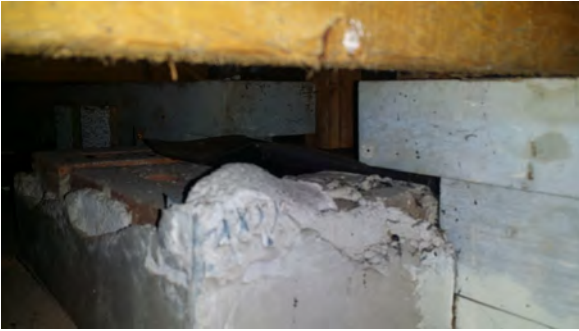
### **Item 46 Ref: As 369922-32**

The felt to external walls (036/breakfast club void above) does not contain asbestos.

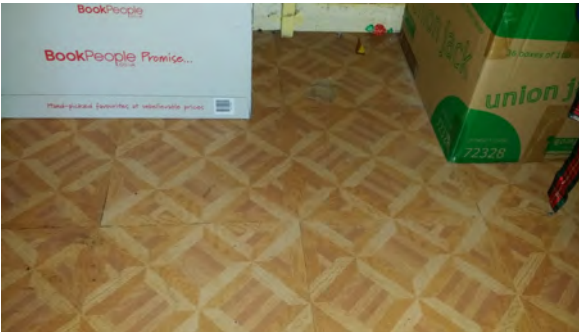
### **Item 47 Ref: 369922-23**

The floor covering (039/store) does not contain asbestos.

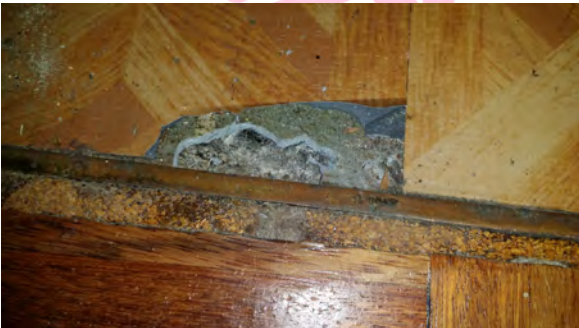
### **Item 48 Ref: 369922-24**

The subfloor (039/store) contains asbestos.

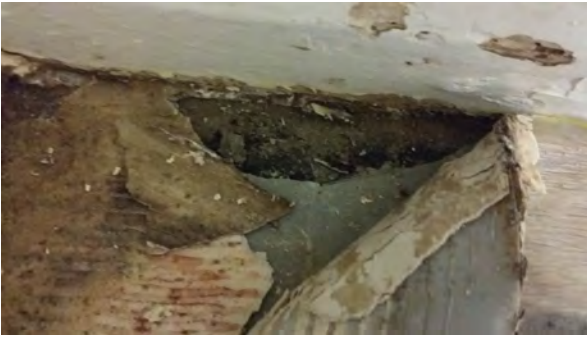
### **Item 49 Ref: 369922-9**

The subfloor (041/classroom area) contains asbestos.

***Informed of Removal 2023***

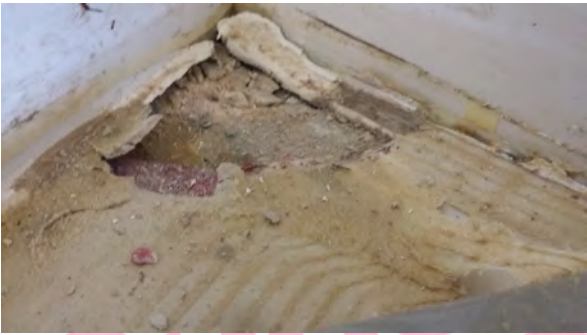
### **Item 50 Ref: 369922-10**

The subfloor (041/classroom area) does not contain asbestos.

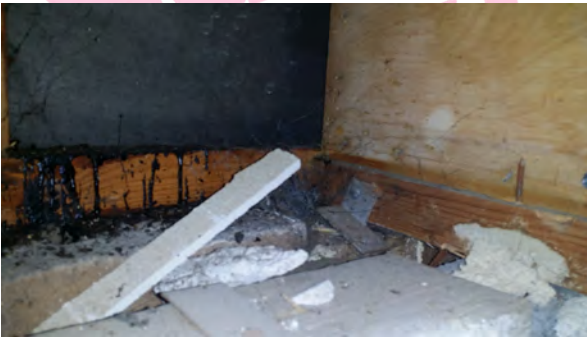
### **Item 51 Ref: As 369922-32**

The felt to external wall (041/classroom area void above) does not contain asbestos.

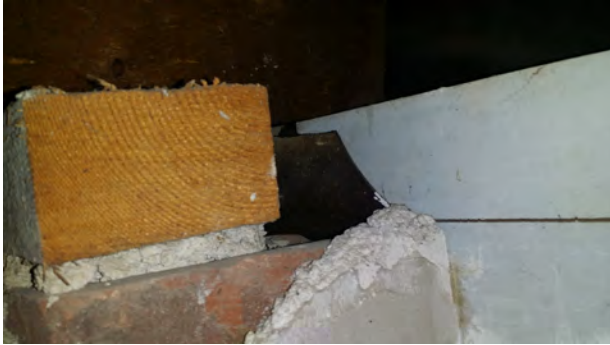
### **Item 52 Ref: 369922-32**

The felt to external wall (041a/shower room void above) does not contain asbestos.

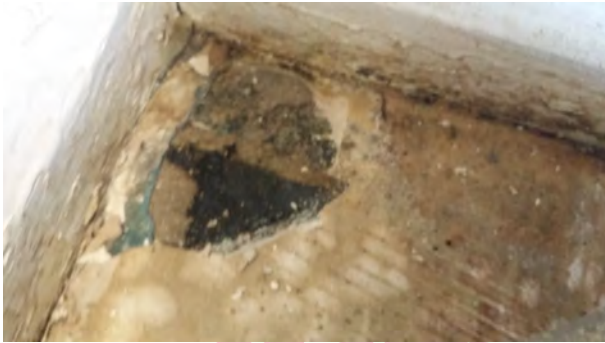
### **Item 53 Ref: 369922-30**

The subfloor (042/classroom area) contains asbestos.

***Informed of Removal 2023***

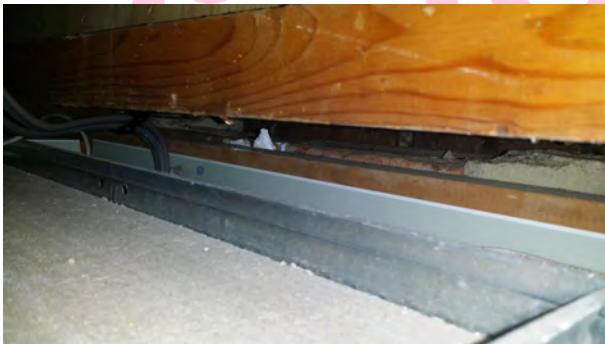
### **Item 54 Ref: 193462-2**

The packers to wall (042/classroom area void above) contain asbestos.

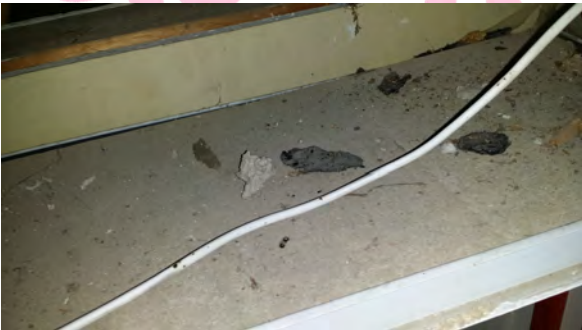
### **Item 57 Ref: 193462-6**

The roof covering debris to topside of suspended ceiling (043/entrance lobby void above) contains asbestos.

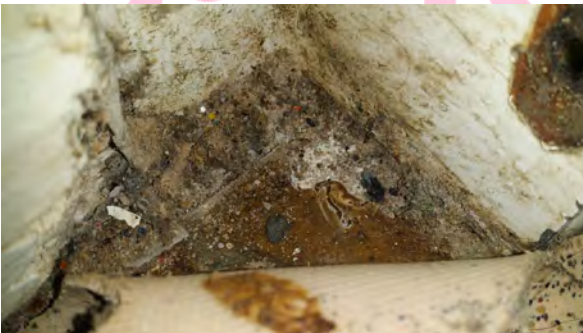
### **Item 66 Ref: 369922-21**

The subfloor (050/kitchen) does not contain asbestos.

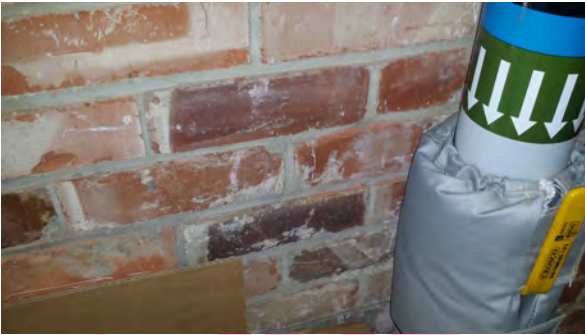
### **Item 68 Ref: 193462-9**

The insulation debris to walls (051/boiler room) does not contain asbestos.

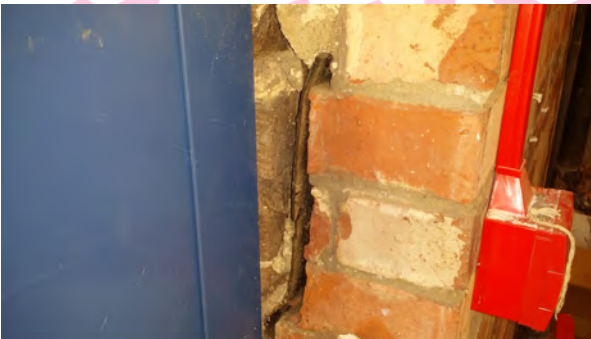
### **Item 69 Ref: 369922-42**

The damp proof membrane (051/boiler room) does not contain asbestos.

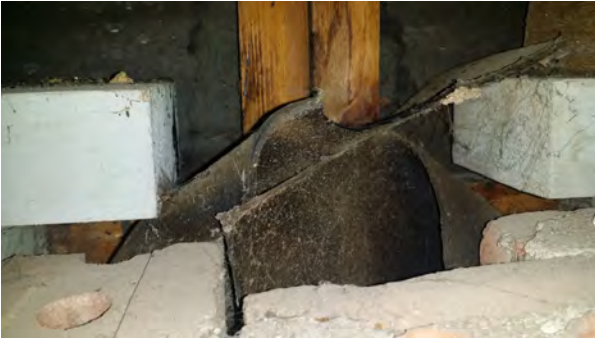
### **Item 73 Ref: 369922-13**

The felt to external wall (053/accessible WC void above) does not contain asbestos.

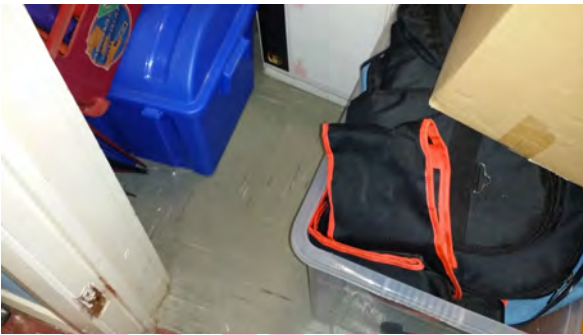
### **Item 74 Ref: As 369922-15**

The floor covering (054/Store) contains asbestos.

Any change in its appearance should be documented and passed to Property Services.

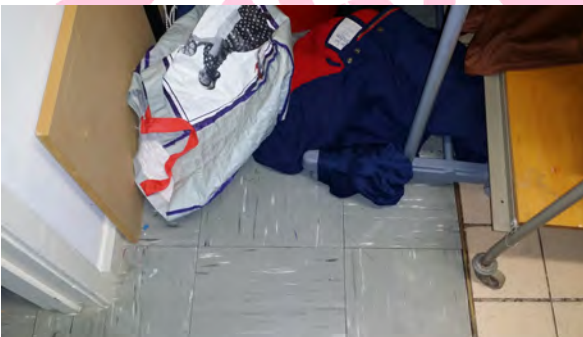
### **Item 75 Ref: As 369922-15**

The floor covering (054a/Store) contains asbestos.

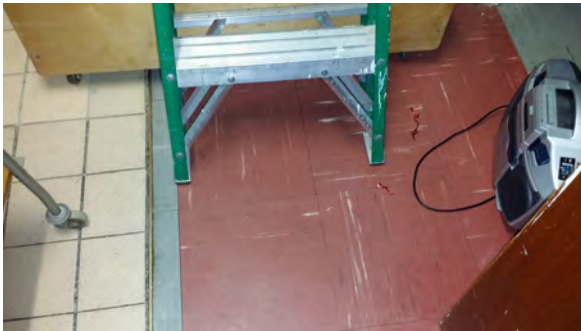
### **Item 76 Ref: As 369922-16**

The floor covering (054a/Store) contains asbestos.

Any change in its appearance should be documented and passed to Property Services.

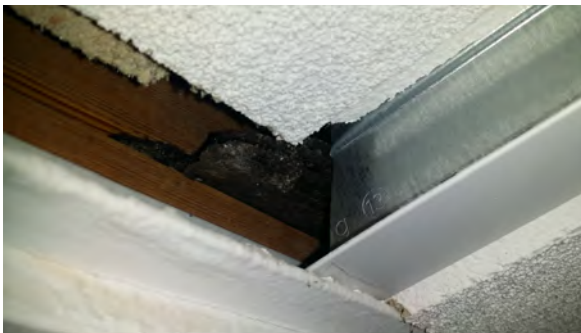
### **Item 77 Ref: 193462-5**

The packing to skylight upstand at suspended ceiling height (054a/Store void above) contains asbestos.

Any change in its appearance should be documented and passed to Property Services.

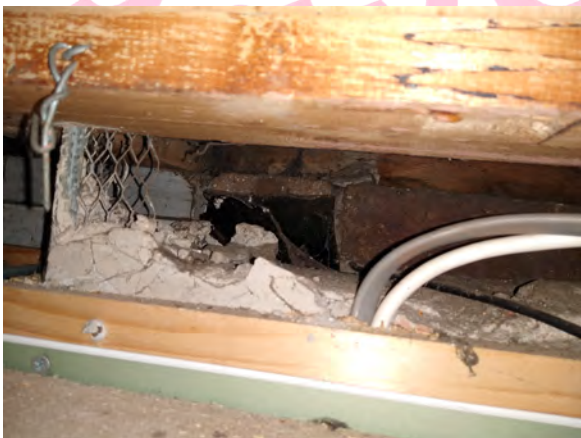
### **Item 78 Ref: 369922-8**

The damp proof course around window (056/Girls WC void above) does not contain asbestos.

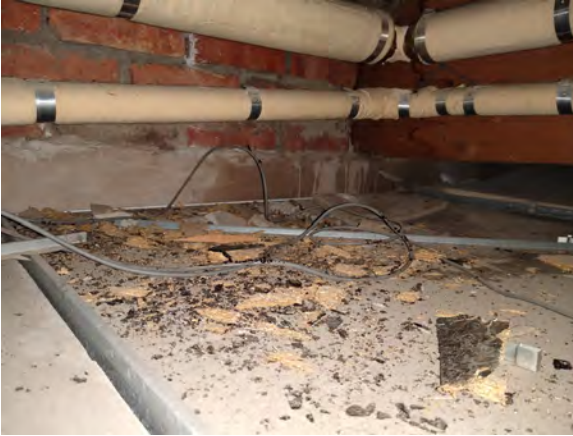
### **Item 79 Ref: 369922-6**

The debris to ceiling tiles (058a/hall store void above) does not contain asbestos.

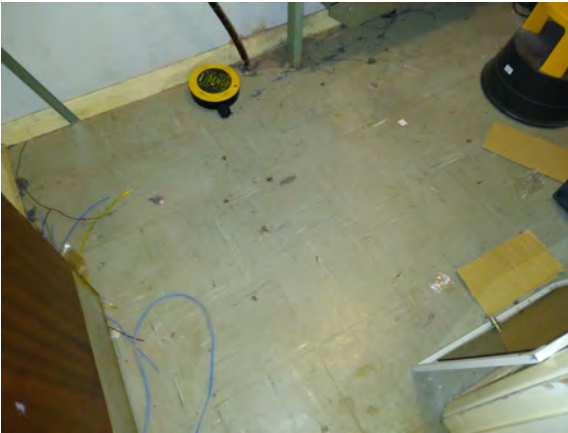
### **Item 80 Ref: As 369922-38**

The grey floor tile and adhesive (059/Switchroom) contain asbestos.

***Removed March 2021***

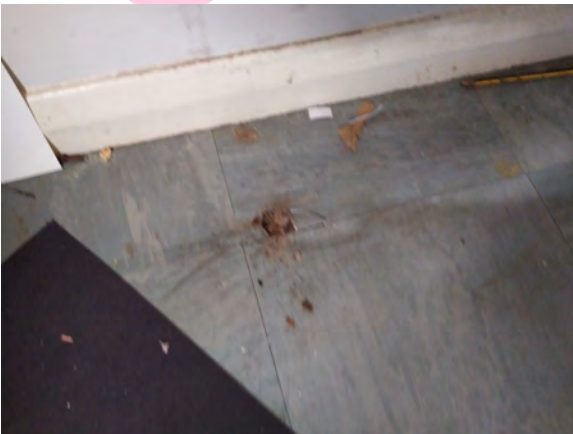
### **Item 81 Ref: 369922-1**

The floor covering remnants under modern blue tiles (061/Stationery Store) contain asbestos.

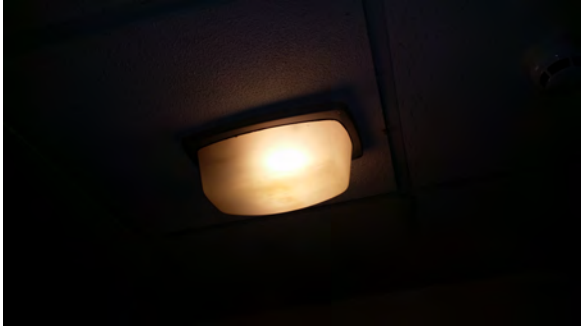
### **Item 82 Ref: 369922-33**

The sealant to light (062/Hall store) contains asbestos.

Any change in its appearance should be documented and passed to Property Services.

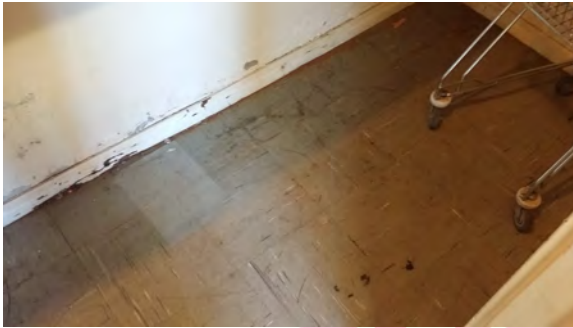
### **Item 83 Ref: 369922-31**

The floor covering (070/Store) contains asbestos.

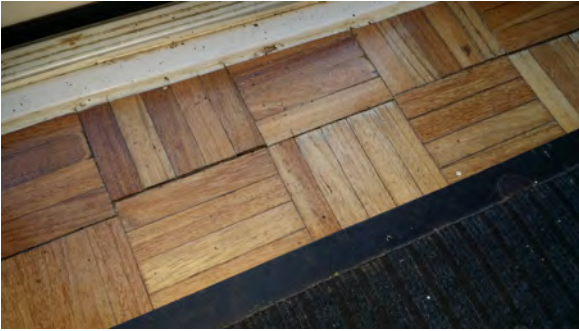
### **Item 85 Ref: 369922-20**

The adhesive backing to parquet flooring (071/Hall) does not contain asbestos.

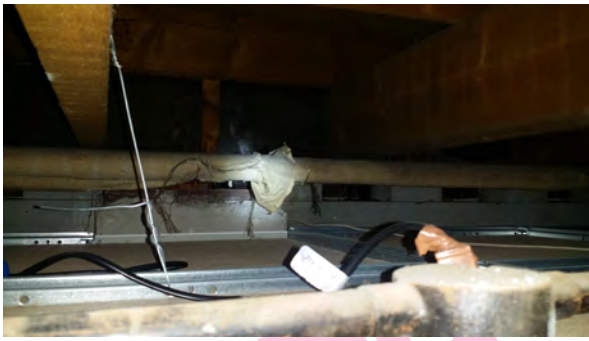
### **Item 89 Ref: As 369922-13**

The felt to external wall above brick columns (075/small classroom void above) does not contain asbestos.

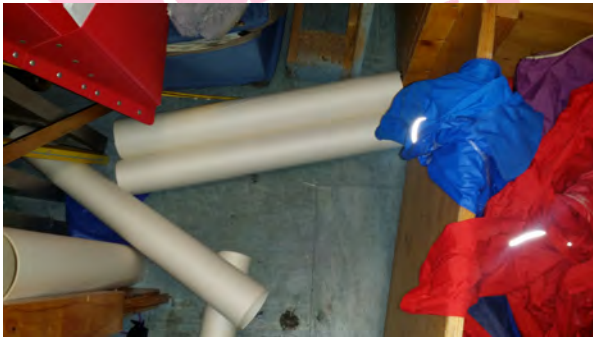
### **Item 90 Ref: As 369922-11**

The floor covering (076/Store upper areas) does not contain asbestos.

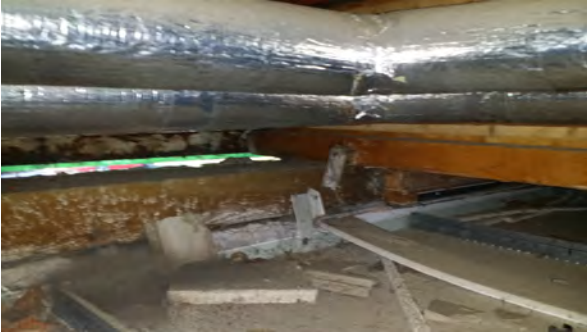
### **Item 91 Ref: 193462-3**

The packers to wood joists (076/Store void above) contain asbestos.

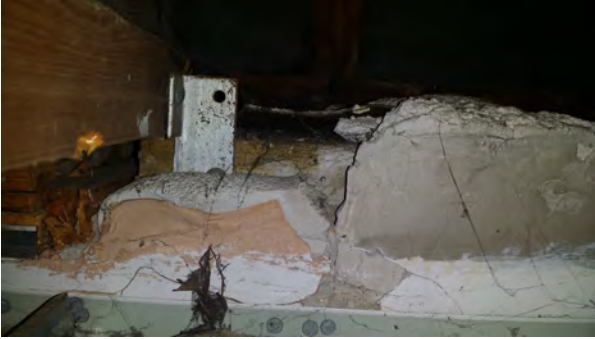
### **Item 94 Ref: As 369922-32**

The felt to external wall (077/Store void above) does not contain asbestos.

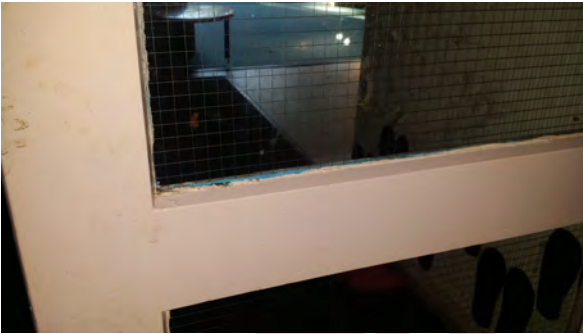
### **Item 95 Ref: 369922-14**

The sealant to glazing at doors (078/Entrance Lobby) does not contain asbestos.

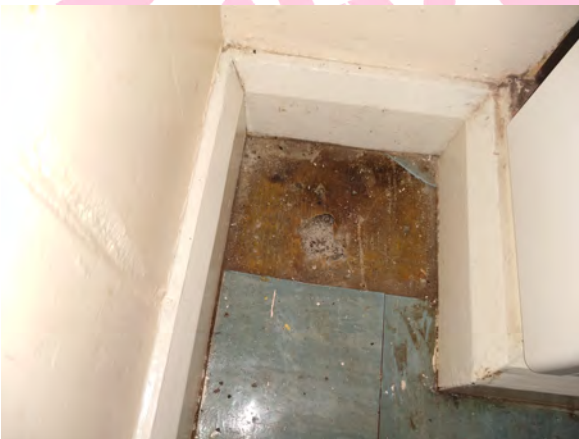
### **Item 96 Ref: 369922-35**

The adhesive to concrete floor (084/Cloakroom) contains asbestos.

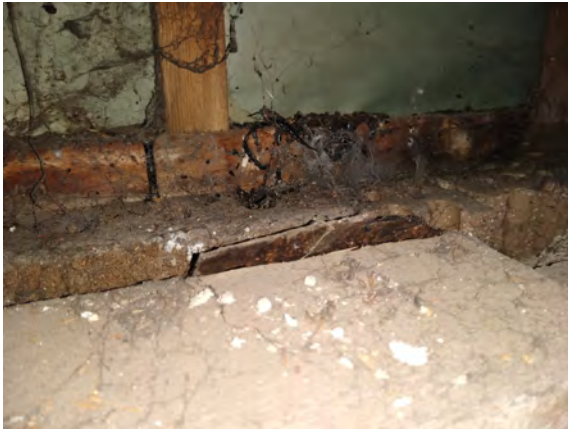
### **Item 97 Ref: 369922-36**

The damp proof course within cavity (084/Cloakroom void above) does not contain asbestos.

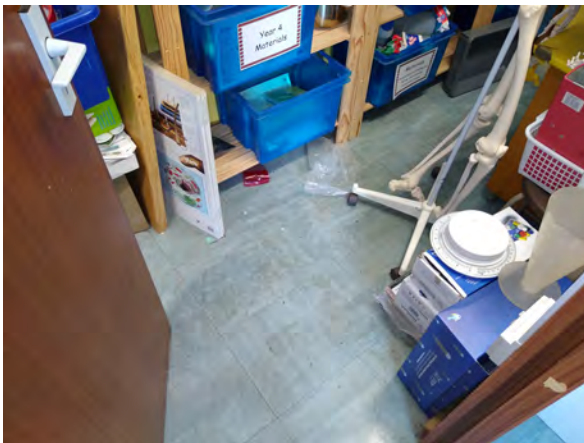
### **Item 98 Ref: As 369922-35**

The adhesive to concrete floor (084a/Store) contains asbestos.

Any change in its appearance should be documented and passed to Property Services.

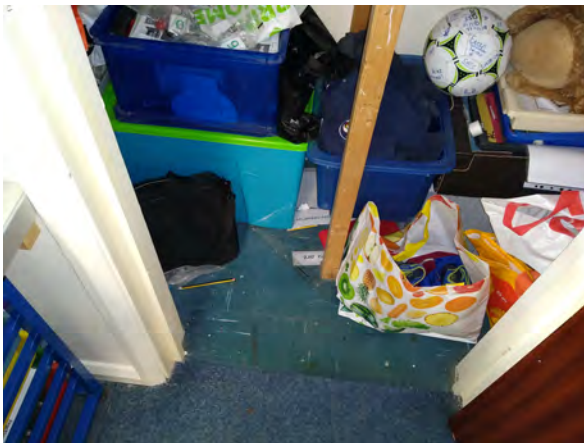
### **Item 99 Ref: As 369922-37**

The blue floor tiles and adhesive (085/Store) contain asbestos.

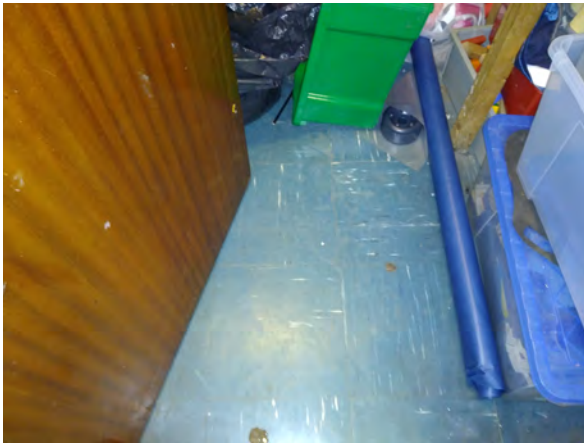
### **Item 100 Ref: As 369922-37**

The blue floor tiles and adhesive (086/Store) contain asbestos.

Any change in its appearance should be documented and passed to Property Services.

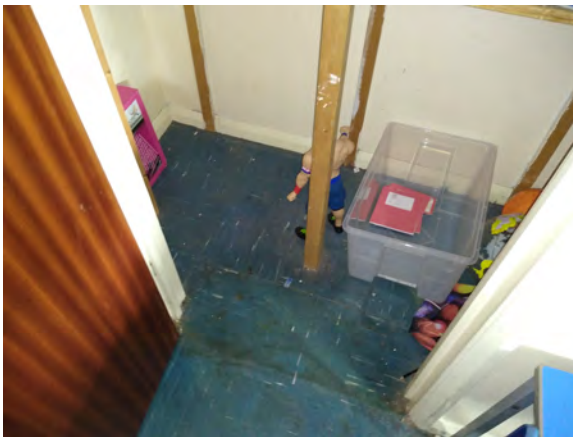
### **Item 101 Ref: As 369922-37**

The blue floor tiles and adhesive (087/Store) contain asbestos.

Any change in its appearance should be documented and passed to Property Services.

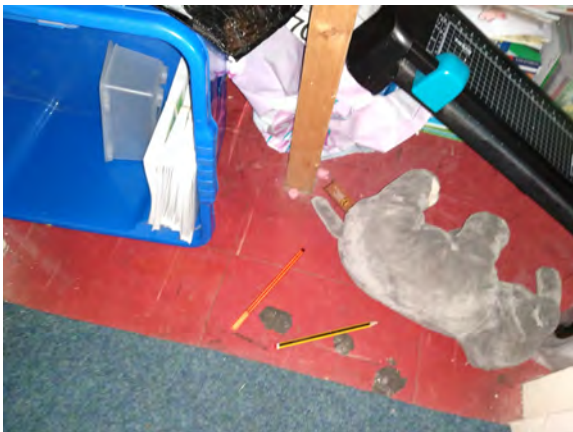
### **Item 102 Ref: As 369922-39**

The red floor tiles and adhesive (089/Store) contain asbestos.

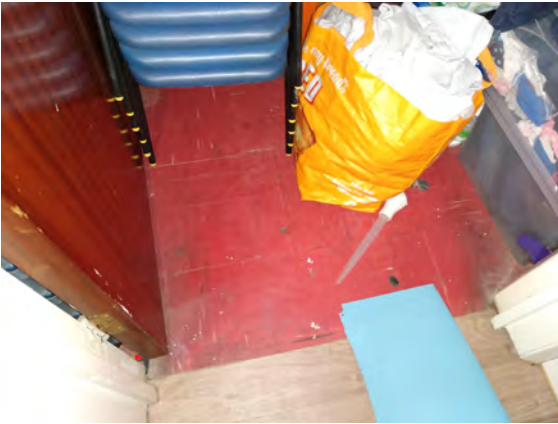
### **Item 103 Ref: As 369922-39**

The red floor tiles and adhesive (090/Store) contain asbestos.

Any change in its appearance should be documented and passed to Property Services.

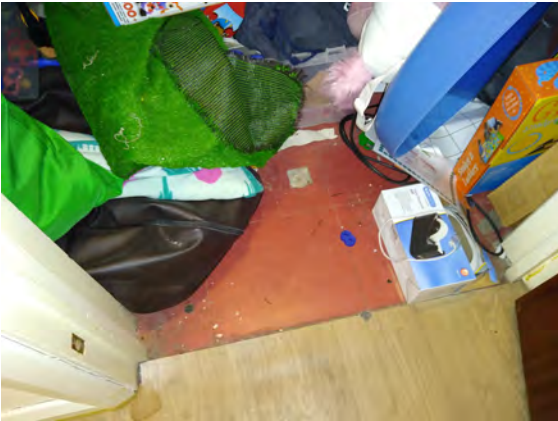
### **Item 104 Ref: 369922-39**

The red floor tiles and adhesive (091/Store) contain asbestos.

Any change in its appearance should be documented and passed to Property Services.

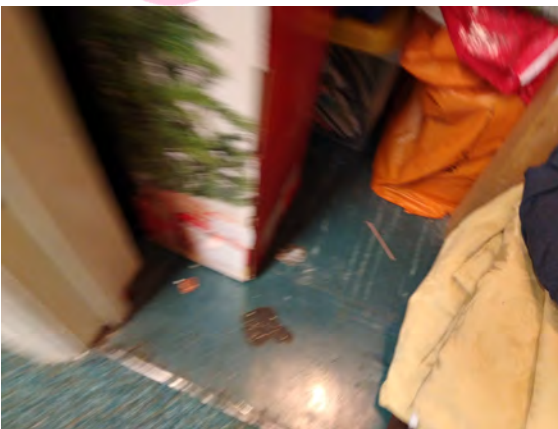
### **Item 105 Ref: As 369922-7**

The floor tile and adhesive (092/Store) contain asbestos.

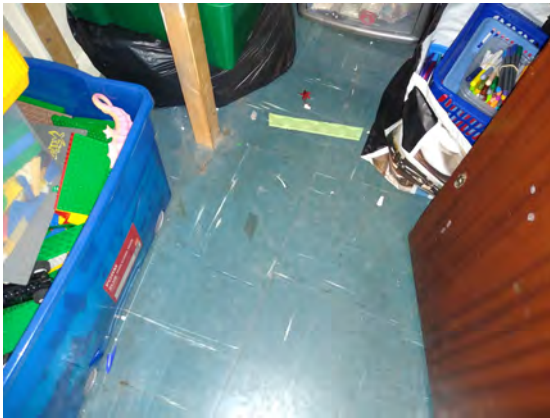
### **Item 106 Ref: As 369922-7**

The floor tile and adhesive (093/Store) contain asbestos.

Any change in its appearance should be documented and passed to Property Services.

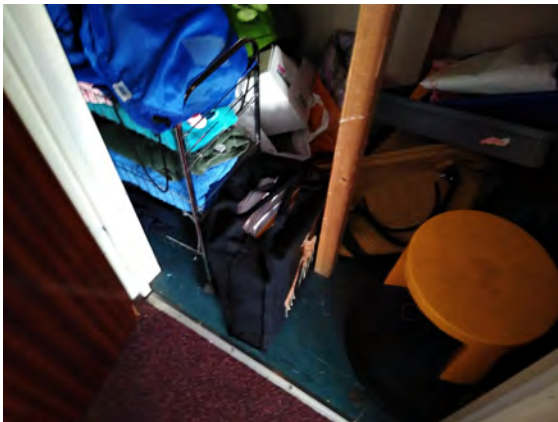
### **Item 107 Ref: As 369922-7**

The floor tile and adhesive (094/Store) contain asbestos.

Any change in its appearance should be documented and passed to Property Services.

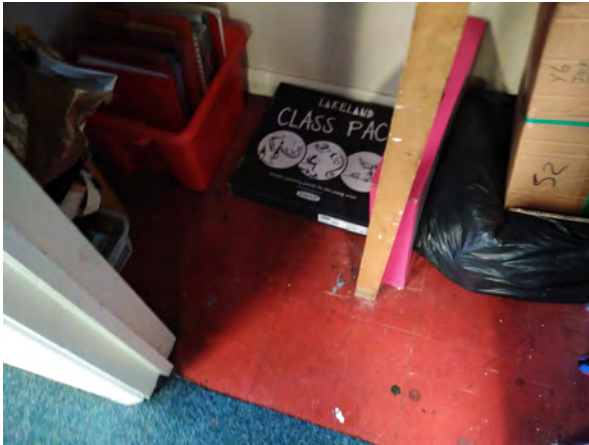
### **Item 109 Ref: As 369922-3**

The floor tile and adhesive (097/Store) contain asbestos.

Any change in its appearance should be documented and passed to Property Services.

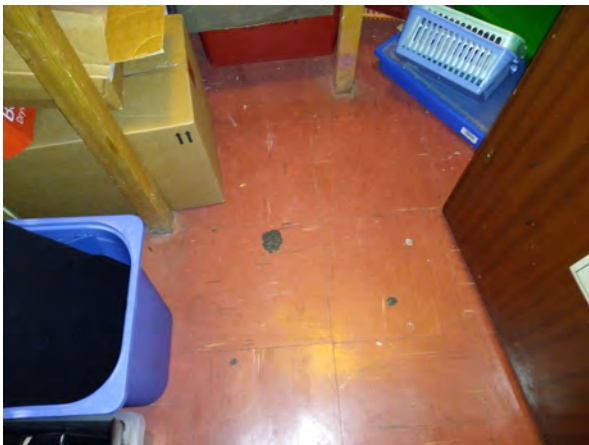
### **Item 110 Ref: As 369922-3**

The floor tile and adhesive (098/Store) contain asbestos.

Any change in its appearance should be documented and passed to Property Services.

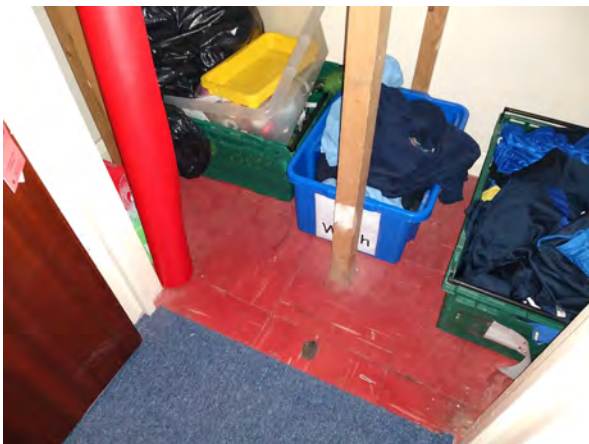
### **Item 111 Ref: As 369922-3**

The floor tile and adhesive (099/Store) contain asbestos.

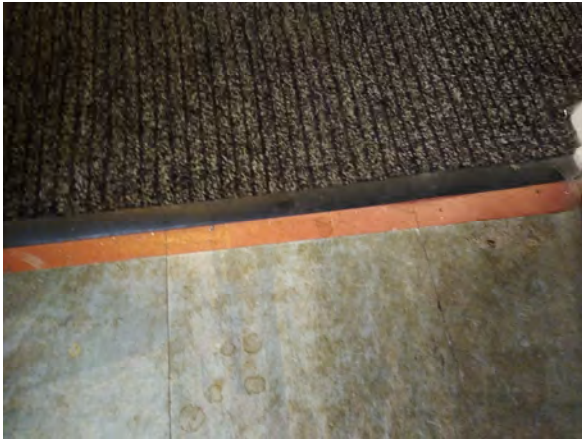
### **Item 112 Ref: As 369922-3**

The floor covering to doorway (122/Store) contains asbestos.

Any change in its appearance should be documented and passed to Property Services.

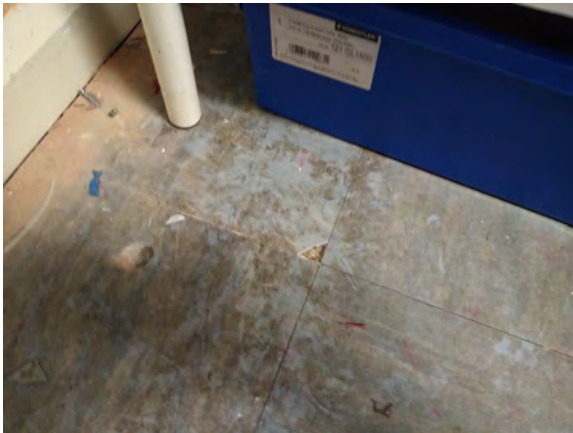
### **Item 113 Ref: 369922-4**

The floor covering under modern tiles (122/Store) contains asbestos.

Any change in its appearance should be documented and passed to Property Services.

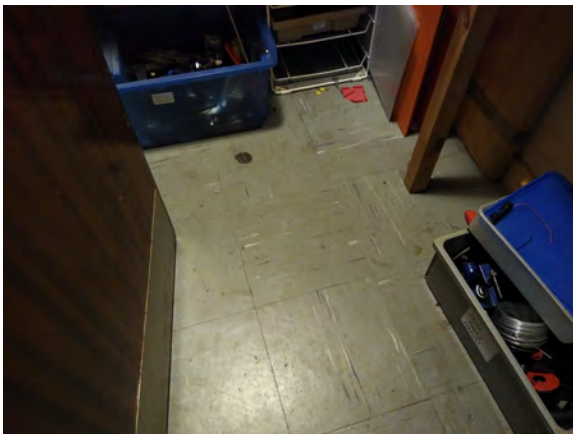
### **Item 114 Ref: As 369922-2**

The floor covering (124/Store) contains asbestos.

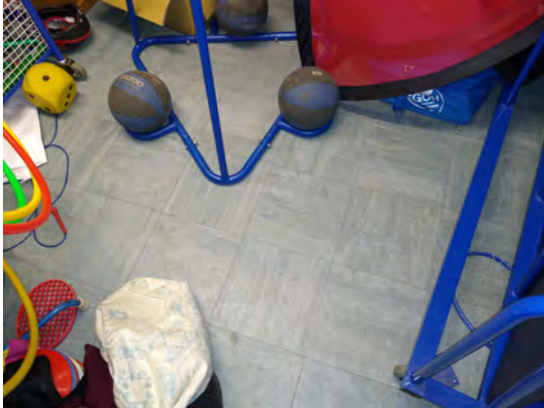
### **Item 115 Ref: As 369922-35**

The adhesive to concrete floor (150/Hall Store) contains asbestos.

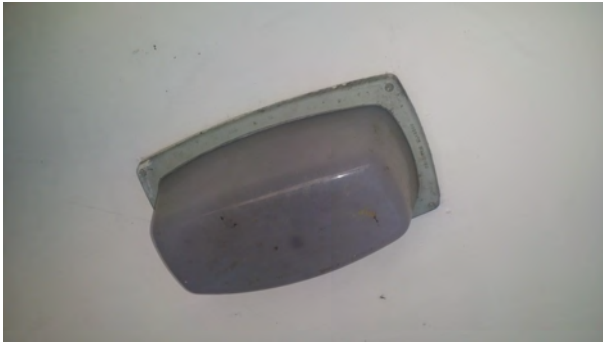
### **Item 118 Ref: 369922-45**

The sealant to bulk head lights (External) contains asbestos.

Any change in its appearance should be documented and passed to Property Services.

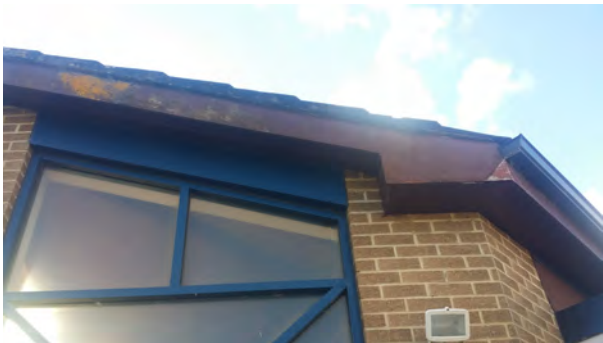
### **Item 119 Ref: 369922-46**

The fillet to pitched roof (External - front of school only) contains asbestos.

Any change in its appearance should be documented and passed to Property Services.

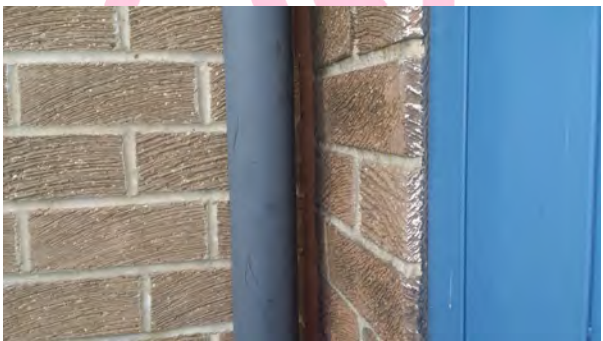
### **Item 120 Ref: 369922-47**

The expansion gap filler (External) does not contain asbestos.

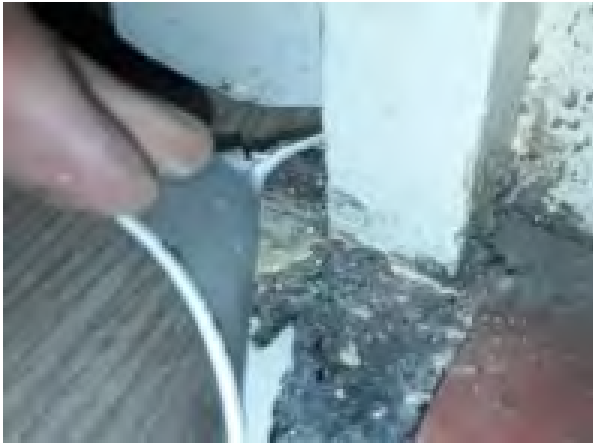
### **Item 121 Ref: 21-33645-1**

The residual adhesive beneath the screed (Area 1/Year 6 Classroom 04) does contain asbestos. Samples taken from cupboard recess.

Any change in its appearance should be documented and passed to Property Services.

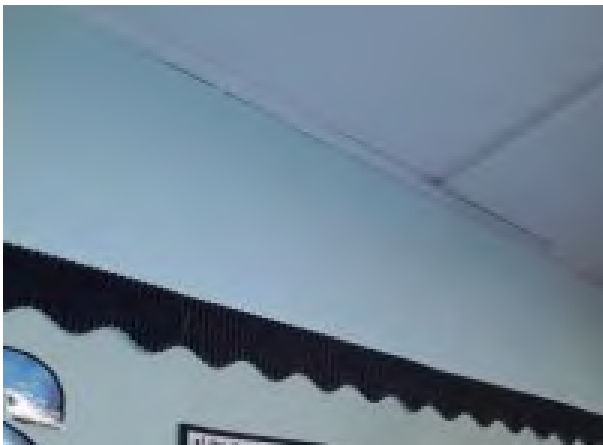
### **Item 122 Ref: 21-33645-2**

The textured coating to the walls (Area 1/Year 6 Classroom) do not contain asbestos.

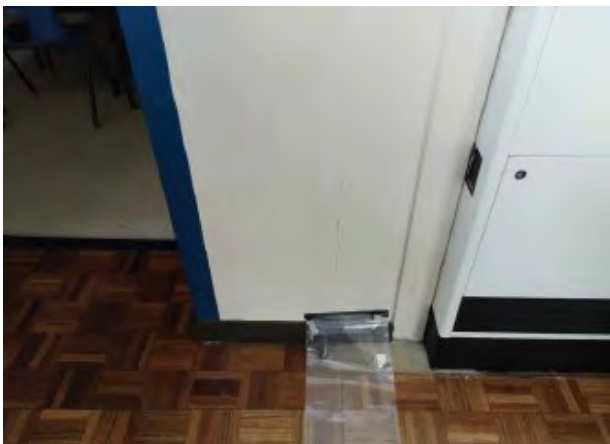
### **Item 123 Ref: 22-47158-1**

The plaster to right hand wall (Area 1/Main Hall) does not contain asbestos.

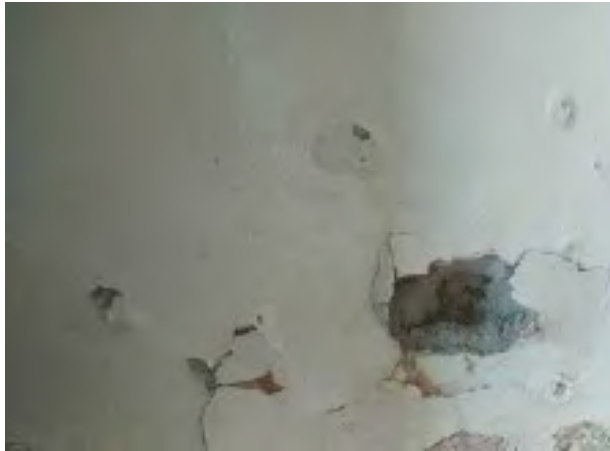
### **Item 124 Ref: 22-47158-1**

The plaster to right hand wall (Area 1/Main Hall) does not contain asbestos.

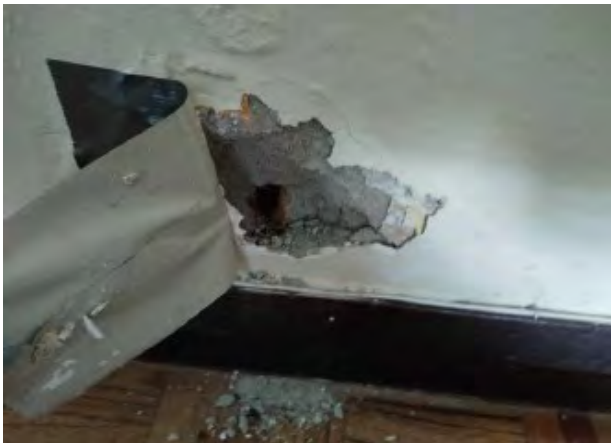
### **Item 125 Ref: 22-47158-2**

The plaster to front wall (Area 1/Main Hall) does not contain asbestos.

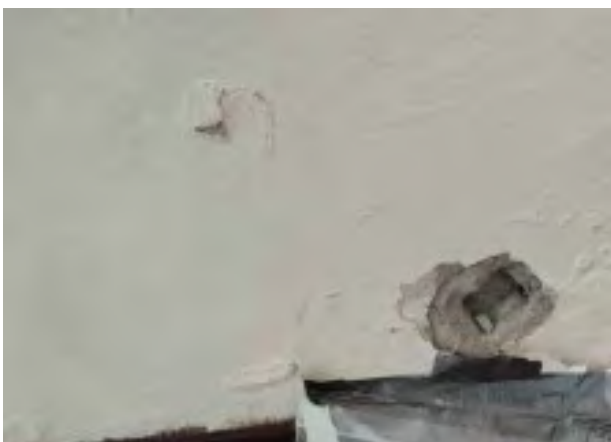
### **Item 126 Ref: 22-47158-3**

The plaster to left wall (Area 1/Main Hall) does not contain asbestos.

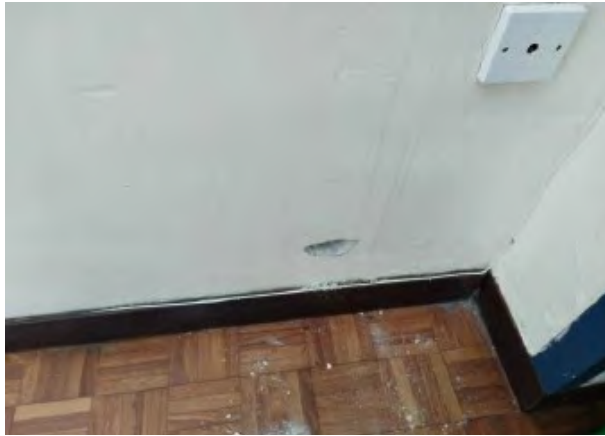
### **Item 127 Ref: 22-47158-4**

The plaster to back wall (Area 1/Main Hall) does not contain asbestos.

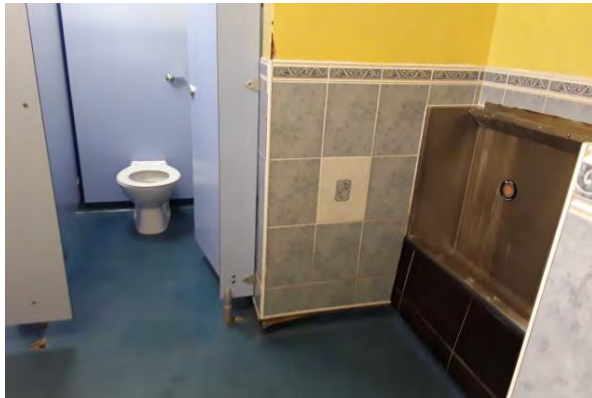
### **Item 128 Ref: 22-50282-1**

The walls – ceramic tiles (adhesive) (Area 1/Boys Toilets) do not contain asbestos.

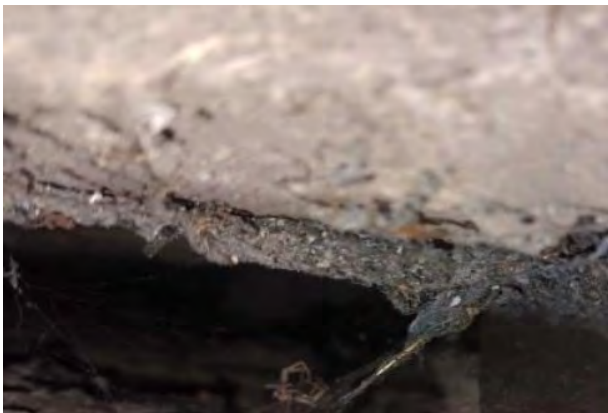
### **Item 129 Ref: 23-61635-1**

The walls – bitumen in wall void in Kitchen (Area 1) does not contain asbestos.

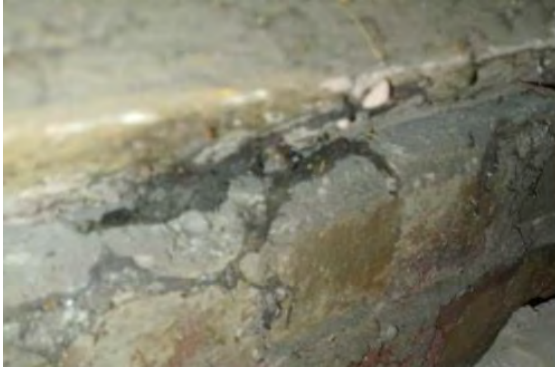
**Item 130 Ref: 23-61635-1**

The walls – bitumen in wall void in Kitchen (Area 1) does not contain asbestos.
