ASBESTOS SURVEY REPORT FOR KEPIER ACADEMY, DAIRY LANE,
HOUGHTON LE SPRING, DH5 9JZ

Asbestos Register for

Kepier Academy School

Premises Manager / Samo: - Tenant Date: 04 March 2026

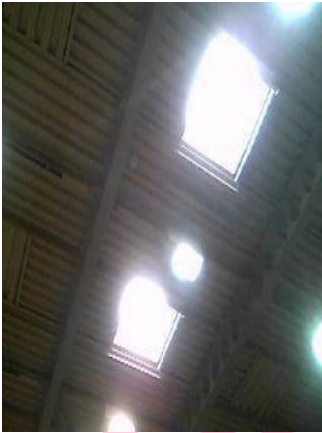
Item 2 – Presumed

- (Item 1) Ref: Presumed – Packing to clasp columns (Sports Building) (R197) – Low Risk
- (Item 2) Ref: Presumed – Skylight Fascia (Sports Building) (R206) – Medium Risk

The skylight fascia in R206 is presumed to contain asbestos. (Due to inaccessible due to height)

Any change in its appearance should be noted and reported to Property Services.

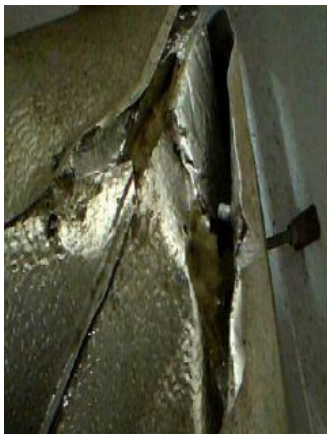
Item 3 – Ref: BB003120

The pipe insulation in R219 does not contain asbestos.

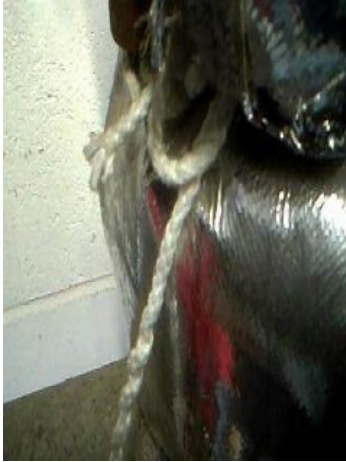
Item 4 – Ref: BB003121

The rope to pipe flange covers in R219 does not contain asbestos.

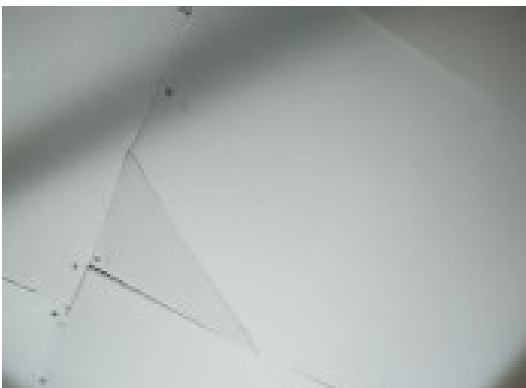
Item 18 – Ref: 21-38551-1

The bitumen to the ceiling in the Music Store 1 ceiling void (Area 16) does not contain asbestos.
