ASBESTOS SURVEY REPORT FOR KEPIER ACADEMY, DAIRY LANE,
HOUGHTON LE SPRING, DH5 9JZ

Asbestos Register for

Kepier Academy School

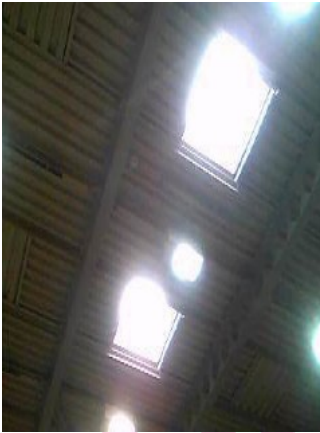
Item 2 – Presumed

The skylight fascia in R206 is presumed to contain asbestos. (Due to inaccessible due to height)

Any change in its appearance should be noted and reported to Property Services.

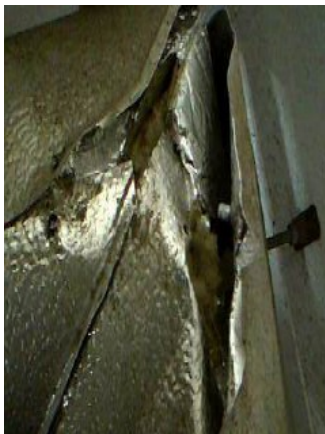
Item 3 – Ref: BB003120

The pipe insulation in R219 does not contain asbestos.

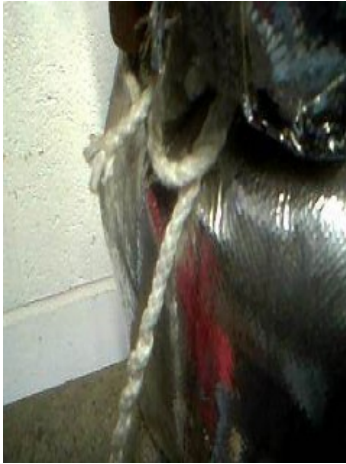
Item 4 – Ref: BB003121

The rope to pipe flange covers in R219 does not contain asbestos.

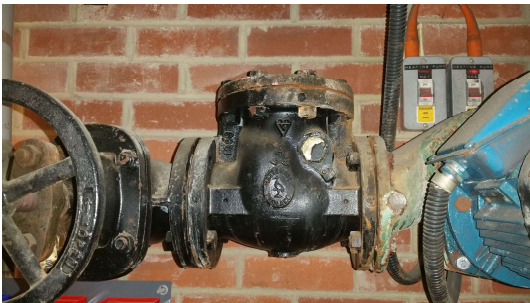
Item 6 – Ref: 263742-1

The gasket to pipework flange in plant room (R 187) contains asbestos.

Removed October 2019

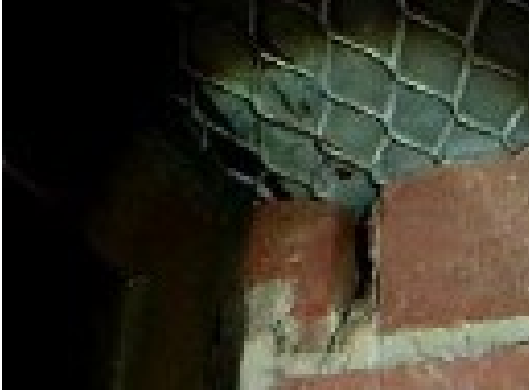
Item 7 – Ref: BB003121

The composite wall debris in R187 does not contain asbestos.

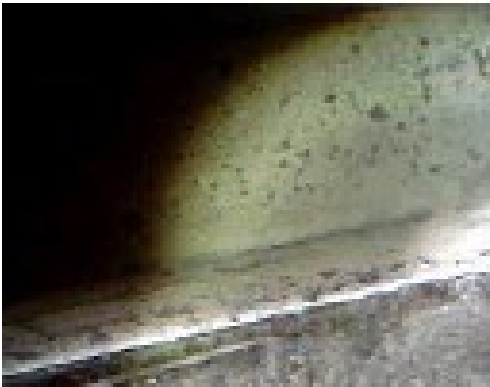
Item 8 – Ref: BB003126

The composite floor debris in R187 does not contain asbestos.

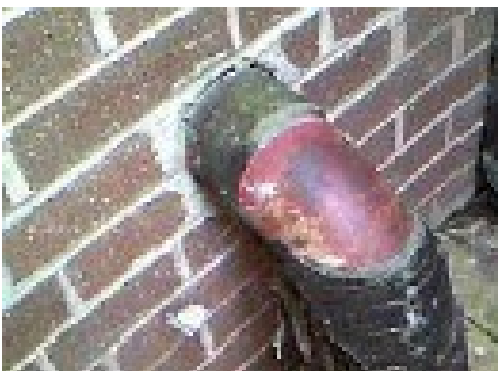
Item 9 – Ref: BB003127

The pipe wrapping (External) to Sports building does not contain asbestos.

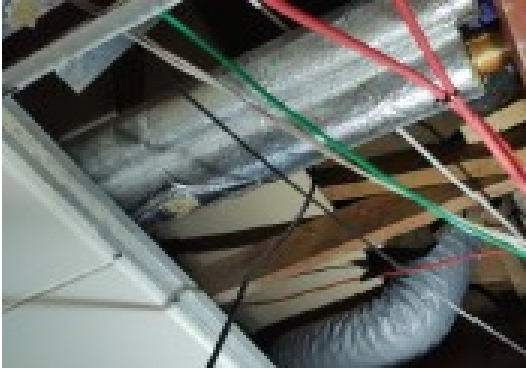
Item 10 – Ref: 21-38551-1

The bitumen sarking felt to the ceiling in the corridor ceiling void (Area 3) does not contain asbestos.

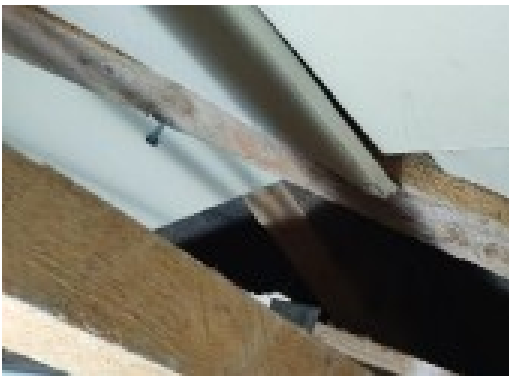
Item 11 – Ref: 21-38551-1

The bitumen to the ceiling in the Music Room 2 ceiling void (Area 9) does not contain asbestos.

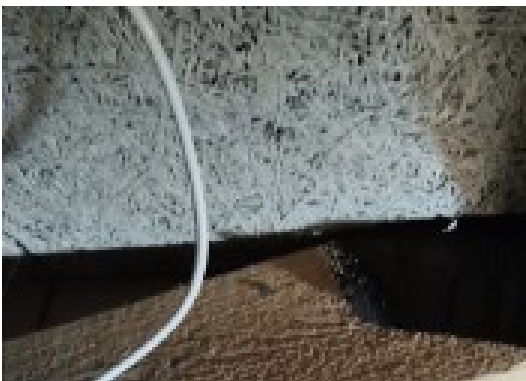
Item 12 – Ref: 21-38551-2

The bitumen sarking felt to the ceiling in the Practice Room 1 ceiling void (Area 10) does not contain asbestos.

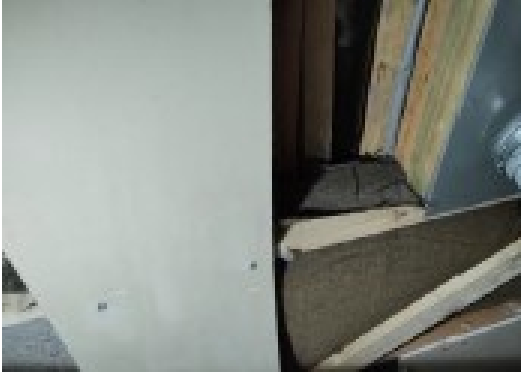
Item 13 – Ref: 21-38551-1

The bitumen to the ceiling in the Practice Room 2 ceiling void (Area 11) does not contain asbestos.

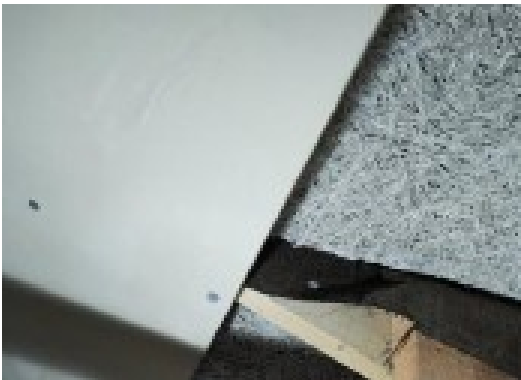
Item 14 – Ref: 21-38551-2

The bitumen sarking felt to the ceiling in the Practice Room 3 ceiling void (Area 12) does not contain asbestos.

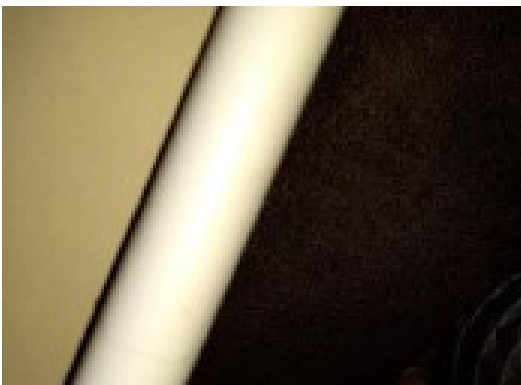
Item 15 – Ref: 21-38551-1

The bitumen to the ceiling in the Recording Studio ceiling void (Area 13) does not contain asbestos.

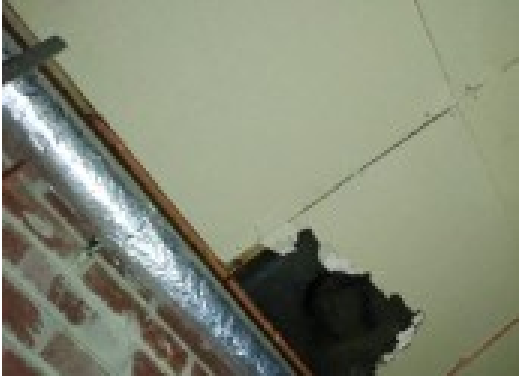
Item 16 – Ref: 21-38551-1

The bitumen to the ceiling in the Boiler Room (Area 14) does not contain asbestos.

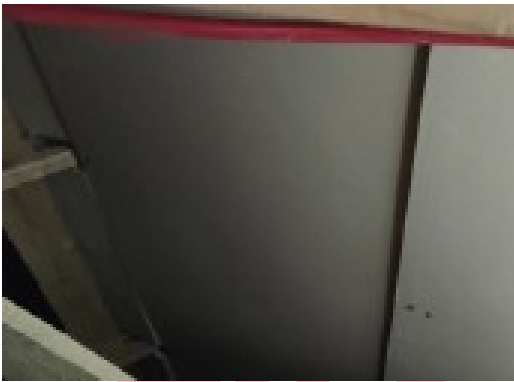
Item 17 – Ref: 21-38551-2

The bitumen to the ceiling in the Head of music ceiling void (Area 15) does not contain asbestos.

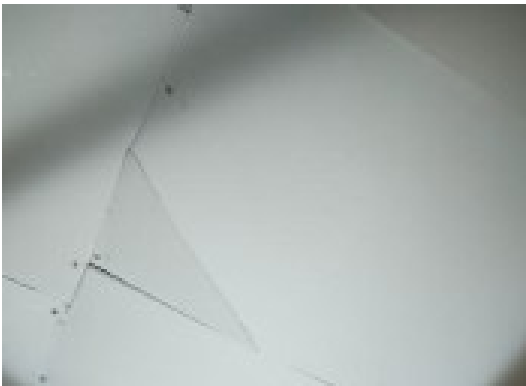
Item 18 – Ref: 21-38551-1

The bitumen to the ceiling in the Music Store 1 ceiling void (Area 16) does not contain asbestos.

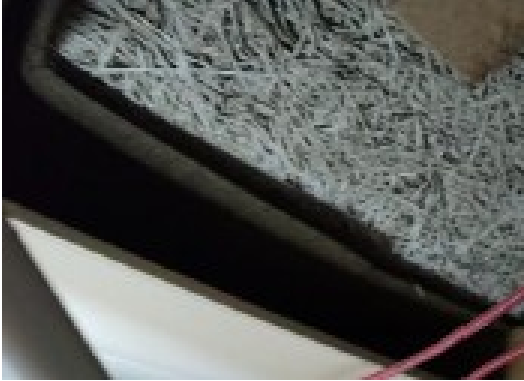
Item 19 – Ref: 21-38551-2

The bitumen to the ceiling in the Table Store 2 ceiling void (Area 18) does not contain asbestos.

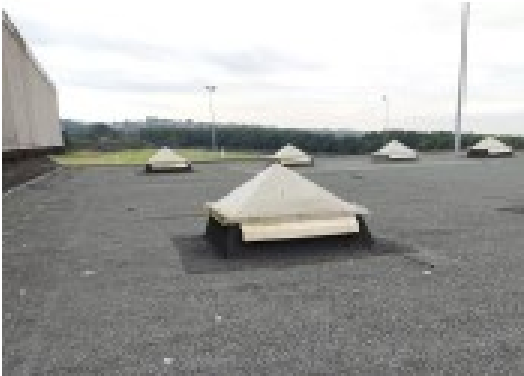
Item 20 – Ref: 21-38551-3

The bitumen roof felt to the roof of gym 1 (Area 20) does not contain asbestos.

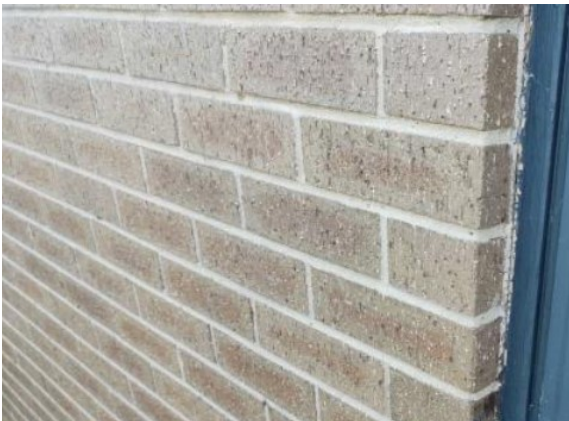
Item 21 – Ref: 22-50810-1

The frame sealants to windows of R195 and R188 (External/Area 3) contains asbestos.

Removed 2022

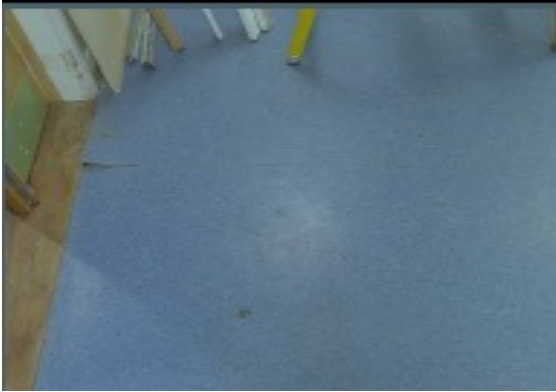
Item 22 – Ref: PK001652

The black screed – floor below modern lino to doorway in the Exam Store (G/02) does not contain asbestos.
