ASBESTOS SURVEY REPORT FOR BROADWAY JUNIOR SCHOOL,  
SPRINGWELL ROAD, SUNDERLAND, SR4 8NW.

*Control of Asbestos  
Regulations 2012*

**Broadway Junior School, Springwell Road, SR4 8NW**

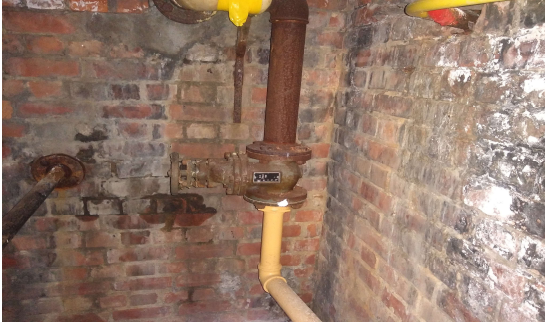
### **Item 1 Ref: 417799-1**

The gas pipework flange gaskets in Rm -1/001 Former Coal Bunker contains asbestos.

Any change in its appearance should be recorded and passed to Property Services.

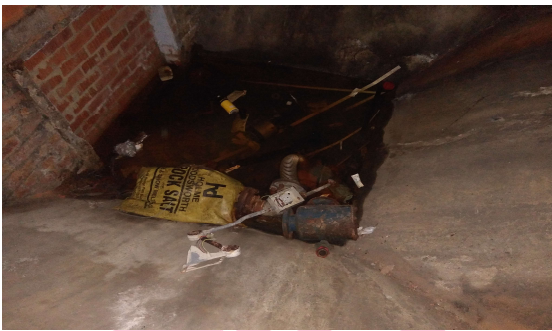
### **Item 2 Ref: As 417799-1**

The gaskets to loose lying flanges in Rm -1/001 Former Coal Bunker contains asbestos.

Any change in its appearance should be recorded and passed to Property Services.

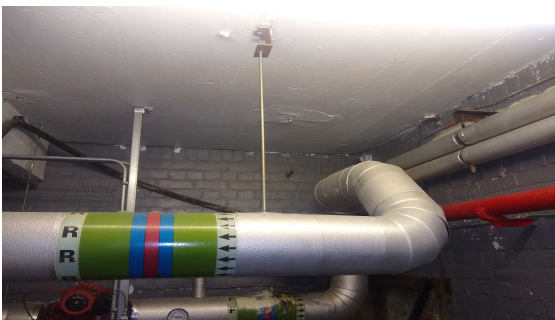
### **Item 3 Ref: 417799-2**

The encapsulated residue to walls in Rm -1/002 Boiler House contains asbestos.

Any change in its appearance should be recorded and passed to Property Services.

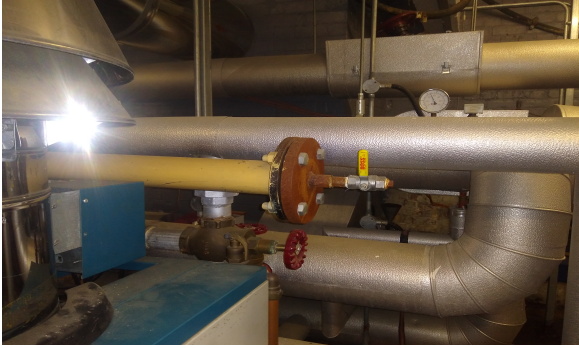
### **Item 4 Ref: As 417799-1**

The gas pipework flange gaskets in Rm -1/002 Boiler House contains asbestos.

*Removed see survey J156853*

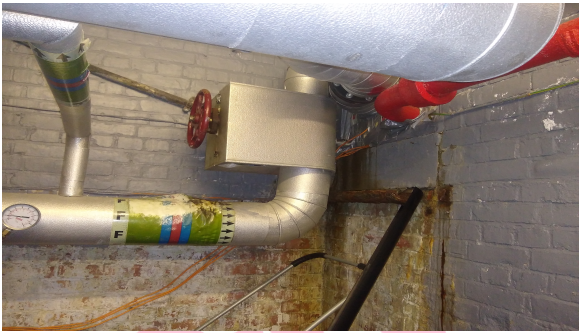
### **Item 5 Ref: 417799-3**

The heating pipework flange gaskets in Rm -1/002 Boiler House do not contain asbestos.

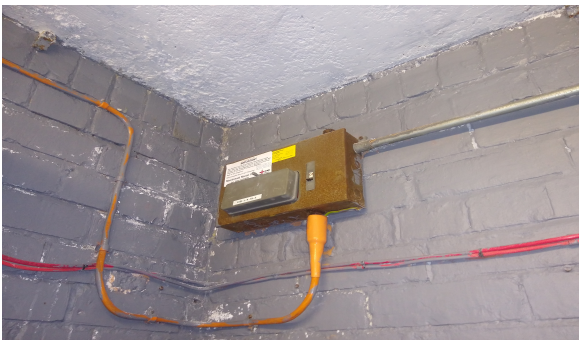
### **Item 6 Ref: Presumed**

The electrics – end caps within cartridge fuses to Wylex DB in Rm -1/002 Boiler House are presumed to contain asbestos.

*Removed see survey J156853*

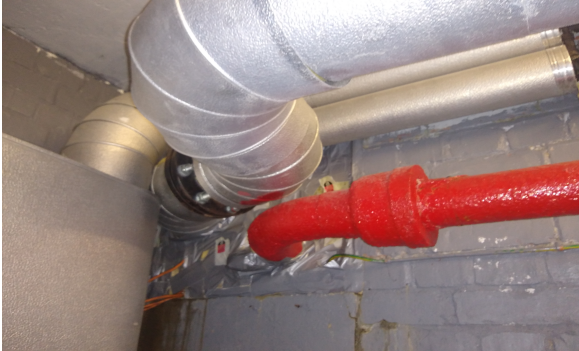
### **Item 7 Ref: Presumed**

The pipe lagging & associated debris in Rm -1/002 Boiler House – floor duct is presumed to contain asbestos.

Any change in its appearance should be recorded and passed to Property Services.

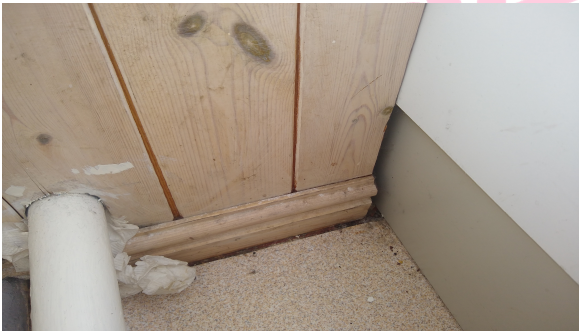
### **Item 8 Ref: 417799-5**

The floor tile with bitumen adhesive in Rm 0/001 canteen contains asbestos.

Any change in its appearance should be recorded and passed to Property Services.

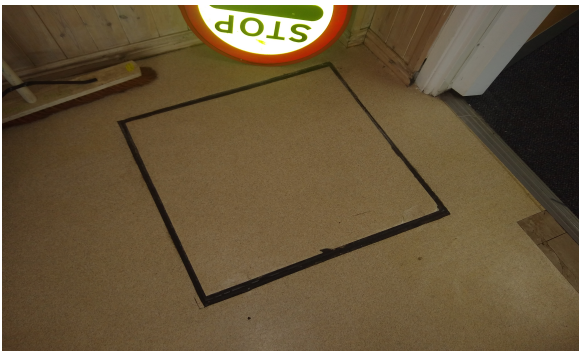
### **Item 9 Ref: Presumed**

The floor duct in Rm 0/001 canteen is presumed to contain asbestos.

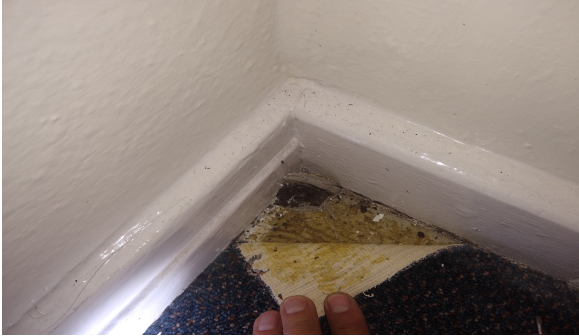
### Item 10 Ref: 417799-4

The brown floor screed in Rm 0/001b Corridor contains asbestos.

Any change in its appearance should be recorded and passed to Property Services.

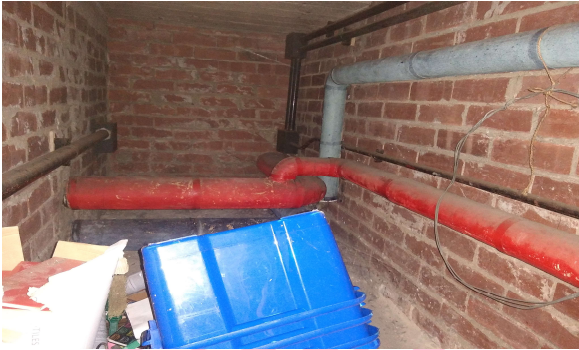
### Item 11 Ref: 417799-7

The pipe lagging in Rm 0/004a Switch Room – void below stairs contains asbestos.

**This area should not be inspected.**

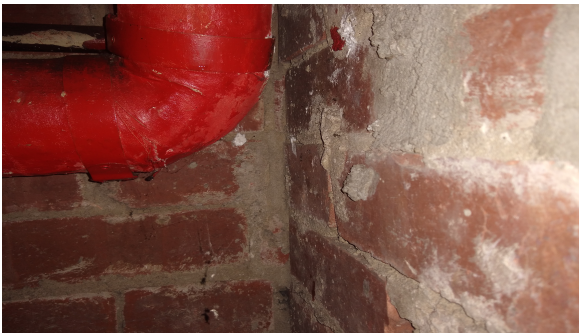
### Item 12 Ref: 417799-8

The debris to walls in Rm 0/004a Switch Room – void below stairs contains asbestos.

**This area should not be inspected.**

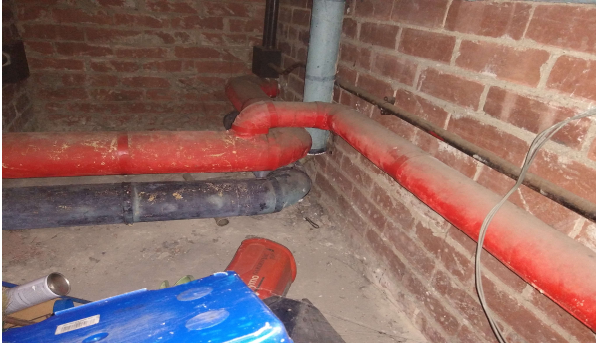
### **Item 13 Ref: 417799-9**

The debris to floor in Rm 0/004a Switch Room – void below stairs contains asbestos.

**This area should not be inspected.**

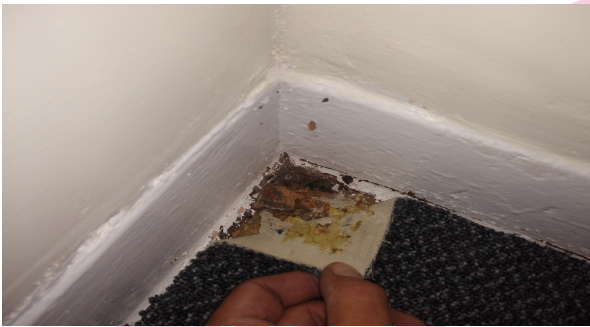
### **Item 14 Ref: As 417799-4**

The brown floor screed in Rm 0/005 Head Teachers contains asbestos.

Any change in its appearance should be recorded and passed to Property Services.

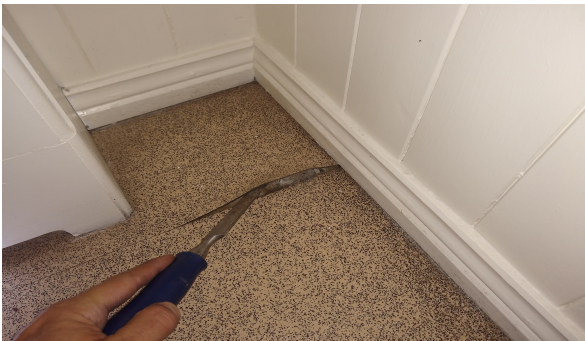
### **Item 15 Ref: 417799-6**

The remnant screed in Rm 0/006 Staff Toilets contains asbestos.

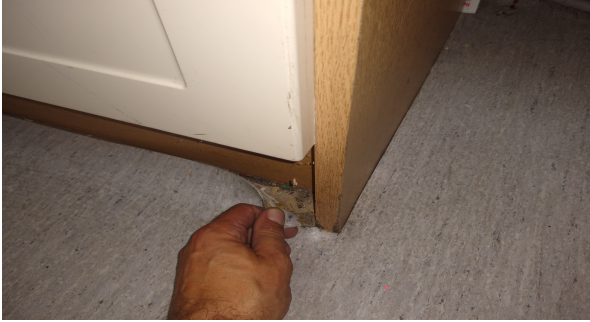
### **Item 16 Ref: 417799-11**

The floor tile with bitumen adhesive in Rm 0/007 Classroom contains asbestos.

Any change in its appearance should be recorded and passed to Property Services.

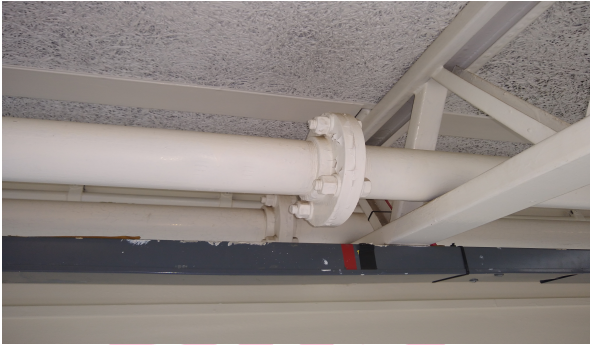
### **Item 17 Ref: Presumed**

The close coupled pipework flange gaskets in 0/007b Corridor contains asbestos.

Any change in its appearance should be recorded and passed to Property Services.

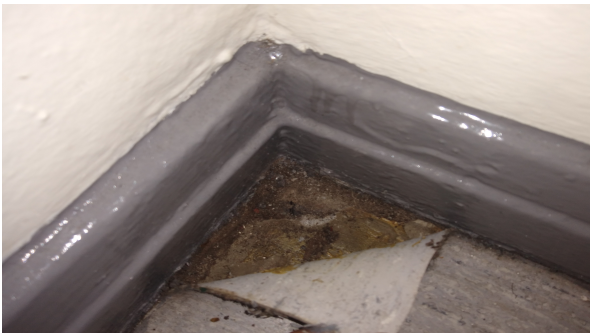
### **Item 18 Ref: As 417799-18**

The remnant adhesive to floor beneath linoleum & screed in Rm 0/007b Corridor contains asbestos.

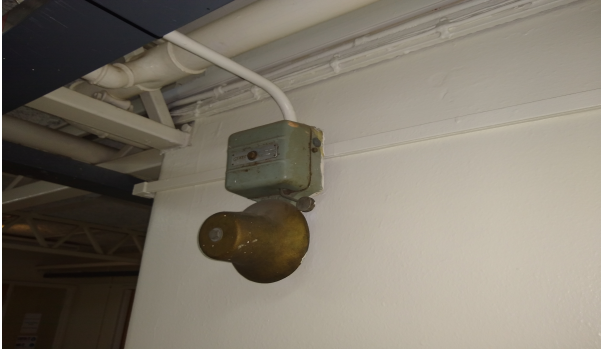
### **Item 19 Ref: 417799-19**

The rope seal to bell mechanism housing in Rm 0/007b Corridor does not contain asbestos.

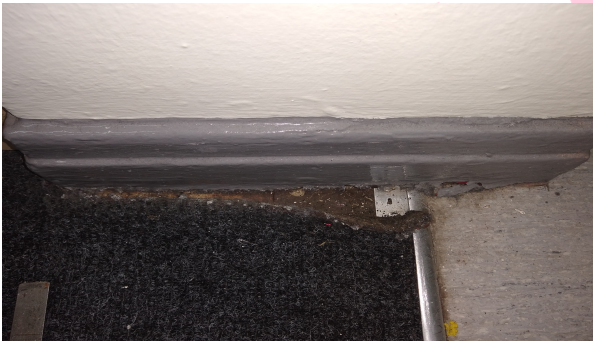
### **Item 20 Ref: As 417799-17**

The floor tile with bitumen adhesive beneath carpeted area in 0/007b Corridor contains asbestos.

Any change in its appearance should be recorded and passed to Property Services.

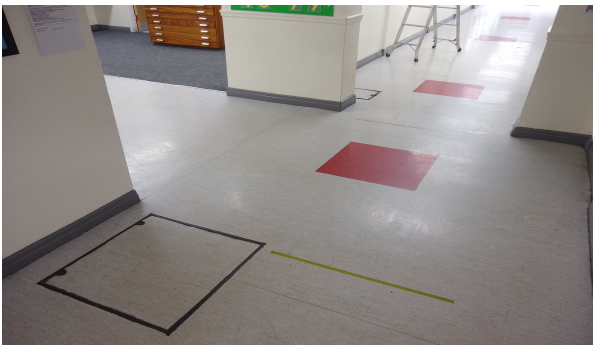
### **Item 21 Ref: Presumed**

The floor duct in Rm 0/007b Corridor is presumed to contain asbestos.

Any change in its appearance should be recorded and passed to Property Services.

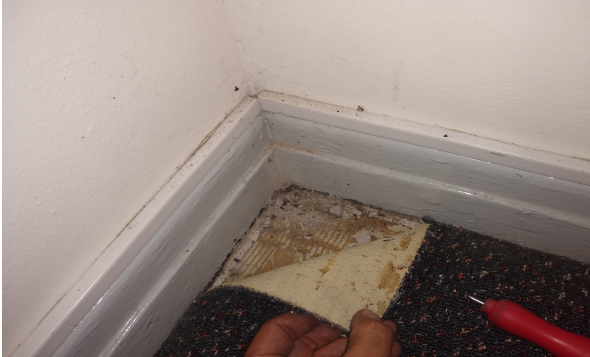
### **Item 22 Ref: 417799-12**

The floor tile with bitumen adhesive in 0/008 ICT Room contains asbestos.

Any change in its appearance should be recorded and passed to Property Services.

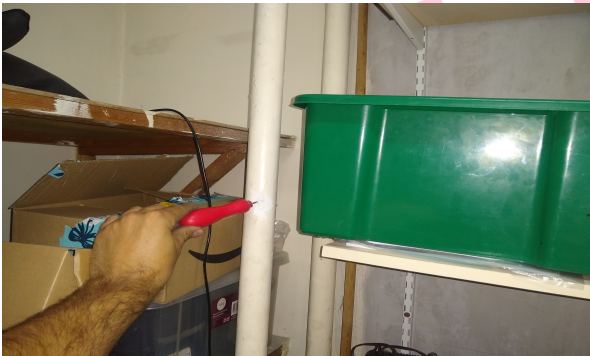
### **Item 23 Ref: 417799-14**

The residue to pipework in 0/008a Store contains asbestos.

Any change in its appearance should be recorded and passed to Property Services.

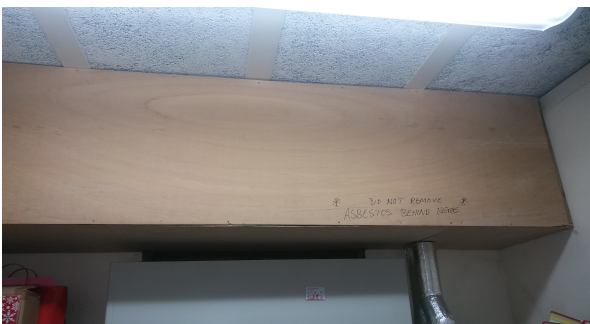
### **Item 24 Ref: 79754-8**

The pipe lagging within boxing in Rm 0/009 Store contains asbestos.

Any change in its appearance should be recorded and passed to Property Services.

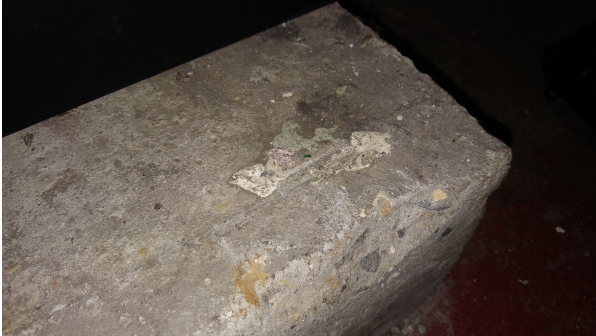
### **Item 25 Ref: 417799-13**

The residue to heater plinth in 0/009 Store does not contain asbestos.

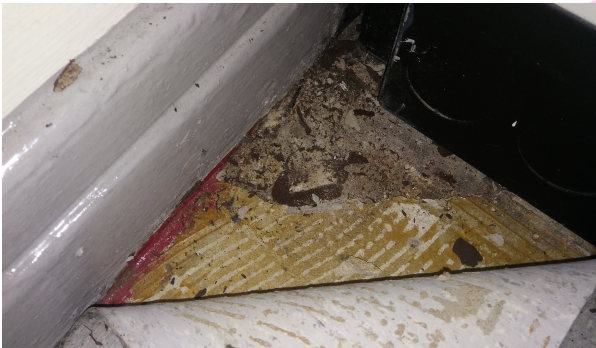
### **Item 26 Ref: As 417799-12**

The floor tile with bitumen adhesive in 0/010 Classroom contains asbestos.

Any change in its appearance should be recorded and passed to Property Services.

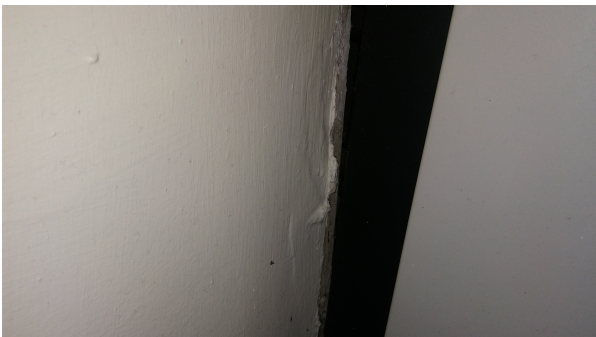
### **Item 27 Ref: 417799-15**

The remnant plaster to wall from former heater (behind modern heater) in Rm 0/010 Classroom does not contain asbestos.

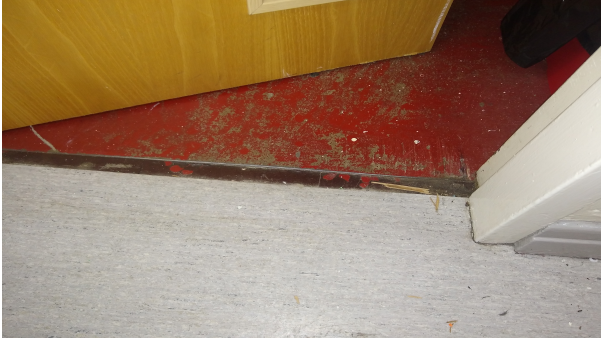
### **Item 28 Ref: As 417799-12**

The floor tile with bitumen adhesive in 0/011 Classroom contains asbestos.

Any change in its appearance should be recorded and passed to Property Services.

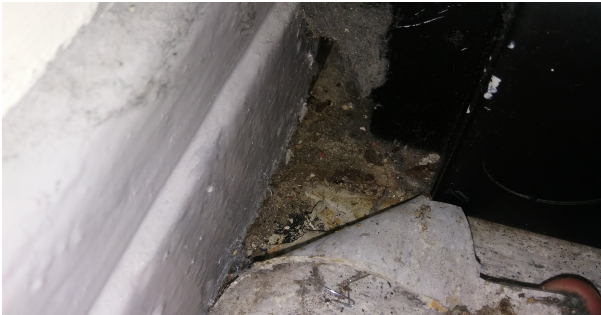
### **Item 29 Ref: As 417799-12**

The floor tile with bitumen adhesive in 0/012 Classroom contains asbestos.

Any change in its appearance should be recorded and passed to Property Services.

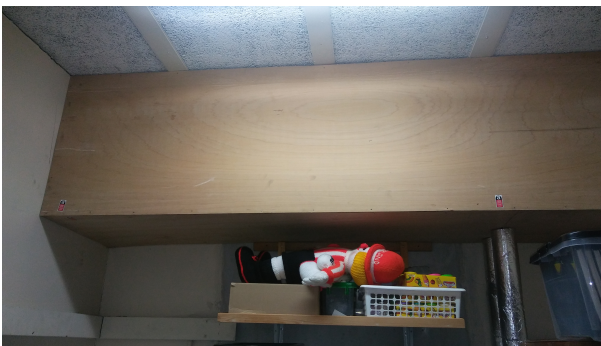
### **Item 30 Ref: Presumed**

The pipe lagging within high level boxing in Rm 0/012a Store is presumed to contain asbestos.

Any change in its appearance should be recorded and passed to Property Services.

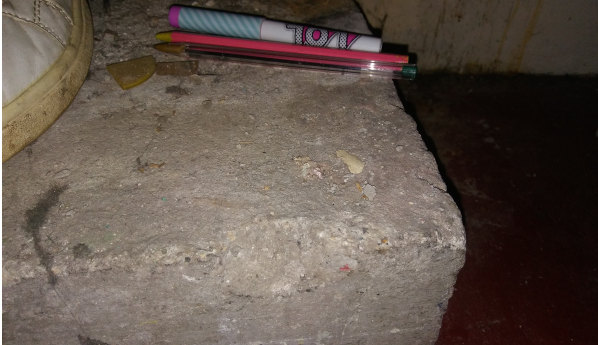
### **Item 31 Ref: 417799-16**

The residue to former heater plinth in 0/012a Store does not contain asbestos.

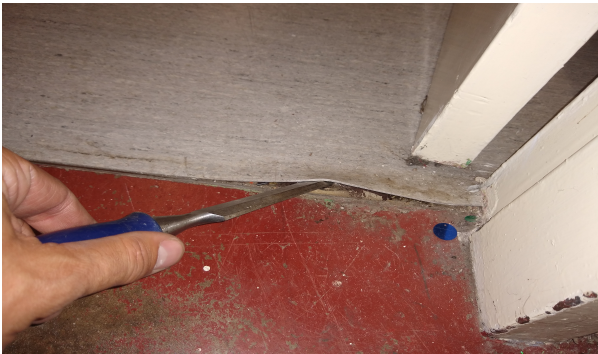
### **Item 32 Ref: 417799-17**

The floor tile with bitumen adhesive in 0/013 Classroom contains asbestos.

Any change in its appearance should be recorded and passed to Property Services.

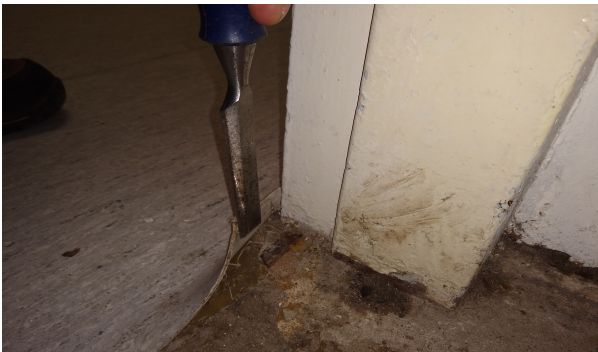
### **Item 33 Ref: As 417799-17**

The floor tile with bitumen adhesive in 0/014 Kitchen contains asbestos.

Any change in its appearance should be recorded and passed to Property Services.

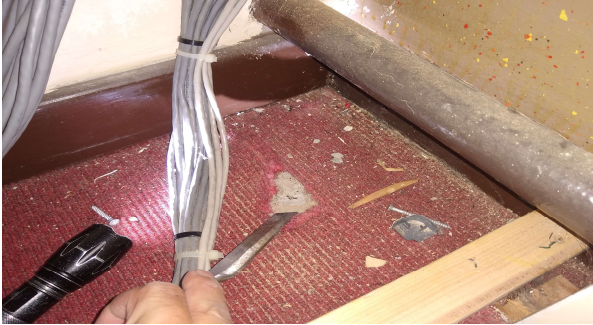
### **Item 34 Ref: 417799-18**

The remnant adhesive to floor beneath screed in 0/015 Library contains asbestos.

Any change in its appearance should be recorded and passed to Property Services.

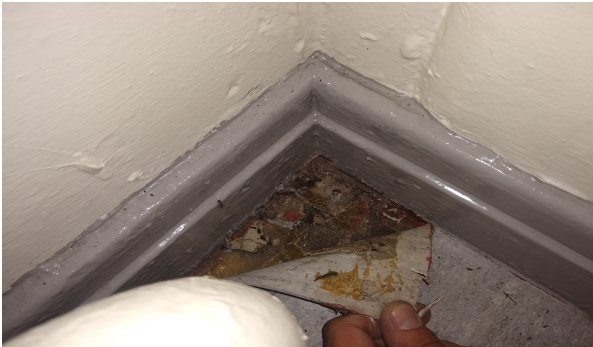
### **Item 35 Ref: 417799-20**

The floor tile with bitumen adhesive in 0/018 Classroom contains asbestos.

Any change in its appearance should be recorded and passed to Property Services.

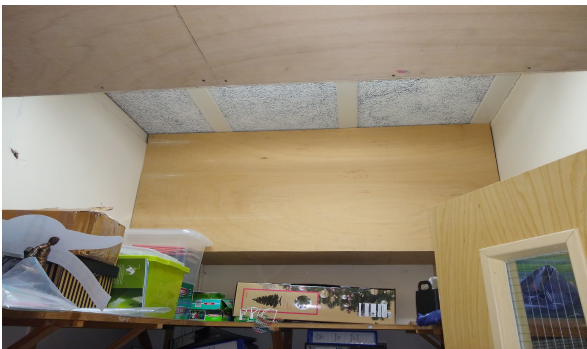
### **Item 36 Ref: Presumed**

The pipe lagging enclosed within boxings in 0/018a Store is presumed to contain asbestos.

Any change in its appearance should be recorded and passed to Property Services.

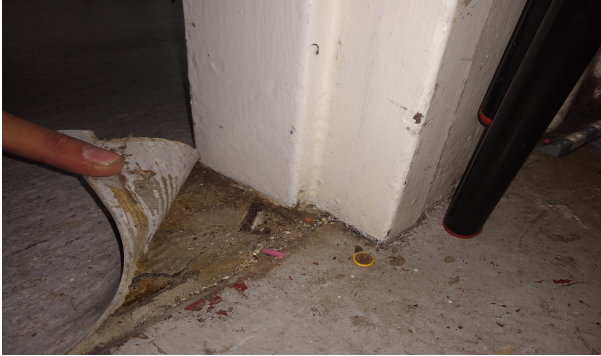
### **Item 37 Ref: As 417799-20**

The floor tile with bitumen adhesive in 0/019 Classroom contains asbestos.

Any change in its appearance should be recorded and passed to Property Services.

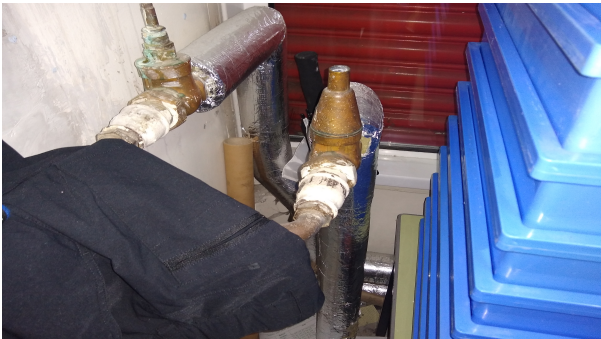
### **Item 38 Ref: 417799-21**

The adhered debris to pipework in 0/019a Store contains asbestos.

*Removed see survey J156853*

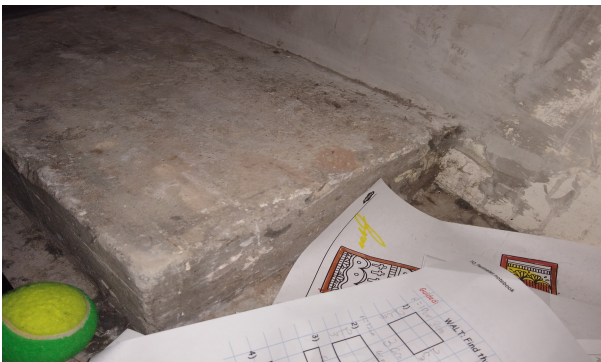
### **Item 39 Ref: 417799-22**

The adhered debris to former heater plinth in 0/019a Store contains asbestos.

Any change in its appearance should be recorded and passed to Property Services.

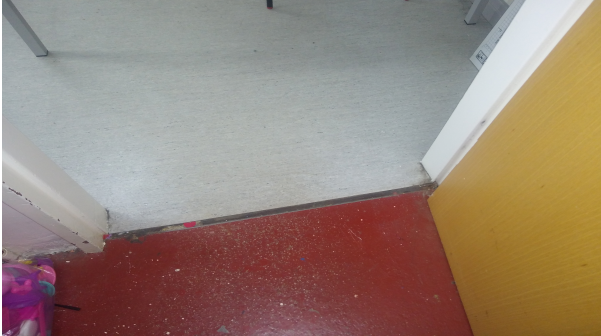
### **Item 40 Ref: As 417799-20**

The floor tile with bitumen adhesive in 0/020 Classroom contains asbestos.

Any change in its appearance should be recorded and passed to Property Services.

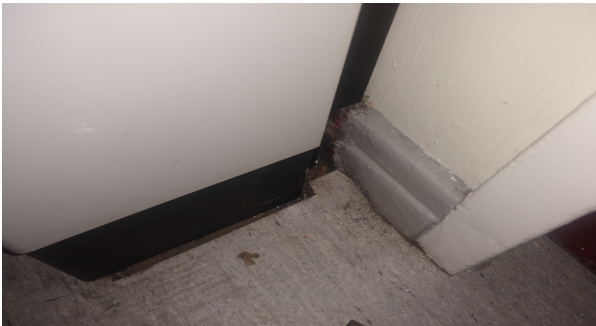
### **Item 41 Ref: As 417799-20**

The floor tile with bitumen adhesive in 0/021 Classroom contains asbestos.

Any change in its appearance should be recorded and passed to Property Services.

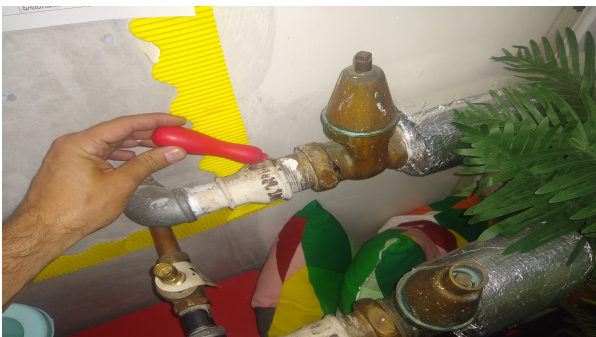
### **Item 42 Ref: 417799-23**

The adhered debris to pipework in 0/021a Store contains asbestos.

*Removed see survey J156853*

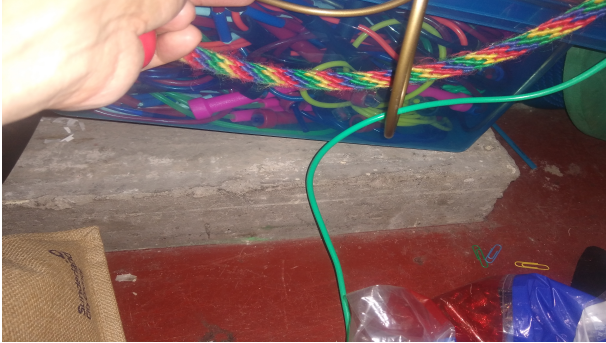
### **Item 43 Ref: 417799-24**

The adhered debris to former heater plinth in 0/021a Store contains asbestos.

Any change in its appearance should be recorded and passed to Property Services.

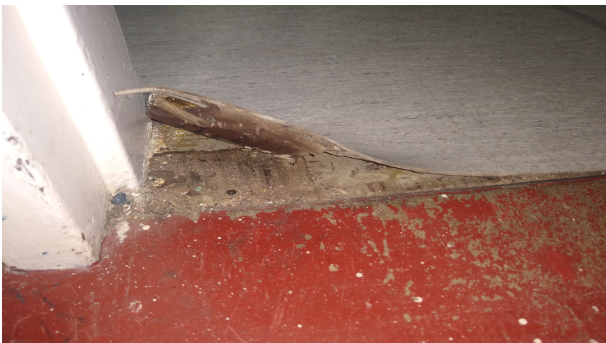
### **Item 44 Ref: As 417799-20**

The floor tile with bitumen adhesive in 0/022 Classroom contains asbestos.

Any change in its appearance should be recorded and passed to Property Services.

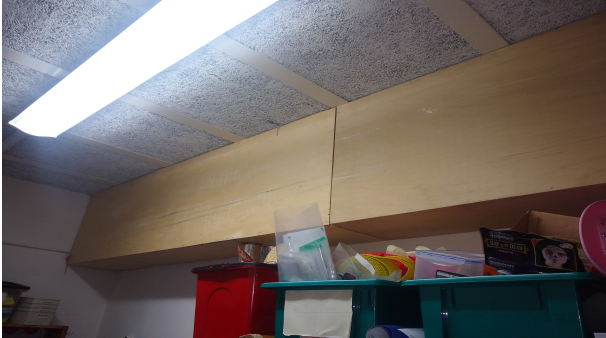
### **Item 46 Ref: Presumed**

The enclosed pipe lagging within boxing in 0/023a Store is presumed to contain asbestos.

Any change in its appearance should be recorded and passed to Property Services.

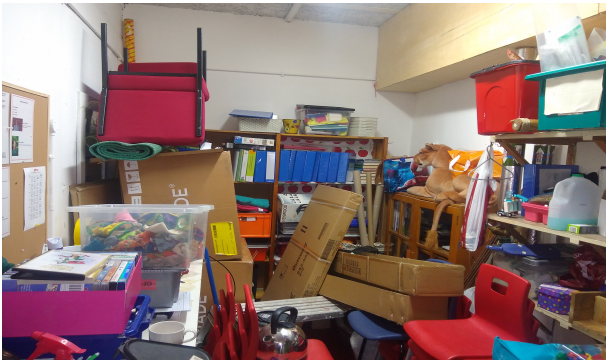
### **Item 47 Ref: 417799-32**

The adhered debris to former heater plinths in 0/023a Store does not contain asbestos.

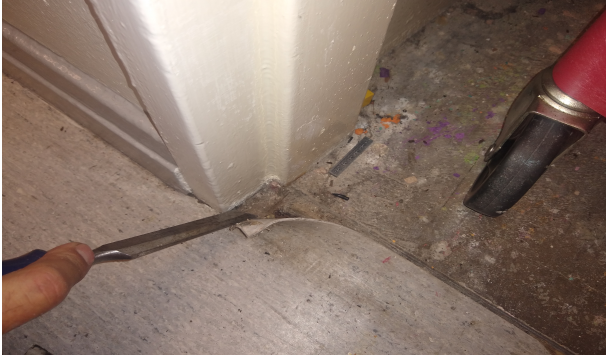
### **Item 49 Ref: 417799-25**

The floor tile with bitumen adhesive in 0/024 Classroom contains asbestos.

Any change in its appearance should be recorded and passed to Property Services.

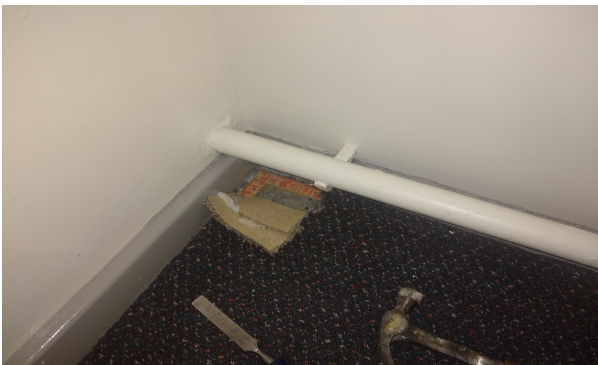
### **Item 50 Ref: 417799-26**

The remnant adhesive to floor beneath floor coverings and screed in 0/025 Classroom contains asbestos.

Any change in its appearance should be recorded and passed to Property Services.

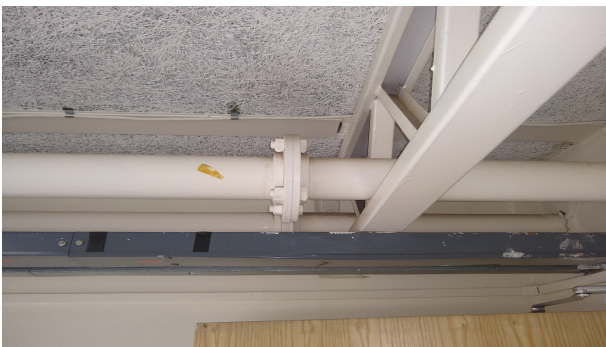
### **Item 51 Ref: Presumed**

The close coupled pipework flange gaskets in 0/025a Corridor is presumed to contain asbestos.

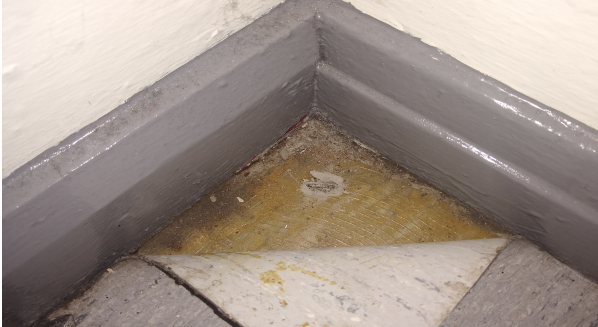
### **Item 52 Ref: As 417799-18**

The remnant adhesive to floor beneath linoleum and screed in 0/025 Classroom contains asbestos.

Any change in its appearance should be recorded and passed to Property Services.

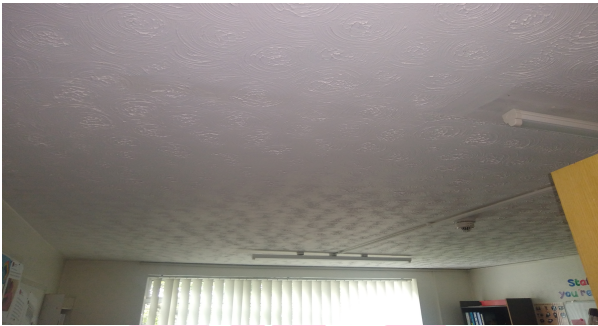
### **Item 53 Ref: 417799-10**

The textured coating ceiling in 0/028 Staff Room does not contain asbestos.

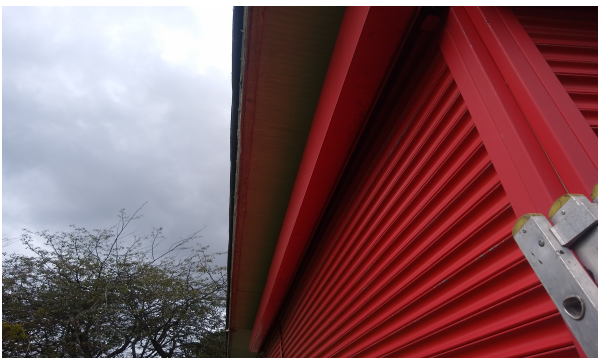
### **Item 54 Ref: 417799-27**

The soffit (External) contains asbestos.

Any change in its appearance should be recorded and passed to Property Services.

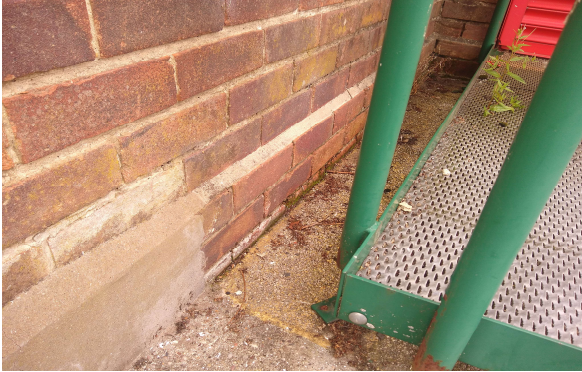
### **Item 55 Ref: 417799-28**

The damp proof course (External) contains asbestos.

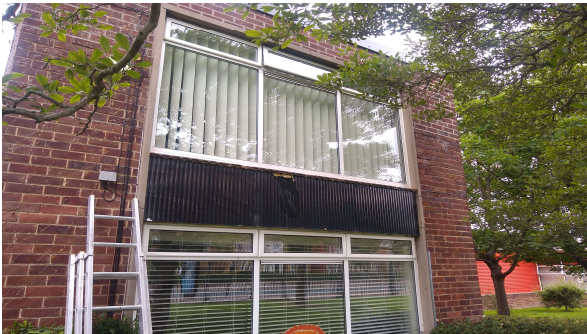
### **Item 56 Ref: 417799-29**

The panels below windows - 1/028 (External) contains asbestos.

*Removed see survey J156853*

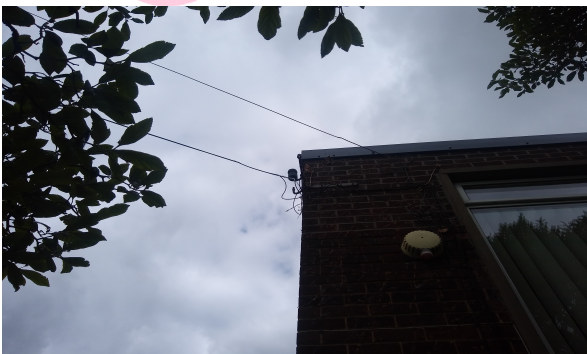
### **Item 57 Ref: Presumed**

The telephone insulator (External) is presumed to contain asbestos.

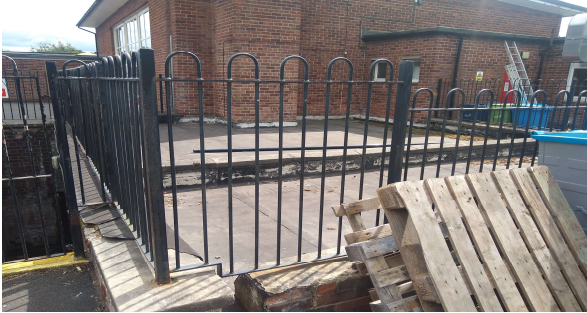
**Item 58 Ref: 417799-30**

The covering to basement boiler house (External) does not contain asbestos.

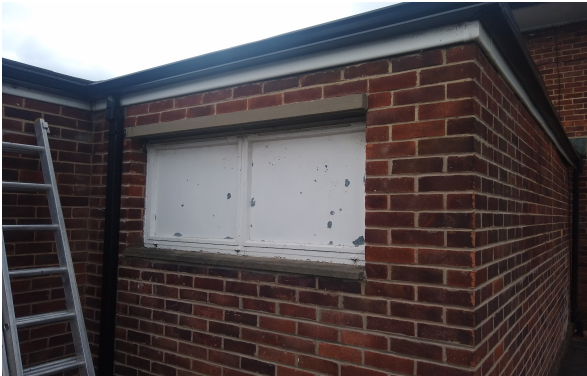
**Item 59 Ref: 417799-31**

The sealant to metal window frames (External) contains asbestos.

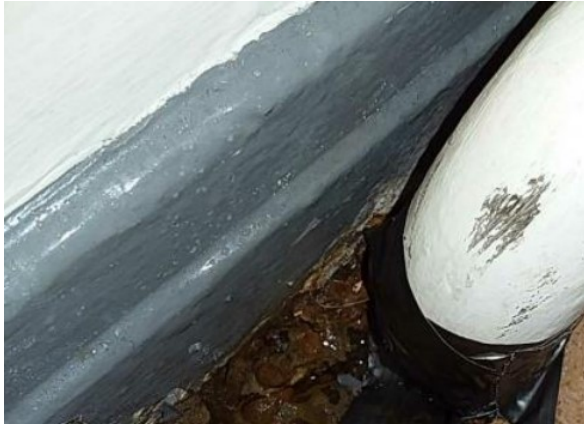
**Item 61 Ref: 21-32170-2**

The residual adhesive follow the flooring around the pipe in the Dining Room (Area 1) does not contain asbestos.

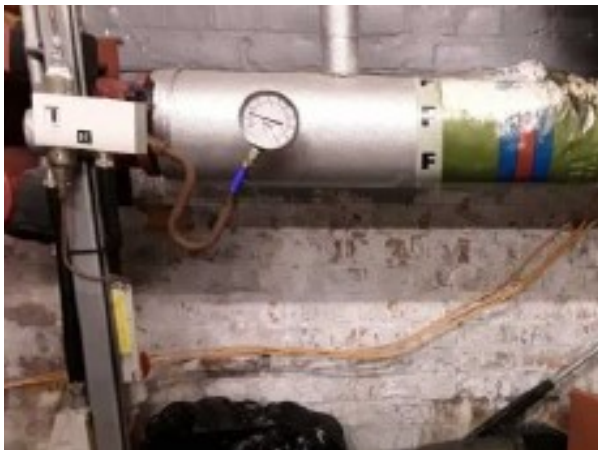
**Item 62 Ref: 22-45075-3**

The debris to un-encapsulated area of the Boiler Room walls (Area 1) does not contain asbestos.
