ASBESTOS SURVEY REPORT FOR THE PALLION CENTRE, WAVERLEY TERRACE, SUNDERLAND

Asbestos Register for The Pallion Centre

Date: 11 February 2026

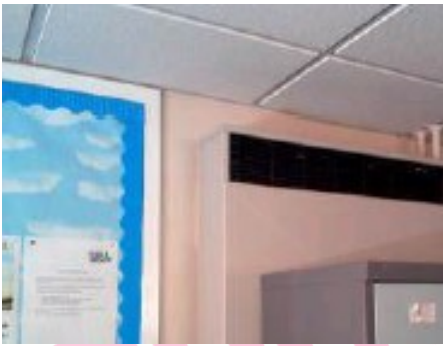
There was no access to the storage heater in the staff room (Room 4) as it was live plant.

Prior to any works, there needs to be further investigation.

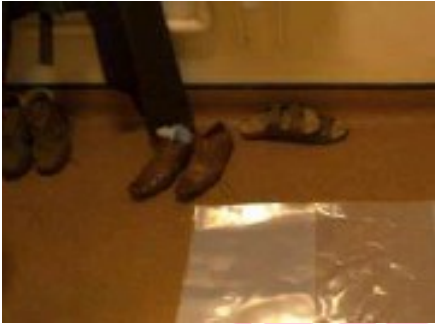
There was no access beneath the modern lino in the male / disabled WC (Room 6) due to possible damage.

Prior to any works, there needs to be further investigation.

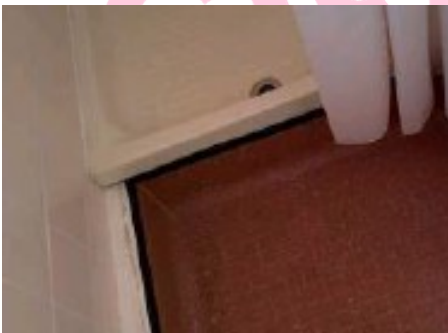
There was no access beneath the modern lino in the male / disabled shower (Room 7) due to possible damage.

Prior to any works, there needs to be further investigation.

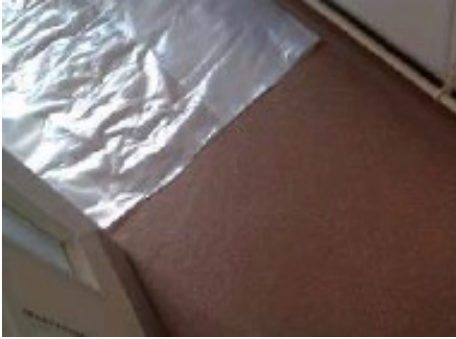
There was no access beneath the modern lino in the female wc (Room 8) due to possible damage.

Prior to any works, there needs to be further investigation.

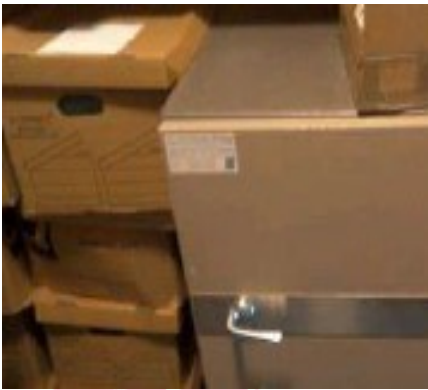
There was no access to the safe in the safe store (Room 27) prior to any works taking place, further checks will be necessary.

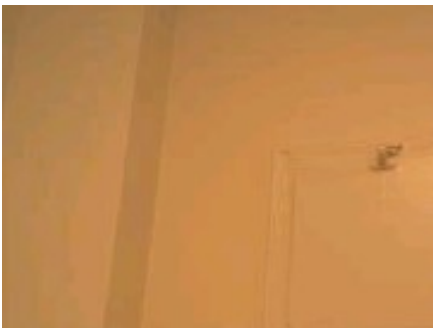
There was no access behind the metal hatch in the community room wc (Room 37) without causing damage.

Therefore, prior to any work, further checks need to be carried out.

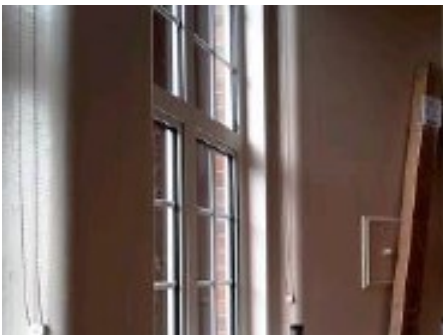
There was no access behind the metal hatch within the plumbing room (Room 38), without causing further damage.

Prior to any work, this needs to be checked out.

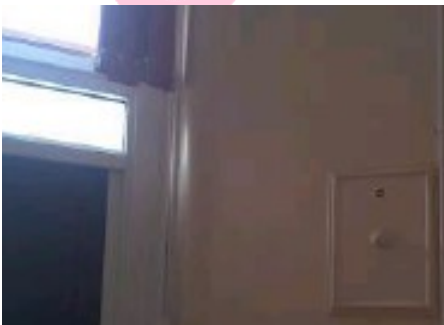
There was no access behind the metal hatch within the joinery machine area (Room 39), without causing further damage.

Prior to any work, this needs to be checked out.

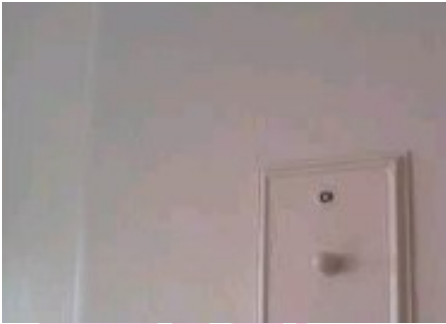
There was no access behind the metal hatches within the restaurant (Room 41), without causing further damage.

Prior to any work, this needs to be checked out.

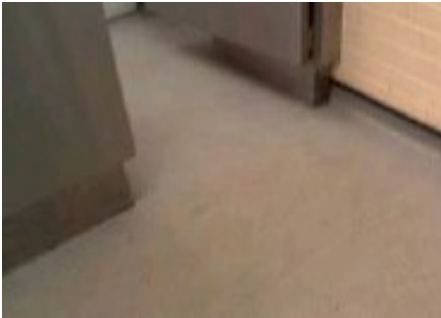
There was no access beneath the modern lino in the servery (Room 48) as it would cause damage.

Prior to any works, additional checks may need to be carried out.

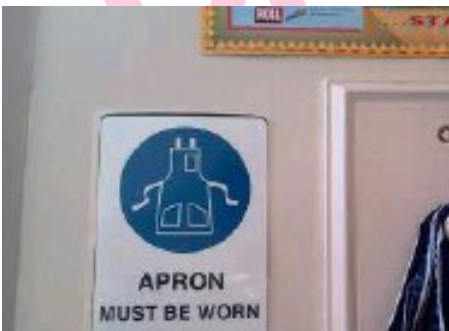
There was no access behind the metal access hatch to the cookery area (Room 51) without causing damage.

Prior to any works, additional checks may need to be carried out.

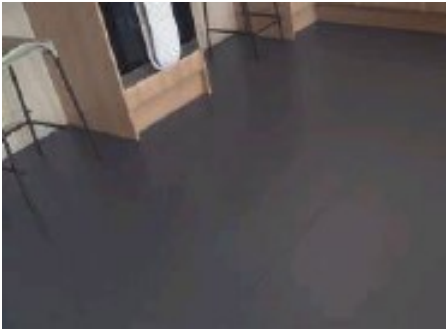
There was no access beneath the modern lino in the cookery (Room 51) as it would cause damage.

Prior to any works, additional checks may need to be carried out.

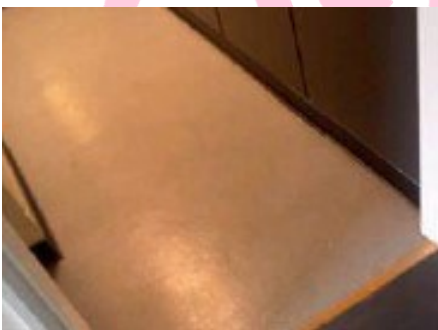
There was no access beneath the modern lino in the female wc (Room 56) as it would cause damage. Prior to any works, additional checks may need to be carried out.

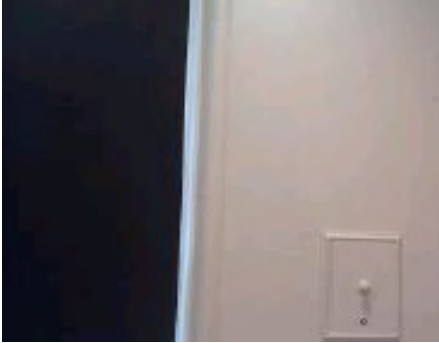
There was no access within the metal hatches to the wall in ICT (Room 1/14) without causing possible damage.

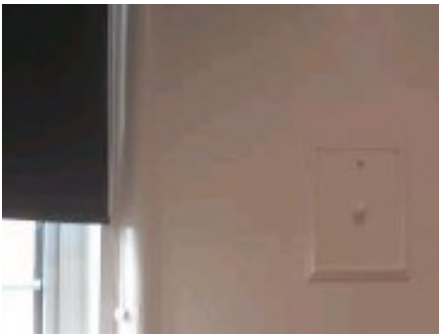
There was no access within the metal hatches to the wall in the classroom (Room 1/15) without causing possible damage.

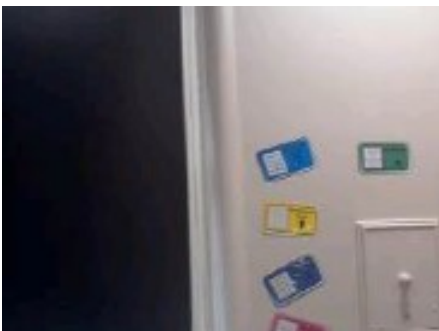
There was no access within the metal hatches to the wall in classroom (Room 1/22) without causing possible damage.

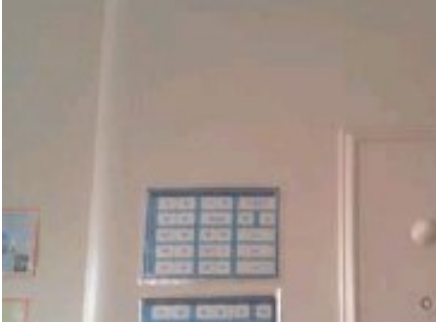
There was no access within the metal hatches to the wall in classroom (Room 1/23) without causing possible damage.

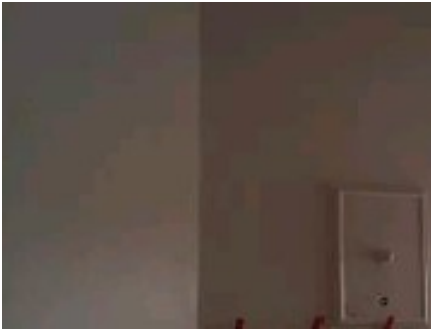
There was no access within the metal hatches to the wall in classroom (Room 1/26) without causing possible damage.

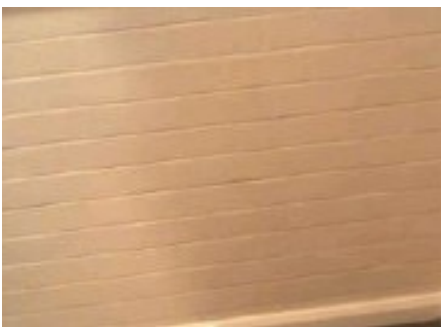
There was no access beneath the newly fitted carpet to the stairwell (Room 1/27) without causing possible damage.

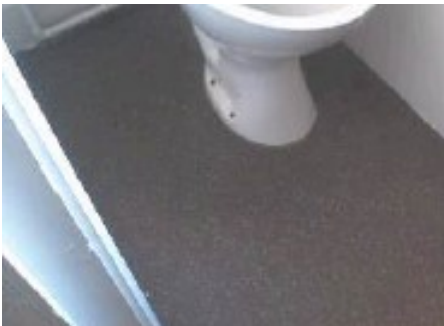
There was no access beneath the lino to the gents WC (Room 1/29) without causing possible damage.

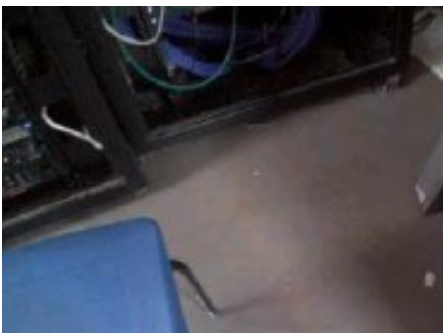
There was no access beneath the modern lino to the server room (Room 1/32) without causing possible damage.

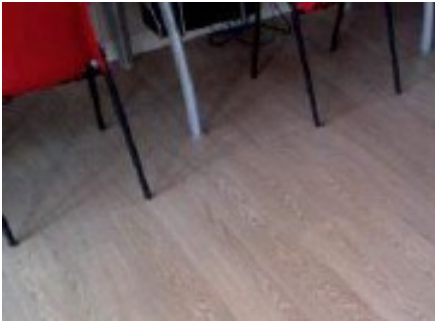
There was no access beneath the modern lino to graphic design (Room 1/36) without causing possible damage.

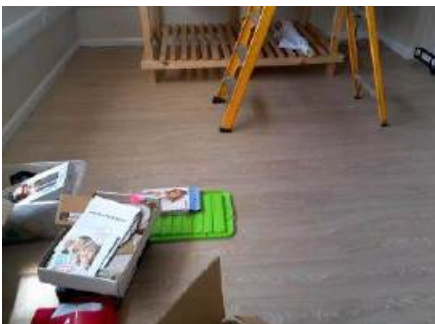
There was no access beneath the modern lino to Audio Room 2 (Room 1/38) without causing possible damage.

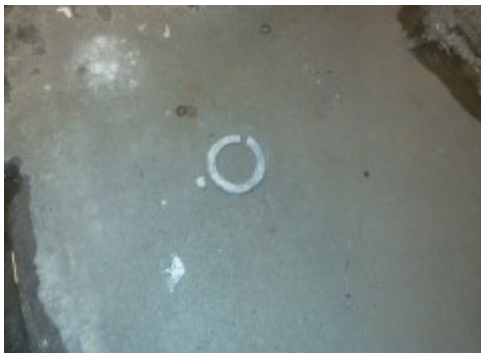
Item 82 Ref: 41620-19

The Loose lying gasket to floor in the Boiler Room/Rm 001 does not contain asbestos.

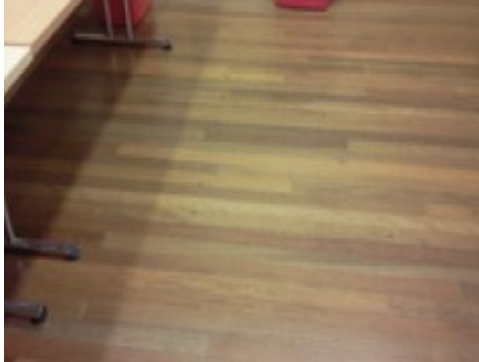
Item 138 Ref: Presumed

The adhesive to parquet flooring in the Corridor/ Rm1/038 is presumed to contain asbestos.

Any change in its appearance should be noted and passed to Property Services.

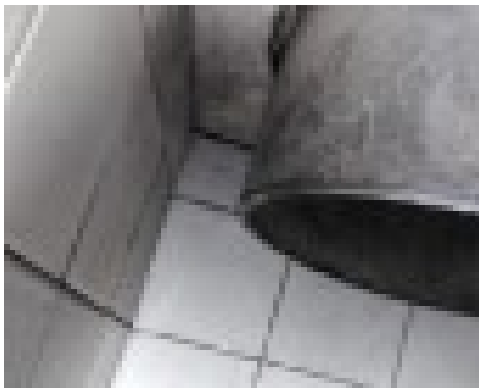
Item 139 Ref: Presumed

The flue pipe in the cavity wall seen through the grilles in the Boiler Room is presumed to contain asbestos.

Any change in its appearance should be noted and passed to Property Services.

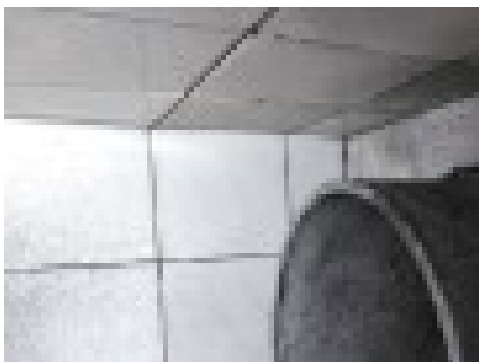
Item 140 Ref: Presumed

The shuttering to flue penetrations behind wall grilles to chimney breast x 2 in the Boiler Room is presumed to contain asbestos.

Any change in its appearance should be noted and passed to Property Services.

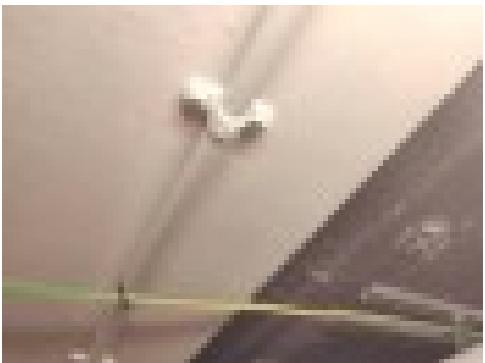
Item 143 Ref: KX001003

The debris/residue to the concrete ceiling above pipes in the area not covered by supalux in the Boiler Room contain asbestos.

Any change in its appearance should be noted and passed to Property Services.
