ASBESTOS SURVEY REPORT FOR GRANGE PARK PRIMARY SCHOOL, SWAN STREET, SUNDERLAND, SR5 1EA.

## Asbestos Register for

**Grange Park Primary School, Swan Street, Sunderland,  
SR5 1EA**

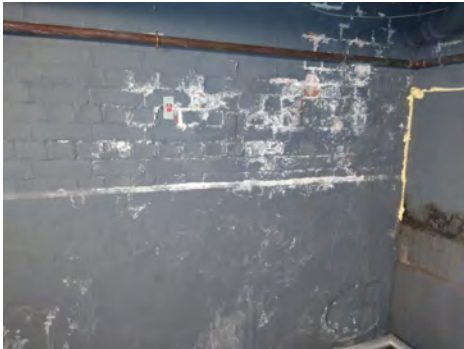
### Item 1 Ref: 78139-7

- (Item 1) Ref: 78139-7 – Lagging debris to wall (-1/001 Boiler Room Switch Room) – Medium Risk
- (Item 2) Ref: 78139-5 – General debris to wall (-1/001 Boiler Room Switch Room) – Medium Risk

The lagging debris to wall in -1/001 Boiler Room Switch Room contains asbestos.

Any change in its appearance should be recorded and passed to Property Services.

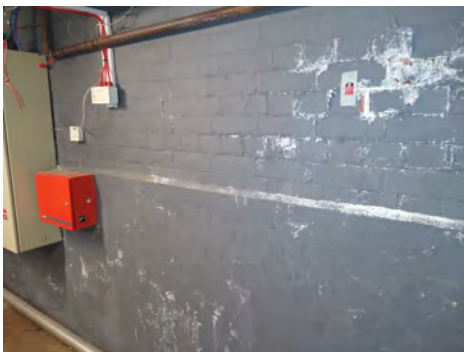
### Item 2 Ref: 78139-5

The general debris to wall in -1/001 Boiler Room Switch Room contains asbestos.

Any change in its appearance should be recorded and passed to Property Services.

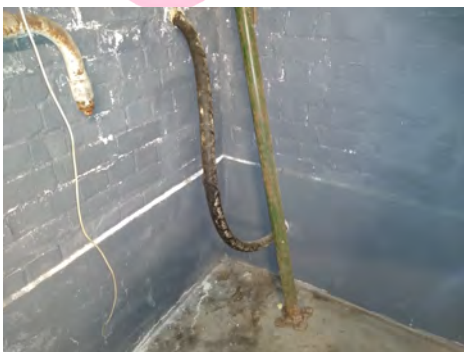
### Item 3 Ref: 78139-4

The wrap to cable in -1/001 Boiler Room Switch Room does not contain asbestos.

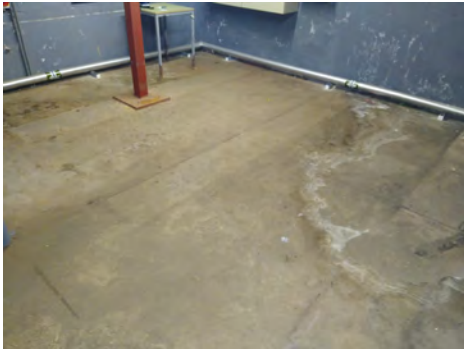
**Item 4 Ref: 429759-21**

The general debris to floor in -1/001 Boiler Room Switch Room does not contain asbestos.

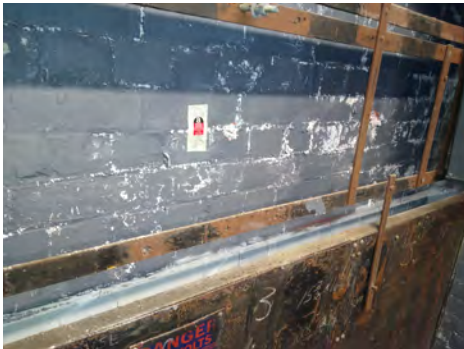
**Item 5 Ref: 78139-12**

The lagging debris to wall in -1/002 Boiler Room contains asbestos.

Any change in its appearance should be recorded and passed to Property Services.

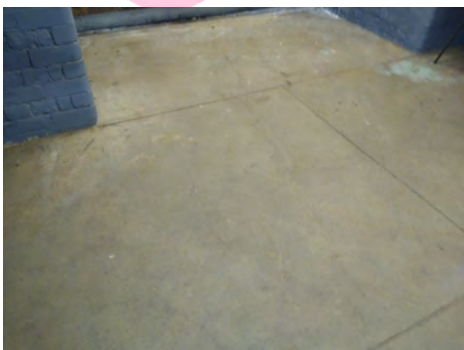
**Item 6 Ref: 429759-15**

The general debris to floor in -1/002 Boiler Room does not contain asbestos.

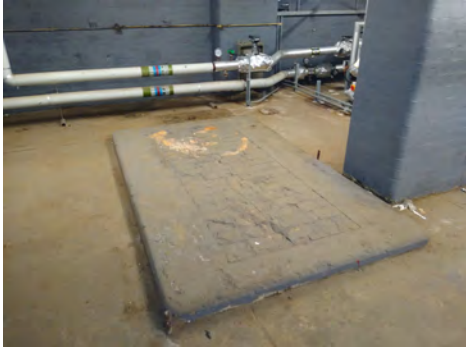
**Item 7 Ref: 429759-16**

The debris to redundant plinth in -1/002 Boiler Room does not contain asbestos.

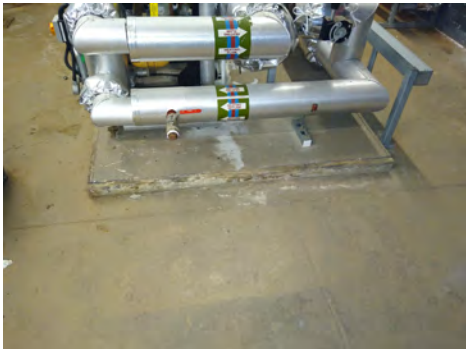
**Item 8 Ref: 429759-17**

The debris to current plinth in -1/002 Boiler Room does not contain asbestos.

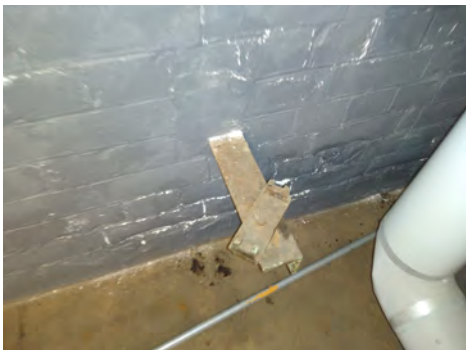
**Item 9 Ref: 429759-18**

The debris to pipe hanger in -1/002 Boiler Room does not contain asbestos.

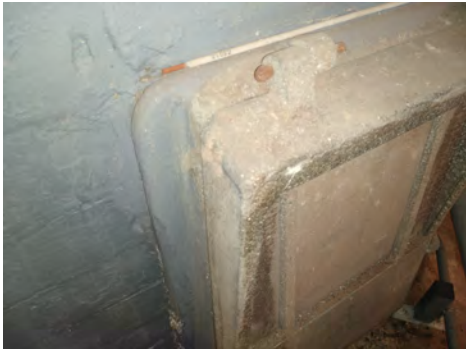
**Item 10 Ref: 78139-16**

The lagging debris to furnace hatch in -1/002 Boiler Room contains asbestos.

Any change in its appearance should be recorded and passed to Property Services.

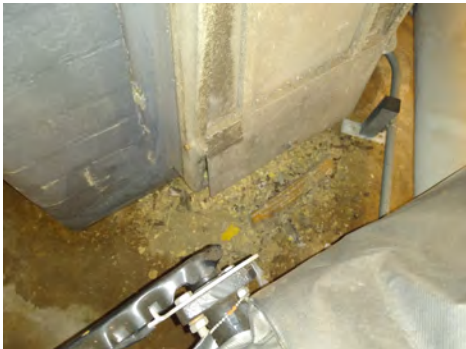
**Item 11 Ref: 429759-19**

The debris below furnace hatch in -1/002 Boiler Room does not contain asbestos.

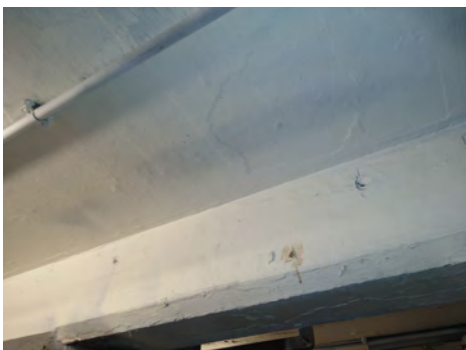
**Item 12 Ref: 47505-106**

The debris to ceiling in -1/002 Boiler Room contains asbestos.

Any change in its appearance should be recorded and passed to Property Services.

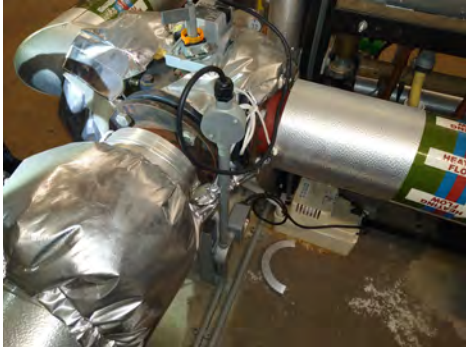
**Item 13 Ref: 429759-20**

The pipework flange gasket in -1/002 Boiler Room does not contain asbestos.

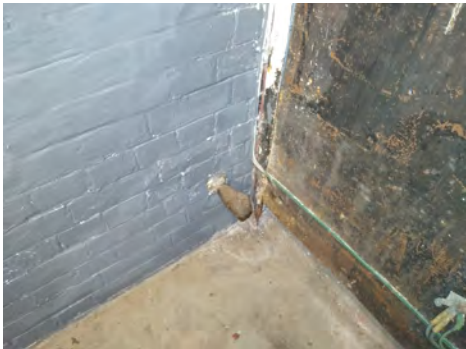
**Item 14 Ref: 429759-19**

The wrap to cable in -1/002 Boiler Room does not contain asbestos.

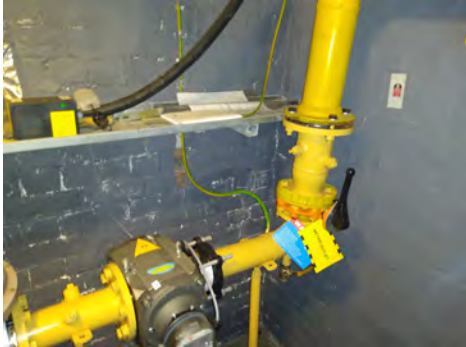
**Item 19 Ref: 78139-21**

The lagging debris to walls in -1/003 Boiler Room Gas Chamber contains asbestos.

Any change in its appearance should be recorded and passed to Property Services.

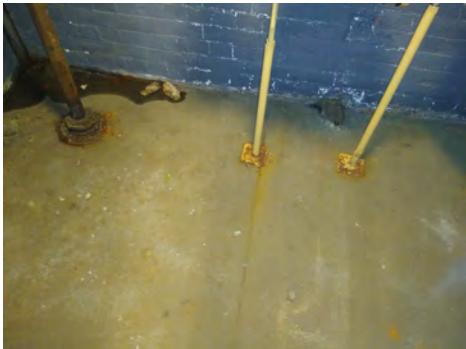
**Item 20 Ref: 429759-14**

The general debris to floor in -1/003 Boiler Room Gas Chamber does not contain asbestos.

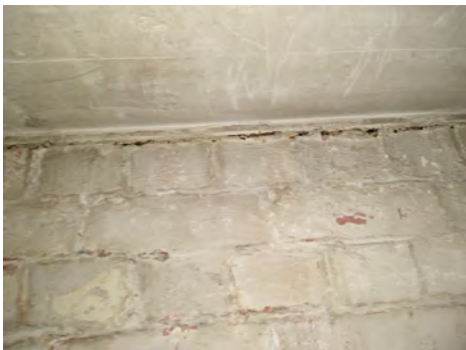
**Item 21 Ref: 429759-22**

The damp proof course in -1/004 Store does not contain asbestos.

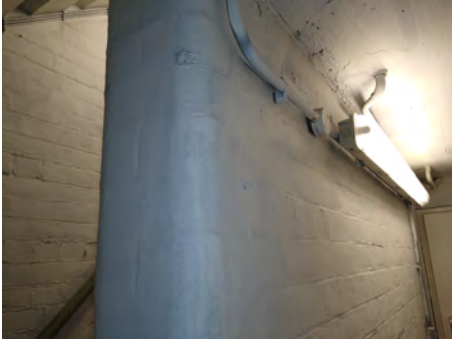
**Item 22 Ref: 47505-112**

The debris to wall in -1/005 Lobby & Stairs (encapsulated) contains asbestos.

Any change in its appearance should be recorded and passed to Property Services.

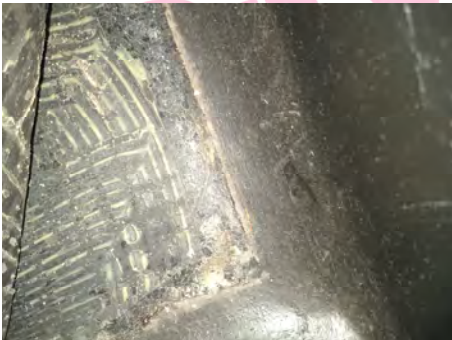
**Item 24 Ref: As 429759-9**

The floor covering below carpet in 0/004 Lobby area does not contain asbestos.

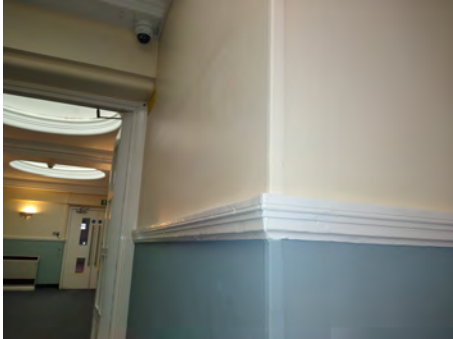
**Item 25 Ref: 429759-11**

The partition wall to riser in 0/004 Lobby area does not contain asbestos.

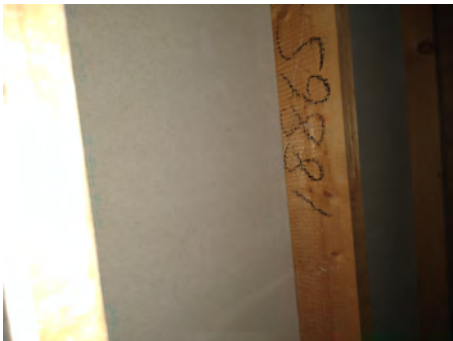
**Item 26 Ref: As 429759-11**

The partition wall in 0/004 Lobby area riser does not contain asbestos.

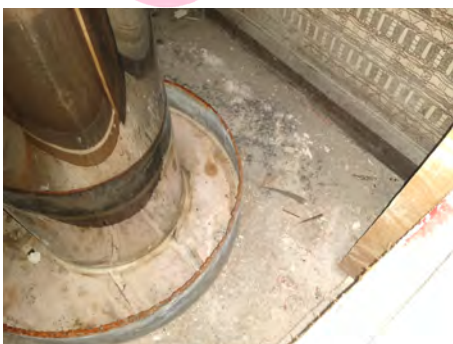
**Item 27 Ref: 429759-12**

The general debris to floor in 0/004 Lobby area riser does not contain asbestos.

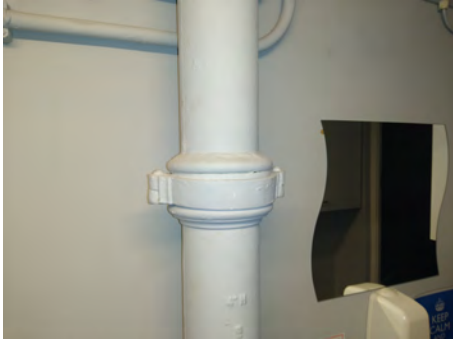
**Item 28 Ref: 429759-11**

The seal to soil pipe joint in 0/005 Disabled WC does not contain asbestos.

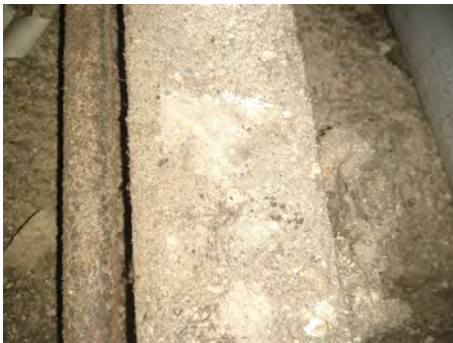
**Item 29 Ref: 429759-6**

The debris to floor in 0/009 Classroom loft above does not contain asbestos.

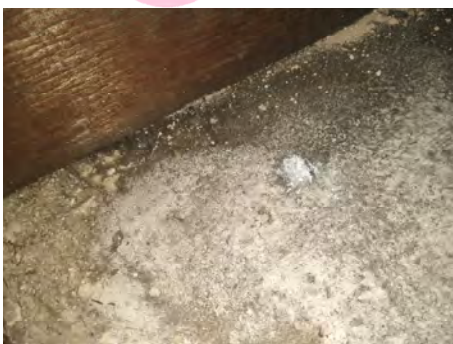
**Item 30 Ref: 429759-24**

The insulation debris below mmmf insulation 0/017 Classroom loft above contains asbestos.

Any change in its appearance should be recorded and passed to Property Services.

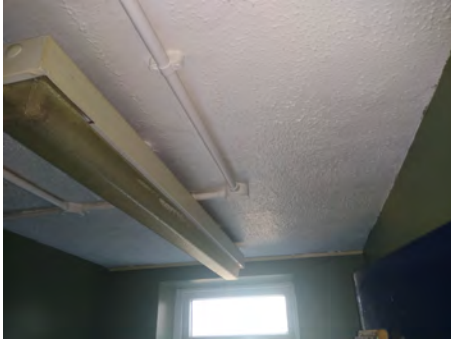
**Item 31 Ref: 429759-25**

The coating onto masonry ceiling in 0/035 Staff WC does not contain asbestos.

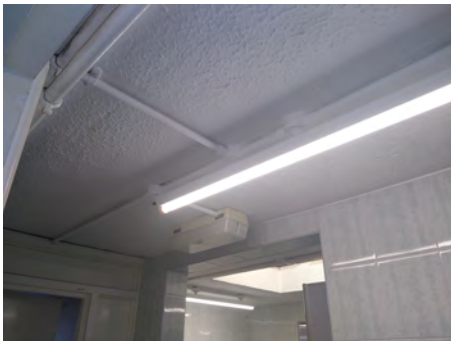
**Item 32 Ref: 429759-26**

The coating onto masonry ceiling in 0/037 Boys WC does not contain asbestos.

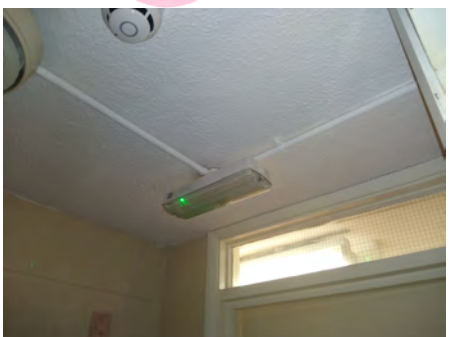
**Item 33 Ref: 429759-27**

The coating onto masonry ceiling in 0/040 Girls WC does not contain asbestos.

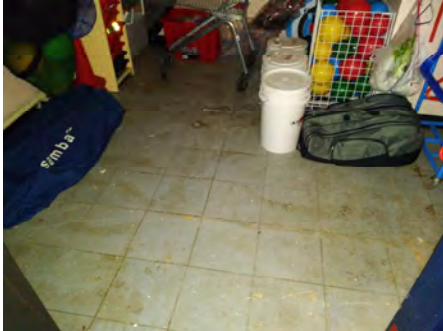
**Item 34 Ref: As 429759-1**

The floor covering in 0/041 Store does not contain asbestos.

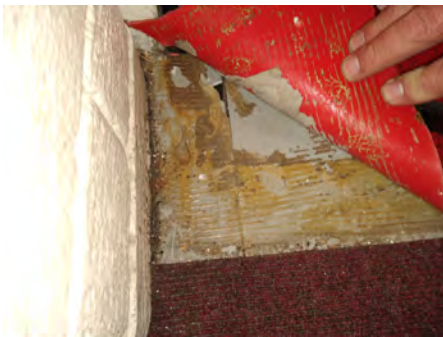
**Item 35 Ref: 429759-1**

The floor covering in 0/042 Lockers does not contain asbestos.

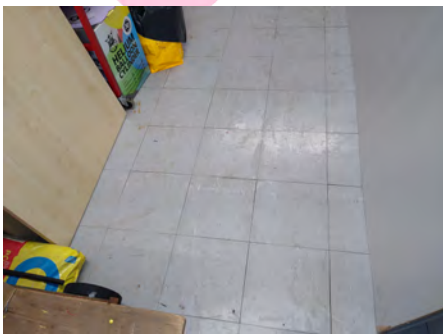
**Item 36 Ref: As 429759-1**

The floor covering in 0/048 Cleaners does not contain asbestos.

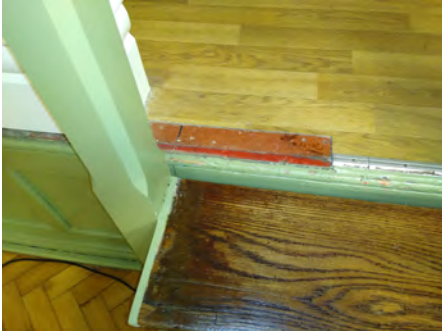
**Item 37 Ref: 105825-1**

The sub floor covering to stage area in 0/055 Small hall and stage does not contain asbestos.

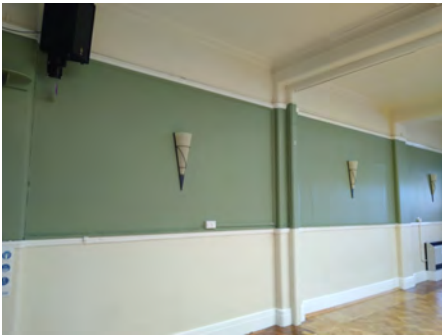
**Item 38 Ref: 105825-2**

The mid section panels to walls in 0/055 Small hall and stage does not contain asbestos.

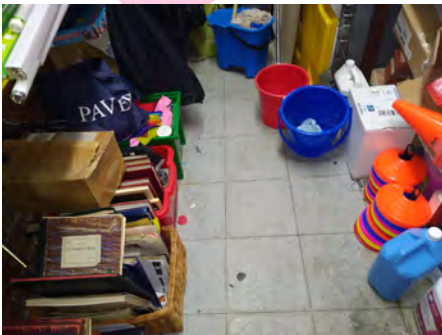
**Item 39 Ref: As 429759-13**

The floor covering in 0/56 Chemical Store does not contain asbestos.

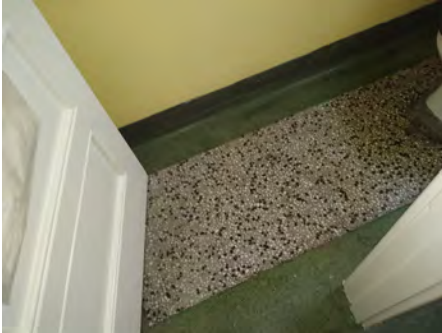
**Item 40 Ref: As 429759-8**

The floor covering in 0/058 WC does not contain asbestos.

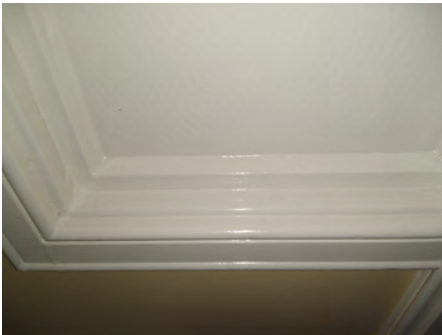
**Item 41 Ref: As 429759-7**

The window Putty in 0/058 WC does not contain asbestos.

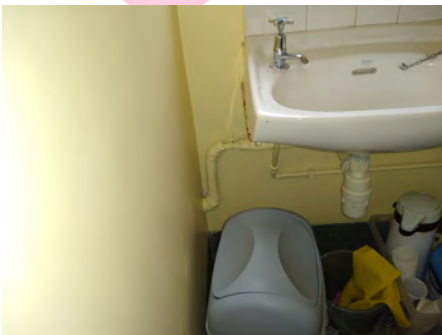
**Item 42 Ref: As 429759-5**

The pipe lagging in 0/058 WC contains asbestos.

Any change in its appearance should be recorded and passed to Property Services.

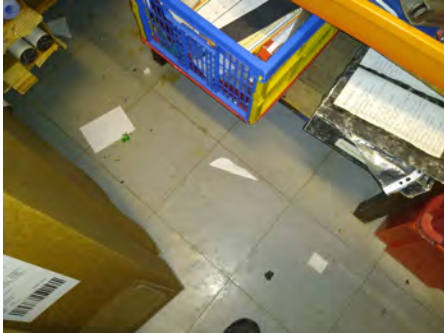
**Item 43 Ref: As 429759-13**

The floor covering in 0/059 Store does not contain asbestos.

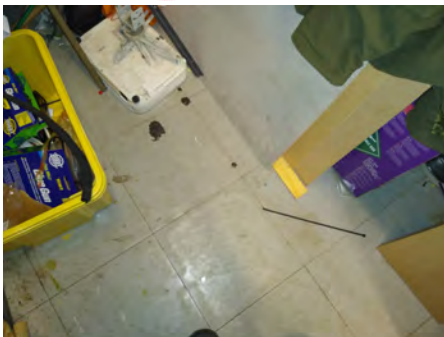
**Item 45 Ref: As 429759-13**

The floor covering in 0/060 Caretakers Store does not contain asbestos.

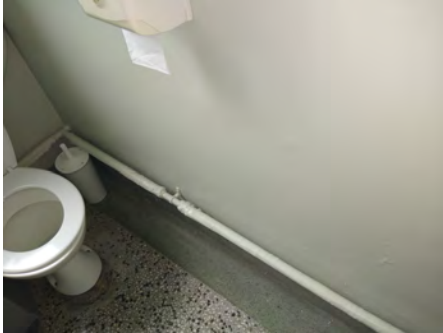
**Item 46 Ref: As 47505-4**

The pipe wrap behind encapsulated cloth in 0/062 WC contains asbestos.

Any change in its appearance should be recorded and passed to Property Services.

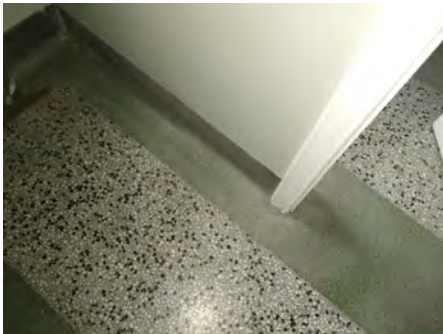
**Item 47 Ref: As 429759-8**

The floor covering in 0/062 WC does not contain asbestos.

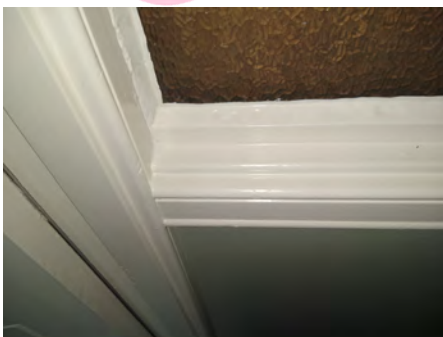
**Item 48 Ref: 429759-7**

The window Putty in 0/062 WC does not contain asbestos.

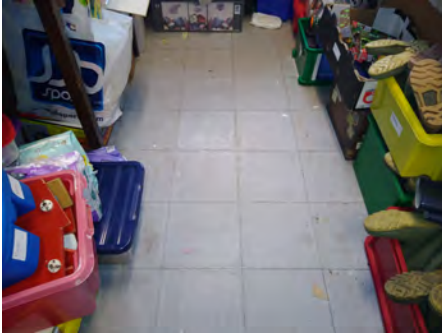
**Item 49 Ref: As 429759-13**

The floor covering in 0/063 Science Store does not contain asbestos.

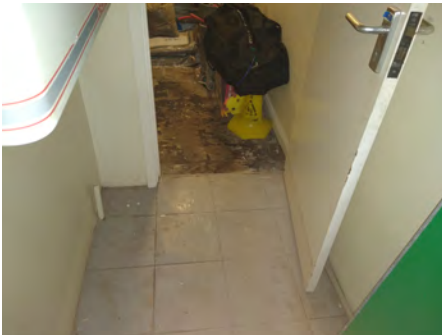
**Item 50 Ref: As 429759-1**

The floor covering and adhesive in 0/065 Cleaner and Lobby does not contain asbestos.

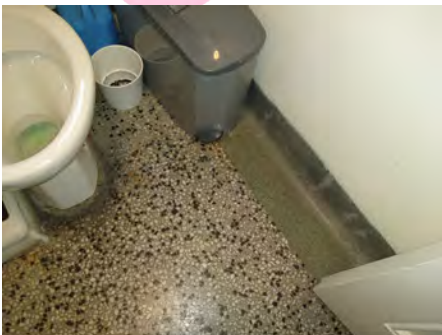
**Item 51 Ref: As 429759-8**

The floor in 0/075 Office WC does not contain asbestos.

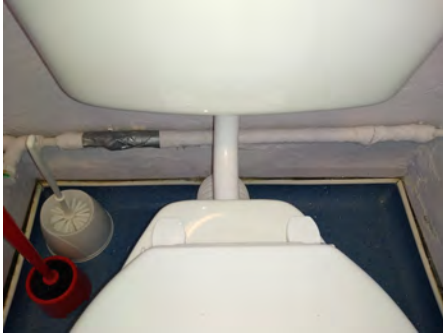
**Item 52 Ref: 429759-5**

The low level pipe lagging below paper in 0/081 Staff changing and WC contains asbestos.

Any change in its appearance should be recorded and passed to Property Services.

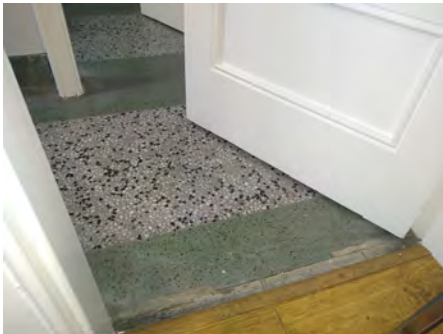
**Item 53 Ref: 429759-8**

The floor covering in 0/084 WC does not contain asbestos.

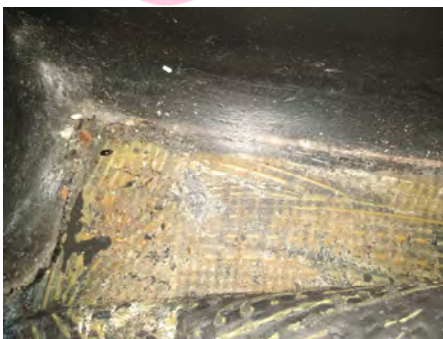
**Item 54 Ref: 429759-9**

The floor covering below carpet in 0/087 Lobby Area does not contain asbestos.

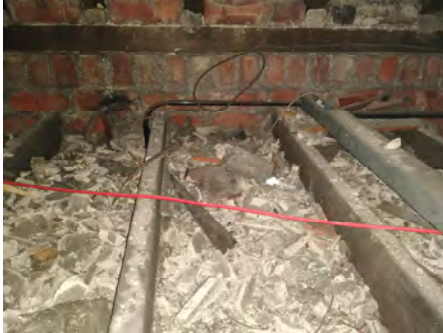
*Item 55 Ref: 429759-23*

*The pipe lagging debris in 0/088 Music and dance loft above contains asbestos.*

**Removed July 2021**

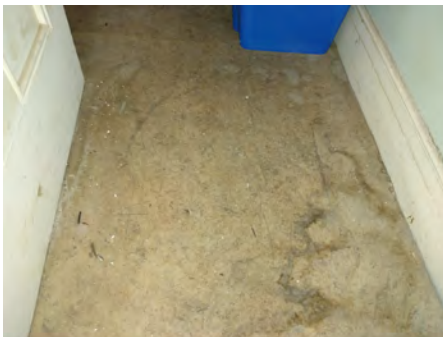
**Item 56 Ref: 429759-2**

The floor covering in 1/001 Store does not contain asbestos.

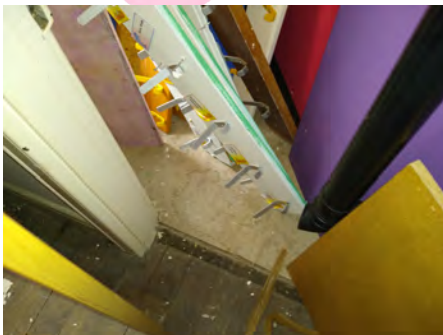
**Item 57 Ref: As 429759-2**

The floor covering in 1/002 Store & WC does not contain asbestos.

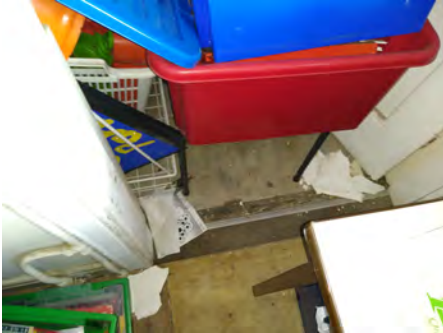
**Item 58 Ref: As 429759-2**

The floor covering to cupboard in 1/003 Office and Store does not contain asbestos.

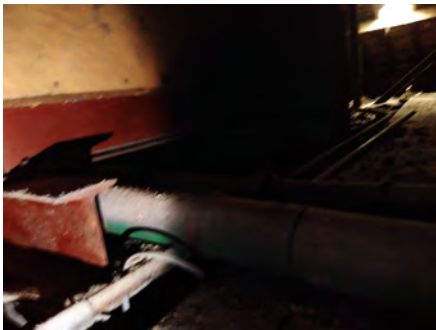
**Item 62 Ref: 78139-25**

The pipe lagging in 2/001 Loft space tank location does not contain asbestos.

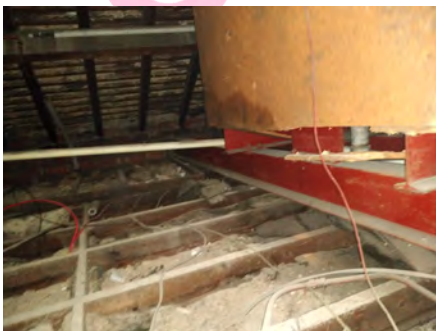
**Item 63 Ref: 78139-24**

The general debris to floor in 2/001 Loft space tank location does not contain asbestos.

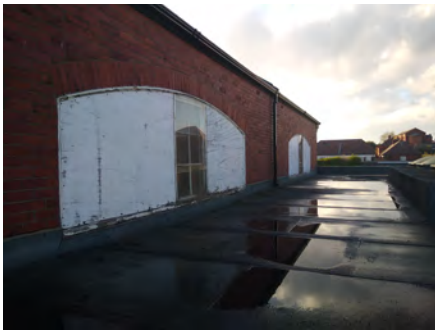
**Item 65 Ref: 429759-28**

The putty to metal window frames behind plastic sheets leading onto flat roof area (External) do not contain asbestos.

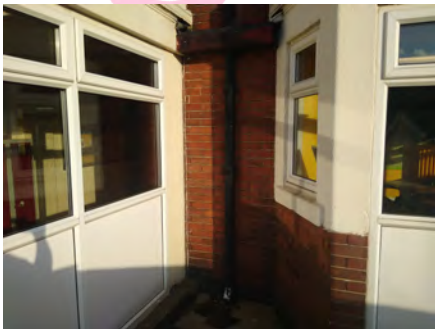
**Item 66 Ref: 429759-29**

The remnant mastic to walls of internal corridor to courtyard (External) do not contain asbestos.

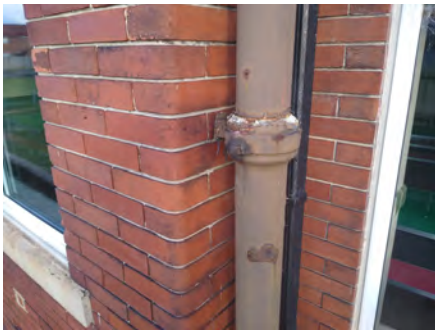
**Item 68 Ref: 429759-31**

The sealant to downpipe collars (External) does not contain asbestos.

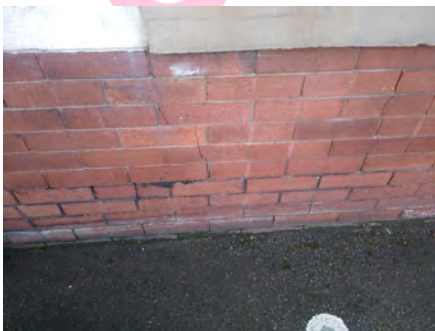
**Item 69 Ref: 429759-32**

The damp proof course (External) does not contain asbestos.

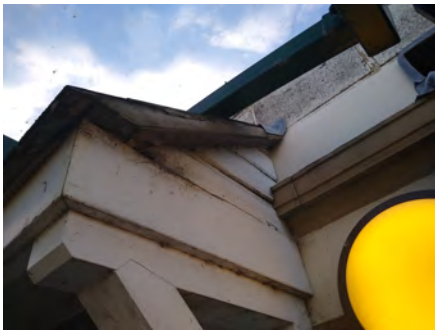
**Item 71 Ref: 429759-34**

The fillet to small door canopy adjacent 0/030 (External) does not contain asbestos.

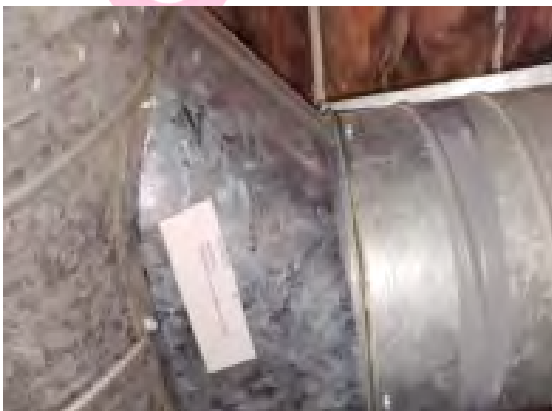
**Item 72 Ref: 21-38155-1**

The mastic to the ducting joints in the void above kitchen (Area 080a) does not contain asbestos.

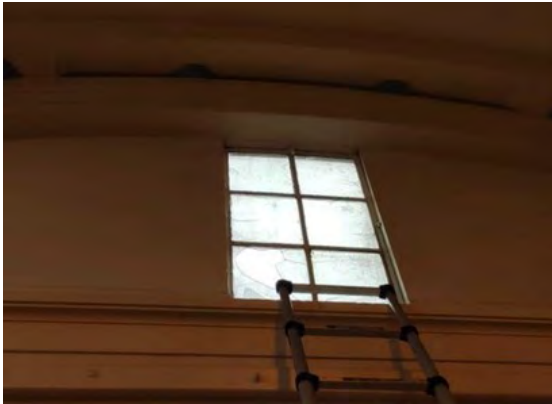
**Item 74 Ref: 22-52615-1**

The putty to the window in the Hall (Area 1) does not contain asbestos.

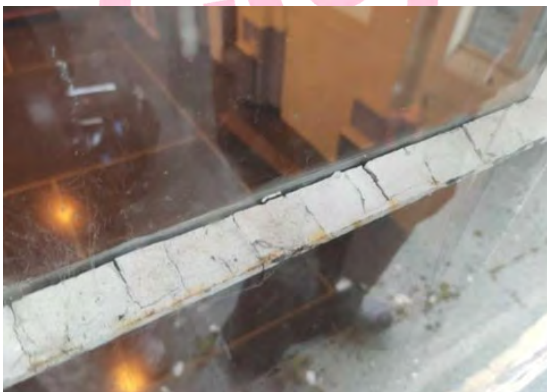
**Item 75 Ref: 22-52615-2**

The glazing putty to the window Externally (Area 2) does not contain asbestos.

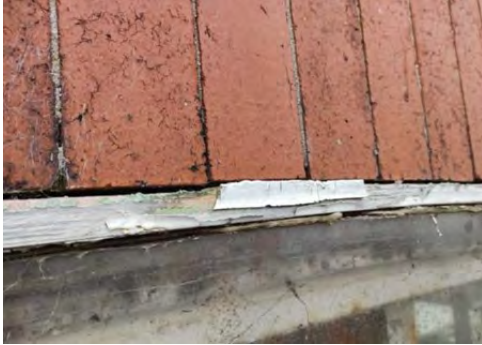
**Item 76 Ref: 22-52615-3**

The sealant to the wood frame around the window (Externally) does not contain asbestos.

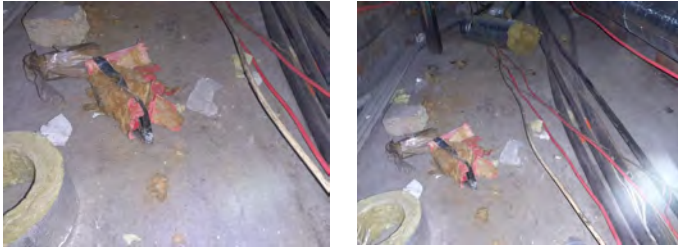
**Item 88 Ref: KG000846**

The debris - centre floor (Boiler room duct, Boiler room, 001) does not contain asbestos.

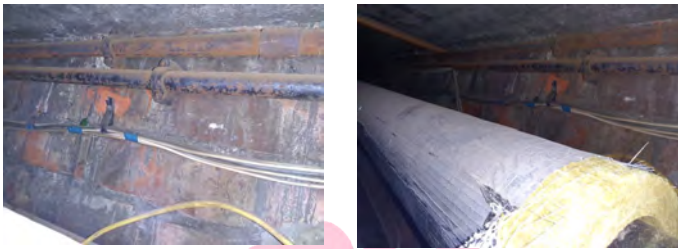
**Item 89 Ref: KG000847**

The residue - Rhs wall (Boiler room duct, Boiler room, 001) does not contain asbestos.

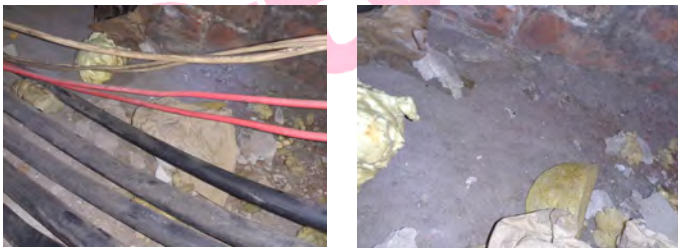
**Item 90 Ref: KG000848**

The debris - floor rhs near door (Boiler room duct, Boiler room, 001) does not contain asbestos.

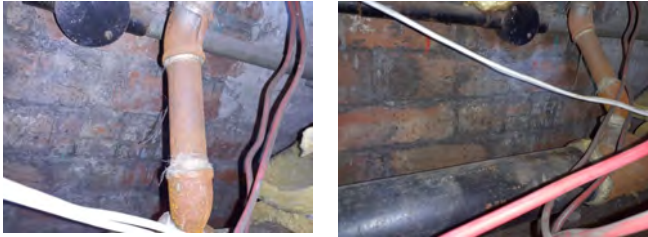
**Item 91 Ref: KG000849**

The residue - Rhs wall near door (Boiler room duct, Boiler room, 001) does not contain asbestos.

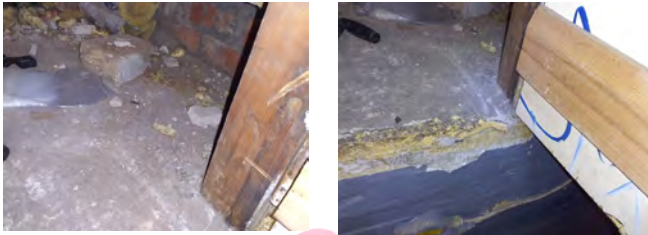
**Item 92 Ref: KG000851**

The debris - floor near door (Boiler room duct, Boiler room, 001) does not contain asbestos.

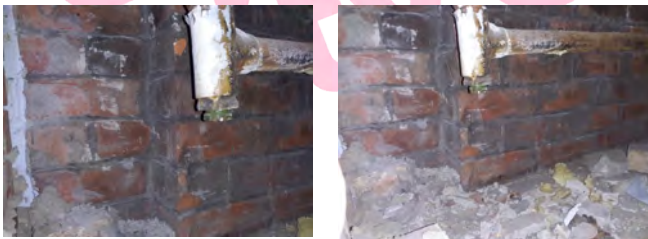
**Item 93 Ref: KG000852**

The residue - LHS wall near door (Boiler room duct, Boiler room, 001) does not contain asbestos.
