### ASBESTOS SURVEY REPORT FOR NORTHERN SAINTS C OF E PRIMARY SCHOOL, SUNDERLAND

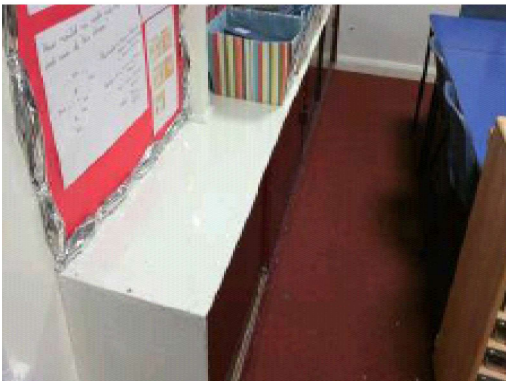
### **Item 33: Presumed**

The skirting to the base of the wall behind the cupboards in the classroom (Room 33) was presumed to contain asbestos.

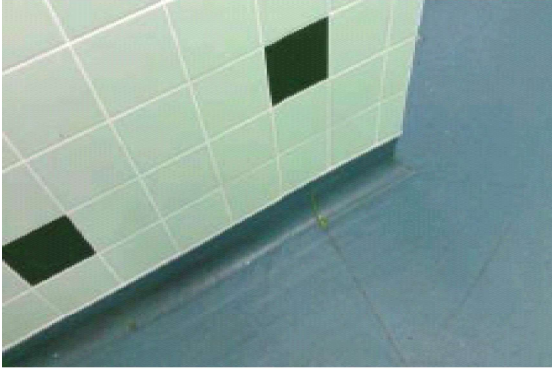
### **Item 43: As KR09/86**

The skirting to wall beneath the lino in the Girls wc (Room 41) is presumed to contain asbestos.

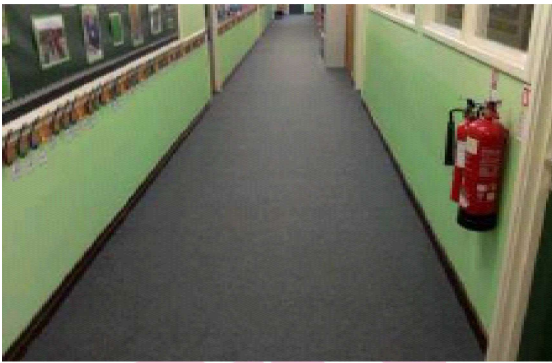
### **Item 44: Presumed**

The vinyl floor tiles beneath the carpet in the corridor (Room 43) were presumed to contain asbestos.

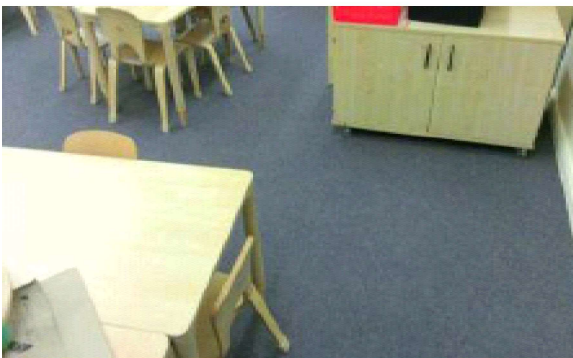
### **Item 50: Presumed**

The vinyl floor tiles beneath the carpet in the classroom (Room 46) are presumed to contain asbestos.

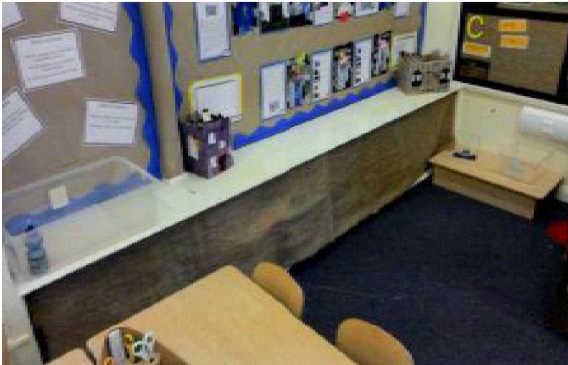
### **Item 55: Presumed**

The skirting to wall beneath the lino in the classroom behind the cupboards (Room 47) was presumed to contain asbestos.

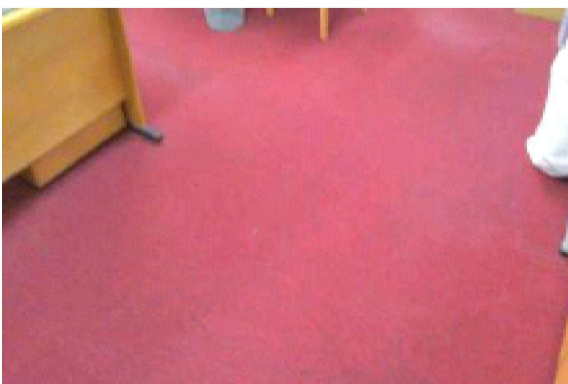
### **Item 57: Presumed**

The bitumen adhesive to the floor in the office (Room 49) is presumed to contain asbestos.

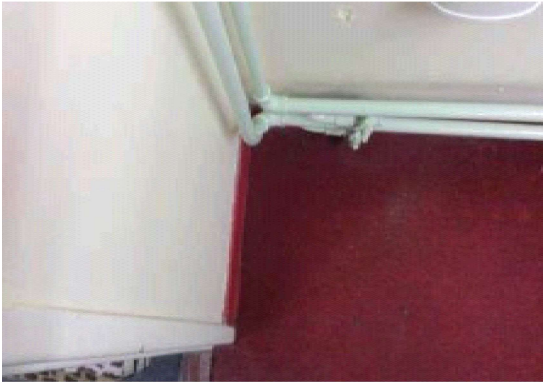
### **Item 58: As KR09/86**

The skirting to wall in the office (Room 49) is presumed to contain asbestos.

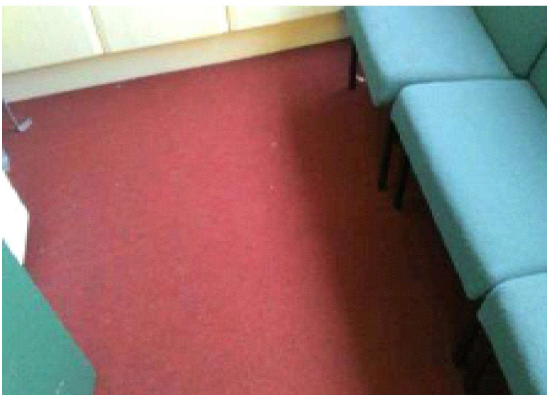
### **Item 59: Presumed**

The bitumen adhesive to the floor below the carpet in the Medical Room (Room 50) is presumed to contain asbestos.

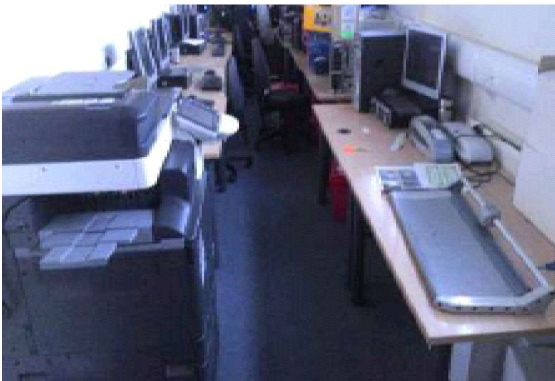
### **Item 60: Presumed**

The bitumen adhesive to the floor below the carpet in the office (Room 51) is presumed to contain asbestos.

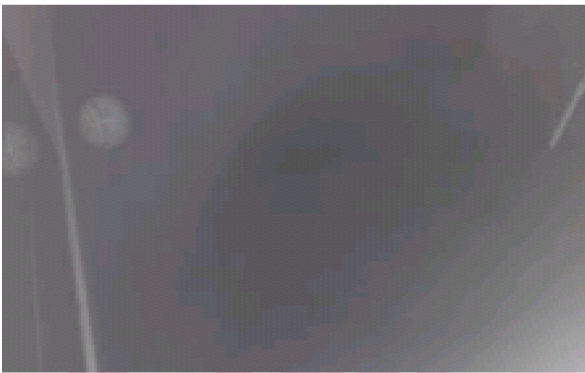
### **Item 65: Presumed**

The vinyl floor tiles beneath the carpet in the office (Room 56) were presumed to contain asbestos.

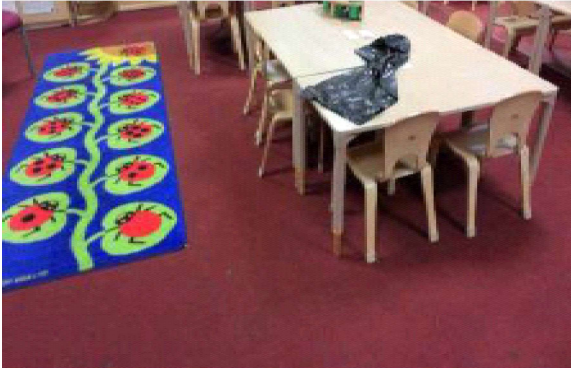
### **Item 67: Presumed**

The bitumen adhesive to the floor below the carpet in the classroom (Room 57) is presumed to contain asbestos.

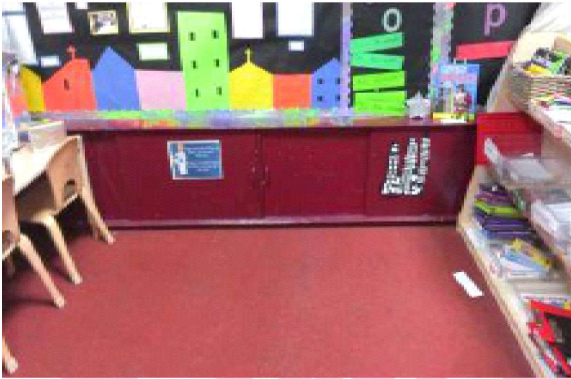
### **Item 68: Presumed**

The skirting to base of wall behind the cupboards in the classroom (Room 57) is presumed to contain asbestos.

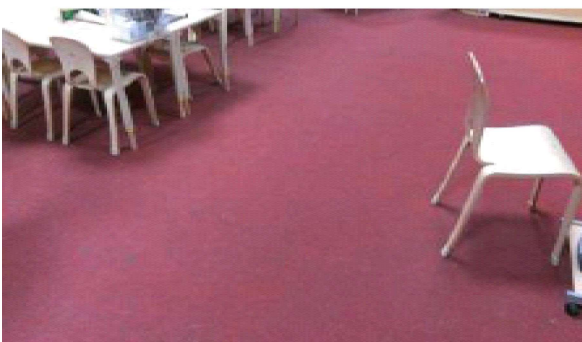
### **Item 69: Presumed**

The bitumen adhesive below the carpet in the classroom (Room 58) is presumed to contain asbestos.

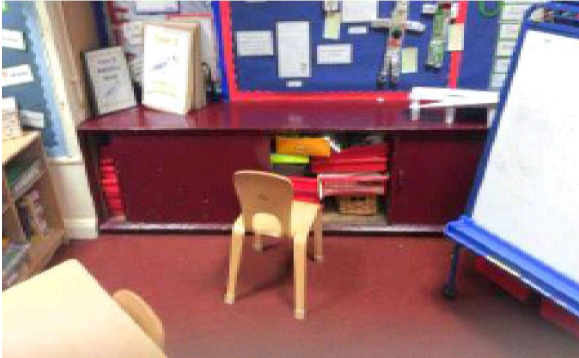
### **Item 70: As KR09/86**

The skirting to base of wall behind the cupboards in the classroom (Room 58) is presumed to contain asbestos.

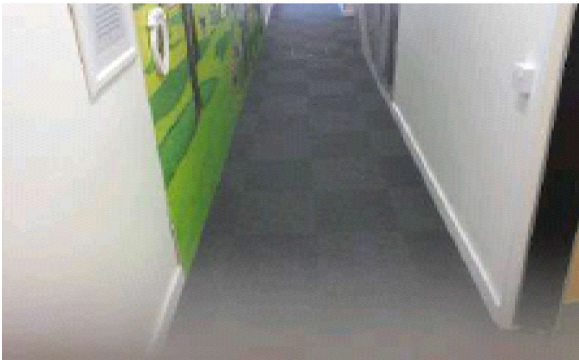
### **Item 71: Presumed**

The bitumen adhesive to the floor below the cement skim to the floor in the corridor (Room 59) is presumed to contain asbestos.

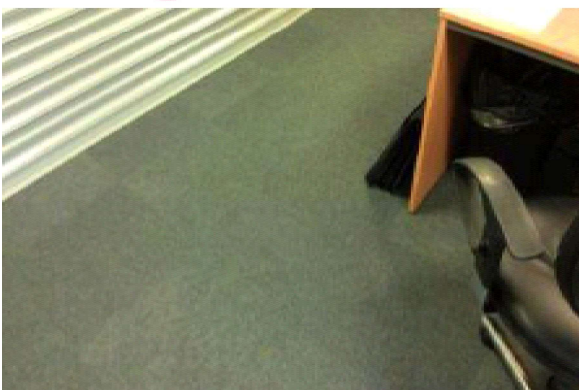
### **Item 72: Presumed**

The bitumen adhesive to the floor below the cement skim to the floor in the reception office (Room 61) is presumed to contain asbestos.

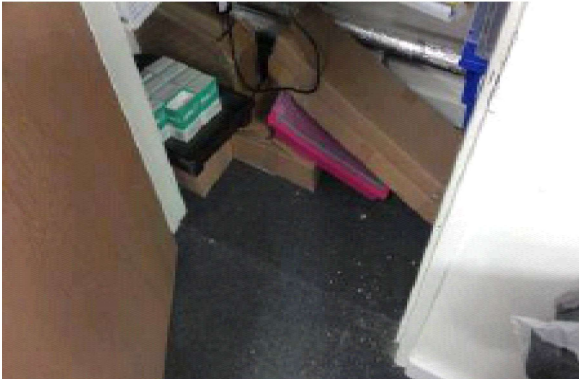
### **Item 73: Presumed**

The bitumen adhesive to the floor below the cement skim to the floor in the reception office cupboard (Room 62) is presumed to contain asbestos.

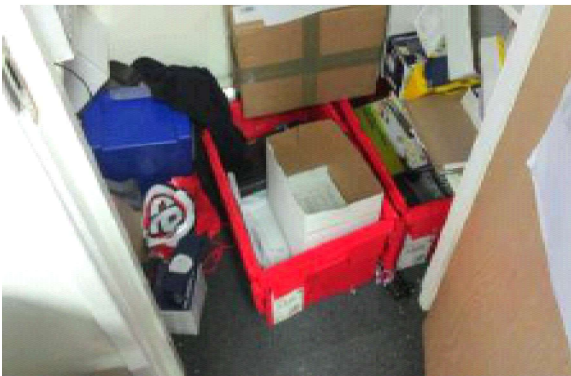
### **Item 74: Presumed**

The bitumen adhesive to the floor below in the reception office cupboard (Room 63) is presumed to contain asbestos.

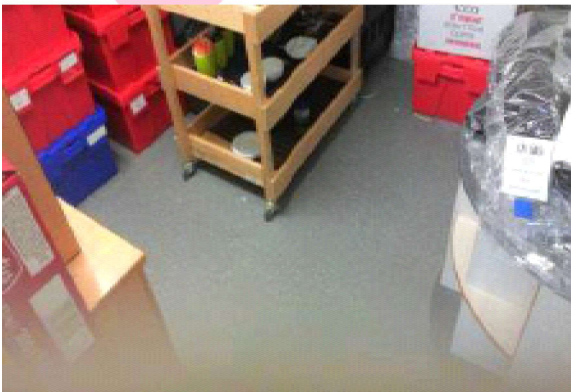
### **Item 75: Presumed**

The bitumen adhesive to the floor below the cement skim in the store (Room 65) is presumed to contain asbestos.

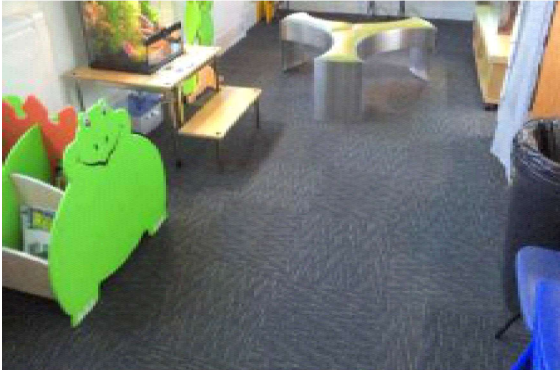
### **Item 76: Presumed**

The bitumen adhesive to the floor below the cement skim to the floor in the reptile room (Room 66) is presumed to contain asbestos.

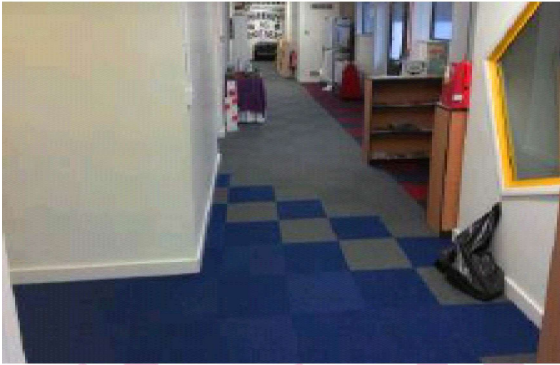
### **Item 77: NSPS/002**

The bitumen adhesive to the floor below the cement skim to the floor in the corridor (Room G002) contains asbestos.

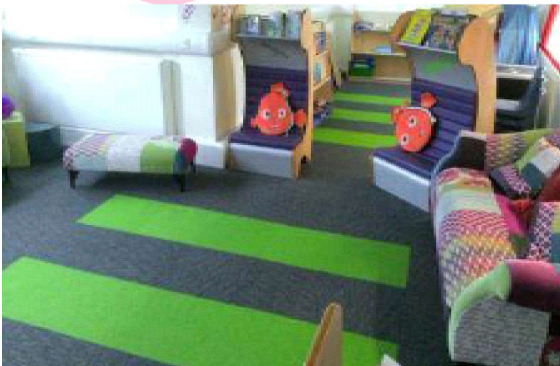
### **Item 78: Presumed**

The bitumen adhesive to the floor below the cement skim to the floor in the library (Room 70) is presumed to contain asbestos.

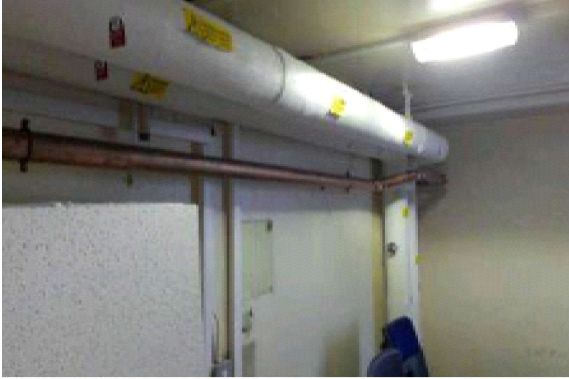
### **Item 79: KR09/97**

The lagging to the pipework in the store (Room 73) is strongly presumed to contain asbestos.

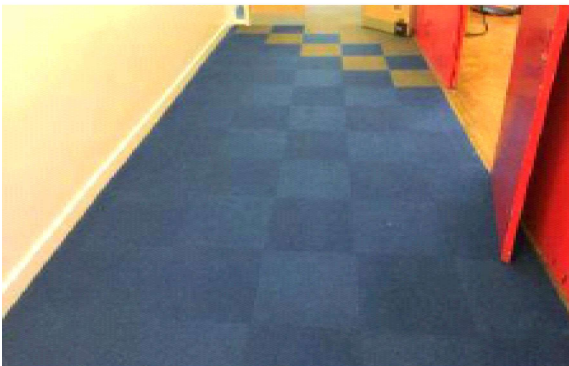
### **Item 80: Presumed**

The vinyl floor tiles beneath the carpet in the corridor (Room 74) are presumed to contain asbestos.

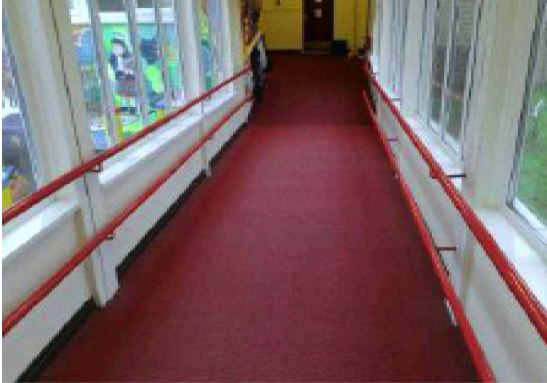
### **Item 82: Presumed**

The vinyl floor tiles beneath the carpet in the corridor (Room 76) are presumed to contain asbestos.

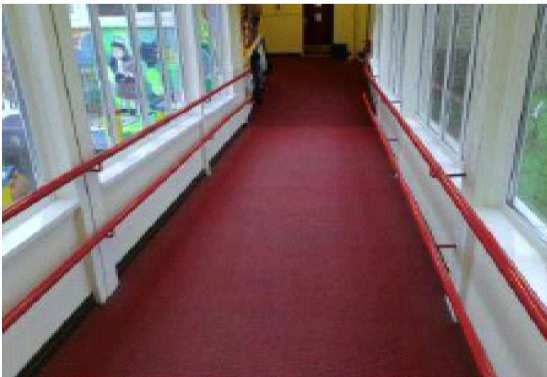
### **Item 83: Presumed**

The bitumen adhesive to the floor in the corridor (Room 76) is presumed to contain asbestos.

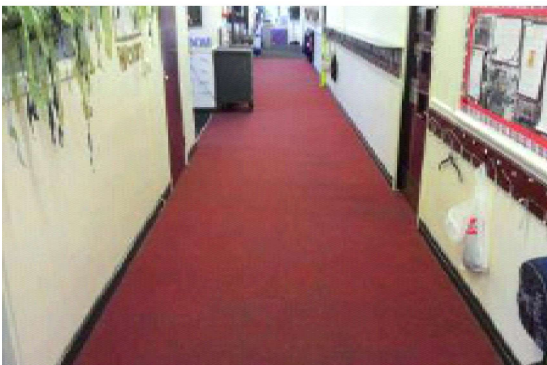
### **Item 84: Presumed**

The vinyl floor tiles beneath the carpet in the corridor (Room 79) are presumed to contain asbestos.

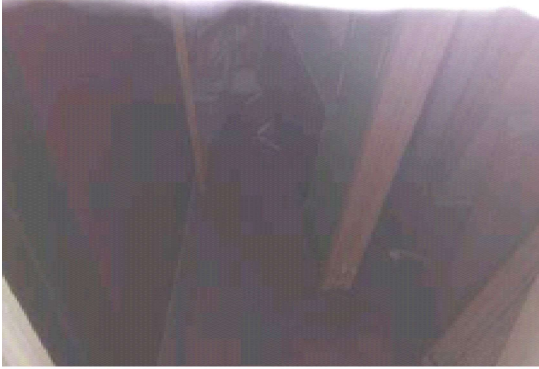
### **Item 88: Presumed**

The vinyl floor tiles beneath the carpet in the store (Room 81) are presumed to contain asbestos.

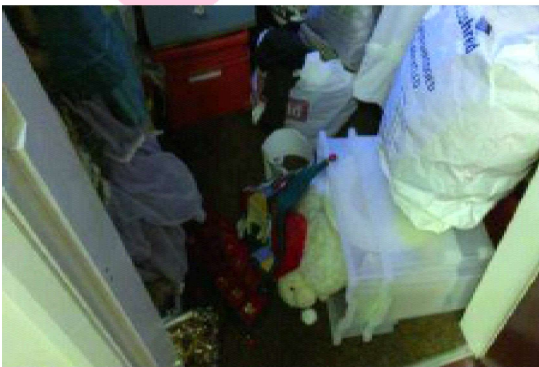
### **Item 90: Presumed**

The vinyl floor tiles beneath the carpet in the store (Room 82) are presumed to contain asbestos.

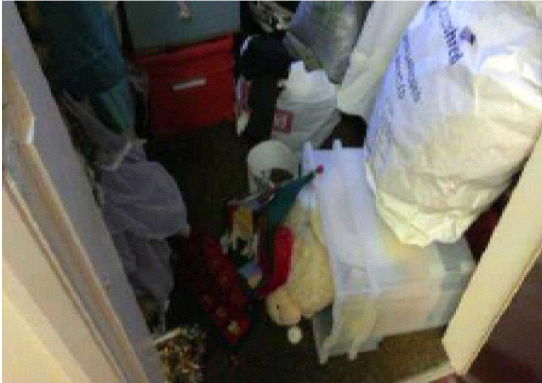
### **Item 91: Presumed**

The bitumen adhesive to the floor in the store (Room 82) is presumed to contain asbestos.

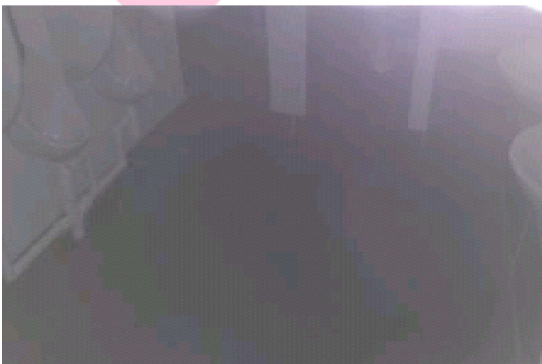
### **Item 93: Presumed**

The bitumen adhesive to the floor below the cement skim to the floor in the Boys toilet (Room 86) is presumed to contain asbestos.

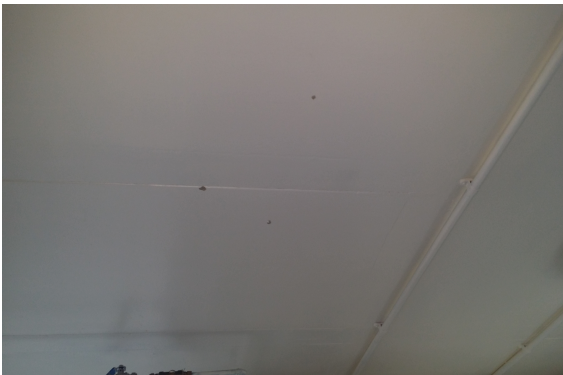
### **Item 131: 107693-3**

The ceiling in the staff toilet does not contain asbestos.

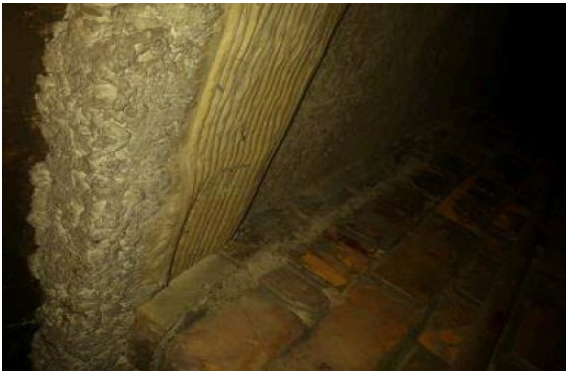
**Item 134: BH000572**

The insulation debris to straw/concrete duct ceiling in the duct adjacent head teacher's office contains asbestos.

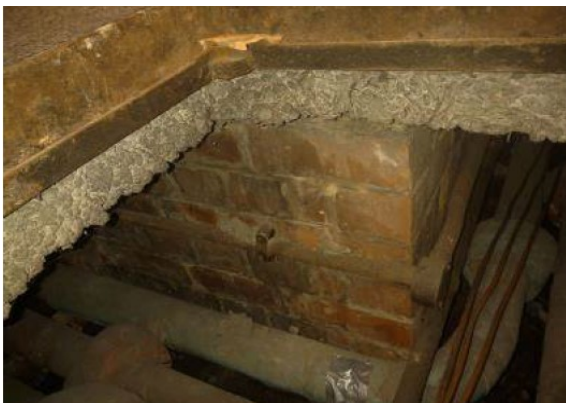
**Item 135: BH000573**

The insulation debris to brick walls in the duct adjacent head teacher's office contains asbestos.

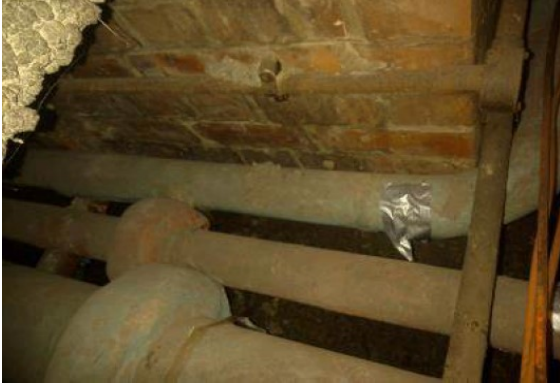
### **Item 136: BH000574**

The small bore insulation – green pipework in the duct adjacent head teacher’s office contains asbestos.

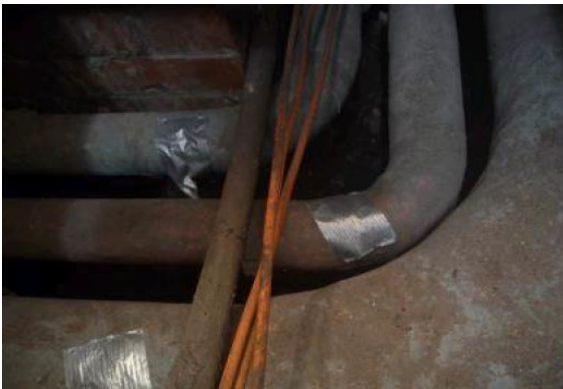
### **Item 137: BH000575**

The small bore insulation – red pipework in the duct adjacent head teacher’s office contains asbestos.

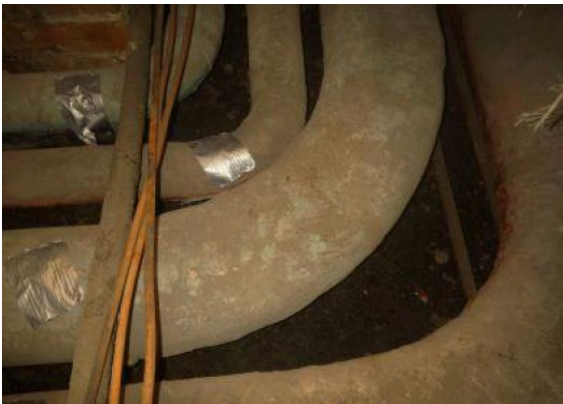
### **Item 138: BH000576**

The large bore insulation – green pipework in the duct adjacent head teacher’s office contains asbestos.

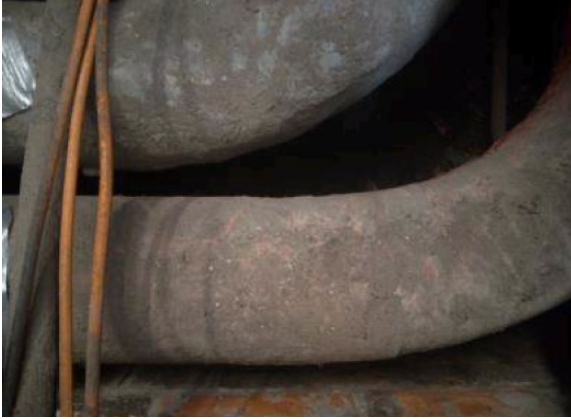
### **Item 139: BH000577**

The large bore insulation – red pipework in the duct adjacent head teacher’s office contains asbestos.

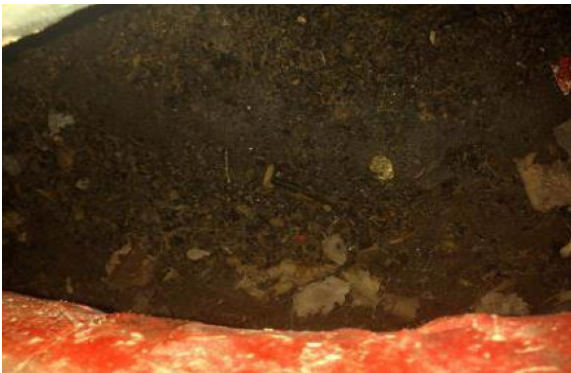
### **Item 140: BH000578**

The insulation debris to concrete floor in the duct adjacent head teacher’s office contains asbestos.

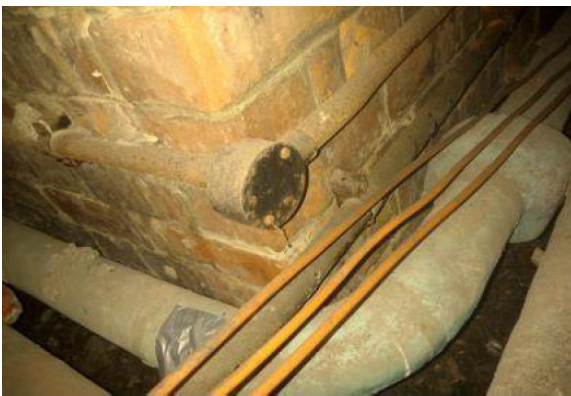
### **Item 141: BH000579**

The insulation debris to metal trunking / cable sheath trunking in the duct adjacent head teacher’s office contains asbestos.

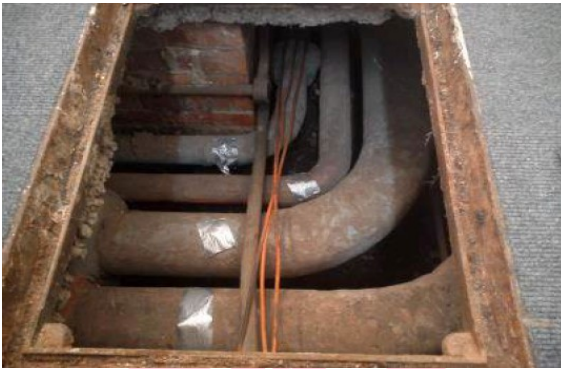
### **Item 143: Presumed**

The mains cable sheath running high level in duct in the duct adjacent head teacher's office is presumed to contain asbestos.

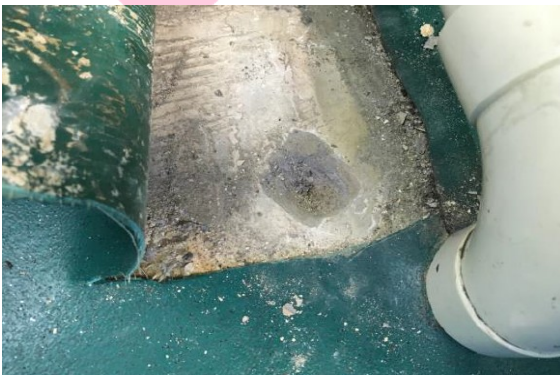
### **Item 144: BS001666**

The floor screed in year 6 Girls toilets does not contain asbestos.
