Foreward

ASBESTOS SURVEY REPORT FOR NORTHERN SAINTS C OF E PRIMARY SCHOOL, SUNDERLAND

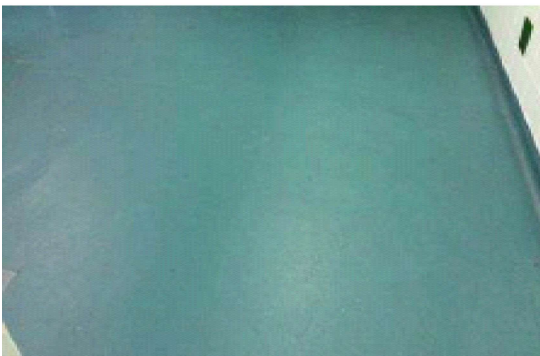
Item 42: Presumed

The bitumen adhesive beneath the modern lino in the girls wc (Room 41) is presumed to contain asbestos.

Any changes in its appearance should be noted and passed to Property Services.

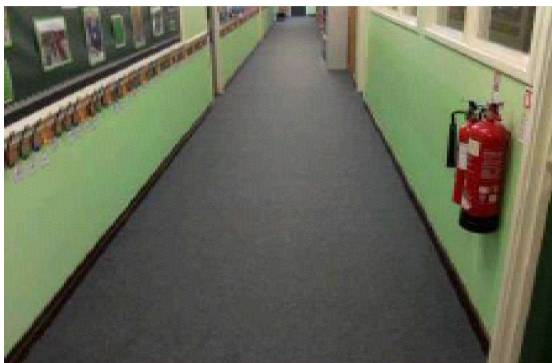
Item 44: Presumed

The vinyl floor tiles beneath the carpet in the corridor (Room 43) were presumed to contain asbestos.

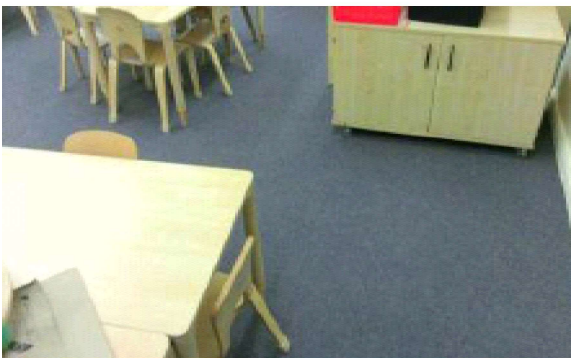
Item 50: Presumed

The vinyl floor tiles beneath the carpet in the classroom (Room 46) are presumed to contain asbestos.

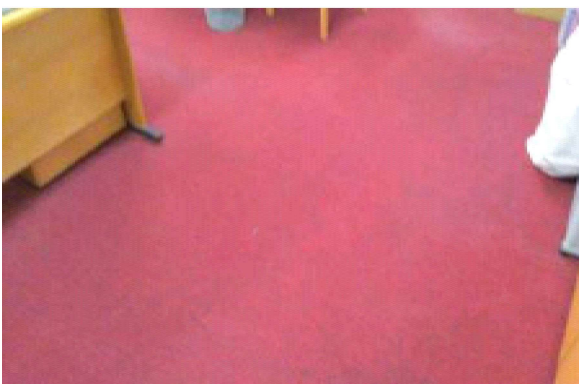
Item 57: Presumed

The bitumen adhesive to the floor in the office (Room 49) is presumed to contain asbestos.

Any changes in its appearance should be noted and passed to Property Services.

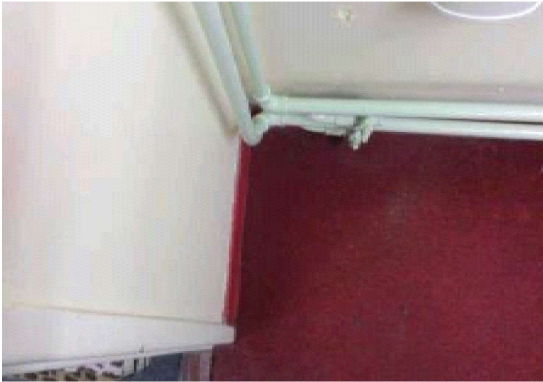
Item 58: As KR09/86

The skirting to wall in the office (Room 49) is presumed to contain asbestos.

Any changes in its appearance should be noted and passed to Property Services.

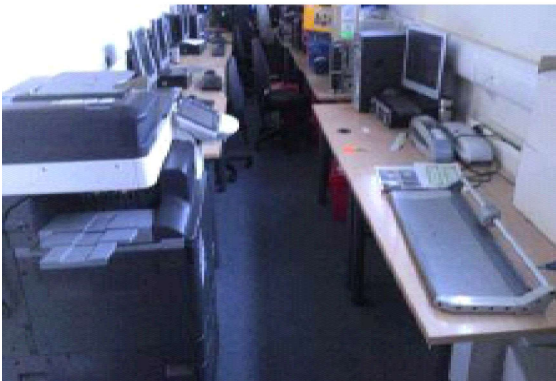
Item 60: Presumed

The bitumen adhesive to the floor below the carpet in the office (Room 51) is presumed to contain asbestos.

Any changes in its appearance should be noted and passed to Property Services.

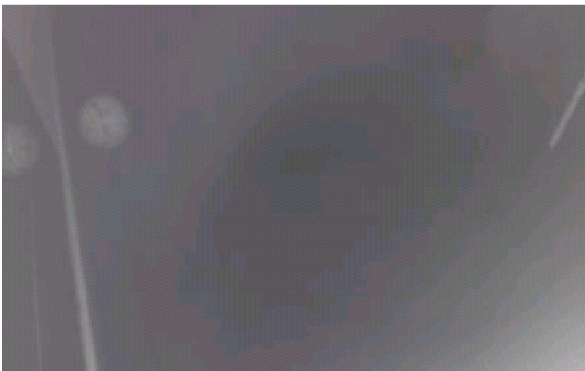
Item 65: Presumed

The vinyl floor tiles beneath the carpet in the office (Room 56) were presumed to contain asbestos.

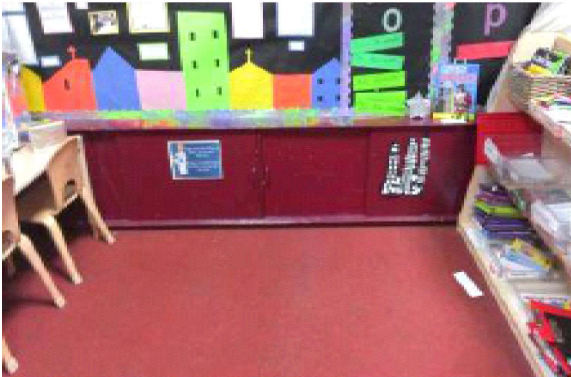
Item 68: Presumed

The skirting to base of wall behind the cupboards in the classroom (Room 57) is presumed to contain asbestos.

Any changes in its appearance should be noted and passed to Property Services.

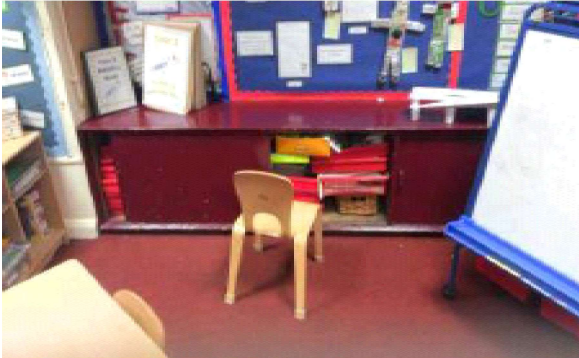
Item 70: As KR09/86

The skirting to base of wall behind the cupboards in the classroom (Room 58) is presumed to contain asbestos.

Any changes in its appearance should be noted and passed to Property Services.

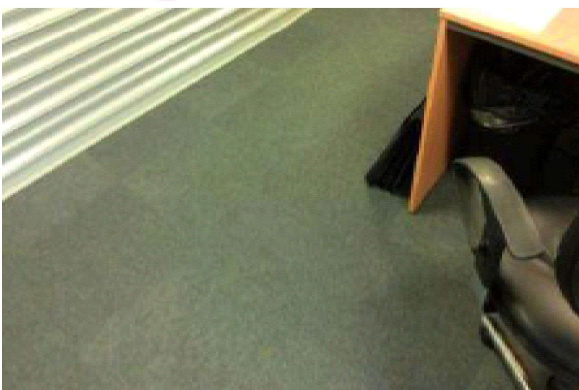
Item 72: Presumed

The bitumen adhesive to the floor below the cement skim to the floor in the reception office (Room 61) is presumed to contain asbestos.

Any changes in its appearance should be noted and passed to Property Services.

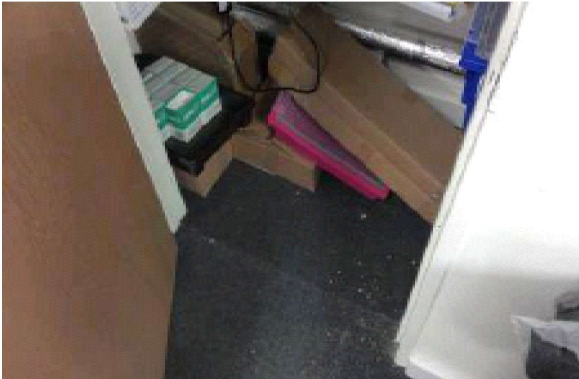
Item 73: Presumed

The bitumen adhesive to the floor below the cement skim to the floor in the reception office cupboard (Room 62) is presumed to contain asbestos.

Any changes in its appearance should be noted and passed to Property Services.

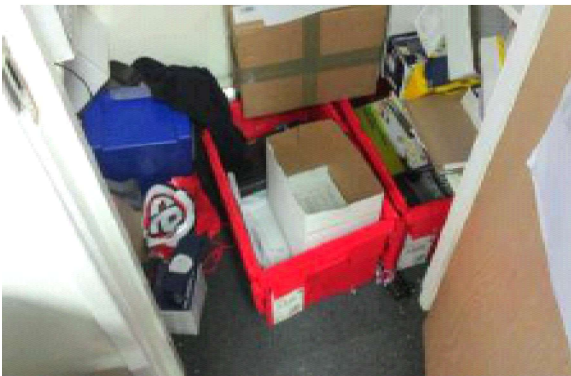
Item 74: Presumed

The bitumen adhesive to the floor below in the reception office cupboard (Room 63) is presumed to contain asbestos.

Any changes in its appearance should be noted and passed to Property Services.

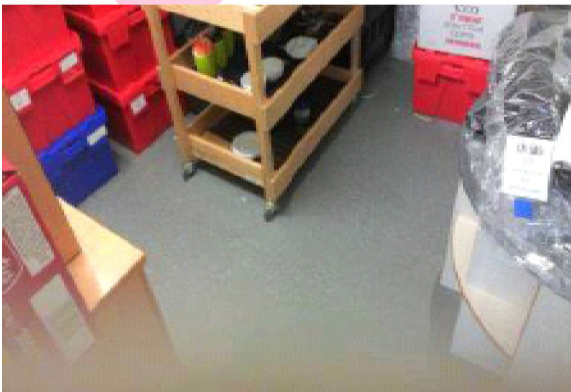
Item 75: Presumed

The bitumen adhesive to the floor below the cement skim in the store (Room 65) is presumed to contain asbestos.

Any changes in its appearance should be noted and passed to Property Services.

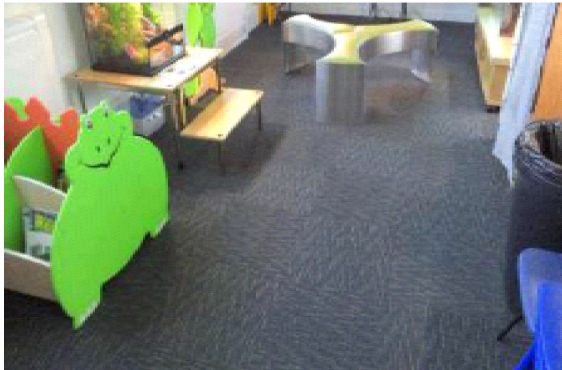
Item 76: Presumed

The bitumen adhesive to the floor below the cement skim to the floor in the reptile room (Room 66) is presumed to contain asbestos.

Any changes in its appearance should be noted and passed to Property Services.

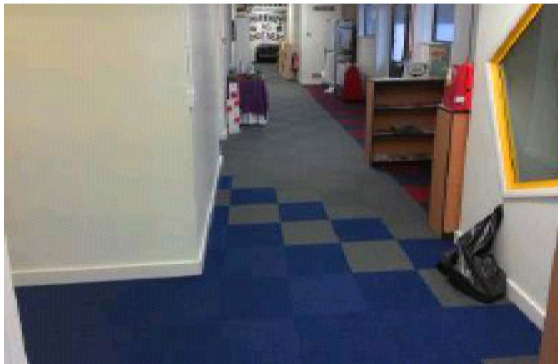
Item 77: NSPS/002

The bitumen adhesive to the floor below the cement skim to the floor in the corridor (Room G002) contains asbestos.

Any changes in its appearance should be noted and passed to Property Services.

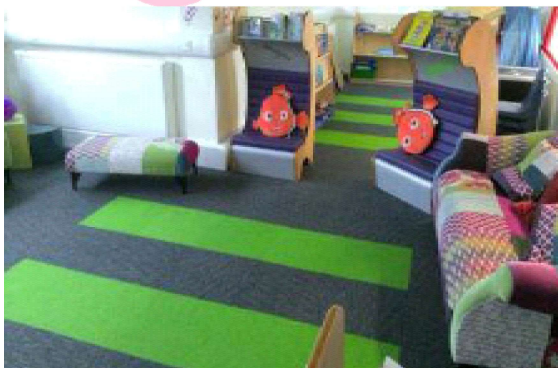
Item 78: Presumed

The bitumen adhesive to the floor below the cement skim to the floor in the library (Room 70) is presumed to contain asbestos.

Any changes in its appearance should be noted and passed to Property Services.

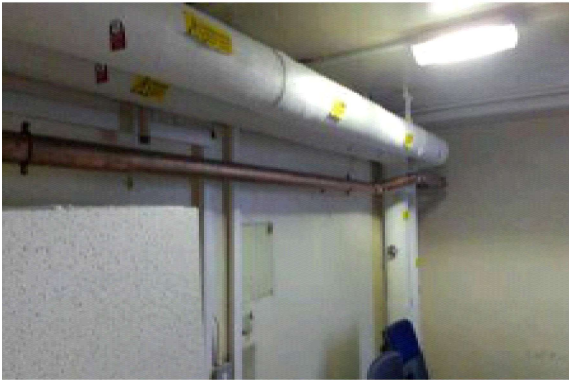
Item 79: KR09/97

The lagging to the pipework in the store (Room 73) is strongly presumed to contain asbestos.

Any changes in its appearance should be noted and passed to Property Services.

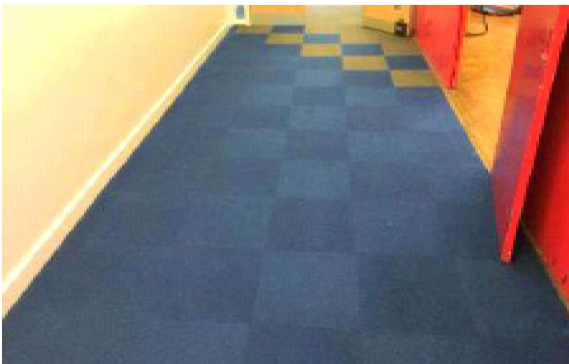
Item 80: Presumed

The vinyl floor tiles beneath the carpet in the corridor (Room 74) are presumed to contain asbestos.

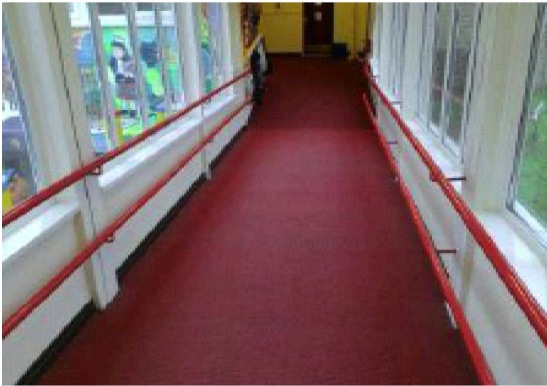
Item 82: Presumed

The vinyl floor tiles beneath the carpet in the corridor (Room 76) are presumed to contain asbestos.

Any changes in its appearance should be noted and passed to Property Services.

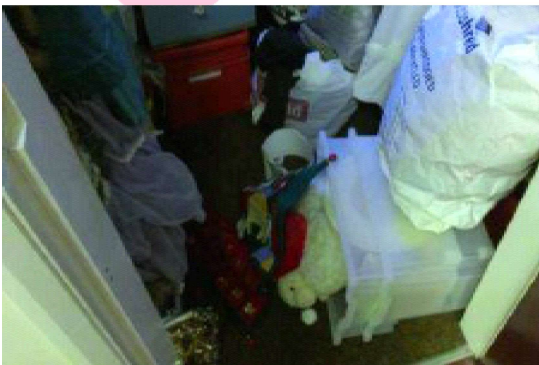
Item 90: Presumed

The vinyl floor tiles beneath the carpet in the store (Room 82) are presumed to contain asbestos.

Any changes in its appearance should be noted and passed to Property Services.

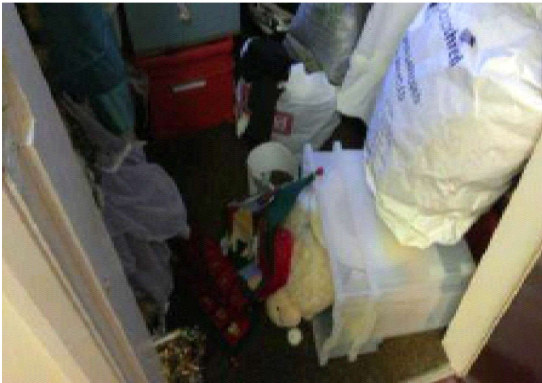
Item 91: Presumed

The bitumen adhesive to the floor in the store (Room 82) is presumed to contain asbestos.

Any changes in its appearance should be noted and passed to Property Services.

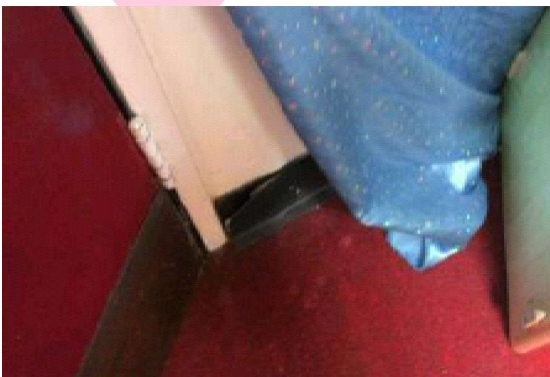
Item 96: Presumed

The skirting to base of wall behind modern in the classroom (Room 87) is presumed to contain asbestos.

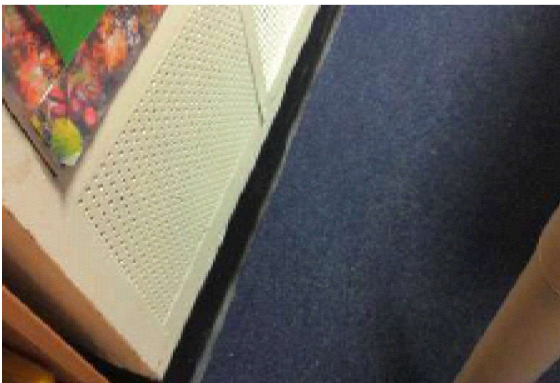
Item 98: Presumed

The skirting to base of wall behind modern in the classroom (Room 88) is presumed to contain asbestos.

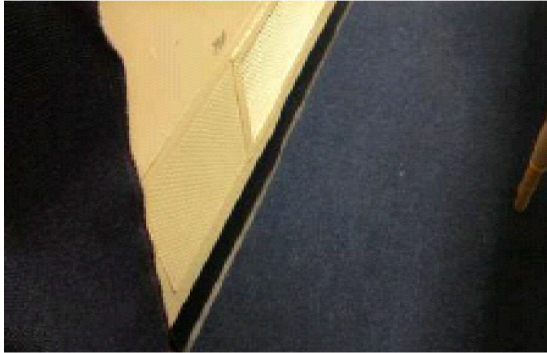
Item 100: Presumed

The skirting to base of wall behind modern in the classroom (Room 89) is presumed to contain asbestos.

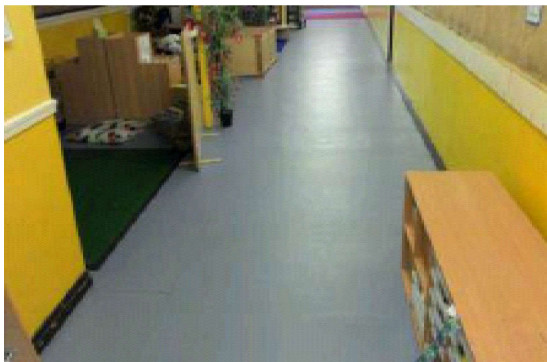
Item 102: Presumed

The vinyl floor tiles beneath the modern lino in the corridor (Room 94) are presumed to contain asbestos.

Any changes in its appearance should be noted and passed to Property Services.

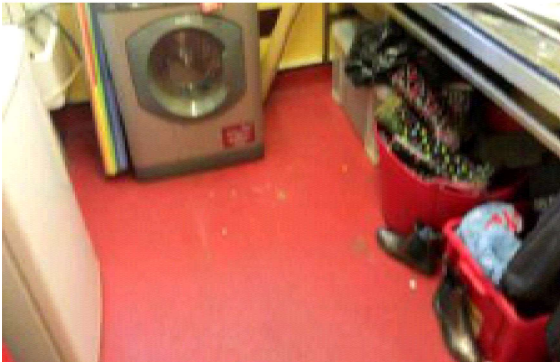
Item 104: Presumed

The bitumen adhesive to the floor in the store (Room 95) is presumed to contain asbestos.

Any changes in its appearance should be noted and passed to Property Services.

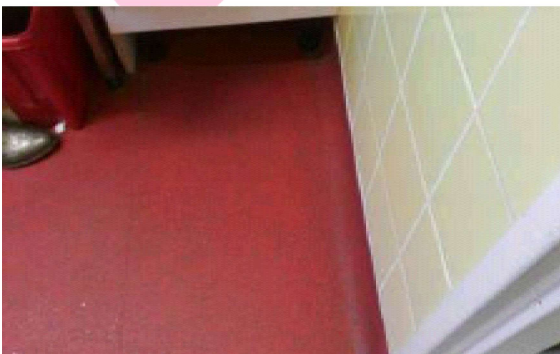
Item 105: As KR09/86

The skirting to base of wall in the store (Room 95) is presumed to contain asbestos.

Any changes in its appearance should be noted and passed to Property Services.

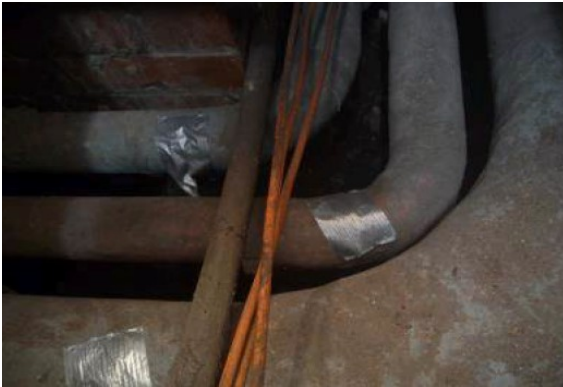
Item 137: BH000575

The small bore insulation – red pipework in the duct adjacent head teacher's office contains asbestos.

Any changes in its appearance should be noted and passed to Property Services.

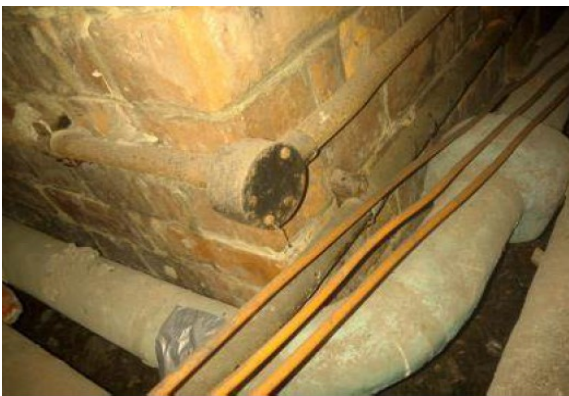
Item 141: BH000579

The insulation debris to metal trunking / cable sheath trunking in the duct adjacent head teacher's office contains asbestos.

Any changes in its appearance should be noted and passed to Property Services.

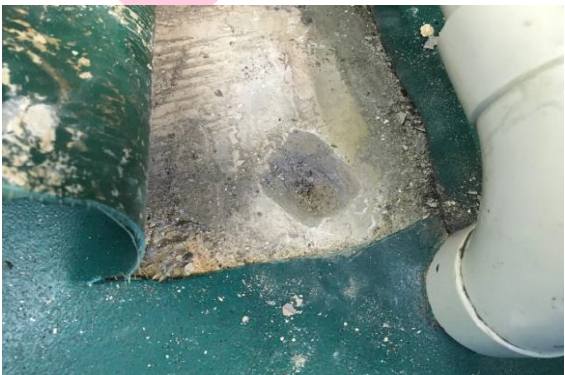
Item 144: BS001666

The floor screed in year 6 Girls toilets does not contain asbestos.
