ASBESTOS SURVEY REPORT FOR REDHOUSE CA, RUTHERGLEN ROAD,
SUNDERLAND, SR5 5LJ

Asbestos Register for

Redhouse CA, Rutherglen Road, Sunderland

Date: 16 May 2025

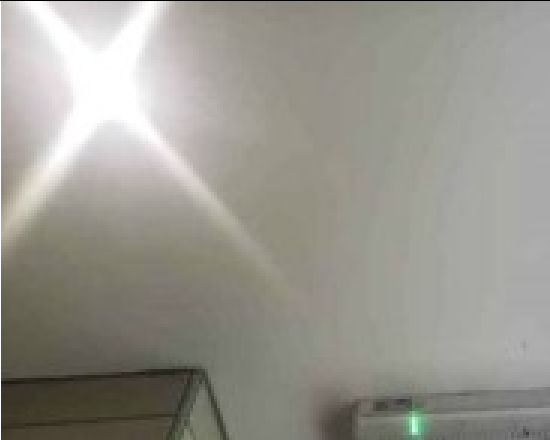
7	As TL000290	Ceiling void – ceiling above	Toilets Female G/18	No Risk

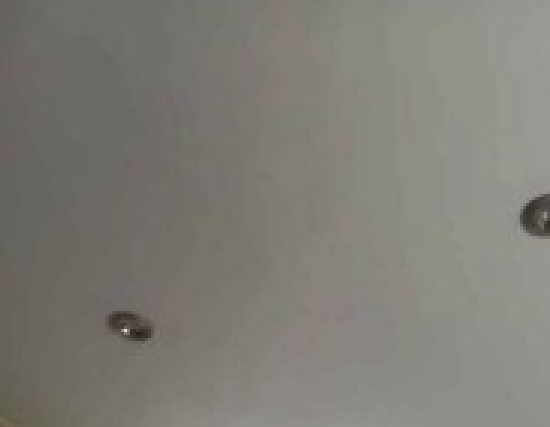
8	As TL000290	Ceiling void – ceiling above	Toilets Male G/019	No Risk

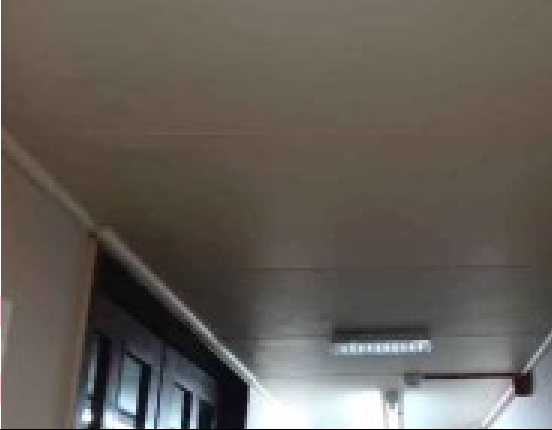
25	As TL000295	Floor covering	Corridor G/004a	No Risk
<p>No Photographic Evidence</p>				
26	TL000296	Ceiling Cladding	Corridor G/004a	No Risk

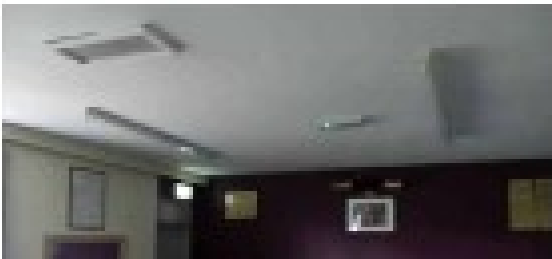
27	TL000302	Ceiling Coating	Room Large G/010	Any change in appearance should be recorded and passed to Property Services.
<p>Photo 1: Wide Angle</p>			<p>Photo 2: Close</p>

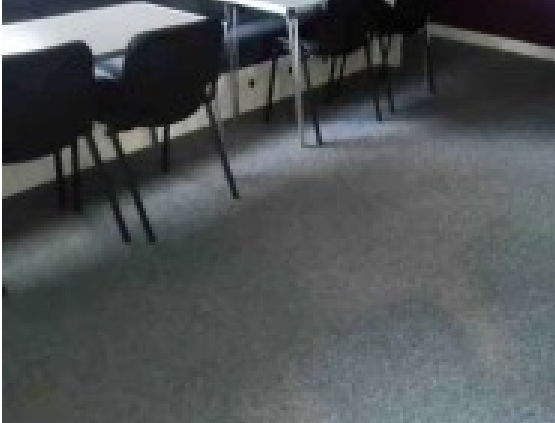
28	TL000303	Floor tile with adhesive	Room Large G/010	No Risk

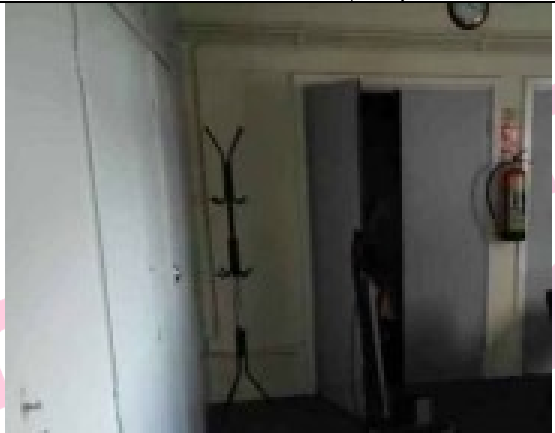
29	TL000304	Floor tile with adhesive	Cupboard G/010b	No Risk

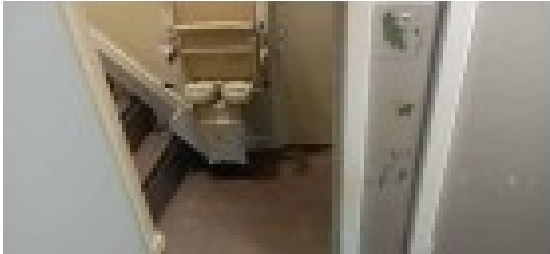
31	TL000305	Floor tile under floor covering	Stage Area G/012	Any change in appearance should be recorded and passed to Property Services.
Photo 1: Wide Angle			Photo 2: Close
