ASBESTOS SURVEY REPORT FOR REDHOUSE CA, RUTHERGLEN ROAD, SUNDERLAND, SR5 5LJ

## **Asbestos Register for**

**Redhouse CA, Rutherglen Road, Sunderland**

**Date: 12 September 2025**

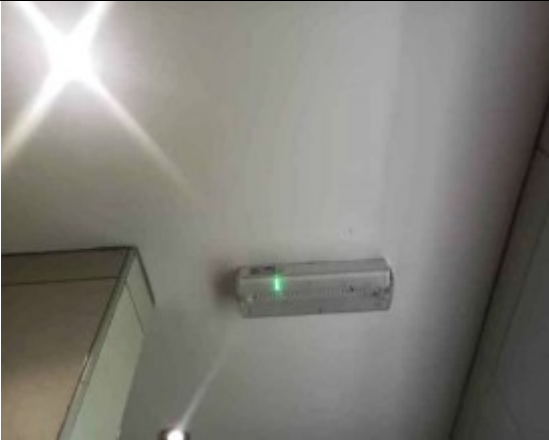
7	As TL000290	Ceiling void – ceiling above	Toilets Female G/18	No Risk

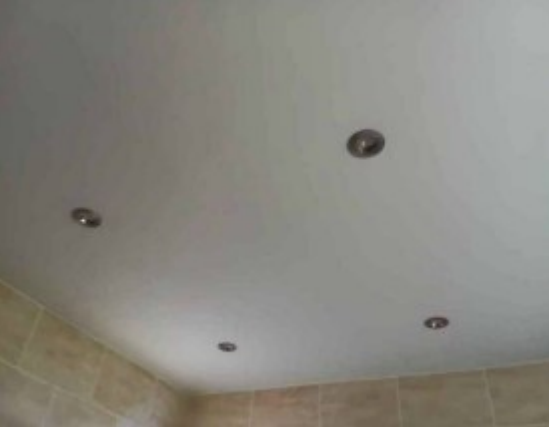
8	As TL000290	Ceiling void – ceiling above	Toilets Male G/019	No Risk

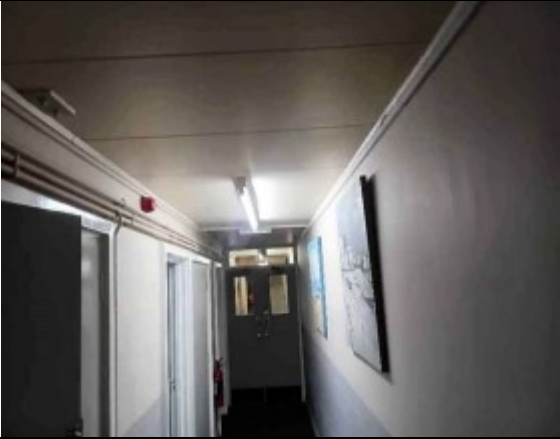
16	TL000296	Ceiling Cladding	Corridor G/004	No Risk

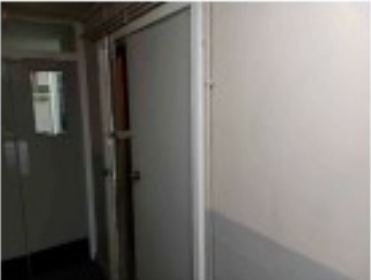
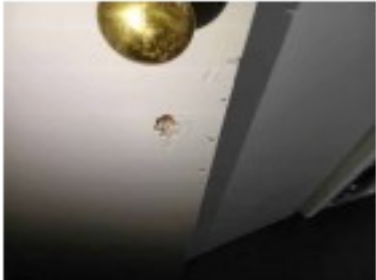
17	TL000297	Door – fire door inner lining	Corridor G/004	Any change in appearance should be recorded and passed to Property Services.
<b>Photo 1: Wide Angle</b>		<b>Photo 2: Close-up</b>

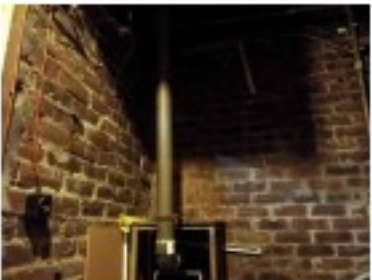
18	TL000298	Flue Pipe	Cupboard – Meter Sports store. Limited access to undercroft opposite wall G/005	Any change in appearance should be recorded and passed to Property Services.
<b>Photo 1: Wide Angle</b>		<b>Photo 2: Close-up</b>

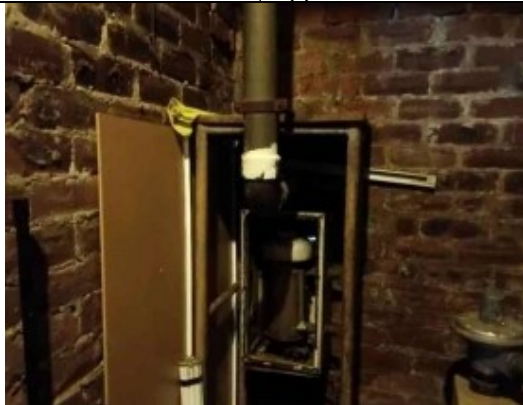
19	TL000299	Pipe joints Caulking/Packing	Cupboard – Meter Sports store. Limited access to undercroft opposite wall G/005	No Risk

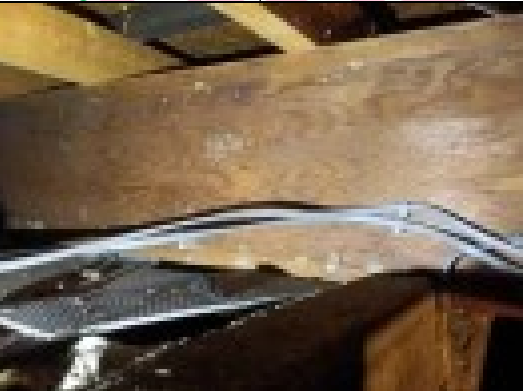
20	TL000299	Debris to void above admin office. Limited access to ceiling voids due to inadequate space and fragile roof	Cupboard – Meter Sports store. Limited access to undercroft opposite wall G/005	Any change in appearance should be recorded and passed to Property Services.

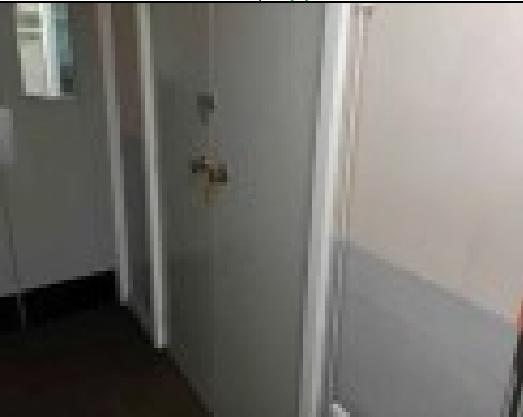
21	As TL000297	Door – fire door inner lining (same door as to corridor)	Cupboard – Meter Sports store. Limited access to undercroft opposite wall G/005	Any change in appearance should be recorded and passed to Property Services.

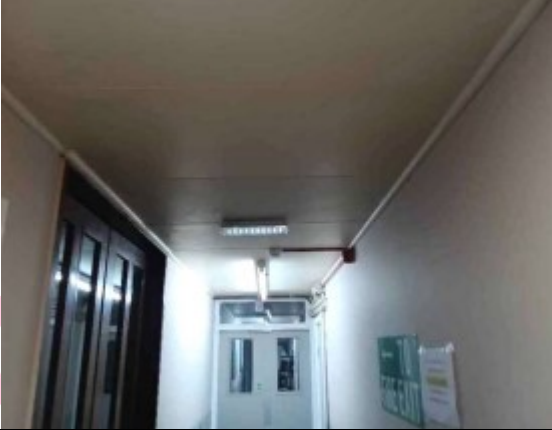
25	As TL000295	Floor covering	Corridor G/004a	No Risk
<p><b>No Photographic Evidence</b></p>				
26	TL000296	Ceiling Cladding	Corridor G/004a	No Risk

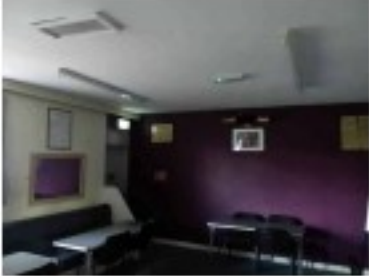
27	TL000302	Ceiling Coating	Room Large G/010	Any change in appearance should be recorded and passed to Property Services.
<p><b>Photo 1: Wide Angle</b></p>			<p><b>Photo 2: Close-up</b></p>

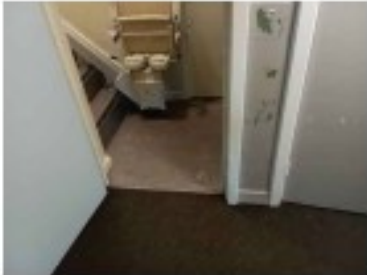
31	TL000305	Floor tile under floor covering	Stage Area G/012	Any change in appearance should be recorded and passed to Property Services.
<b>Photo 1: Wide Angle</b>			<b>Photo 2: Close-up</b>
