ASBESTOS SURVEY REPORT FOR GILLAS LANE PRIMARY SCHOOL, HOUGHTON

Asbestos Register for

GILLAS LANE PRIMARY SCHOOL HOUGHTON

Date: 10 June 2025

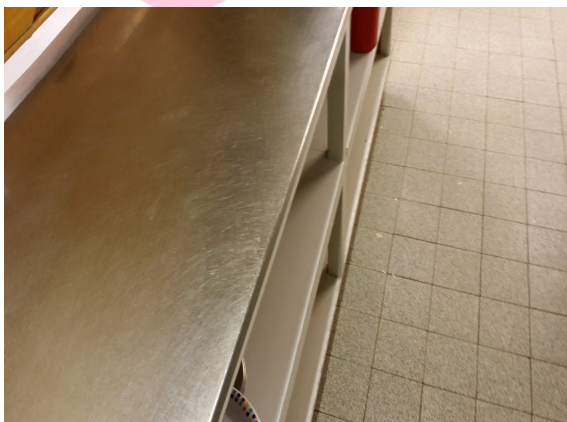
Item 71 – 148020-3

Liner to counter top under stainless steel in the kitchen area does not contain asbestos.

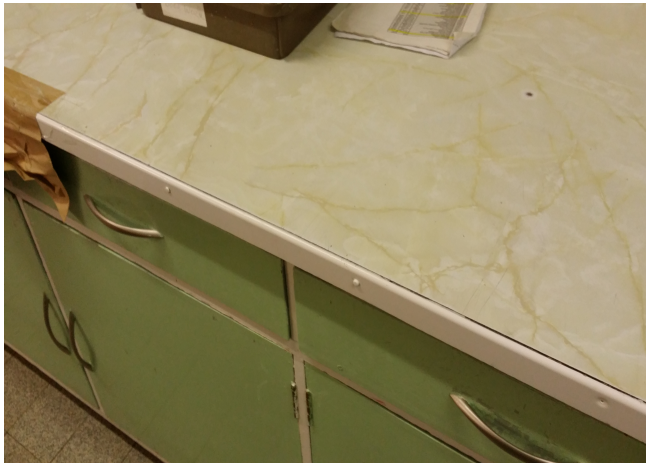
Item 75 – 148020-3

Bench linings in the kitchen area does not contain asbestos

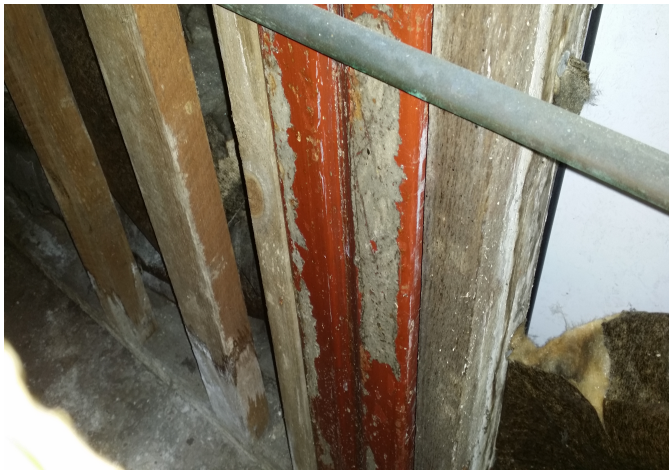
Item 76 – 148020-6

Insulating board debris to column face behind rear benches in the kitchen area does not contain asbestos

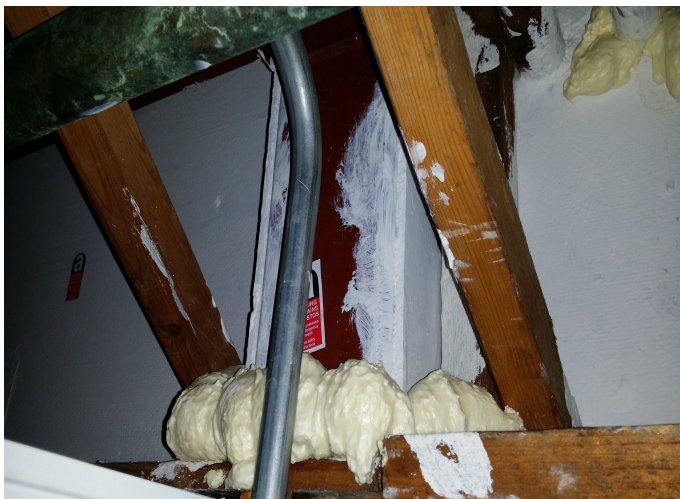
Item 77 – 148020-1

Packers to columns in the void above the suspended ceiling in the kitchen area. This is presumed to contain asbestos.

Any change should be recorded and passed to Property Services.

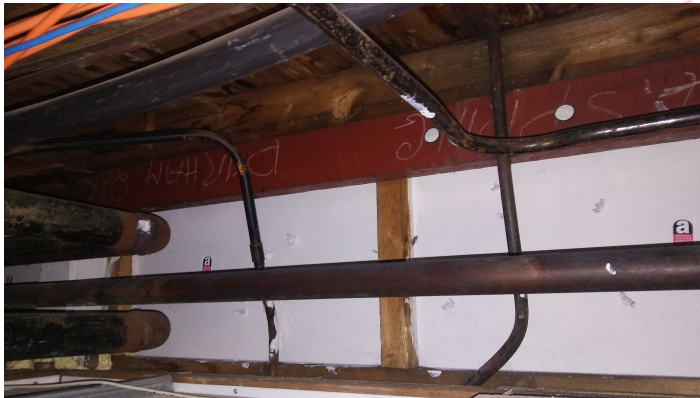
Item 79 – Presumed

Firebreak and packers at column tops in the void above suspension ceiling in the dry store is presumed to contain asbestos.

Any change should be recorded and passed to Property Services.

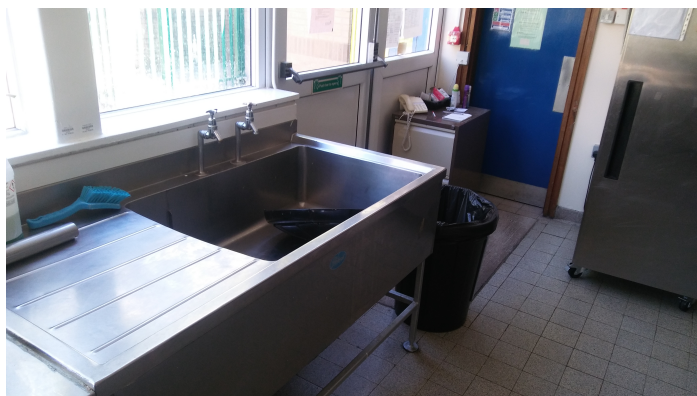
Item 81 – 273862-2

The sink pad in the kitchen contains asbestos.

Any change should be recorded and passed to Property Services.

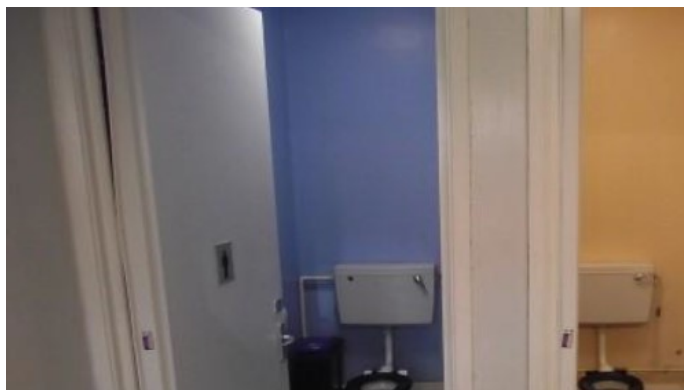
Item 85 – Presumed

The two black toilet seats in East End WC's are presumed to contain asbestos.

Removed 2019

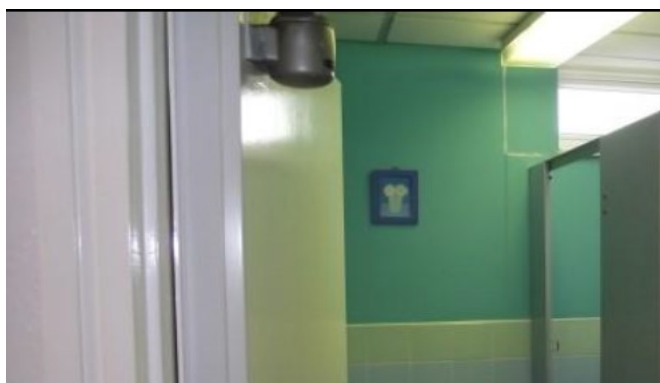
Item 91 – Presumed

The two black toilet seats in KS2 Girls WC's are presumed to contain asbestos.

Removed 2019

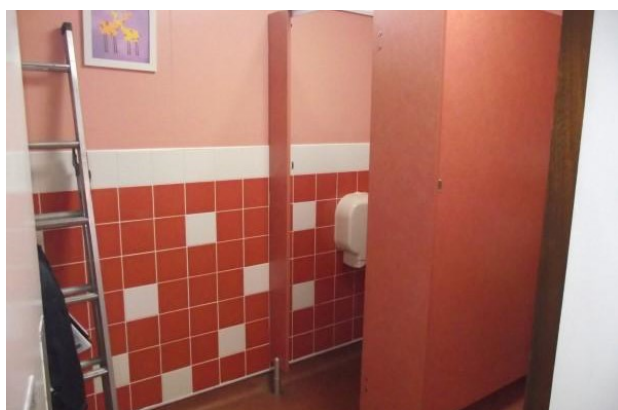
Item 97 – Presumed

The two black toilet seats in KS2 Girls WC's are presumed to contain asbestos.

Removed 2019

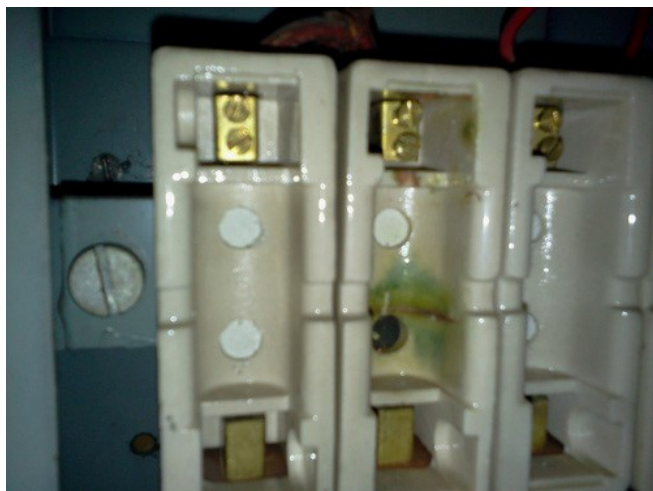
Item 114 – 47413-2

The electrics in Classroom/Rm 011 contain asbestos.

Any change should be recorded and passed to Property Services.

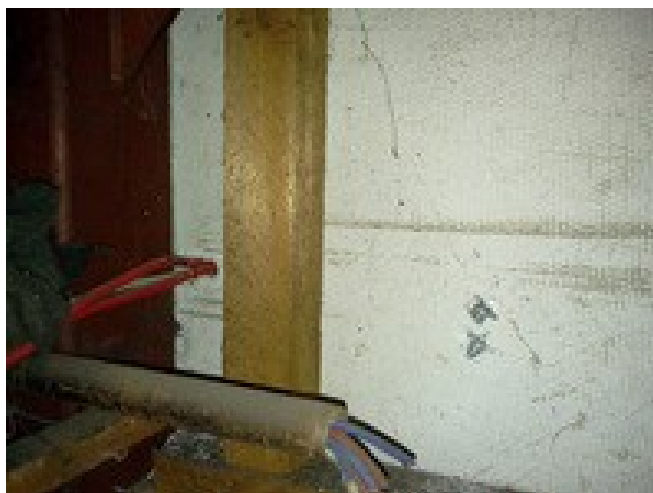
Item 115 – As 47413-4

The unsealed board to rear of main hall in Lobby and reception void above contain asbestos.

Any change should be recorded and passed to Property Services.

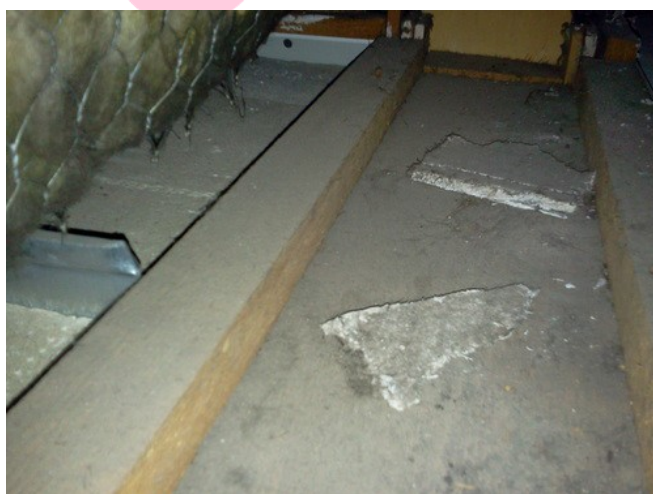
Item 116 – 47413-5

The debris to door frame in Lobby and reception void above/Rm 025 contained asbestos.

Removed 2014

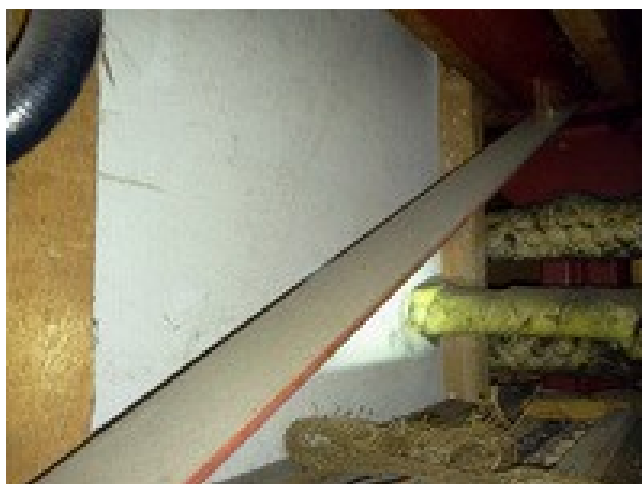
Item 117 – 47413-6

The extract surround in the Store void above/Rm 026 contains asbestos.

Any change should be recorded and passed to Property Services.

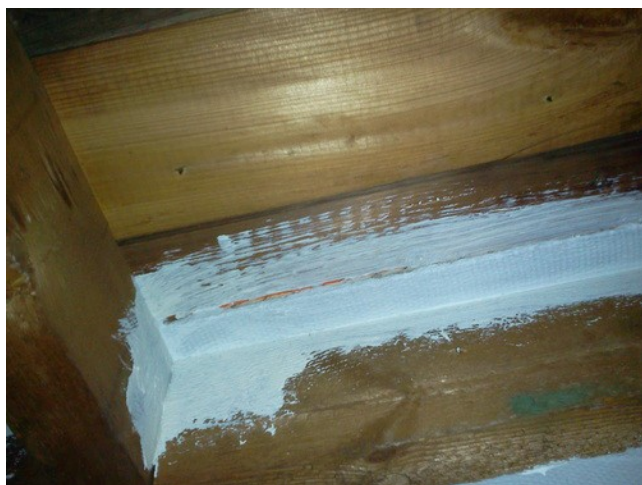
Item 118 – As 47413-6

The fillet above metal extract plate in the Store void above/Rm 026 contains asbestos.

Any change should be recorded and passed to Property Services.

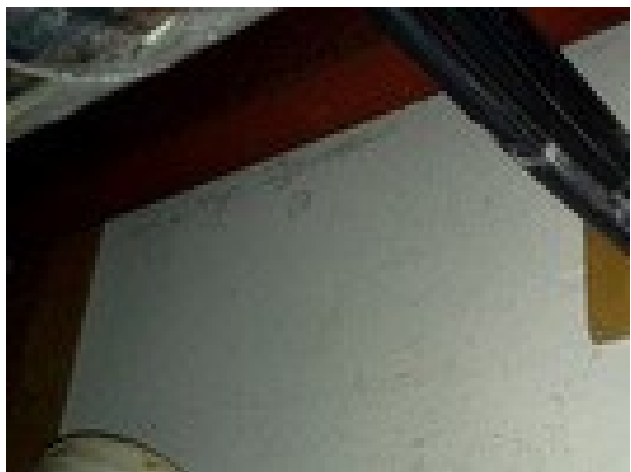
Item 119 – As 47413-7

The unsealed board to rear of main hall in the Corridor void above/Rm 037 contains asbestos.

Any change should be recorded and passed to Property Services.

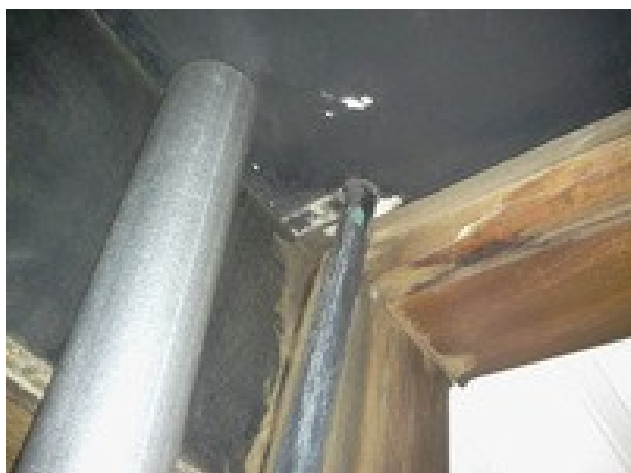
Item 120 – As 47413-3

The ceiling boards in former heater cupboard/Rm 038 contains asbestos.

Any change should be recorded and passed to Property Services.

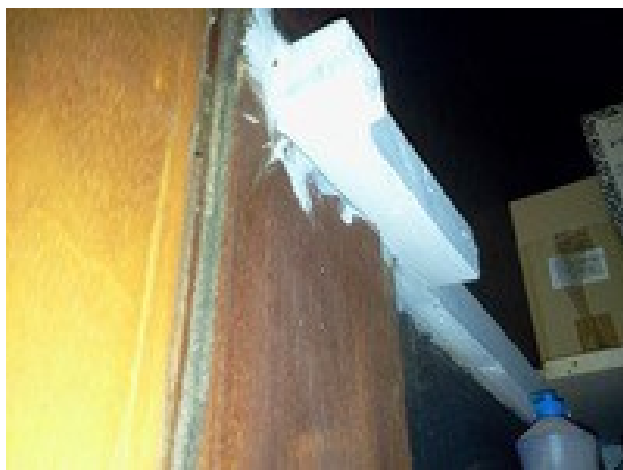
Item 121 – Presumed

The debris in nail holes to battens in the Former heater cupboard/Rm 038 is presumed to contain asbestos.

Item 121	Debris in nail holes to battens (Former heater cupboard/Rm 038)	Low		Removed 2014
Item 122	Loose debris (Former heater cupboard void above/Rm 038)	Low		Removed 2014

Removed 2014

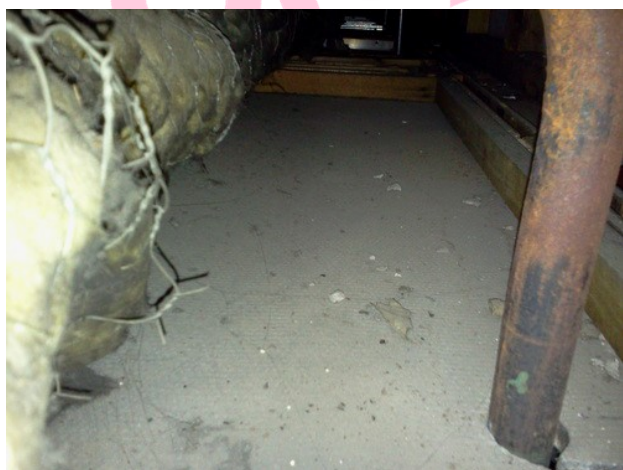
Item 122 – As 47413-3

As 47413-3 – Loose debris (Former heater cupboard void above/Rm 038) (Item 122) – Removed 2014

The loose debris in the Former heater cupboard void above/Rm 038 is presumed to contain asbestos.

Removed 2014

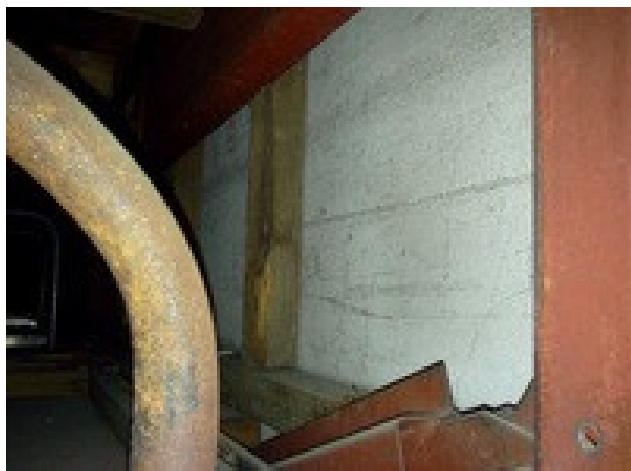
Item 123 – As 47413-7

The unsealed board to rear of main hall in the Former heater cupboard void above/Rm 038 contains asbestos.

Any change should be recorded and passed to Property Services.

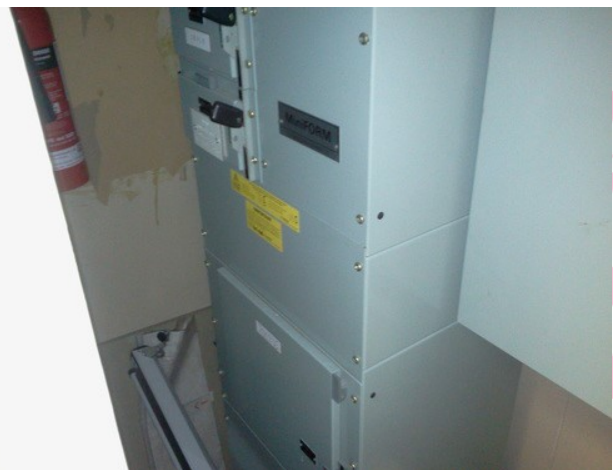
Item 124 – Presumed

The Electrics in the Switch cupboard/Rm 039 is presumed to contain asbestos.

Any change should be recorded and passed to Property Services.

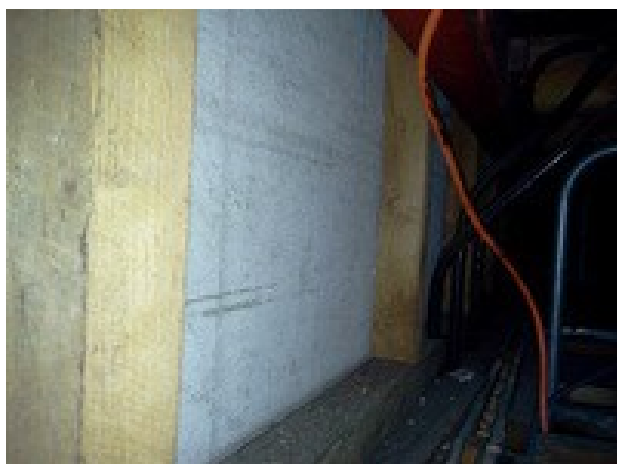
Item 125 – As 47413-7

The unsealed board to rear of main hall wall in Cleaner void above/Rm 040 contains asbestos.

Any change should be recorded and passed to Property Services.

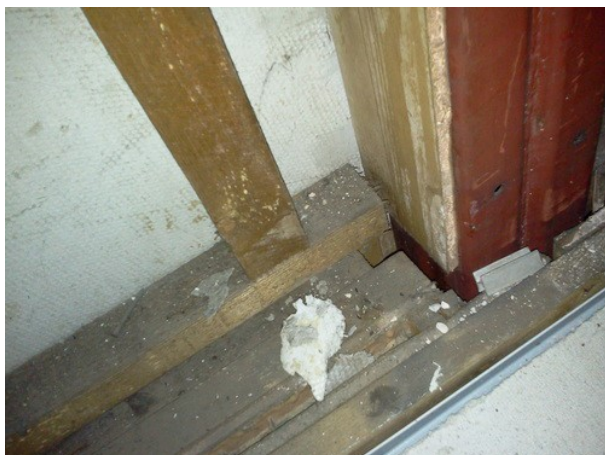
Item 126 – As 47413-3

As 47413-3 – Loose debris (Boys WC void above/Rm 041) (Item 126) – Removed 2014

The loose debris in the Boys WC void above/Rm 041 contains asbestos.

Any change should be recorded and passed to Property Services.

Removed 2014

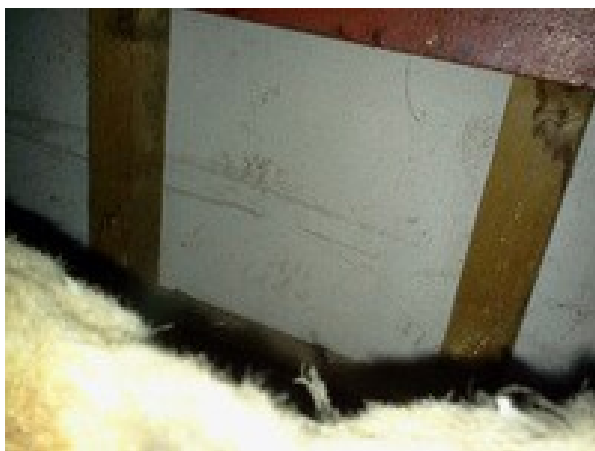
Item 127 – As 47413-7

The unsealed board to rear of main hall wall in the Boys WC void above/Rm 041 contains asbestos.

Any change should be recorded and passed to Property Services.

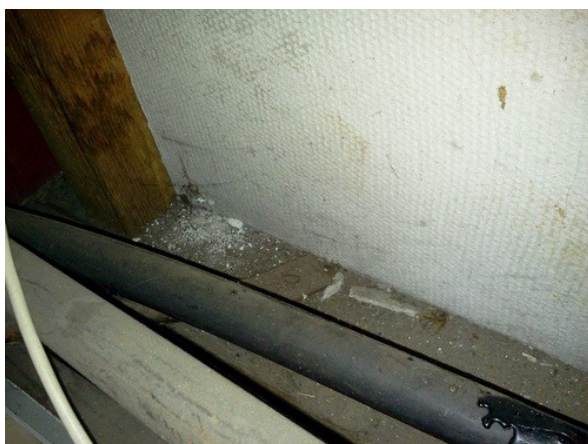
Item 132 – As 47413-3

As 47413-3 – Loose debris (Gym store void above/Rm 045) (Item 132) – Removed 2014

The loose debris in the Gym store void above/Rm 045 contains asbestos.

Any change should be recorded and passed to Property Services.

Removed 2014

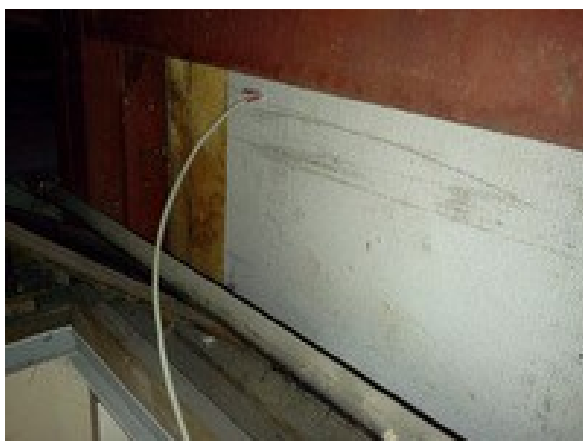
Item 133 – As 47413-3

The unsealed board to rear of main hall wall in the Gym store void above/Rm 045 contains asbestos.

Any change should be recorded and passed to Property Services.

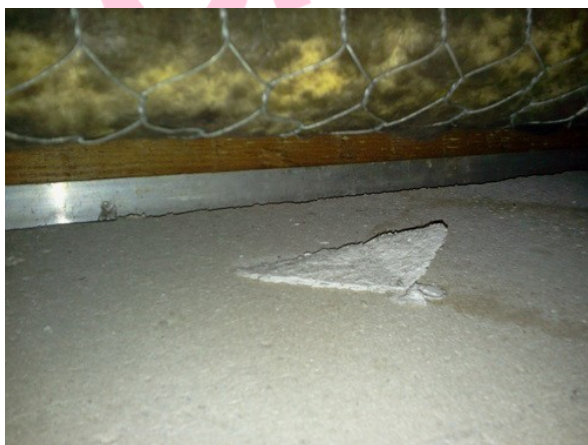
Item 134 – As 47413-7

As 47413-7 – Loose debris (Chair store void above/Rm 046) (Item 134) – Removed 2014

The loose debris in the Chair store void above/Rm 046 contains asbestos.

Any change should be recorded and passed to Property Services.

Removed 2014

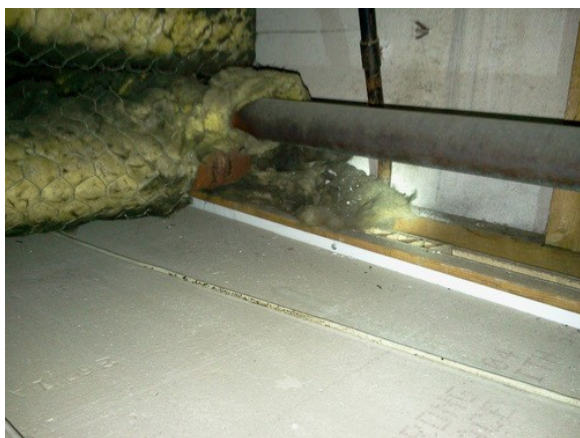
Item 136 – As 47413-7

As 47413-7 – Loose debris (Dry Store void above/Rm 048) (Item 136) – Removed 2014

The loose debris in the Dry Store void above/Rm 048 contains asbestos.

Any change should be recorded and passed to Property Services.

Removed 2014

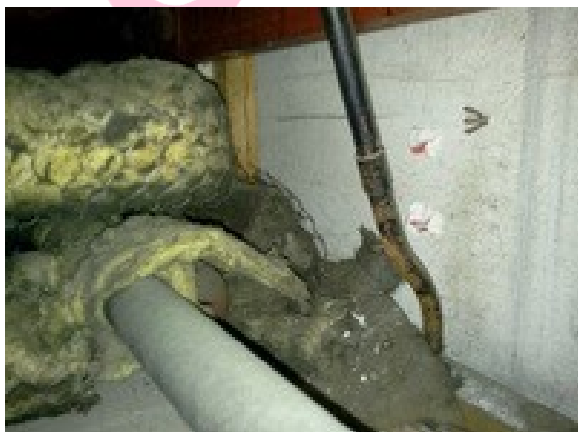
Item 137 – As 47413-7

The unsealed board to rear of main hall wall in the Dry Store void above/Rm 048 contains asbestos.

Any change should be recorded and passed to Property Services.

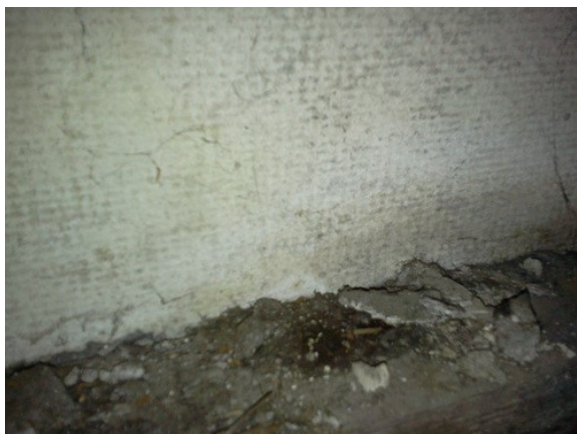
Item 138 – As 47413-7

As 47413-7 – Loose debris (Kitchen void above/Rm 049) (Item 138) – Removed 2014

The loose debris in the Kitchen void above/Rm 049 contains asbestos.

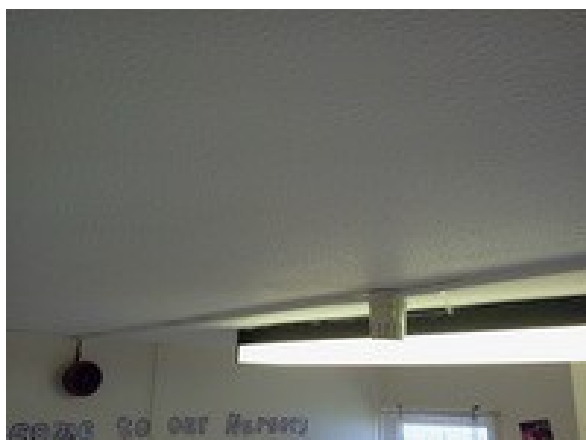
Item 144 – As 47413-13

The coating to plasterboard ceiling in the Entrance Lobby/Rm 002 contains asbestos.

Any change should be recorded and passed to Property Services.

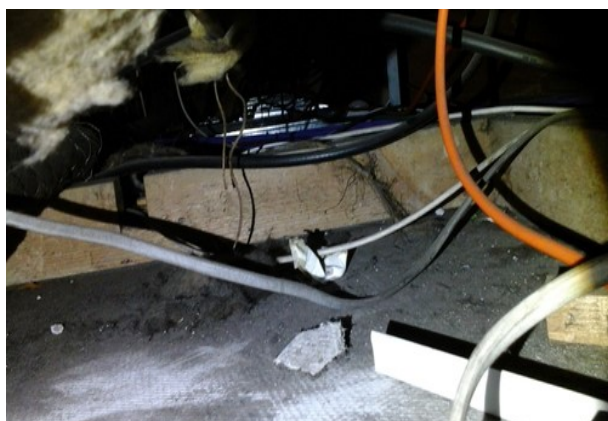
Item 159 – 74282-1

74282-1 – Loose debris (former staff cloaks void above/Rm 017) (Item 159) – Removed 2015

The loose debris in the former staff cloaks void above/Rm 017 contains asbestos.

Any change should be recorded and passed to Property Services.

Removed 2015

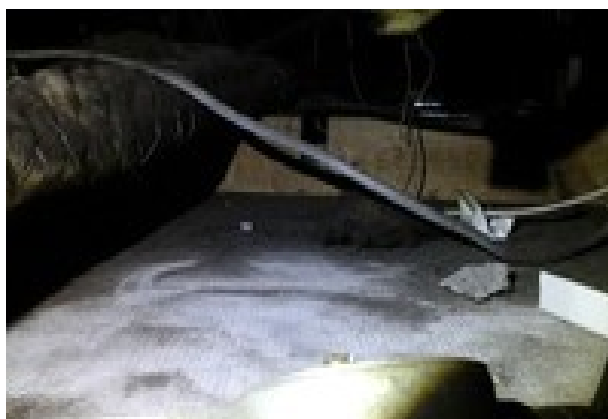
Item 160 – 74282-2

The top of ceiling to redundant heater in the former staff cloaks void above/Rm 017 contains asbestos.

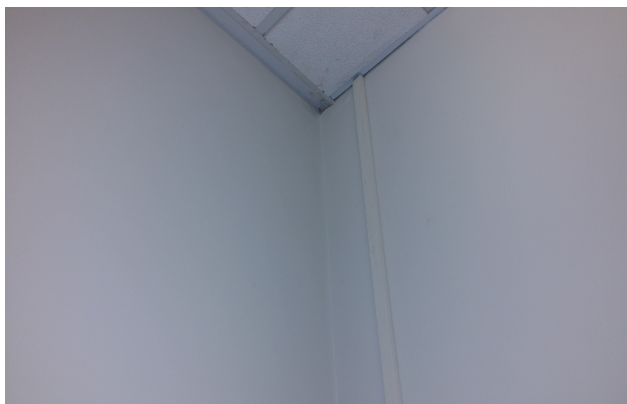
Item 171 – As 230423-1

The cladding to columns behind plasterboard walls in the Corridor/Rm 008 contains asbestos.

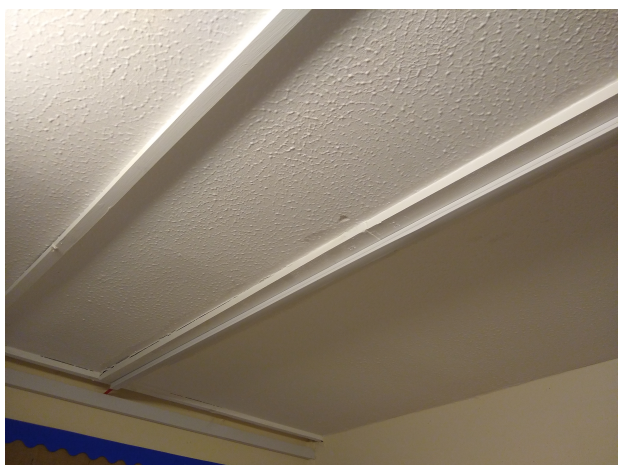
Item 177 – As 47413-13

The coating to plasterboard ceiling in the Entrance Lobby/Rm 0/002 contains asbestos.

Any change should be recorded and passed to Property Services.

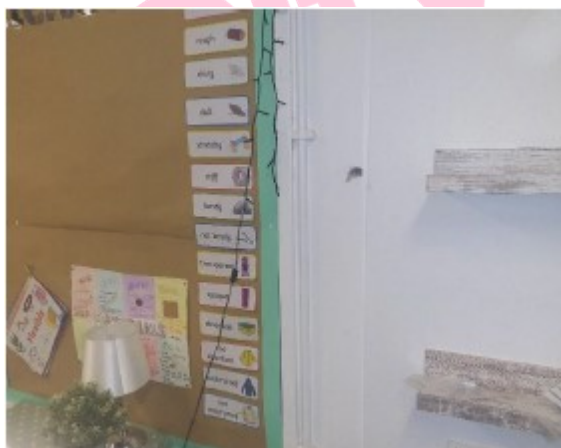
Item 188 – EV006806

The insulating board steel columns in Class 1 (Rm G/001) does contain asbestos.
