ASBESTOS SURVEY REPORT FOR GILLAS LANE PRIMARY ACADEMY,  
SEATON AVENUE, HOUGHTON LE SPRING, DH5 8EH.

*Control of Asbestos  
Regulations 2012*

**Gillas Lane Primary Academy, Seaton Avenue,  
Houghton le Spring**

**Date: 24 March 2026**

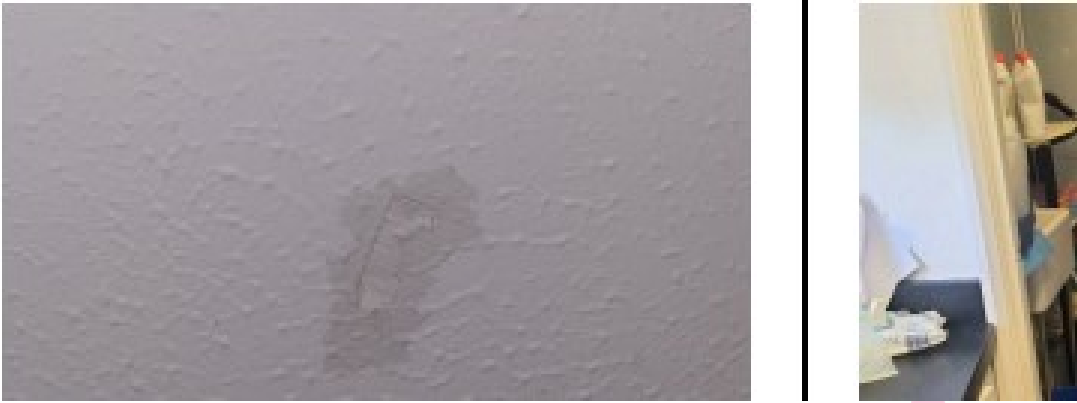
1	EV006798	Textured coated ceiling	Store G/001	Low Risk – 6 monthly

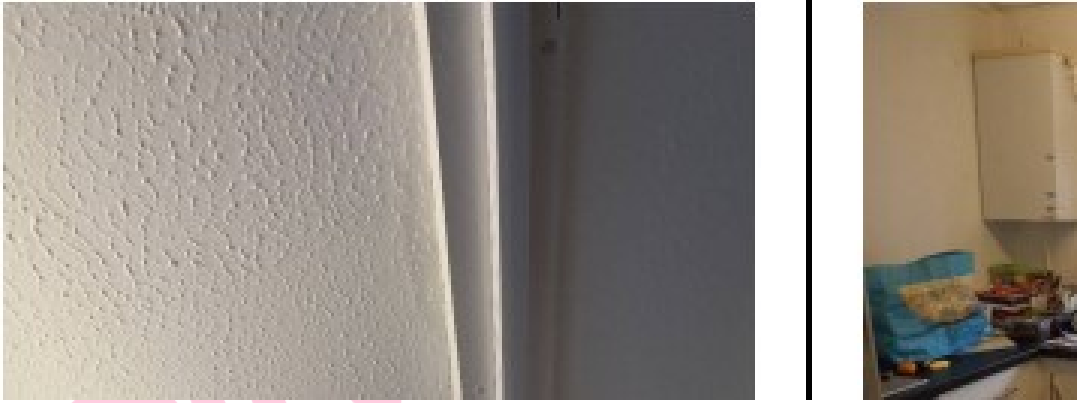
2	As EV006798	Textured coated ceiling	Kitchen G/002	Low Risk – 6 monthly

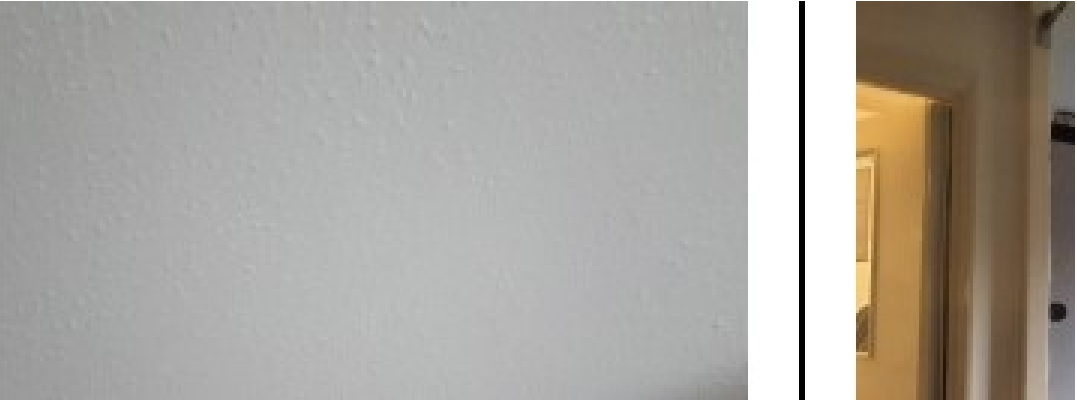
3	As EV006798	Textured coated ceiling	WC G/003	Low Risk – 6 monthly

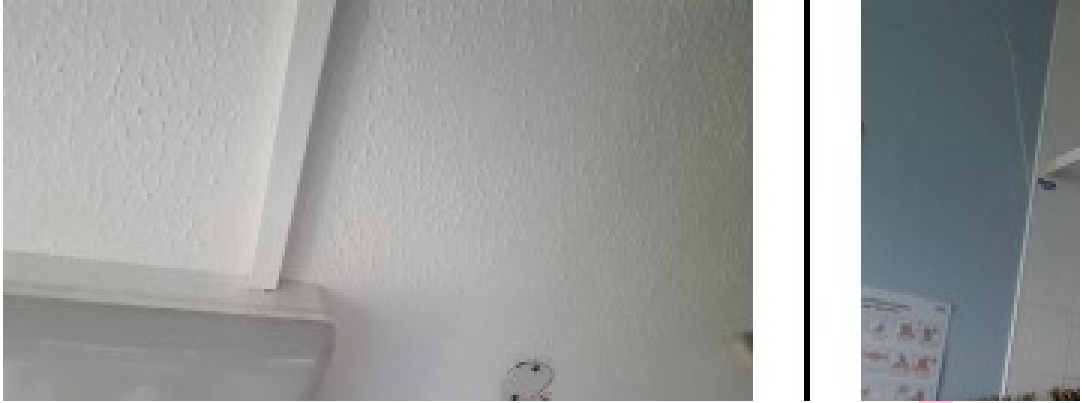
4	As EV006798	Textured coated ceiling	Shower Room G/004	Low Risk – 6 monthly

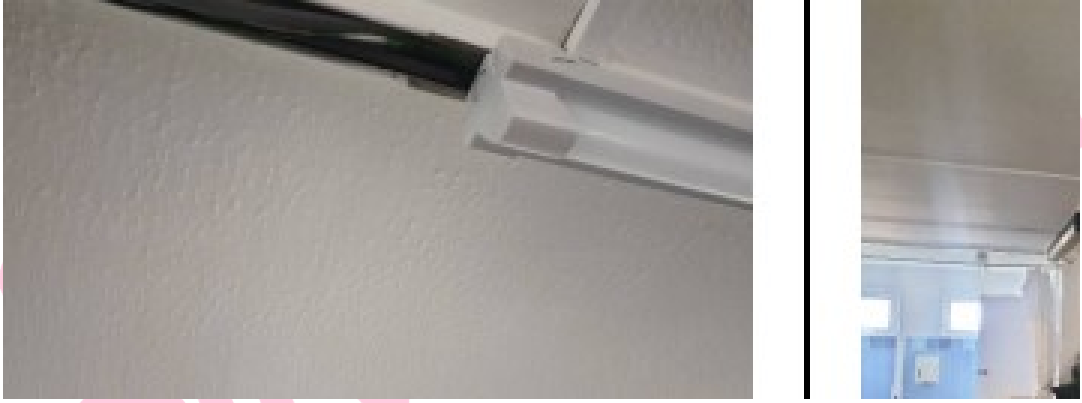
5	EV006799	Textured coated ceiling	Main floor area G/005	Low Risk – 6 monthly

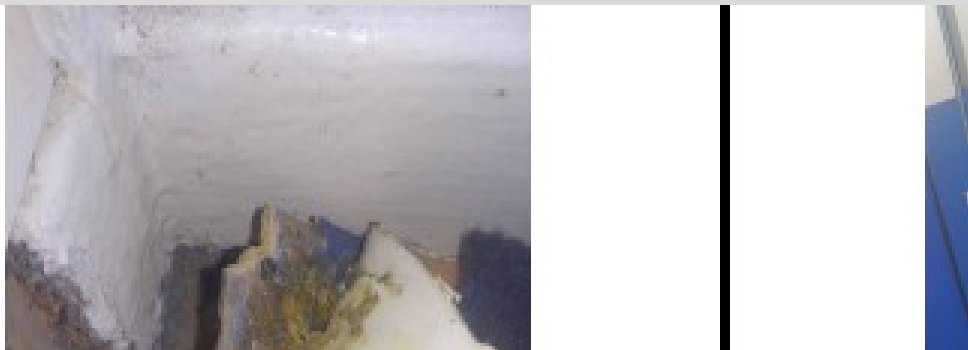
6	EV006800	Vinyl tiles and bitumen floor	Reception Area G/006	No Risk

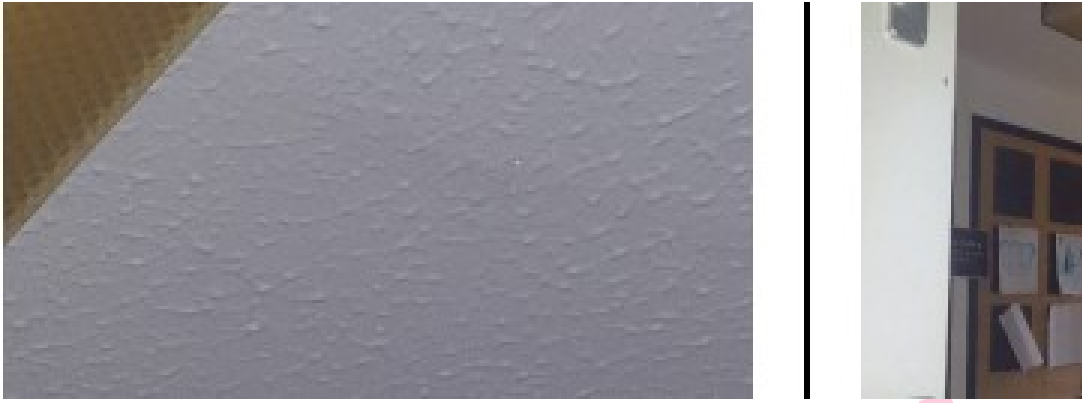
7	EV006802	Textured coated ceiling	Reception Area G/006	Low Risk – 6 monthly

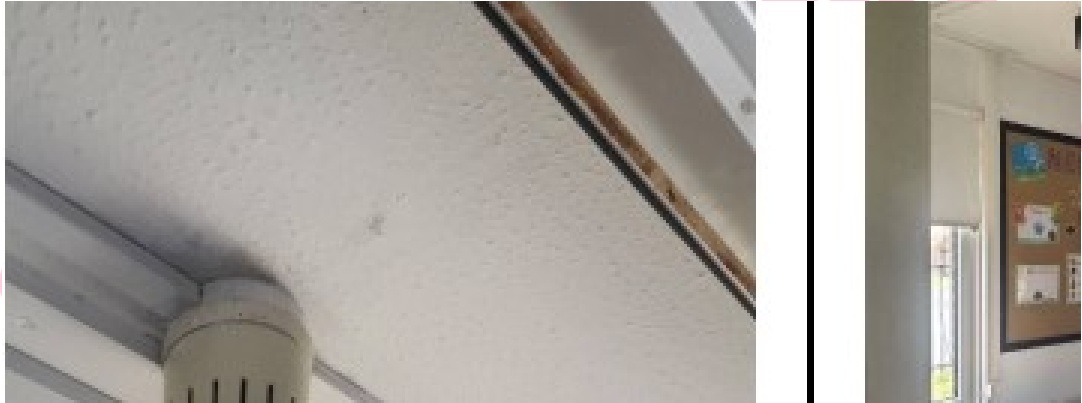
8	As EV006802	Textured coated ceiling	Office G/007	Low Risk – 6 monthly

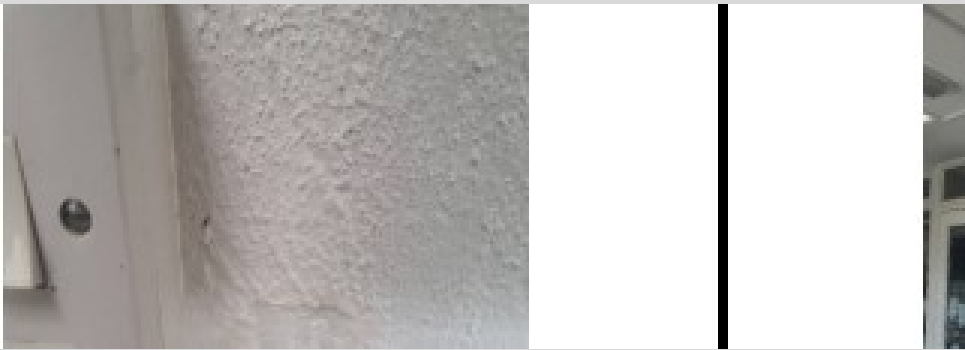
9	EV006803	Textured coated walls	Soft Play Area G/008	No Risk

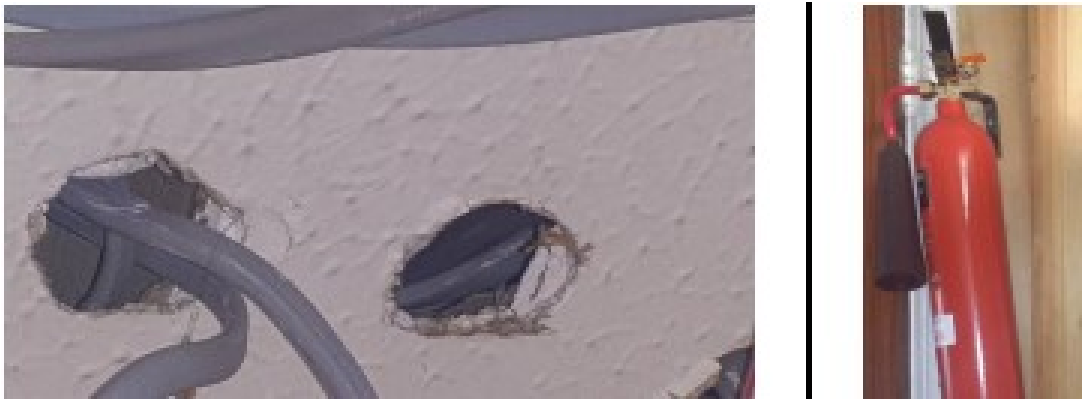
10	EV006804	Textured coated ceiling	Meter cupboard G/009	Low Risk – 6 monthly

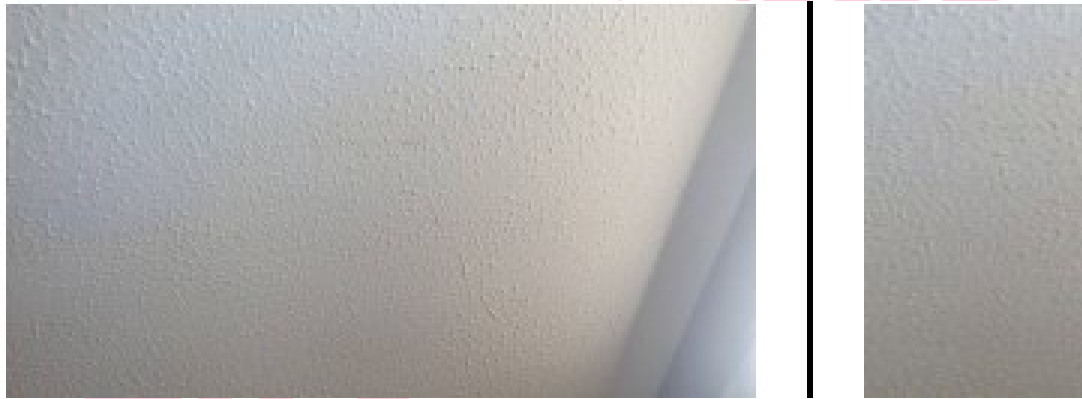
11	As EV006804	Textured coated ceiling	Store Room G/010	Low Risk – 6 monthly

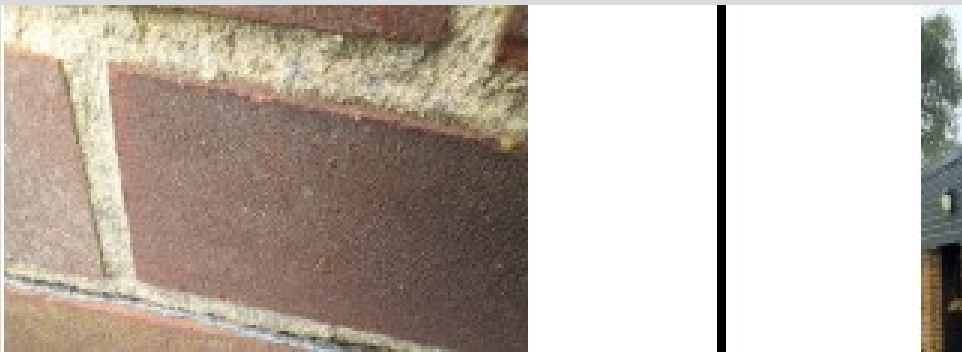
12	EV006805	Damp proof course walls	External E/01	No Risk

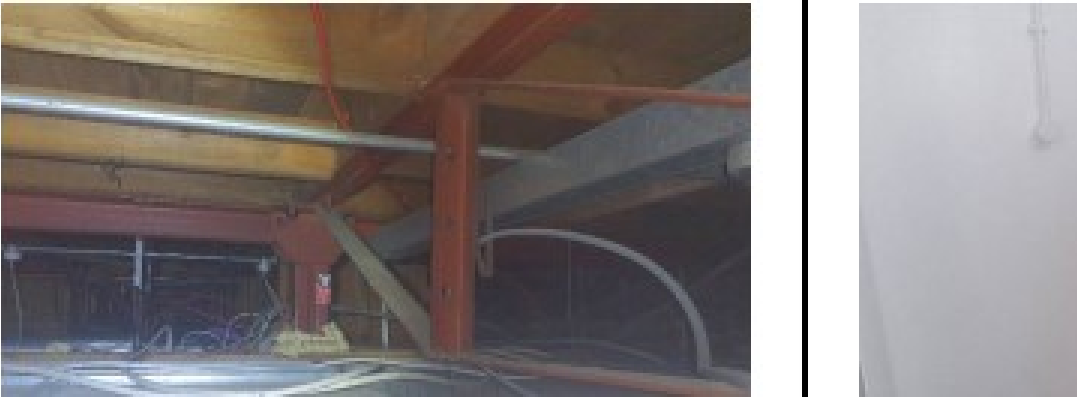
16	Presumed	Insulating board – steel columns	WC G/005	Low Risk – 6 monthly

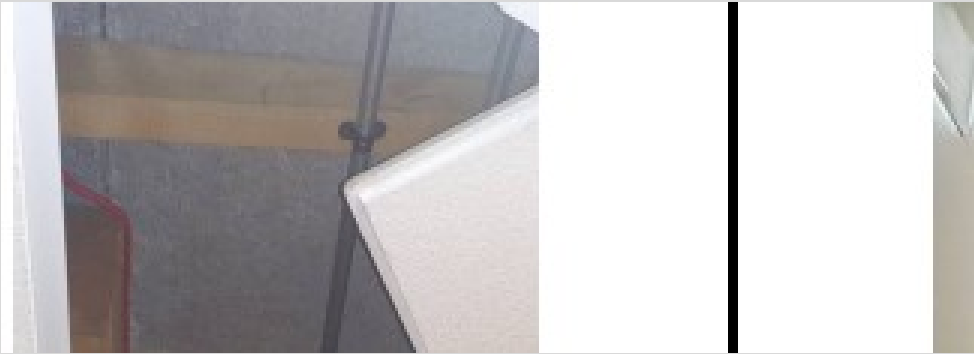
19	EV006820	Insulating board void	Store G/009	No Risk

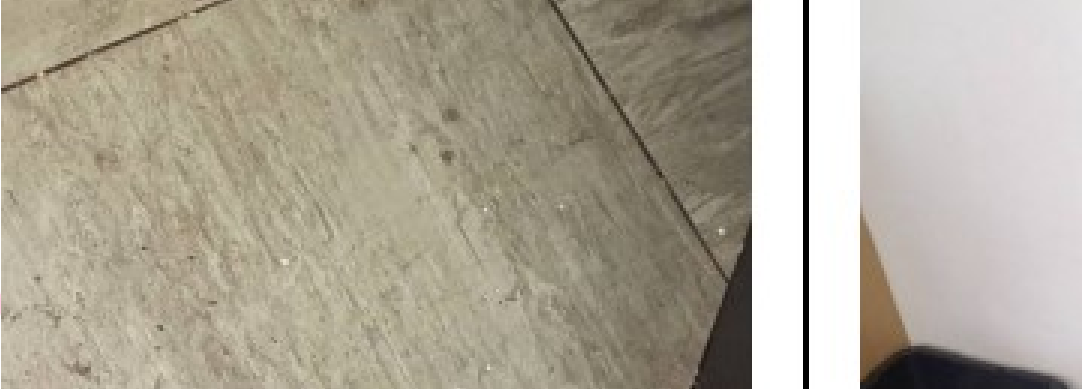
20	As EV006819	Vinyl Floor tiles	Store G/009	Low Risk – 6 monthly

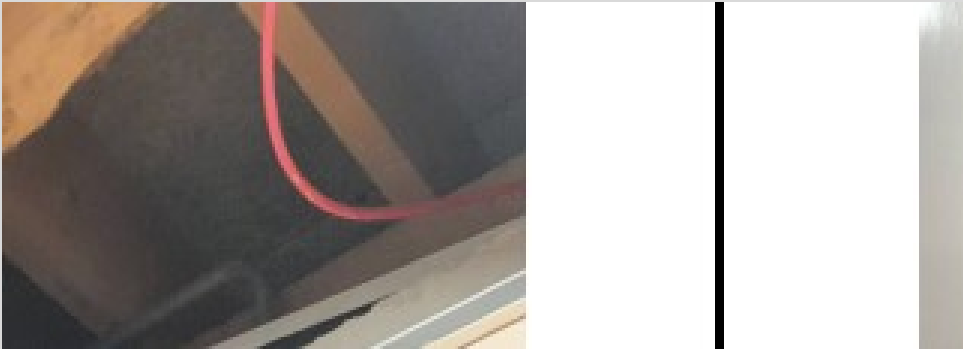
21	As EV006820	As Stramit void	Store G/010	No Risk

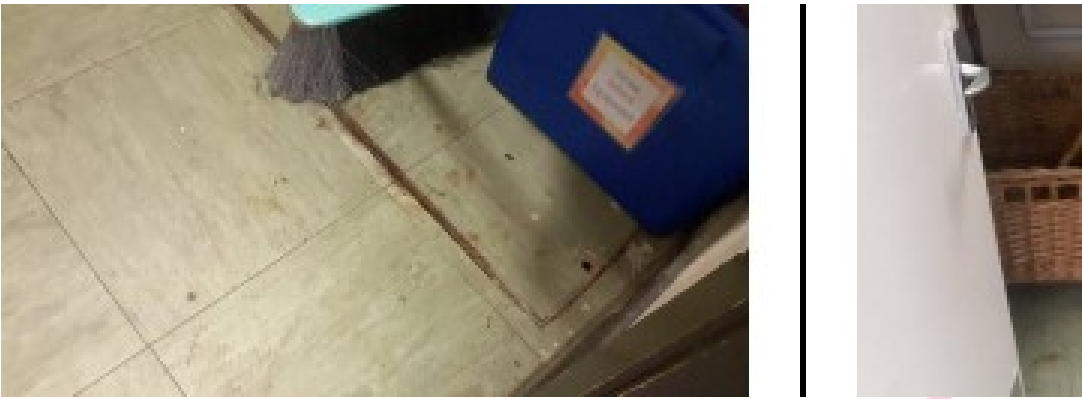
22	As EV006819	Vinyl floor tiles	Store G/010	Low Risk – 6 monthly

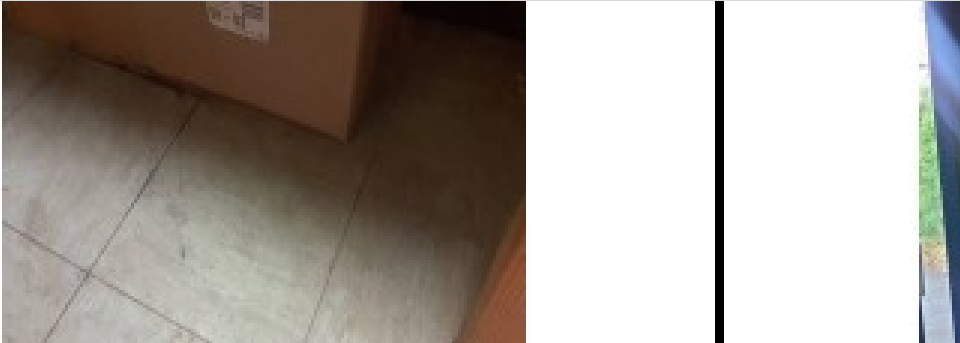
23	EV006815	Vinyl floor tiles	Store G/012	No Risk

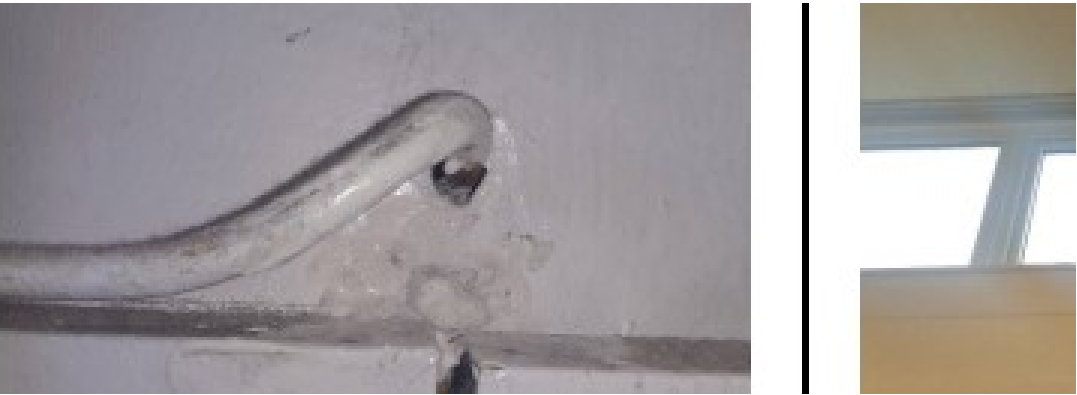
24	EV006816	Insulating board walls	Main Hall G/015	Medium Risk – 3 monthly

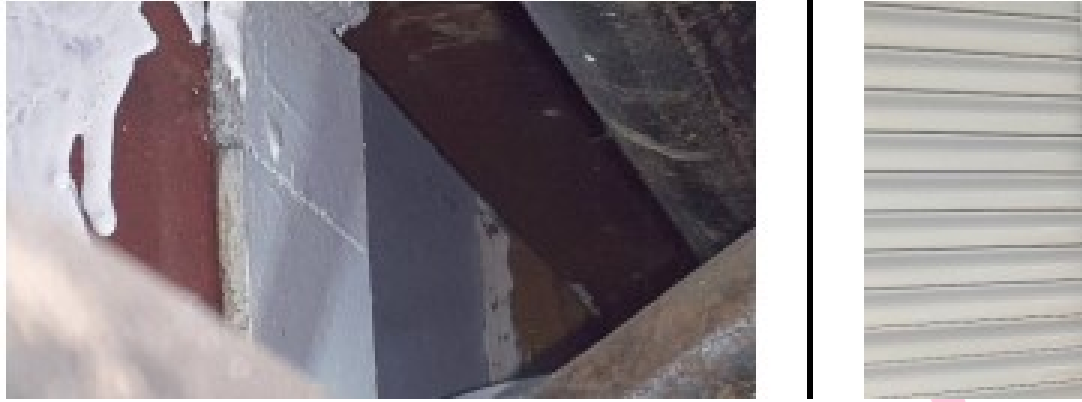
25	EV006818	Insulating board columns in ceiling void	Main Hall G/015	Meduim Risk however would advise analyst checks annually

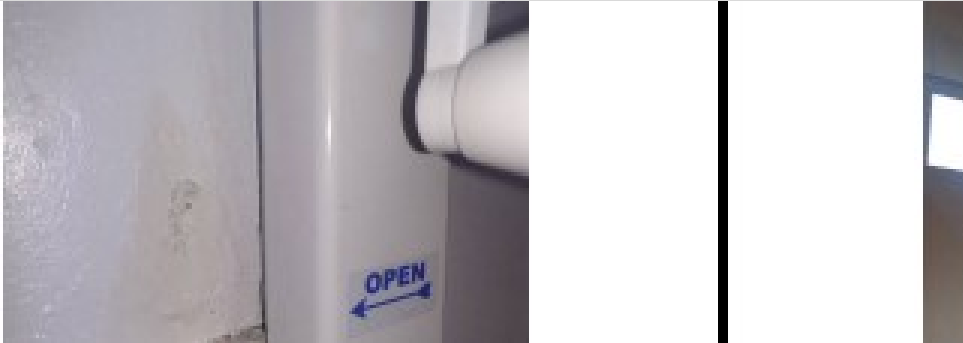
26	EV006817	Pin board walls	Main Hall G/015	No Risk

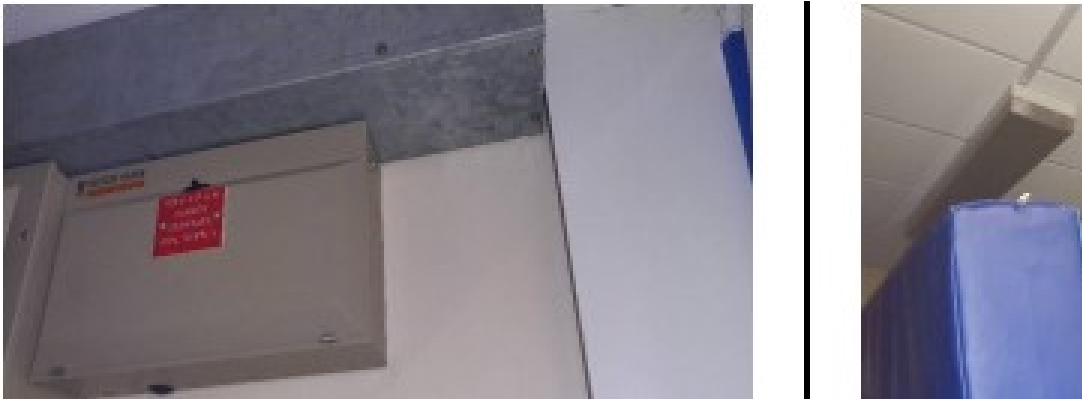
27	Presumed	Textiles – switch gear	Store G/017	Low Risk – 6 monthly

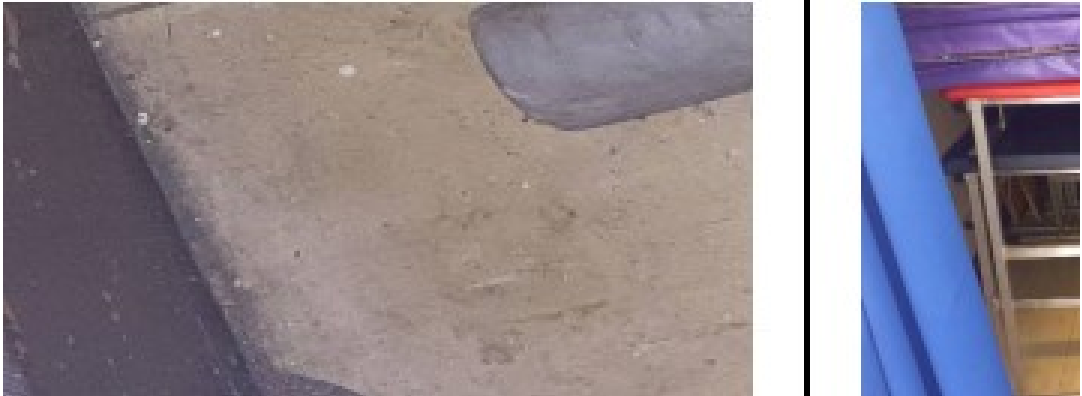
28	EV006819	Vinyl floor tiles	Store G/017	Low Risk – 6 monthly

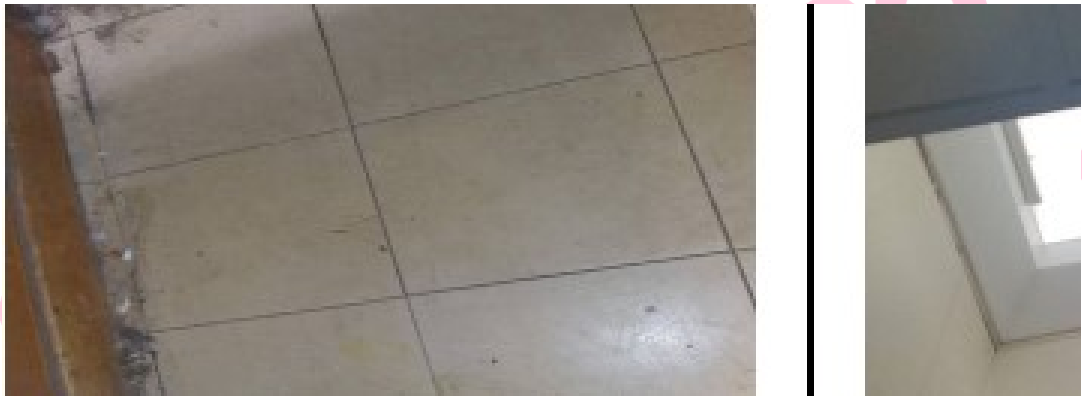
29	As EV006819	Vinyl floor tiles	Store G/018	Low Risk – 6 monthly

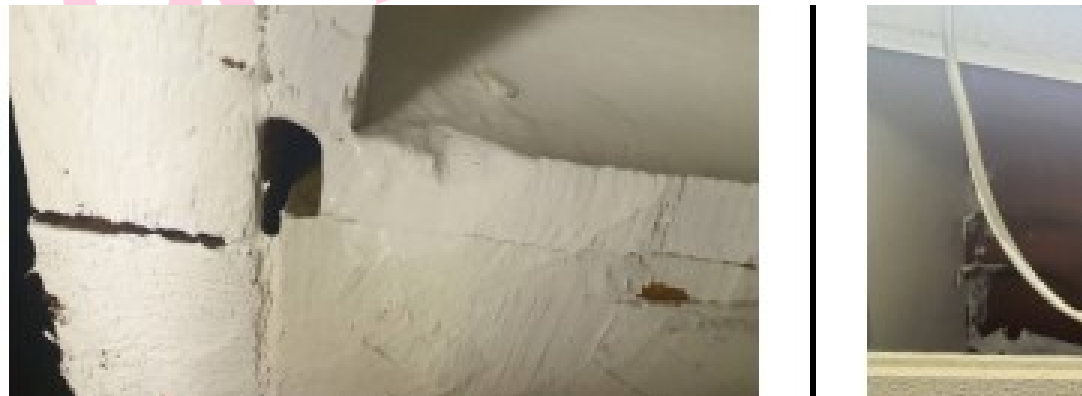
30	EV006821	Insulating board void	Store G/020	Low Risk – 6 monthly

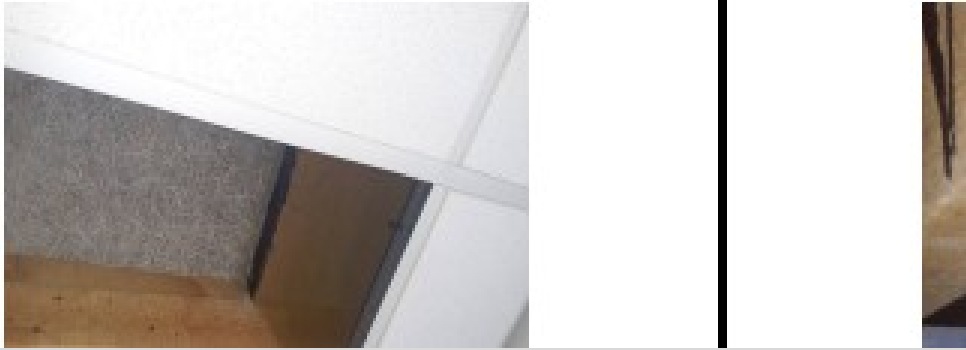
31	EV006822	Stramit – ceiling	Classroom 6 G/032	No Risk

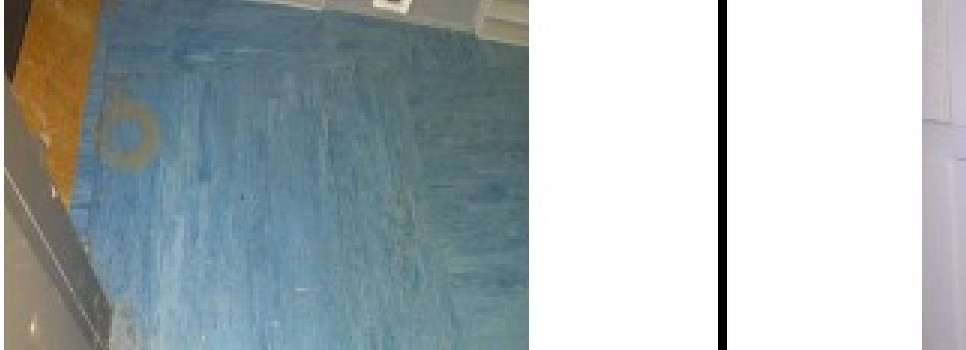
32	EV006823	Vinyl tiles floor	Store G/033	No Risk

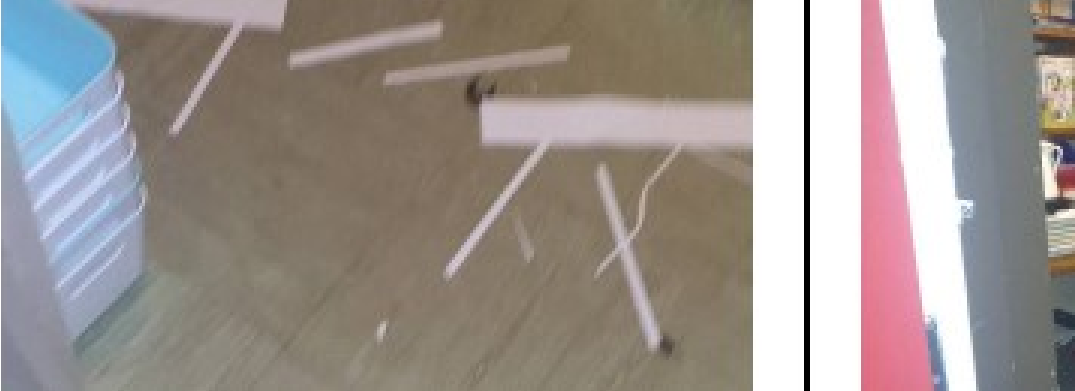
33	As EV006819	Vinyl floor tiles	Store G/034	Low Risk – 6 monthly

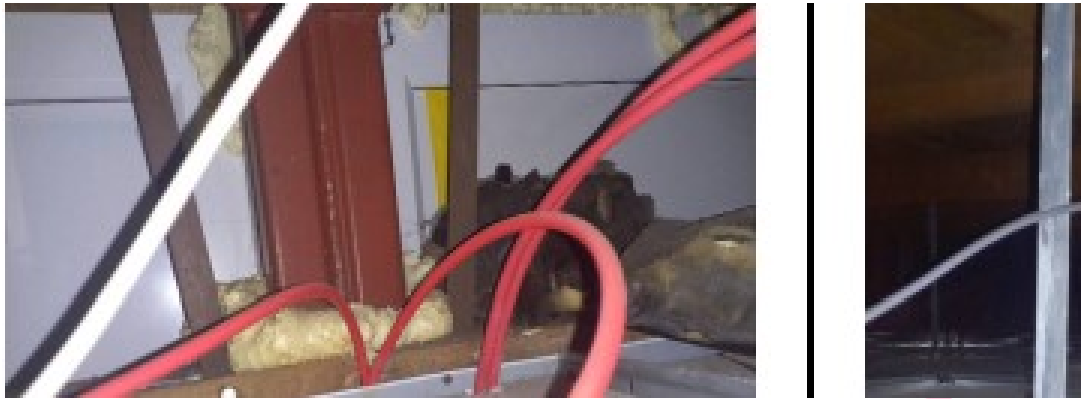
34	Presumed	Insulating board – steel columns	Intervention room G/035	Low Risk – 6 monthly

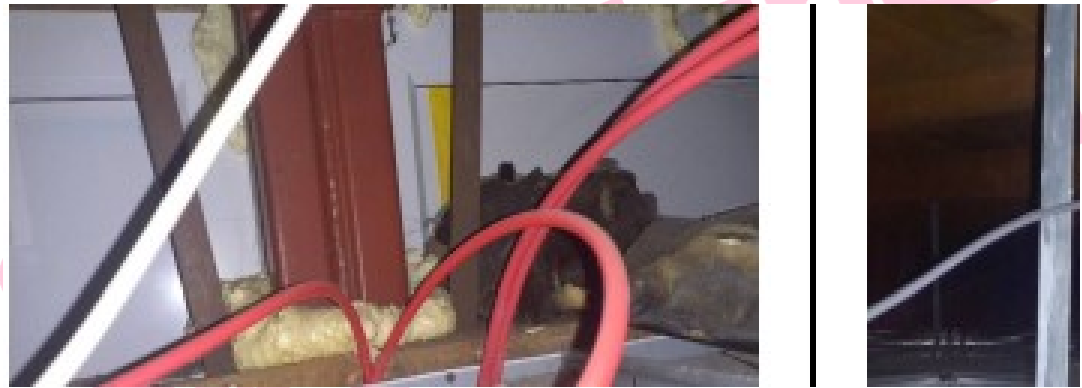
35	Presumed	Insulating board – steel columns	Class 4 G/036	Low Risk – 6 monthly

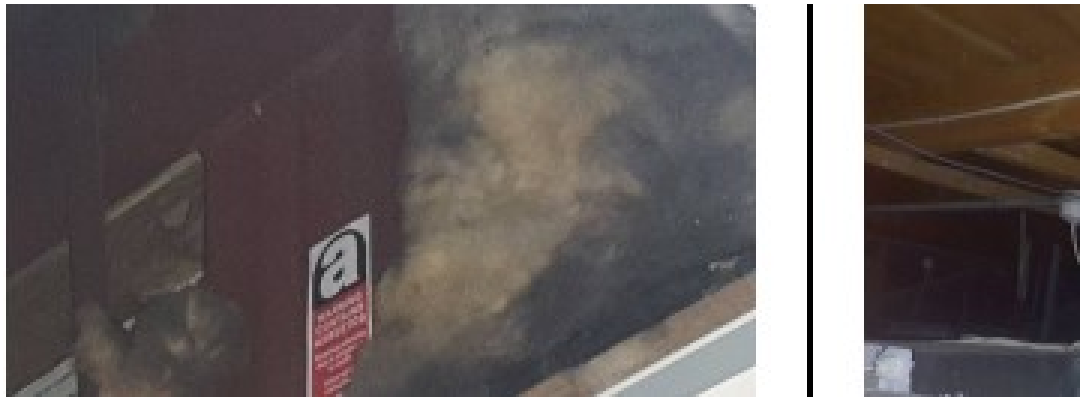
36	Presumed	Insulating board – steel columns	Class 3 G/037	Low Risk – 6 monthly

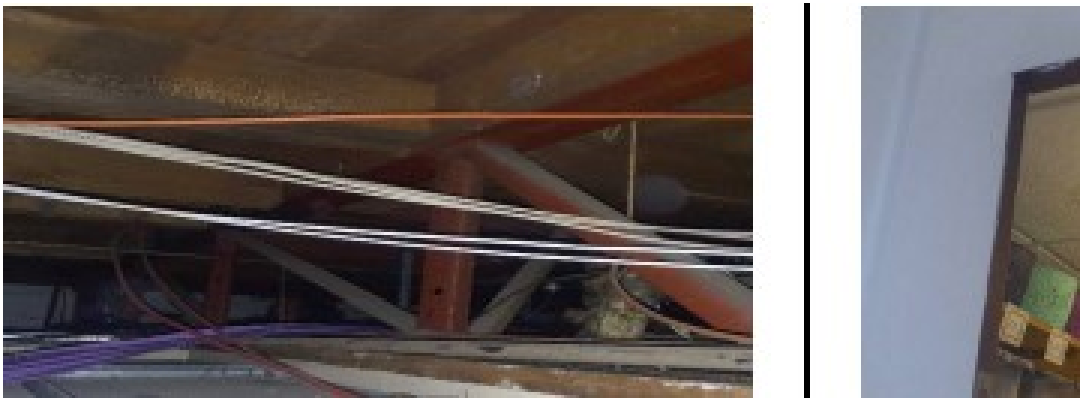
37	Presumed	Insulating board – steel columns	Store G/040	Low Risk – 6 monthly

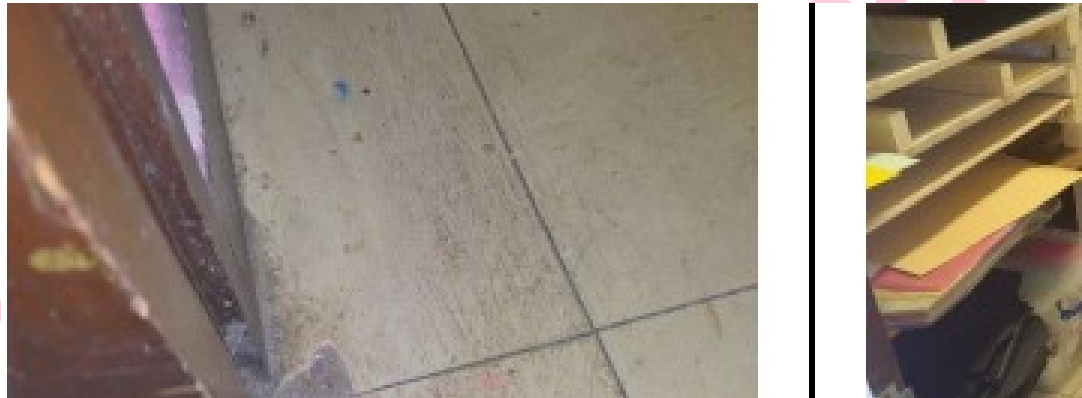
38	EV006824	Vinyl floor tiles	Store G/040	Low Risk – 6 monthly

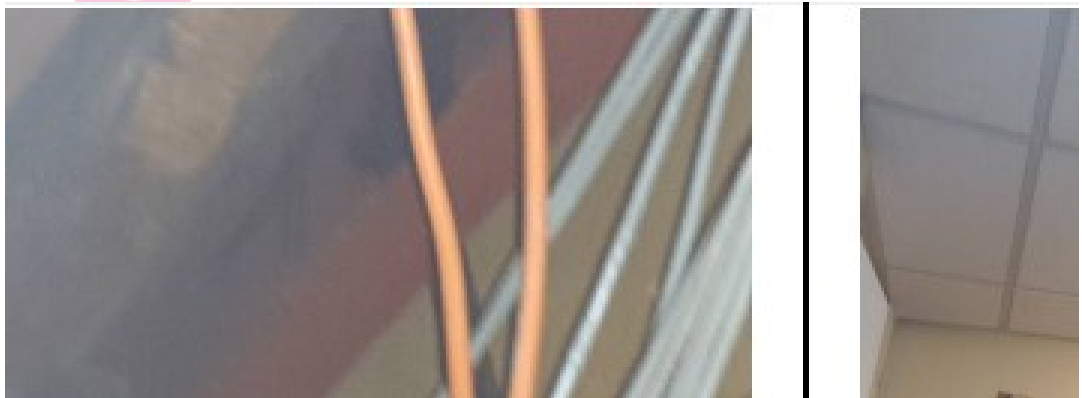
39	Presumed	Insulating board – steel columns	Store G/041	Low Risk – 6 monthly

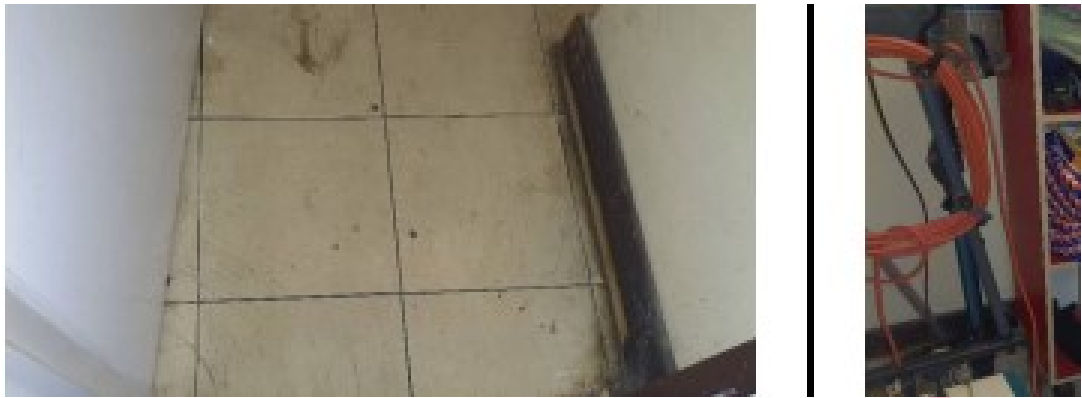
40	As EV006824	Vinyl floor tiles	Store G/041	Low Risk – 6 monthly

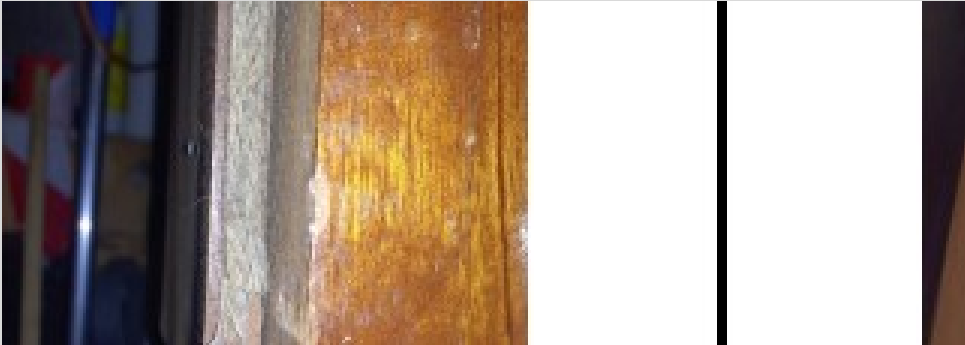
41	EV006825	Rope Doorframe	Cupboard G/042	No Risk

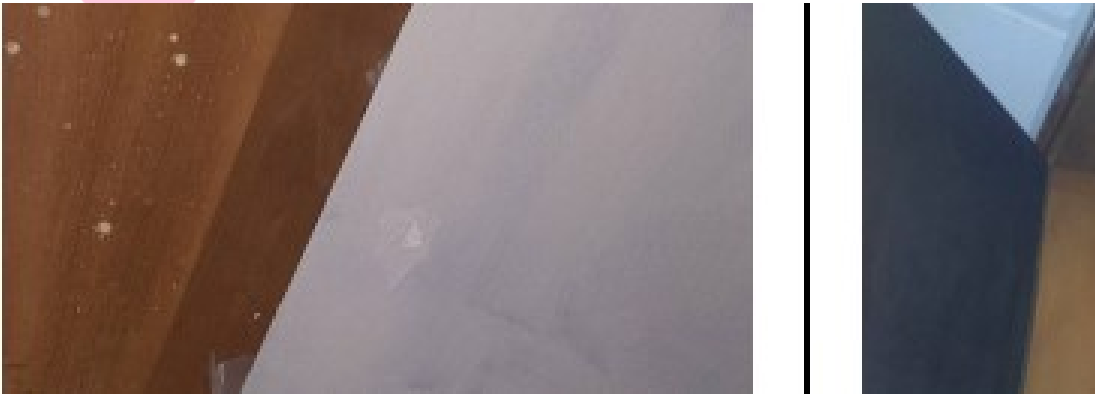
42	EV006826	Insulating board ceiling	Cupboard G/042	Low Risk – 6 monthly

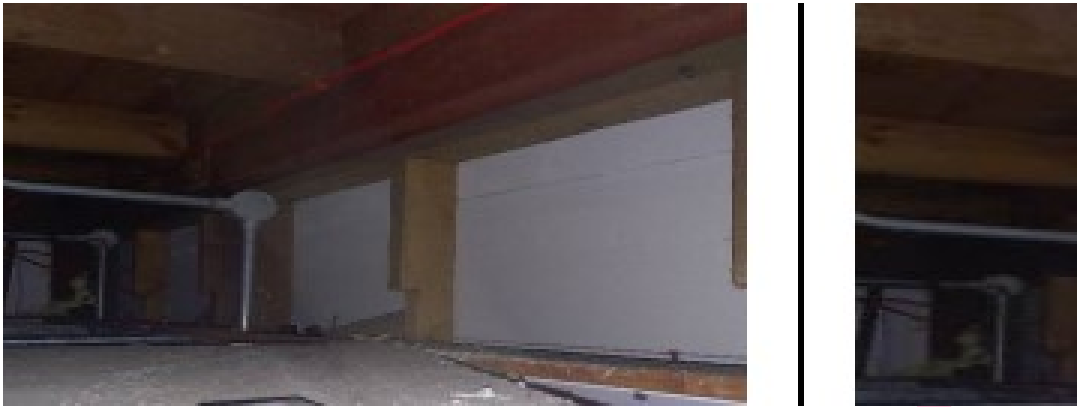
43	Presumed	Insulating board – steel columns	IT G/043	Low Risk – 6 monthly

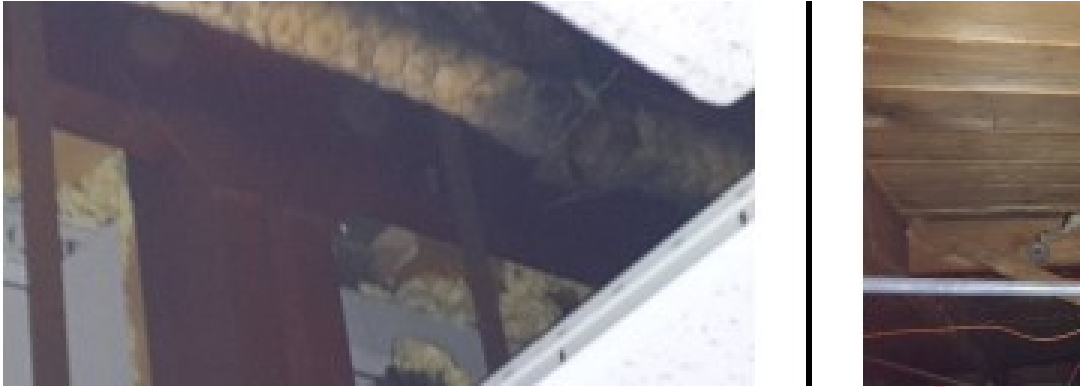
46	Presumed	Insulating board – steel columns	Main kitchen G/047	Low Risk – 6 monthly

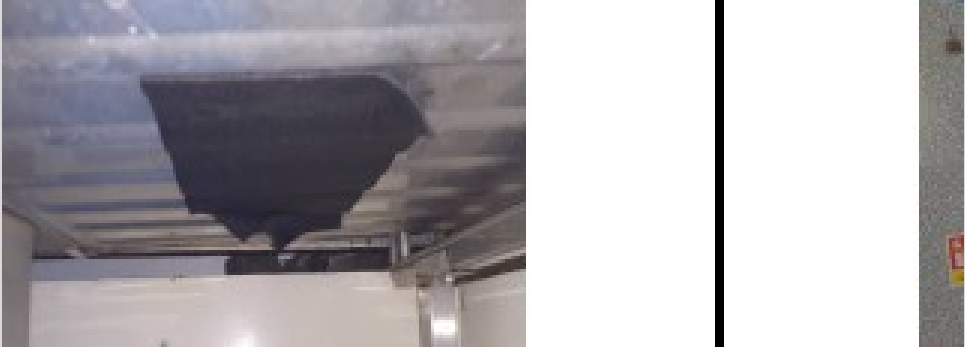
47	EV006828	Bitumen sink pad	Main kitchen G/047	No Risk

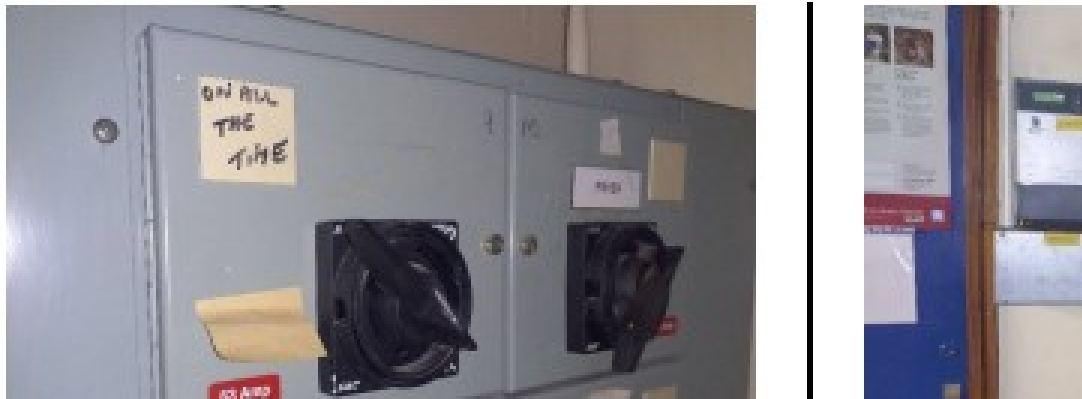
49	Presumed	Textiles Electrical Equipment	Main kitchen G/047	Low Risk – 6 monthly

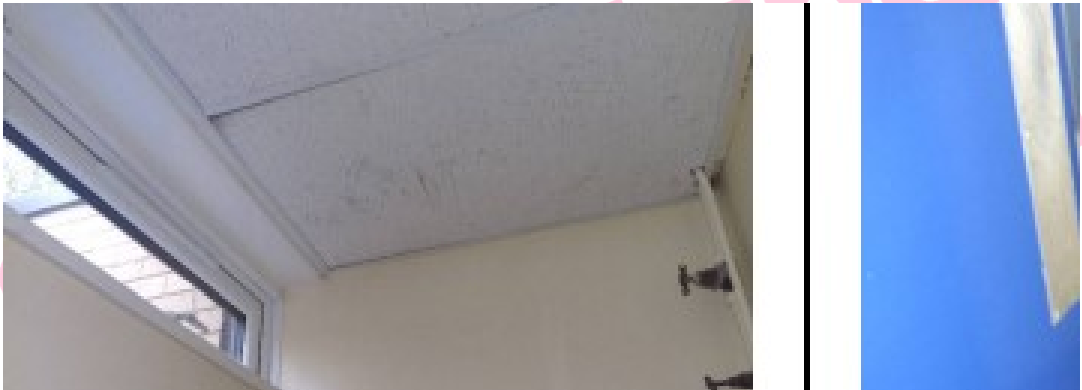
50	Presumed	Insulating board – steel columns	Washroom G/048	Low Risk – 6 monthly

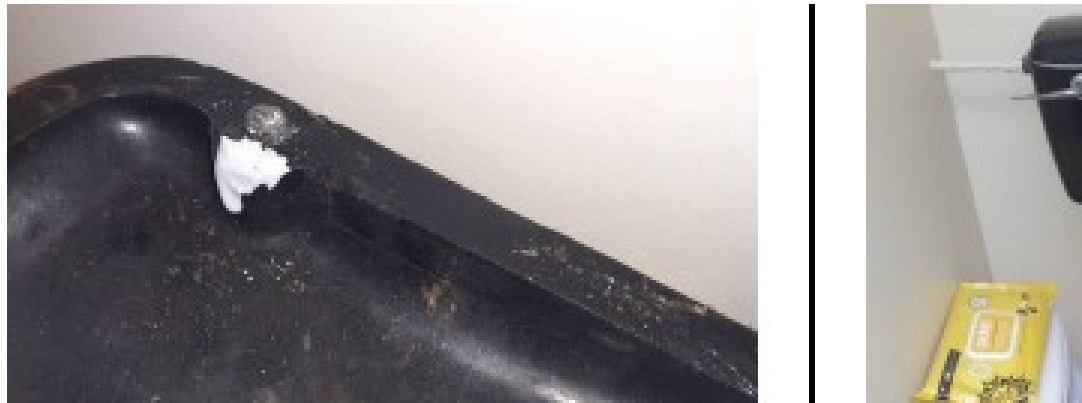
51	EV006831	Bakerlight material Cistern and toilet seat	WC G/049	Low Risk – 6 monthly
