ASBESTOS SURVEY REPORT FOR REDBY PRIMARY SCHOOL, SUNDERLAND

Asbestos Register for REDBY ACADEMY

Date: 01/05/2026

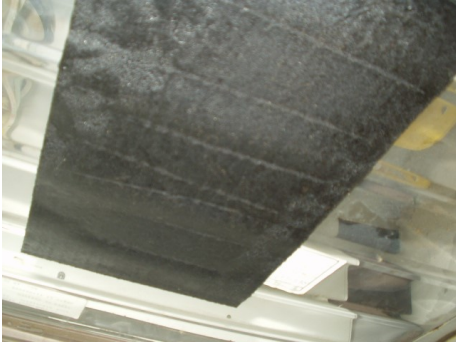
Item 1 Ref: AW0861/08

The sink pad to the Reception Classroom (Rm 0/05) does not contain asbestos.

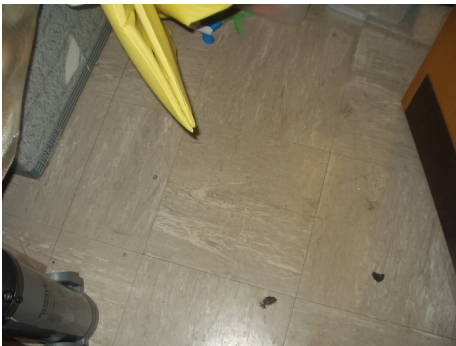
Item 2 - Ref: AW0841/08

The grey floor tiles to the store cupboard (Rm 0/06) do not contain asbestos.

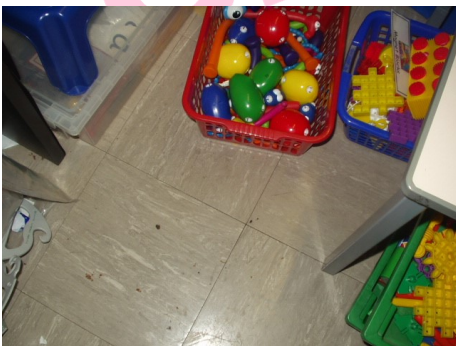
Various - Ref:AW0842/08

The grey floor tile to the store cupboard (Rm 0/07) does not contain asbestos.

Similar flooring is located in rooms 0/08, 0/09, 0/11, 0/12, 0/17, 0/93, 0/102, 0/105 and 0/108.

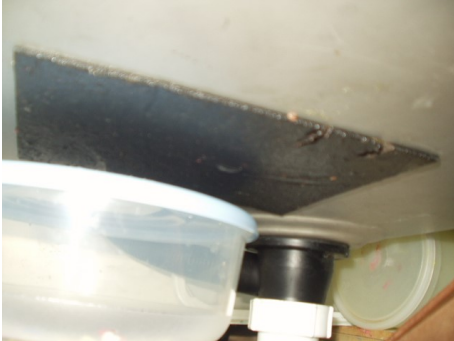
Item 8 - Ref: AW0843/08

The sink pad to the classroom (Rm 0/14) does not contain asbestos.

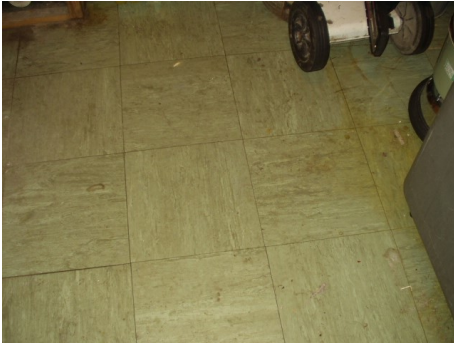
Various - Ref:AW0844/08

The green floor tiles to the cleaners cupboard (Rm 0/22) do not contain asbestos.

Similar floor tiles are located in rooms 0/39, 0/52, 0/55, 0/56, 0/65, 0/70 and 0/71.

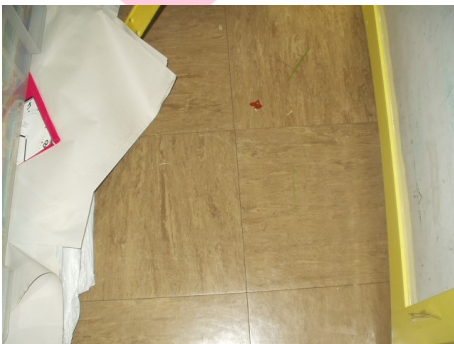
Item 11 - Ref:AW0845/08

The brown floor tiles to the store cupboard (Rm 0/24) do not contain asbestos.

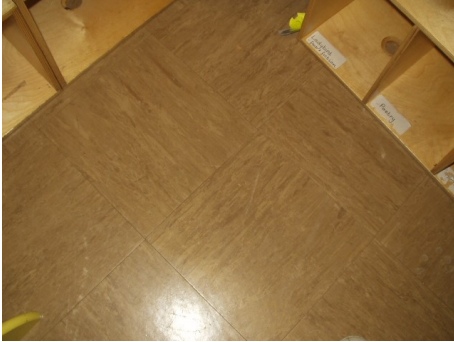
Various- Ref: AW0846/08

The brown floor tiles to the store cupboard (Rm 0/27) do not contain asbestos.

Similar floor tiles are located in rooms 0/30, 0/33, 0/37, 0/44, 0/46, 0/48, 0/88, 0/89 and 0/101.

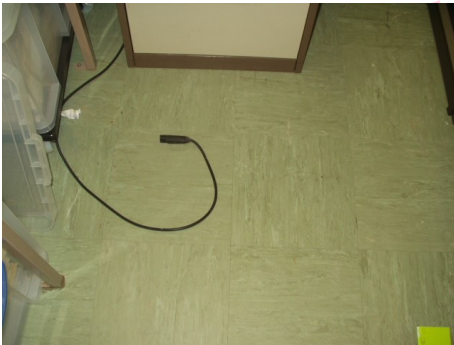
Various- Ref: AW0847/08

The green floor tiles to the store cupboard (Rm 0/31) do not contain asbestos.

Similar flooring is located in rooms 0/64 and 0/74.

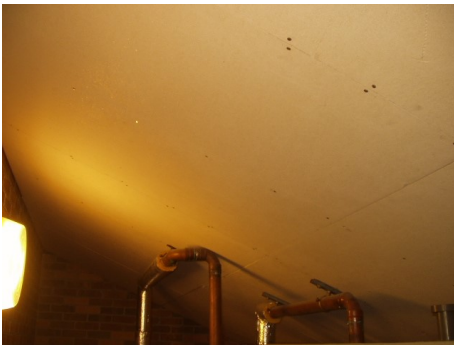
Item 29 - Ref: AW0848/08

The ceiling to the boiler room (Rm 0/84) does not contain asbestos.

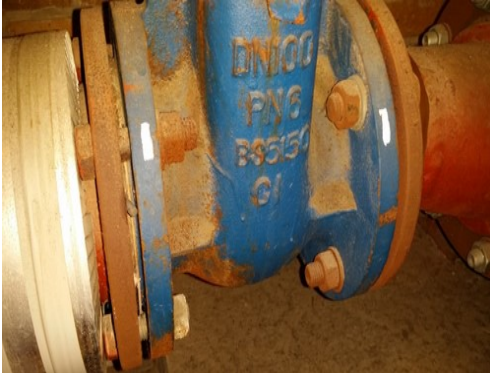
Item 30 – Ref: 102024-1

The 2 gaskets to the pipework in the boiler room (Rm 0/84 – location 1) contain asbestos.

Removed July 2022

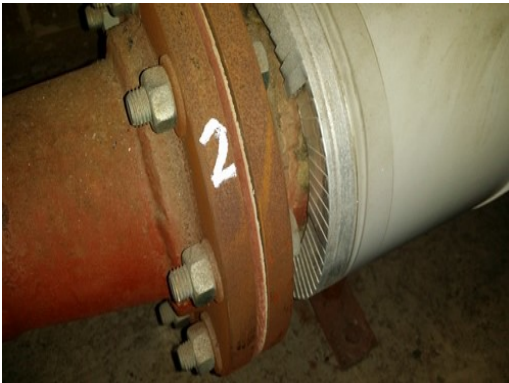
Item 31 – Ref: 102024-2

The gasket to the pipework in the boiler room (Rm 0/84 – location 2) contains asbestos.

Removed July 2022

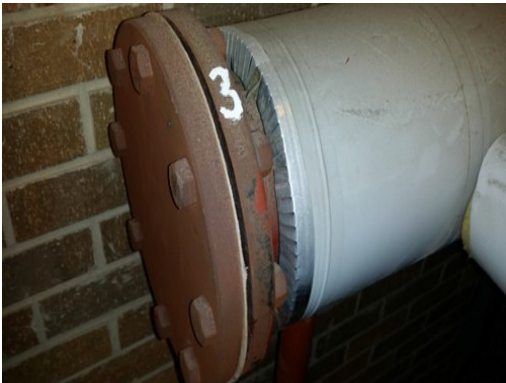
Item 32 – Ref: 102024-3

The gasket to the pipework in the boiler room (Rm 0/84 – location 3) contains asbestos.

Removed July 2022

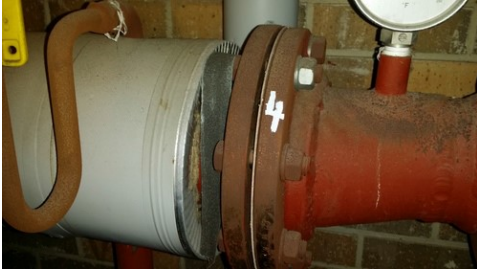
Item 33 – Ref: 102024-4

The gasket to the pipework in the boiler room (Rm 0/84 – location 4) contains asbestos.

Removed July 2022

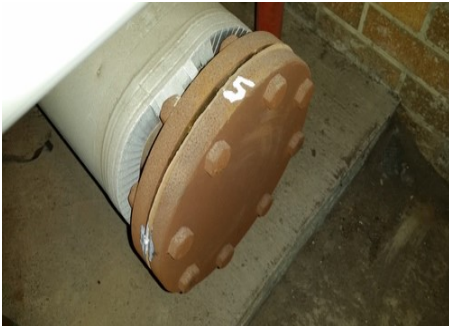
Item 34 – Ref: 102024-5

The gasket to the pipework in the boiler room (Rm 0/84 – location 5) contains asbestos.

Removed July 2022

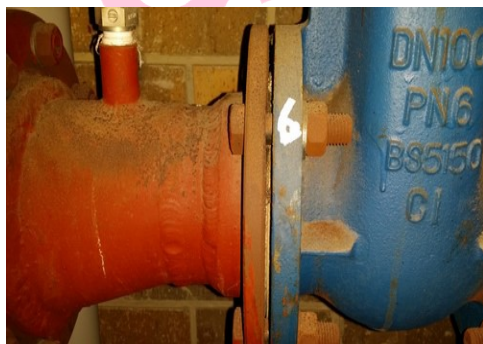
Item 35 – Ref: 102024-6

The gasket to the pipework in the boiler room (Rm 0/84 – location 6) contains asbestos.

Removed July 2022

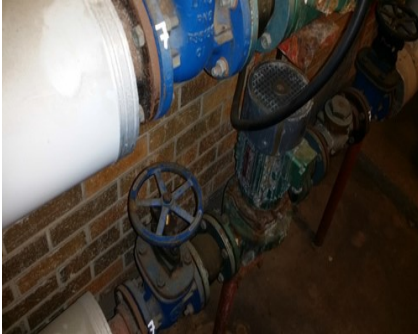
Item 36 – Ref: 102024-7

The gaskets (x4) to the pipework in the boiler room (Rm 0/84 – location 7) contain asbestos.

Removed July 2022

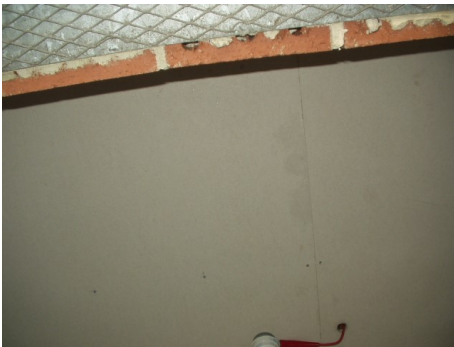
Item 37 - Ref: AW0850/08

The ceiling to the gas intake room (Rm 0/85) does not contain asbestos.

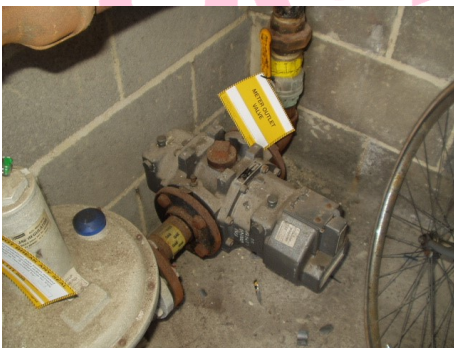
Item 38 - Ref: 102024-8

The flange gaskets to the pipework in the gas intake room (Rm 0/85) do not contain asbestos.

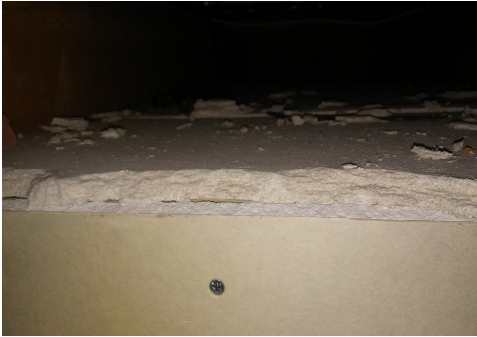
Item 47 Ref: 278204-1

The topside of the fixed ceiling in the void above the kitchen office (Room 081) does not contain asbestos.

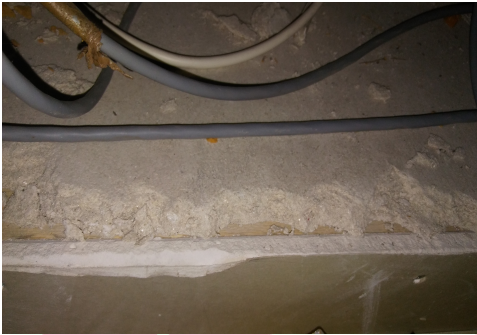
Item 48 Ref: As 278204-1

The topside of the fixed ceiling in the void above the kitchen cloakroom (Room 082) does not contain asbestos.

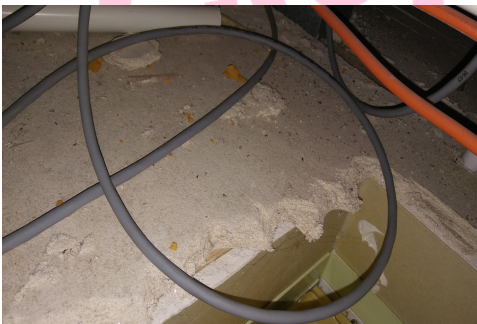
Item 49 Ref: As 278204-1

The topside of the fixed ceiling in the void above the kitchen wc (Room 083) does not contain asbestos.

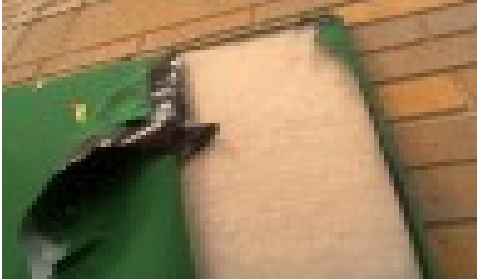
Item 50 Ref: AP004221

The Notice board in Room 1/Hall does not contain asbestos.

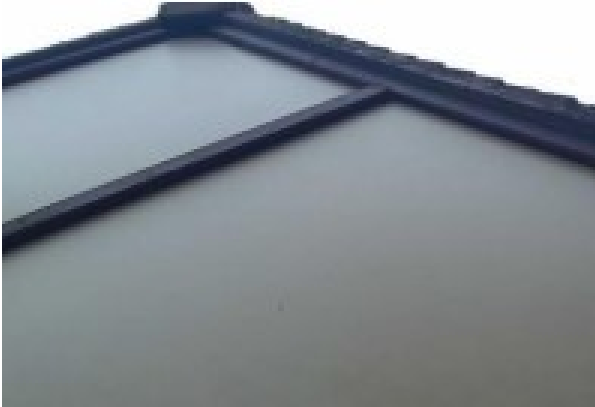
Item 53 Ref: 24-76365-1

The roof - undercloak to entrance roof apexes (x5) (Cement) (Rm 004 External) contains asbestos.

Item 53	Roof - Undercloak to Entrance roof apexes (x5) (Cement) (Rm 004 External)	Very Low	12 Monthly	29/05/2027
Item 54	No asbestos	Is present		
Item 55	No asbestos	Is present

Any change in its appearance should be recorded and passed to Property Services.

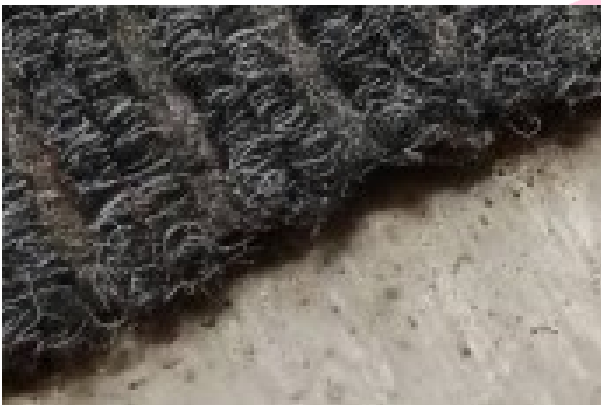
Item 54 Ref: AT000102

The floor covering and adhesive in the Nursery Cloakroom does not contain asbestos.

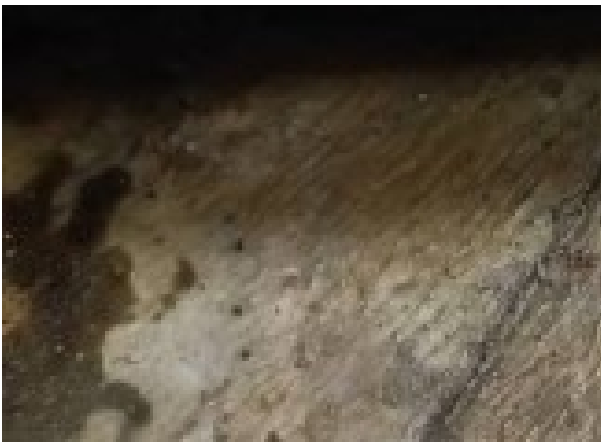
Item 55 Ref: AT000103

The floor screed in the main reception does not contain asbestos.

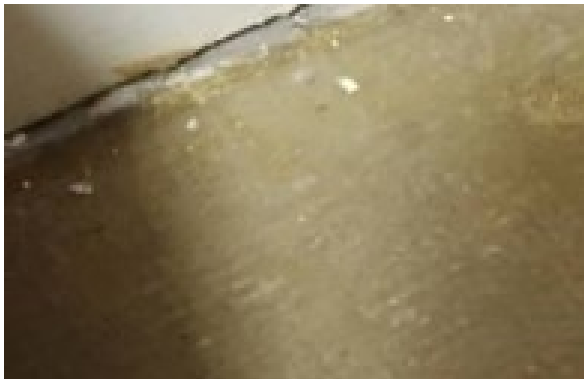
Item 57 Ref: AT000105

The floor screed in the main office does not contain asbestos.

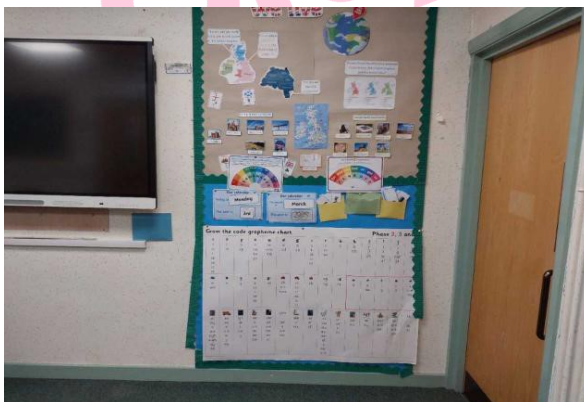
Item 58 Ref: 25-84779-4

The textured coating to walls (Rainbow Room Rm 001) do not contain asbestos.

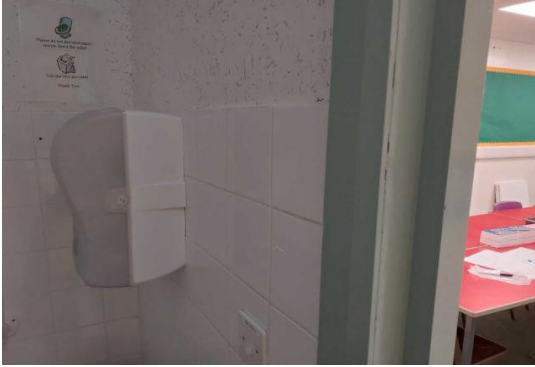
Item 59 Ref: 25-84779-1

The walls ceramic tiles to walls (adhesive) (Disabled toilet Rm 002) do not contain asbestos.

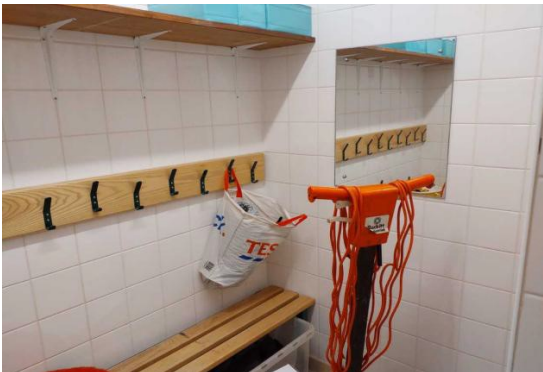
Item 60 Ref: 25-84779-2

The walls ceramic tiles to walls (adhesive) (Shower Rm 004) do not contain asbestos.

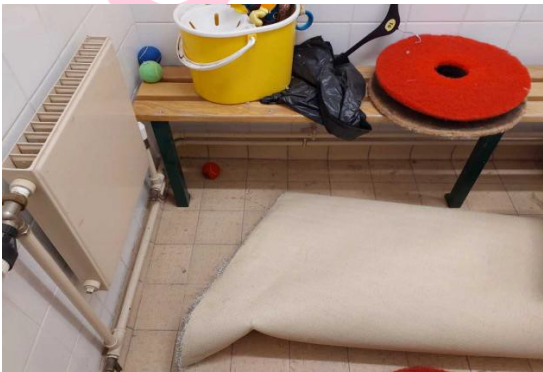
Item 61 Ref: 25-84779-3

The ceramic tiles to floor (adhesive) (Shower Rm 004) do not contain asbestos.
