### ASBESTOS SURVEY REPORT FOR RICHARD AVENUE PRIMARY SCHOOL, SUNDERLAND

**RICHARD AVENUE PRIMARY SCHOOL**

**Date: 28 May 2026**

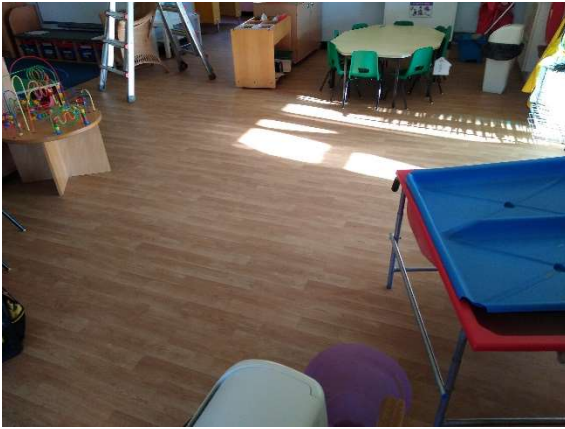
### **Item 1 - Ref: 369924-5**

The screed under modern screed (001/nursery) does not contain asbestos.

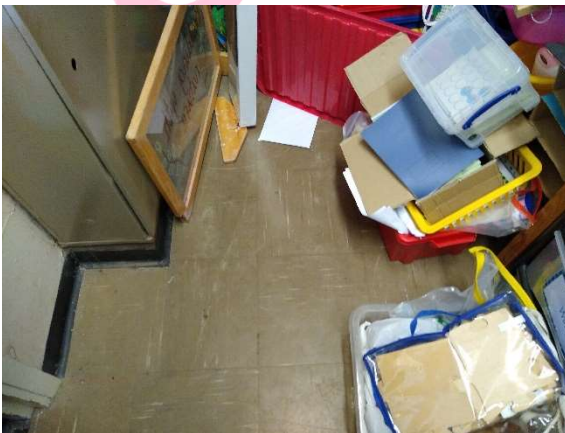
### **Item 3 - Ref: 369924-4**

The floor tile with bitumen adhesive (001A/electric cupboard) contains asbestos.

Any change in its appearance should be recorded and passed to Property Services.

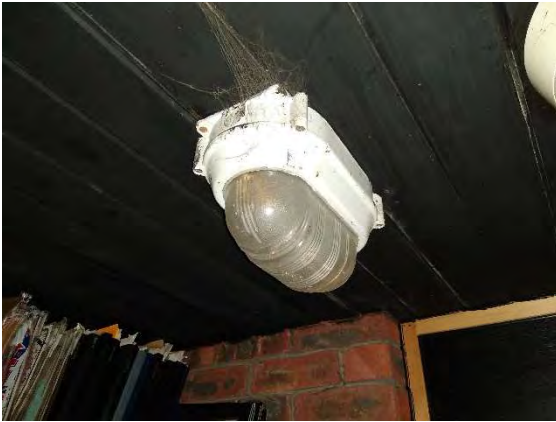
### **Item 4 - Ref: 369924-2**

The sealant to light (001C/store) does not contain asbestos.

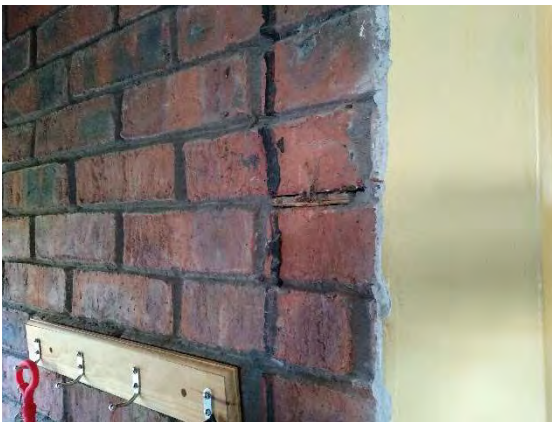
### **Item 5 - Ref: 369924-3**

The remnant sealant to brickwork from former door frame (001C/store) contains asbestos.

Any change in its appearance should be recorded and passed to Property Services.

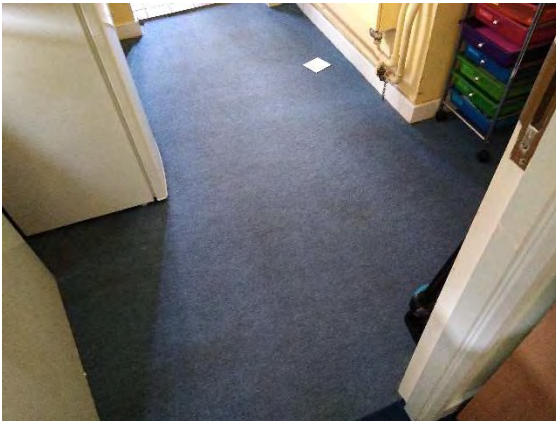
### **Item 6 - Ref: As 369924-5**

The screed under modern screed (001C/store) does not contain asbestos.

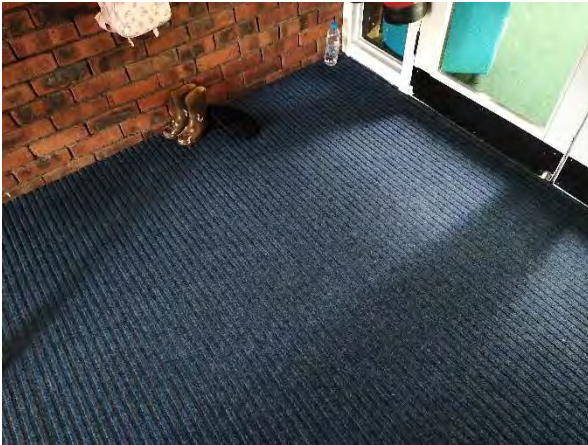
### **Item 7 - Ref: As 369924-5**

The screed under modern covering (002/lobby) does not contain asbestos.

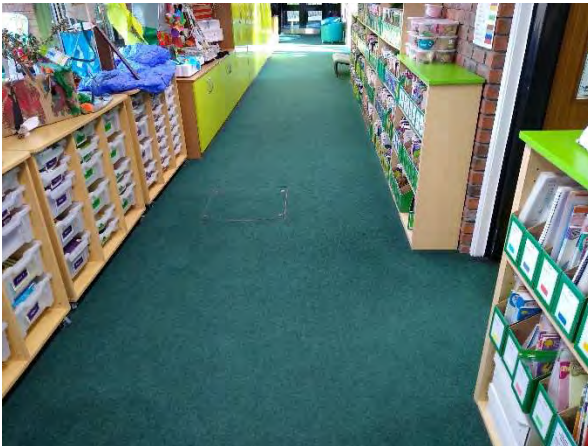
### **Item 8 - Ref: As 369924-5**

The screed under modern covering (003/corridor) does not contain asbestos.

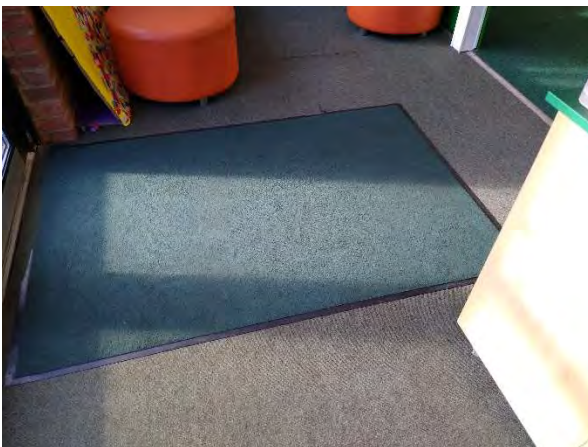
### **Item 9 - Ref: As 369924-5**

The screed under modern covering (004/conservatory) does not contain asbestos.

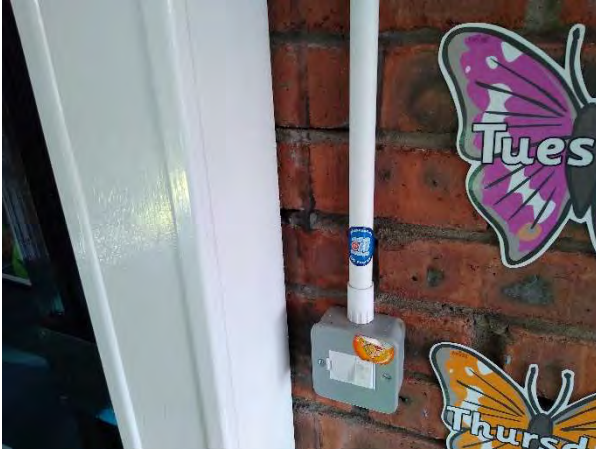
### **Item 10 - Ref: As 369924-3**

The remnant sealant from removed frame (004/conservatory) contains asbestos.

Any change in its appearance should be recorded and passed to Property Services.

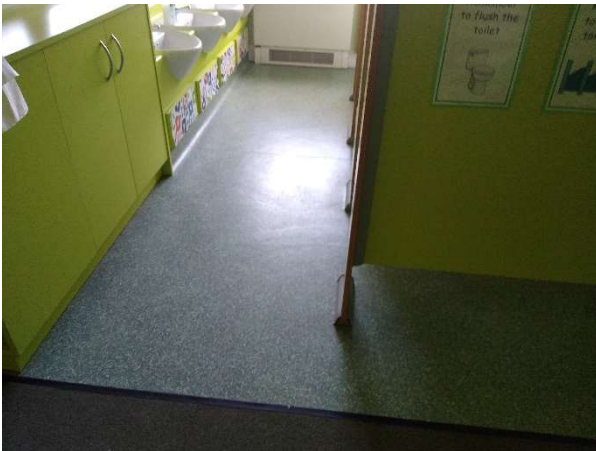
### **Item 11 - Ref: As 369924-5**

The screed under modern screed (005/WC) does not contain asbestos.

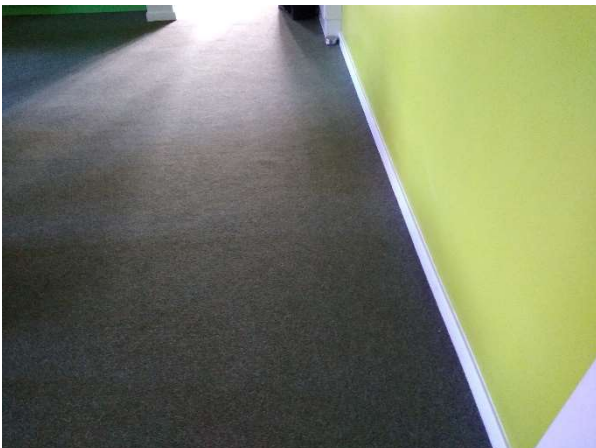
### **Item 12 - Ref: As 369924-5**

The screed under modern screed (006/corridor) does not contain asbestos.

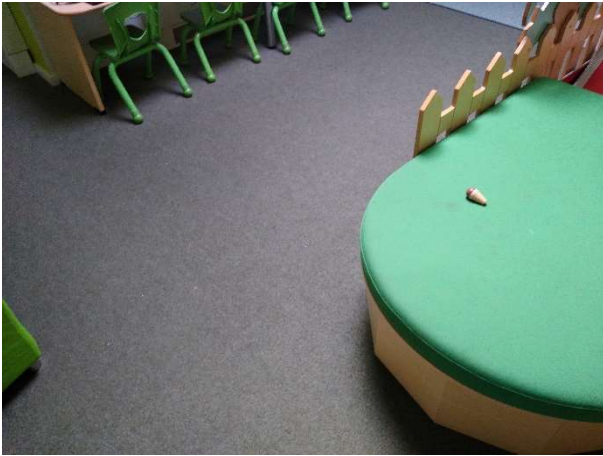
### **Item 13 - Ref: As 369924-5**

The screed under modern screed (006A/library area) does not contain asbestos.

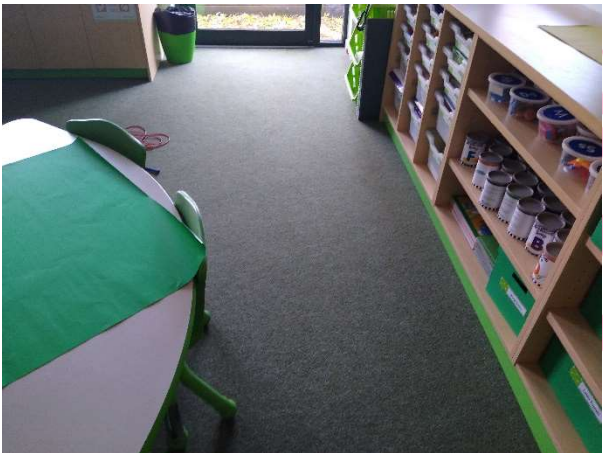
### **Item 14 - Ref: As 369924-5**

The screed under modern screed (007/classroom) does not contain asbestos.

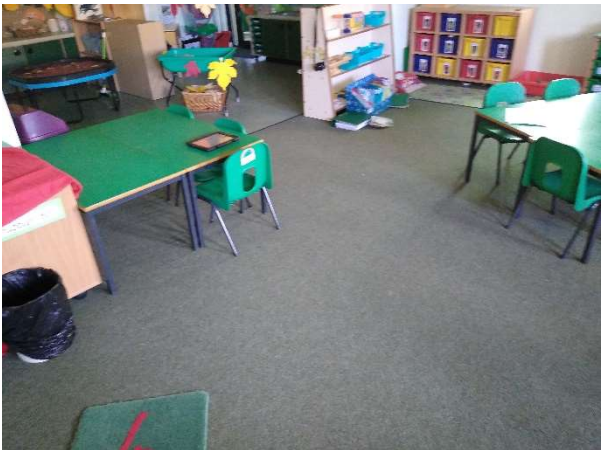
### **Item 15 - Ref: As 369924-5**

The screed under modern screed (008/classroom) does not contain asbestos.

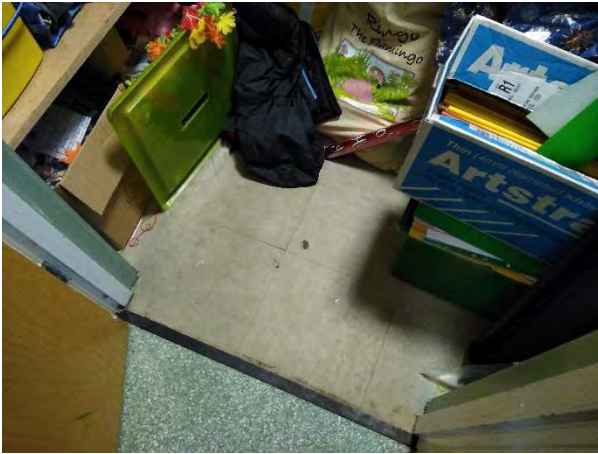
**Item 16 - Ref: As 369924-5**

The screed (009/store) does not contain asbestos.

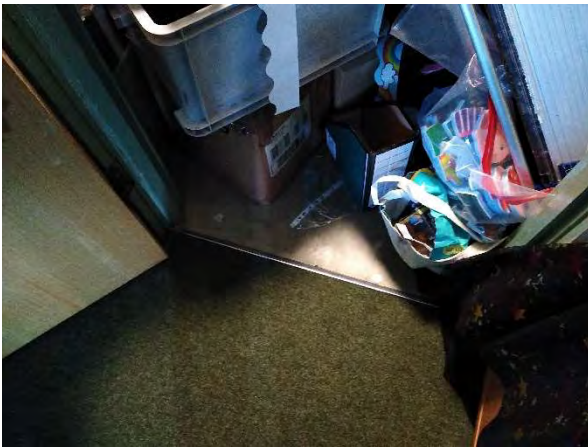
**Item 17 - Ref: As 369924-5**

The screed under modern tiles (010/store) does not contain asbestos.

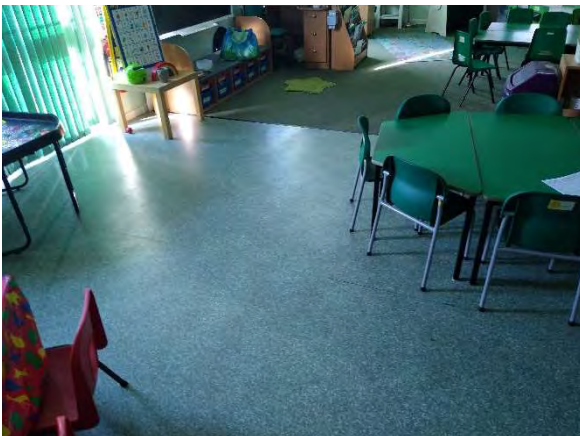
**Item 18 - Ref: As 369924-5**

The screed under modern screed (010/classroom) does not contain asbestos.

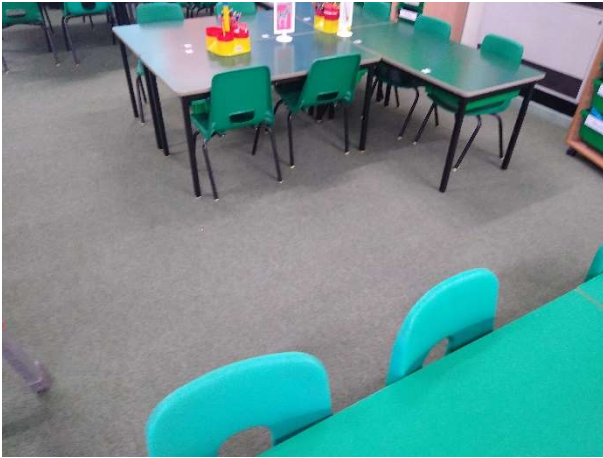
### **Item 19 - Ref: As 369924-5**

The screed under modern screed (013/classroom) does not contain asbestos.

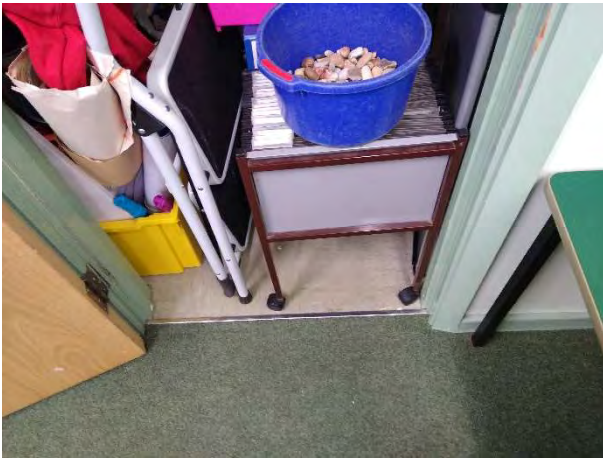
### **Item 20 - Ref: As 369924-5**

The screed (014/store) does not contain asbestos.

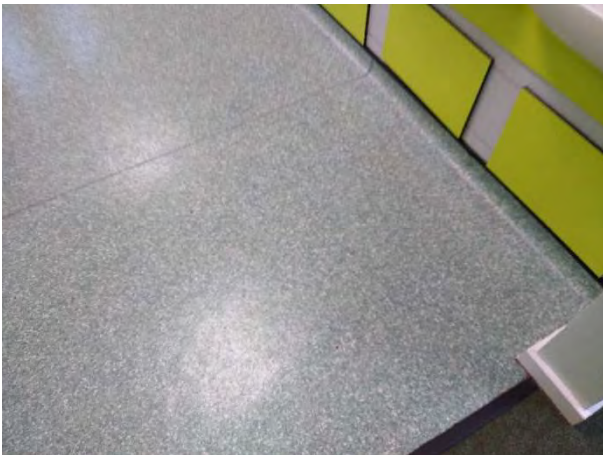
### **Item 21 - Ref: As 369924-5**

The screed under modern screed (015/WC) does not contain asbestos.

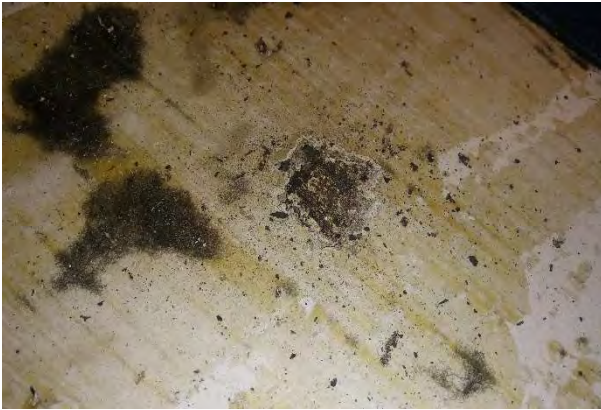
### **Item 22 - Ref: 369924-6**

The floor screed beneath modern screed (015A/ corridor) does not contain asbestos.

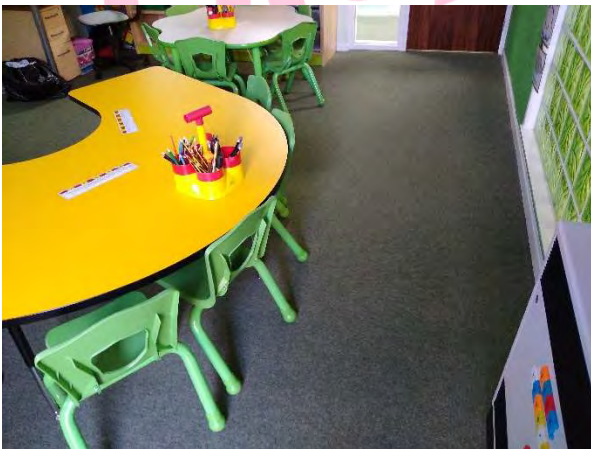
### **Item 24 - Ref: As 369924-5**

The screed under modern screed (016/classroom) does not contain asbestos.

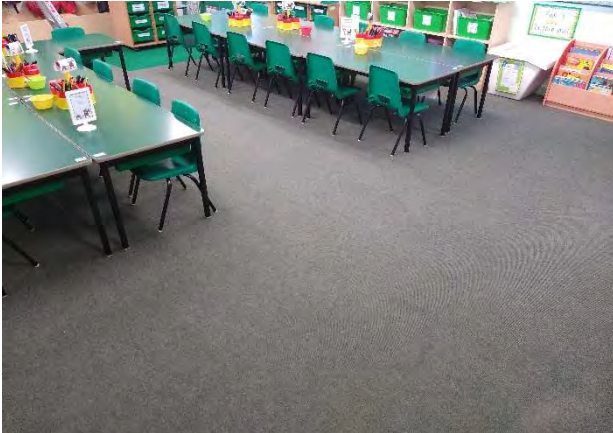
### **Item 25 - Ref: As 369924-5**

The screed under modern screed (017/classroom) does not contain asbestos.

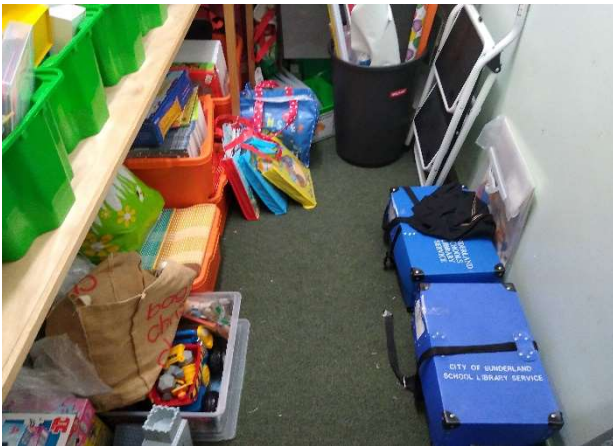
### **Item 26 - Ref: As 369924-5**

The screed under modern screed (018/store) does not contain asbestos.

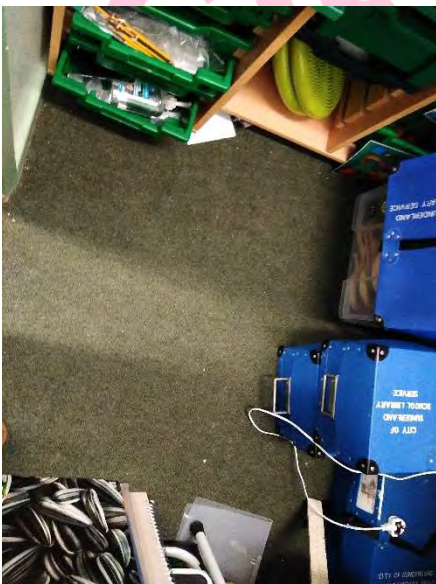
### **Item 27 - Ref: As 369924-5**

The screed under modern screed (019/store) does not contain asbestos.

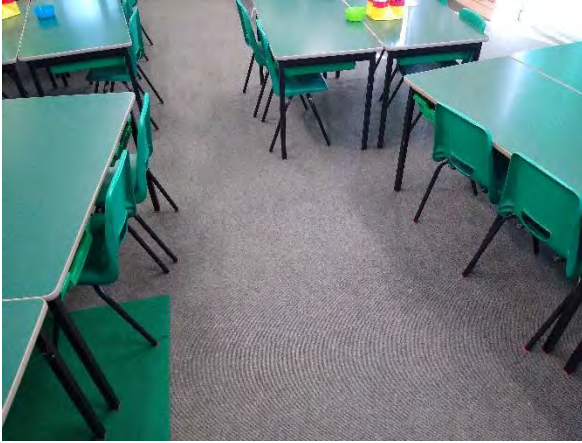
### **Item 28 - Ref: As 369924-5**

The screed under modern screed (020/classroom) does not contain asbestos.

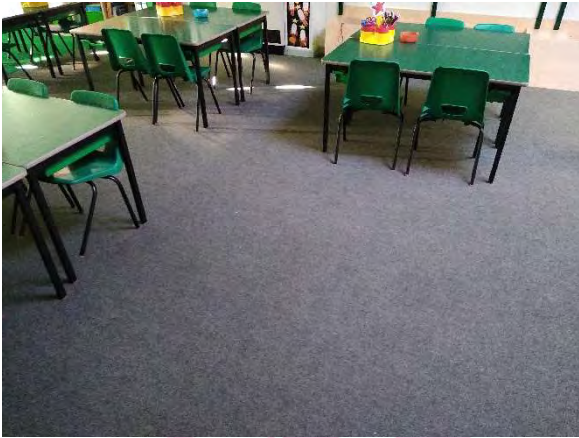
### **Item 29 - Ref: As 369924-5**

The screed under modern screed (021/classroom) does not contain asbestos.

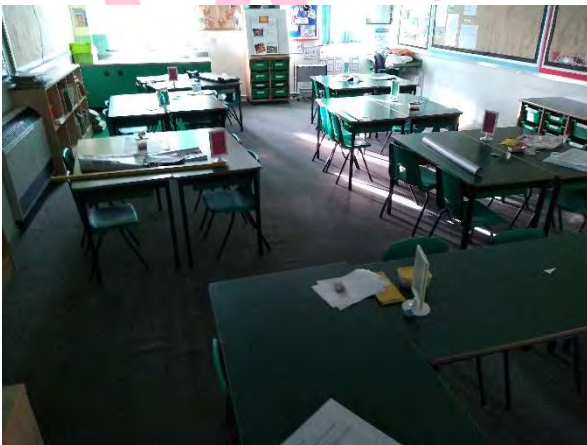
### **Item 30 - Ref: As 369924-5**

The screed under modern screed (022/classroom) does not contain asbestos.

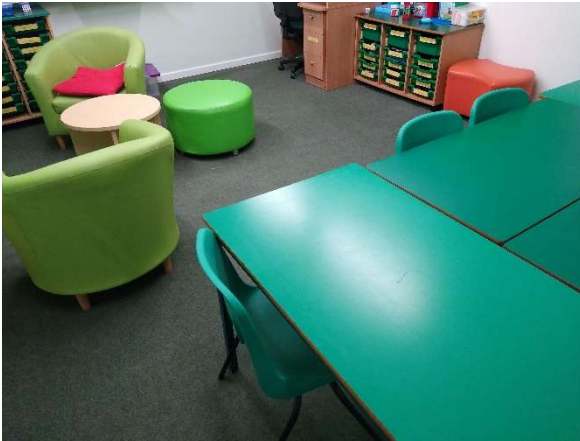
### **Item 31 - Ref: As 369924-5**

The screed under modern screed (023/classroom) does not contain asbestos.

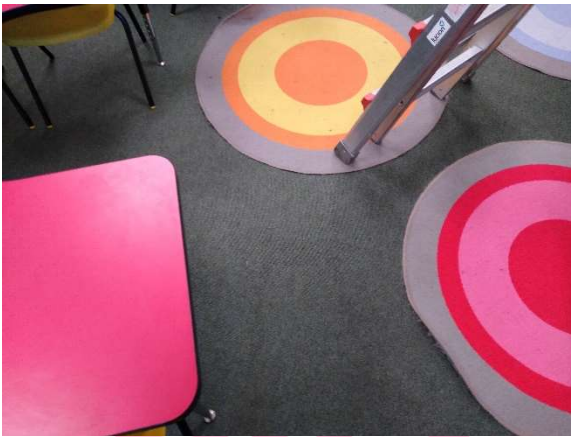
### **Item 32 - Ref: As 369924-5**

The screed under modern screed (024/classroom) does not contain asbestos.

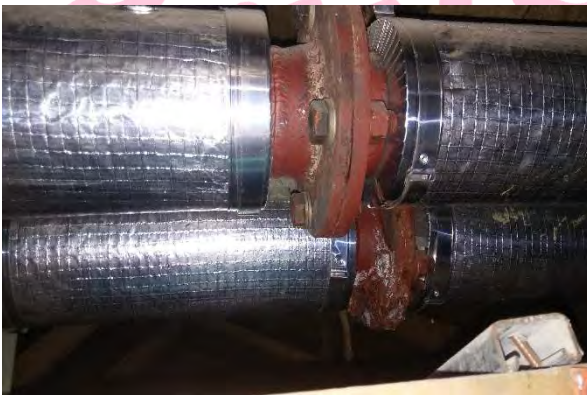
### **Item 36 - Ref: Presumed**

The closed coupled flange gasket (025/corridor-void above) is presumed to contain asbestos.

Any change in its appearance should be recorded and passed to Property Services.

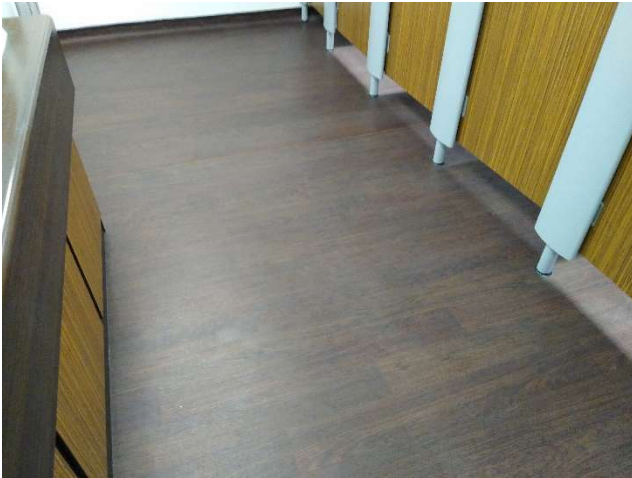
### **Item 37 - Ref: As 369924-5**

The screed under modern screed (026/staff WC) does not contain asbestos.

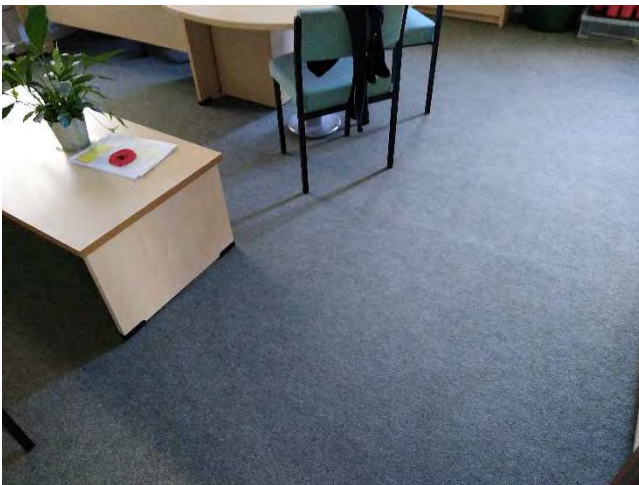
### **Item 38 - Ref: As 369924-5**

The screed under modern screed (027/head teachers office) does not contain asbestos.

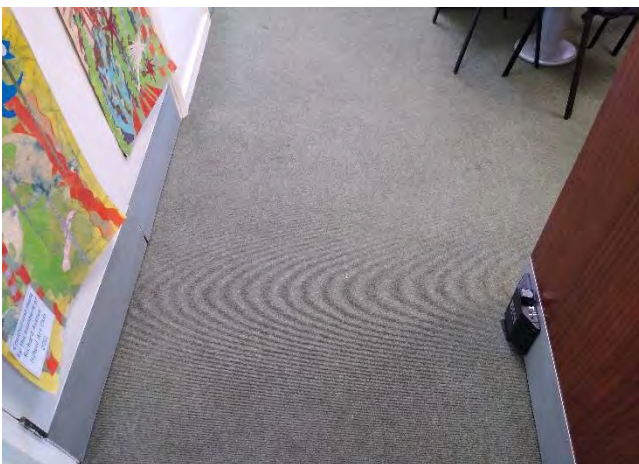
### **Item 39 - Ref: As 369924-5**

The screed under modern screed (028/office) does not contain asbestos.

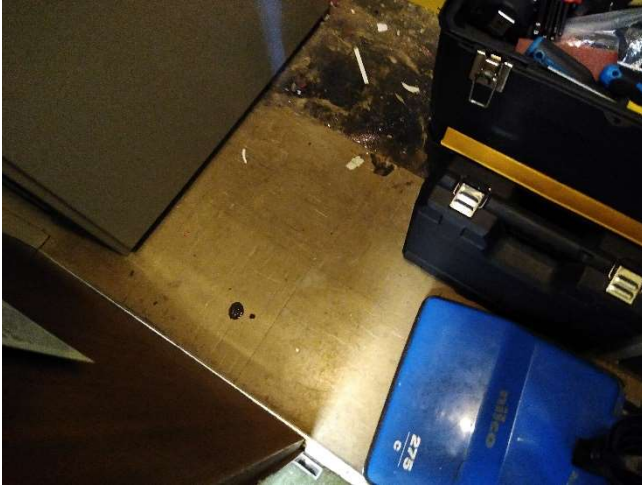
### **Item 40 - Ref: 369924-9**

The floor tile without bitumen adhesive (030/store) does not contain asbestos.

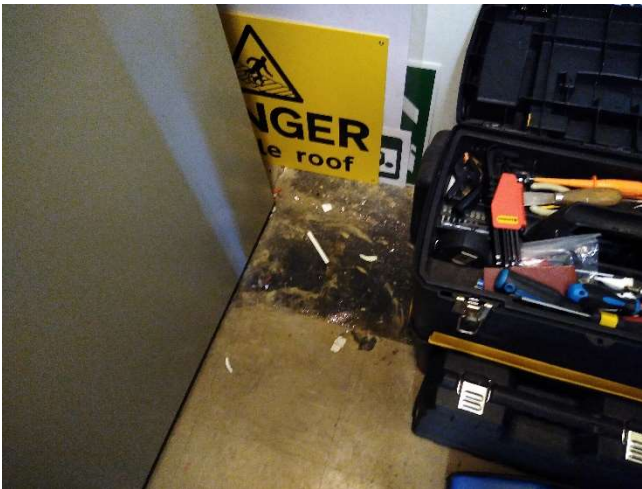
### **Item 41 - Ref: As 369924-5**

The screed under floor tiles (030/store) does not contain asbestos.

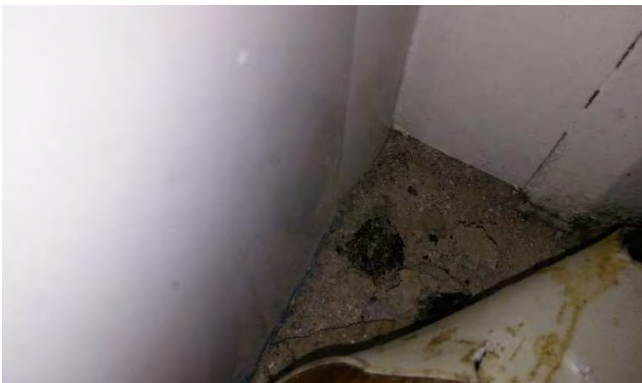
### **Item 42 - Ref: As 369924-7**

The screed under floor tiles (031/staff room) does not contain asbestos.

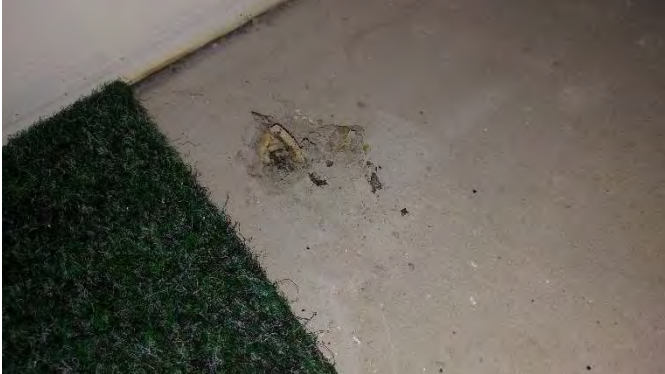
**Item 43 - Ref: As 369924-7**

The screed to floor below floor covering (032/office) does not contain asbestos.

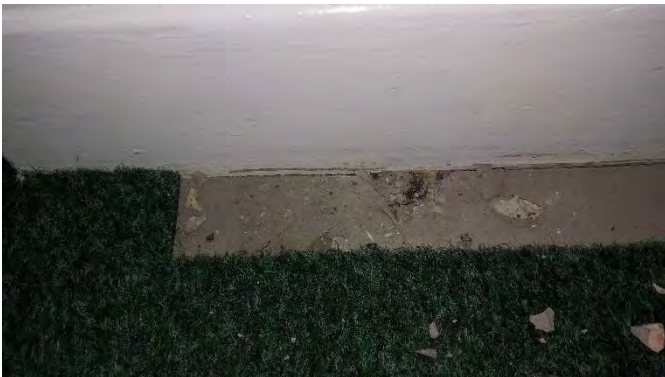
**Item 44 - Ref: As 369924-7**

The screed to floor below floor covering (033/meeting room) does not contain asbestos.

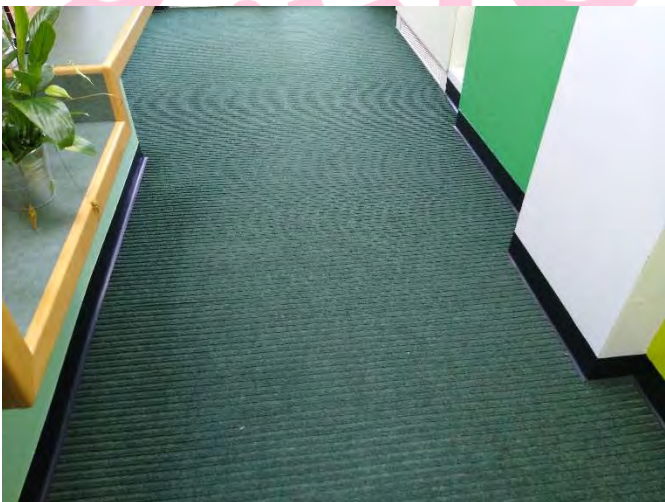
**Item 45 - Ref: As 369924-5**

The screed under modern screed (034/lobby) does not contain asbestos.

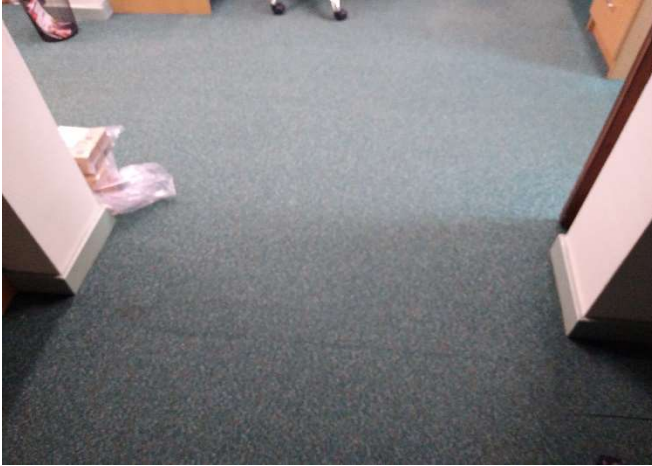
### **Item 46 - Ref: 369924-9**

The floor covering under carpet (035/reception) does not contain asbestos.

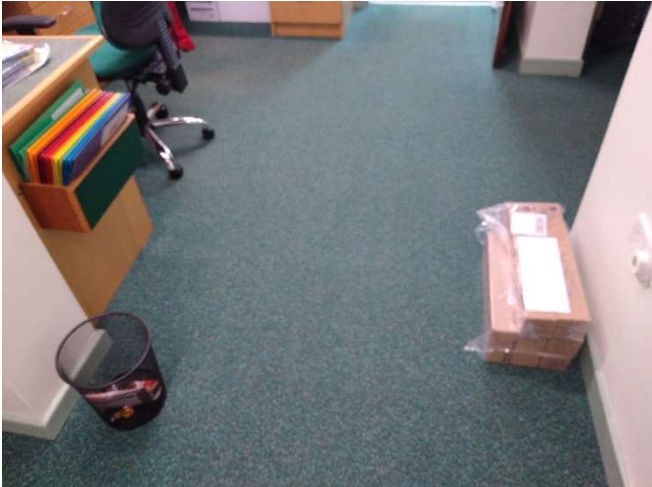
### **Item 47 - Ref: As 369924-5**

The screed under tiles (035/reception) does not contain asbestos.

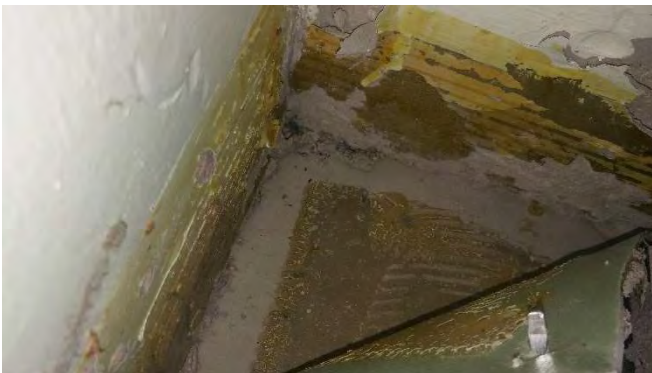
### **Item 48 - Ref: As 369924-7**

The screed to floor below floor covering (036/PE store) does not contain asbestos.

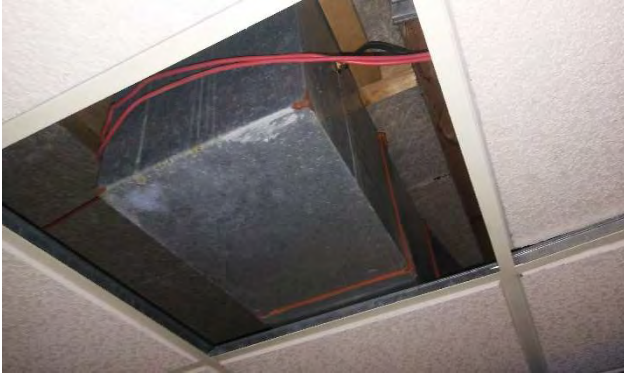
### **Item 49 - Ref: As 369924-12**

The red mastic to ductwork (036/PE store-void above) contains asbestos.

Any change in its appearance should be recorded and passed to Property Services.

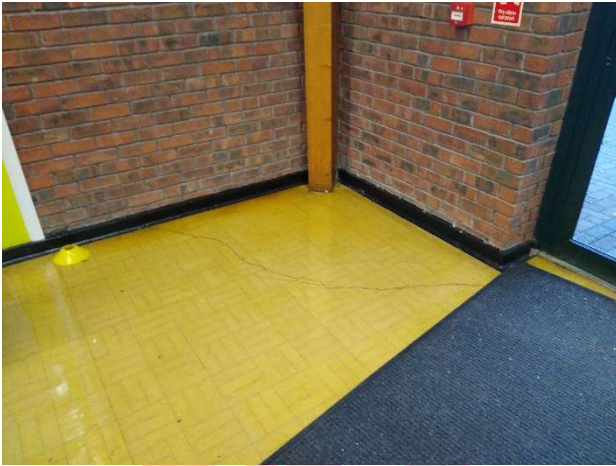
### **Item 50 - Ref: 369924-14**

The coating to skirting within centre area of hall (037/hall) does not contain asbestos.

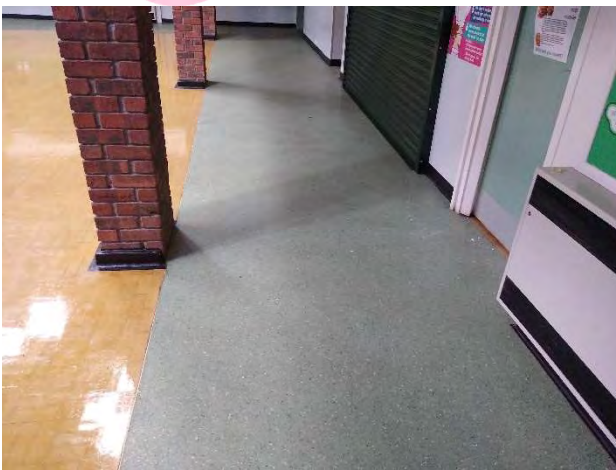
### **Item 51 - Ref: As 369924-5**

The screed under modern screed to perimeter (037/hall) does not contain asbestos.

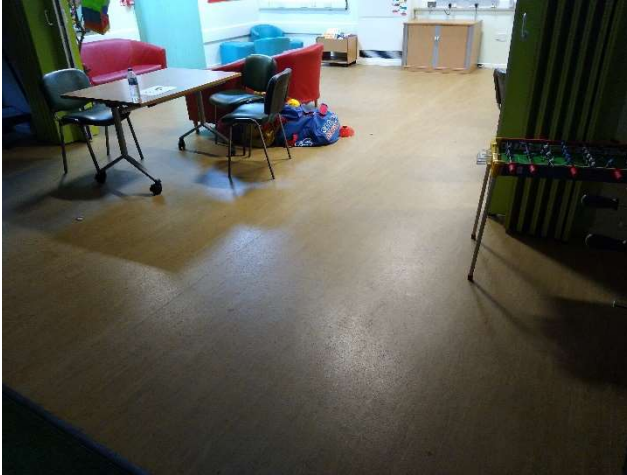
### **Item 52 - Ref: As 369924-5**

The screed under modern screed (038/community room) does not contain asbestos.

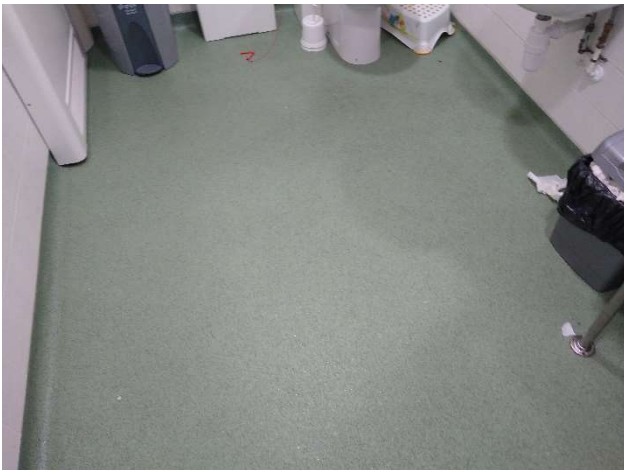
### **Item 53 - Ref: As 369924-5**

The screed under modern screed (039/community WC) does not contain asbestos.

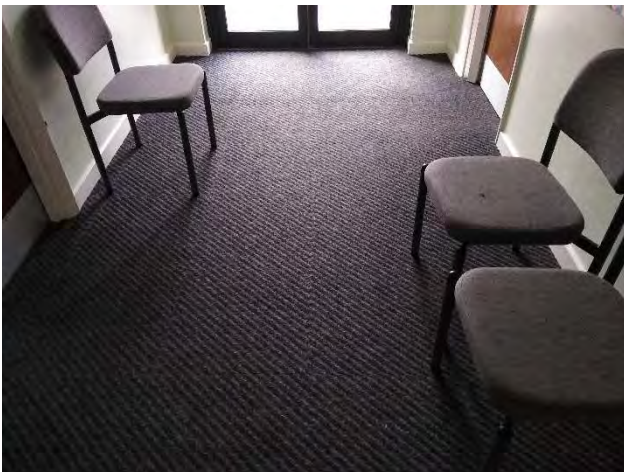
### **Item 54 - Ref: As 369924-5**

The screed under modern screed (041/lobby) does not contain asbestos.

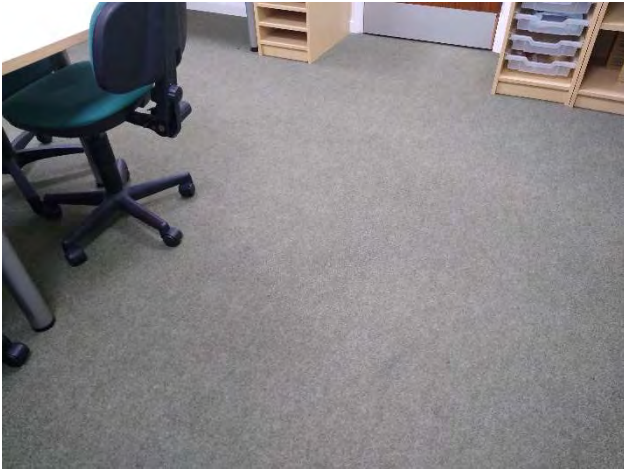
### **Item 55 - Ref: As 369924-5**

The screed under modern screed (042/PPA room) does not contain asbestos.

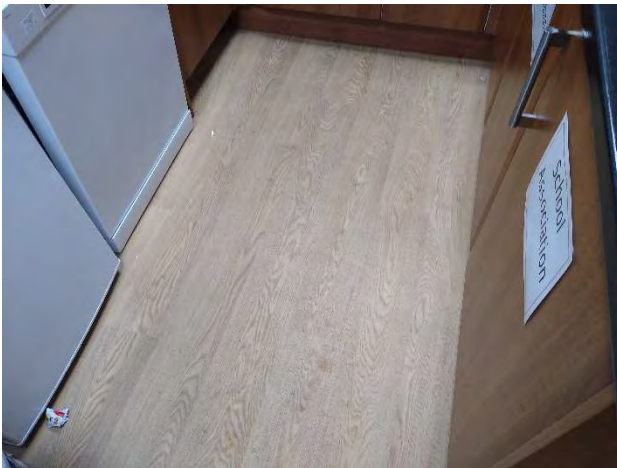
### **Item 56 - Ref: As 369924-5**

The screed under modern screed (043/community kitchen) does not contain asbestos.

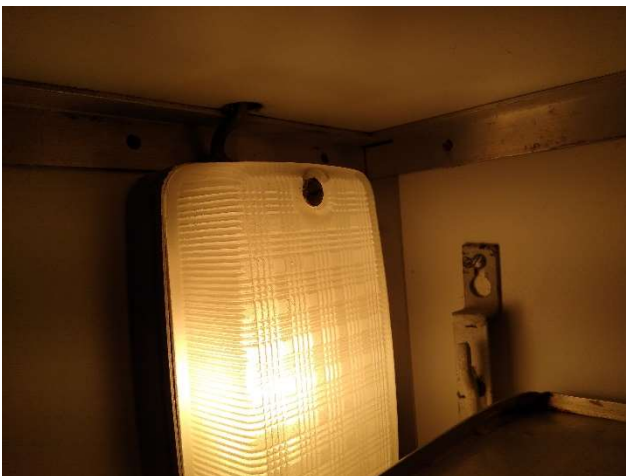
### **Item 57 - Ref: 369924-10**

The sealant around wall light screws (044/cold store) contains asbestos.

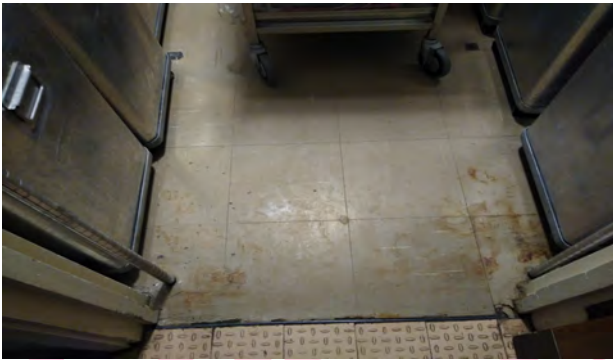
### **Item 65 - Ref: As 369924-9**

The floor covering (049/kitchen pantry) does not contain asbestos.

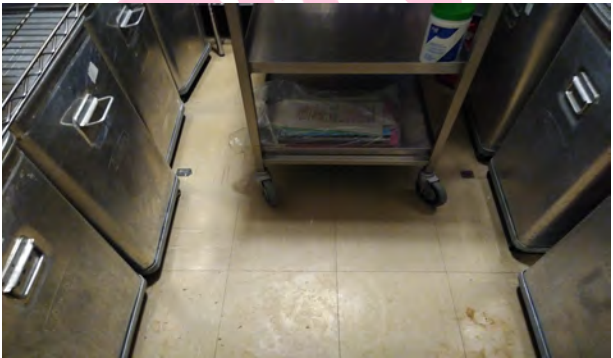
### **Item 66 - Ref: As 369924-5**

The screed under tiles (049/kitchen pantry) does not contain asbestos.

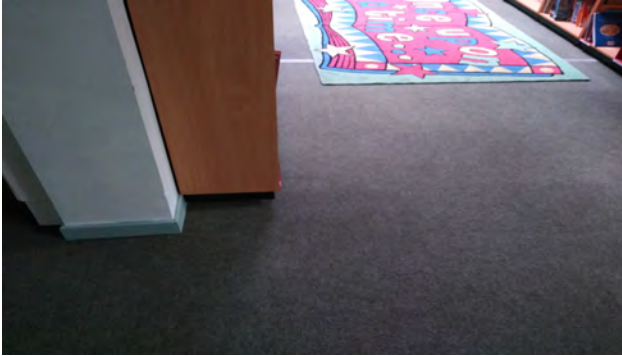
### **Item 85 - Ref: As 369924-13**

The screed under modern screed (068/classroom) does not contain asbestos.

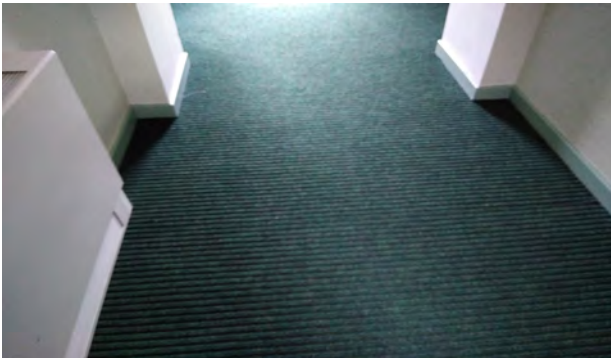
### **Item 86 - Ref: As 369924-13**

The screed under modern screed (069/lobby) does not contain asbestos.

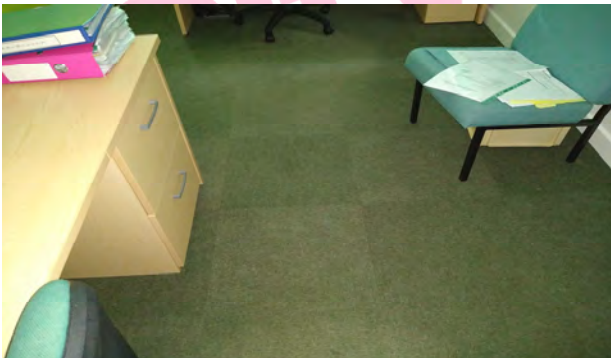
### **Item 87 - Ref: As 369924-13**

The screed under modern screed (070/office) does not contain asbestos.

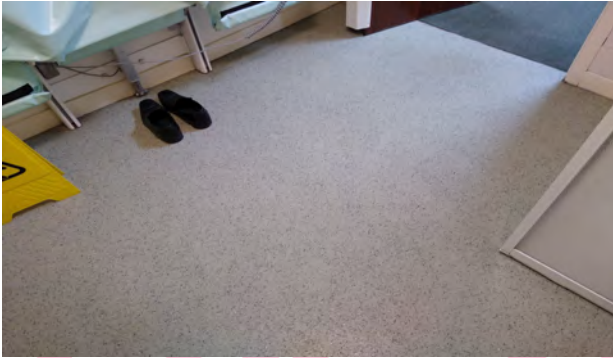
### **Item 89 - Ref: As 369924-13**

The screed under modern screed (071/accessible WC) does not contain asbestos.

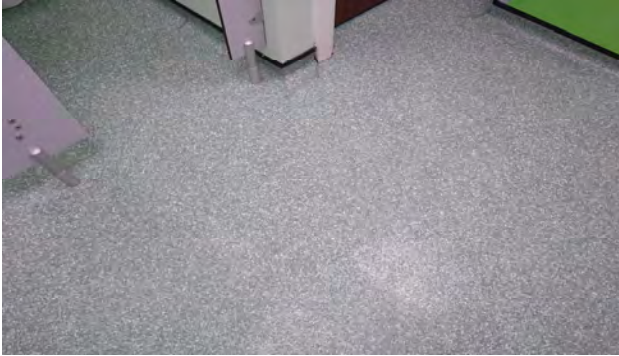
### **Item 94 - Ref: As 369924-13**

The screed under modern screed (076/male WC) does not contain asbestos.

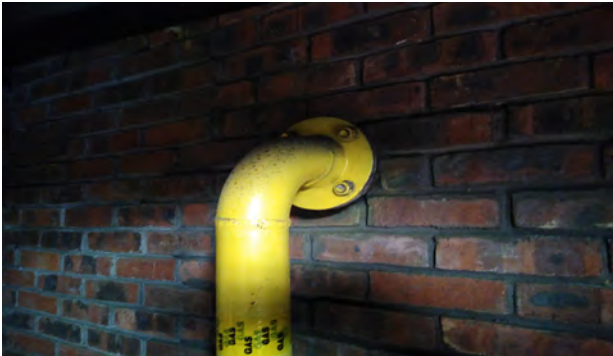
### **Item 101 - Ref: 369924-18**

The pipework flange gasket (083/gas store) does not contain asbestos.

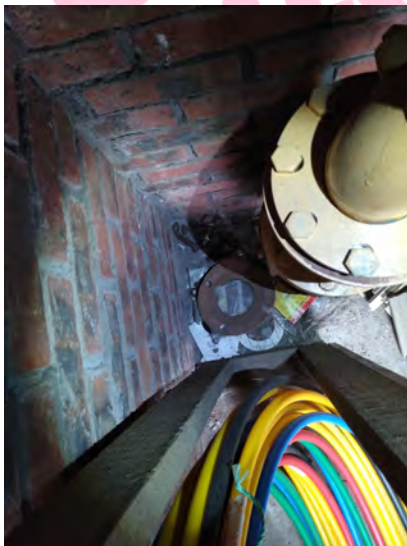
### **Item 102 - Ref: 369924-19**

The debris to floor (083/gas store) does not contain asbestos.

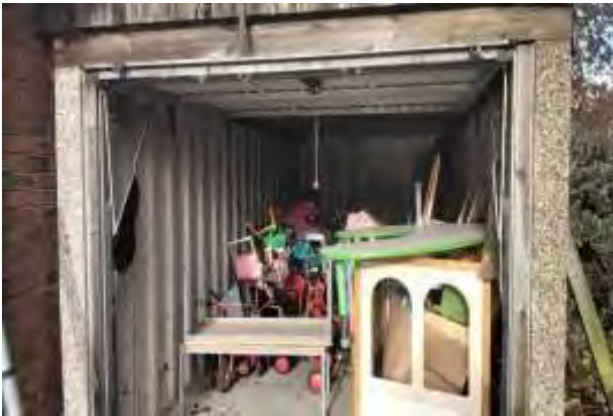
### **Item 113 - Ref: NO000636**

The sealant to door to the garage (externals E/001) does not contain asbestos.

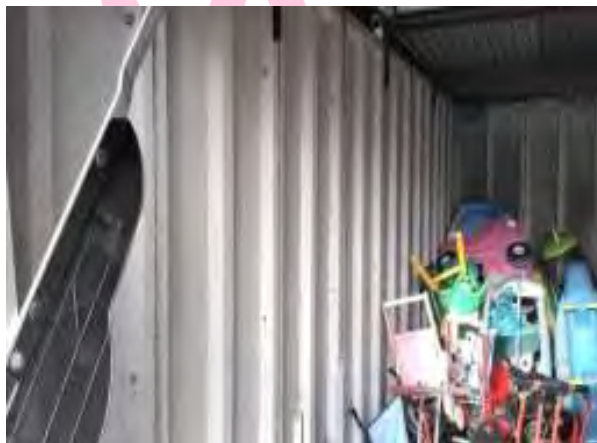
### **Item 114 - Ref: NO000637**

The wall jointing compound to the garage (externals E/001) does not contain asbestos.

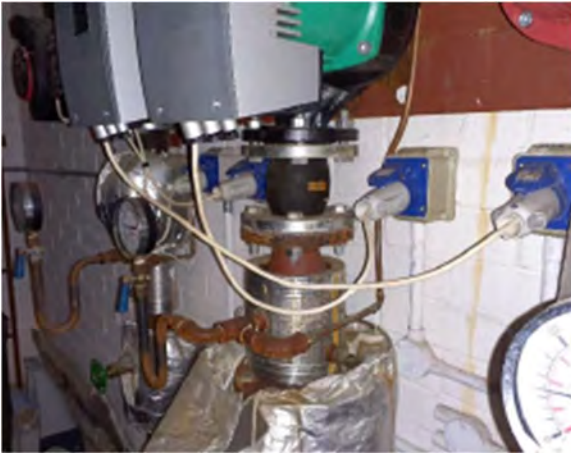
### **Item 115 - Ref: Presumed**

The Gaskets pipework (Boiler Room G/01) is presumed to contain asbestos.

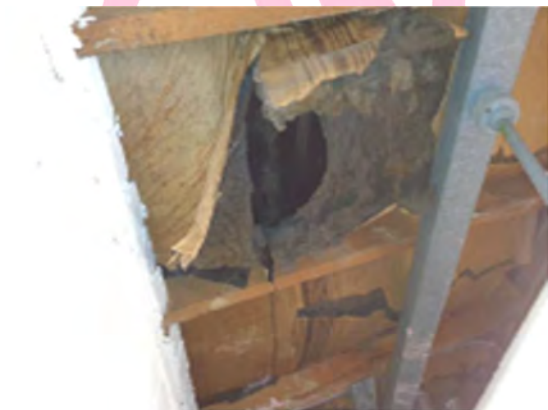
### **Item 117 - Ref: HD000896**

The Thermal installation walls (Boiler Room G/01) does not contain asbestos.

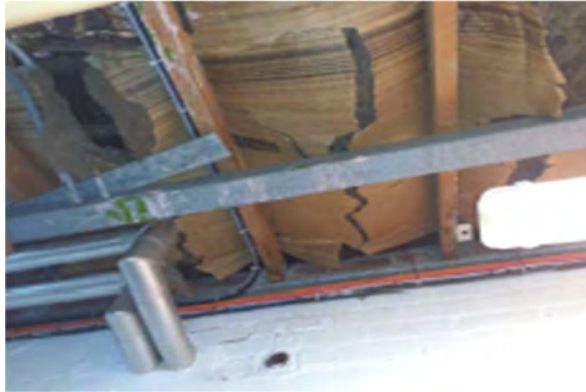
### **Item 118 - Ref: HD000898**

The Thermal installation ceiling (Boiler Room G/01) does not contain asbestos.

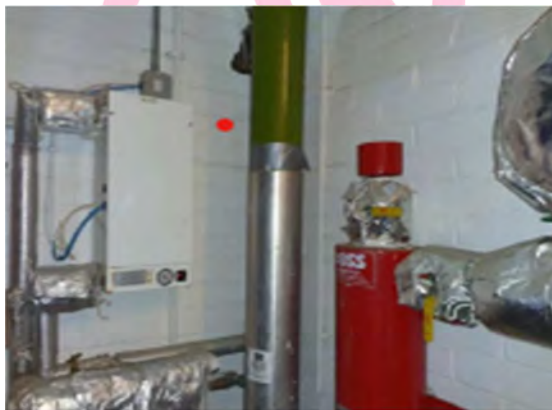
### **Item 119 - Ref: HD000900**

The Thermal installation pipework (Boiler Room G/01) does not contain asbestos.

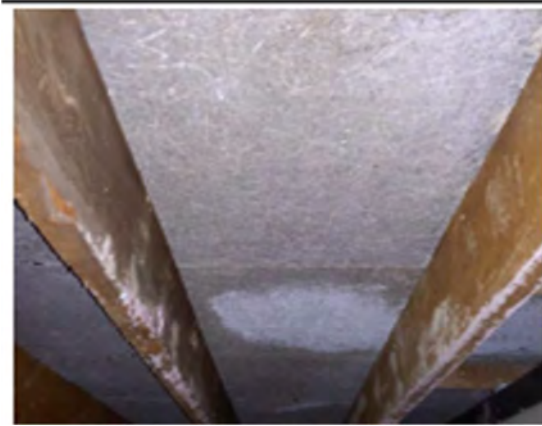
**Item 132 - Ref: HD000914**

The Stammit boards ceiling (Boiler Room Tank Room 1/01) does not contain asbestos.

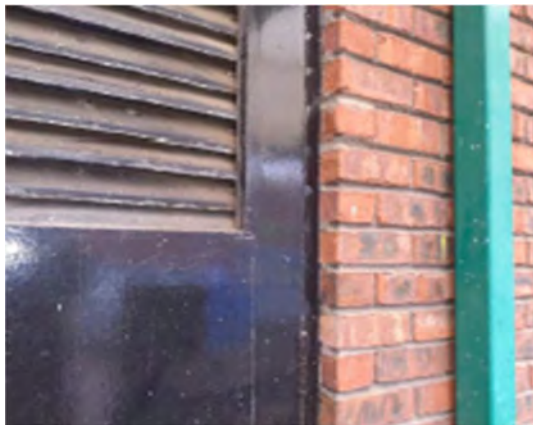
**Item 134 - Ref: HD000916**

The Mastic door (Boiler Room Tank Room 1/01) does not contain asbestos.
