ASBESTOS SURVEY REPORT FOR RICKLETON PRIMARY SCHOOL,  
WASHINGTON, NE38 9EZ.

*Control of Asbestos  
Regulations 2012*

**Rickleton Primary School, Washington, NE38 9EZ**

**Date: 05 June 2026**

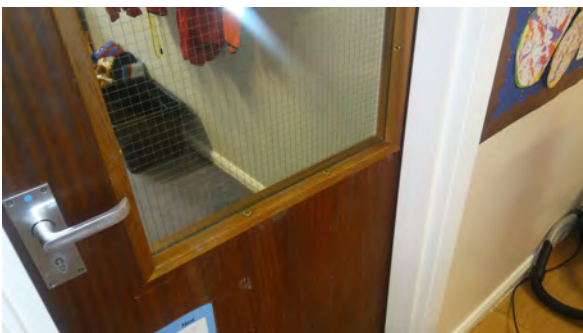
### **Item 3 Ref: As 412937-4**

The sealant to glazed door panel to 0/009 Rm 0/003 Nursery Classroom contains asbestos.

Any change in its appearance should be recorded and passed to Property Services.

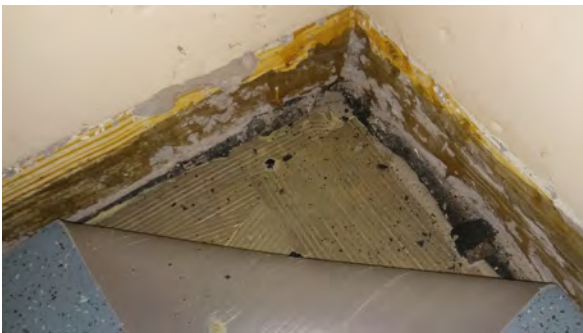
### **Item 6 Ref: 412937-1**

The floor screed in 0/004 Cleaners cupboard contains asbestos.

Any change in its appearance should be recorded and passed to Property Services.

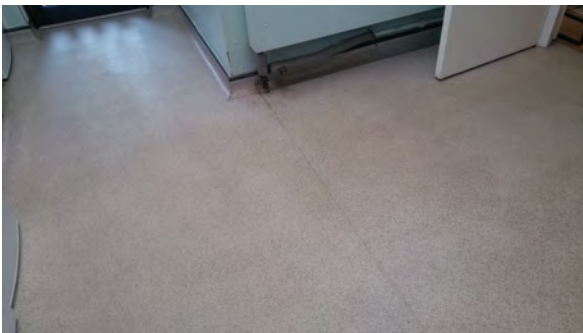
### **Item 9 Ref: As 412937-1**

The floor screed beneath lino in Rm 0/007 Kitchen contains asbestos.

Any change in its appearance should be recorded and passed to Property Services.

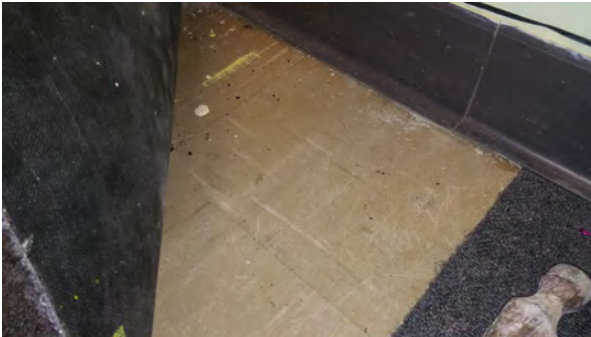
### **Item 62 Ref: 412937-16**

The sub floor covering in Rm 0/41 Store contains asbestos.

Any change in its appearance should be recorded and passed to Property Services.

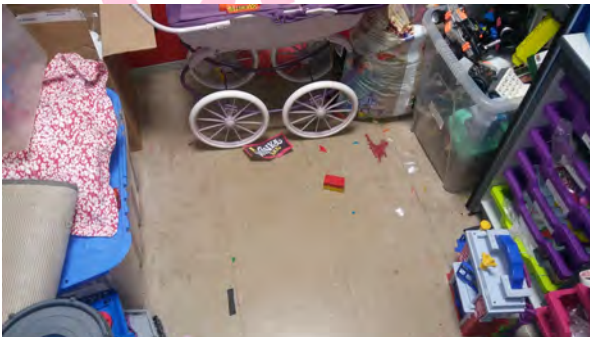
### **Item 66 Ref: As 412937-16**

The floor covering in Rm 0/42b Store contains asbestos.

Any change in its appearance should be recorded and passed to Property Services.

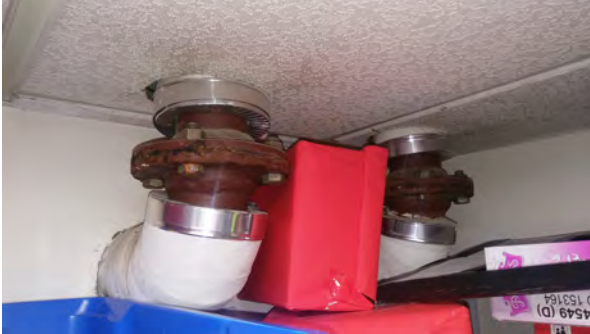
### **Item 67 Ref: Presumed**

The pipework flange gasket in Rm 0/42b Store is presumed to contain asbestos.

Any change in its appearance should be recorded and passed to Property Services.

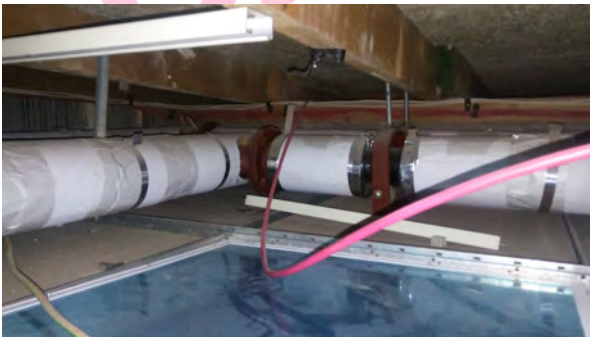
### **Item 69 Ref: Presumed**

The pipework flange gasket in Rm 0/42b Store cupboard void above is presumed to contain asbestos.

Any change in its appearance should be recorded and passed to Property Services.

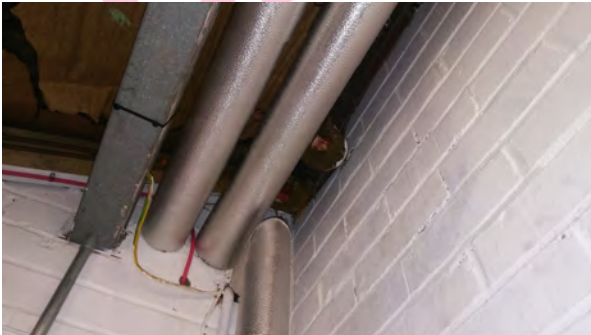
### **Item 78 Ref: Presumed**

The gasket to bleed valves in Rm 0/47 Boiler Room is presumed to contain asbestos.

Any change in its appearance should be recorded and passed to Property Services.

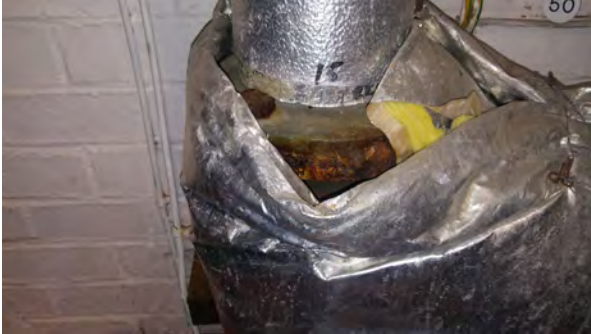
### **Item 79 Ref: Presumed**

The pipework flange gasket in Rm 0/47 Boiler Room is presumed to contain asbestos.

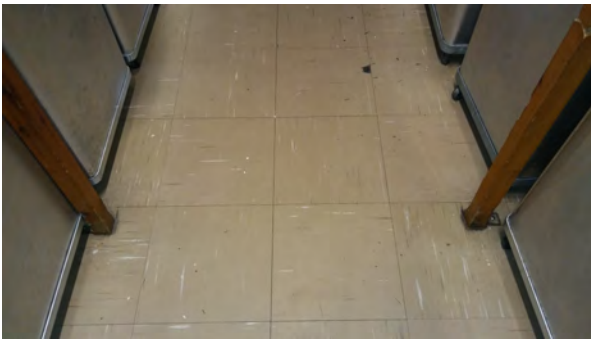
### **Item 80 Ref: As 412937-20**

The floor covering in Rm 0/48 Kitchen Store and void above contains asbestos.

Any change in its appearance should be recorded and passed to Property Services.

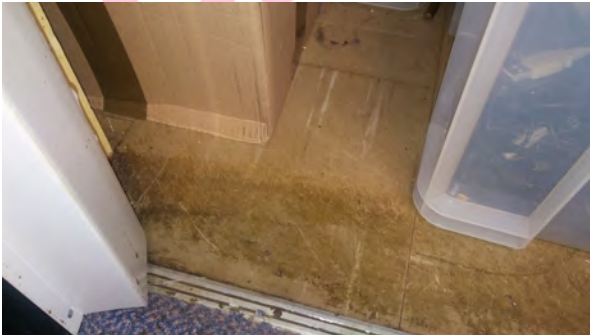
### **Item 93 Ref: 412937-24**

The floor covering in Rm 0/50a Store contains asbestos.

Any change in its appearance should be recorded and passed to Property Services.

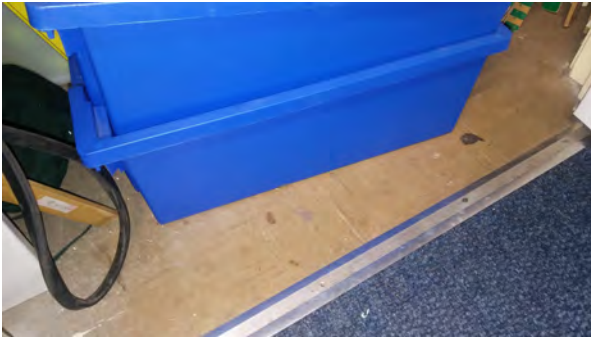
### **Item 95 Ref: As 412937-24**

The floor covering in Rm 0/50b Electric cupboard contains asbestos.

Any change in its appearance should be recorded and passed to Property Services.

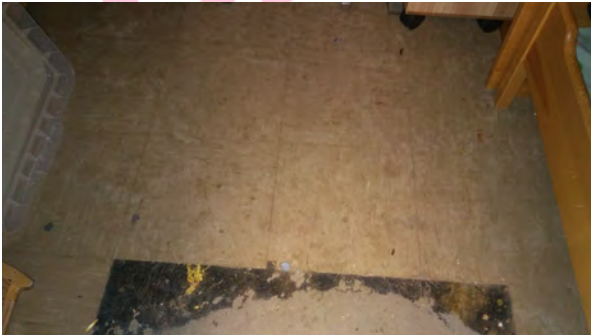
### **Item 105 Ref: As 412937-24**

The floor covering in Rm 0/57 Store contains asbestos.

Any change in its appearance should be recorded and passed to Property Services.

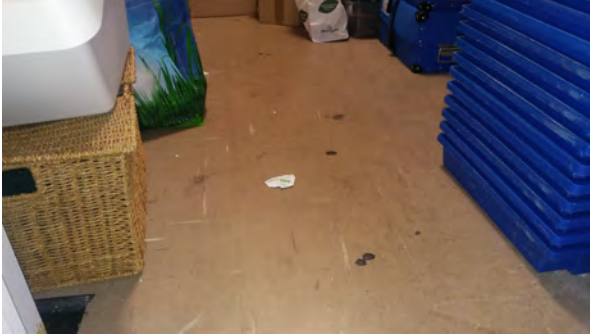
### Item 118 Ref: As 412937-24

The floor covering in Rm 0/63 Store contains asbestos.

Any change in its appearance should be recorded and passed to Property Services.

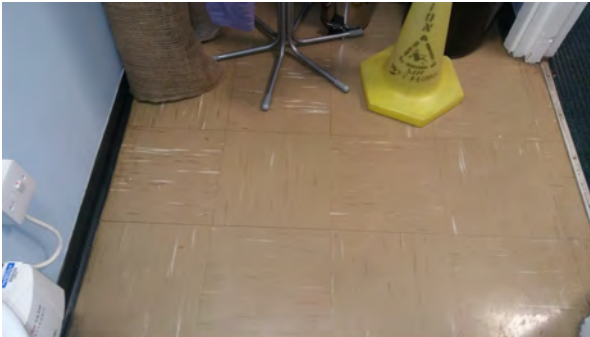
### Item 119 Ref: As 412937-24

The floor covering in Rm 0/64 Accessible WC contains asbestos.

***Removed March 2021***

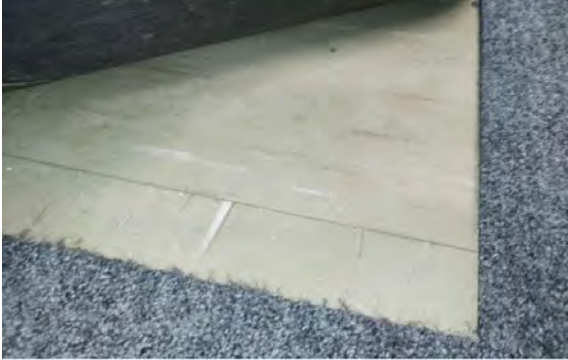
### **Item 151 Ref: 21-35983-4**

The beige thermoplastic tiles in Rm 2 Sensory room contain asbestos.

Any change in its appearance should be recorded and passed to Property Services.

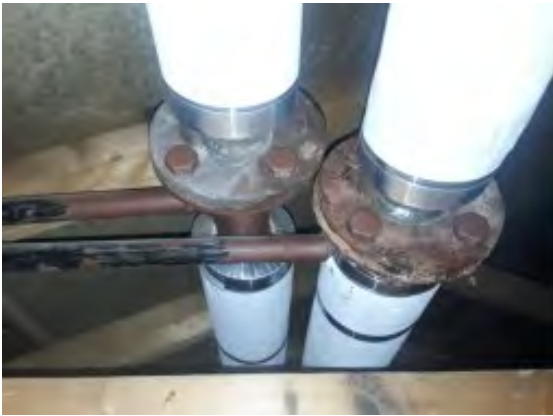
### **Item 154 Ref: Presumed**

The Pipework gasket within ceiling void adjacent light 31 too deeply recessed to sample (Classroom lights 26, 27, 28, 29, 31 G/003) contain asbestos.

Any change in its appearance should be recorded and passed to Property Services.

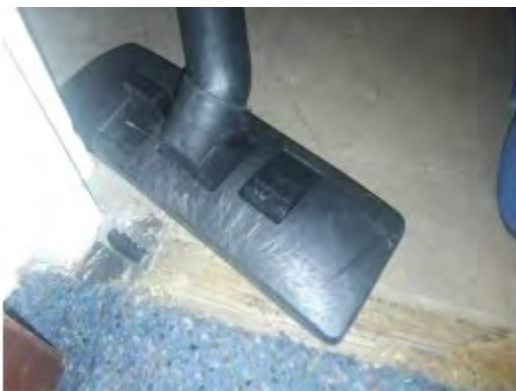
### **Item 156 Ref: NX001618**

The floor tile with adhesive (Cupboard Electrical G/008) contain asbestos.

Any change in its appearance should be recorded and passed to Property Services.

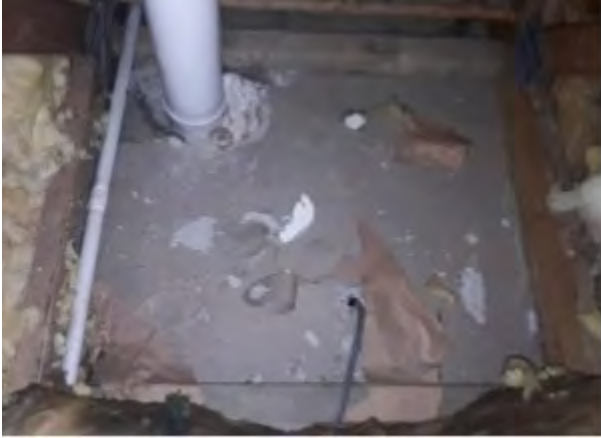
**Item 13 Ref: 21-31833-1**

The debris to the floor surrounding the flue penetration (Loft) contains asbestos.

Any change in its appearance should be recorded and passed to Property Services.
