ASBESTOS SURVEY REPORT FOR RICKLETON PRIMARY SCHOOL,
WASHINGTON, NE38 9EZ.

Rickleton Primary School, Washington, NE38 9EZ

Date: 05 December 2025

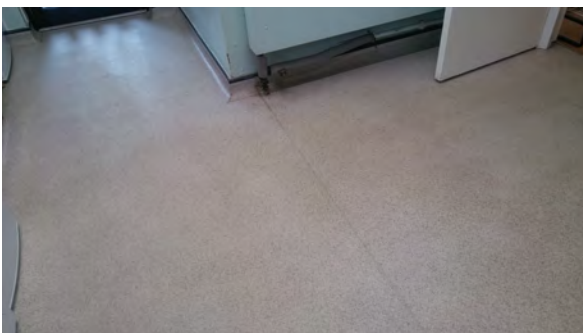
Item 9 Ref: As 412937-1

The floor screed beneath lino in Rm 0/007 Kitchen contains asbestos.

Any change in its appearance should be recorded and passed to Property Services.

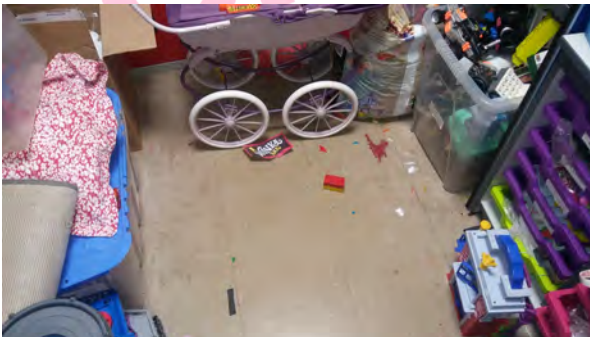
Item 66 Ref: As 412937-16

The floor covering in Rm 0/42b Store contains asbestos.

Any change in its appearance should be recorded and passed to Property Services.

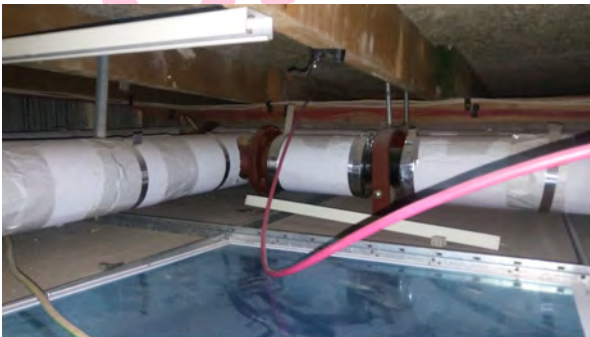
Item 69 Ref: Presumed

The pipework flange gasket in Rm 0/42b Store cupboard void above is presumed to contain asbestos.

Any change in its appearance should be recorded and passed to Property Services.

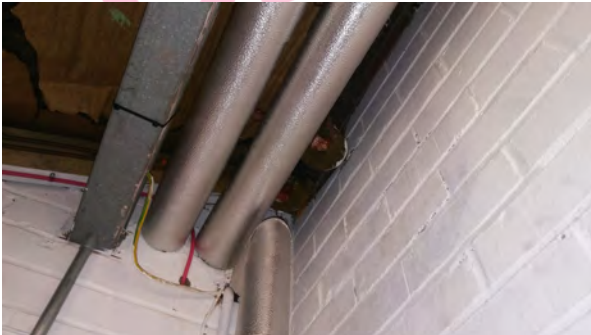
Item 78 Ref: Presumed

The gasket to bleed valves in Rm 0/47 Boiler Room is presumed to contain asbestos.

Any change in its appearance should be recorded and passed to Property Services.

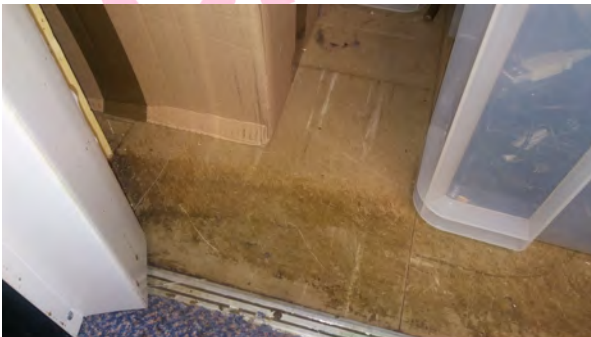
Item 93 Ref: 412937-24

- (Item 93) Ref: 412937-24 – Floor covering (0/50a Store) – Very Low Risk

The floor covering in Rm 0/50a Store contains asbestos.

Any change in its appearance should be recorded and passed to Property Services.

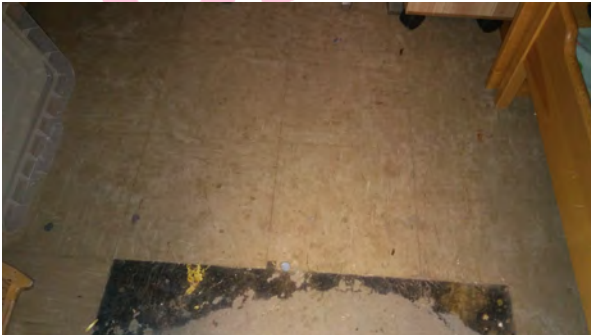
Item 105 Ref: As 412937-24

The floor covering in Rm 0/57 Store contains asbestos.

Any change in its appearance should be recorded and passed to Property Services.

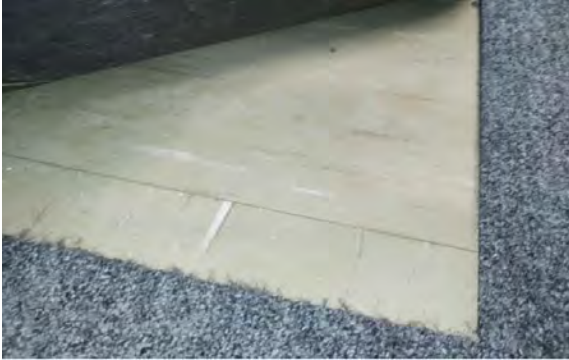
Item 151 Ref: 21-35983-4

The beige thermoplastic tiles in Rm 2 Sensory room contain asbestos.

Any change in its appearance should be recorded and passed to Property Services.

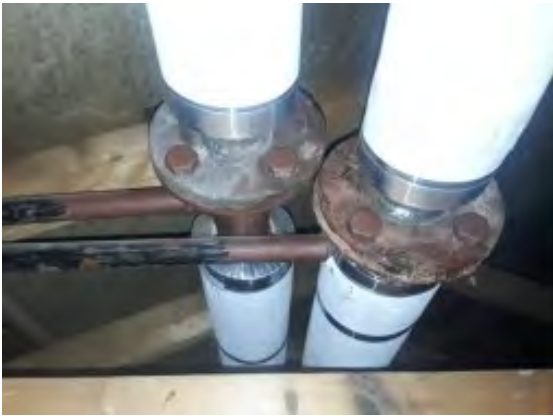
Item 154 Ref: Presumed

The Pipework gasket within ceiling void adjacent light 31 too deeply recessed to sample (Classroom lights 26, 27, 28, 29, 31 G/003) contain asbestos.

Any change in its appearance should be recorded and passed to Property Services.

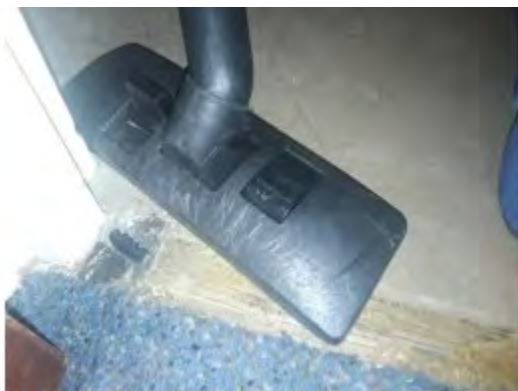
Item 156 Ref: NX001618

The floor tile with adhesive (Cupboard Electrical G/008) contain asbestos.

Any change in its appearance should be recorded and passed to Property Services.

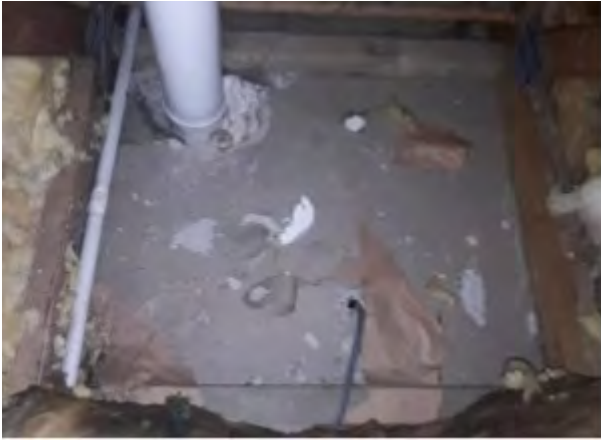
Item 13 Ref: 21-31833-1

The debris to the floor surrounding the flue penetration (Loft) contains asbestos.

Any change in its appearance should be recorded and passed to Property Services.
