### ASBESTOS SURVEY REPORT FOR SEABURN DENE PRIMARY SCHOOL, SUNDERLAND

## **Asbestos Register for Seaburn Dene Primary School**

Last updated 29/04/2026 V.2.0

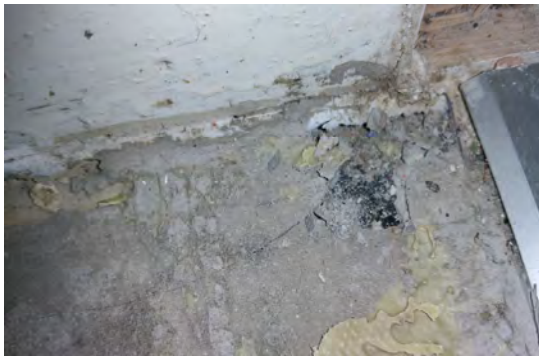
### **Item 5 Ref: As 179537-1**

The subfloor covering (Rm 0/10) containing remnant bitumen contains asbestos.

Any change in its appearance should be recorded and passed to Property Services.

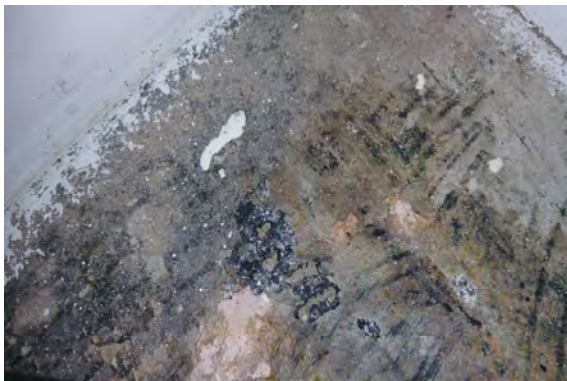
### **Item 6 Ref: As 179537-1**

The subfloor covering (Rm 0/11) containing remnant bitumen contains asbestos.

Any change in its appearance should be recorded and passed to Property Services.

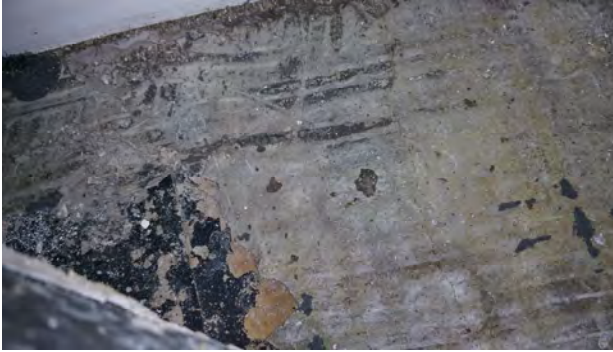
#### **Item 7 Ref: As 179537-1**

The subfloor covering (Rm 0/12) containing remnant bitumen contains asbestos.

Any change in its appearance should be recorded and passed to Property Services.

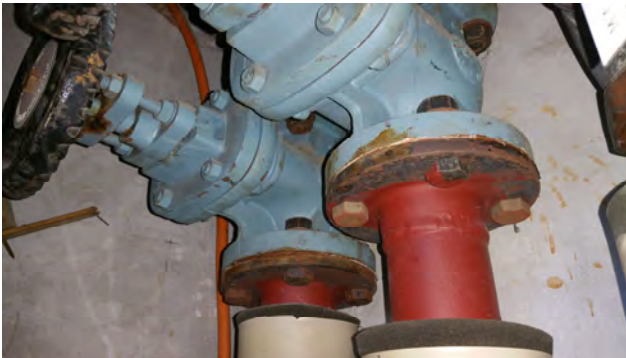
#### **Item 8 Ref: 179537-2**

The Gasket to pipework flange (Rm 0/17) contains asbestos.

Any change in its appearance should be recorded and passed to Property Services.

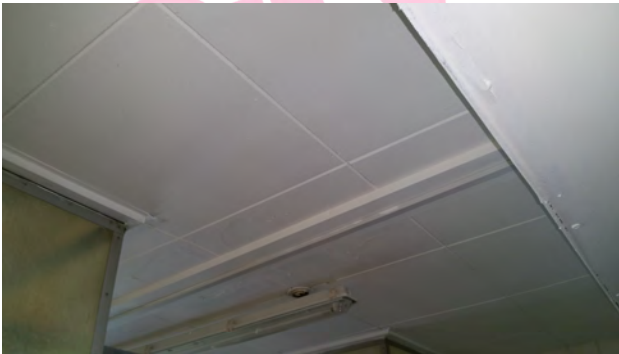
#### **Item 9 Ref: 179537-3**

The ceiling tiles (Rm 0/36) contain asbestos.

Any change in its appearance should be recorded and passed to Property Services.

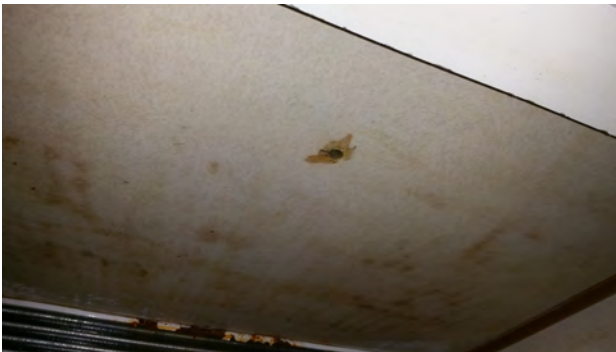
### **Item 11 Ref: 179537-5**

The ceiling in Kitchen Fridge (Rm 0/36) contains asbestos.

Any change in its appearance should be recorded and passed to Property Services.

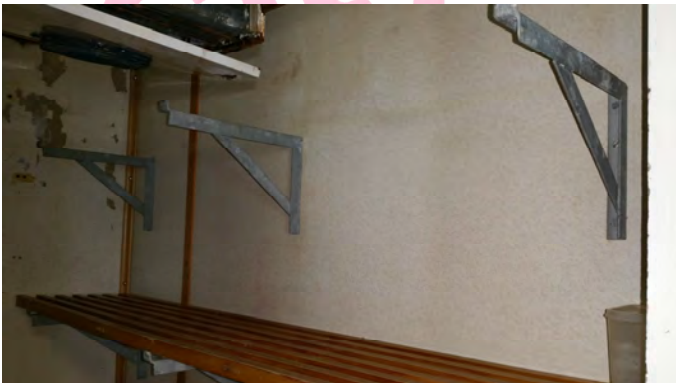
### **Item 12 Ref: As 179537-5**

The walls in Kitchen Fridge (Rm 0/36) contain asbestos.

Any change in its appearance should be recorded and passed to Property Services.

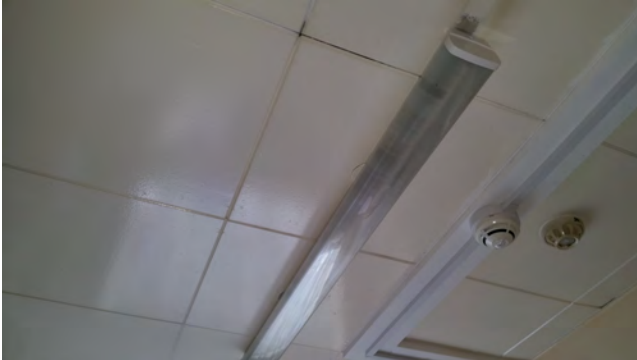
### **Item 13 Ref: As 179537-3**

The ceiling tiles (Rm 0/39) contain asbestos.

Any change in its appearance should be recorded and passed to Property Services.

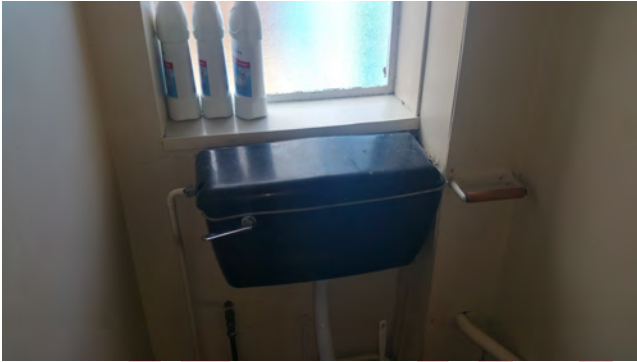
### **Item 14 Ref: 179537-6**

The Toilet Cistern (Rm 0/40) contains asbestos.

Any change in its appearance should be recorded and passed to Property Services.

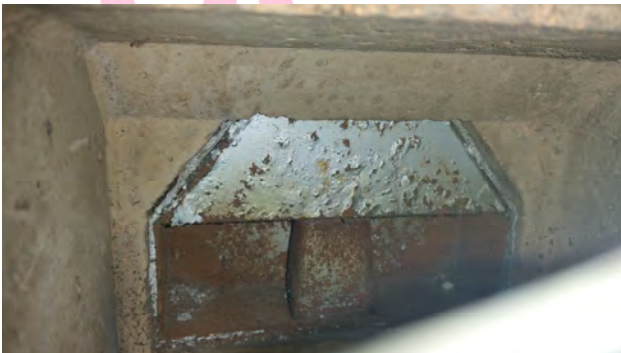
### **Item 15 Ref: 179537-7**

The Lining to Bunnie Boiler (Rm 0/40) contains asbestos.

Any change in its appearance should be recorded and passed to Property Services.

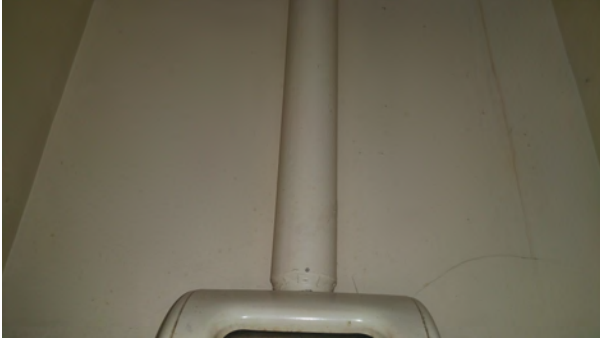
### **Item 16 Ref: 179537-8**

The Bunnie Boiler Flue (Rm 0/40) contains asbestos.

Any change in its appearance should be recorded and passed to Property Services.

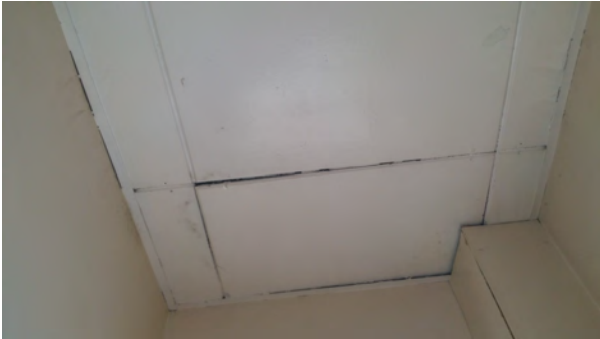
### **Item 17 Ref: As 179537-3**

The ceiling tiles (Rm 0/40) contain asbestos.

Any change in its appearance should be recorded and passed to Property Services.

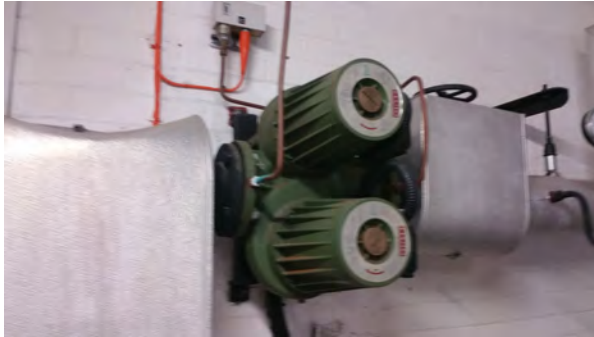
### **Item 20 Ref: 179537-11**

The gasket (Rm 0/81) does not contain asbestos.

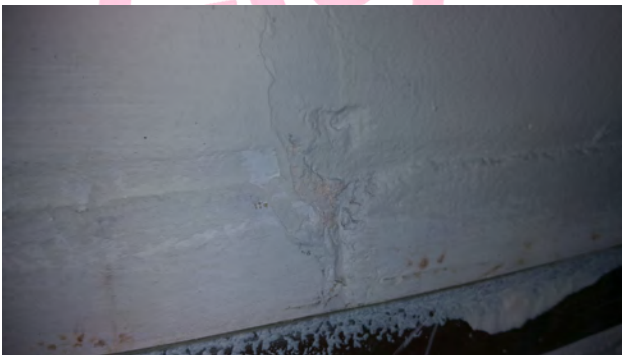
### **Item 21 Ref: 179537-12**

The debris to walls containing lagging (Rm 0/81) contains asbestos.

Any change in its appearance should be recorded and passed to Property Services.

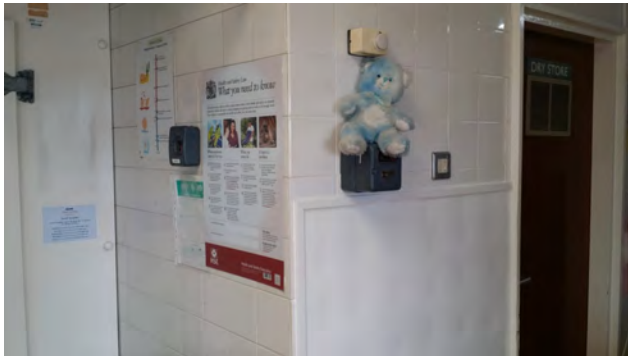
### **Item 29 Ref: Presumed**

The electrics in the kitchen (Room 036) are presumed to contain asbestos.

Any work will require further investigation.

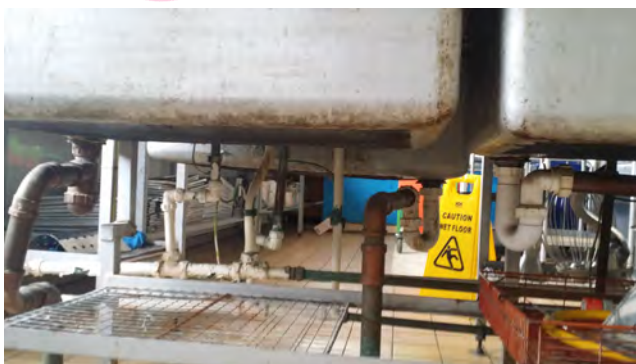
### **Item 30 Ref: 277554-2**

The gasket to the sink waste connections in the kitchen (Room 036) does contain asbestos.

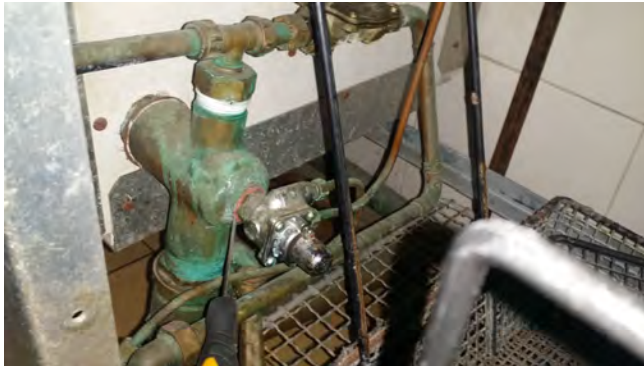
### **Item 34 Ref: 277554-7**

The red gasket to steriliser sink waste connection in the kitchen (Room 036) does contain asbestos.

Any change in its appearance should be recorded and passed to Property Services.

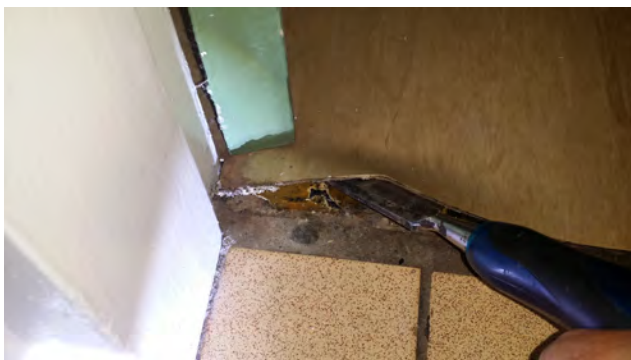
### **Item 36 Ref: 277554-13**

The adhesive to floor beneath lino in office and store (Room 039) does contain asbestos.

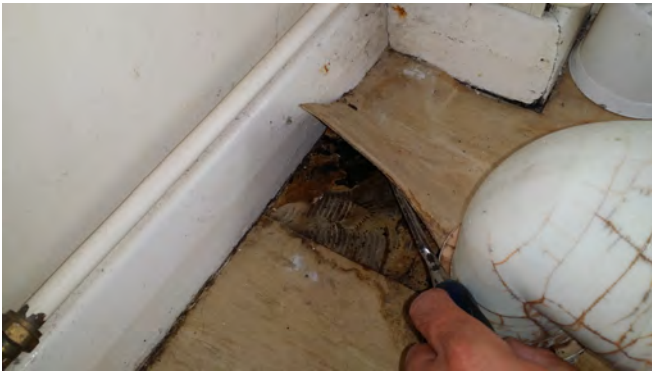
### **Item 38 Ref: As 277554-13**

The adhesive to floor beneath lino in WC (Room 040) does contain asbestos.

Any change in its appearance should be recorded and passed to Property Services.

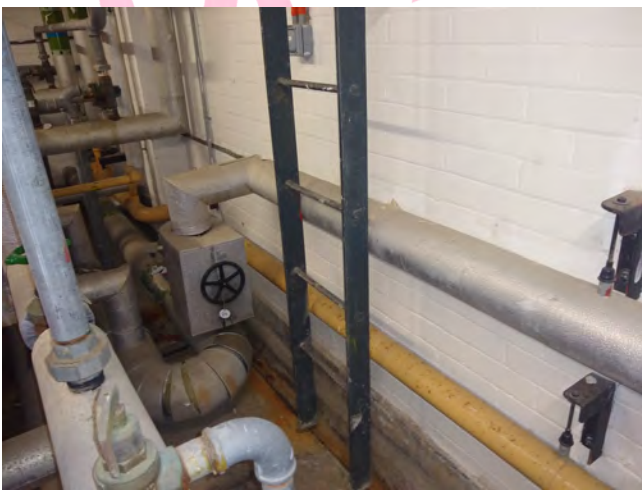
### **Item 39 Ref: 342052-1**

The debris to the walls at low level (encapsulated) in the Boiler Room (Room 0/81) contain asbestos.

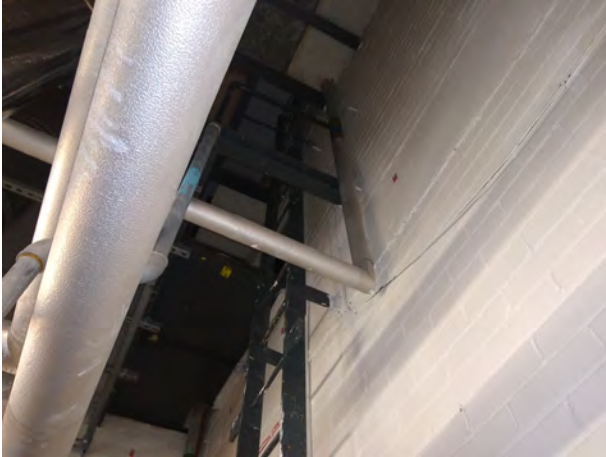
### **Item 40 Ref: 342052-2**

The debris to the walls at high level (encapsulated) in the Boiler Room (Room 0/81) contain asbestos.

Any change in its appearance should be recorded and passed to Property Services.

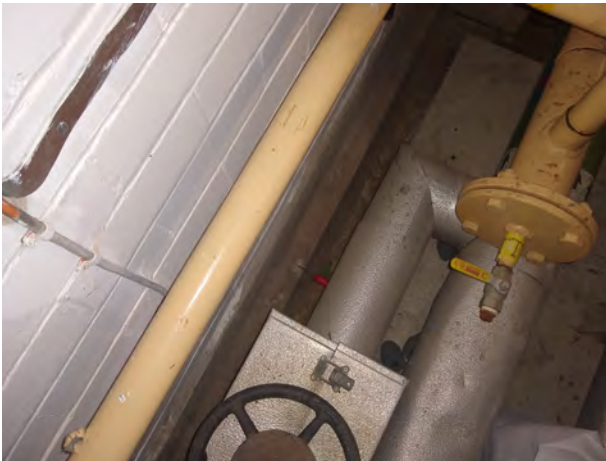
### **Item 41 Ref: 342052-3**

The debris to the ledge behind the boiler in the Boiler Room (Room 0/81) does contain asbestos.

Any change in its appearance should be recorded and passed to Property Services.

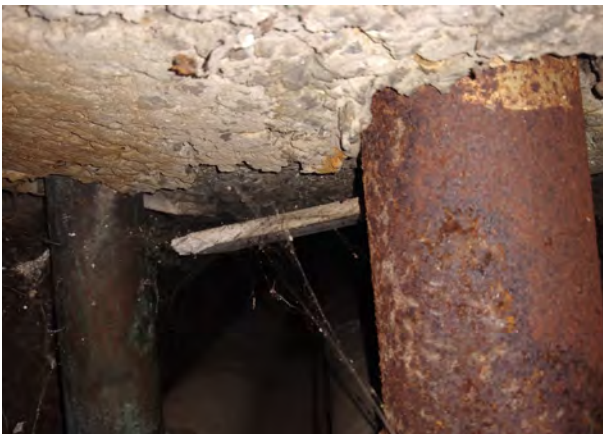
### **Item 44 Ref: 342052-6**

The shuttering to underside of floor above in the Boiler Room floor duct (Room 0/81) does contain asbestos.

Any change in its appearance should be recorded and passed to Property Services.

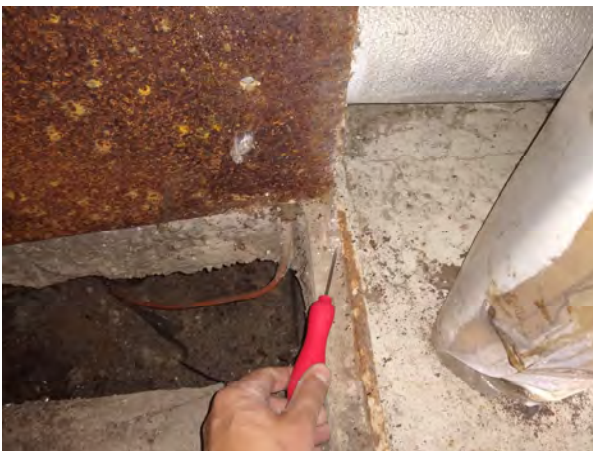
### **Item 45 Ref: 342052-7**

The debris to edge of wall top beneath metal cover plate in the Boiler Room floor duct (Room 0/81) does contain asbestos.

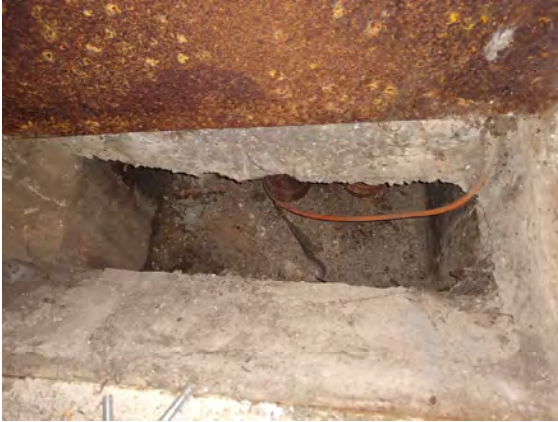
### **Item 46 Ref: 342052-8**

The general debris to the floor in the Boiler Room floor duct (Room 0/81) does contain asbestos.

Any change in its appearance should be recorded and passed to Property Services.

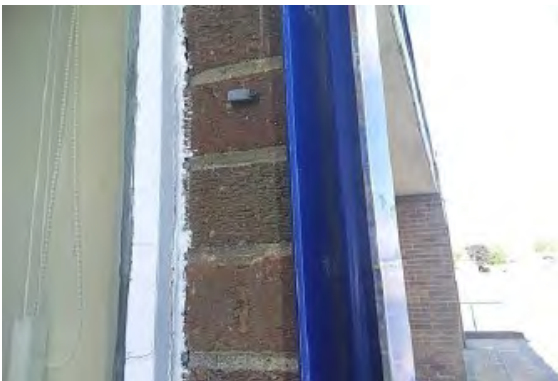
### **Item 48 Ref: 22-47237-2**

The residual frame sealant around windows in Area 2 – Junior Class 1 /Point A does contain asbestos.

*Removed August 2022*

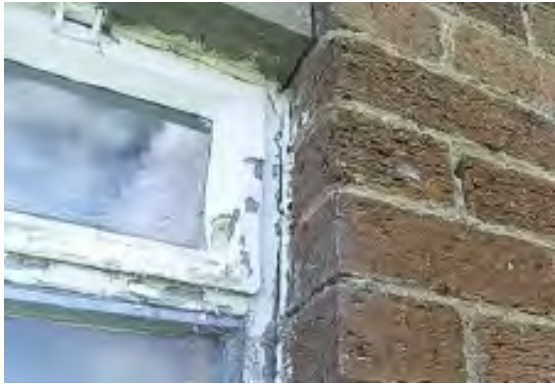
**Item 49 Ref: 22-47237-2**

The residual frame sealant around windows in Area 3 – Junior Class 3 /Point B does contain asbestos.

*Removed August 2022*

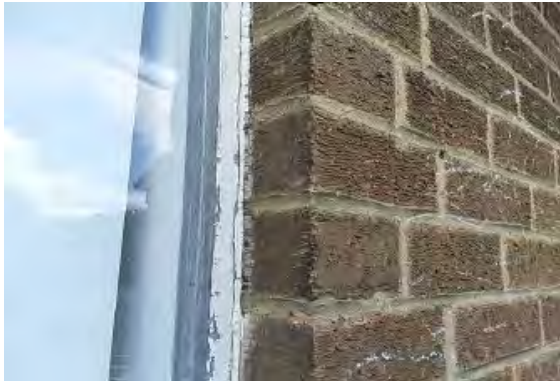
**Item 52 Ref: 22-47237-6**

The residual frame sealant around windows in Area 4 – Junior Class 4 /Point B does contain asbestos.

*Removed August 2022*

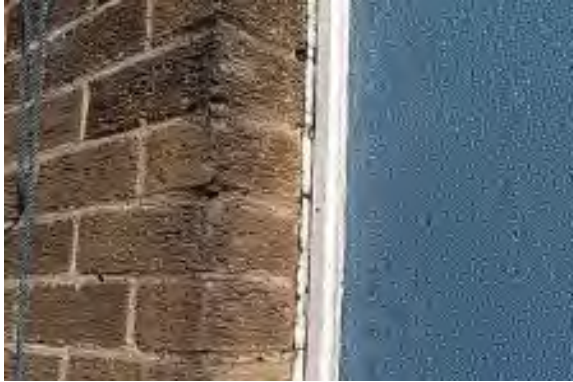
### **Item 55 Ref: 22-47237-6**

The residual frame sealant around windows in Area 6 – WC 2 /Point C does contain asbestos.

*Removed August 2022*

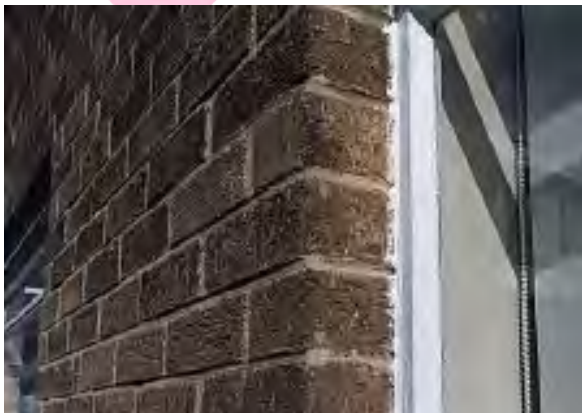
### **Item 57 Ref: 22-47237-3**

The residual frame sealant around windows in Area 7 – Head Teacher /Point D does contain asbestos.

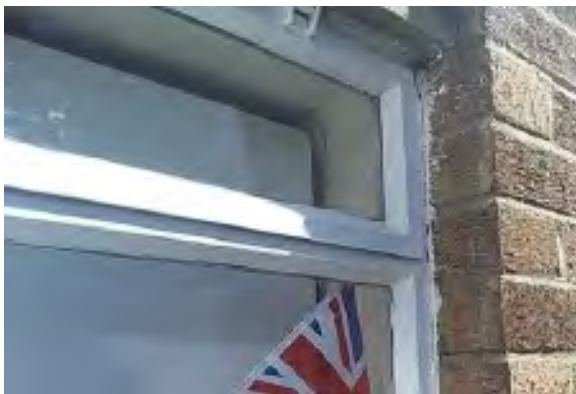
**Item 59 Ref: 22-47237-3**

The residual frame sealant around windows in Area 8 – Bursar /Point D does contain asbestos.

*Removed August 2022*

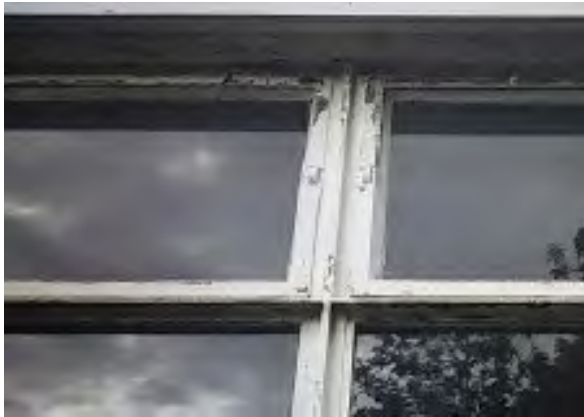
**Item 65 Ref: 22-47237-6**

The residual frame sealant around windows in Area 11 – Library /Point G does contain asbestos.

*Removed August 2022*

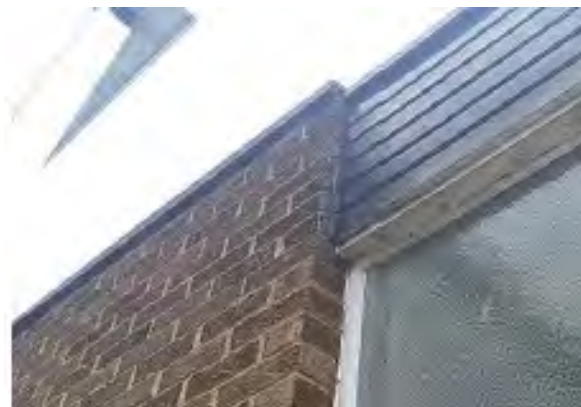
**Item 68 Ref: 22-47237-11**

The residual frame sealant around windows in Area 12 – Kitchen 1 /Point H does contain asbestos.

*Removed August 2022*

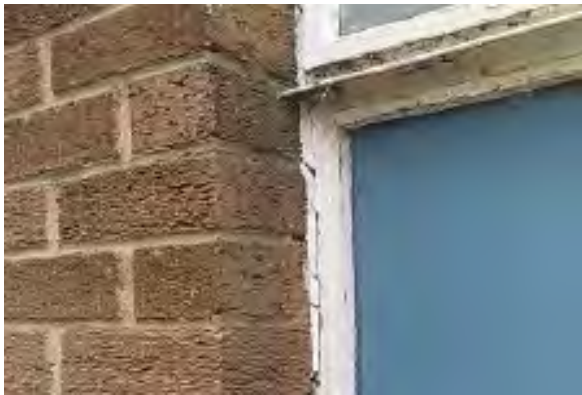
**Item 71 Ref: 22-47237-11**

The residual frame sealant around window and wood panelling in Area 13 – WC 3 /Point H does contain asbestos.

*Removed August 2022*

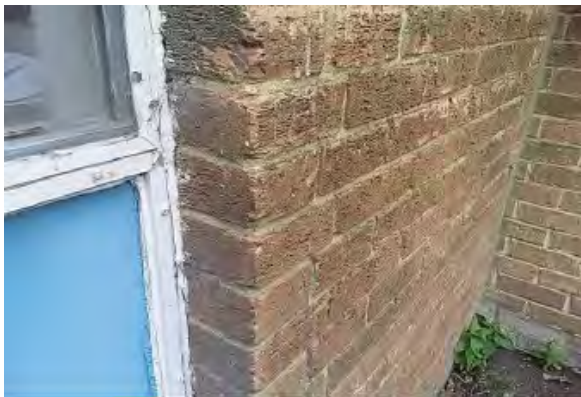
**Item 74 Ref: 22-47237-13**

The residual frame sealant around windows in Area 15 – Point I, J, K does contain asbestos.

*Removed August 2022*
