### **ASBESTOS SURVEY REPORT FOR THORNEY CLOSE PRIMARY SCHOOL, SUNDERLAND**

## THORNEY CLOSE PRIMARY SCHOOL, SUNDERLAND

**Date: 18 March 2025**

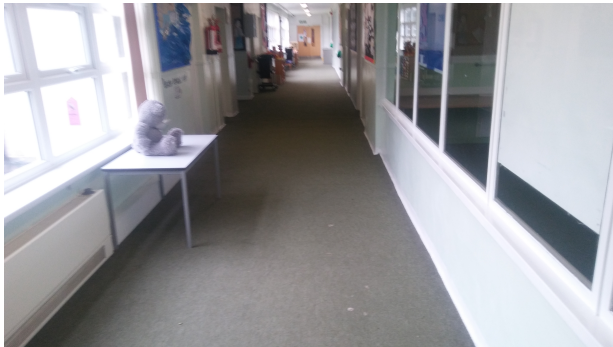
### **Item 1 - Presumed**

The Pipe lagging (01/School floor duct system) is presumed to contain asbestos.

Any change in its appearance should be recorded, and passed to Property Services.

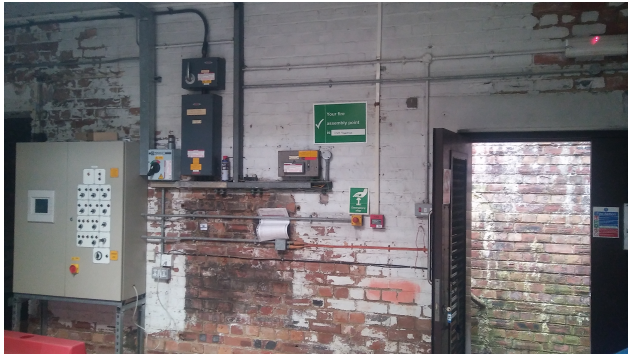
### **Item 2 - Ref: 203553-25**

The Debris to south wall (02/Boiler Room) does not contain asbestos.

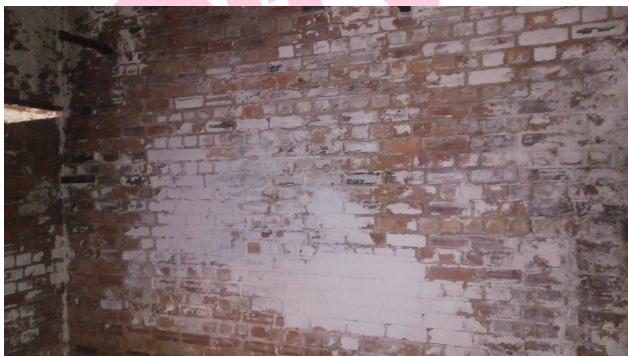
### **Item 3 - Ref: 203553-27**

The Debris to walls (03/Boiler Room Store) does not contain asbestos.

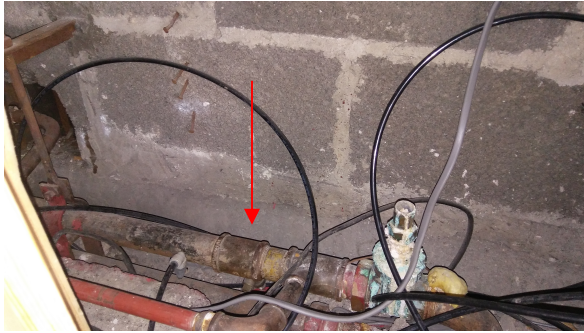
### **Item 4 - Ref: 203553-1**

Debris to walls and pipework (02/place 2be – old wall heater service void) contains asbestos

Any change in its appearance should be recorded, and passed to Property Services.

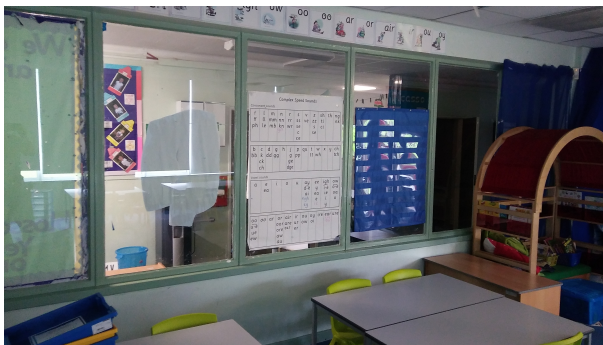
### **Item 5 - Ref: 203553-3**

The Putty to internal windows (04/Classroom 18) does not contain asbestos.

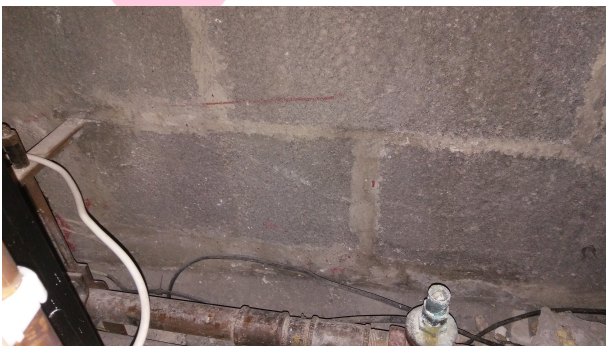
### **Item 6 - Ref: 203553-2**

The Debris to wall and pipework (04/Classroom 18-old wall heater service void) does not contain asbestos.

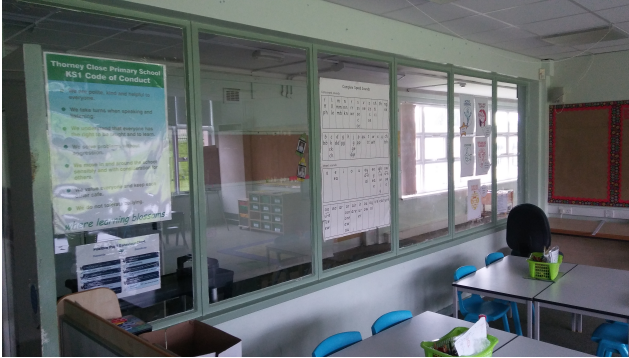
### **Item 7 - Ref: As 203553-3**

The Putty to internal windows (05/Classroom 17) does not contain asbestos.

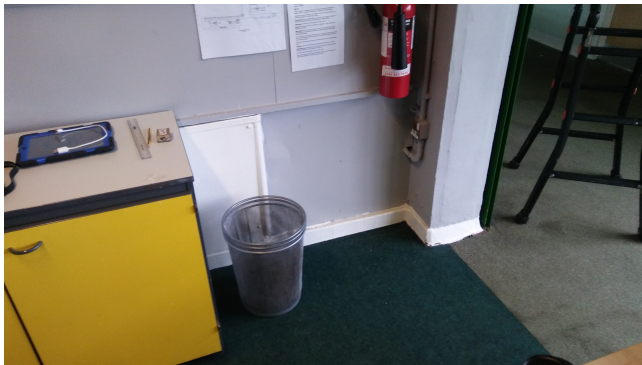
### **Item 8 - Presumed**

The Pipe Lagging (06/ICT suite – old wall heater service void) is presumed to contain asbestos.

Any change in its appearance should be recorded, and passed to Property Services.

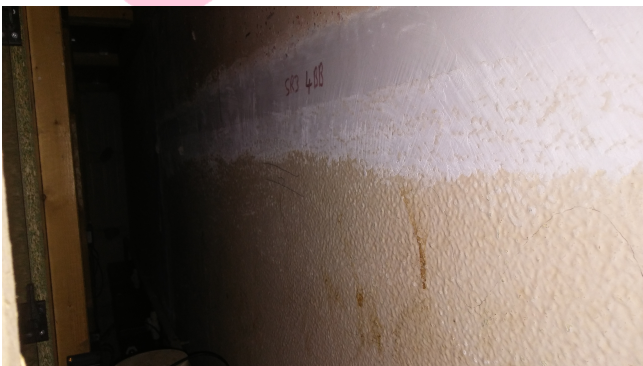
### **Item 9 – Ref:203553-4**

The Walls within cistern boxings (07/Girls toilet) does not contain asbestos.

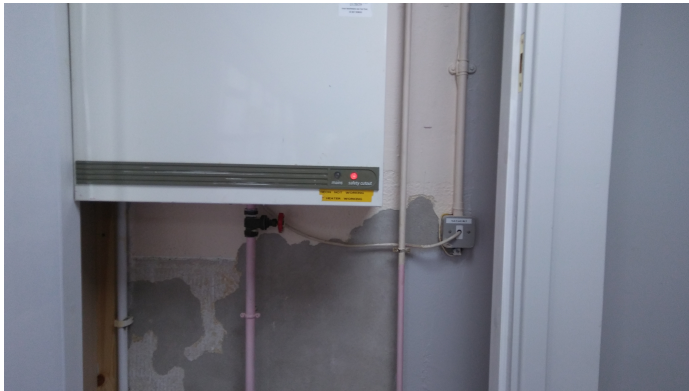
**Item 10- Ref: As203553-4**

The Walls (07/Girls toilet boiler cupboard) does not contain asbestos.

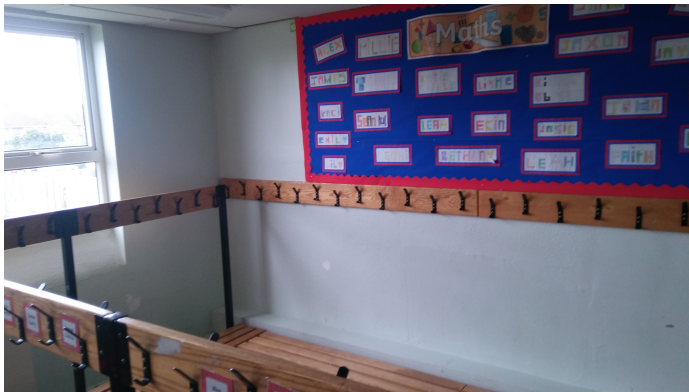
**Item 11- Ref: 203553-5**

The Walls (17/Cloakroom) do not contain asbestos.

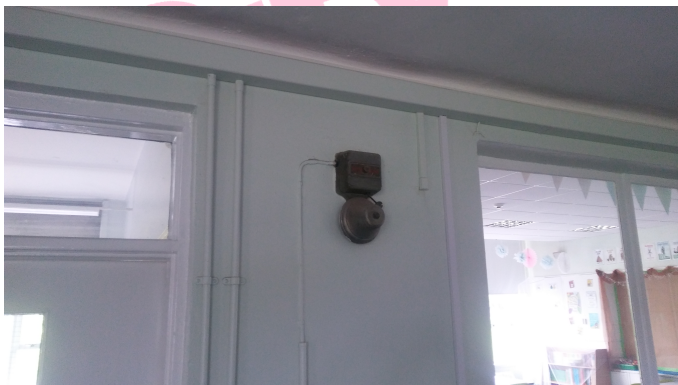
**Item 12- Ref: 203553-7**

The Rope to gents bell ringer (18/Top corridor) does not contain asbestos.

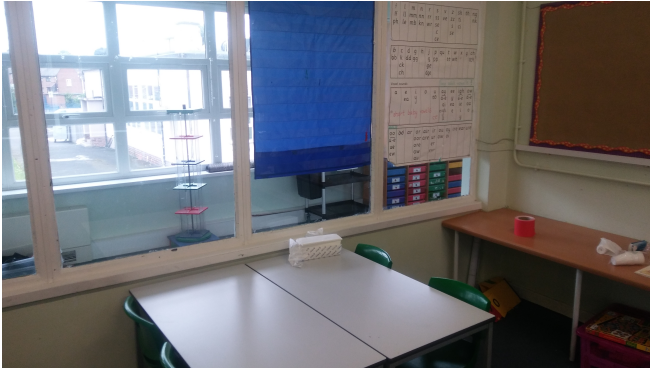
### **Item 13- Ref: As203553-3**

The Putty to internal windows (019/Classroom 16) does not contain asbestos.

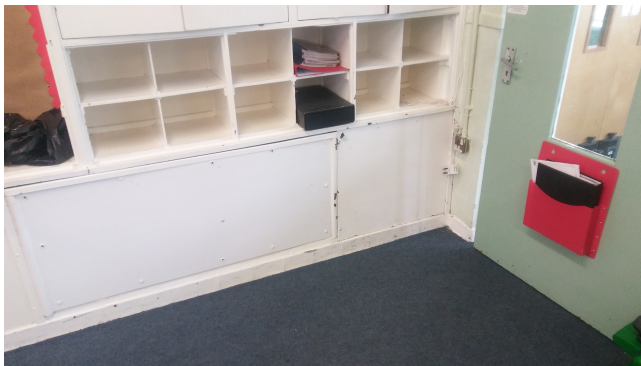
### **Item 14- Ref: 203553-6**

The Heater pipework lagging (019/Classroom 16-old wall heater service void) contains asbestos.

Any change in its appearance should be recorded, and passed to Property Services.

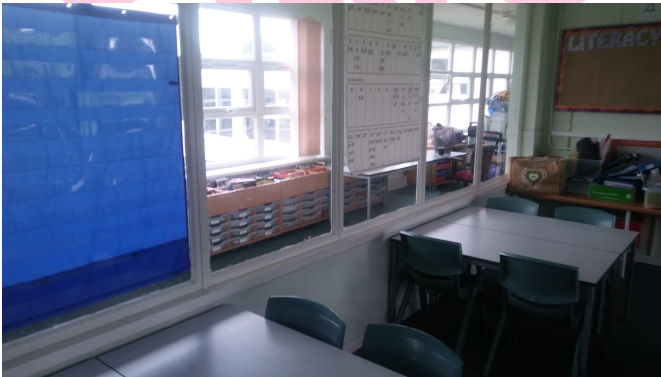
### **Item 15- Ref: As203553-3**

The Putty to internal windows (020/Classroom 15) does not contain asbestos.

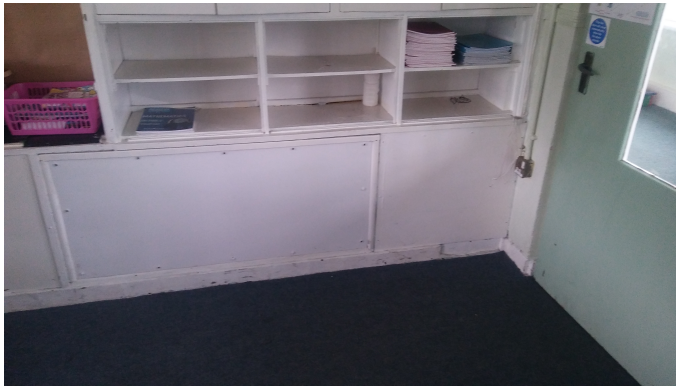
### **Item 16- Ref: As203553-6**

The Heater pipework lagging (020/Classroom 15-old wall heater service void) contains asbestos.

Any change in its appearance should be recorded, and passed to Property Services.

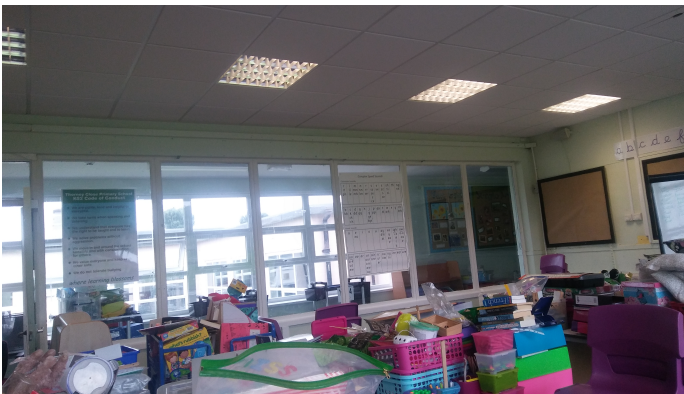
### **Item 17- Ref: As203553-3**

The Putty to internal windows (021/Classroom 14) does not contain asbestos.

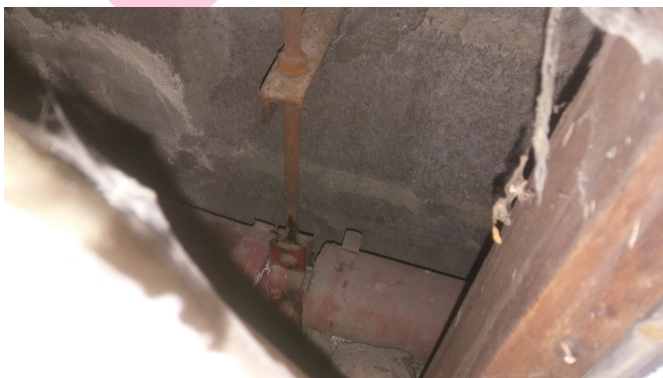
### **Item 18- Ref: As203553-6**

The Heater pipework lagging (021/Classroom 14-old wall heater service void) contains asbestos.

Any change in its appearance should be recorded and passed to Property Services.

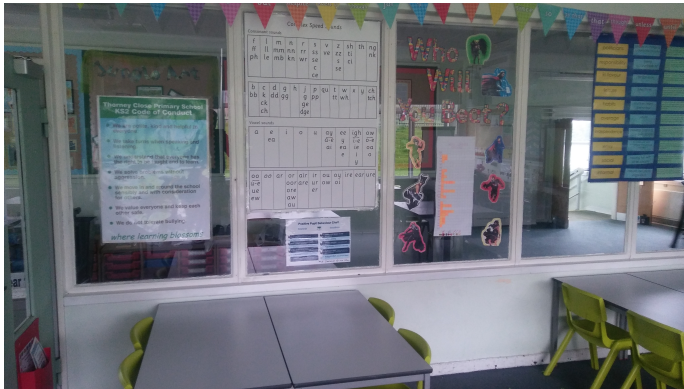
### **Item 19- Ref: As203553-3**

The Putty to internal windows (022/Classroom 13) does not contain asbestos.

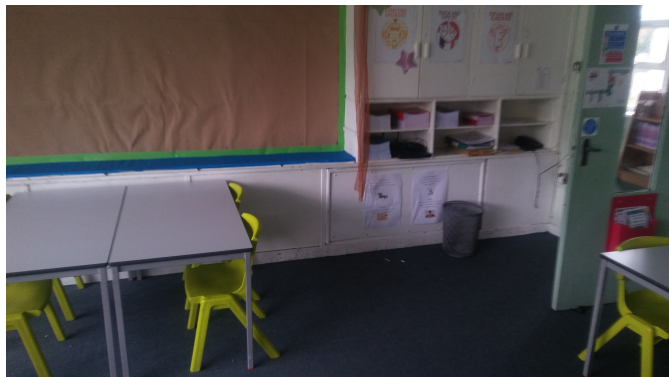
### **Item 20- Ref: As203553-6**

The Heater pipework lagging (022/Classroom 13-old wall heater service void) contains asbestos.

Any change in its appearance should be recorded and passed to Property Services.

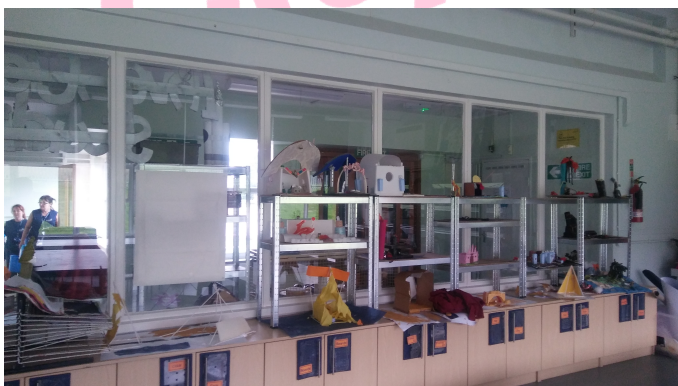
### **Item 21- Ref: As203553-3**

The Putty to internal windows (023/Intervention Shed Art Room) does not contain asbestos.

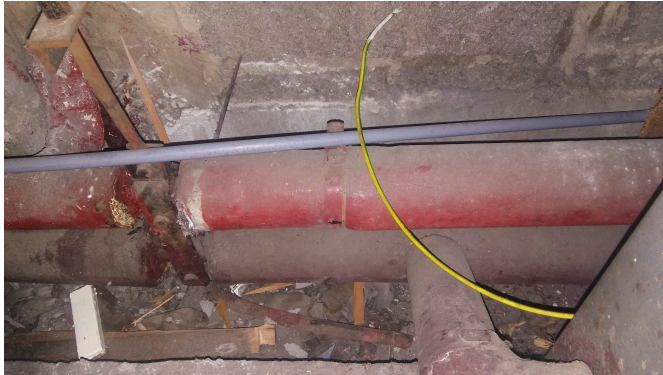
### **Item 22- Ref: As203553-6**

The Heater pipework lagging (023/ Intervention Shed Art Room-old wall heater service void) contains asbestos.

Any change in its appearance should be recorded and passed to Property Services.

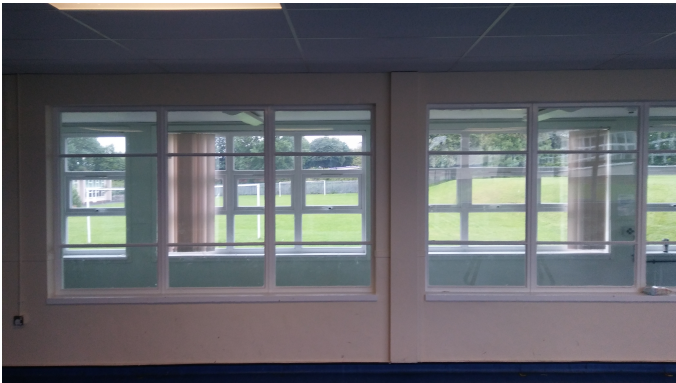
### **Item 23- Ref: 203553-8**

The Putty to internal windows (029/Diner) does not contain asbestos.

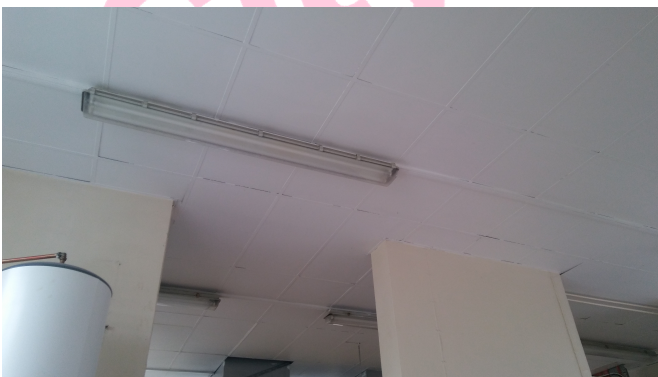
### **Item 24- Ref: 203553-10**

The Suspended ceiling tiles (030/Kitchen) does not contain asbestos.

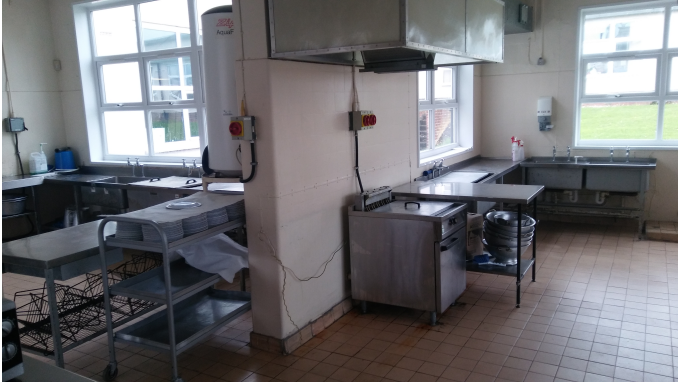
### **Item 25- Ref: 203553-11**

The sink paint (030/Kitchen) does not contain asbestos.

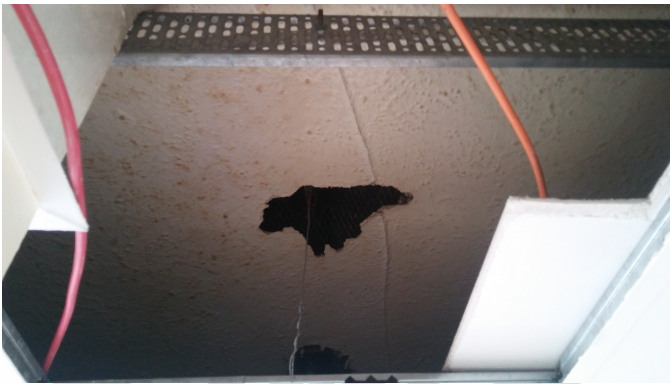
### **Item 26- Ref: 203553-9**

The Ceiling (030/Kitchen-void above) contains asbestos.

Any change in its appearance should be recorded and passed to Property Services.

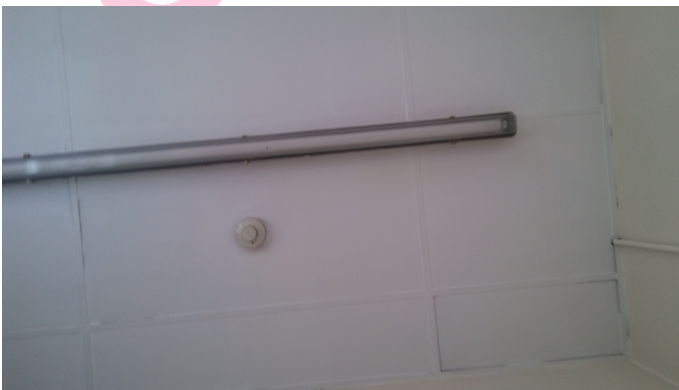
### **Item 27-Ref:As203553-10**

The Suspended ceiling tiles (032/Kitchen office) do not contain asbestos.

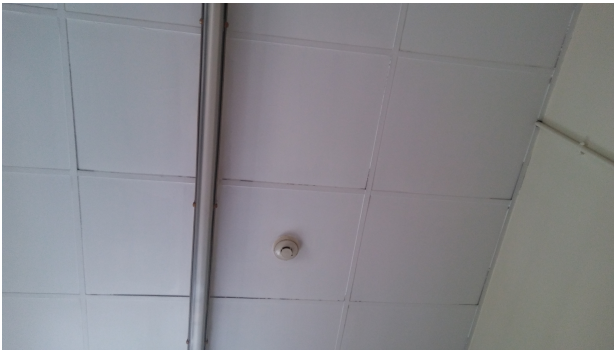
**Item 28-Ref:As203553-10**

The Suspended ceiling tiles (033/Kitchen store) do not contain asbestos.

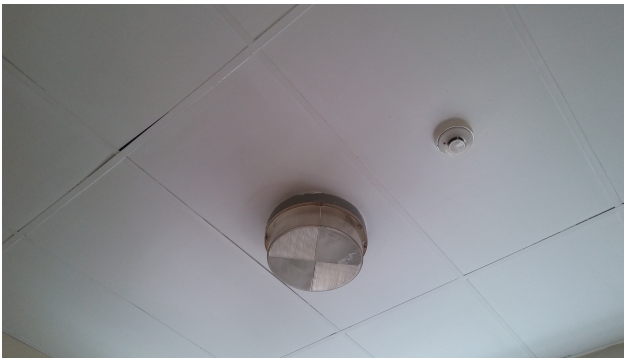
**Item 29-Ref:As203553-10**

The Suspended ceiling tiles (035/Chiller Room) do not contain asbestos.

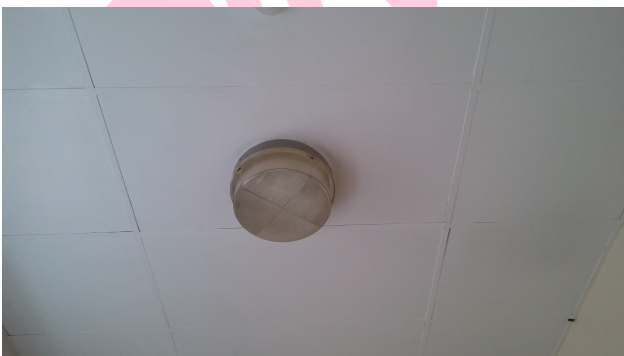
**Item 30-Ref:As203553-10**

The Suspended ceiling tiles (036/Pantry) do not contain asbestos.

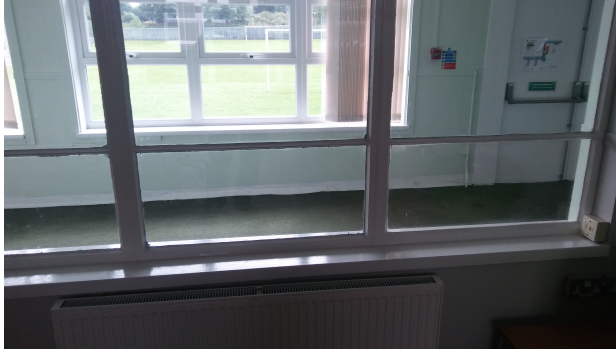
**Item 31- Ref: As203553-8**

The Putty to internal windows (038/Office) does not contain asbestos.

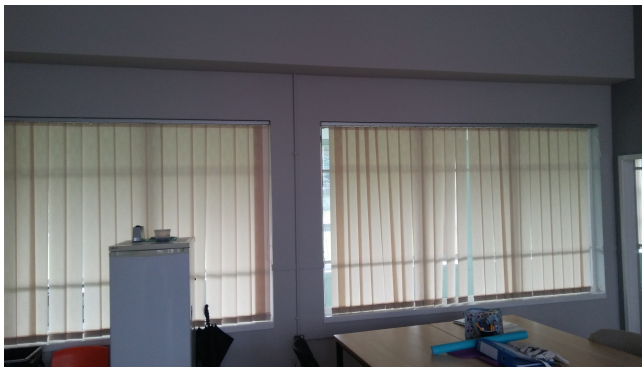
**Item 32- Ref: As203553-8**

The Putty to internal windows (039/Staff room) does not contain asbestos.

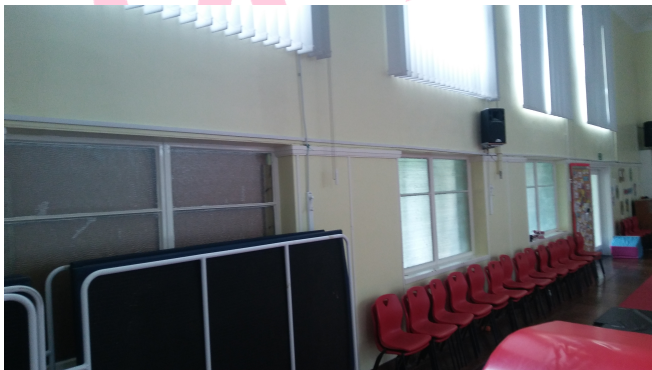
**Item 33- Ref: As203553-8**

The Putty to internal windows (046/Gym) does not contain asbestos.

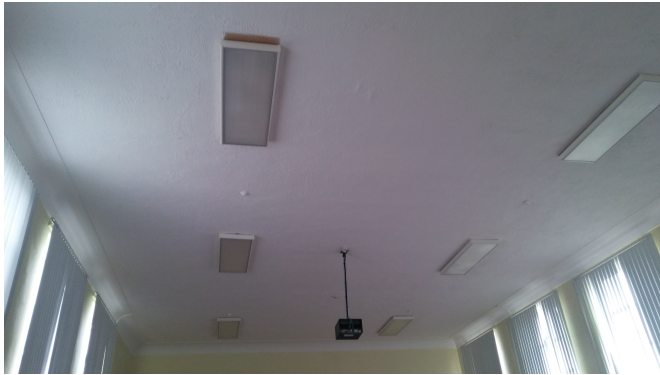
### **Item 34 - Presumed**

The Ceiling (046/Gym) is presumed to contain asbestos.

Any change in its appearance should be recorded and passed to Property Services.

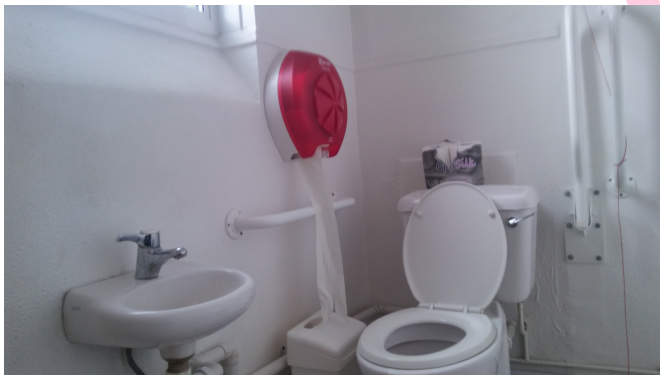
### **Item 35- Ref: 203553-12**

The Walls (051/Disabled WC) do not contain asbestos.

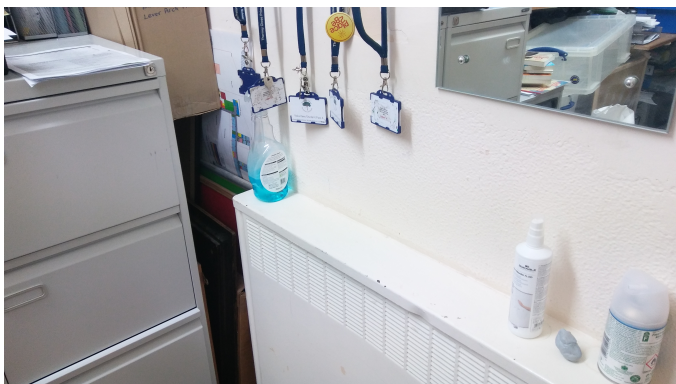
### **Item 36-Ref:As203553-12**

The Walls (056/File Room) do not contain asbestos.

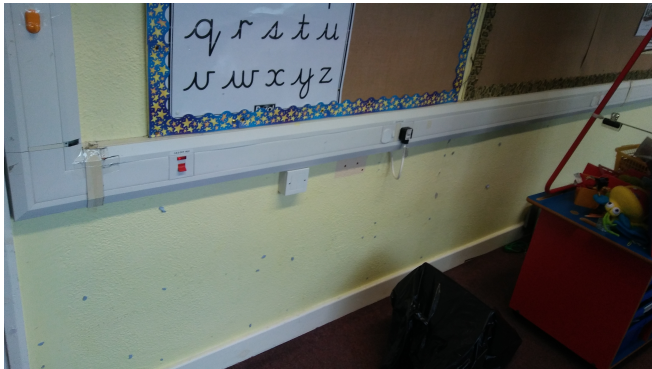
### **Item 37- Ref: 203553-13**

The Walls (063/Classroom 11)  
do not contain asbestos.

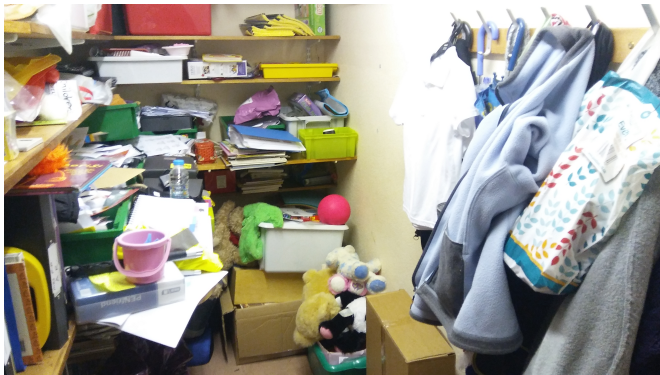
### **Item 38-Ref:As203553-13**

The Walls (064/Games Store)  
do not contain asbestos.

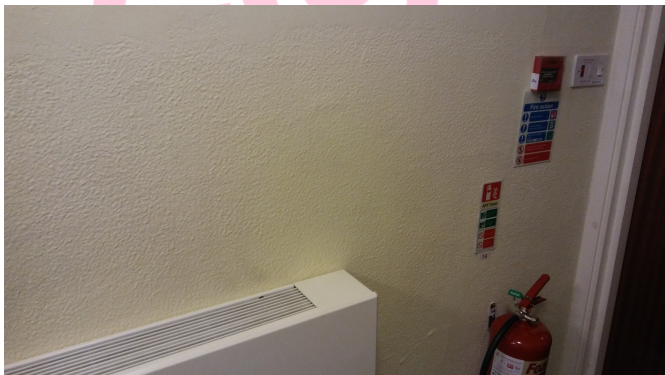
### **Item 39-Ref:As203553-13**

The Walls (065/Corridor) do  
not contain asbestos.

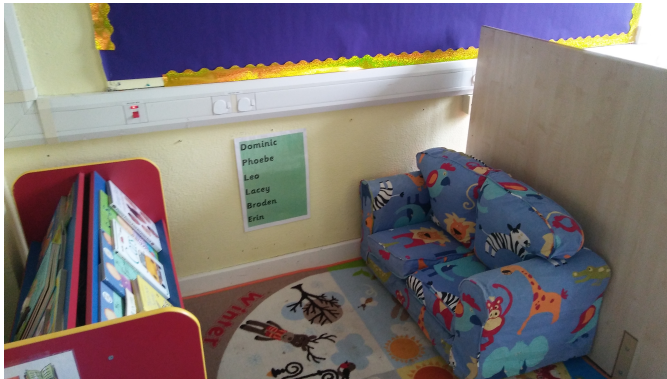
**Item 40-Ref:As203553-13**

The Walls (066/Classroom 10)  
do not contain asbestos.

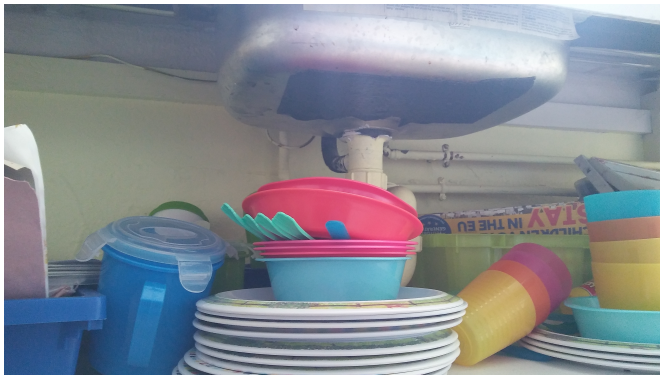
**Item 41-Ref: 203553-14**

The Sink Pad (066/Classroom  
10) do not contain asbestos.

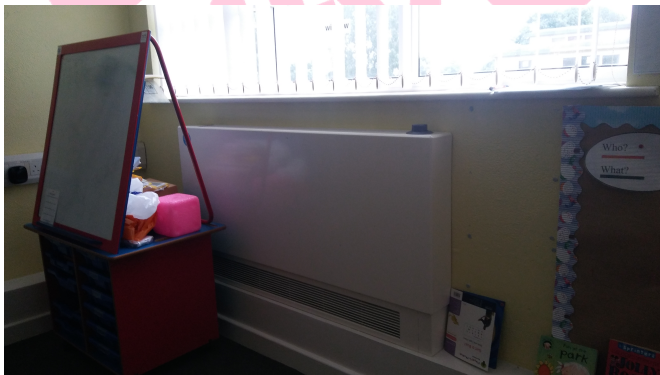
**Item 42-Ref:As203553-13**

The Walls (067/Classroom 9)  
do not contain asbestos.

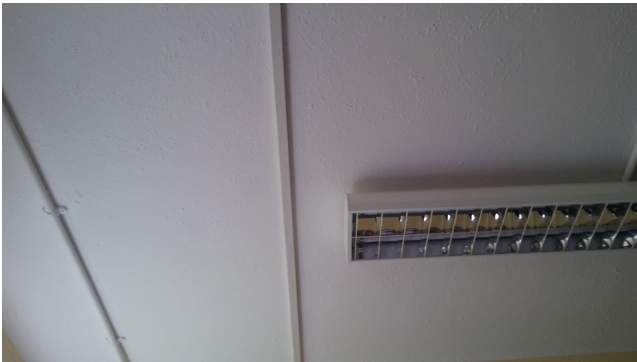
**Item 43-Ref: 203553-15**

The Ceiling (071/Deputy Head Office Lobby) does not contain asbestos.

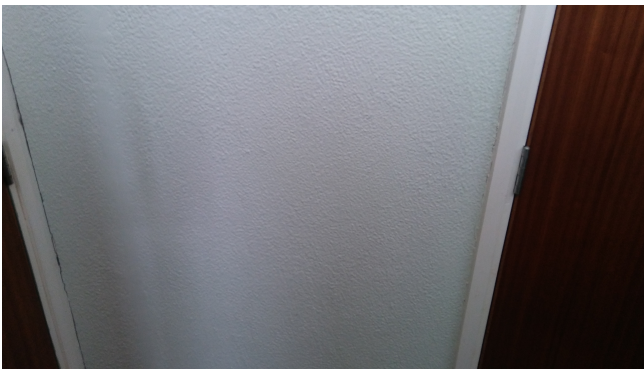
**Item 44-Ref:As203553-13**

The Walls (071/Deputy Heads office lobby) do not contain asbestos.

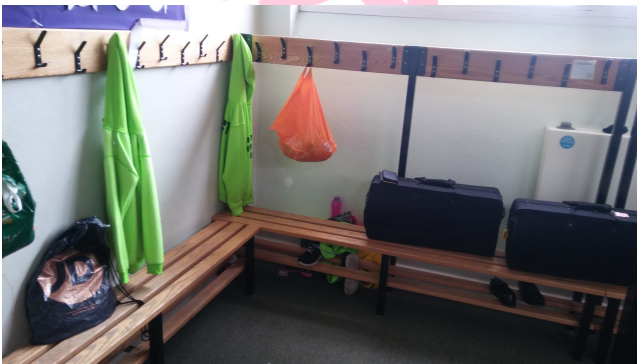
**Item 45-Ref: 203553-16**

The Ceiling (072/Cloakroom) does not contain asbestos.

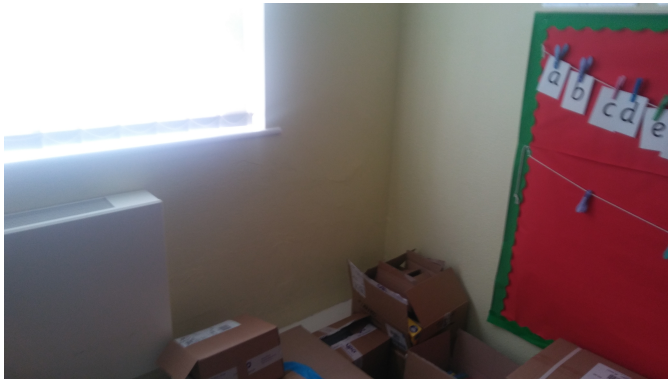
**Item 46-Ref: 203553-18**

The Walls (085/Classroom 3)  
do not contain asbestos.

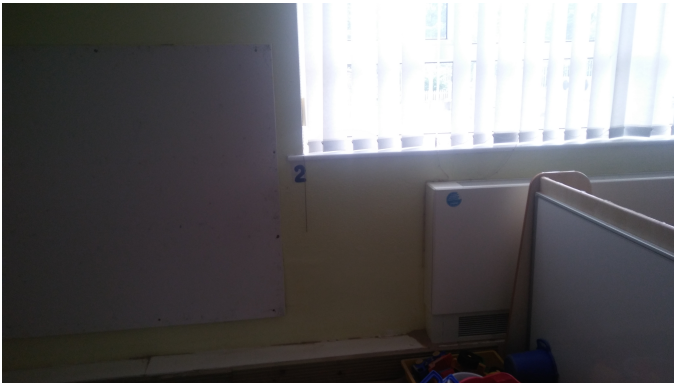
**Item 47-Ref:As203553-18**

The Walls (087/Nursery  
Classroom 1) do not contain  
asbestos.

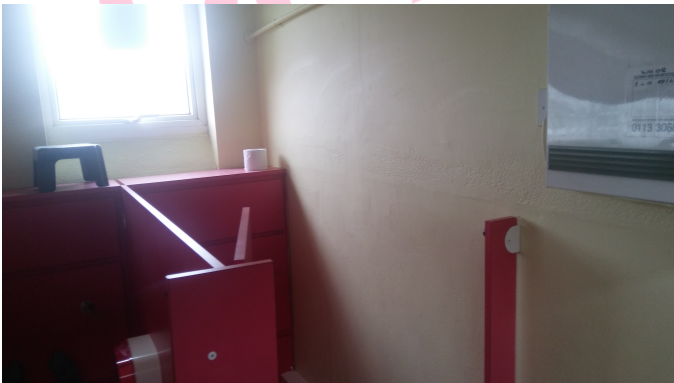
**Item 48-Ref:As203553-18**

The Walls (088/Nursery  
Classroom 1 toilet) do not  
contain asbestos.

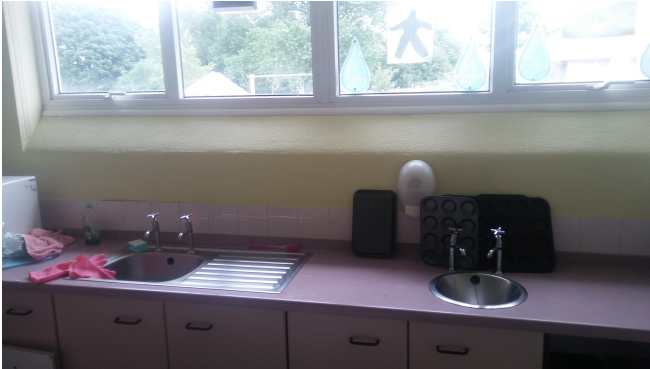
### **Item 49-Ref:As203553-18**

The Walls (089/Nursery Classroom 1 kitchen) do not contain asbestos.

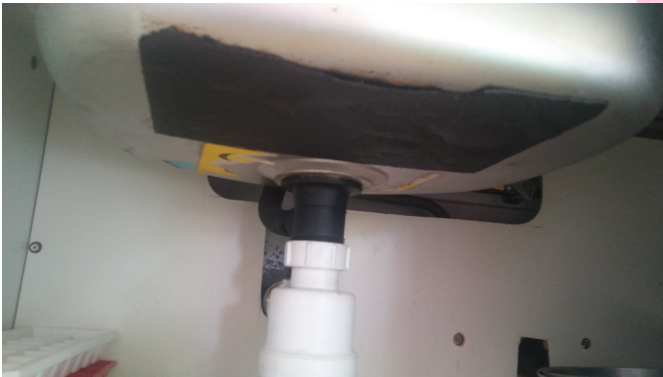
### **Item 50-Ref: 203553-19**

The Sink Pad (089/Nursery Classroom 1 kitchen) do not contain asbestos.

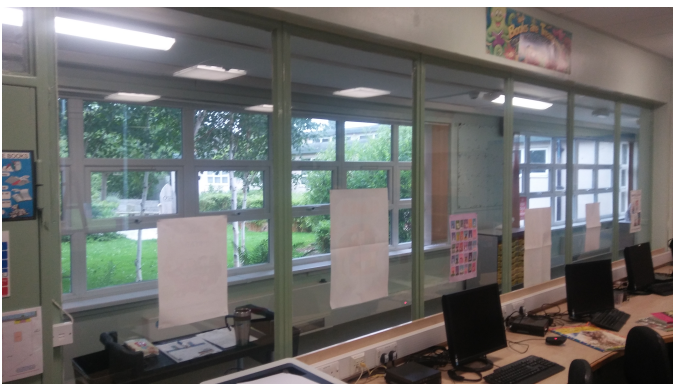
### **Item 51-Ref: 203553-20**

The Window Putty (095/Library) does not contain asbestos.

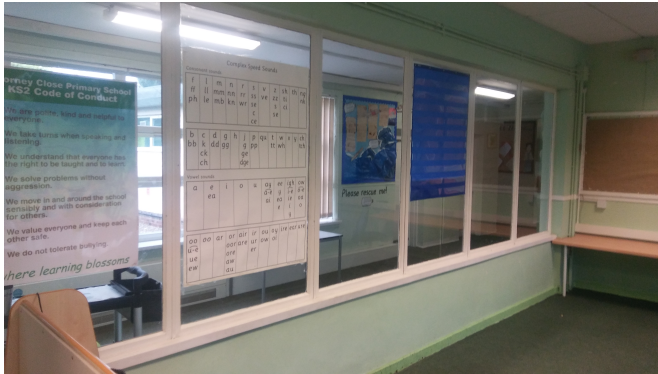
### **Item 52-Ref:As203553-20**

The Window Putty (096/Classroom 8) does not contain asbestos.

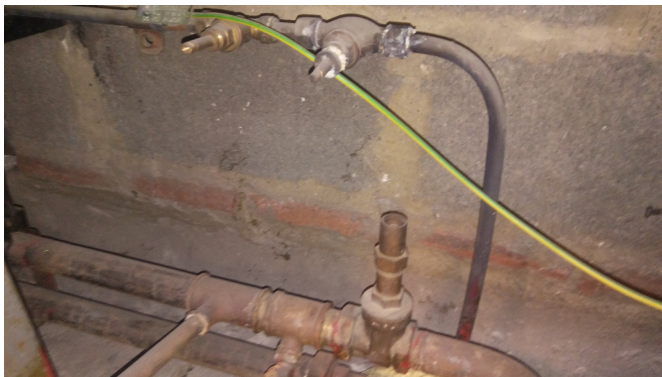
### **Item 53-Ref: 203553-21**

The Debris to wall and pipework (096/Classroom 8-old wall heater service void) does not contain asbestos.

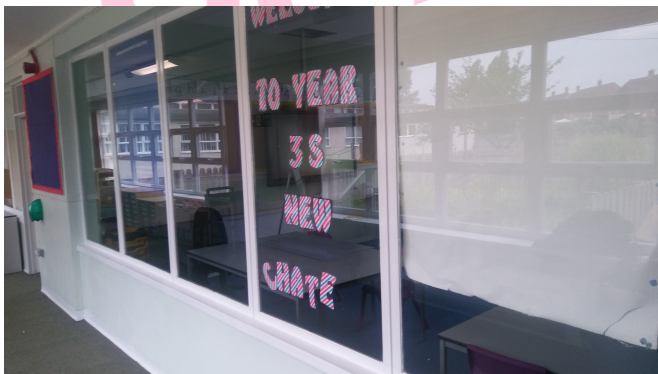
### **Item 54-Ref:As203553-20**

The Window Putty (099/Classroom 7) does not contain asbestos.

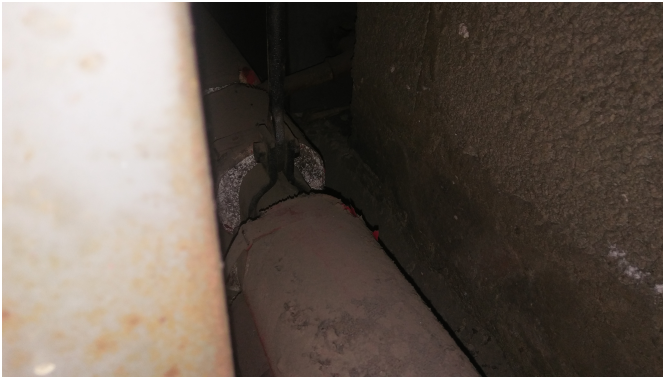
### **Item 55-Ref: 203553-22**

The Pipework (099/Classroom 7-old wall heater service void) contains asbestos.

Any change in its appearance should be recorded, and passed to Property Services.

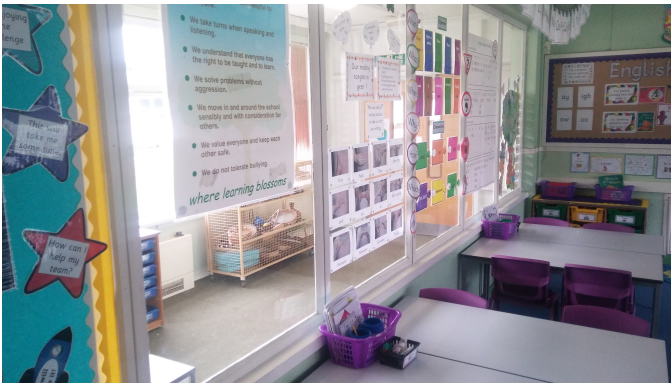
### **Item 56-Ref:As203553-20**

The Window Putty (100/Classroom 6) does not contain asbestos.

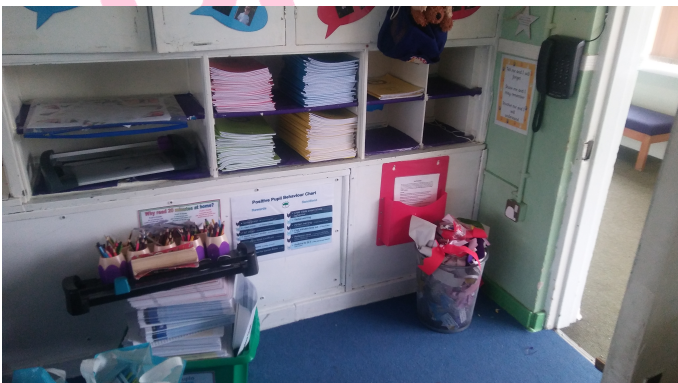
### **Item 57-Ref:As203553-22**

The Pipework (099/Classroom 6-old wall heater service void) contains asbestos.

Any change in its appearance should be recorded and passed to Property Services.

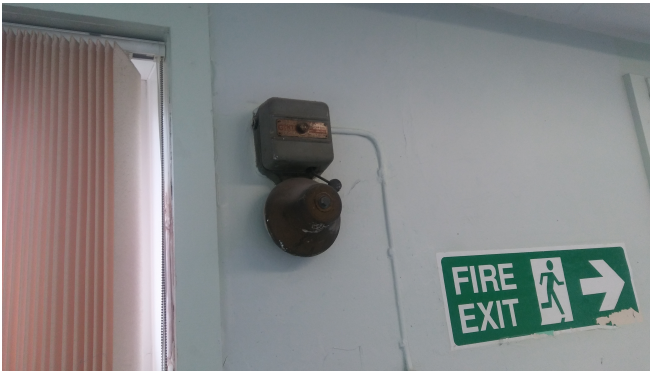
### **Item 58- Ref:As203553-7**

The Rope to gents bell ringer (101/lower corridor) does not contain asbestos.

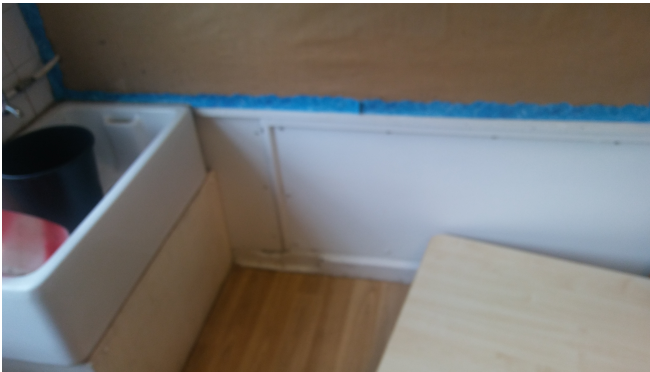
### **Item 59-Ref:As203553-22**

The Pipework (104/Classroom 5-old wall heater service void) contains asbestos.

Any change in its appearance should be recorded and passed to Property Services.

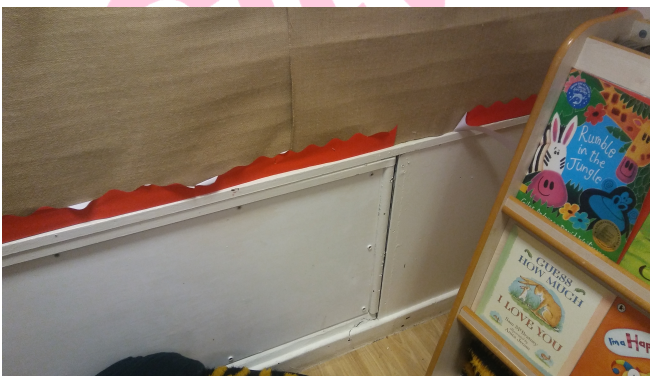
### **Item 60-Ref:As203553-22**

The Pipework (105/Classroom 4-old wall heater service void) contains asbestos.

Any change in its appearance should be recorded, and passed to Property Services.

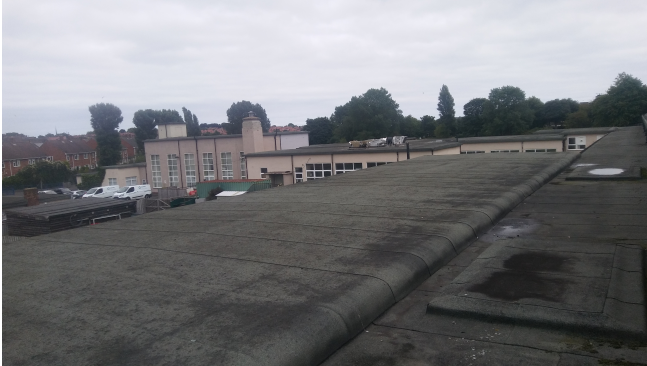
### **Item 61- Ref: 203553-17**

The Flat roof felt (999/Externals) does not contain asbestos.

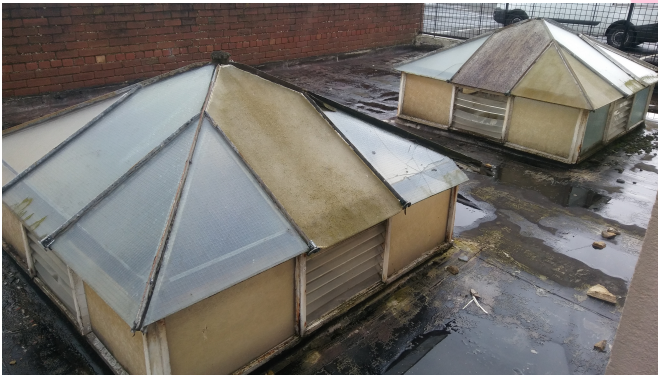
### **Item 62-Ref: 203553-30**

The Rope to boiler room skylights (999/Externals) contains asbestos.

Any change in its appearance should be recorded and passed to Property Services.

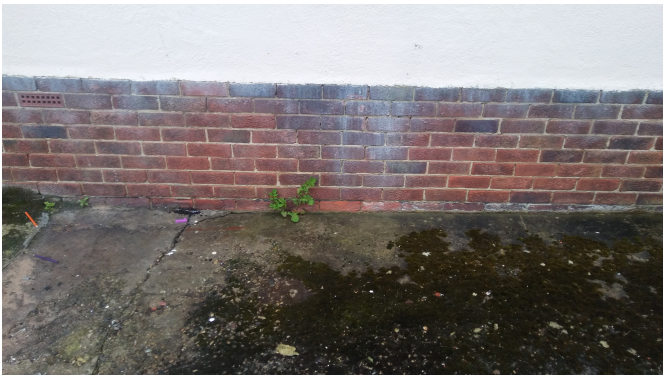
### **Item 63- Ref: 203553-31**

The Damp proof course (999/Externals) does not contain asbestos.

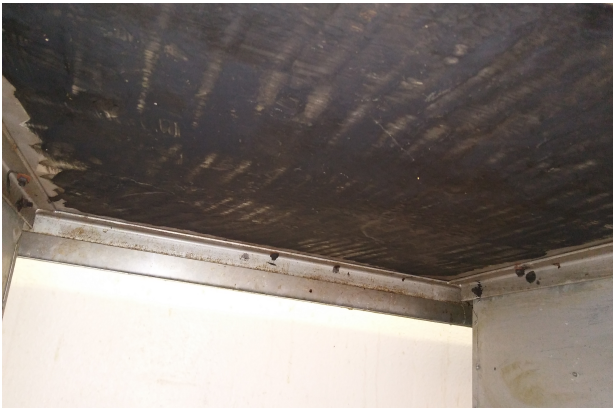
### **Item 67 – 271311-2**

The acoustic paint to the underside of metal work benches (Room 030/kitchen) does not contain asbestos.

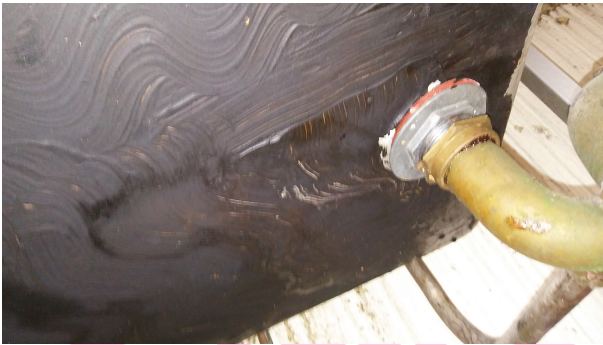
### **Item 68 – 271311-3**

The gasket to the hot water sinks (Room 030/kitchen) does contain asbestos.

Any change in its appearance should be reported to Property Services.
