ASBESTOS SURVEY REPORT FOR THORNEY CLOSE PRIMARY SCHOOL, SUNDERLAND

Asbestos Register for

THORNEY CLOSE PRIMARY SCHOOL, SUNDERLAND

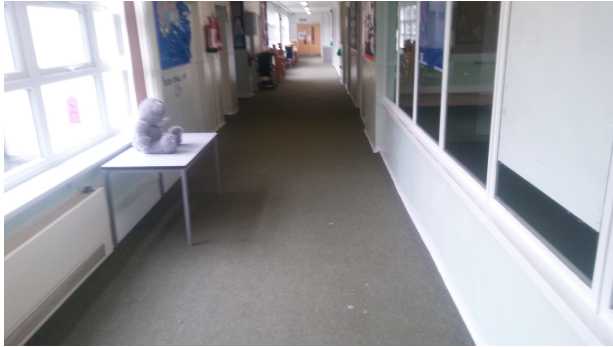
Item 1 - Presumed

The Pipe lagging (01/School floor duct system) is presumed to contain asbestos.

Any change in its appearance should be recorded, and passed to Property Services.

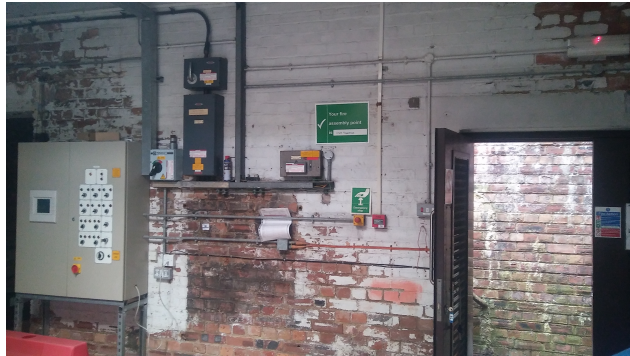
Item 2 - Ref: 203553-25

The Debris to south wall (02/Boiler Room) does not contain asbestos.

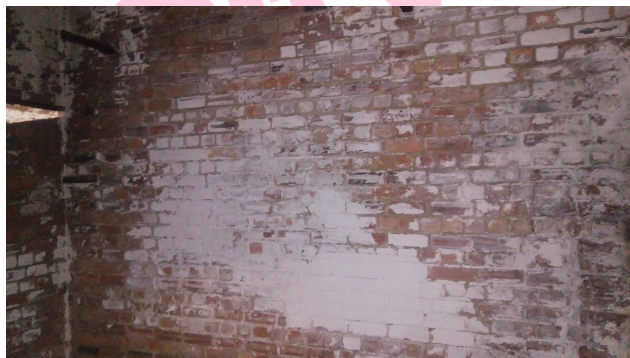
Item 3 - Ref: 203553-27

The Debris to walls (03/Boiler Room Store) does not contain asbestos.

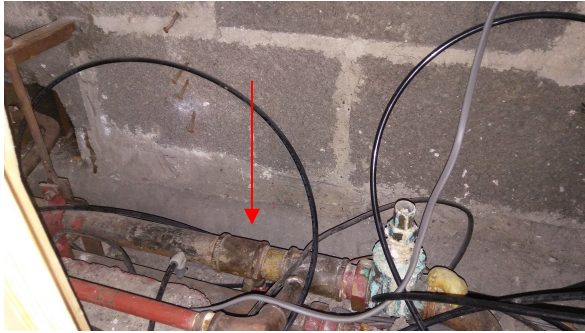
Item 4 - Ref: 203553-1

Debris to walls and pipework (02/place 2be – old wall heater service void) contains asbestos

Any change in its appearance should be recorded, and passed to Property Services.

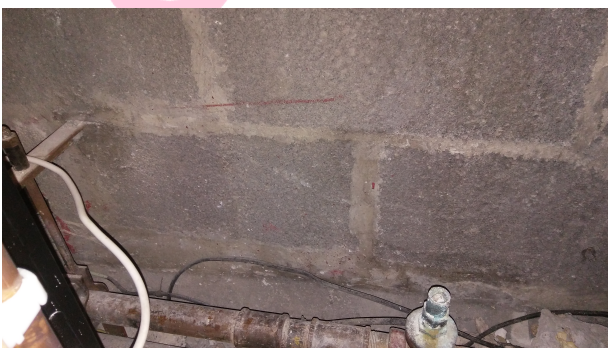
Item 6 - Ref: 203553-2

The Debris to wall and pipework (04/Classroom 18-old wall heater service void) does not contain asbestos.

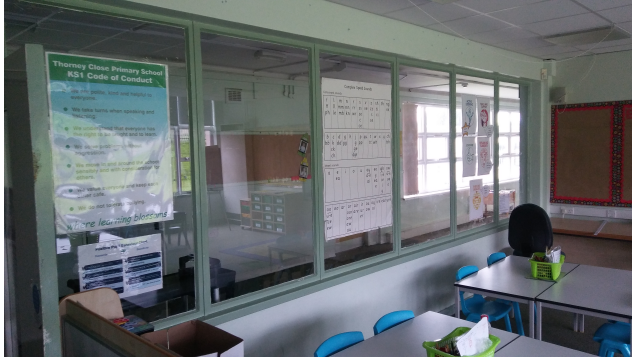
Item 7 - Ref: As 203553-3

The Putty to internal windows (05/Classroom 17) does not contain asbestos.

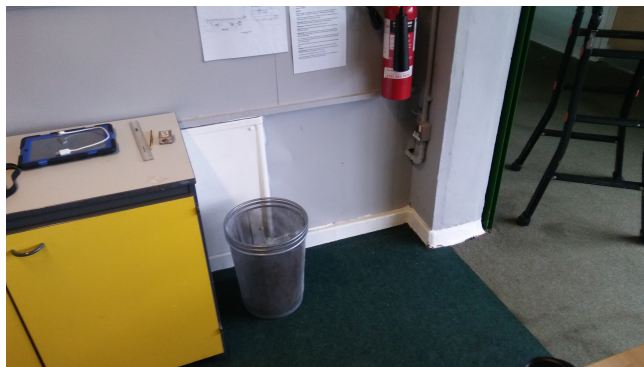
Item 8 - Presumed

The Pipe Lagging (06/ICT suite – old wall heater service void) is presumed to contain asbestos.

Any change in its appearance should be recorded, and passed to Property Services.

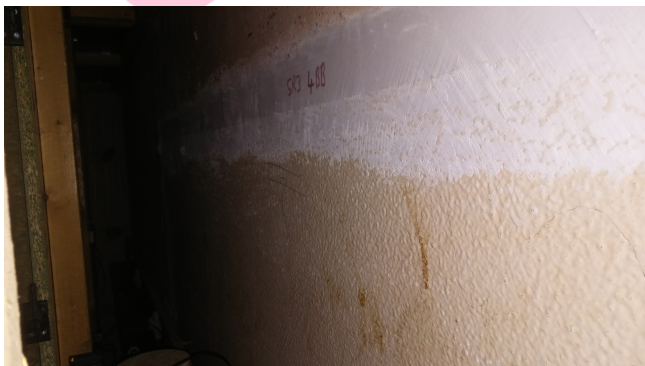
Item 9 – Ref:203553-4

The Walls within cistern boxings (07/Girls toilet) does not contain asbestos.

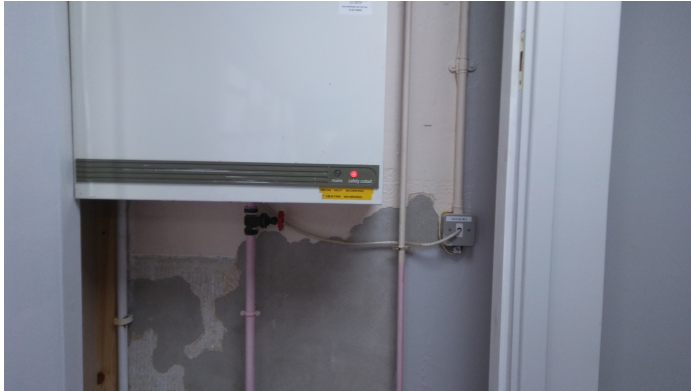
Item 10- Ref: As203553-4

The Walls (07/Girls toilet boiler cupboard) does not contain asbestos.

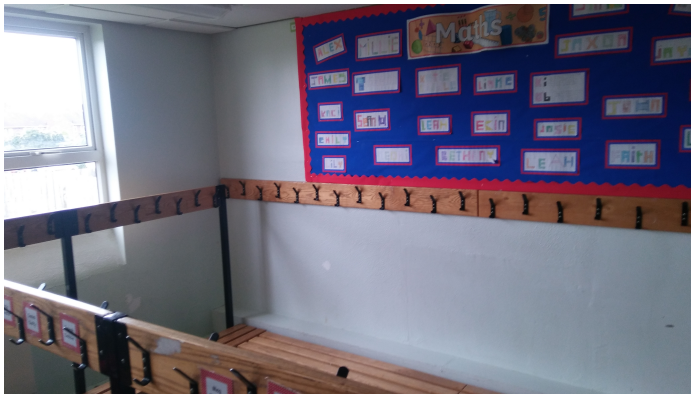
Item 11- Ref: 203553-5

The Walls (17/Cloakroom) do not contain asbestos.

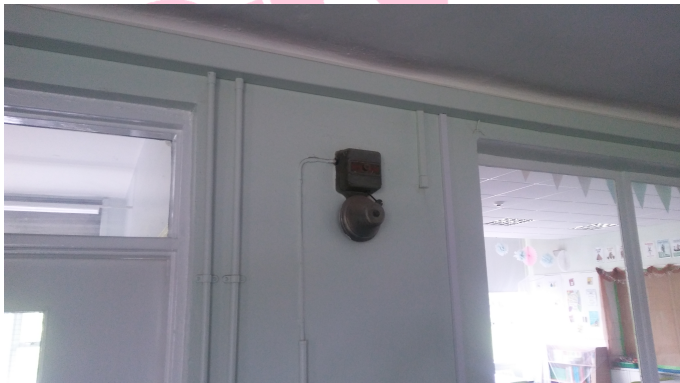
Item 12- Ref: 203553-7

The Rope to gents bell ringer (18/Top corridor) does not contain asbestos.

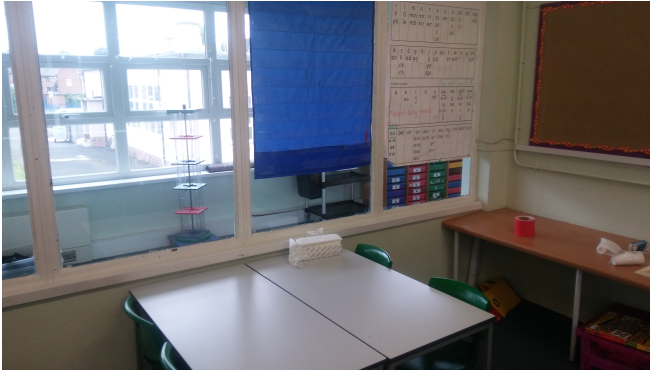
Item 13- Ref: As203553-3

The Putty to internal windows (019/Classroom 16) does not contain asbestos.

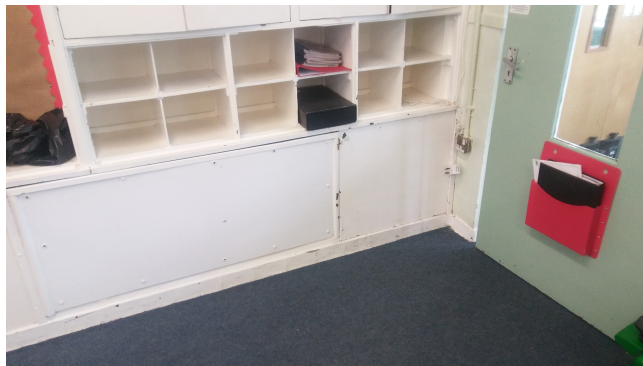
Item 14- Ref: 203553-6

The Heater pipework lagging (019/Classroom 16-old wall heater service void) contains asbestos.

Any change in its appearance should be recorded, and passed to Property Services.

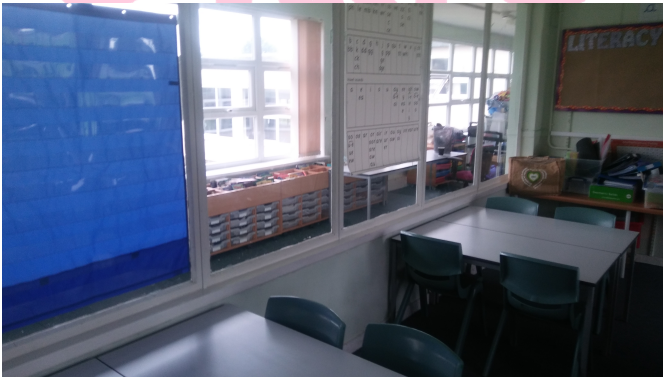
Item 15- Ref: As203553-3

The Putty to internal windows (020/Classroom 15) does not contain asbestos.

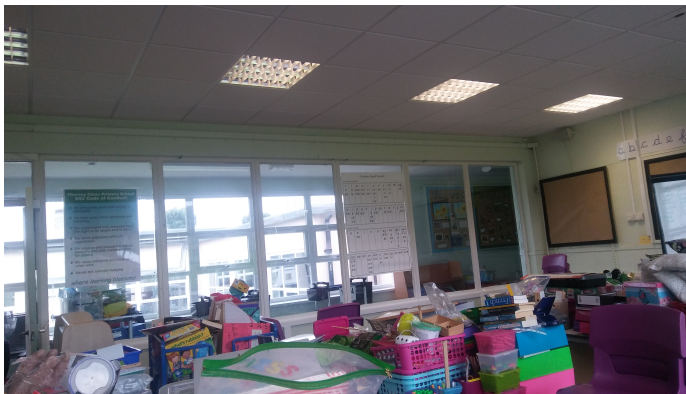
Item 17- Ref: As203553-3

The Putty to internal windows (021/Classroom 14) does not contain asbestos.

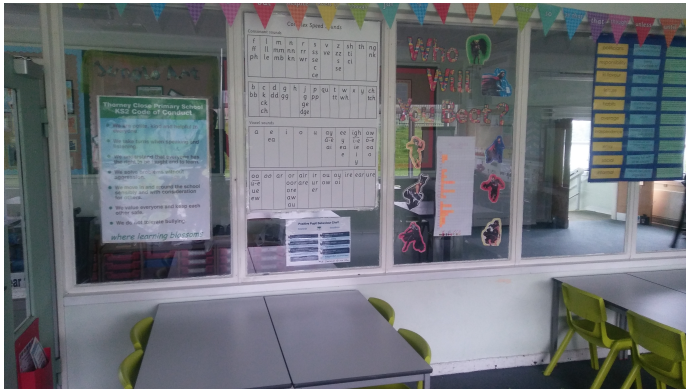
Item 19- Ref: As203553-3

The Putty to internal windows (022/Classroom 13) does not contain asbestos.

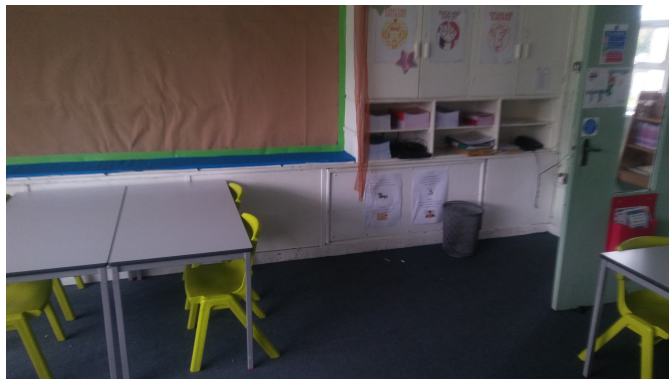
Item 20- Ref: As203553-6

The Heater pipework lagging (022/Classroom 13-old wall heater service void) contains asbestos.

Any change in its appearance should be recorded and passed to Property Services.

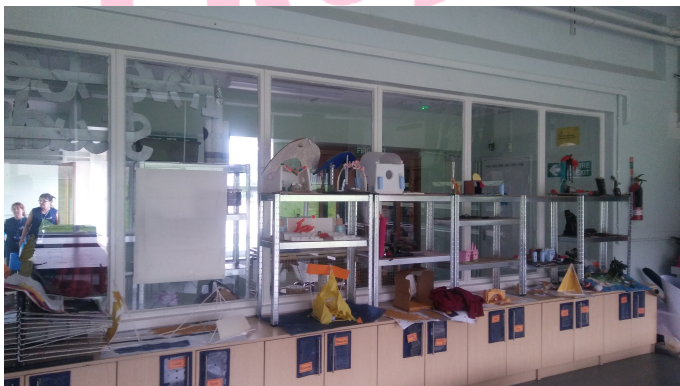
Item 21- Ref: As203553-3

The Putty to internal windows (023/Intervention Shed Art Room) does not contain asbestos.

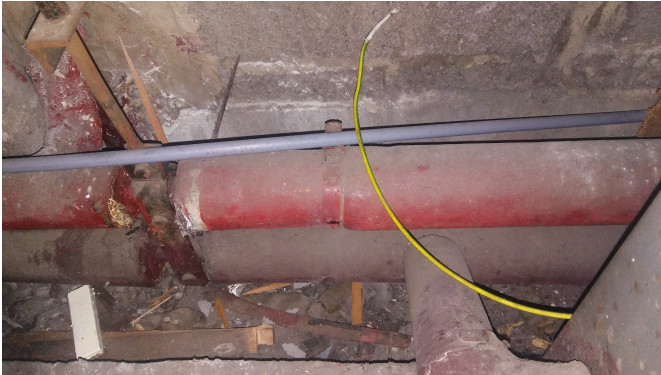
Item 22- Ref: As203553-6

The Heater pipework lagging (023/ Intervention Shed Art Room-old wall heater service void) contains asbestos.

Any change in its appearance should be recorded and passed to Property Services.

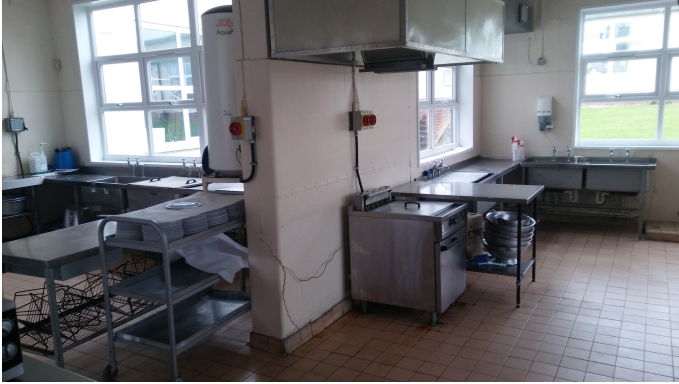
Item 25- Ref: 203553-11

The sink paint (030/Kitchen) does not contain asbestos.

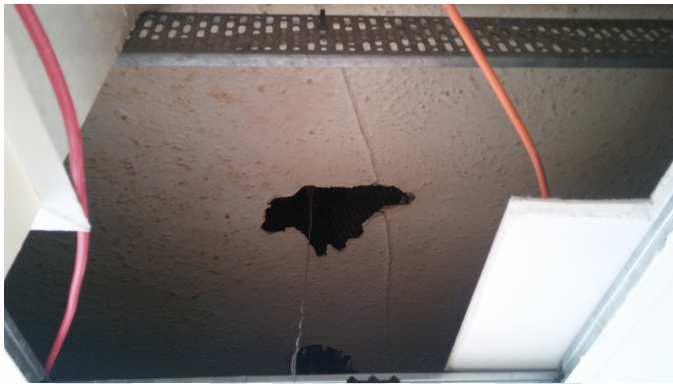
Item 26- Ref: 203553-9

The Ceiling (030/Kitchen-void above) contains asbestos.

Any change in its appearance should be recorded and passed to Property Services.

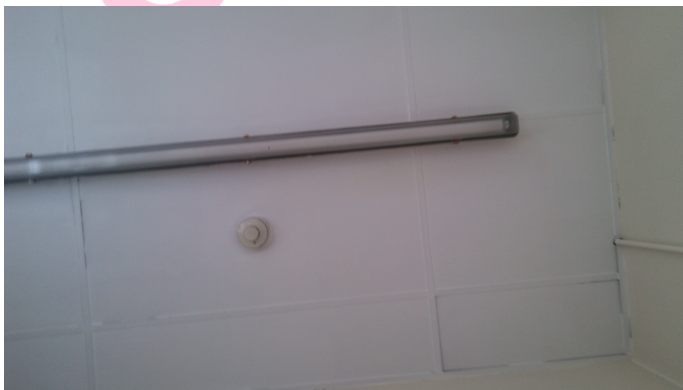
Item 27-Ref:As203553-10

The Suspended ceiling tiles (032/Kitchen office) do not contain asbestos.

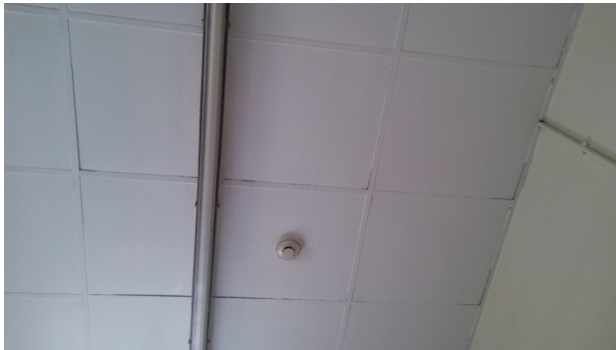
Item 28-Ref:As203553-10

The Suspended ceiling tiles (033/Kitchen store) do not contain asbestos.

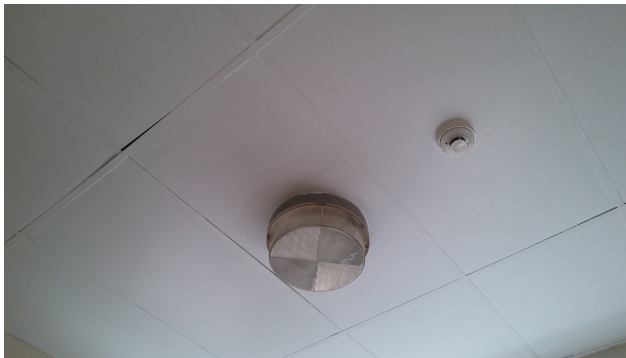
Item 29-Ref:As203553-10

The Suspended ceiling tiles (035/Chiller Room) do not contain asbestos.

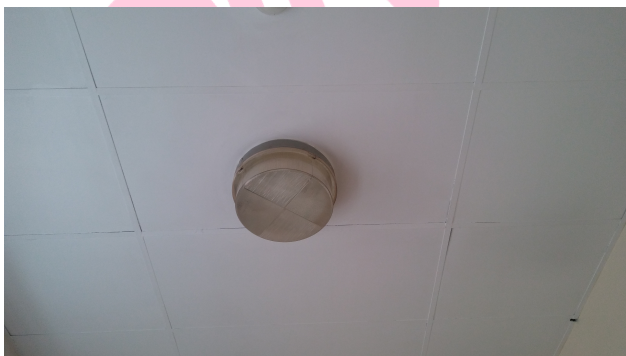
Item 30-Ref:As203553-10

The Suspended ceiling tiles (036/Pantry) do not contain asbestos.

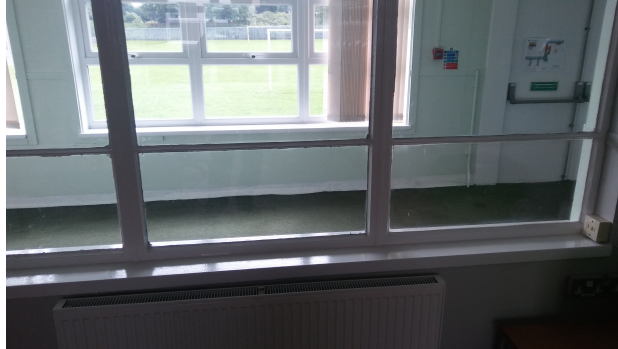
Item 31- Ref: As203553-8

The Putty to internal windows (038/Office) does not contain asbestos.

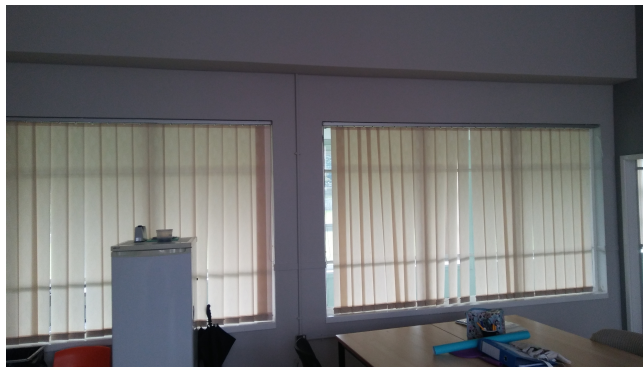
Item 32- Ref: As203553-8

The Putty to internal windows (039/Staff room) does not contain asbestos.

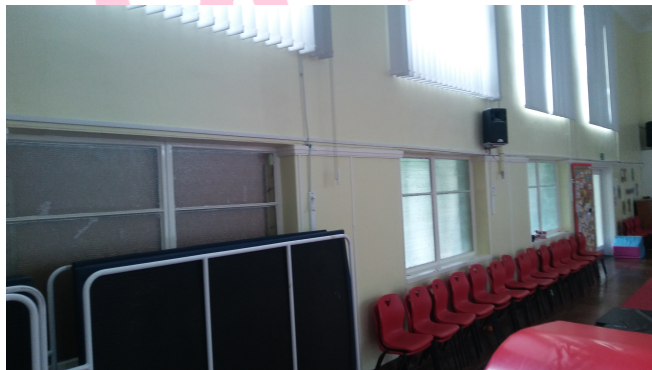
Item 33- Ref: As203553-8

The Putty to internal windows (046/Gym) does not contain asbestos.

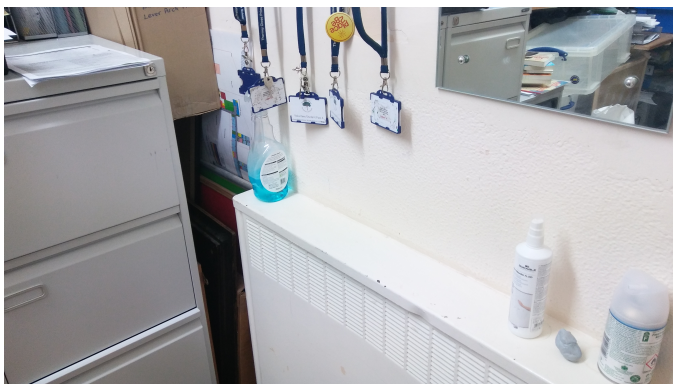
Item 36-Ref:As203553-12

The Walls (056/File Room) do not contain asbestos.

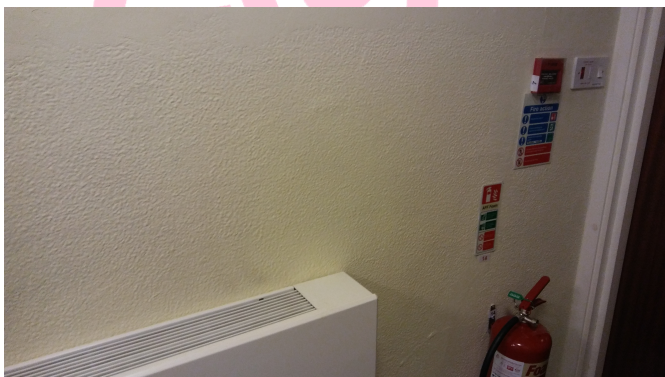
Item 39-Ref:As203553-13

The Walls (065/Corridor) do
not contain asbestos.

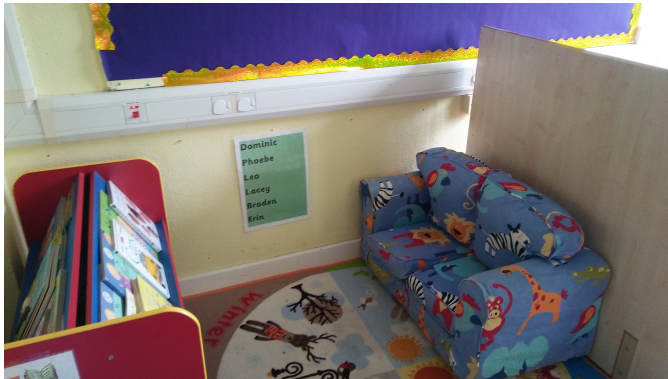
Item 40-Ref:As203553-13

The Walls (066/Classroom 10) do not contain asbestos.

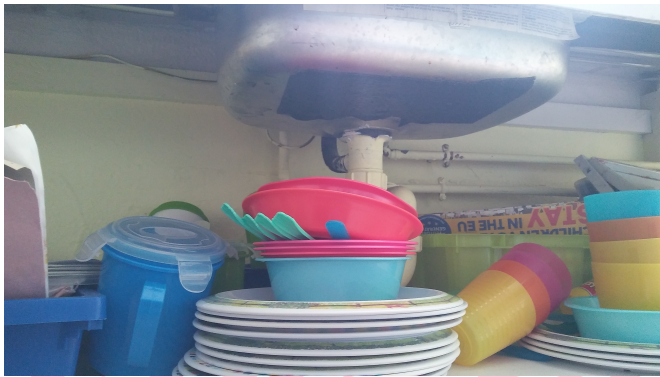
Item 41-Ref: 203553-14

The Sink Pad (066/Classroom 10) do not contain asbestos.

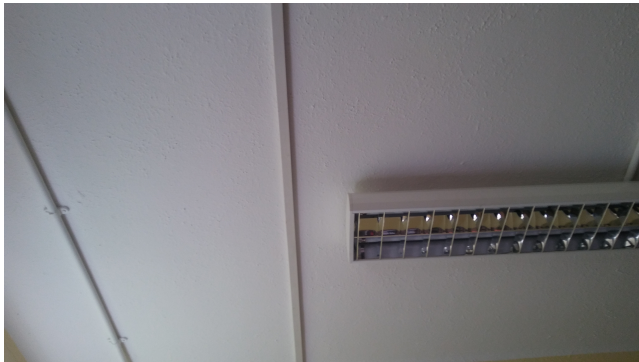
Item 43-Ref: 203553-15

The Ceiling (071/Deputy Head Office Lobby) does not contain asbestos.

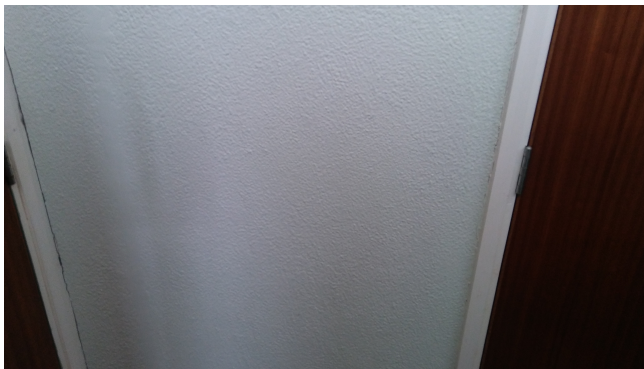
Item 44-Ref:As203553-13

The Walls (071/Deputy Heads office lobby) do not contain asbestos.

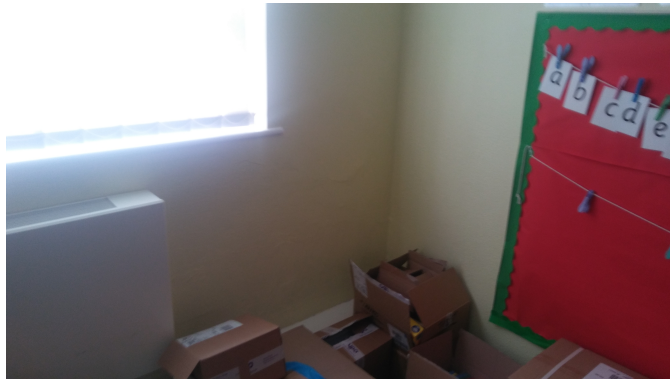
Item 46-Ref: 203553-18

The Walls (085/Classroom 3) do not contain asbestos.

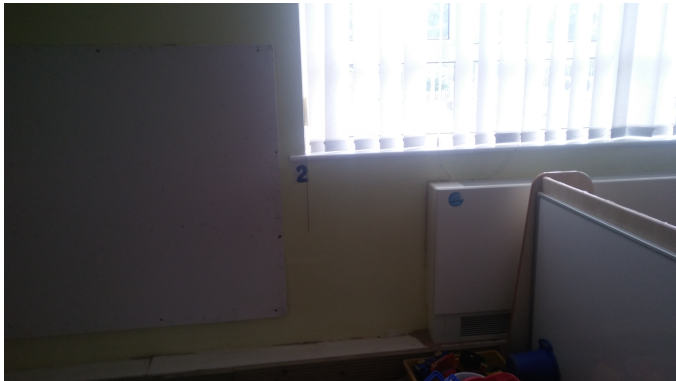
Item 47-Ref:As203553-18

The Walls (087/Nursery Classroom 1) do not contain asbestos.

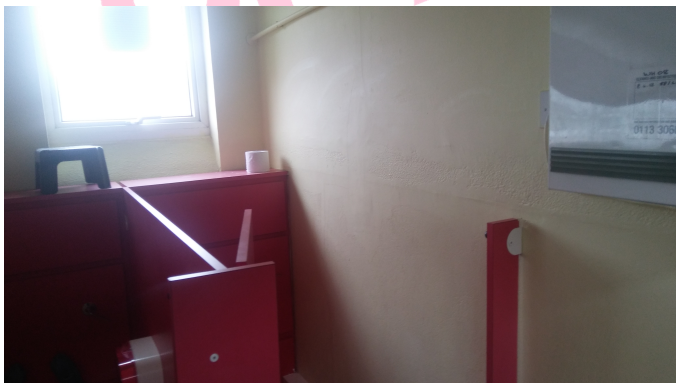
Item 48-Ref:As203553-18

The Walls (088/Nursery Classroom 1 toilet) do not contain asbestos.

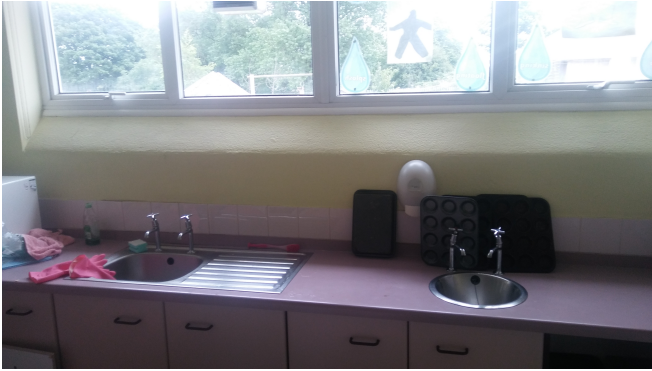
Item 49-Ref:As203553-18

The Walls (089/Nursery Classroom 1 kitchen) do not contain asbestos.

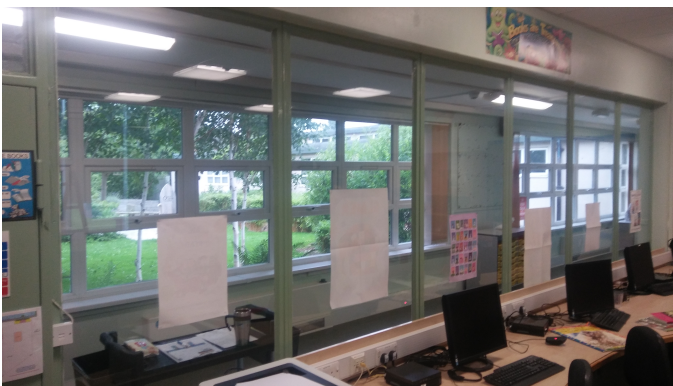
Item 51-Ref: 203553-20

The Window Putty (095/Library) does not contain asbestos.

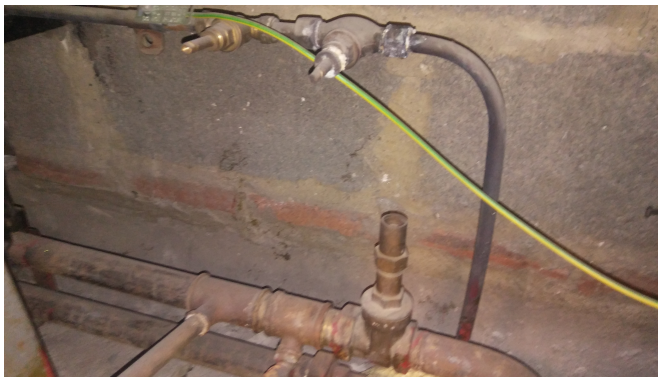
Item 53-Ref: 203553-21

The Debris to wall and pipework (096/Classroom 8-old wall heater service void) does not contain asbestos.

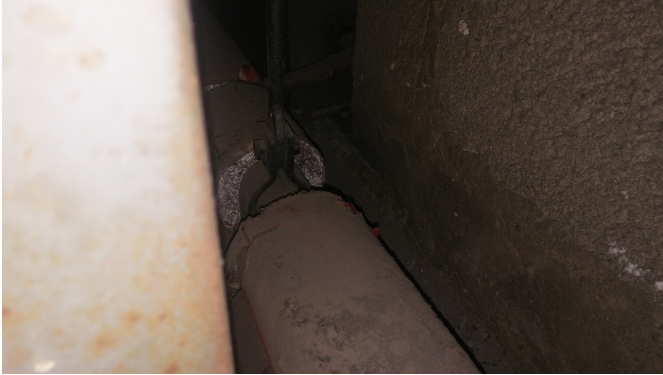
Item 55-Ref: 203553-22

The Pipework (099/Classroom 7-old wall heater service void) contains asbestos.

Any change in its appearance should be recorded, and passed to Property Services.

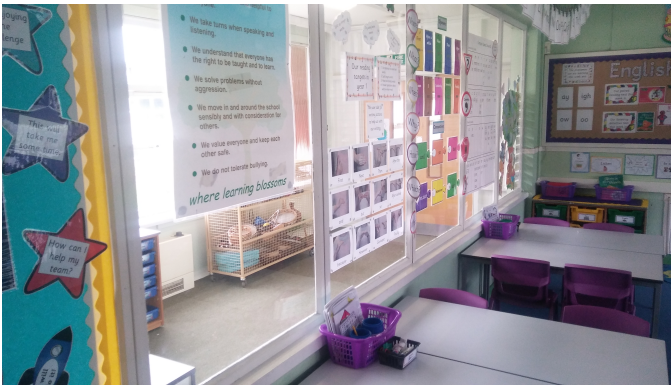
Item 56-Ref:As203553-20

The Window Putty (100/Classroom 6) does not contain asbestos.

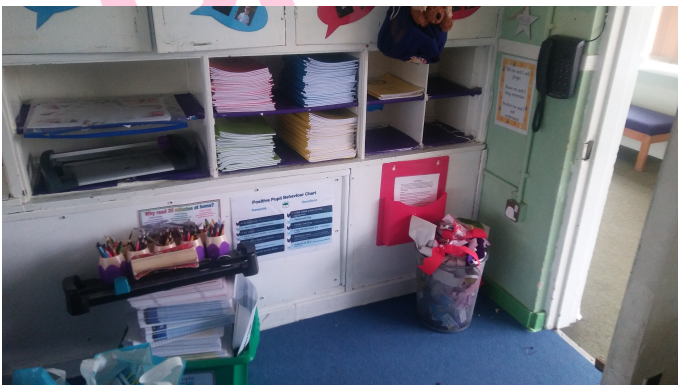
Item 57-Ref:As203553-22

The Pipework (099/Classroom 6-old wall heater service void) contains asbestos.

Any change in its appearance should be recorded and passed to Property Services.

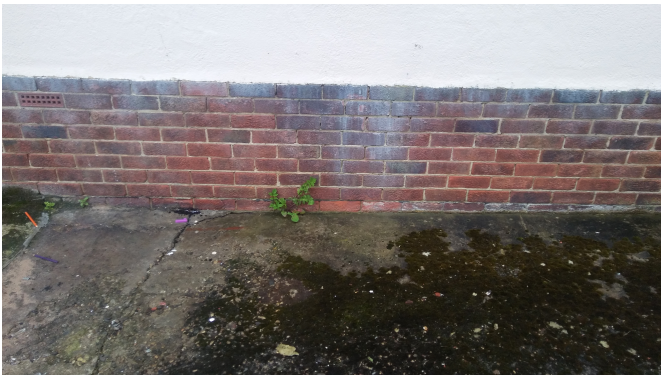
Item 63- Ref: 203553-31

The Damp proof course (999/Externals) does not contain asbestos.

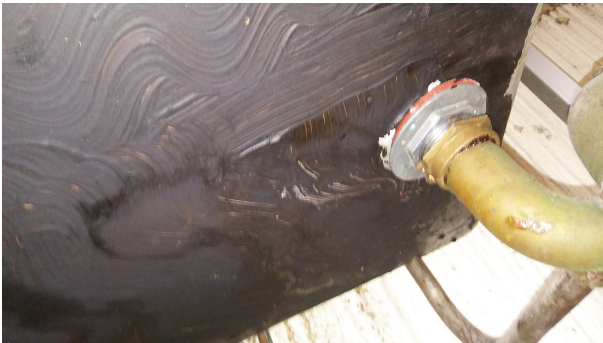
Item 68 – 271311-3

The gasket to the hot water sinks (Room 030/kitchen) does contain asbestos.

Any change in its appearance should be reported to Property Services.
