ASBESTOS SURVEY REPORT FOR BIDDICK PRIMARY SCHOOL, KIRKHAM BIDDICK VILLAGE, WASHINGTON

Asbestos Register for Biddick Primary School

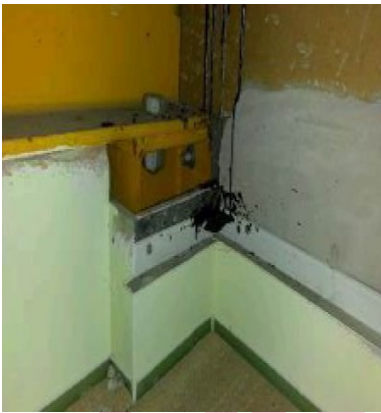
Item 1 As EB002449

The insulating board cladding to the metal columns within Classroom 11 (Room 1) contain asbestos.

Any change in its appearance should be noted and reported to Property Services.

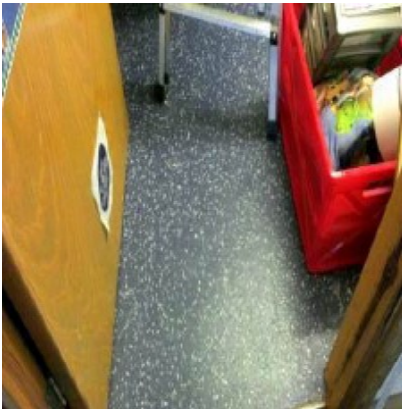
Item 2 Ref: EB002449

The insulating board cladding to the metal columns within the store (Room 2) contain asbestos.

Any change in its appearance should be noted and reported to Property Services.

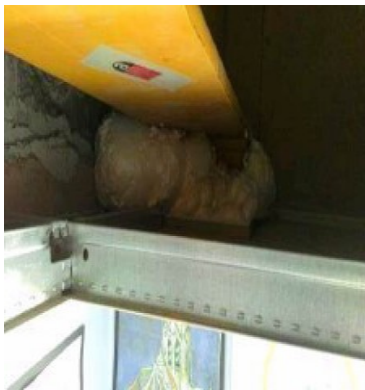
Item 14 As: EB002449

The insulating board cladding to the metal columns within the Cloak area (Room 10) contains asbestos.

Any change in its appearance should be noted and reported to Property Services.

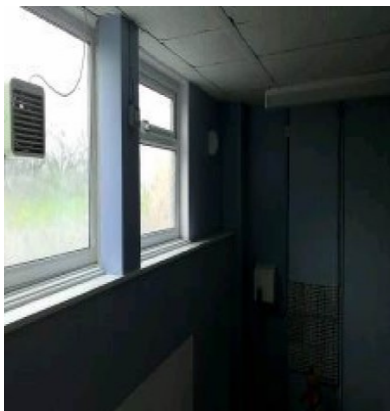
Item 15 As: EB002449

The insulating board cladding to the metal columns within the Boys WC area (Room 11) contains asbestos.

Any change in its appearance should be noted and reported to Property Services.

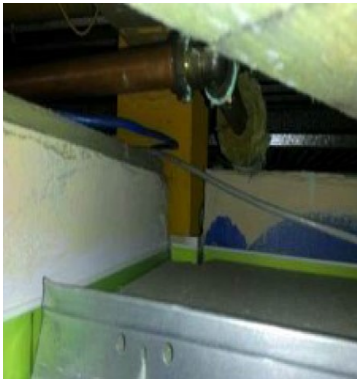
Item 17 As: EB002449

The insulating board cladding to the metal columns Classroom 6 (Room 13) contains asbestos.

Any change in its appearance should be noted and reported to Property Services.

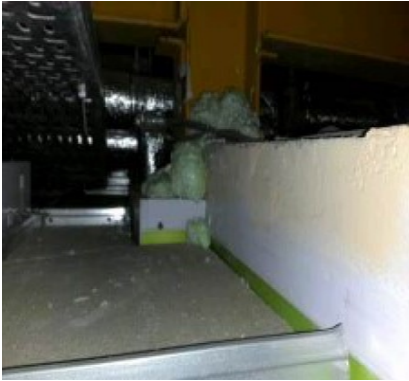
Item 19 As EB002449

The insulating board cladding to the metal columns within the corridor area (Room 15) contains asbestos.

Any change in its appearance should be noted and reported to Property Services.

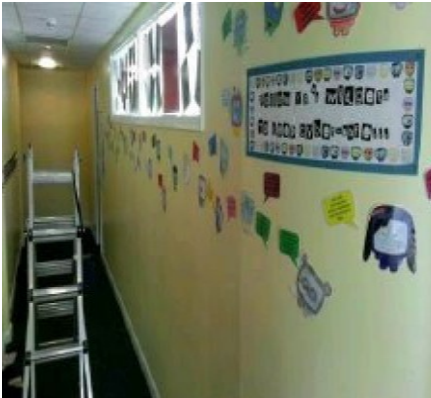
Item 20: EB002452

The insulating board panels to the partition wall in the corridor area (Room 15) do not contain asbestos.

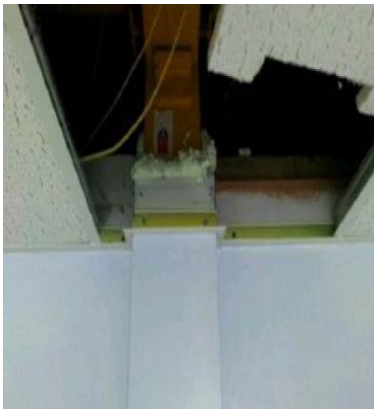
Item 23 As EB002449

The insulating board cladding to the metal columns within the Classroom 9 (Room 17) contains asbestos.

Any change in its appearance should be noted and reported to Property Services.

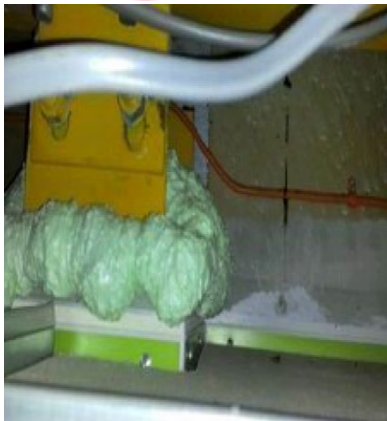
Item 24 As: EB002449

The insulating board cladding to the metal columns within Classroom 9 (Room 17) contains asbestos.

Any change in its appearance should be noted and reported to Property Services.

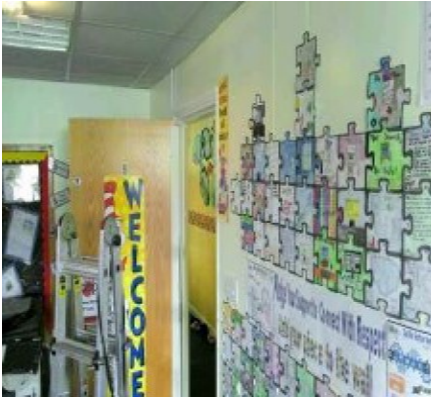
Item 25 As EB002452

The insulating board cladding to the metal columns within Classroom 9 (Room 17) contains asbestos.

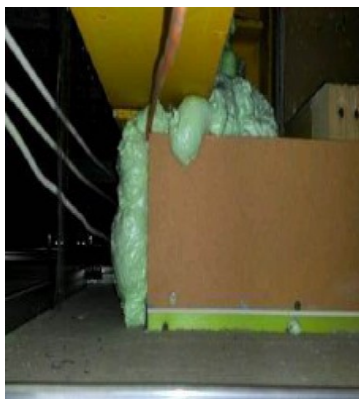
Item 27 As: EB002449

The insulating board cladding to the metal columns within Classroom 7 (Room 18) contains asbestos.

Any change in its appearance should be noted and reported to Property Services.

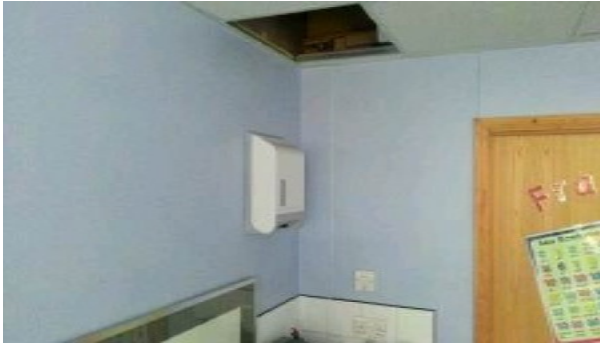
Item 28 As EB002449

The insulating board cladding to the metal columns within Classroom 7 (Room 18) contains asbestos.

Any change in its appearance should be noted and reported to Property Services.

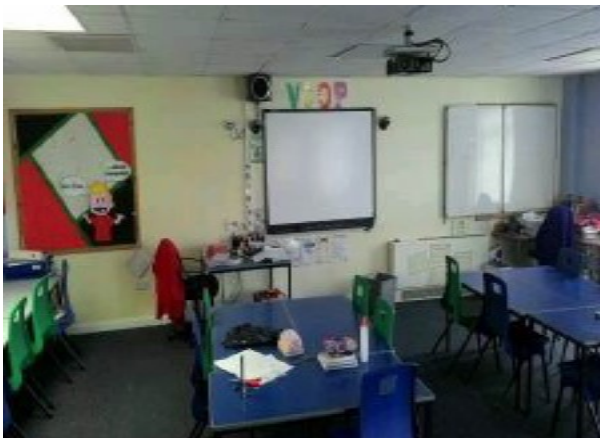
Item 29 Ref: EB002452

The insulating board panels to the partition wall in Classroom 7 (Room 18) do not contain asbestos.

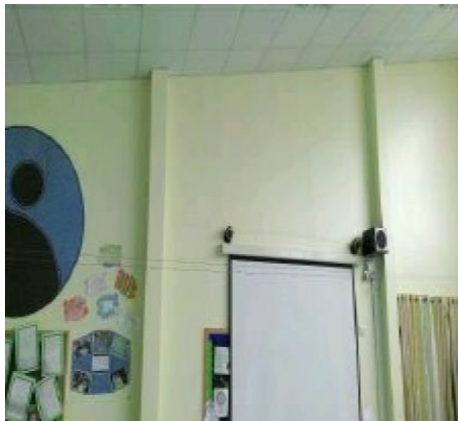
Item 32 Ref: EB002453

The insulating board cladding to the metal columns within the assembly hall (Room 37) contains asbestos.

Any change in its appearance should be noted and reported to Property Services.

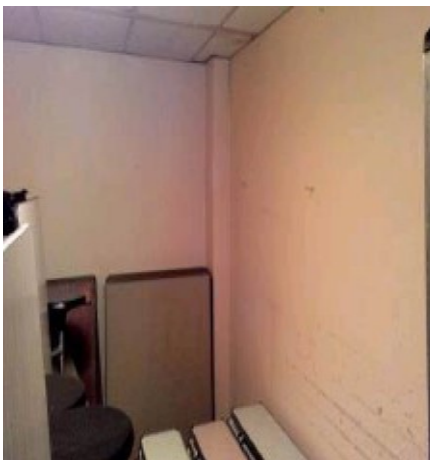
Item 33 As: EB002454

The insulating board cladding to the columns within the chair store (Room 38) contains asbestos.

Any change in its appearance should be noted and reported to Property Services.

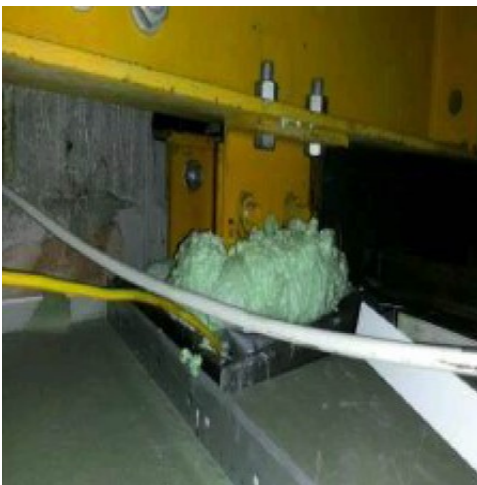
Item 36 As: EB002453

The insulating board cladding to the columns (x5) within the kitchen (Room 40) contains asbestos.

Any change in its appearance should be noted and reported to Property Services.

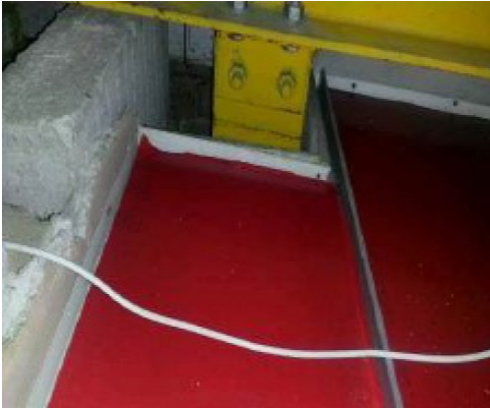
Item 37 Ref: EB002453

The insulating board cladding to the metal columns within the kitchen store (Room 40) contains asbestos.

Any change in its appearance should be noted and reported to Property Services.

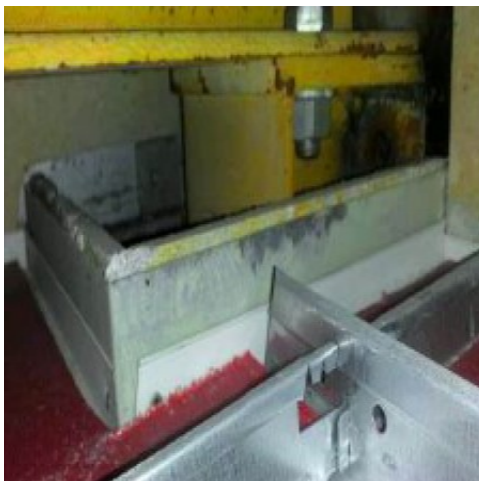
Item 38 Ref: EB002453

The insulating board cladding to the metal columns within the kitchen WC and Larder (Room 40) contains asbestos.

Any change in its appearance should be noted and reported to Property Services.

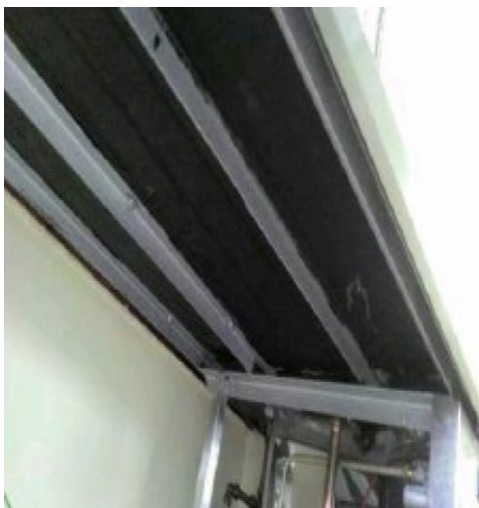
Item 39 As: EB002456

The bitumen coating below the sink units in the kitchen (Room 40) do not contain asbestos.

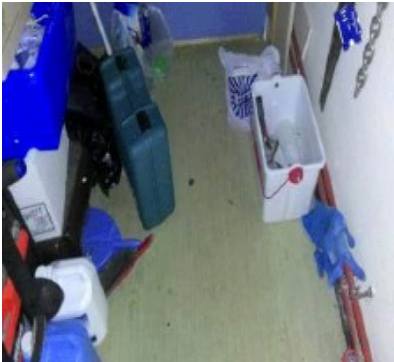
Item 47 Ref: EB002460

The beige vinyl flooring to the store room (Room 48) does not contain asbestos.

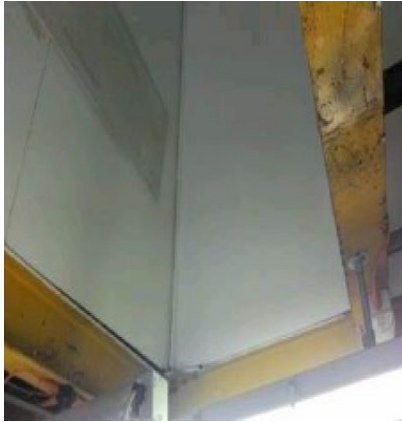
Item 49 Ref: EB002462

The insulating board panels to the wall at high level in the boiler room (External Room 1) contain asbestos.

Any change in its appearance should be noted and reported to Property Services.

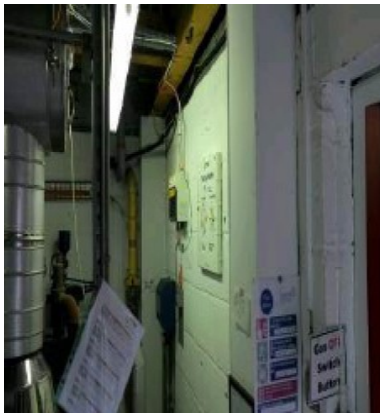
Item 50 Ref: EB002463

The insulating board boxing to metal columns (x2) in the Boiler Room (External Room 1) does not contain asbestos.

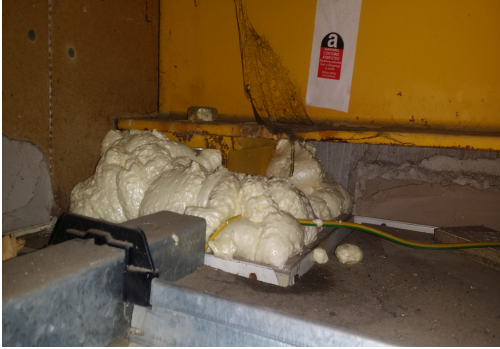
Item 52 Ref: 203580-1

The insulating board in the boys toilet ceiling void (Room 015) contains asbestos.

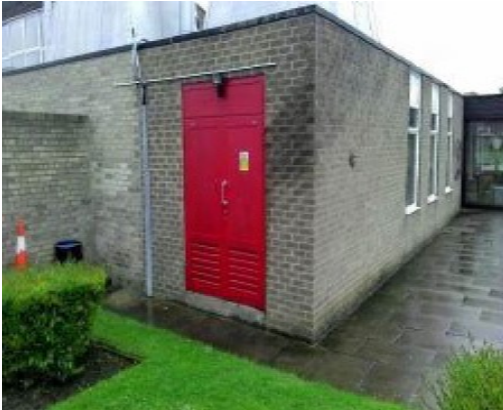
At the time of the survey there were no keys available for the external store. It is advised that this is revisited and inspected when the keys are available.

Prior to any works taking place in the store, there needs to be further investigation carried out.
