ASBESTOS SURVEY REPORT FOR BIDDICK PRIMARY SCHOOL, KIRKHAM BIDDICK VILLAGE, WASHINGTON

Asbestos Register for Biddick Primary School

Date: 01 July 2025

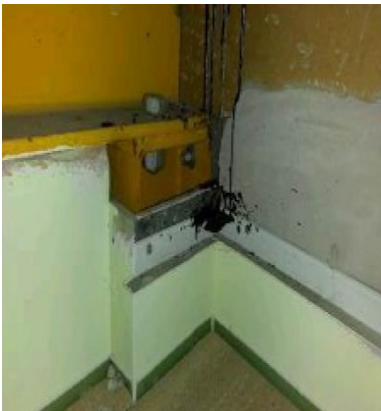
Item 2 Ref: EB002449

The insulating board cladding to the metal columns within the store (Room 2) contain asbestos.

Any change in its appearance should be noted and reported to Property Services.

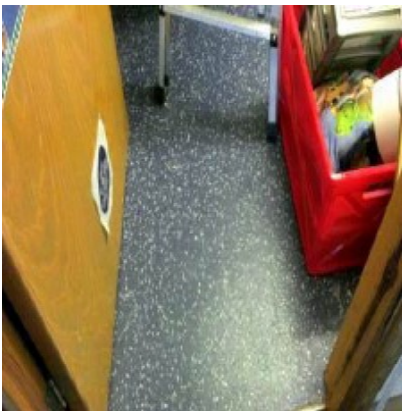
Item 3 Ref: EB002450

The blue vinyl floor covering to the store (Room 2) does not contain asbestos.

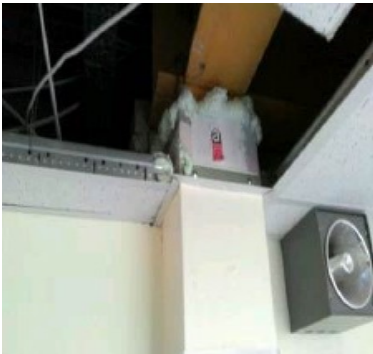
Item 5 As EB002449

The insulating board cladding to the metal columns within the lobby (Room 4) contain asbestos.

Any change in its appearance should be noted and reported to Property Services.

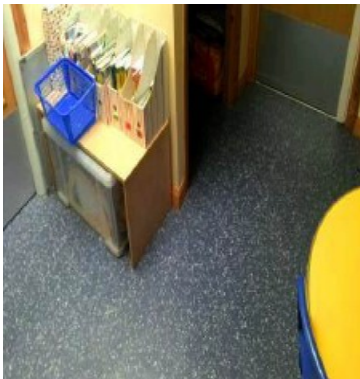
Item 6 As EB002450

The blue vinyl floor covering to the lobby (Room 4) does not contain asbestos.

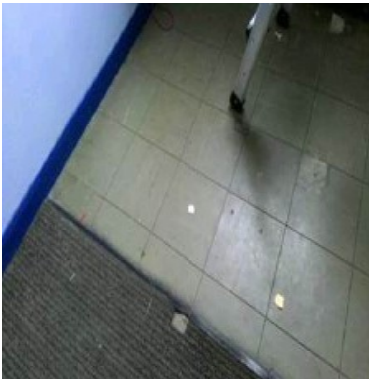
Item 8 As: EB002451

The green floor tiles to the cloak room (Room 5) do not contain asbestos.

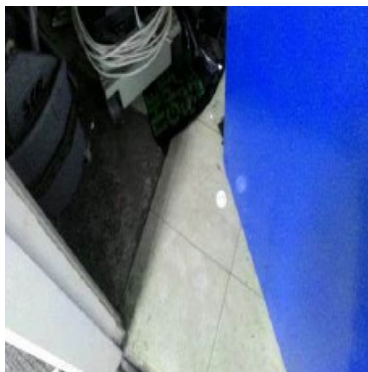
Item 12 As: EB002451

The green floor tiles to the cleaner's cupboard (Room 9) do not contain asbestos.

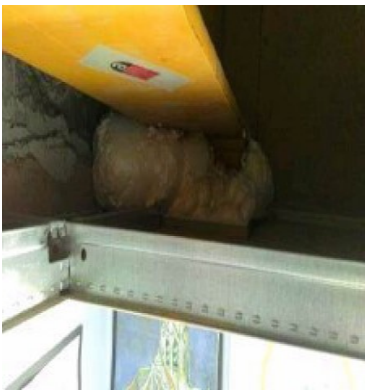
Item 14 As: EB002449

The insulating board cladding to the metal columns within the Cloak area (Room 10) contains asbestos.

Any change in its appearance should be noted and reported to Property Services.

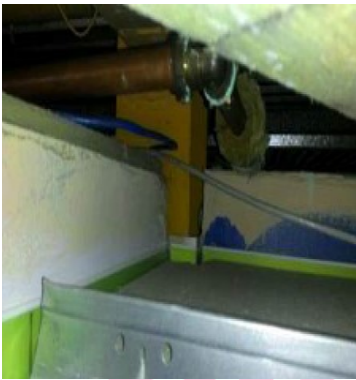
Item 17 As: EB002449

The insulating board cladding to the metal columns Classroom 6 (Room 13) contains asbestos.

Any change in its appearance should be noted and reported to Property Services.

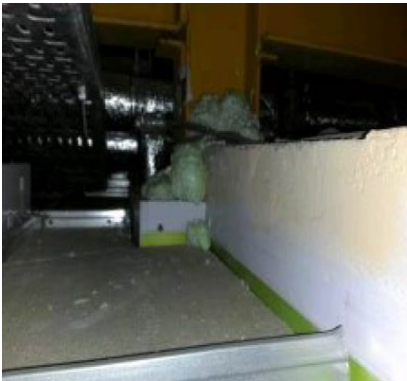
Item 19 As EB002449

The insulating board cladding to the metal columns within the corridor area (Room 15) contains asbestos.

Any change in its appearance should be noted and reported to Property Services.

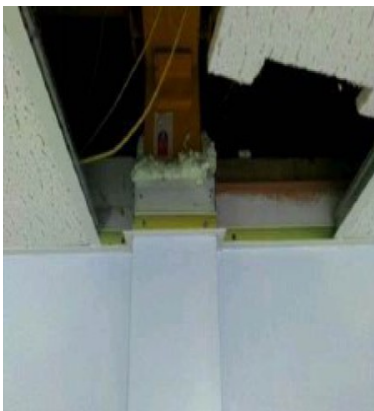
Item 23 As EB002449

The insulating board cladding to the metal columns within the Classroom 9 (Room 17) contains asbestos.

Any change in its appearance should be noted and reported to Property Services.

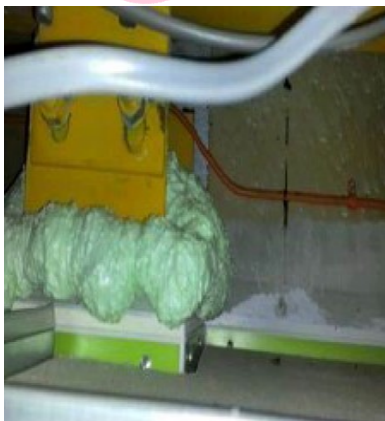
Item 24 As: EB002449

The insulating board cladding to the metal columns within Classroom 9 (Room 17) contains asbestos.

Any change in its appearance should be noted and reported to Property Services.

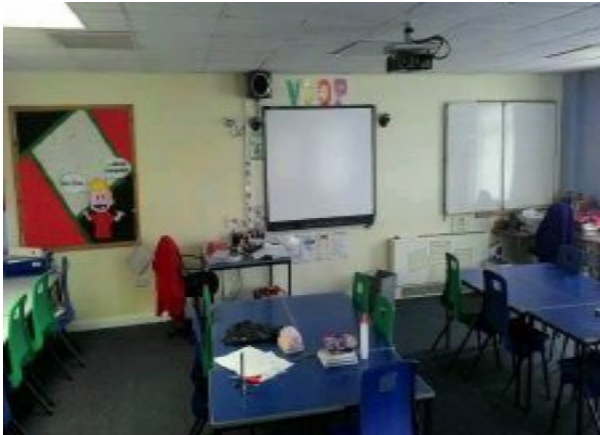
Item 29 Ref: EB002452

The insulating board panels to the partition wall in Classroom 7 (Room 18) do not contain asbestos.

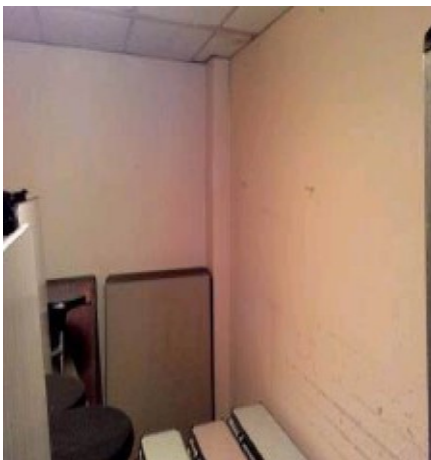
Item 33 As: EB002454

The insulating board cladding to the columns within the chair store (Room 38) contains asbestos.

Any change in its appearance should be noted and reported to Property Services.

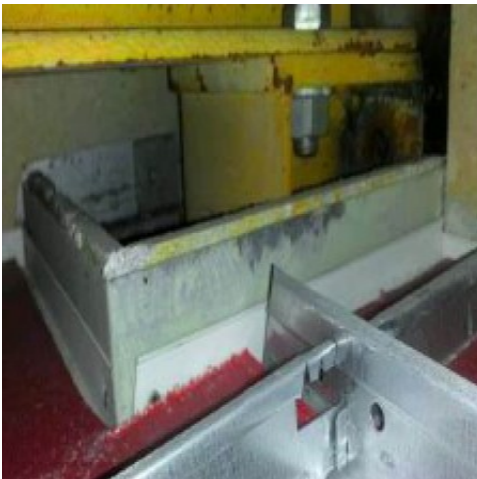
Item 38 Ref: EB002453

The insulating board cladding to the metal columns within the kitchen WC and Larder (Room 40) contains asbestos.

Any change in its appearance should be noted and reported to Property Services.

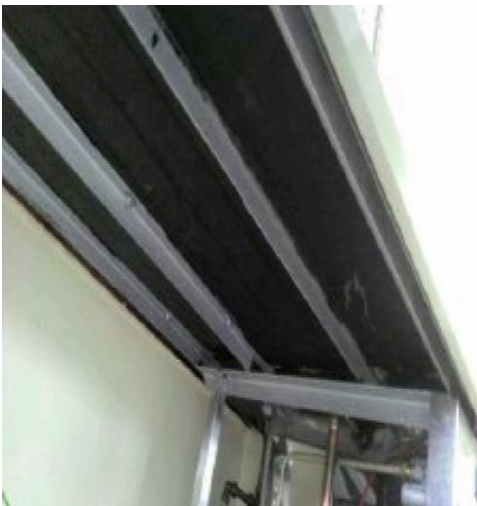
Item 39 As: EB002456

The bitumen coating below the sink units in the kitchen (Room 40) do not contain asbestos.

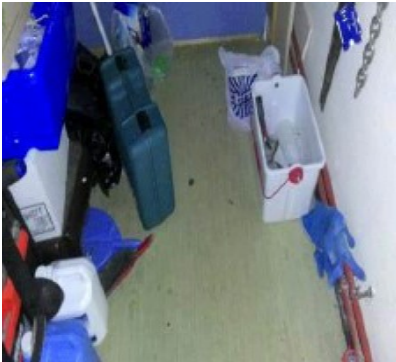
Item 47 Ref: EB002460

The beige vinyl flooring to the store room (Room 48) does not contain asbestos.
