ASBESTOS SURVEY REPORT FOR BLACKFELL PRIMARY SCHOOL,
BLACKFELL VILLAGE, WASHINGTON, NE37 1HA.

Asbestos Register for

**Blackfell Primary School, Blackfell Village, Washington,
NE37 1HA**

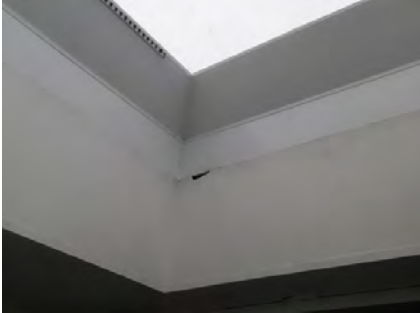
Item 1 Ref: 20-28461-1

The walls (Area 5/Girls Toilet) does not contain asbestos.

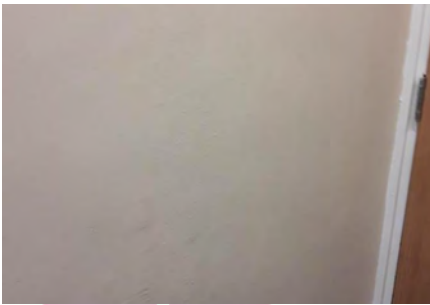
Item 2 Ref: 20-28461-7

The textured coating to walls (Area 7/Hallway and Cloakroom) does not contain asbestos.

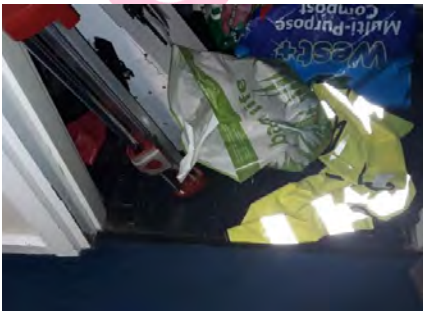
Item 3 Ref: 20-28461-2

The floor tiles and adhesive (Area 8/Store Cupboard) contain asbestos.

Any change in its appearance should be recorded and passed to Property Services.

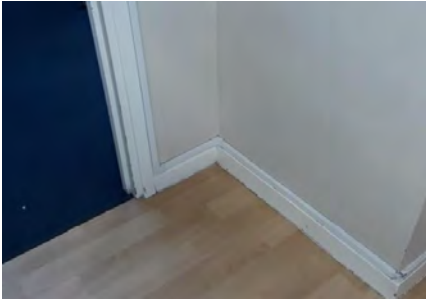
Item 4 Ref: 20-28461-3

The floor tiles and adhesive (Area 9/Dining Room) contain asbestos.

Any change in its appearance should be recorded and passed to Property Services.

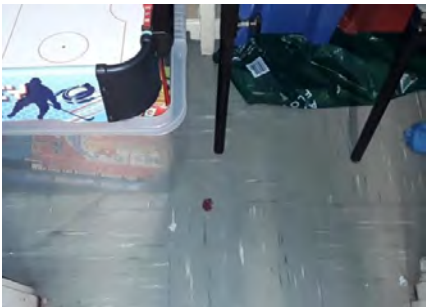
Item 5 Ref: 20-28461-3

The floor tiles and adhesive (Area 10/Store cupboard) contain asbestos.

Any change in its appearance should be recorded and passed to Property Services.

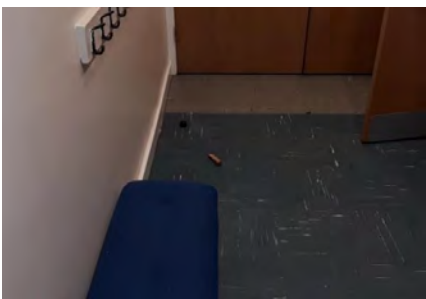
Item 6 Ref: 20-28461-4

The floor tiles and adhesive (Area 11/Hallway) contain asbestos.

Any change in its appearance should be recorded and passed to Property Services.

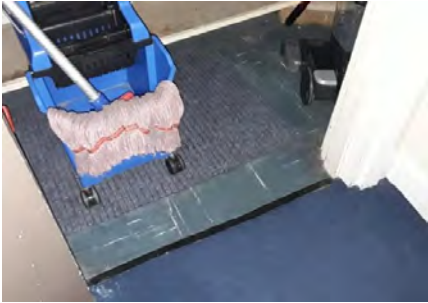
Item 7 Ref: 20-28461-4

The floor tiles and adhesive (Area 18/Cleaners cupboard) contain asbestos.

Any change in its appearance should be recorded and passed to Property Services.

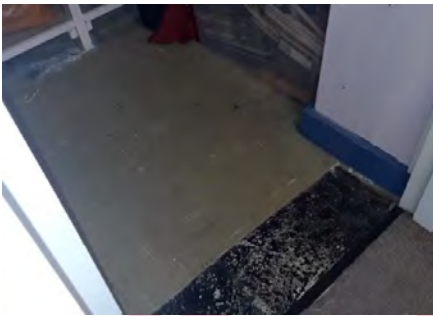
Item 8 Ref: 20-28461-5

The floor tiles and adhesive (Area 20/Year 4 Classroom cupboard) contain asbestos.

Removed April 2023

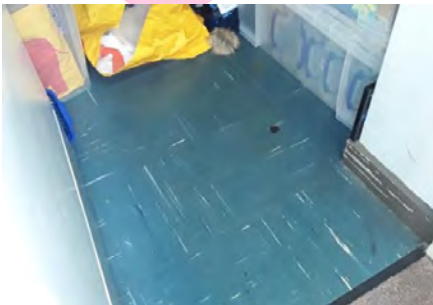
Item 9 Ref: 20-28461-4

The floor tiles and adhesive (Area 2/Year 3 cupboard) contain asbestos.

Any change in its appearance should be recorded and passed to Property Services.

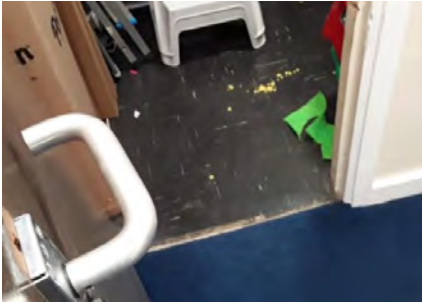
Item 10 Ref: 20-28461-2

The floor tiles and adhesive (Area 25/Store cupboard) contain asbestos.

Any change in its appearance should be recorded and passed to Property Services.

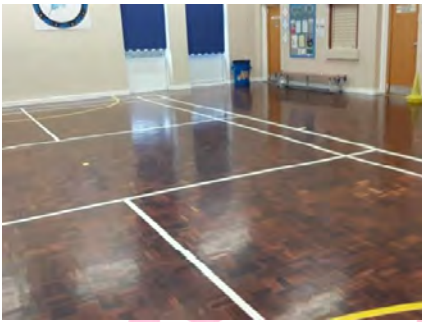
Item 11 Ref: PRESUMED

The floor beneath fitted parquet flooring (Area 26/Hall) is presumed to contain asbestos.

Noted as not asbestos – see SGS survey J205006 and Ref: Item 63 & 64

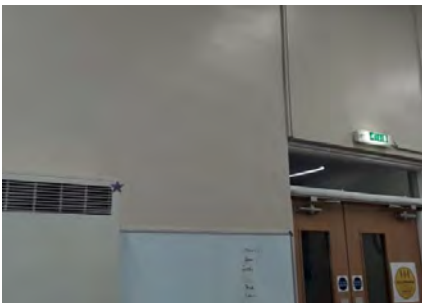
Item 12 Ref: 20-28461-7

The textured coating to walls (Area 26/Hall) does not contain asbestos.

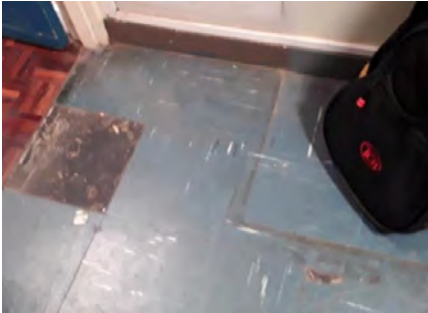
Item 13 Ref: 20-28461-4

The floor tiles and adhesive (Area 27/Cupboard Electric Meter) contain asbestos.

Any change in its appearance should be recorded and passed to Property Services.

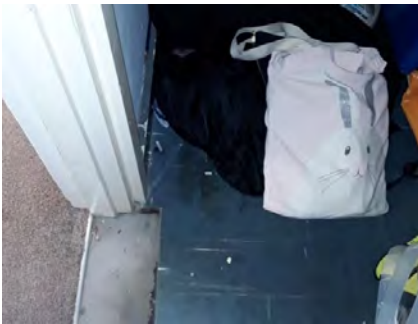
Item 14 Ref: 20-28461-4

The floor tiles and adhesive (Area 35/Classroom cupboard) contain asbestos.

Any change in its appearance should be recorded and passed to Property Services.

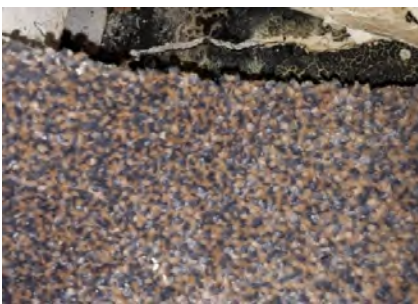
Item 15 Ref: 20-28461-8

The floor (Area 37/Classroom cupboard) contains asbestos.

Any change in its appearance should be recorded and passed to Property Services.

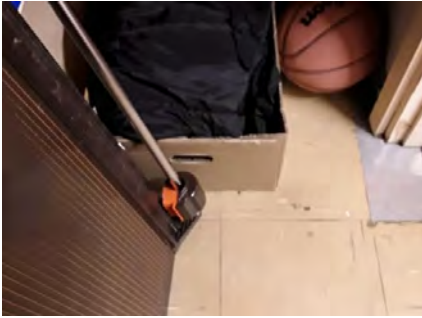
Item 16 Ref: 20-28461-5

The floor tiles and adhesive (Area 39/Store Cupboard) contain asbestos.

Any change in its appearance should be recorded and passed to Property Services.

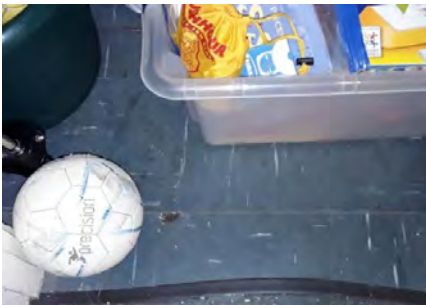
Item 17 Ref: 20-28461-4

The floor tiles and adhesive (Area 40/Store cupboard) contain asbestos.

Any change in its appearance should be recorded and passed to Property Services.

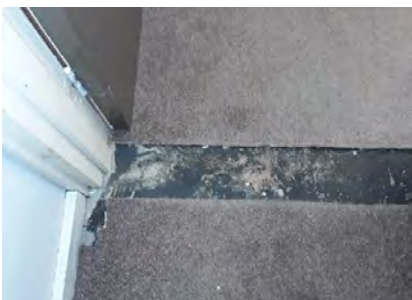
Item 18 Ref: 20-28461-8

The floor (Area 42/Store cupboard, Year 6 Classroom) contains asbestos.

Any change in its appearance should be recorded and passed to Property Services.

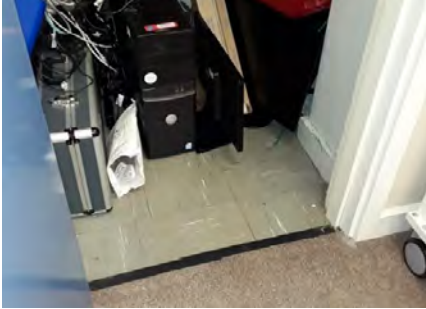
Item 19 Ref: 20-28461-3

The floor tiles and adhesive (Area 44/Store cupboard and IT Room) contain asbestos.

Any change in its appearance should be recorded and passed to Property Services.

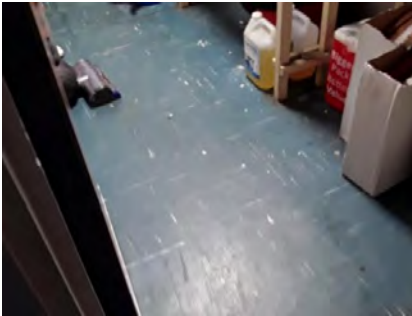
Item 20 Ref: 20-28461-4

The floor tiles and adhesive (Area 45/Cleaners cupboard) contain asbestos.

Any change in its appearance should be recorded and passed to Property Services.

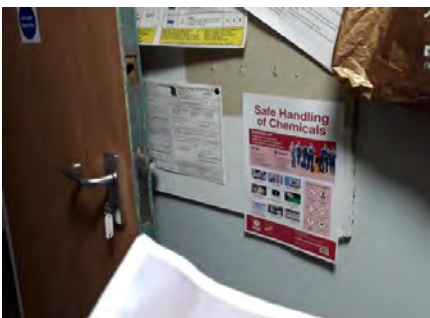
Item 21 Ref: 20-28461-9

The walls notice board (Area 45/Cleaners cupboard) does not contain asbestos.

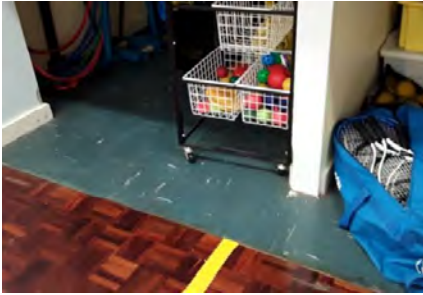
Item 22 Ref: 20-28461-4

The floor tiles and adhesive (Area 46/Hall Store) contain asbestos.

Any change in its appearance should be recorded and passed to Property Services.

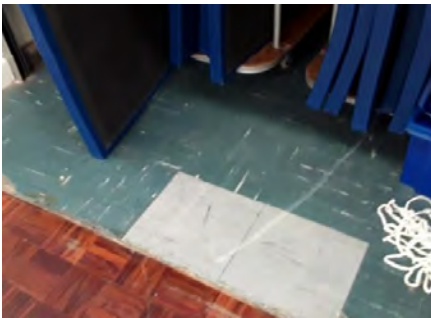
Item 23 Ref: 20-28461-4

The floor tiles and adhesive (Area 47/Hall Store) contain asbestos.

Any change in its appearance should be recorded and passed to Property Services.

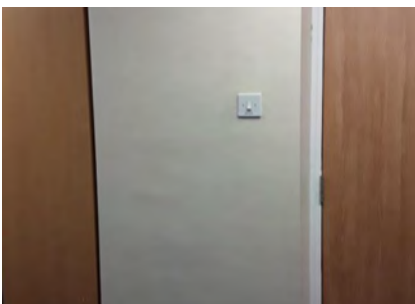
Item 24 Ref: 20-28461-7

The textured coating to walls (Area 54/Corridor) do not contain asbestos.

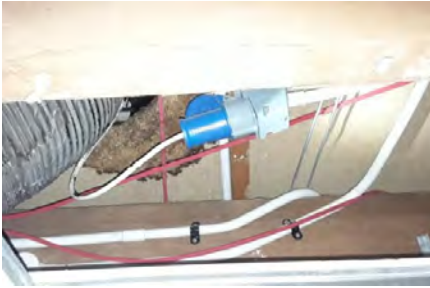
Item 25 Ref: 20-28461-10

The ceiling (Area 55/Medical Room) does not contain asbestos.

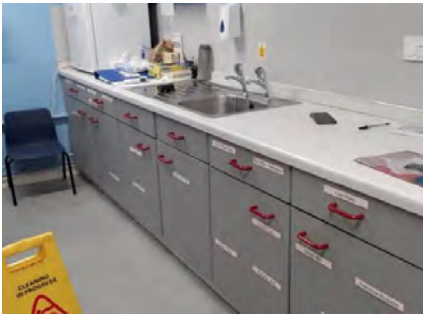
Item 26 Ref: 20-28461-11

The sink pad (Area 55/Medical Room) does not contain asbestos.

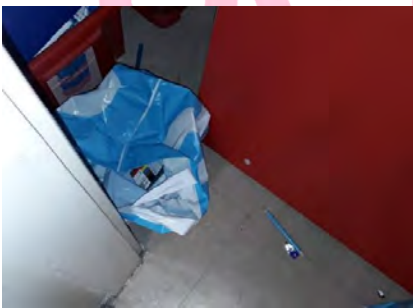
Item 27 Ref: 20-28461-5

The floor tiles and adhesive (Area 65/Year 1 Classroom cupboard) contain asbestos.

Any change in its appearance should be recorded and passed to Property Services.

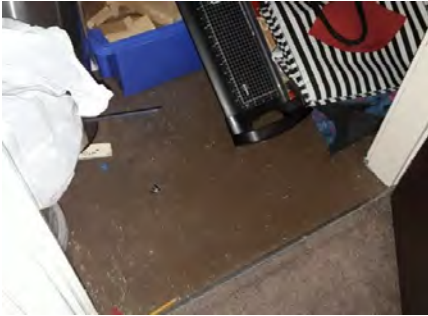
Item 28 Ref: 20-28461-12

The floor tiles and adhesive (Area 66/Year 1 Classroom cupboard) contain asbestos.

Any change in its appearance should be recorded and passed to Property Services.

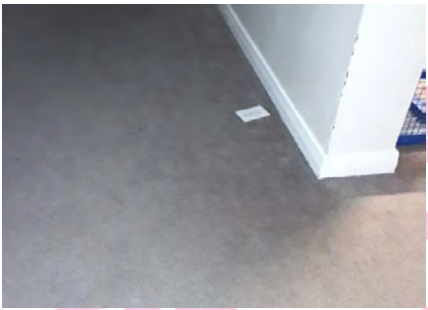
Item 29 Ref: 20-28461-8

The floor (Area 69/Year 2 Classroom) contains asbestos.

Any change in its appearance should be recorded and passed to Property Services.

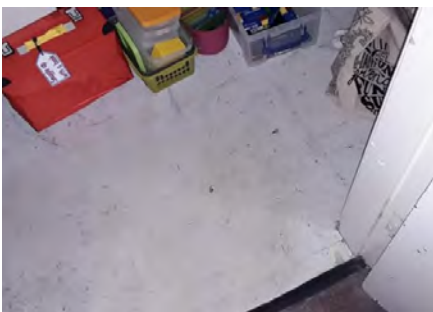
Item 30 Ref: 20-28461-13

The floor tiles and adhesive (Area 71/Year 2 Classroom cupboard) contain asbestos.

Any change in its appearance should be recorded and passed to Property Services.

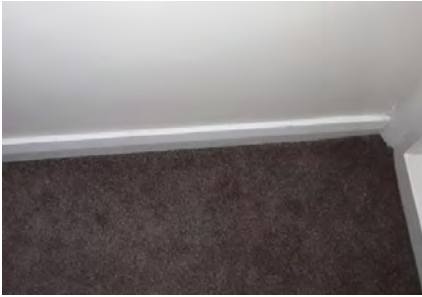
Item 31 Ref: 20-28461-8

The floor (Area 72/Year 2 Classroom) contains asbestos.

Any change in its appearance should be recorded and passed to Property Services.

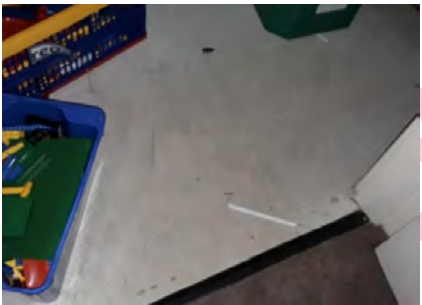
Item 32 Ref: 20-28461-13

The floor tiles and adhesive (Area 73/Year 2 Classroom cupboard) contain asbestos.

Any change in its appearance should be recorded and passed to Property Services.

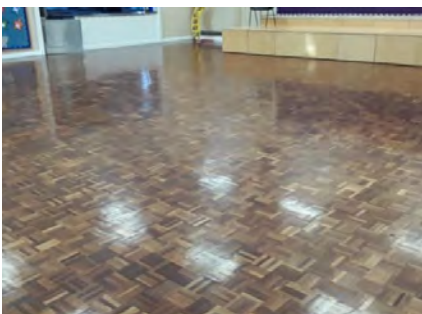
Item 33 Ref: PRESUMED

The floor (Area 78/Hall) is presumed to contain asbestos.

Any change in its appearance should be recorded and passed to Property Services.

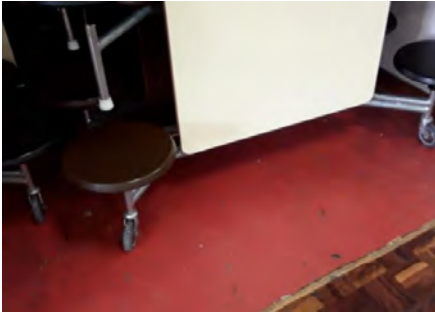
Item 34 Ref: 20-28461-15

The floor tiles and adhesive (Area 78/Hall) contain asbestos.

Removed Feb 2026

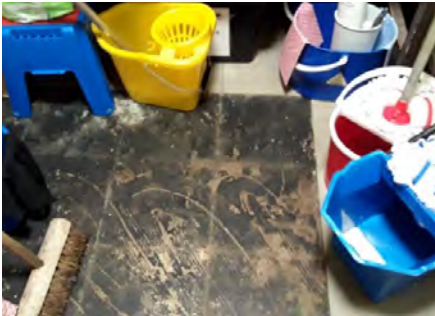
Item 35 Ref: 20-28461-16

The floor tiles and adhesive (Area 91/Cupboard Cleaners) contain asbestos.

Any change in its appearance should be recorded and passed to Property Services.

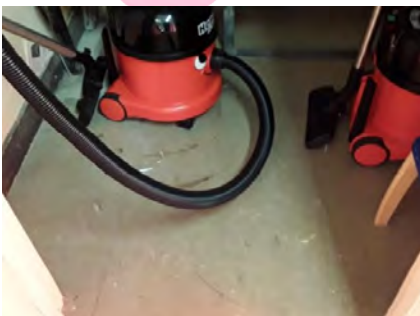
Item 36 Ref: 20-28461-17

The floor tiles and adhesive (Area 92/Electrical Cupboard) contain asbestos.

Any change in its appearance should be recorded and passed to Property Services.

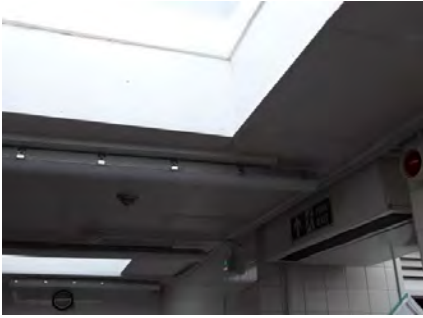
Item 37 Ref: 20-28461-18

The ceiling (Area 93/Kitchen) contains asbestos.

Any change in its appearance should be recorded and passed to Property Services.

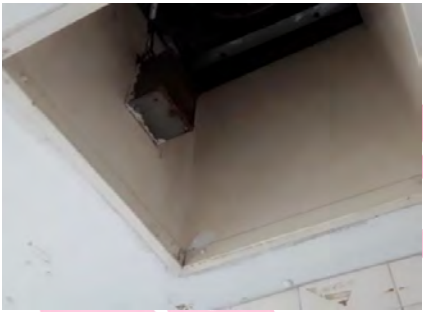
Item 38 Ref: 20-28461-19

The upstands to old extraction unit (Area93/Kitchen) contain asbestos.

Any change in its appearance should be recorded and passed to Property Services.

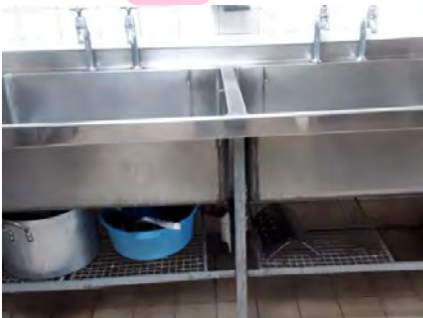
Item 39 Ref: 20-28461-20

The sink pad (Area 93/Kitchen) does not contain asbestos.

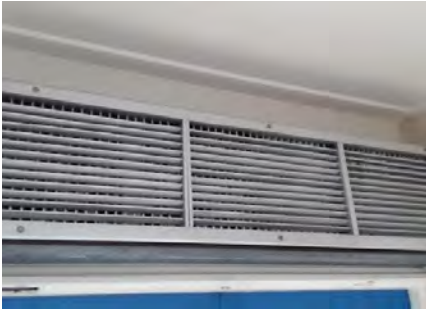
Item 40 Ref: 20-28461-21

The door header (Area 95/Rear Entrance) does not contain asbestos.

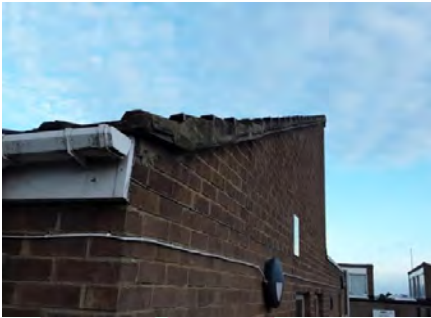
Item 41 Ref: 20-28461-22

The undercloaking (External) contains asbestos.

Any change in its appearance should be recorded and passed to Property Services.

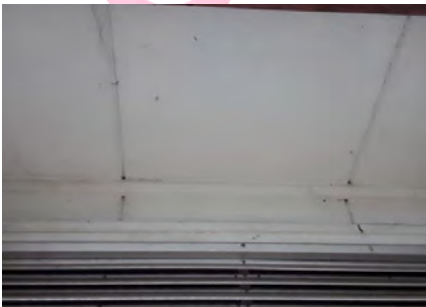
Item 42 Ref: 20-28461-23

The canopy (External) contains asbestos.

Any change in its appearance should be recorded and passed to Property Services.

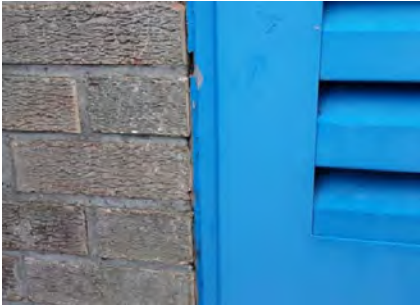
Item 43 Ref: 20-28461-24

The door frame sealant (External) does not contain asbestos.

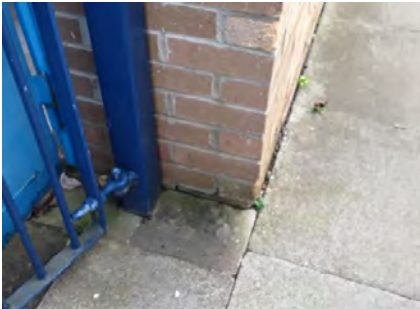
Item 44 Ref: 20-28461-25

The damp proof course (External) does not contain asbestos.

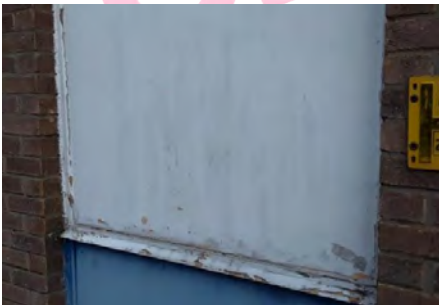
Item 45 Ref: 20-28461-26

The window frame sealant (External) does not contain asbestos.

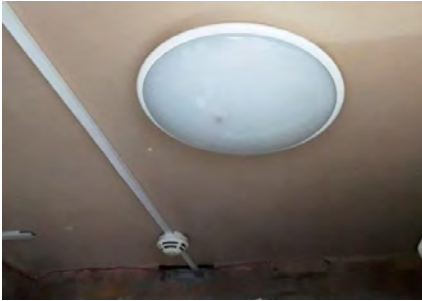
Item 46 Ref: 20-28461-27

The ceiling (Area 100/Store) does not contain asbestos.

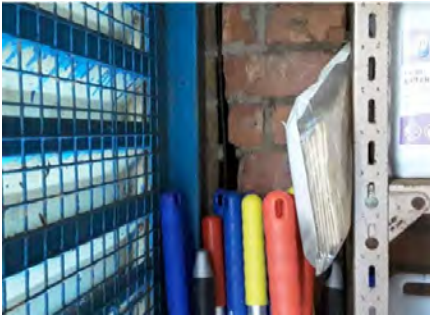
Item 47 Ref: 20-28461-28

The bitumen behind door frame (Area 100/Store) does not contain asbestos.

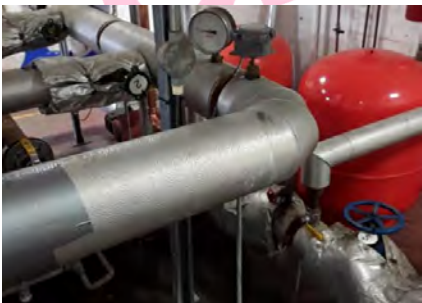
Item 48 Ref: PRESUMED

The gaskets (Area 102/Plant Room) are presumed to contain asbestos.

Any change in its appearance should be recorded and passed to Property Services.

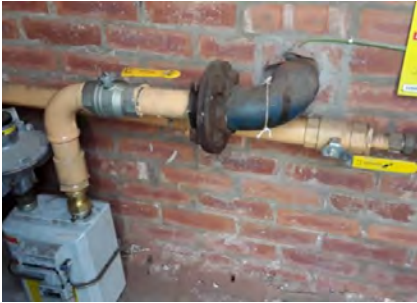
Item 49 Ref: 20-28461-30

The gaskets (Area 103/Gas Room) do not contain asbestos.

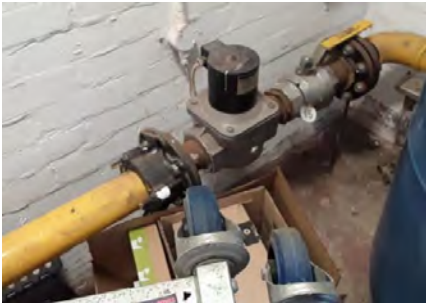
Item 50 Ref: 20-28461-31

The gaskets (Area 104/Plant Room) do not contain asbestos.

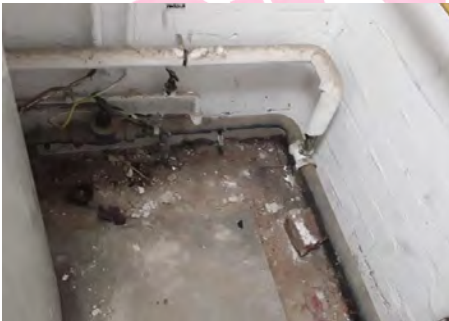
Item 51 – Ref: 20-27752-2

The debris to floor behind the water tank in the Infant/Nursery Boiler Room does not contain asbestos.

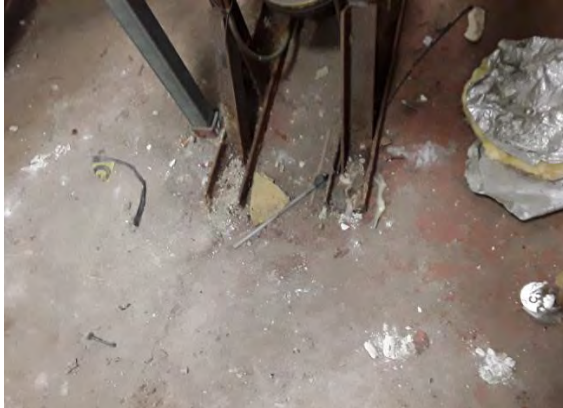
Item 52 – Ref: 20-27752-3

The debris to floor adjacent the water tank in the Infant/Nursery Boiler Room does not contain asbestos.

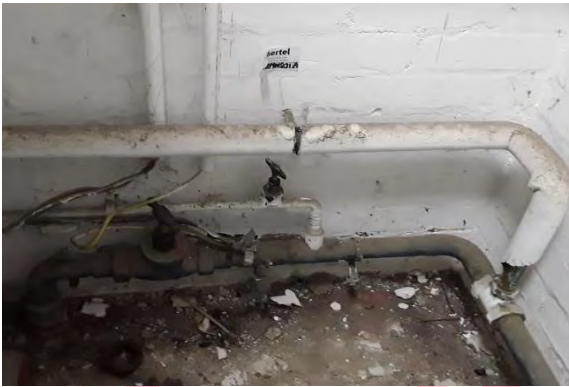
Item 53 – Ref: Presumed

The stop tap gaskets in the Infant/Nursery Boiler Room is presumed to contain asbestos.

Removed July 2021

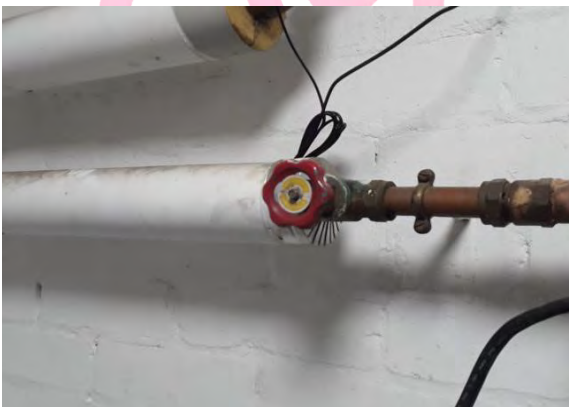
Item 54 – Ref: Presumed

The gate valve gaskets in the Infant/Nursery Boiler Room is presumed to contain asbestos.

Removed July 20201

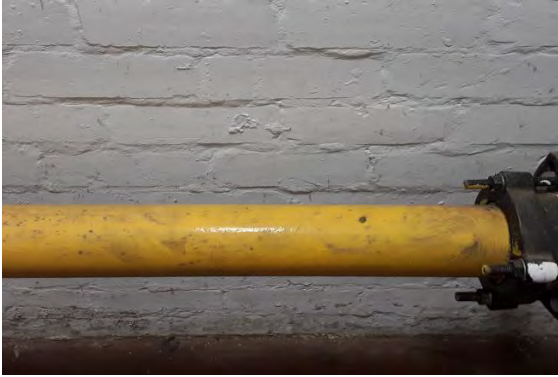
Item 55 – Ref: 20-27752-6

The residual insulation to the main wall in the Infant/Nursery Boiler Room does not contain asbestos.

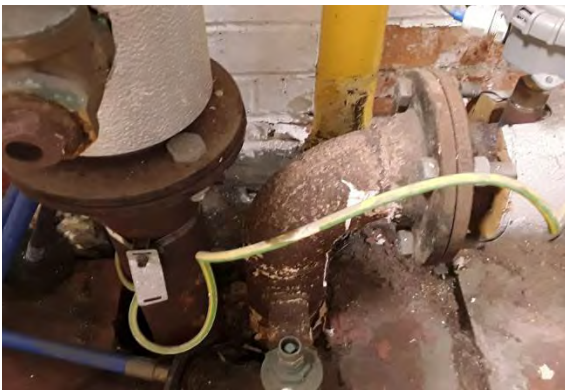
Item 56 – Ref: Presumed

The gaskets in the Primary Boiler Room are presumed to contain asbestos.

Removed July 2021

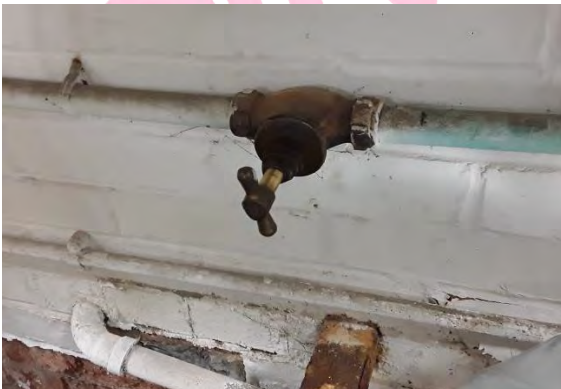
Item 57 – Ref: Presumed

The stop gap gaskets in the Primary Boiler Room are presumed to contain asbestos.

Removed July 20201

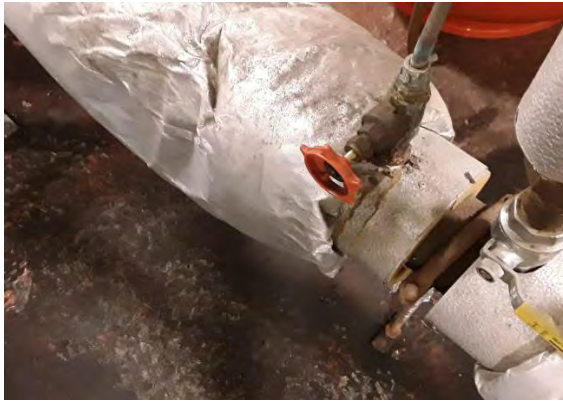
Item 58 – Ref: Presumed

The gate valve gaskets in the Primary Boiler Room is presumed to contain asbestos.

Removed July 2021

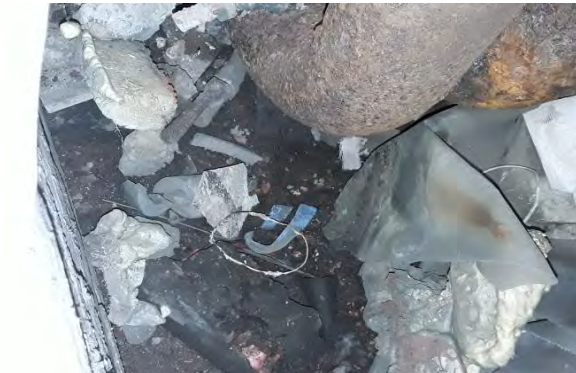
Item 59 – Ref: 20-27752-4

The cement debris within the pipe duct in the Primary Boiler Room contains asbestos.

Removed July 2021

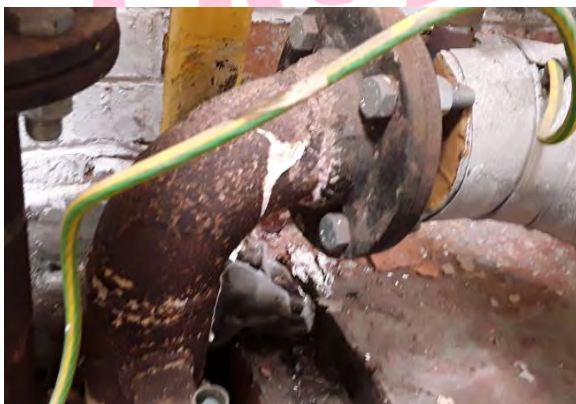
Item 60 – Ref: 20-27752-5

The insulation debris within the pipework duct in the Primary Boiler Room does not contain asbestos.

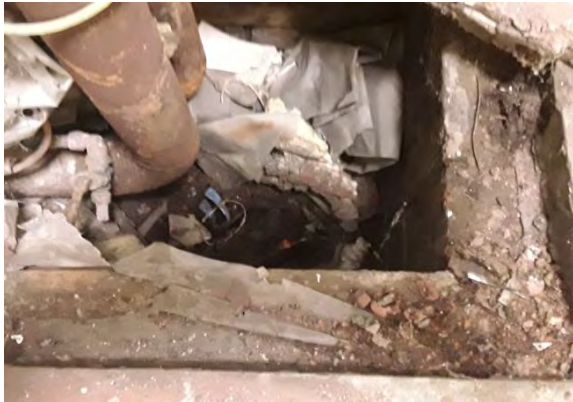
Item 61 – Ref: 20-27752-6

The debris within the pipework duct in the Primary Boiler Room does not contain asbestos.

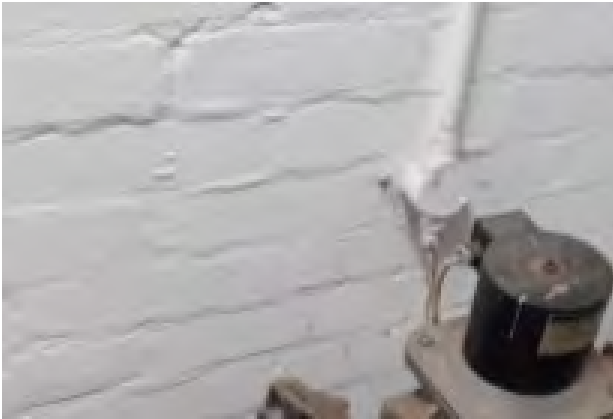
Item 62 – Ref: 20-27752-1

The pipework throughout x 7 gaskets in the Infant – Nursery Boiler Room are contain asbestos.

Removed July 2021

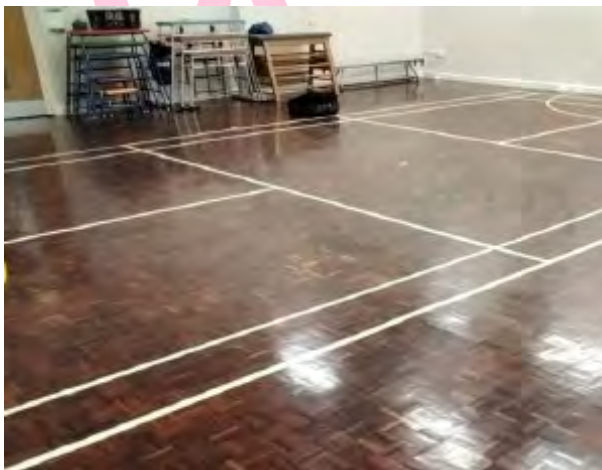
Item 63 – Ref: DC003094

The floor covering adhesive to parquet flooring does not contain asbestos.

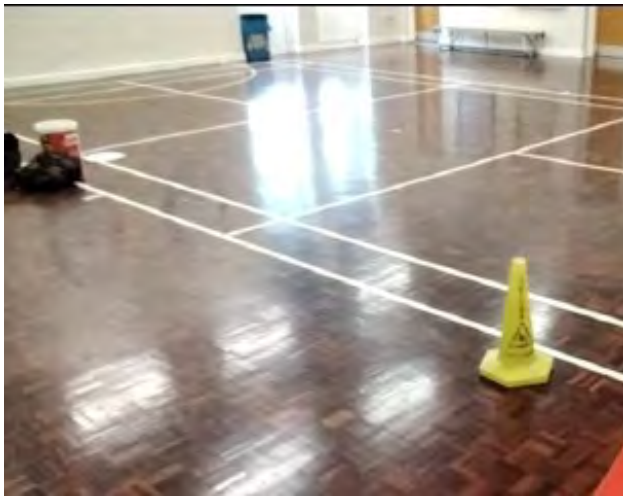
Item 64 – Ref: DC003095

The floor covering adhesive to parquet flooring does not contain asbestos.
