ASBESTOS SURVEY REPORT FOR RYHOPE JUNIOR SCHOOL,  
SHAFTESBURY AVENUE, SUNDERLAND, SR2 0RT.

### **Asbestos Register for Ryhope Junior School**

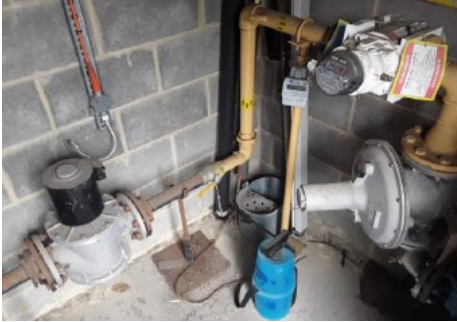
### **Item 1 Ref: 21-33697-2**

The pipe flange gaskets (area 52 gas meter cupboard) do not contain asbestos.

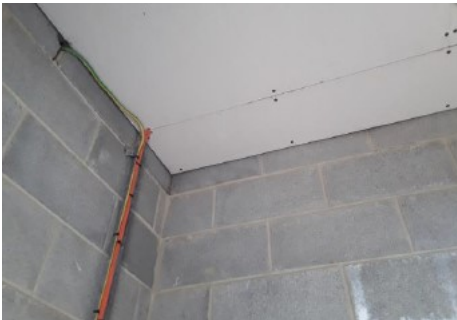
### **Item 2 Ref: 21-33697-3**

The ceiling insulating board (area 52 gas meter cupboard) does not contain asbestos.

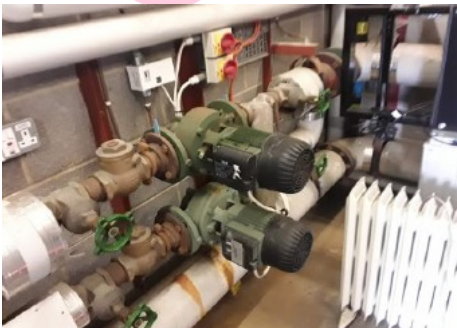
### **Item 3 Ref: 21-33697-4**

The pipe flange gaskets (area 53 boiler room) does not contain asbestos.

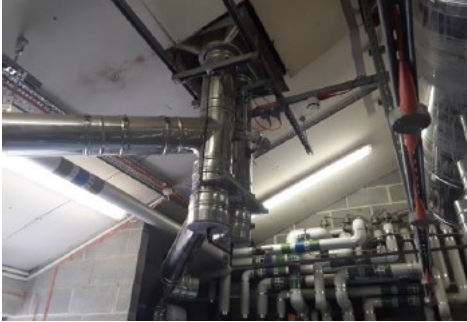
### Item 4 Ref: 21-33697-5

The ceiling insulating board (area 53 boiler room) does not contain asbestos.

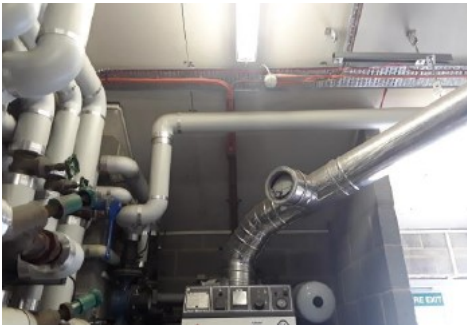
### Item 5 Ref: 21-33697-6

The ceiling insulating board (area 53 boiler room) does not contain asbestos.

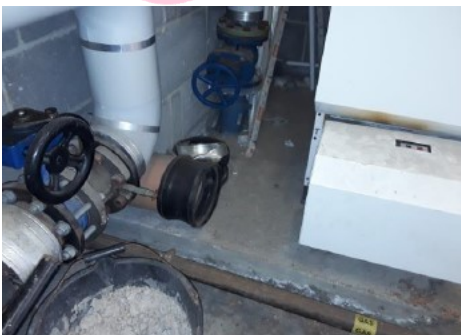
### Item 6 Ref: 21-33697-7

The floor – debris (insulating board) (area 53 boiler room) does not contain asbestos.

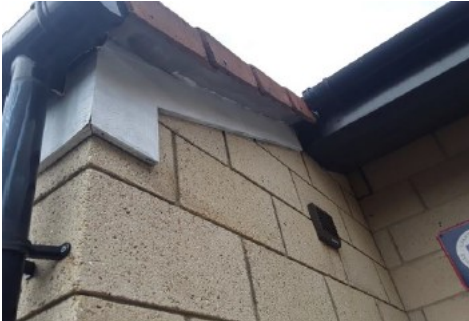
**Item 7 Ref: 21-33697-1**

The roof undercloaks (cement) (area 100 external) do not contain asbestos.

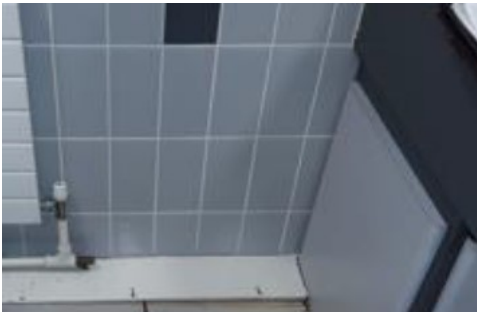
**Item 8 Ref: 21-33510-1**

The ceramic tiles to wall (area 1 ladies toilet) do not contain asbestos.

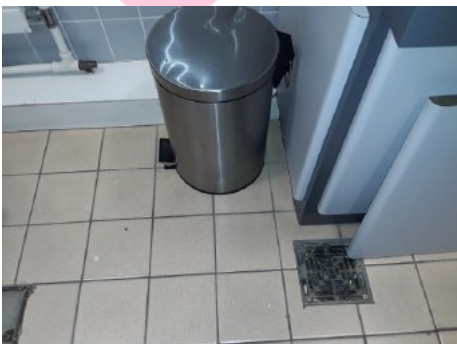
**Item 9 Ref: 21-33510-2**

The ceramic tiles to floor (area 1 ladies toilet) do not contain asbestos.

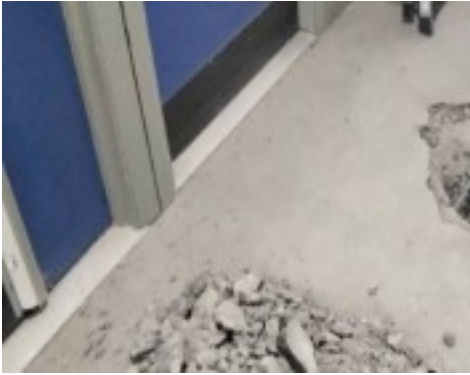
### **Item 10 Ref: NO000250**

The floor screed (G/001/Corridor Outside Staff Toilets, Adjacent IT Room) does not contain asbestos.

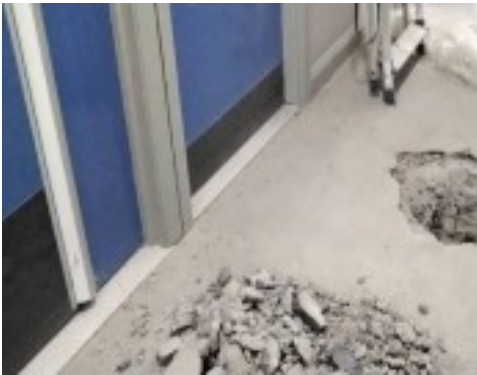
### **Item 11 Ref: NO000249**

The insulation within floor layers (G/001/Corridor Outside Staff Toilets, Adjacent IT Room) does not contain asbestos.

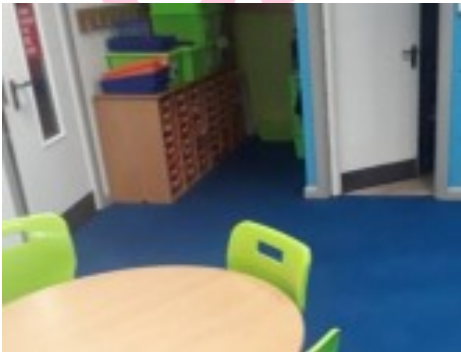
### **Item 12 Ref: NZ001198**

The screed under modern flooring and carpet in Classroom (G/001) does not contain asbestos.

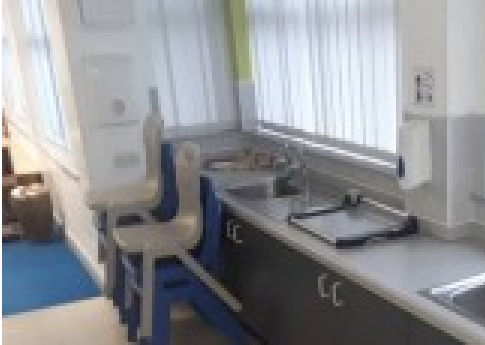
### **Item 13 Ref: NZ001199**

The under sink mat within walkway been classrooms in Classroom (G/001) does not contain asbestos.

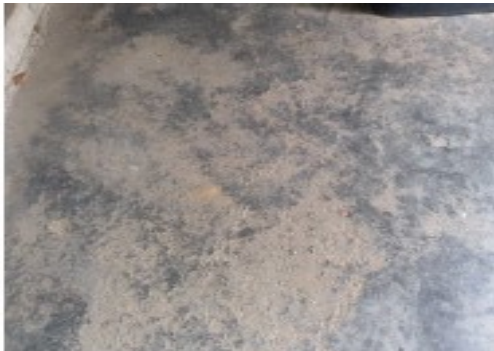
### **Item 14 Ref: HD000918**

The Bitumen adhesive – floor (Boiler Room G/01) does not contain asbestos.

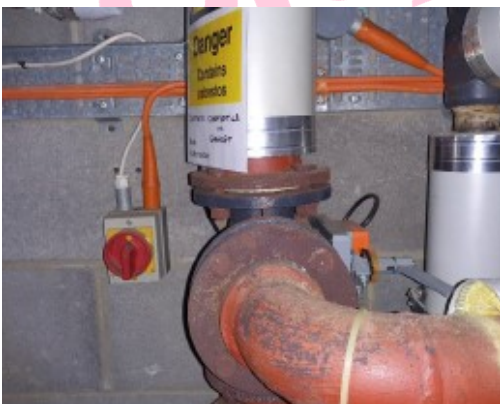
### **Item 15 Ref: HD000919**

- (Item 15) HD000919 – Gaskets within red and silver/black flanges to left wall from entrance doors x4 (Boiler Room G/01) – Low Risk
- (Item 16) Presumed – Recessed gaskets within pipework flanges <27 (Boiler Room G/01) – No Risk

The Gaskets within red and silver/black flanges to left wall from entrance doors x4 (Boiler Room G/01) does contain asbestos.

Any change in appearance should be reported to Property Services.

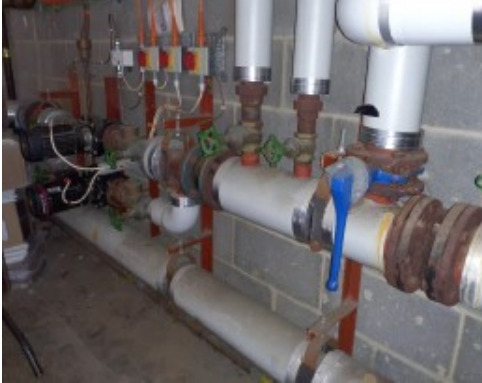
### Item 16 Ref: Presumed

The Recessed gaskets within pipework flanges <27 (Boiler Room G/01) is presumed to contain asbestos.

Any change in appearance should be reported to Property Services.
