ASBESTOS SURVEY REPORT FOR SPRINGWELL DENE SCHOOL, SUNDERLAND

Asbestos Register for SPRINGWELL DENE SCHOOL, SUNDERLAND

Date: 11 March 2025

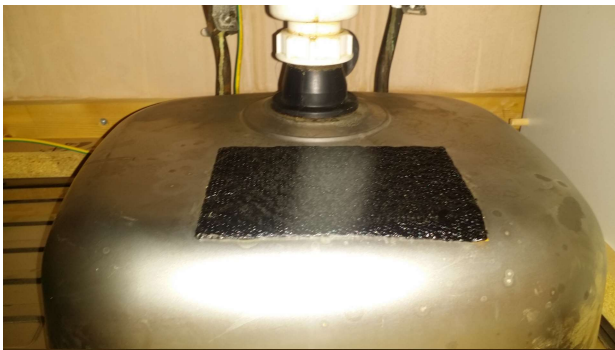
Item 11 Ref: 291230-4

Sink pad in 014/kitchen does not contain asbestos.

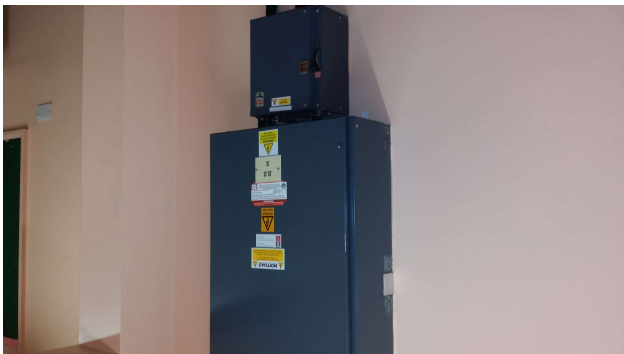
Item 12 Ref: Presumed

Electrics-MEM boxes in 014/kitchen are presumed to contain asbestos.

Any change in its appearance should be recorded and passed to Property Services.

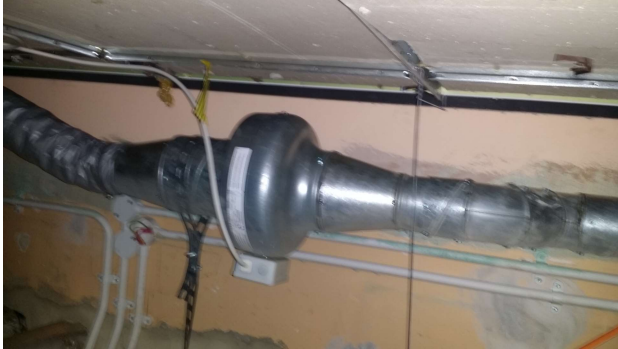
Item 13 Ref: As 291230-5

Sealant to ductwork in 014/kitchen-void above does not contain asbestos.

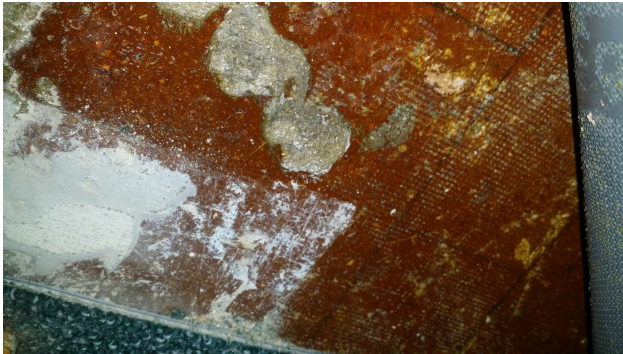
Item 14 Ref: As 291230-3

Subfloor in 015/foyer does not contain asbestos.

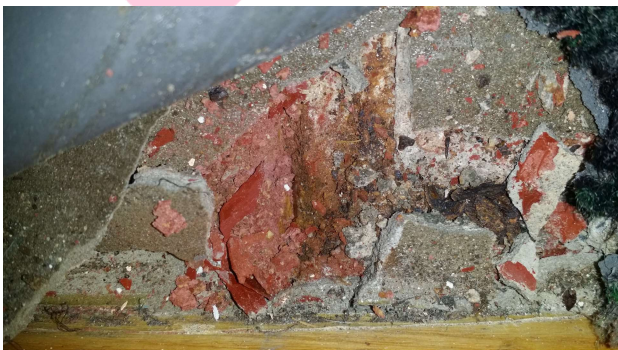
Item 15 Ref: 291230-6

Subfloor in 015/foyer does not contain asbestos.

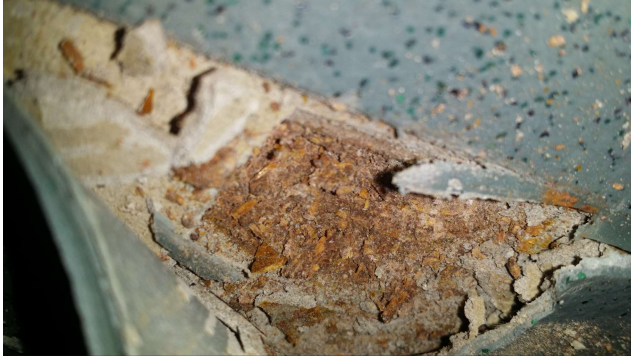
Item 16 Ref: 291230-7

Subfloor in 017/kitchen does not contain asbestos.

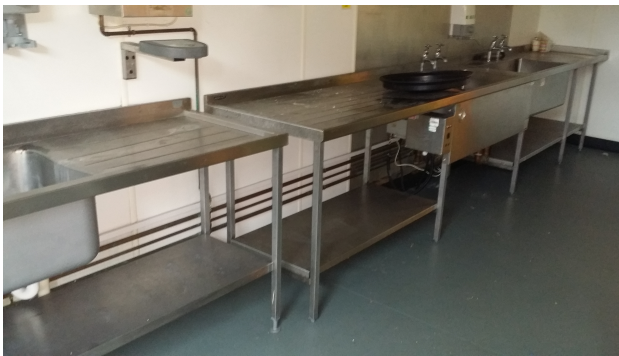
Item 17 Ref: 291230-8

Acoustic paint in 017/kitchen does not contain asbestos.

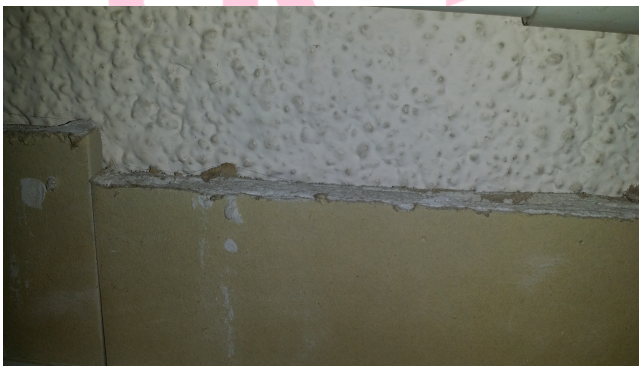
Item 18 Ref: As 291230-10

Sprayed coating to walls behind PVC & plasterboard in 017/kitchen contains asbestos.

Any change in its appearance should be recorded and passed to Property Services.

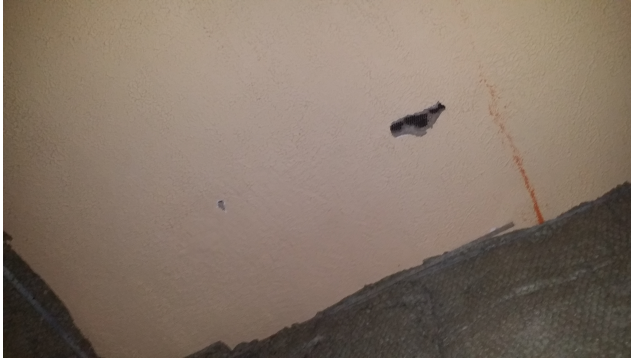
Item 19 Ref: 291230-9

Ceiling in 017/kitchen-void above contains asbestos.

Removed June 2019

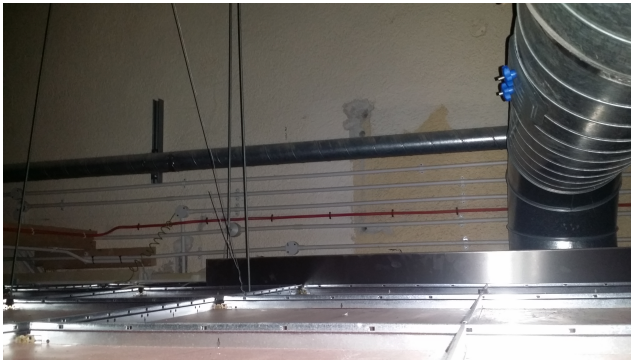
Item 20 Ref: 291230-10

Sprayed coating to walls in 017/kitchen-void above contains asbestos.

Any change in its appearance should be recorded and passed to Property Services.

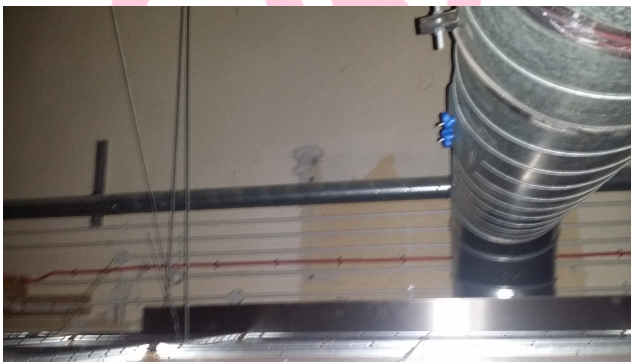
Item 21 Ref: As 291230-5

Mastic to ductwork in 017/kitchen-void above does not contain asbestos.

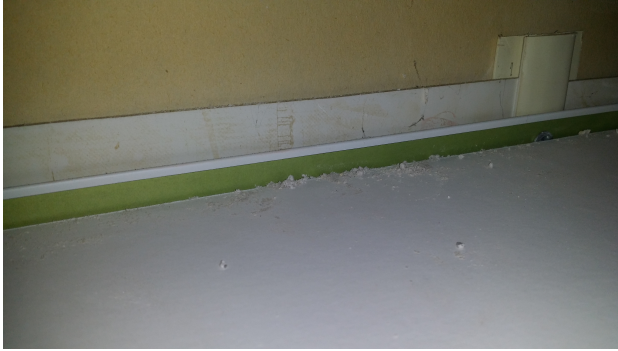
Item 22 Ref: 291230-11

Debris to tops of surfaces in 017/kitchen-void above contains asbestos.

Removed June 2019

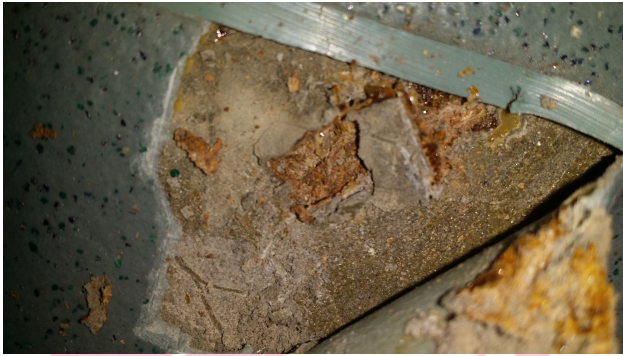
Item 23 Ref: As 291230-7

Subfloor in 018/kitchen toilet does not contain asbestos.

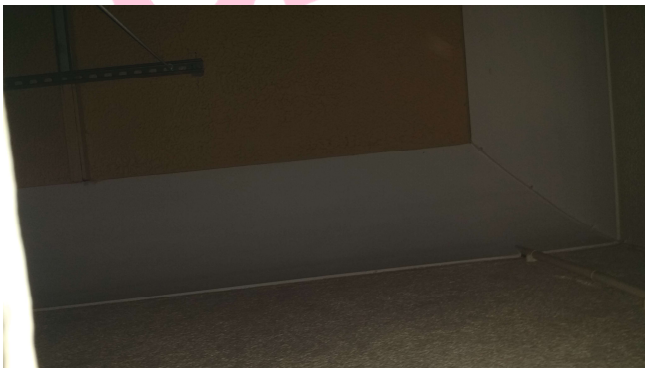
Item 24 Ref: As 291230-9

Ceiling in 018/kitchen toilet-void above contains asbestos.

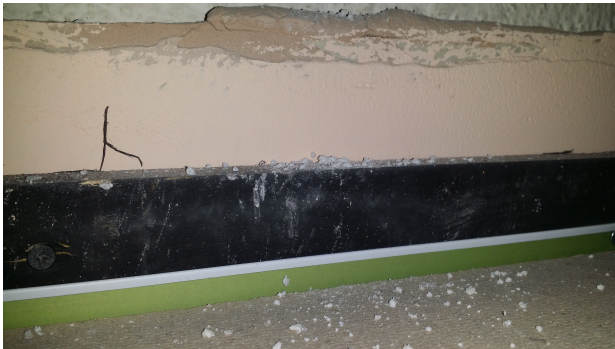
Item 26 Ref: 291230-13

Debris to tops of surfaces in 018/kitchen toilet-void above contain asbestos.

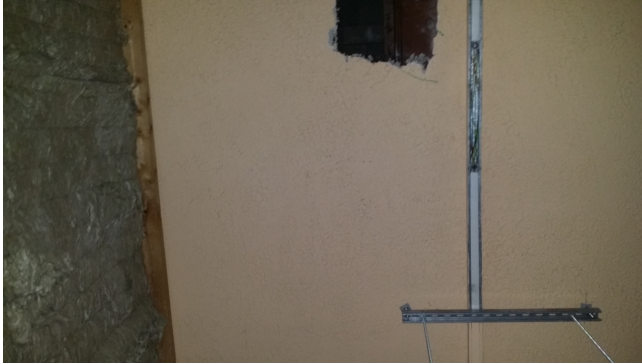
Item 28 Ref: As 291230-9

Ceiling in 019/kitchen office-void above contain asbestos.

Removed June 2019

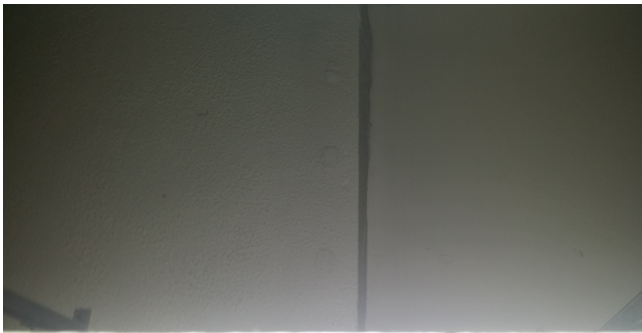
Item 29 Ref: As 291230-10

Sprayed coating to walls in 019/kitchen office-void above contain asbestos.

Any change in its appearance should be recorded and passed to Property Services.

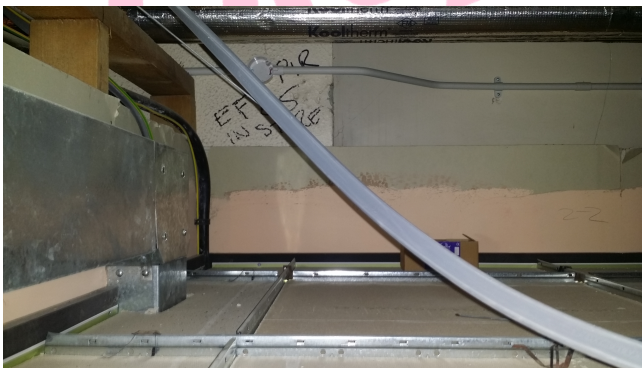
Item 30 Ref: 291230-12

Debris to tops of surfaces in 019/kitchen office-void above contain asbestos.

Removed June 2019

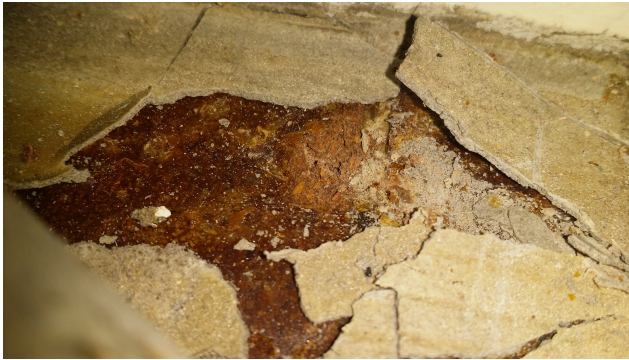
Item 31 Ref: As 291230-7

Subfloor in 020/kitchen store does not contain asbestos.

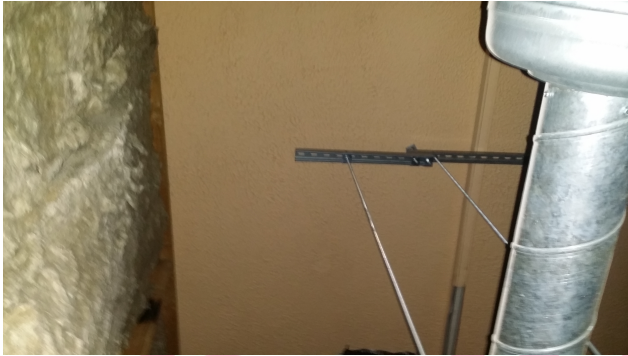
Item 32 Ref: As 291230-9

Ceiling in 020/kitchen store-void above contain asbestos.

Removed June 2019.

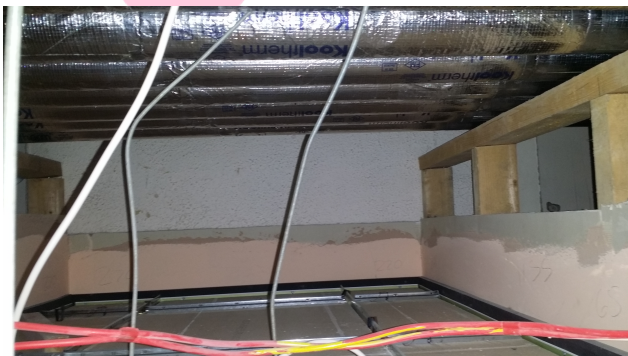
Item 33 Ref: As 291230-10

Sprayed coating to walls in 020/kitchen store-void above contain asbestos.

Any change in its appearance should be recorded and passed to Property Services.

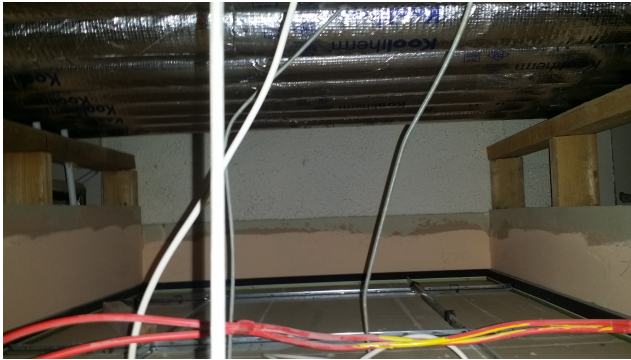
Item 34 Ref: 291230-14

Debris to tops of surfaces in 020/kitchen store-void above contain asbestos.

Removed June 2019

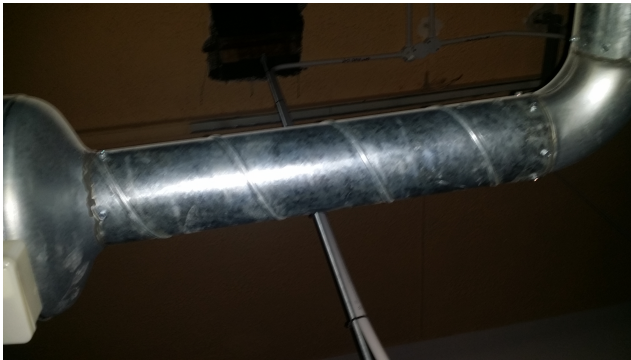
Item 35 Ref: As 291230-5

Mastic to ductwork in 020/kitchen store void above does not contain asbestos.

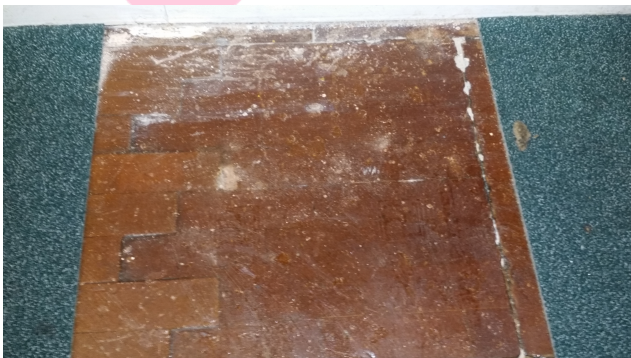
Item 36 Ref: 291230-15

Subfloor in 021/recreational hall does not contain asbestos.

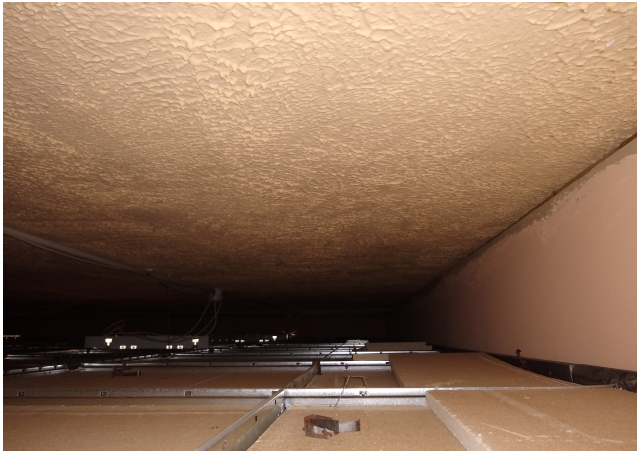
Item 37 Ref: 299208-1

Textured coating on plaster on mesh ceiling in 021/recreation hall-void above does not contain asbestos.

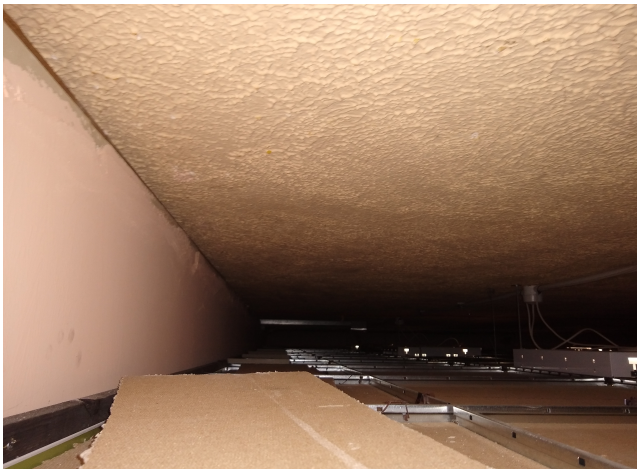
Item 38 Ref: 299208-2

Textured coating on plaster on mesh ceiling in 021/recreation hall-void above does not contain asbestos.

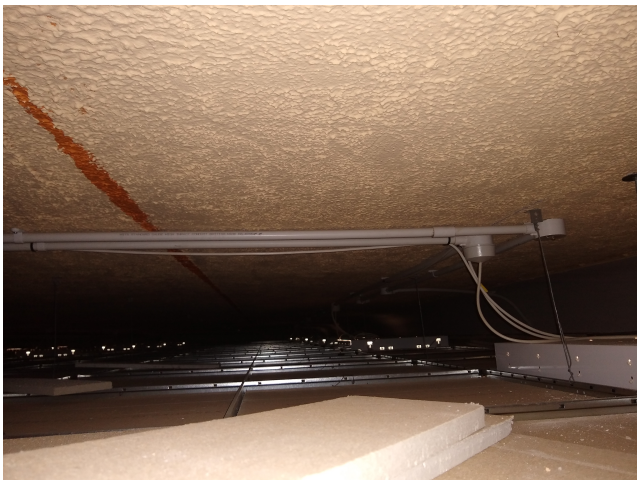
Item 39 Ref: 299208-3

Textured coating on plaster on mesh ceiling in 021/recreation hall-void above does not contain asbestos.

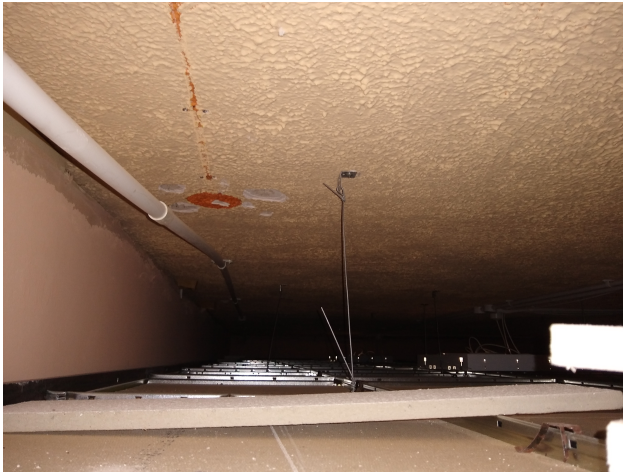
Item 40 Ref: 299208-4

Textured coating on plaster on mesh ceiling in 021/recreation hall-void above does not contain asbestos.

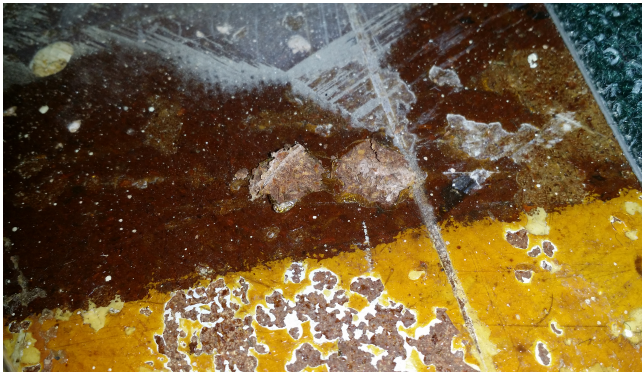
Item 41 Ref: As 291230-15

Subfloor in 022/store does not contain asbestos.

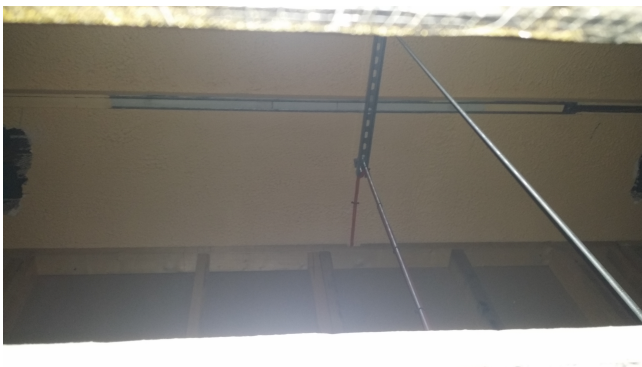
Item 42 Ref: As 291230-9

Ceiling in 022/kitchen store-void above contain asbestos.

Removed June 2019

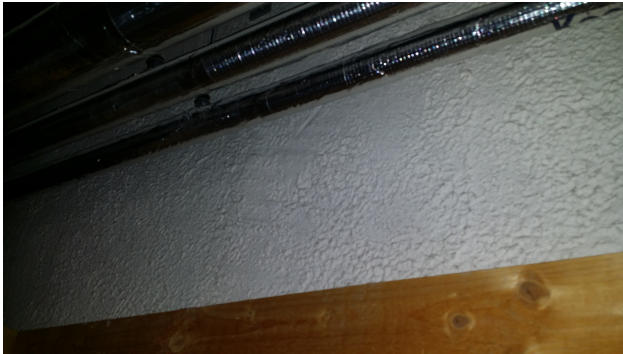
Item 43 Ref: 291230-16

Textured coating to walls in 022/store-void above does not contain asbestos.

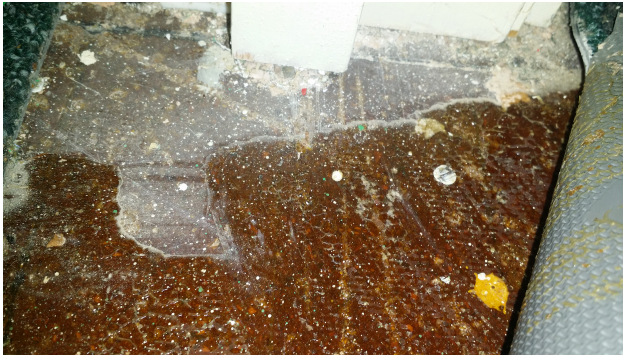
Item 44 Ref: As 291230-15

Subfloor in 023/store does not contain asbestos.

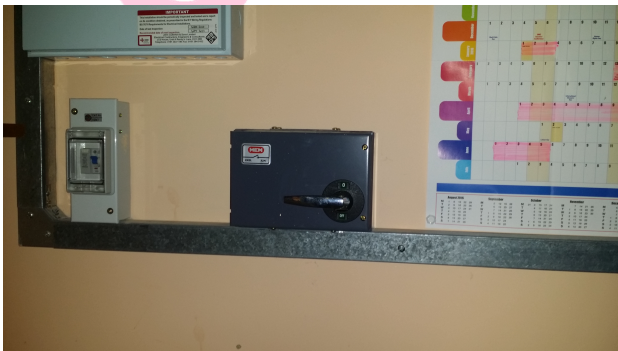
Item 45 Ref: Presumed

Electrics MEM box in 023/store is presumed to contain asbestos.

Any change in its appearance should be recorded and passed to Property Services.

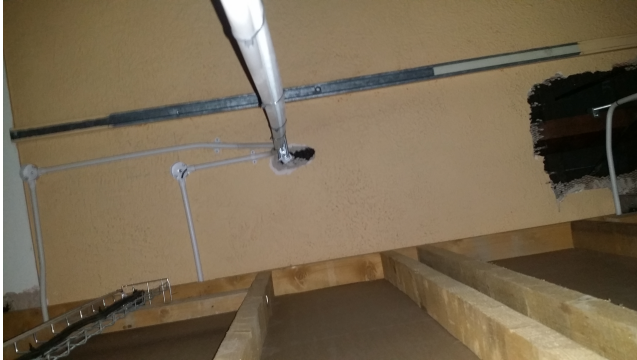
Item 46 Ref: As 291230-9

Ceiling box in 023/store-void above contains asbestos.

Removed June 2019

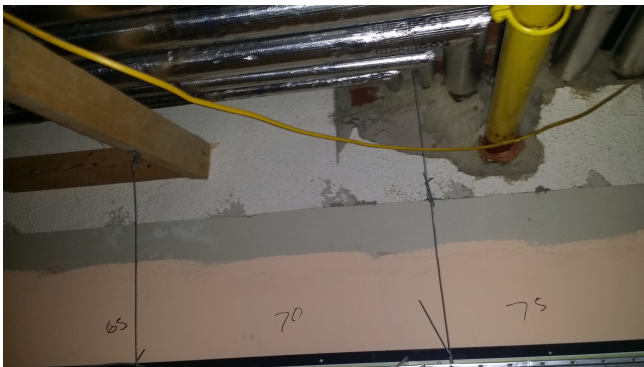
Item 47 Ref: As 291230-16

Textured coating to walls in 023/store-void above does not contain asbestos.

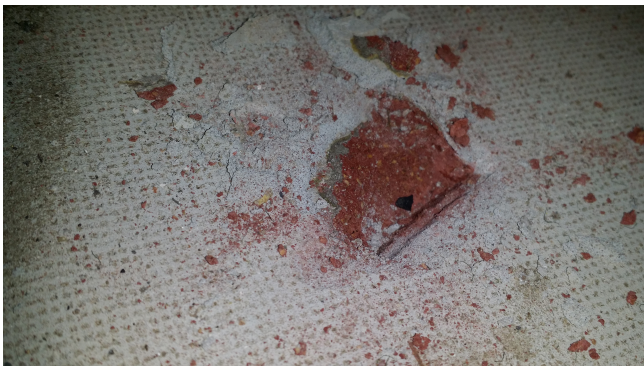
Item 48 Ref: 291230-17

Subfloor in 024/recording studio does not contain asbestos.

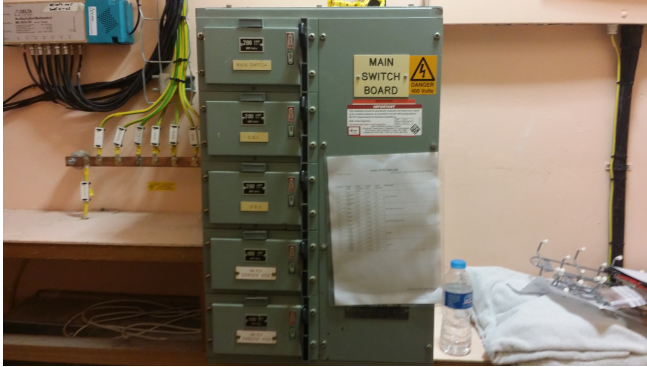
Item 49 Ref: Presumed

Electrics main switchboard in 026/switch room is presumed to contain asbestos.

Any change in its appearance should be recorded and passed to Property Services.

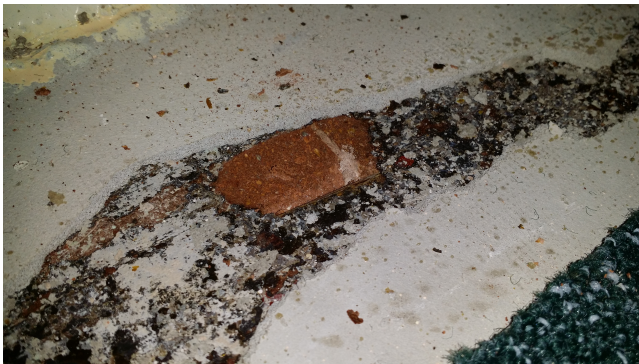
Item 50 Ref: 291230-18

Subfloor in 027/classroom contains asbestos.

Any change in its appearance should be recorded and passed to Property Services.

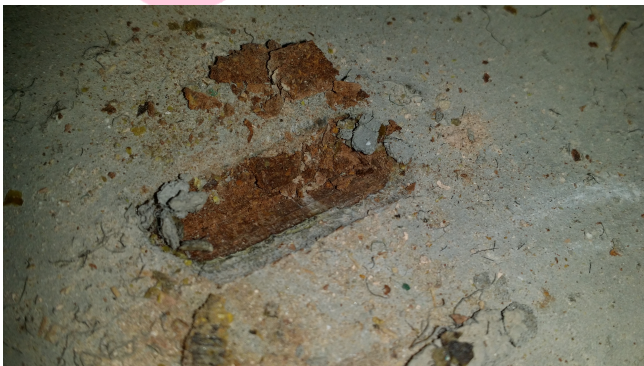
Item 51 Ref: As 291230-18

Subfloor in 028/classroom contains asbestos.

Any change in its appearance should be recorded and passed to Property Services.

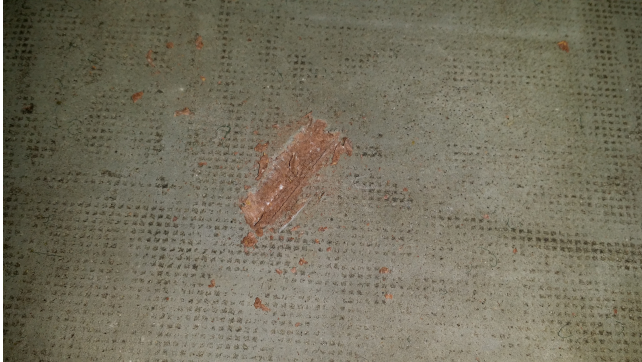
Item 52 Ref: As 291230-18

Subfloor in 029/classroom contains asbestos.

Any change in its appearance should be recorded and passed to Property Services.

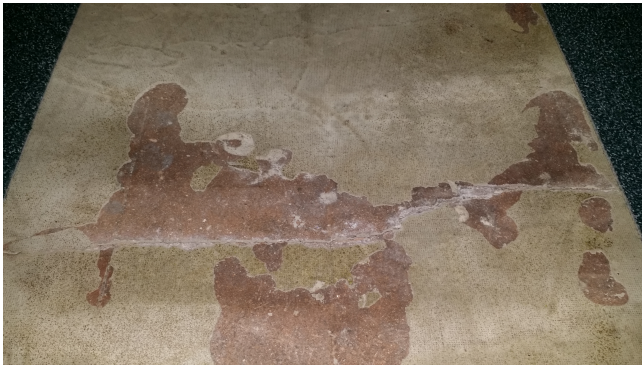
Item 53 Ref: As 291230-18

Subfloor in 030/classroom contains asbestos.

Any change in its appearance should be recorded and passed to Property Services.

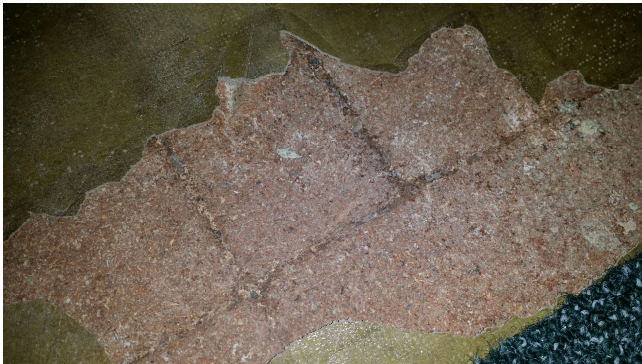
Item 54 Ref: As 291230-18

Subfloor in 031/classroom contains asbestos.

Any change in its appearance should be recorded and passed to Property Services.

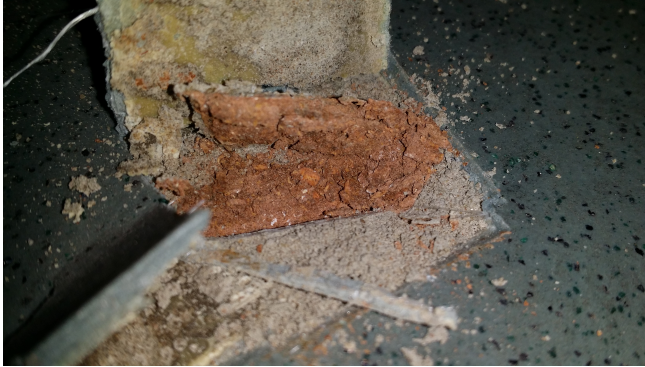
Item 55 Ref: As 291230-18

Subfloor in 032/science lab contains asbestos.

Any change in its appearance should be recorded and passed to Property Services.

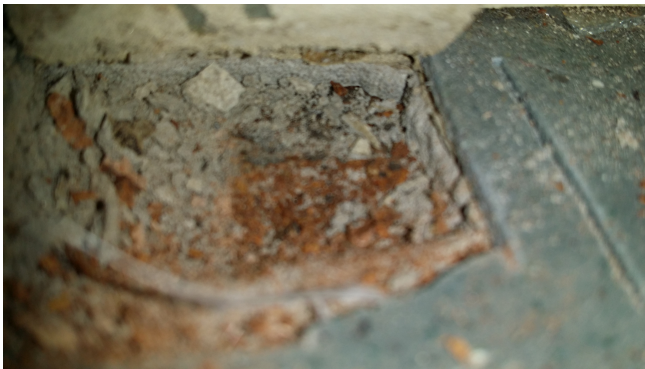
Item 56 Ref: 291230-19

Subfloor in 033/science lab store contains asbestos.

Any change in its appearance should be recorded and passed to Property Services.

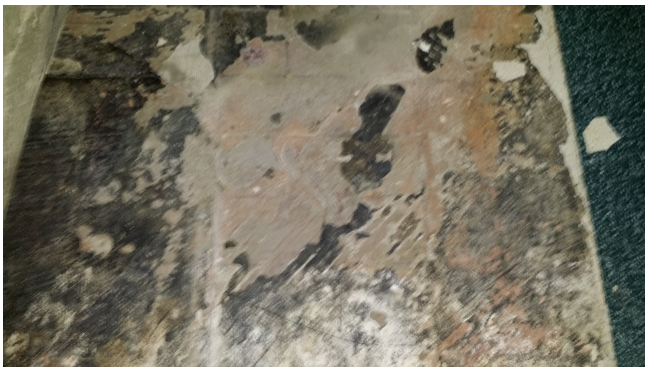
Item 57 Ref: As 291230-19

Subfloor in 034/classroom contains asbestos.

Any change in its appearance should be recorded and passed to Property Services.

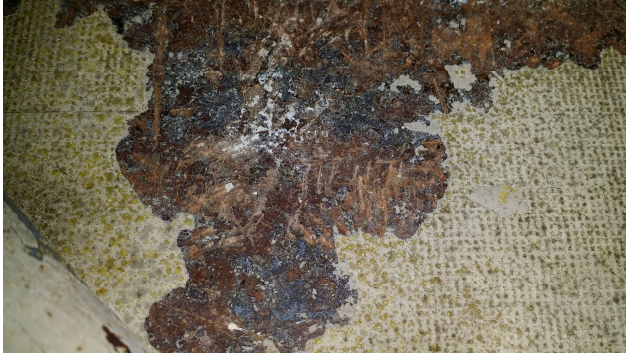
Item 58 Ref: As 291230-18

Subfloor in 035/games room contains asbestos.

Any change in its appearance should be recorded and passed to Property Services.

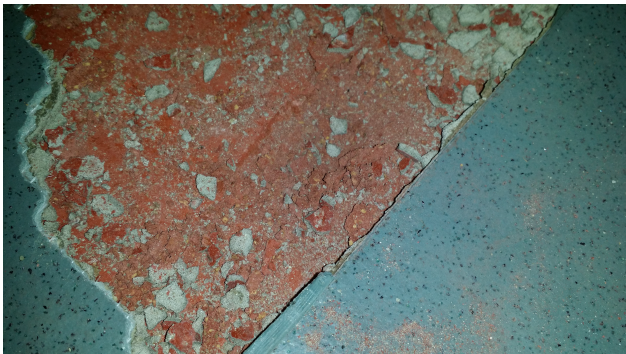
Item 59 Ref: 291230-20

Subfloor in 036/snack bar does not contain asbestos.

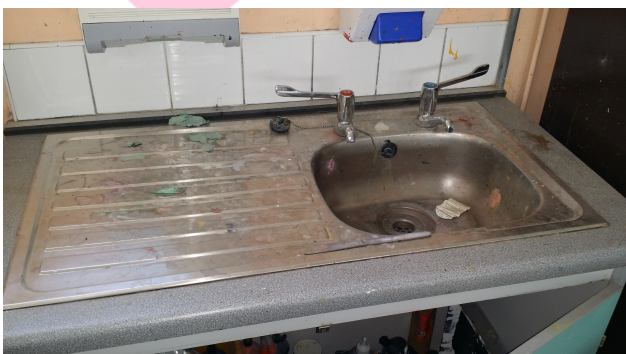
Item 60 Ref: 291230-21

Sink pads in 043/woodshop does not contain asbestos.

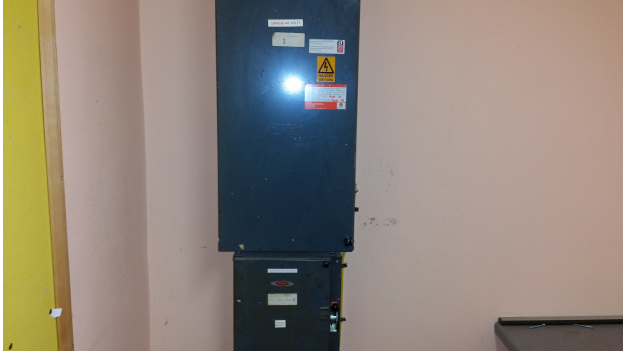
Item 61 Ref: Presumed

Electrics in 051/cleaners store is presumed to contain asbestos.

Any change in its appearance should be recorded and passed to Property Services.

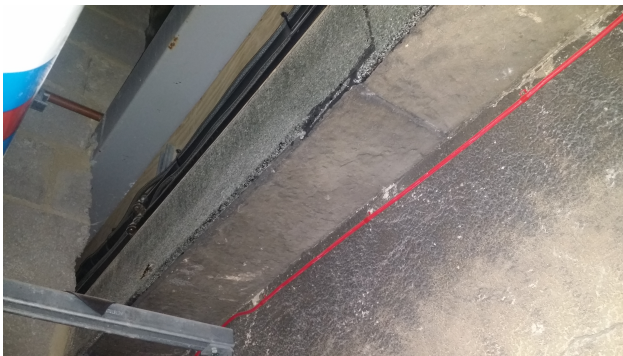
Item 62 Ref: 291230-22

Roof covering to flat roof in 057/male changing-void above does not contain asbestos.

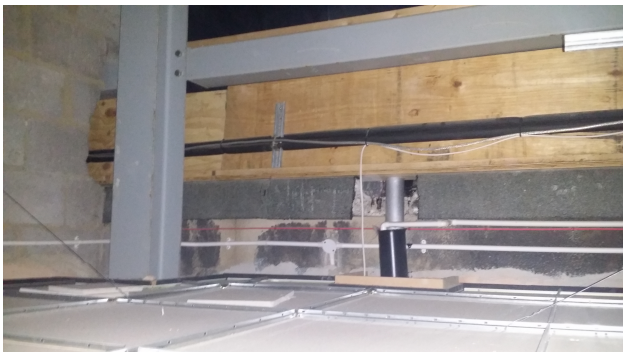
Item 63 Ref: As 291230-22

Roof covering to flat roof in 059/gym-void above does not contain asbestos.

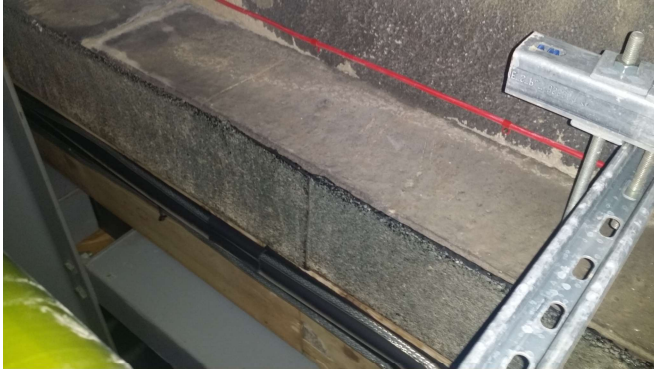
Item 64 Ref: As 291230-22

Roof covering to flat roof in 064/corridor-void above does not contain asbestos.

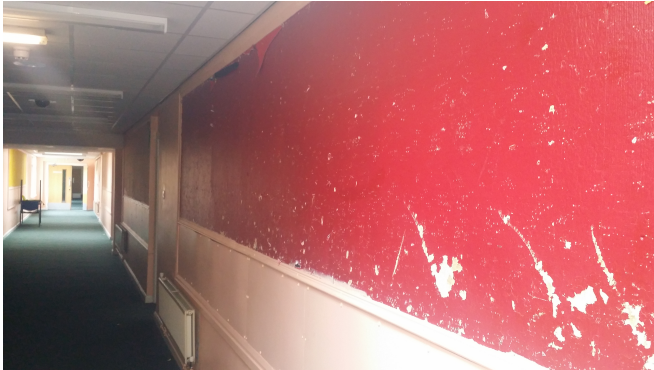
Item 65 Ref: 291230-23

Pinboards to walls in 065/corridor does not contain asbestos.

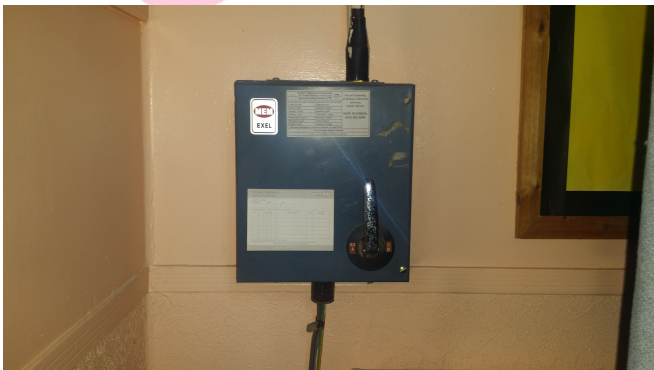
Item 66 Ref: Presumed

Electrics MEM box in 066/stairwell is presumed to contain asbestos.

Any change in its appearance should be recorded and passed to Property Services.

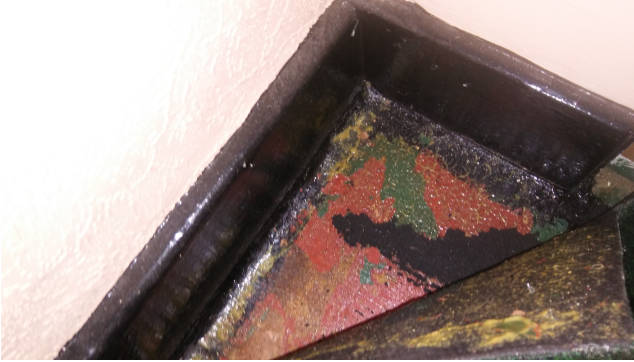
Item 67 Ref: 291230-26

Floor covering below carpet in Level 1/001/flat stairwell does not contain asbestos.

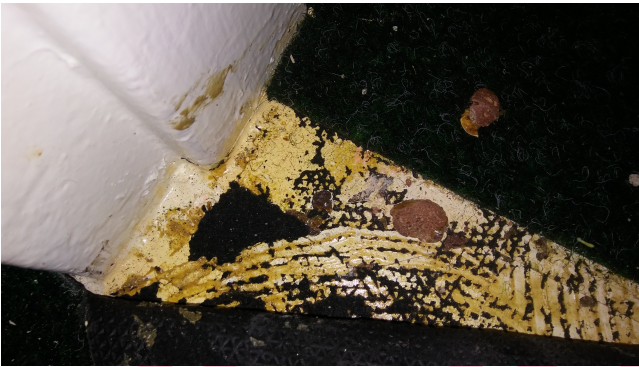
Item 68 Ref: As 291230-26

Floor covering below carpet in Level 1/002/corridor does not contain asbestos.

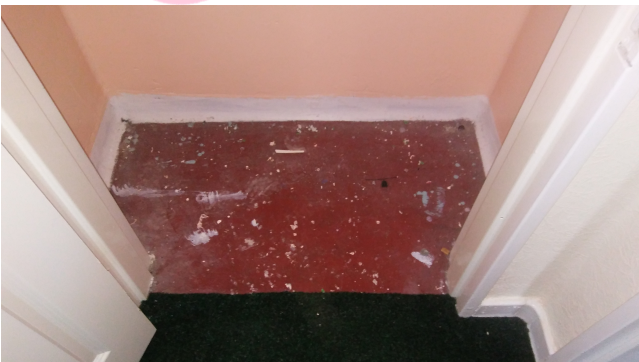
Item 69 Ref: As 291230-26

Floor covering below carpet in Level 1/003/bedroom does not contain asbestos.

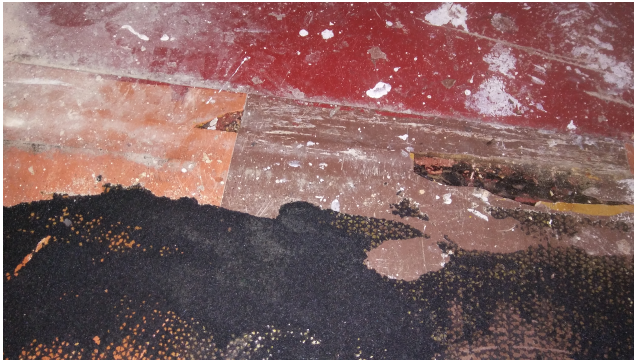
Item 70 Ref: 291230-27

Floor covering below carpet in Level 1/008/kitchen contains asbestos.

Removed July 2020

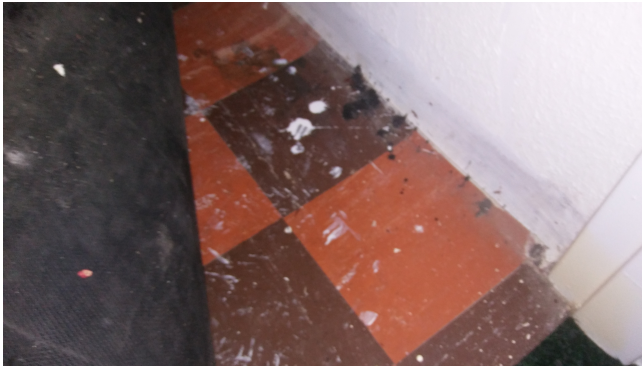
Item 71 Ref: As 291230-27

Floor covering below carpet in Level 1/008b/cupboard contains asbestos.

Removed July 2020

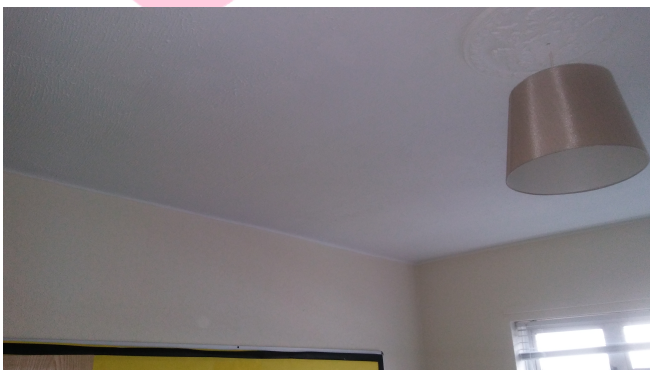
Item 72 Ref: 291230-28

Coating to ceiling in Level 1/009/living room does not contain asbestos.

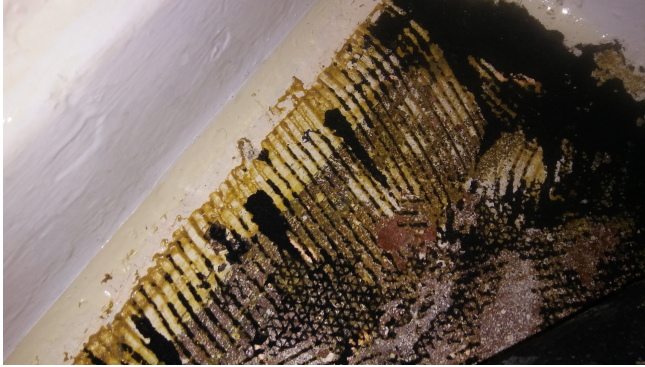
Item 73 Ref: As 291230-26

Floor covering below carpet in Level 1/009/living room does not contain asbestos.

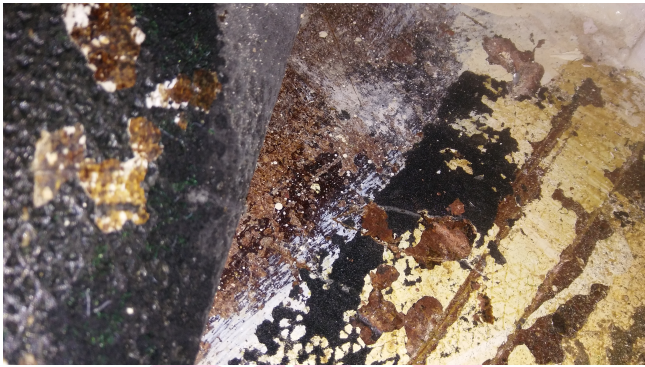
Item 74 Ref: As 291230-26

Floor covering below carpet in Level 1/010/room does not contain asbestos.

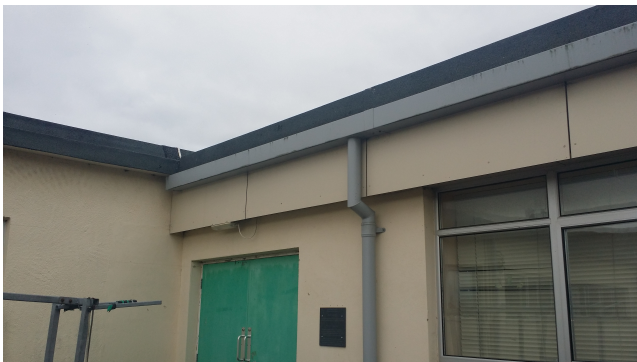
Item 75 Ref: 291230-24

The external fascia to proposed art room extension does not contain asbestos.

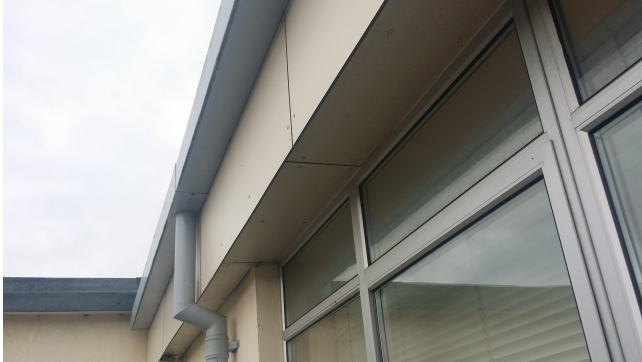
Item 76 Ref: As 291230-24

The external soffit to proposed art room extension does not contain asbestos.

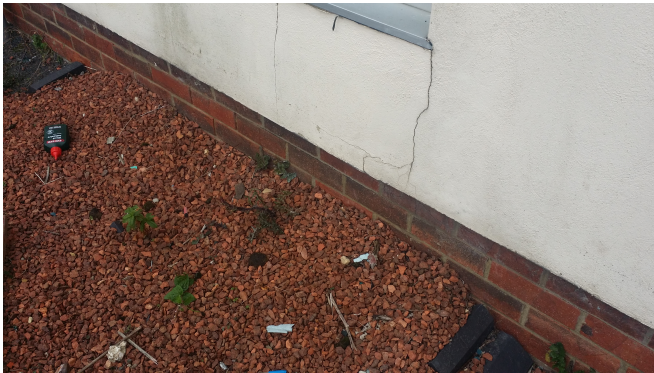
Item 77 Ref: 291230-25

The external damp proof course does not contain asbestos.

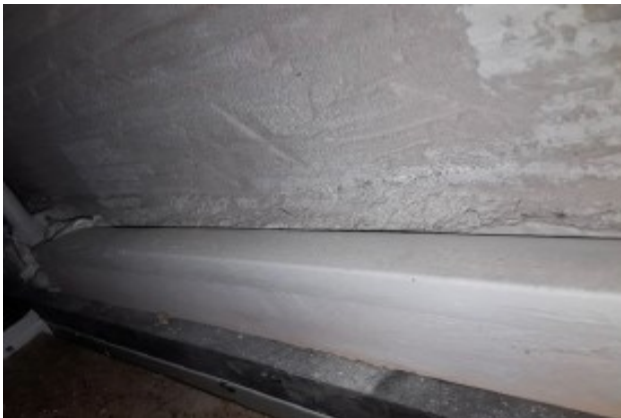
Item 95 Ref: LK003509

The sprayed coating behind plasterboard partition walls in the Kitchen Office Toilet (041) does contain asbestos.

Any change in its appearance should be recorded and passed to Property Services.

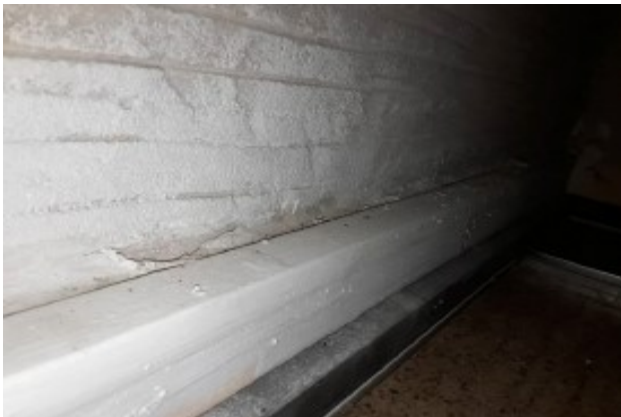
Item 96 Ref: LK003510

The sprayed coating debris in the Kitchen Office Toilet (041) does contain asbestos.

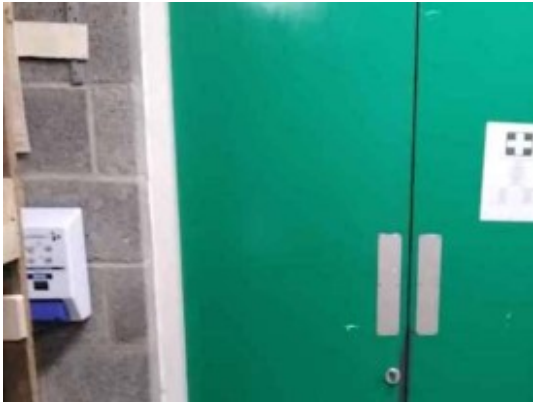
Item 103 - Ref: AW005906

The door frame sealant (composite mastic) (External E/003 Workshop) does not contain asbestos.

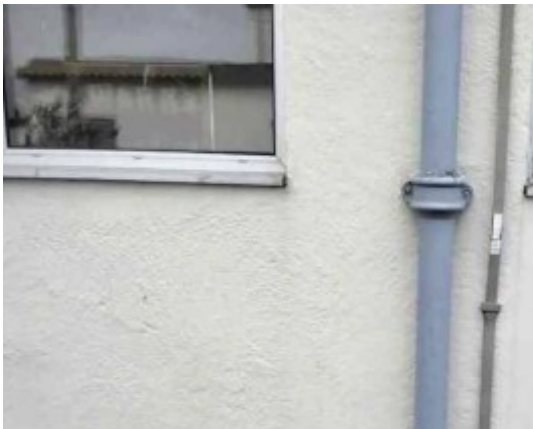
Item 104 - Ref: AW005907

The drain pipe packing (composite mastic) (External E/004) does not contain asbestos.
