*Control of Asbestos
Regulations 2012*

Asbestos Register for

St Benets RC Primary School

UPRN: - 133791

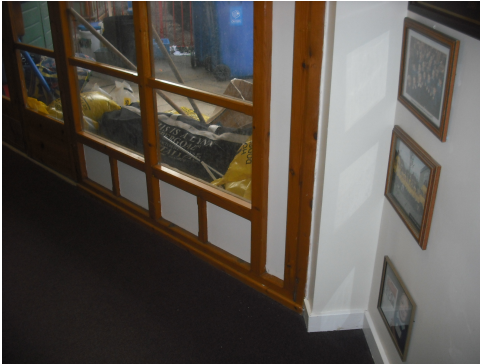
Various Ref: JJ0254/10

The window Infill Panel to Corridor 0/02 does not contain asbestos.
Similar Panels can be found in Entrance/Foyer/Lobby 0/01.

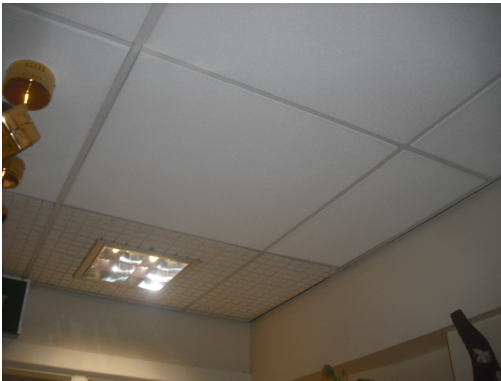
Item 2 Ref: JJ0255/10

The ceiling tile to Corridor 0/02 does not contain asbestos.

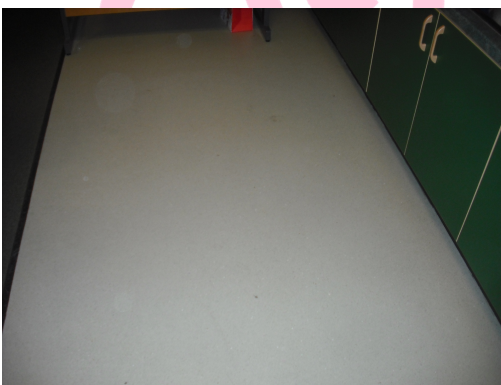
Various Ref: JJ0258/10

The floor tiles to Classroom 10 0/10 do not contain asbestos.
Similar tiles can be found in Classroom 9 0/12, Classroom 6 0/19, Classroom 5 0/21, Classroom 4 0/30, Classroom 3 0/31, Classroom 2 0/36, Classroom 1 0/37, Classroom Reception Class 1 0/39, Classroom Reception Class 2 0/41, Store to Classroom Reception Class 2 0/42, Toilets 0/47, Cupboard Store Nursery 0/52, Disabled Toilets 0/59, Male Toilets 0/60 and Female Toilets 0/61.

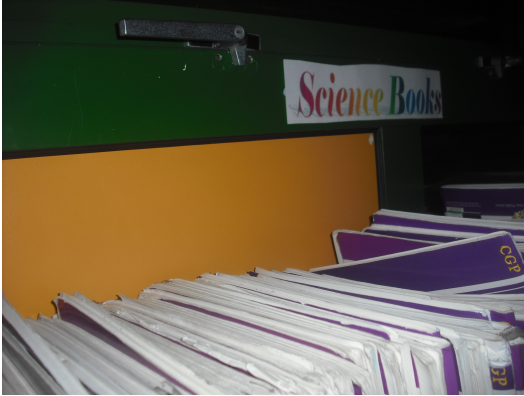
Various Ref: JJ0260/10

The window infill panel in the Classroom Group Room 0/11 does not contain asbestos. Similar panels can be found in Staff Room 0/08, Classroom group room 0/20 and External All Areas E/1.

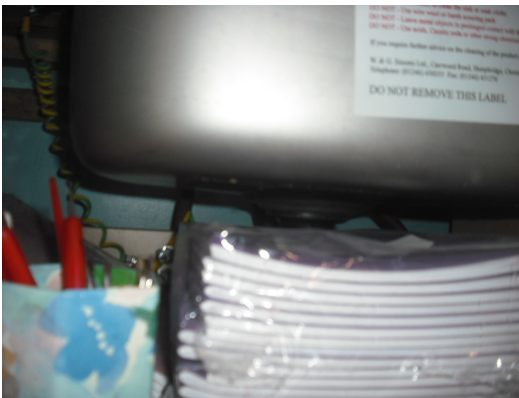
Item 6 Ref: JJ0259/10

The Sink Pad to Classroom 10 0/10 does not contain asbestos.

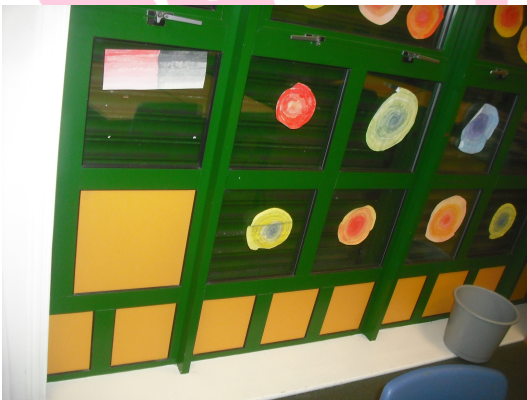
Various Ref: JJ0257/10

The window infill panel in Classroom 10 0/10 does not contain asbestos. Similar panels can be found in Classroom 9 0/12, Library/Classroom 0/14, Classroom 6 0/19, Classroom 5 0/21, ICT Room 0/27 and Classroom Reception Class 2 0/41.

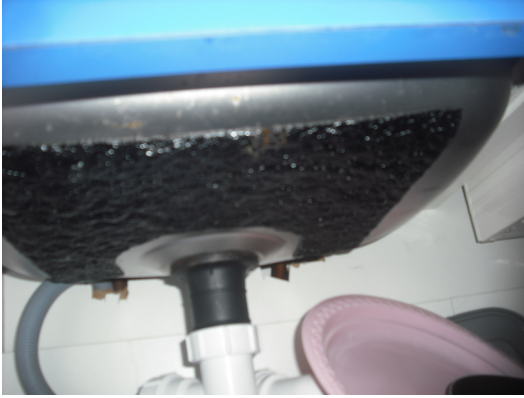
Various Ref: JJ0261/10

The sink pad in classroom 9 0/12 does not contain asbestos.
Similar Sink pads can be found in Classroom 6 0/19, Classroom 5 0/21, Classroom 4 0/30, Classroom 3 0/31, Classroom 2 0/36, Classroom 1 0/37, Classroom Reception Class 1 0/39 and Classroom Nursery 0/50.

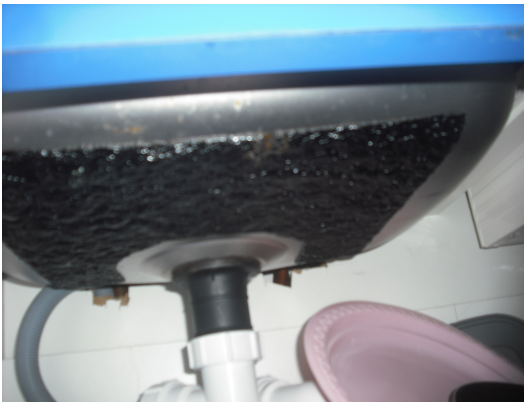
Item 36 Ref: JJ0262/10

The sink pad in the Office Rest Area 0/49 does not contain asbestos.

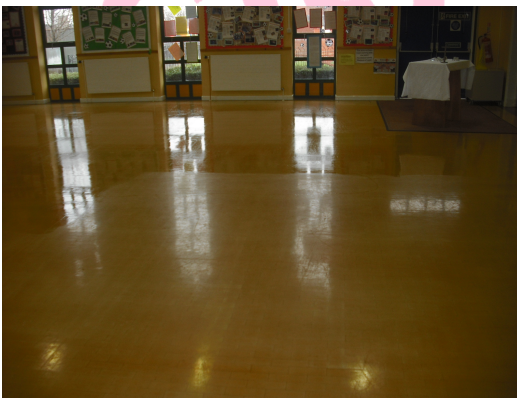
Item 42 Ref: JJ0263/10

The floor tiles in the Main Hall 0/62 do not contain asbestos.

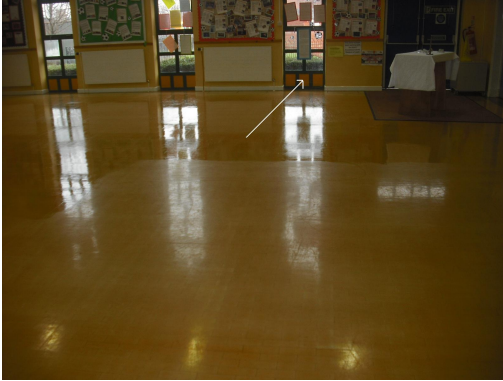
Item 43 Ref: JJ0264/10

The window infill panel in the Main Hall 0/62 does not contain asbestos.

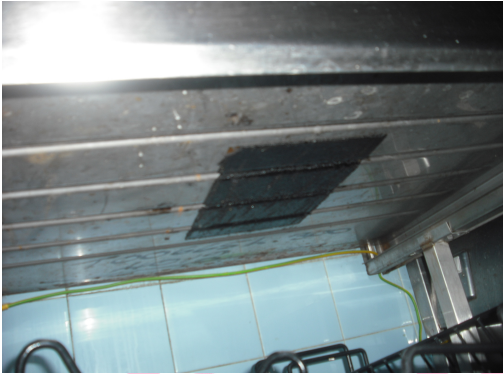
Item 44 Ref: JJ0265/10

The sink pad in the Kitchen Servery 0/65 does not contain asbestos.

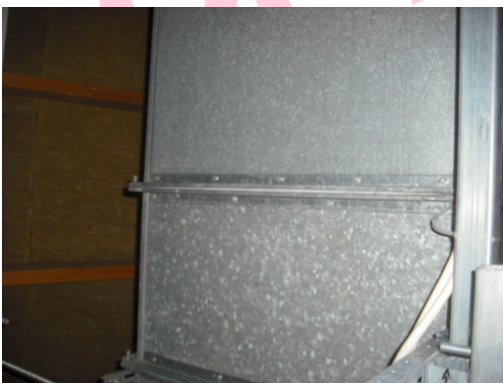
Item 45 Ref: JJ0252/10

The ductwork joints in the Boiler Room E1/04 do not contain asbestos.

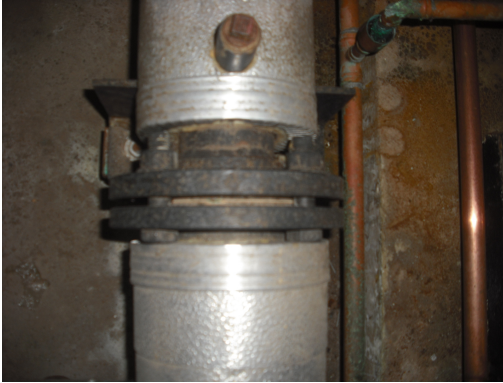
Item 46 Ref: JJ0251/10

The pipework gaskets in the Boiler Room E1/04 do not contain asbestos.

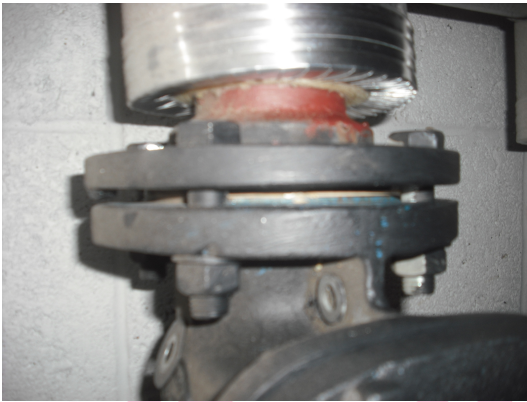
Item 47 Ref: JJ0253/10

The pipework gaskets in the Boiler Room E1/04 do not contain asbestos.

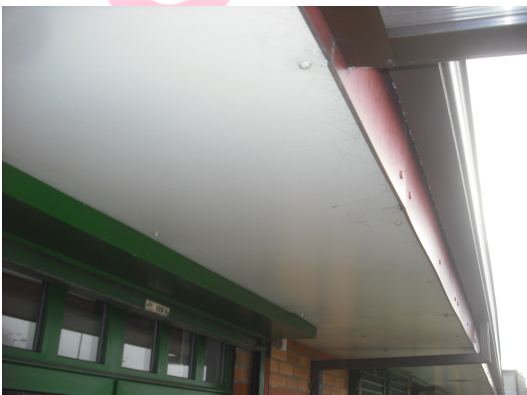
Item 48 Ref: JJ0267/10

The canopy ceiling to external all areas E/1 does not contain asbestos.

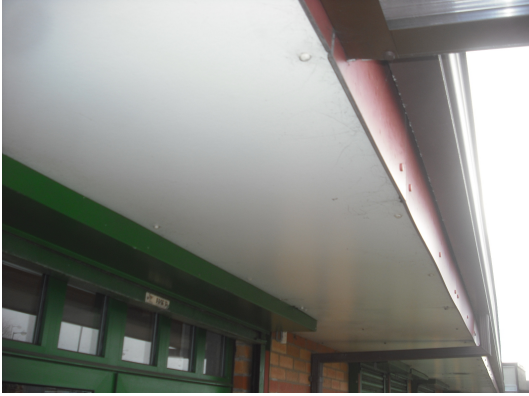
Item 49 Ref: JJ0266/10

The fascia to external all areas E/1 does not contain asbestos.

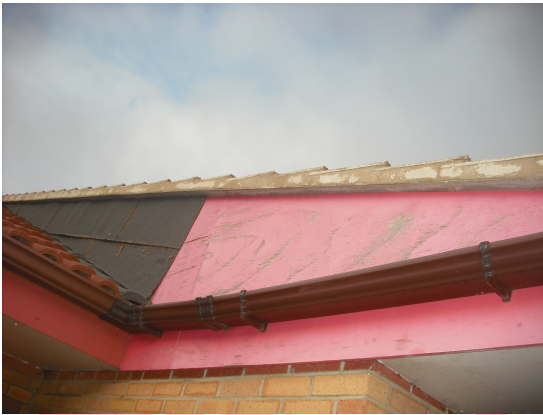
Item 51 Ref: JJ0268/10

The undercloak to external all areas E/1 does not contain asbestos. Similar undercloak can be found in the roof tiles of the externals E/1.

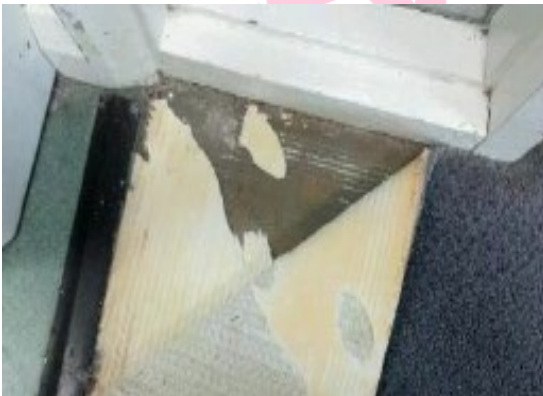
Item 53 Ref: EB000485

The floor screed below carpet in the Nursery (Room 1) does not contain asbestos.

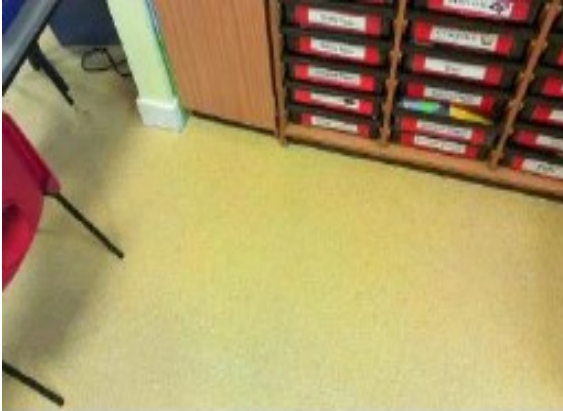
Item 54 Ref: EB000486

The floor screed in the Reception Class 1 (Room 2) does not contain asbestos.

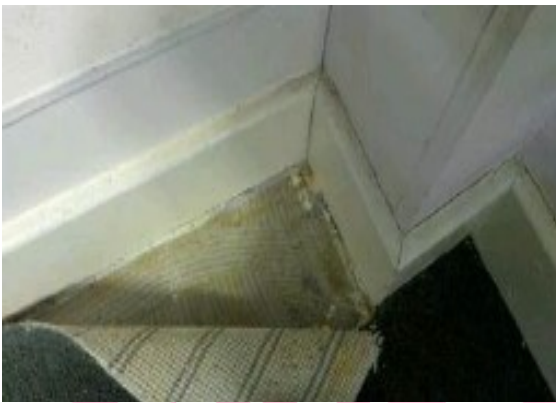
Item 55 Ref:As EB000486

The floor screed below carpet in Class 1 (Room 3) does not contain asbestos.

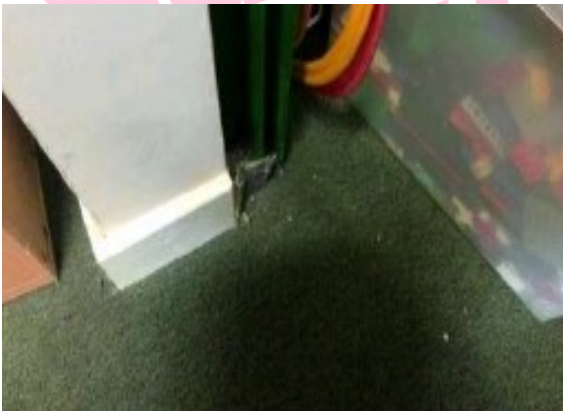
Item 56 Ref:As EB000486

The floor screed below carpet in Class 2 (Room 4) does not contain asbestos.

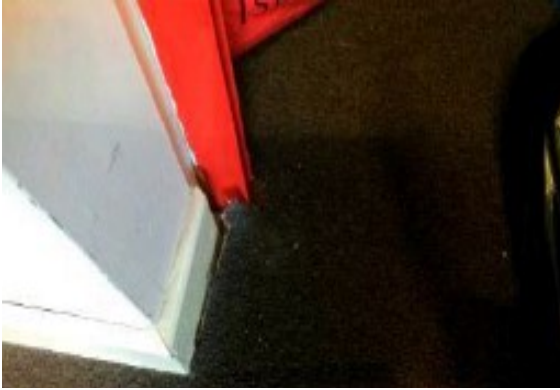
Item 57 Ref:As EB000486

The floor screed below carpet in Studio (Room 7) does not contain asbestos.

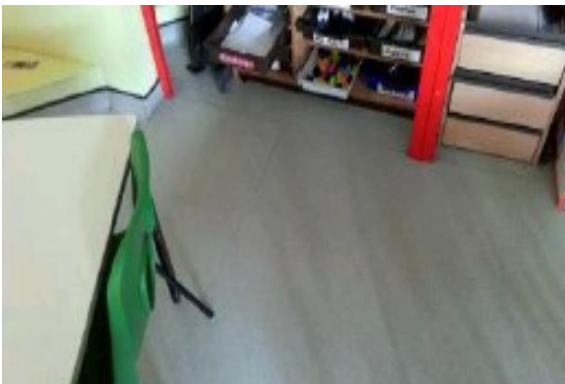
Item 58 Ref: EB000487

The floor screed below carpet in Food Technology (Room 8) does not contain asbestos.

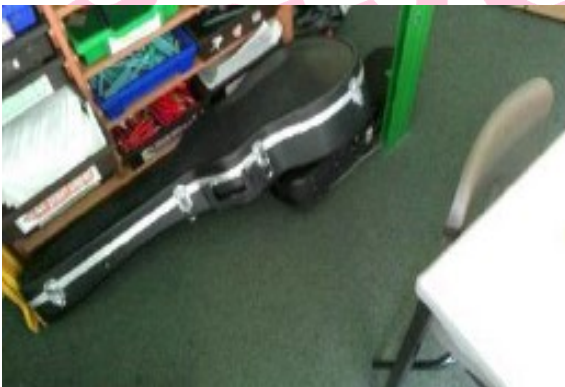
Item 59 Ref:As EB000486

The floor screed below carpet in Class 7 (Room 11) does not contain asbestos.

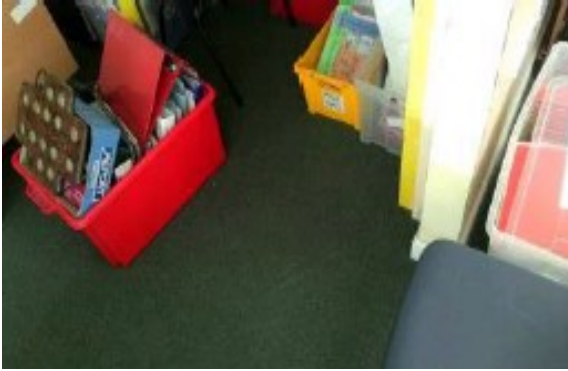
Item 60 Ref:As EB000486

The floor screed below carpet in Class 8 (Room 12) does not contain asbestos.

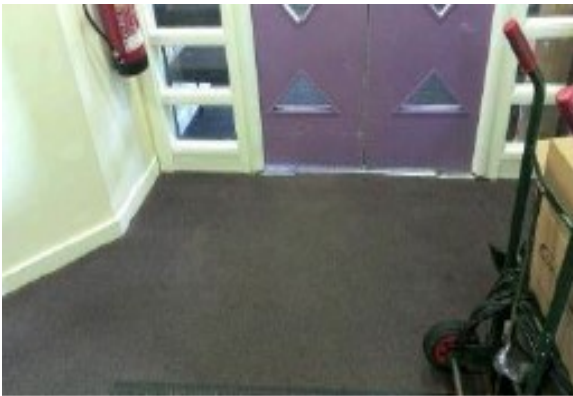
Item 61 Ref: EB000488

The floor screed below carpet in Circulation Corridor (Room 15) does not contain asbestos.

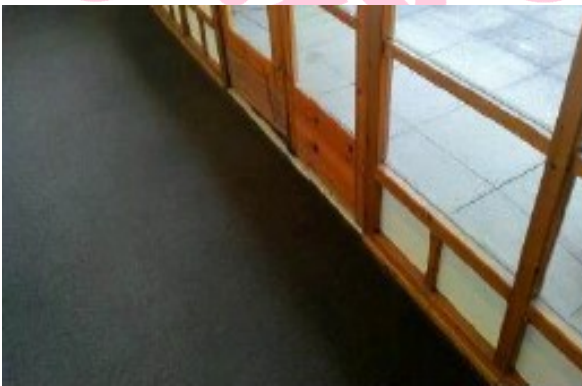
Item 62 Ref:As EB000488

The floor screed below carpet in Circulation Corridor (Room 15) does not contain asbestos.

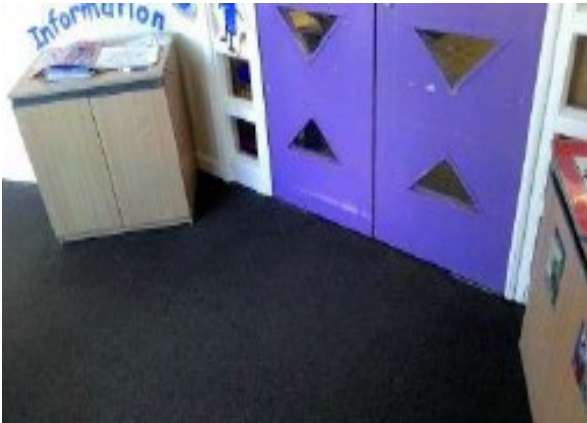
Item 63 Ref:As EB000488

The floor screed below carpet in Circulation Corridor (Room 15) does not contain asbestos.

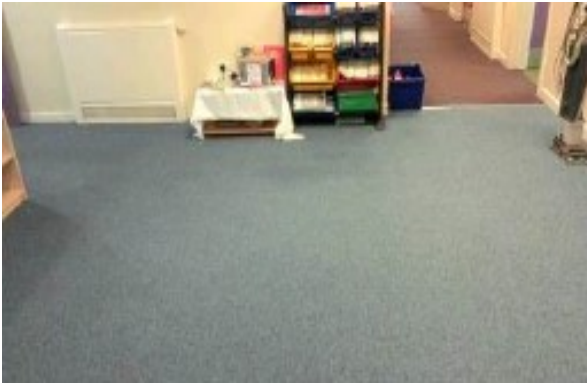
Item 64 Ref:As EB000488

The floor screed below carpet in Circulation Corridor (Room 15) does not contain asbestos.

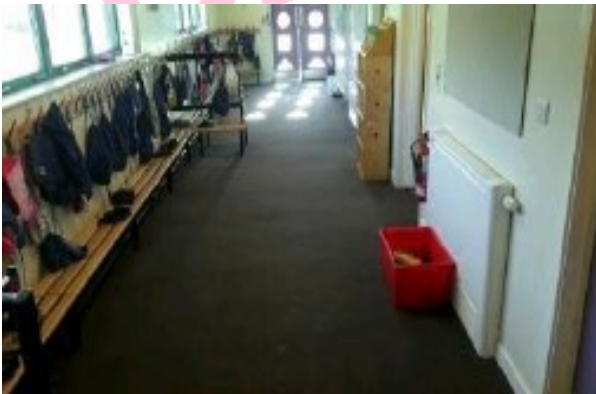
Item 65 Ref:As EB000488

The floor screed below carpet in Circulation Corridor (Room 15) does not contain asbestos.

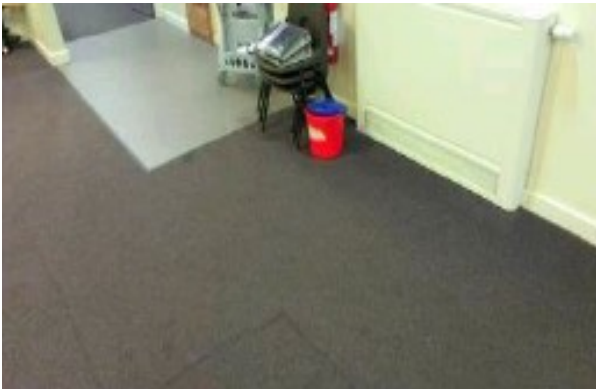
Item 67 Ref:As EB000488

The floor screed below carpet in Circulation Corridor (Room 15) does not contain asbestos.

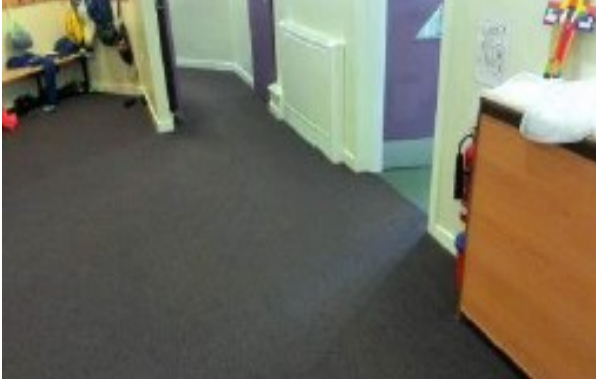
Item 69 Ref:As EB000488

The floor screed below carpet in Circulation Corridor (Room 15) does not contain asbestos.

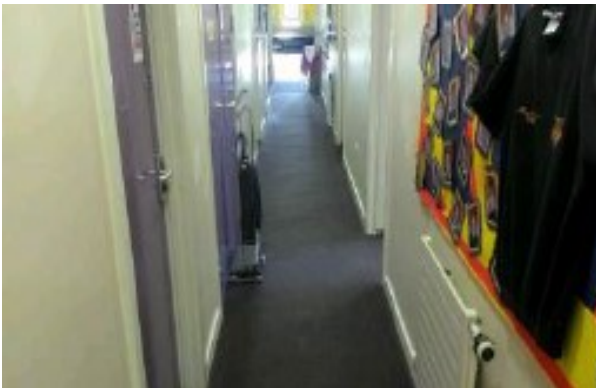
Item 70 Ref:As EB000488

The floor screed below carpet in Circulation Corridor (Room 15) does not contain asbestos.

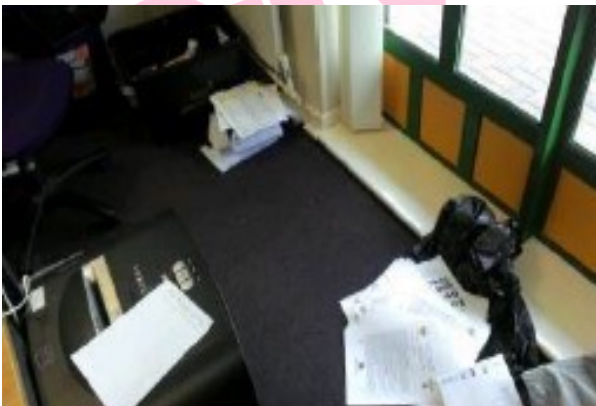
Item 71 Ref:As EB000488

The floor screed below carpet in Head Office (Room 16) does not contain asbestos.

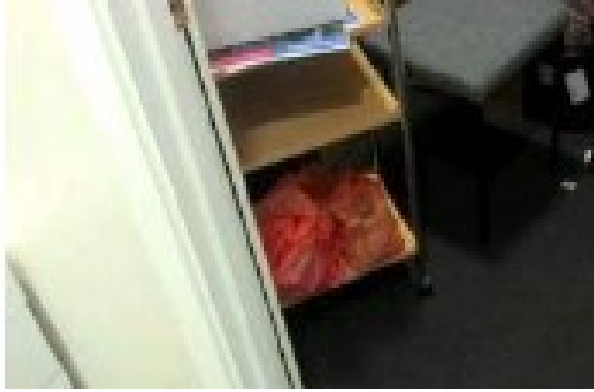
Item 72 Ref:As EB000488

The floor screed below carpet in Store Room (Room 17) does not contain asbestos.

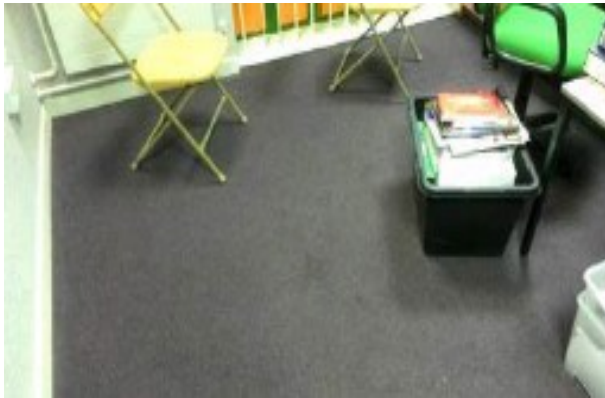
Item 73 Ref:As EB000488

The floor screed below carpet in Medical Room (Room 18) does not contain asbestos.

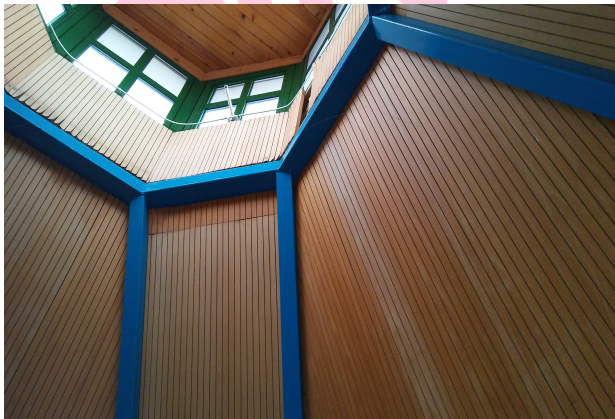
Item 74 Ref: 226754-2

The skylight surround in Classroom 10 (Room 0/01) does not contain asbestos.

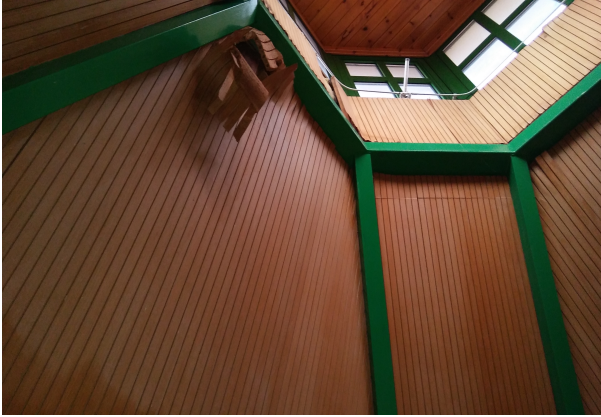
Item 75 Ref:As 226754-2

The skylight surround in Mr Aldersons Classroom (Room 0/02) does not contain asbestos.

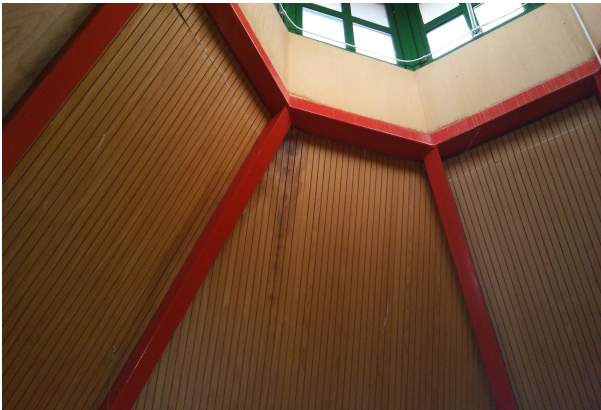
Item 76 Ref: As 226754-2

The skylight surround in Infants Corridor (Room 0/03) does not contain asbestos.

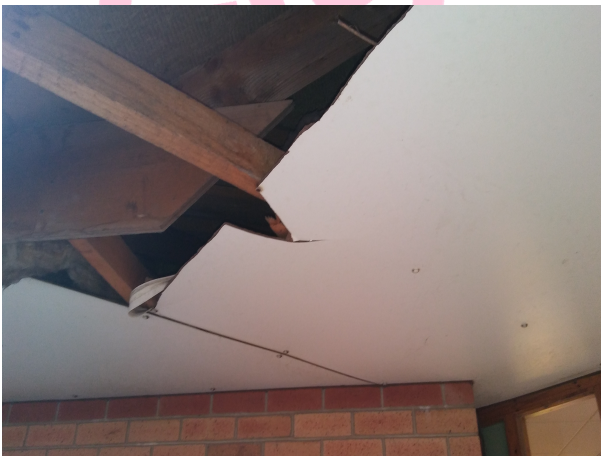
Item 77 Ref: 226754-1

The soffit boards (External) does not contain asbestos.

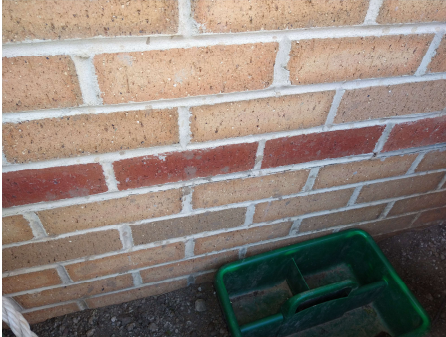
Item 78 Ref: 419339-1

The damp proof course (External) does not contain asbestos.

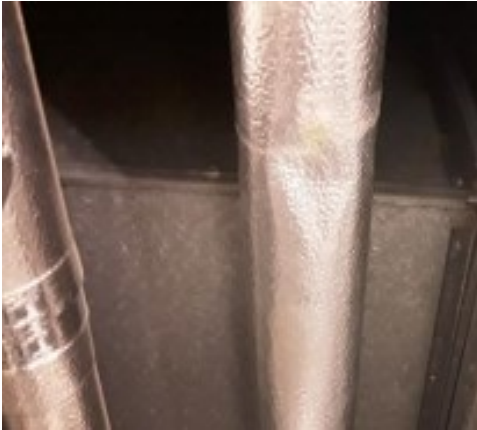
Item 79 Ref: 21-36952-1

The mastic to the vessel in the Plant Room (Area 2) does not contain asbestos.

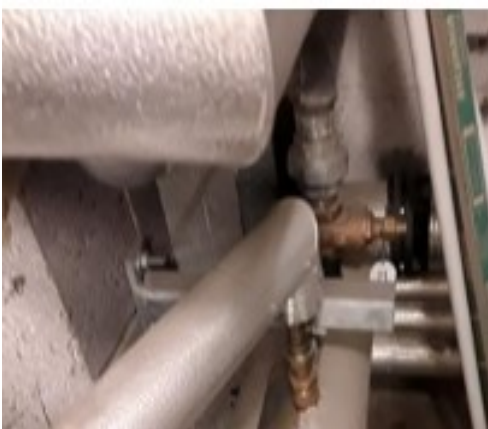
Item 80 Ref: 21-36952-2

The pipe flanges/gaskets in the Plant Room (Area 2) does contain asbestos.

Item 77	No asbestos	Is present		
Item 78	No asbestos	Is present		
Item 79	No asbestos	Is present		
Item 80	Gasket to pipe flanges (Area 2/Plant Room)	Very Low Risk	12 monthly	17/08/2026

Any change in appearance should be reported to Property Services.

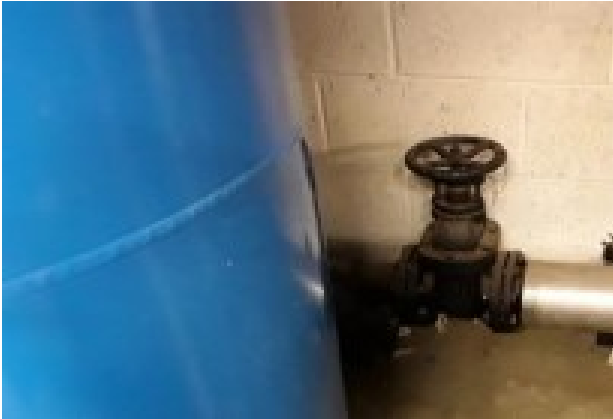
Item 81 Ref: 21-36952-2

The pipe flanges/gaskets in the Plant Room (Area 2) does contain asbestos.

Item 81	Gasket to pipe flanges (Area 2/Plant Room)	Very Low Risk	12 monthly	17/08/2026

Any change in appearance should be reported to Property Services.

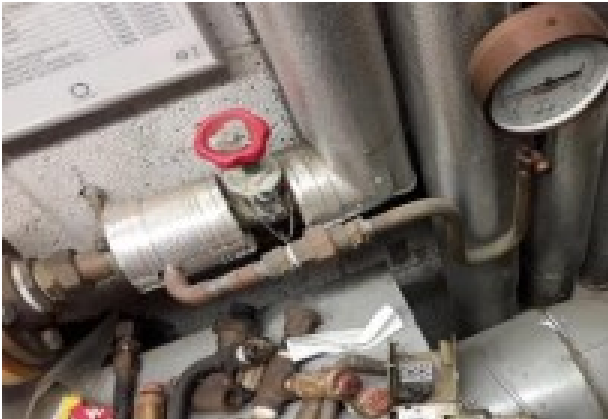
Item 82 Ref: 21-36952-3

The mastic to the extraction flue to floor in the Plant Room (Area 2) does not contain asbestos.

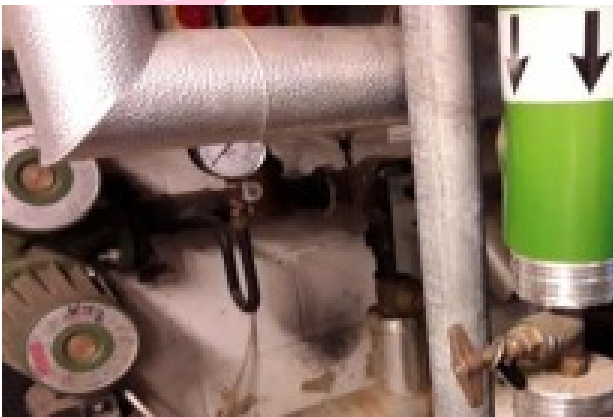
Item 83 Ref: 21-36952-4

The pipes/stop taps (gaskets) in the Plant Room (Area 2) does not contain asbestos.

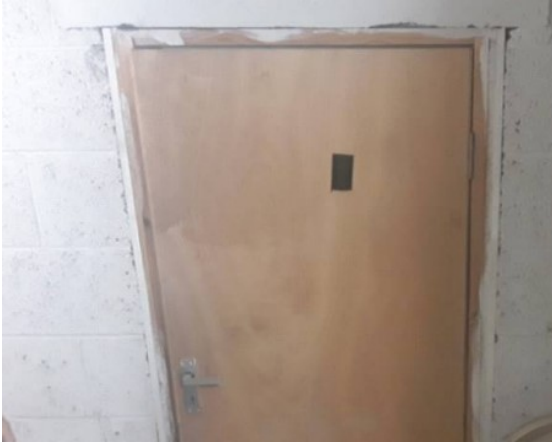
Item 84 Ref: NZ000495

The fire door x2 in the entrance hall/foyer/lobby including landing (E/003) does not contain asbestos.

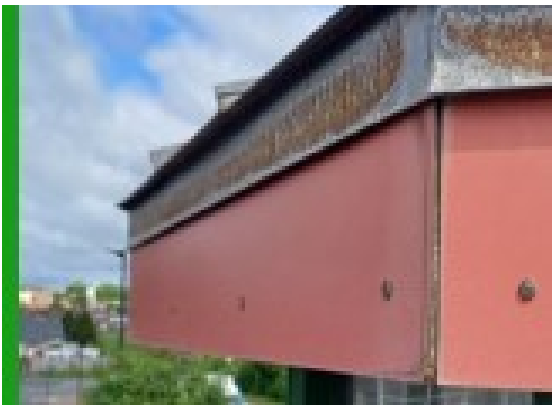
Item 85 Ref: 628944-1

The fascia externally does not contain asbestos.

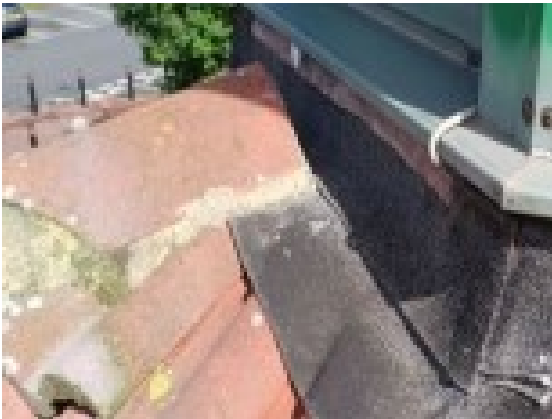
Item 86 Ref: 628944-2

The flashing externally does not contain asbestos.

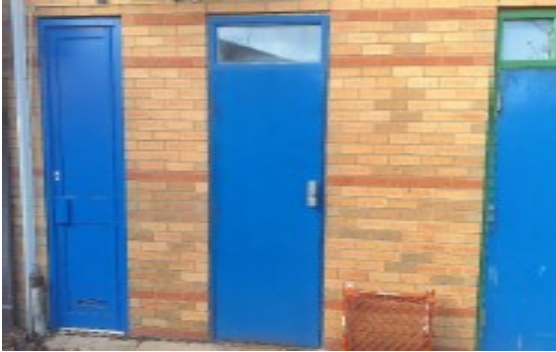
Item 87 Ref: RT000670

The mastic seals to door frame (door set 11 G/10) does not contain asbestos.
