ASBESTOS SURVEY REPORT FOR NEW SEAHAM ACADEMY, BYRON TERRACE, SEAHAM, SR7 0HX

Asbestos Register for

New Seaham Academy, Seaham, SR7 0HX

Date: 03 September 2025

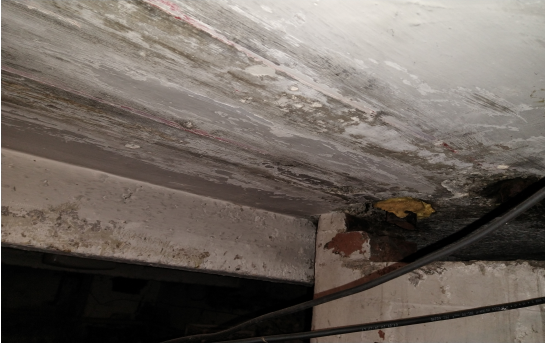
Item 1 Ref: 425813-14

- (Item 1) Ref: 425813-14 – Residues to underside of floor (Basement/Rm -1/001) – No Risk
- (Item 2) Ref: 425813-15 – Residues to wall behind gas meter (Basement/Rm -1/001) – No Risk

The residues to underside of floor above adjacent door in the basement (Rm -1/001) does not contain asbestos.

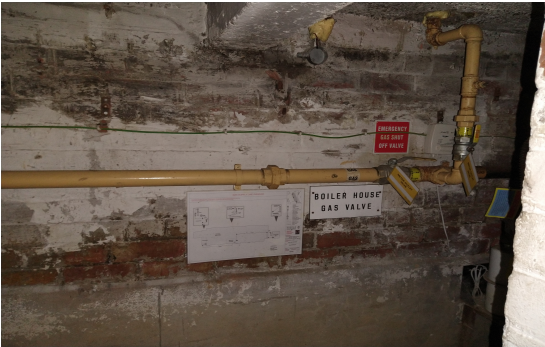
Item 2 Ref: 425813-15

The residues to wall behind gas meter in the basement (Rm -1/001) does not contain asbestos.

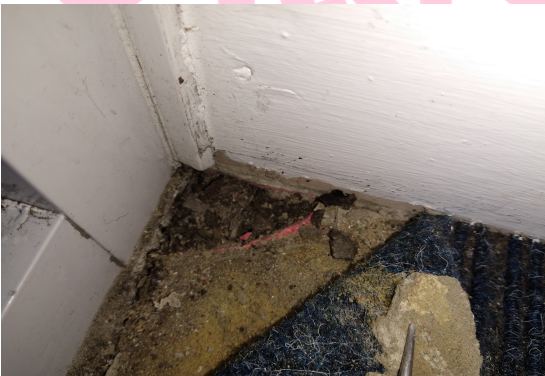
Item 3 Ref: 425813-1

The floor covering beneath carpet & screed in the entrance lobby (Rm 0/001) contains asbestos.

| Picture | Location | Risk | Inspection Frequency | Date of return |
|---|---|---|---|---|
| Item 3 | Floor covering (Entrance lobby/Rm 0/001) | Very Low Risk | 12 monthly | 19/08/2026 |

Any change in its appearance should be recorded and passed to Property Services.

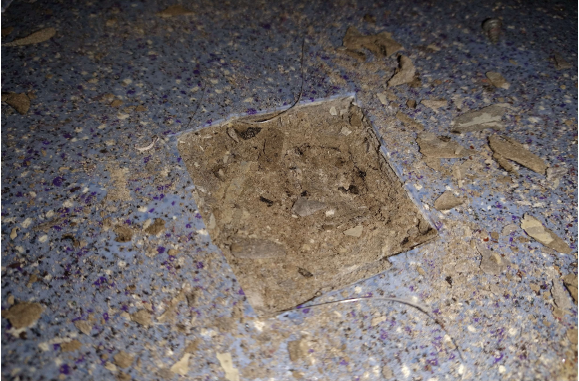
Item 4 Ref: 425813-2

The remnant adhesive to floor beneath linoleum and screed in the boy's WC (Rm 0/004) does contain asbestos.

| Picture | Location | Risk | Inspection Frequency | Date of return |
|---|---|---|---|---|
| Item 4 | Remnant adhesive (Boys WC/Rm 0/004) | Very Low Risk | 12 monthly | 19/08/2026 |

Any change in its appearance should be recorded and passed to Property Services.

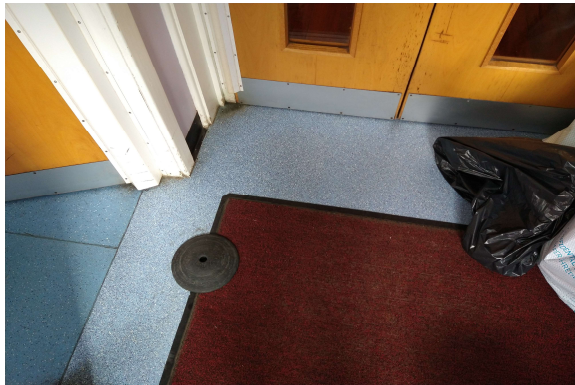
Item 5 Ref: 425813-2

The remnant adhesive to floor beneath linoleum and screed in the lobby (Rm 0/005) does contain asbestos.

| Picture | Location | Risk | Inspection Frequency | Date of return |
|---|---|---|---|---|
| Item 5 | Remnant adhesive (Lobby/Rm 0/005) | Very Low Risk | 12 monthly | 19/08/2026 |

Any change in its appearance should be recorded and passed to Property Services.

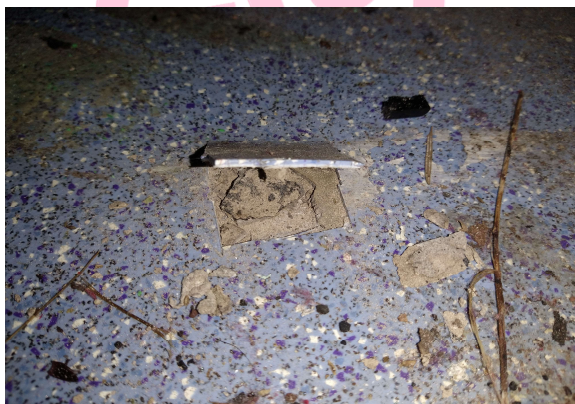
Item 6 Ref: As 425813-2

The remnant adhesive to floor beneath linoleum and screed in the girl's WC (Rm 0/007) does contain asbestos.

| Picture | Location | Risk | Inspection Frequency | Date of return |
|---|---|---|---|---|
| Item 6 | Remnant adhesive (Girls WC/Rm 0/007) | Very Low Risk | 12 monthly | 19/08/2026 |

Any change in its appearance should be recorded and passed to Property Services.

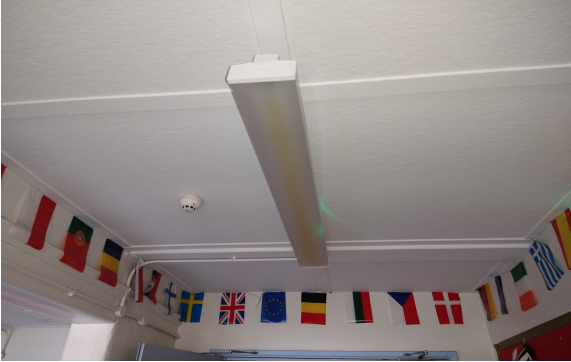
Item 7 Ref: 425813-3

The ceiling in the lobby (Rm 0/014) does not contain asbestos.

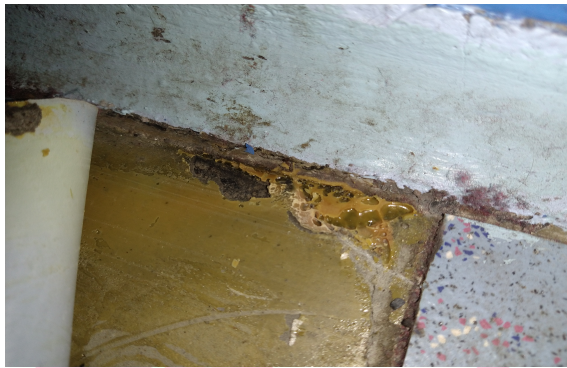
Item 8 Ref: 425813-4

The remnant floor adhesive beneath screed in the cloak room (Rm 0/0015) does contain asbestos.

| Picture | Location | Risk | Inspection Frequency | Date of return |
|---|---|---|---|---|
| Item 8 | Remnant adhesive (Cloak room/Rm 0/015) | Very Low Risk | 12 monthly | 19/08/2026 |

Any change in its appearance should be recorded and passed to Property Services.

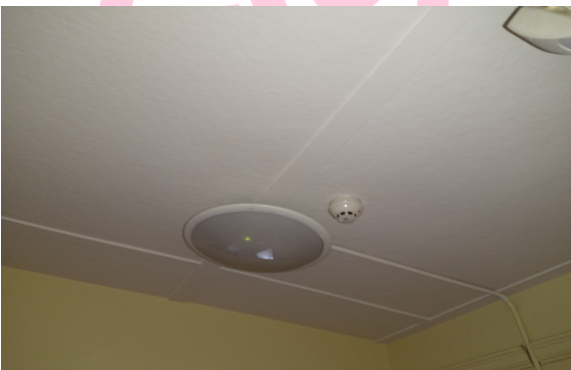
Item 9 Ref: As 425813-3

The ceiling in the lobby (Rm 0/016) does not contain asbestos.

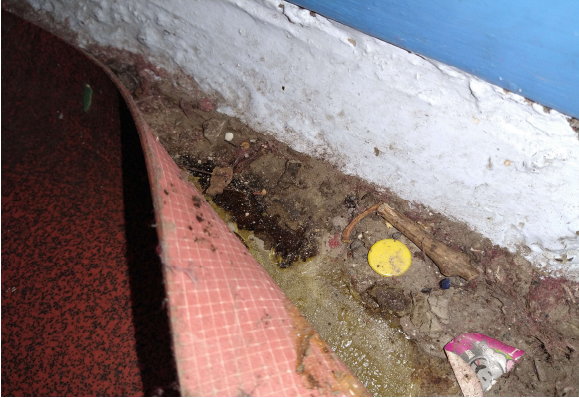
Item 10 Ref: As 425813-4

The remnant floor adhesive beneath screed in the cloak room (Rm 0/019) does contain asbestos.

| Picture | Location | Risk | Inspection Frequency | Date of return |
|---|---|---|---|---|
| Item 10 | Remnant adhesive (Cloak room/Rm 0/019) | Very Low Risk | 12 monthly | 19/08/2026 |

Any change in its appearance should be recorded and passed to Property Services.

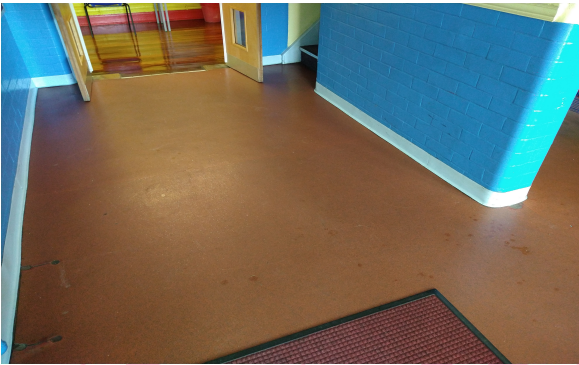
Item 11 Ref: As 425813-4

The remnant floor adhesive beneath screed in the lobby (Rm 0/020) does contain asbestos.

| Picture | Location | Risk | Inspection Frequency | Date of return |
|---|---|---|---|---|
| Item 11 | Remnant adhesive (Lobby/Rm 0/020) | Very Low Risk | 12 monthly | 19/08/2026 |

Any change in its appearance should be recorded and passed to Property Services.

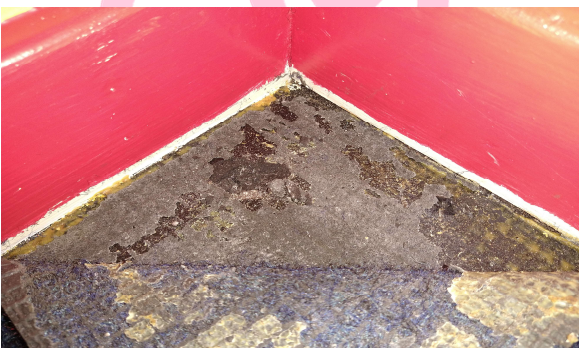
Item 12 Ref: 425813-5

The floor screed in the classroom (Rm 0/024) does not contain asbestos.

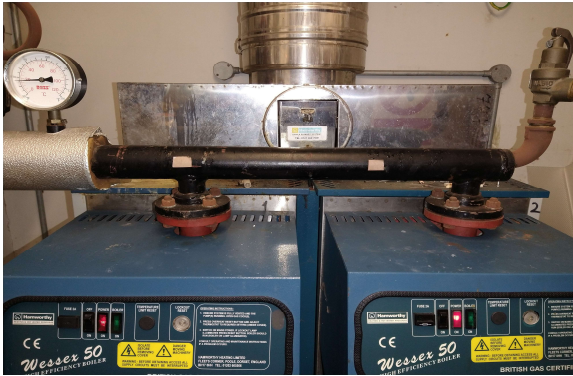
Item 13 Ref: 425813-6

The pipework flange gasket in the boiler room (Rm 0/030A) does not contain asbestos.

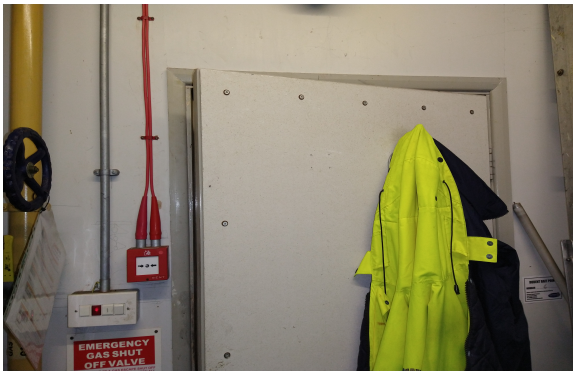
Item 14 Ref: 425813-7

The panel to door in the boiler room (Rm 0/030A) does not contain asbestos.

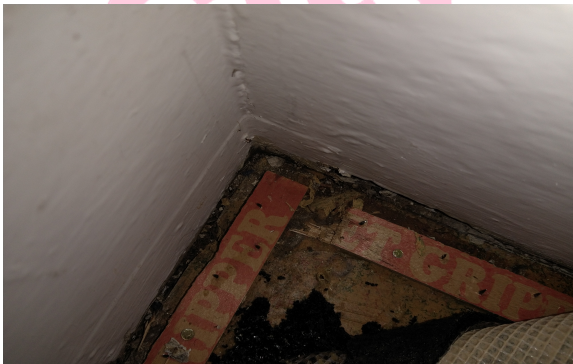
Item 15 Ref: 425813-9

The floor covering beneath carpet in the boiler room (Rm 0/030A) does not contain asbestos.

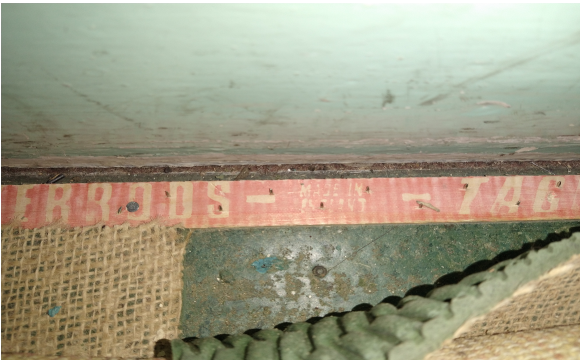
Item 16 Ref: 425813-8

The floor covering beneath carpet in the ICT room (Rm 1/009) does not contain asbestos.

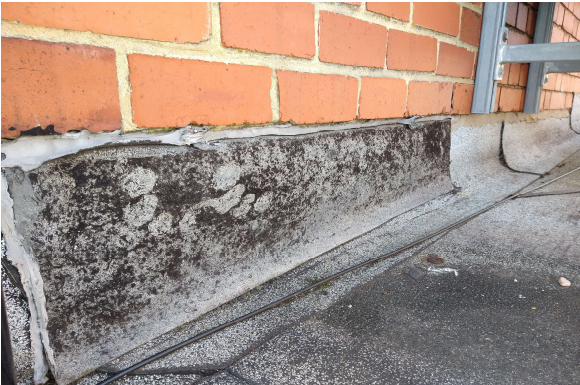
Item 17 Ref: 425813-10

The roof flashing to high level flat roof backing onto 1/001 (External) does not contain asbestos.

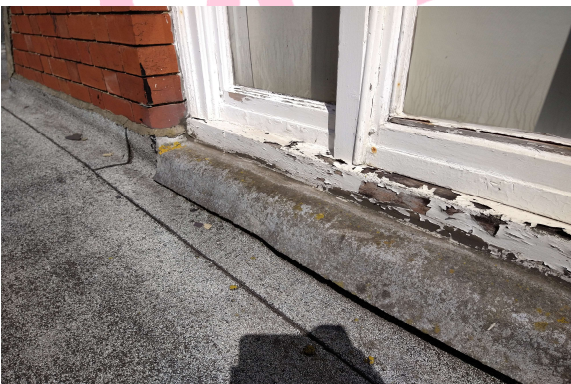
Item 18 Ref: 425813-11

The flashing to high level window cills (External) does contain asbestos.

| Picture | Location | Risk | Inspection Frequency | Date of return |
|---|---|---|---|---|
| Item 18 | Flashing to window cills (External) | Very Low Risk | 12 monthly | N/A – can not be access due |

Any change in its appearance should be recorded and passed to Property Services.

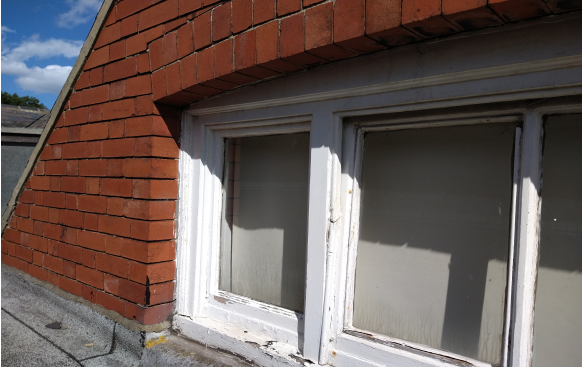
Item 19 Ref: 425813-12

The sealant to high level window frames (on high level flat roof) (External) does not contain asbestos.

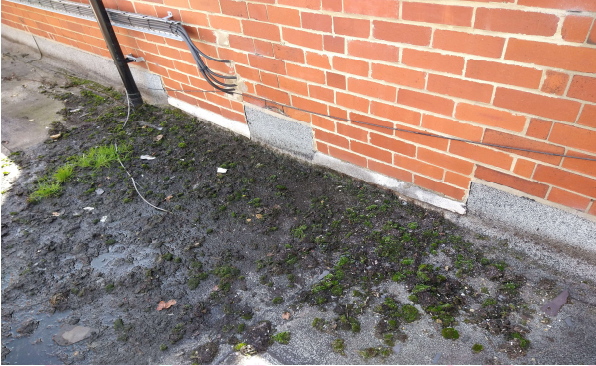
Item 20 Ref: As 425813-10

The roof flashing to high level flat roof (section adjacent dining hall) (External) does not contain asbestos.

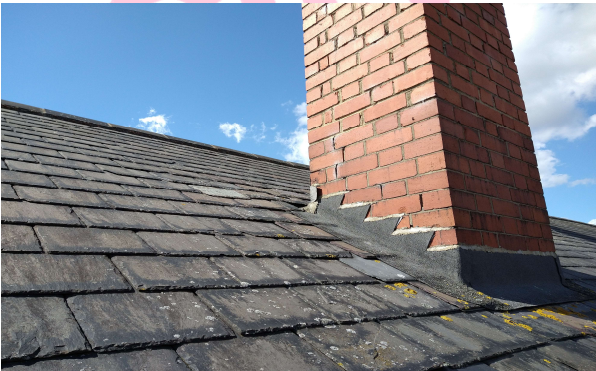
Item 21 Ref: As 425813-10

The roof flashing to rear of central chimney stack (External) does not contain asbestos.

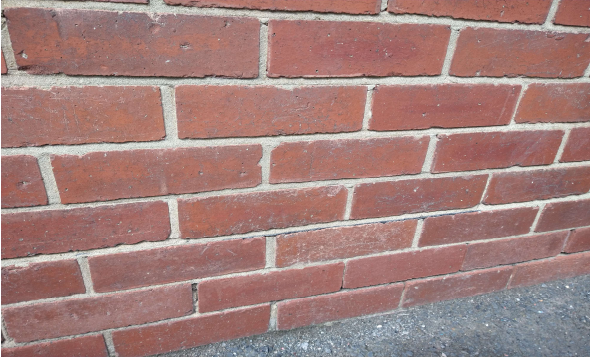
Item 22 Ref: 425813-13

The damp proof course
(External) does not contain
asbestos.
