ASBESTOS SURVEY REPORT FOR BARNES INFANT ACADEMY, SUNDERLAND

Asbestos Register for Barnes Infant Academy School

UPRN: - C-50614

Date: 09 March 2026

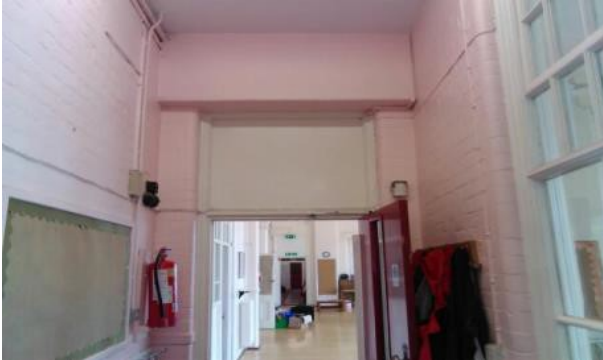
Item 1 Ref: 002

002 – Door Header Panel (Room 008) (Item 1) – Low Risk

The door header panel in the corridor (Rm 008) contain asbestos.

Any change in its appearance should be recorded and passed to Property Services.

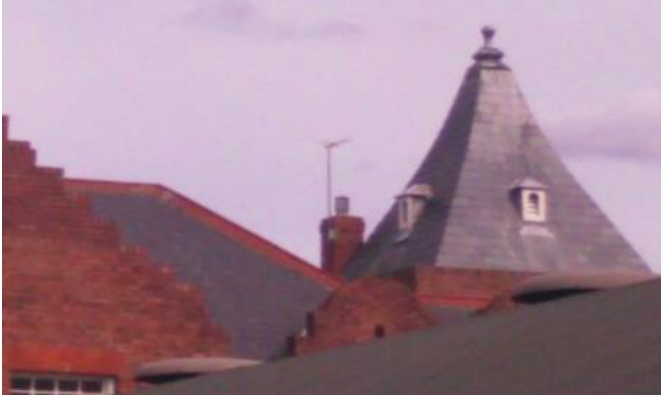
Item 4: Presumed

Presumed – Cowl (External) (Item 4) – Low Risk

The cowl to the roof (External) due to height restrictions was unable to be sampled therefore it was presumed to contain asbestos.

This should be inspected from the ground only and any change in its appearance should be recorded and passed to Property Services.

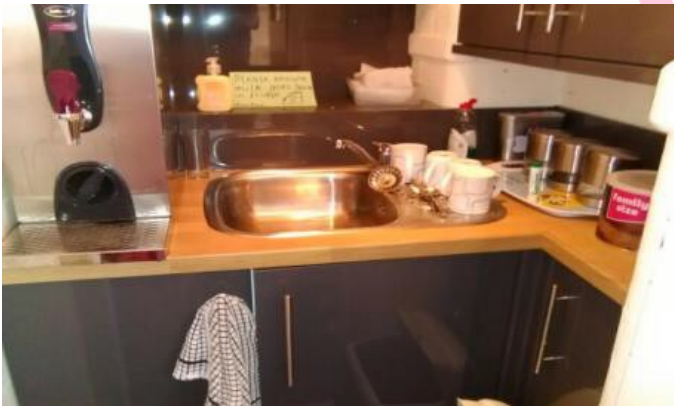
Item 5 Ref: 008

The sink pad to the kitchen (Rm 045) does not contain asbestos.

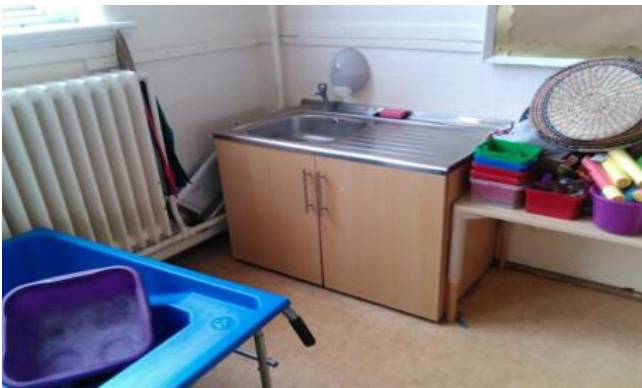
Item 6 Ref: 006

The sink pad to the classroom 8 (Rm 032) does not contain asbestos.

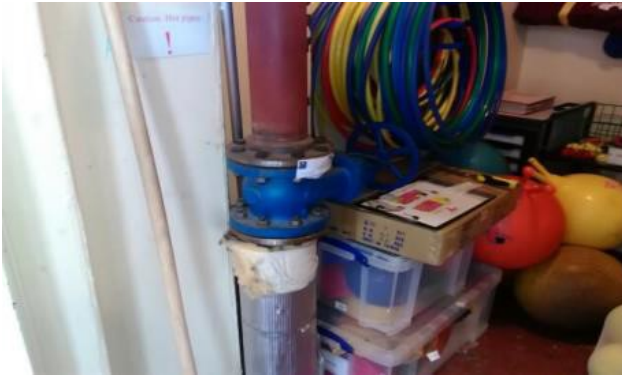
Item 7 Ref: 007

The gaskets to the store (Rm 035) does not contain asbestos.

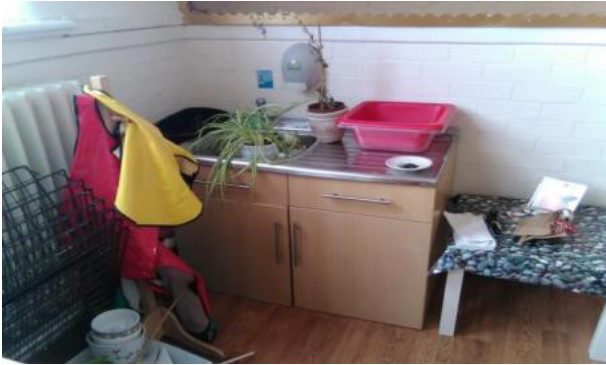
Item 10 Ref: 003

The sink pad to the classroom (Rm 014) does not contain asbestos.

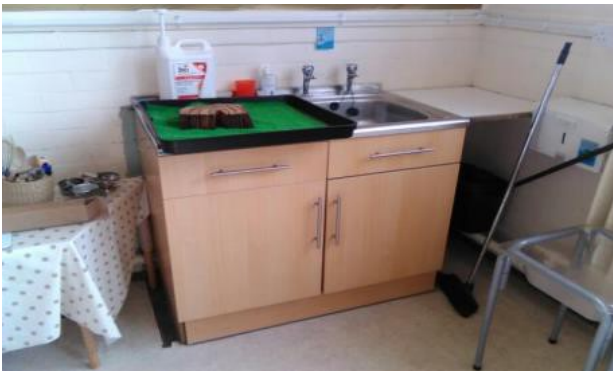
Item 11 Ref: As 003

The sink pad to classroom 3 (Rm 015) does not contain asbestos.

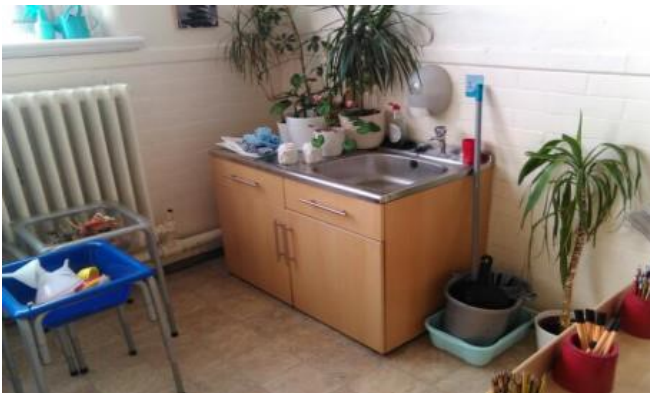
Item 12 Ref: As 003

The sink pad to classroom (Rm 017) does not contain asbestos.

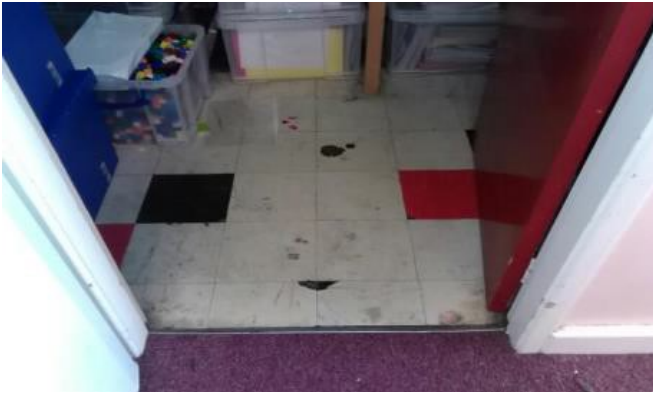
Item 13 Ref: 004

The floor tiles to the store (Rm 022) does not contain asbestos.
