ASBESTOS SURVEY REPORT FOR BARNWELL ACADEMY, PENSHAW

Asbestos Register for

BARNWELL ACADEMY, PENSRAW

Date: 04 June 2025

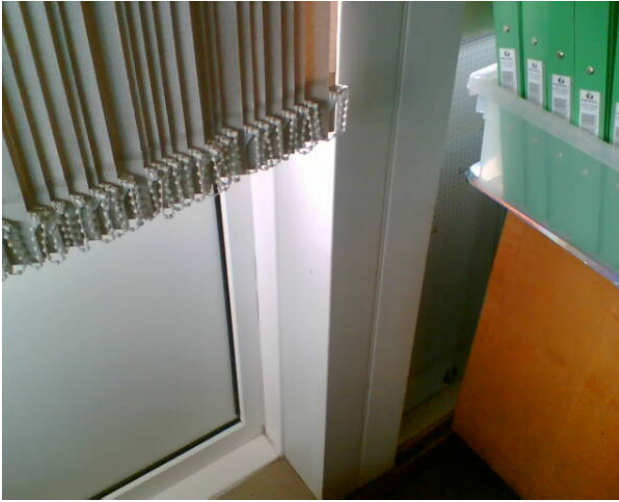
Item 1 - Presumed

The boxed in linings to columns in all areas contain asbestos.

Any change in their appearance should be recorded, and passed to Property Services.

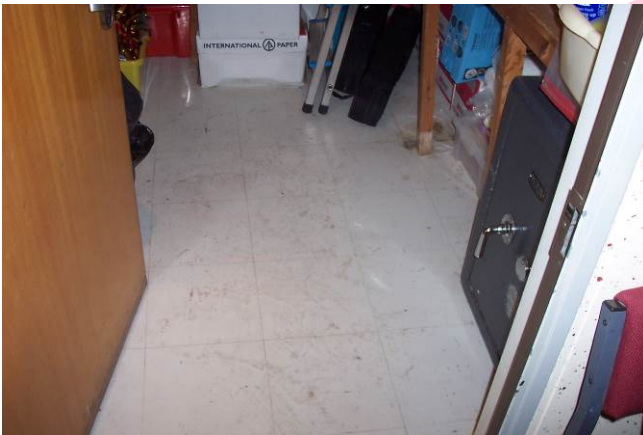
Item 2 - JL06/4153

The white floor tiles and adhesive in room 1 (CB Office) contain asbestos. These floor tiles have been overlaid by carpet.

Any change in their appearance should be recorded, and passed to Property Services.

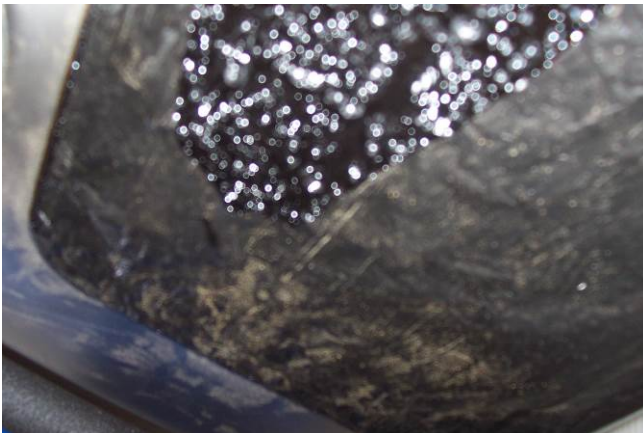
Item 3 - JL06/4154

The sink pad in room 9 (staff room) does not contain asbestos.

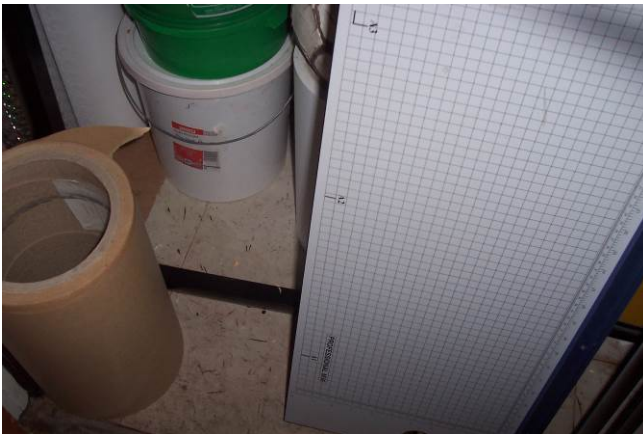
Item 5 – As JL06/4143

The white floor tiles and adhesive in area 39 (store cupboard) contain asbestos.

Any change in its appearance should be recorded, and passed to Property Services.

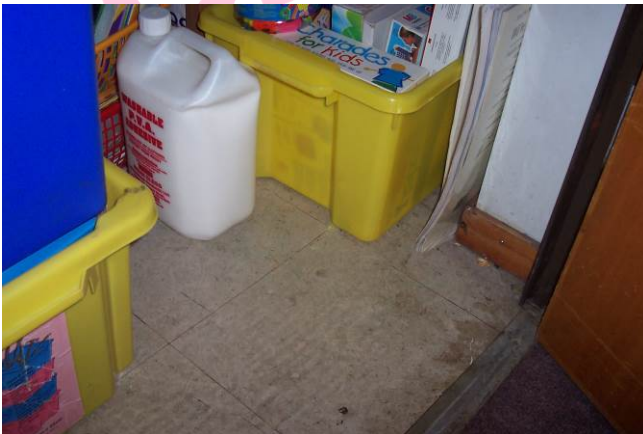
Item 6 – As JL06/4153

The white floor tiles and adhesive in area 15 (store cupboard) contain asbestos.

Any change in their appearance should be recorded, and passed to Property Services.

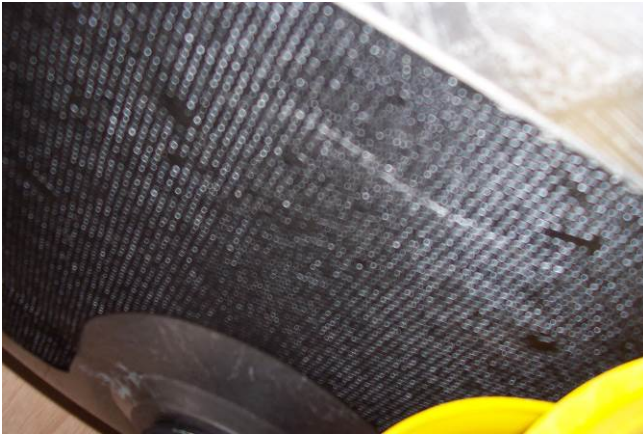
Item 7 – As JL06/4154

The sink pads in areas 12, 13 & 14 (classroom) do not contain asbestos.

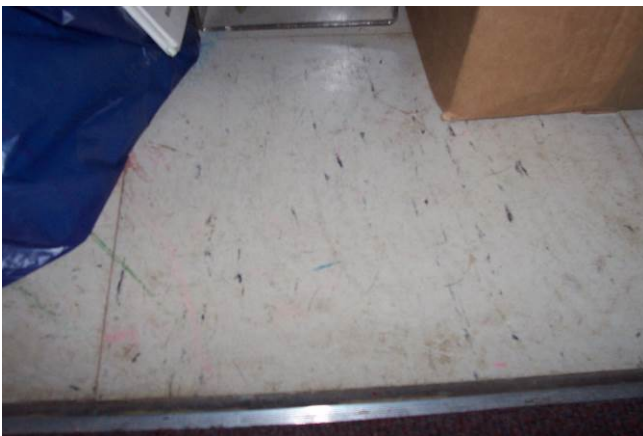
Item 8 – As JL06/4153

The white floor tiles and adhesive in area 11 (store cupboard) contains asbestos.

Any change in their appearance should be recorded, and passed to Property Services.

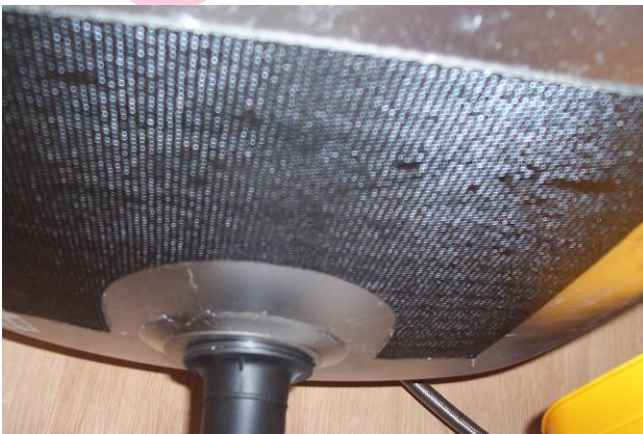
Item 9 – As JL06/4154

The sink pad in area 26 (classroom) does not contain asbestos.

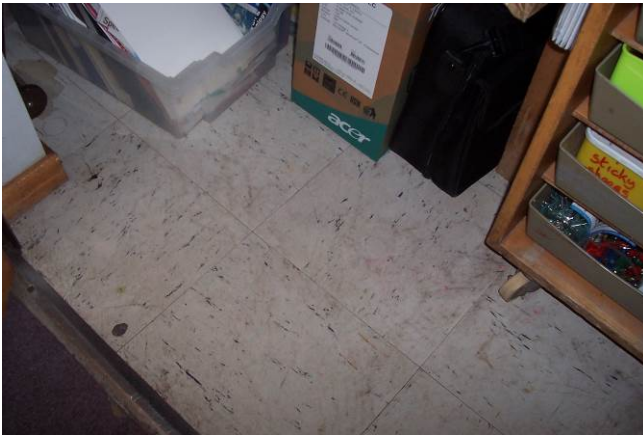
Item 10 – As JL06/4153

The white floor tiles and adhesive in area 6 (store cupboard) contains asbestos.

Any change in their appearance should be recorded, and passed to Property Services.

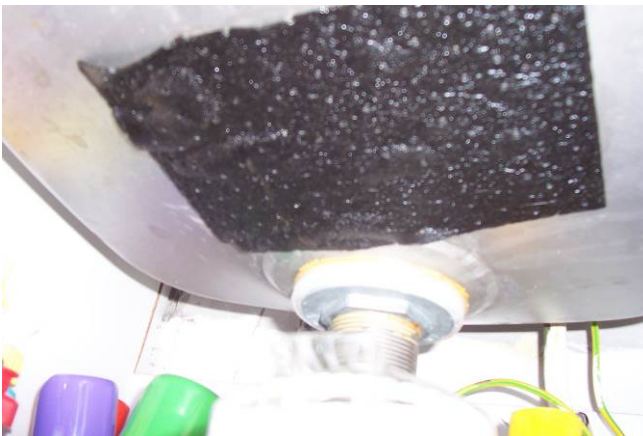
Item 11 – As JL06/4154

The sink pad in area 25 (classroom) does not contain asbestos.

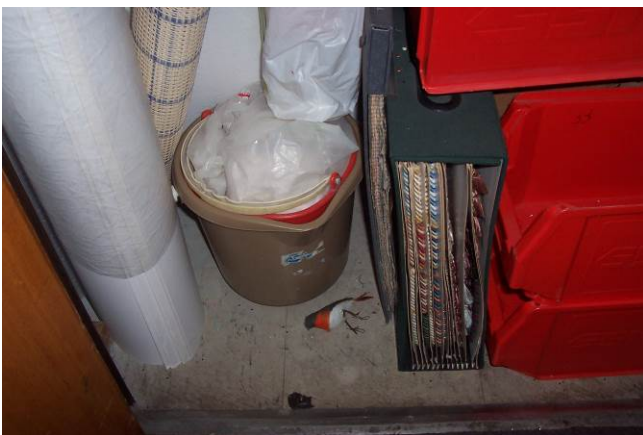
Item 12 – As JL06/4153

The white floor tiles and adhesive in area 5 (store cupboard) contain asbestos.

Any change in their appearance should be recorded, and passed to Property Services.

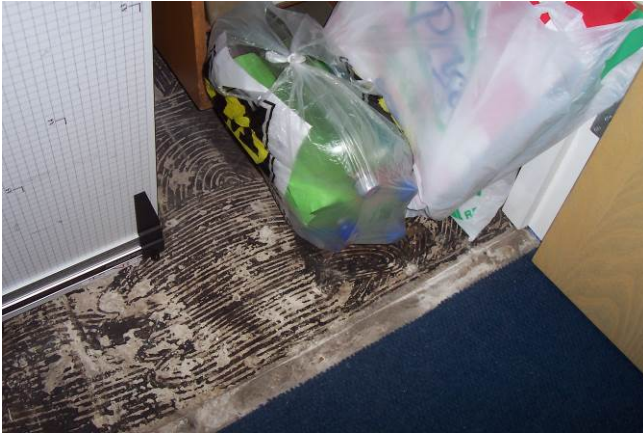
Item 13 – JL06/4155

The floor tiles and adhesive in area 3 (store cupboard) contains asbestos.

Any change in their appearance should be recorded, and passed to Property Services.

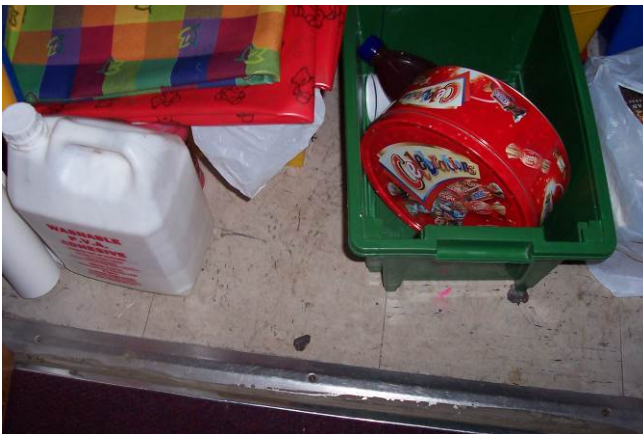
Item 14 – As JL06/4153

The white floor tiles and adhesive in area 4 (store cupboard) contain asbestos.

Any change in their appearance should be recorded, and passed to Property Services.

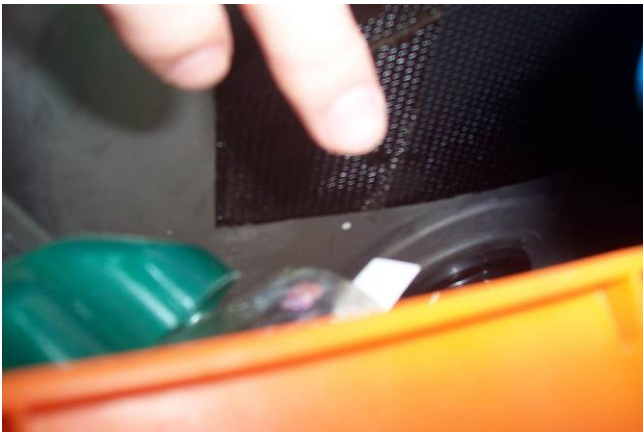
Item 15 – As JL06/4154

The sink pad in area 31 (classroom) does not contain asbestos.

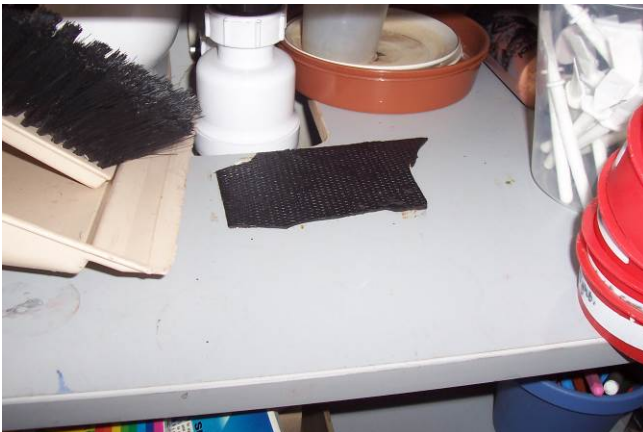
Item 18 – As JL06/4154

The sink pad (fallen off sink – stuck on shelf) in area 34 (classroom) does not contain asbestos.

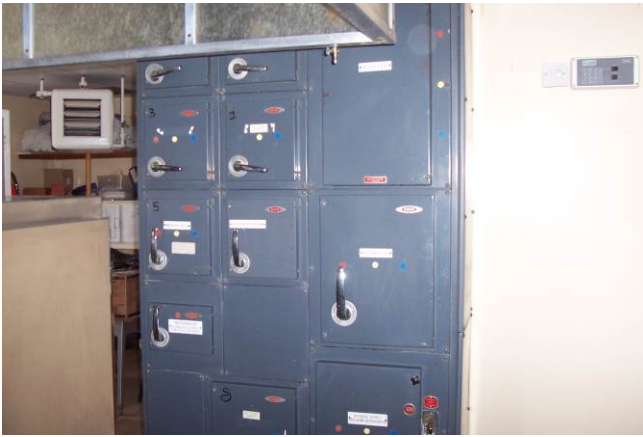
Item 19 – Presumed

The flash guards to fuse box in area 19 (kitchen) contains asbestos.

Any change in its appearance should be recorded, and passed to Property Services.

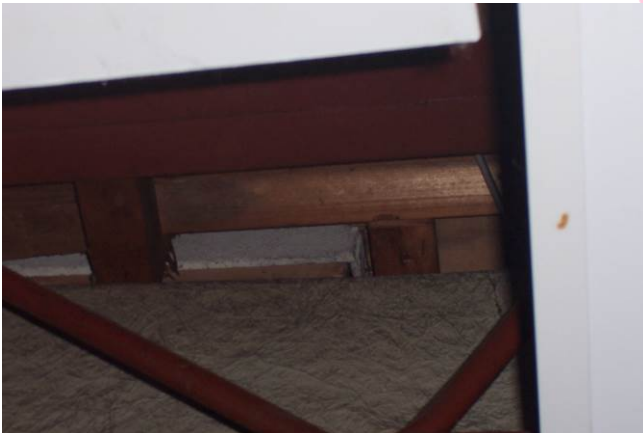
Item 20 – JL06/4156

The boards to upstands in vent in ceiling void in area 19 (kitchen) contain asbestos.

Any change in its appearance should be recorded, and passed to Property Services.

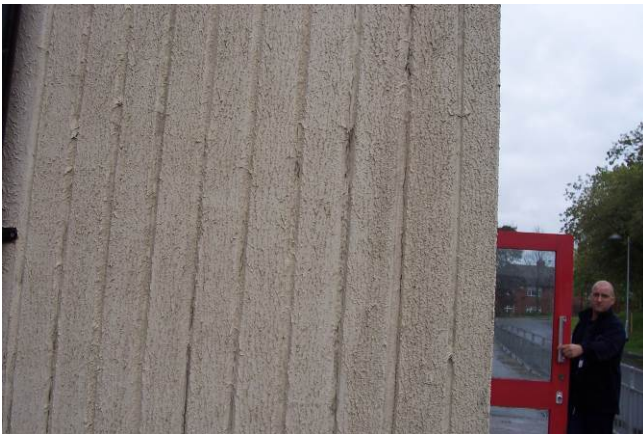
Item 21 – JL06/4157

The textured coating to outside walls (exterior) does not contain asbestos.

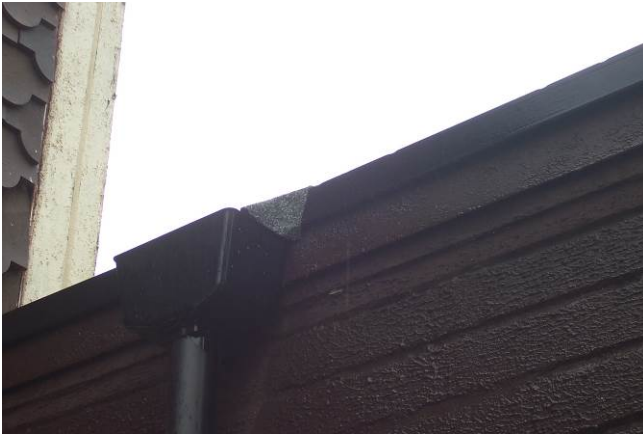
Item 22 – JL06/4158

The roofing felt to flat roofs (exterior) does not contain asbestos.

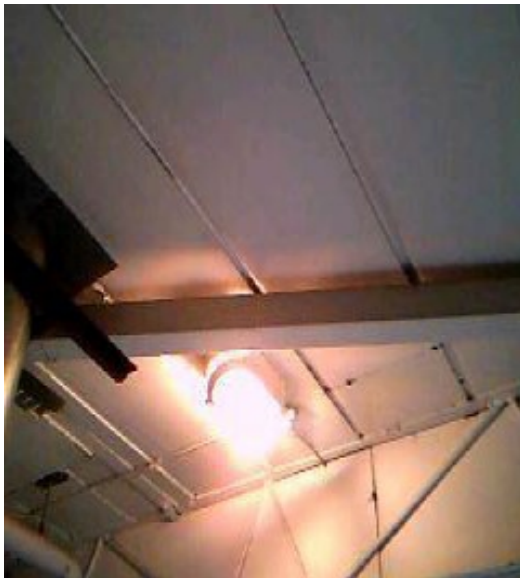
Item 23 – AD000530

The ceiling panels to the boiler room contain asbestos.

Any change in its appearance should be recorded, and passed to Property Services.

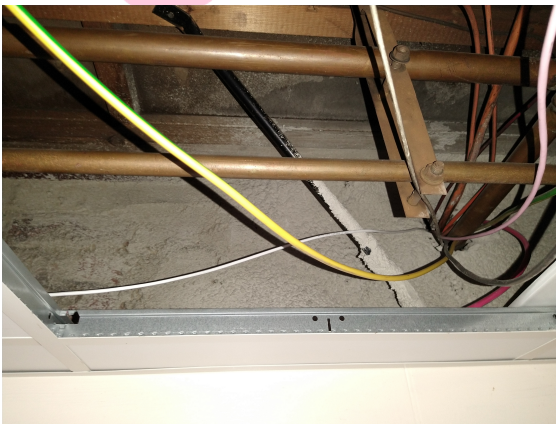
Item 26 Ref: 416936-1

The firebreak in Kitchen void above/ 0/19 does not contain asbestos.

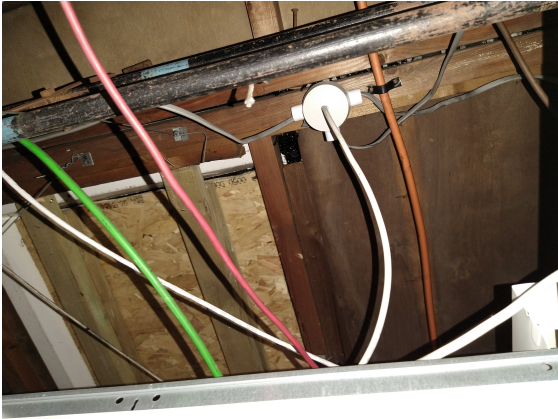
Item 27 Ref: 416936-2

The roof adhesive residue to joists in Kitchen void above/ 0/19 does not contain asbestos.

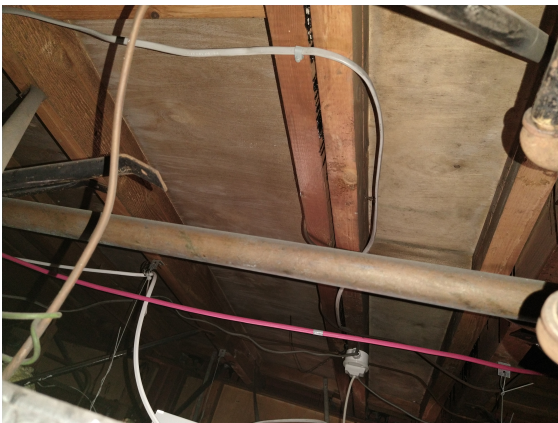
Item 28 Ref: As 416936-2

The roof adhesive residue to joists in Kitchen void above/ 0/20 does not contain asbestos.

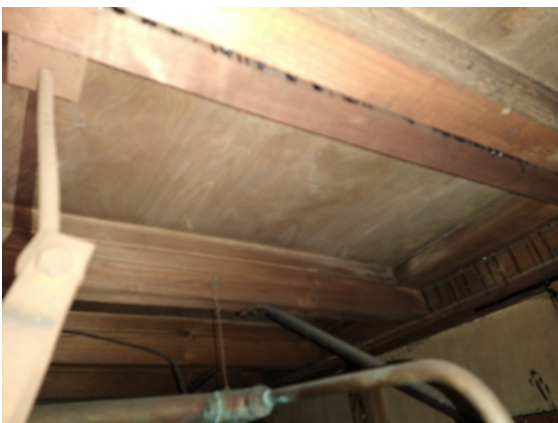
Item 29 Ref: As 416936-2

The roof adhesive residue to joists in Kitchen locker room void above/ 0/21 does not contain asbestos.

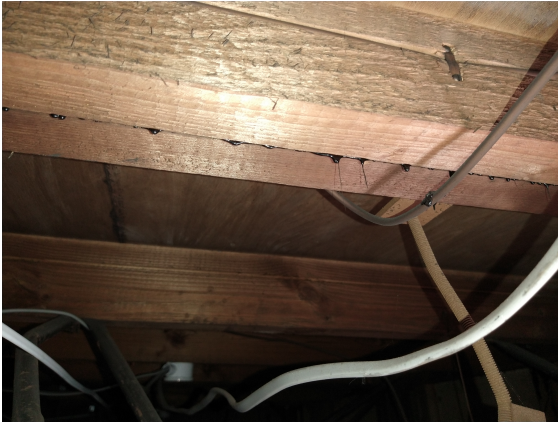
Item 30 Ref: As 416936-2

The roof adhesive residue to joists in Kitchen wc void above/ 0/22 does not contain asbestos.

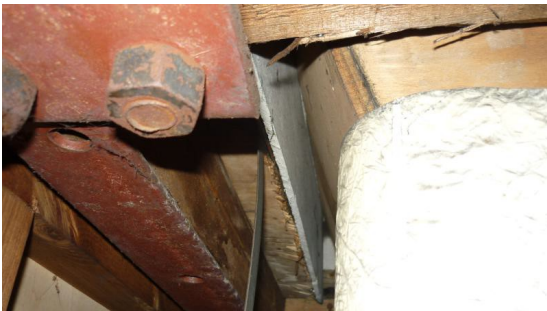
Item 31 Ref: AW0703/11

The skylight surrounds in 0/32 Kitchen void above contain asbestos.

Any change in its appearance should be recorded and passed to Property Services.

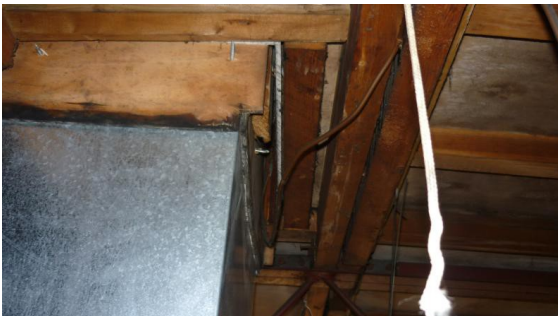
Item 32 Ref: Presumed

The central extraction duct lining in 0/32 Kitchen void above is presumed to contain asbestos.

Any change in its appearance should be recorded and passed to Property Services.

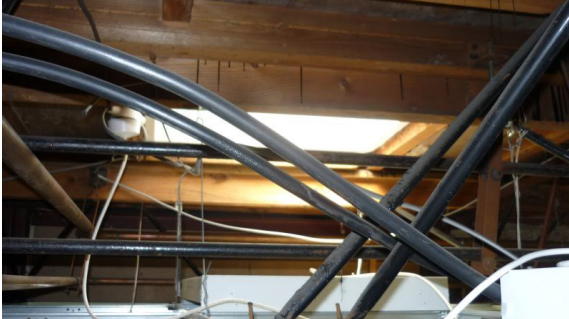
Item 34 Ref: As AW0703/11

The skylight surrounds in 0/33 Kitchen Store void above contain asbestos.

Any change in its appearance should be recorded and passed to Property Services.

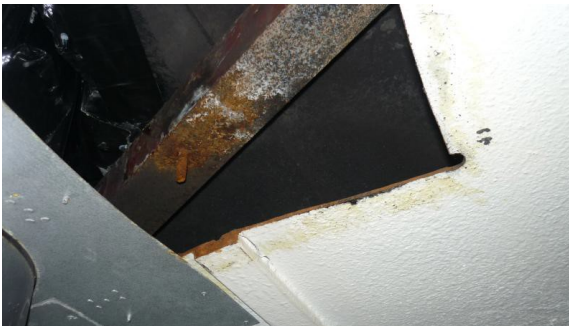
Item 35 Ref: Presumed

The ceiling above within smaller section of 0/36 Boiler Room Ceiling Void is presumed to contain asbestos.

Any change in its appearance should be recorded and passed to Property Services.

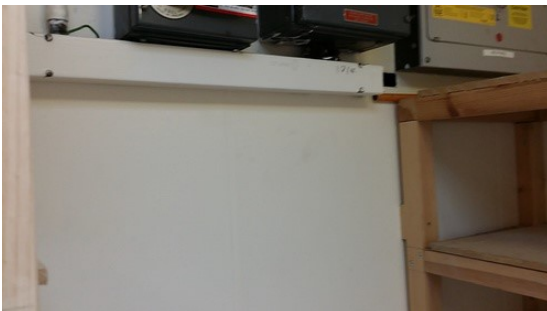
Item 36 Ref: 80235-3

The coating to metal walls in 035/cupboard does not contain asbestos.

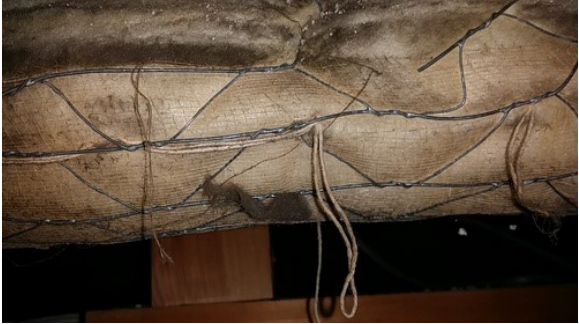
Item 37 Ref: 80235-1

The string to pipe lagging in 035/cupboard – void above does not contain asbestos.

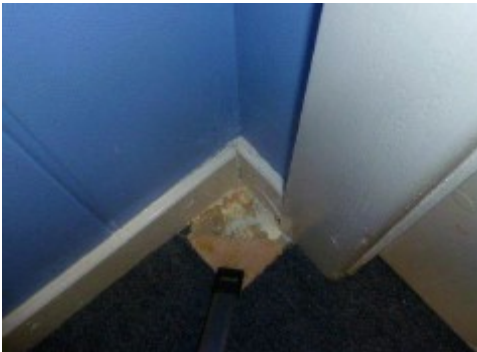
Item 38 Ref: AC000357

The concrete floor under carpet in Room 1 office off reception does not contain asbestos.

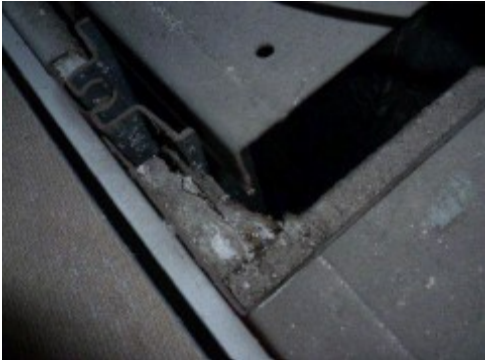
Item 40 Ref: AC000358

The column plasterboard in Room 1 office off reception does not contain asbestos.

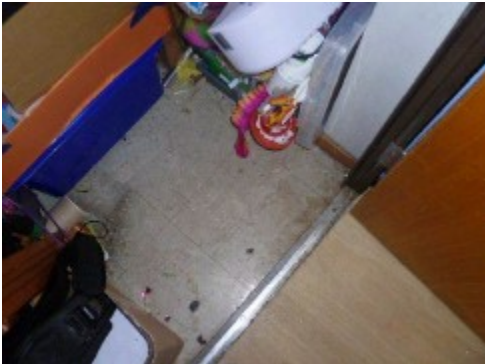
Item 41 Ref: AC000359

The vinyl floor tiles & bitumen adhesive below in Room 2 cupboard to class 1 contain asbestos.

Removed 2012

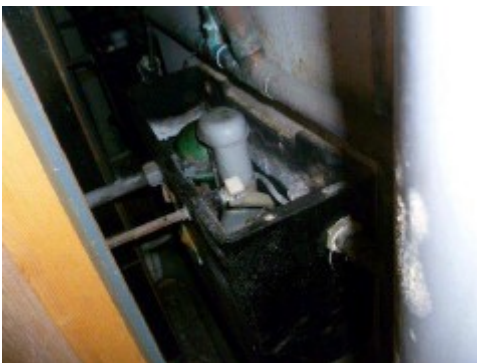
Item 42 Ref: AC000360

The toilet cistern in Room 3 Boys toilet behind panels contains asbestos.

Removed 2012

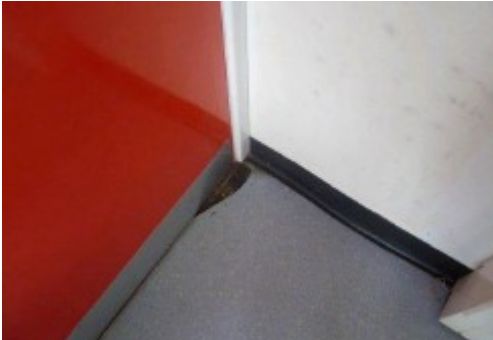
Item 43 Ref: AC000361

The vinyl floor sheeting in Room 3 Boys toilet does not contain asbestos.

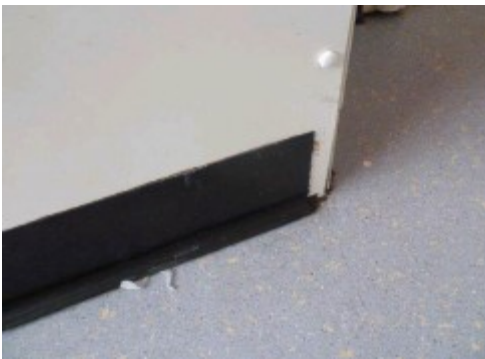
Item 44 Ref: AC000362

The vinyl skirting in Room 3 Boys toilet does not contain asbestos.

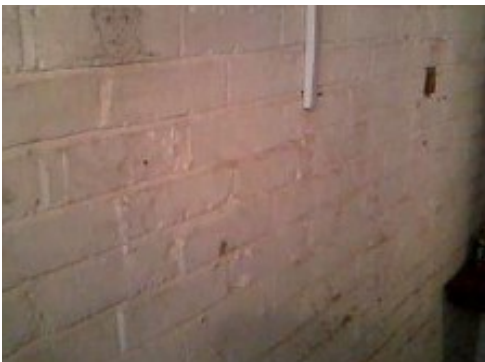
Item 45 Ref: AD000531

The debris to wall in Room 1 Boiler House does not contain asbestos.

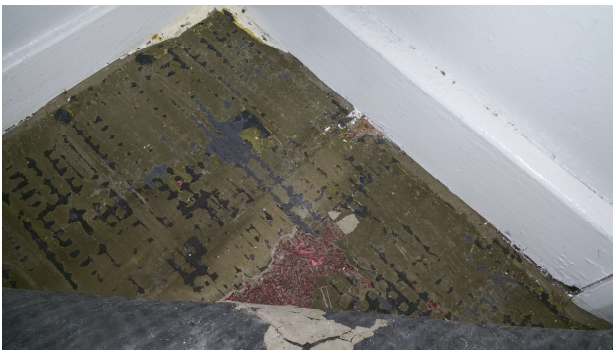
Item 62 Ref: 117113-2

The subfloor covering in 01/entrance lobby does not contain asbestos.

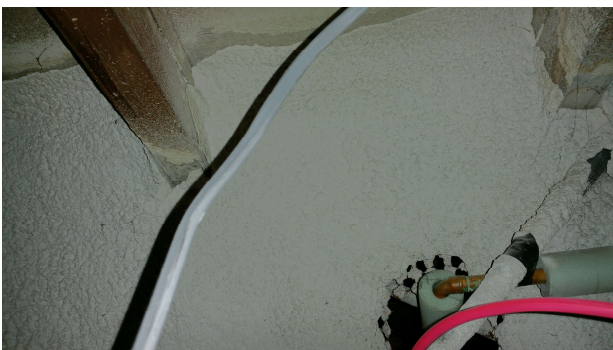
Item 63 Ref: 117113-1

The firebreak & associated debris in 01/entrance lobby-void above does not contain asbestos.

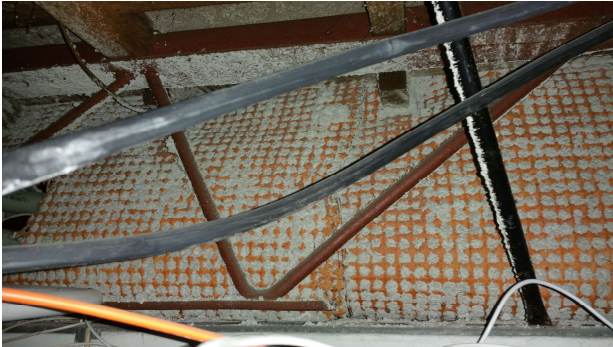
Item 64 Ref: As 117113-1

The firebreak & associated debris in 02/headteachers office-void above does not contain asbestos.

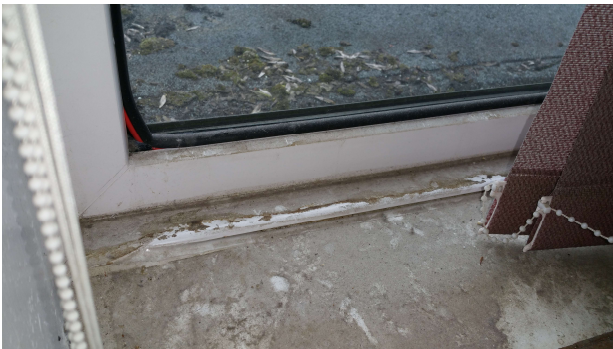
Item 65 Ref: 117113-3

The membrane below high level window cill in 03/main hall contains asbestos.

Any change in its appearance should be recorded and passed to Property Services.

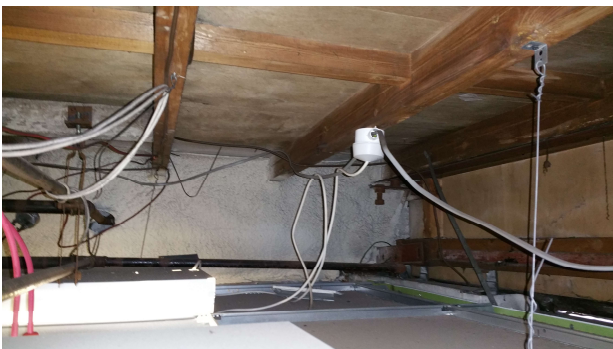
Item 66 Ref: As 117113-1

The firebreak & associated debris in 04/kitchen -void above does not contain asbestos.

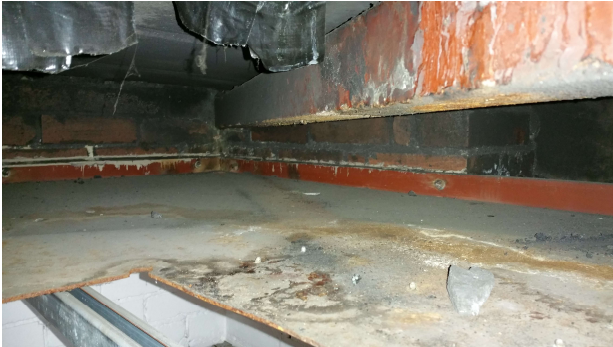
Item 67 Ref: 117113-6

The debris to topside of lower wood ceiling in 06/boiler room contains asbestos.

Any change in its appearance should be recorded and passed to Property Services.

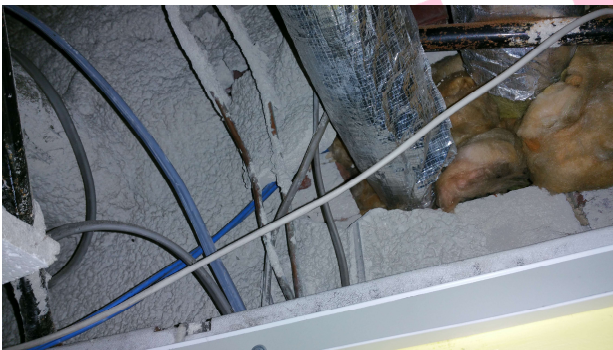
Item 68 Ref: As 117113-1

The firebreak & associated debris in 07/classroom-void above does not contain asbestos.

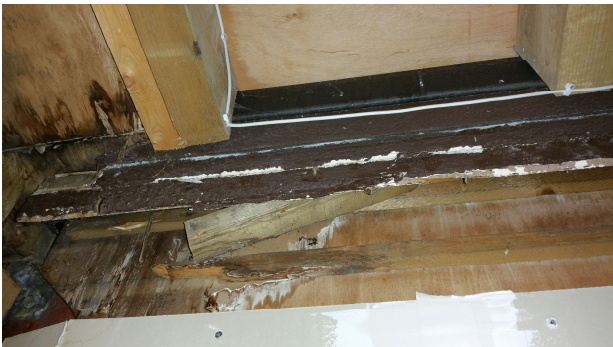
Item 69 Ref: 117113-8

The render to original fascia in 017/cupboard-void above does not contain asbestos.

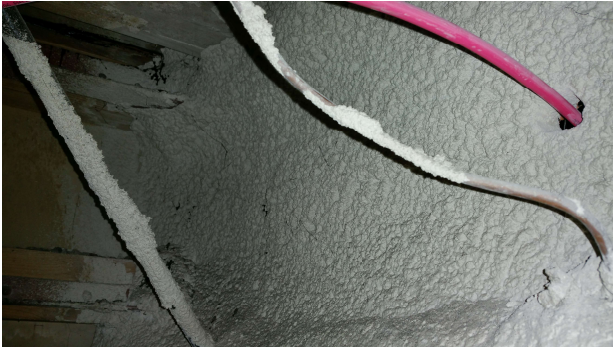
Item 70 Ref: 117113-10

The firebreak & associated debris in 019/staffroom-void above does not contain asbestos.

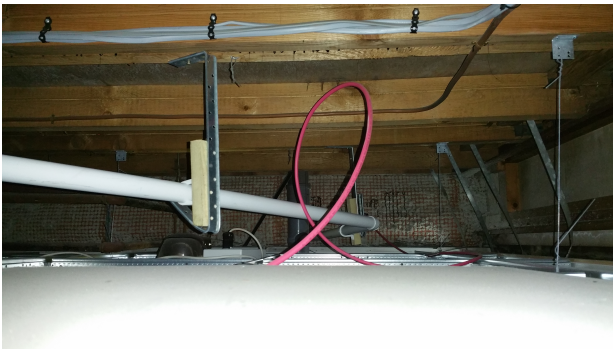
Item 71 Ref: As 117113-10

The firebreak & associated debris in 021/boys wc-void above does not contain asbestos.

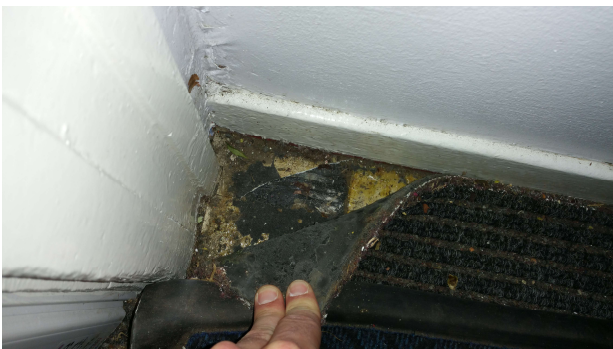
Item 72 Ref: 117113-11

The subfloor covering in 022/corridor contains asbestos.

Any change in its appearance should be recorded and passed to Property Services.

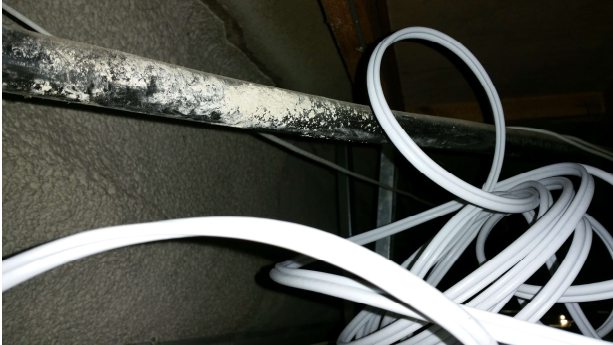
Item 73 Ref: As 117113-10

The firebreak & associated debris in 023/girls wc -void above does not contain asbestos.

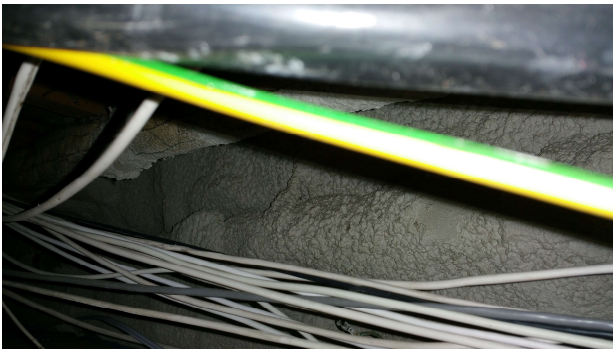
Item 74 Ref: As 117113-10

The firebreak & associated debris in 024/girls wc -void above does not contain asbestos.

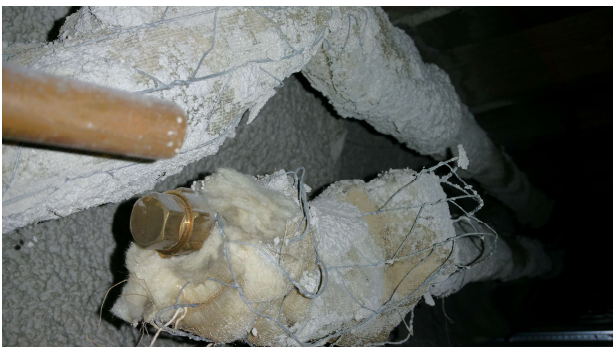
Item 75 Ref: As 117113-10

The firebreak & associated debris in 025/boys wc -void above does not contain asbestos.

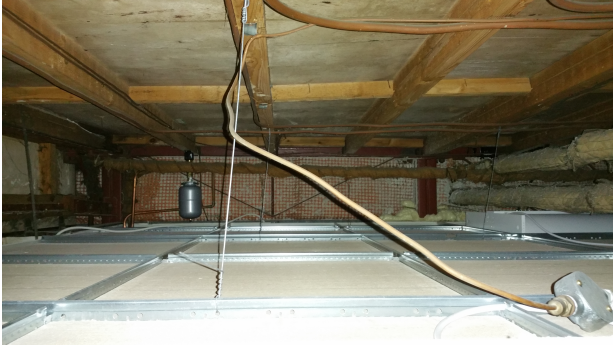
Item 76 Ref: As 117113-10

The firebreak & associated debris in 026/staffroom -void above does not contain asbestos.

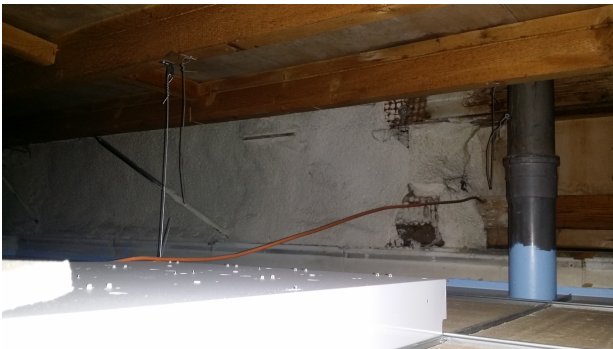
Item 77 Ref: As 117113-10

The firebreak & associated debris in 027/boys wc -void above does not contain asbestos.

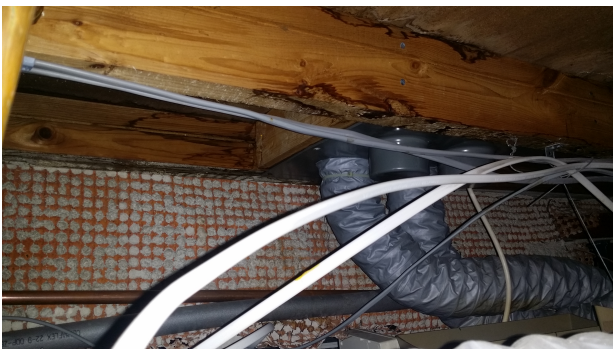
Item 78 Ref: As 117113-10

The firebreak & associated debris in 029/reception -void above does not contain asbestos.

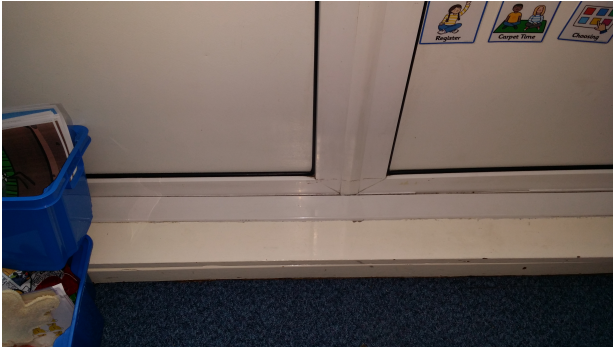
Item 79 Ref: 117113-14

The remnant floor covering within wood boxing below windows in 033/classroom contains asbestos.

Any change in its appearance should be recorded and passed to Property Services.

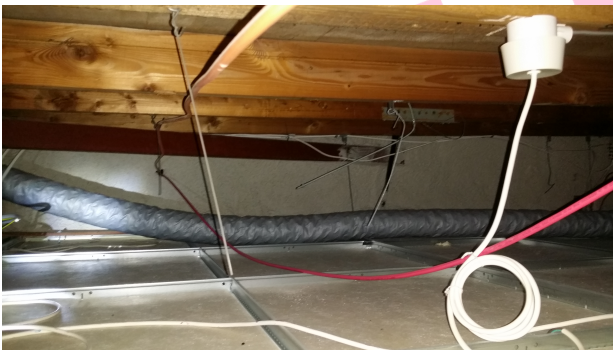
Item 80 Ref: As 117113-15

The firebreak & associated debris in 033/classroom - void above does not contain asbestos.

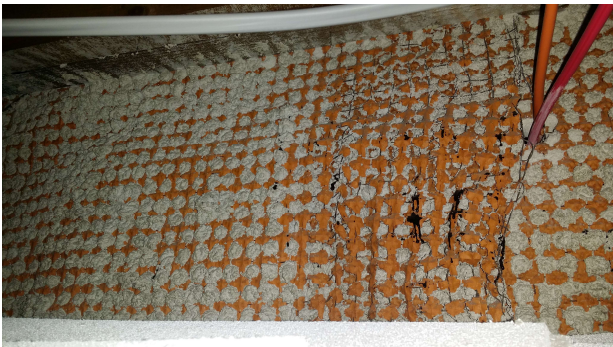
Item 81 Ref: 117113-15

The firebreak & associated debris in 034/classroom - void above does not contain asbestos.

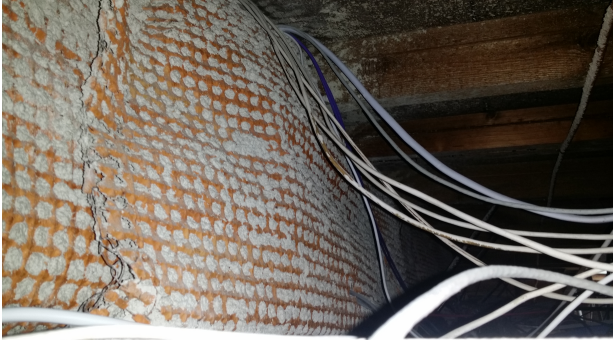
Item 82 Ref: As 117113-15

The firebreak & associated debris in 035/office -void above does not contain asbestos.

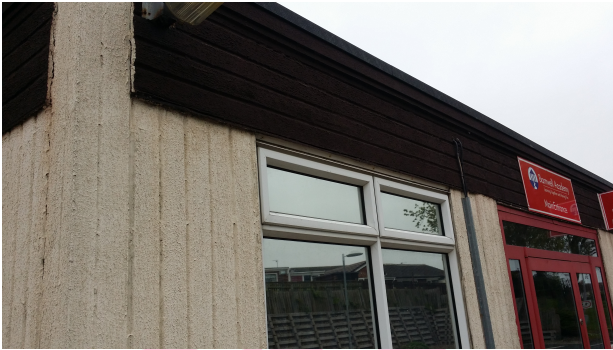
Item 83 Ref: 117113-17

The render to walls & fascia (External) does not contain asbestos.

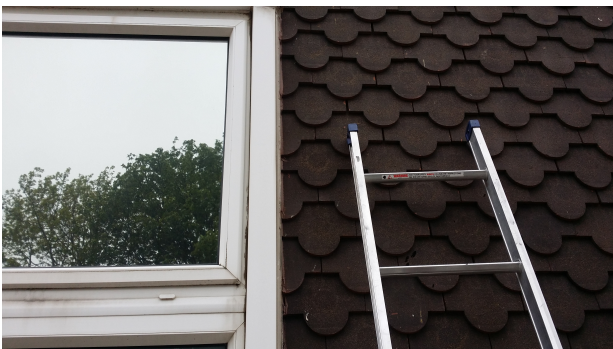
Item 84 Ref: 117113-18

The brown sealant to clay tile wall cladding (External) does not contain asbestos.

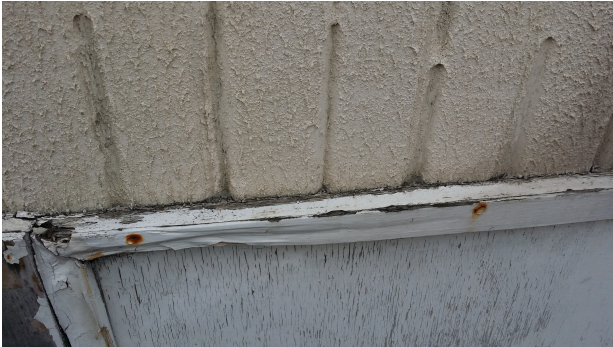
Item 85 Ref: 117113-19

The sealant to wood cladding panels (External) does not contain asbestos.

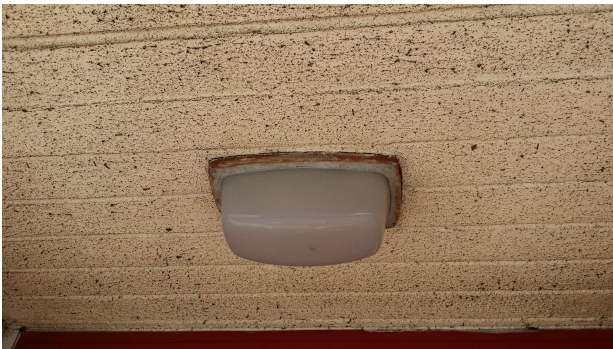
Item 86 Ref: 117113-21

The sealant to glass of bulkhead light fitting (External) contains asbestos.

Any change in its appearance should be recorded and passed to Property Services.

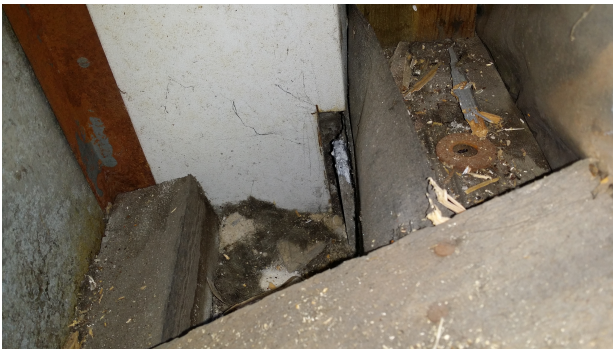
Item 87 Ref: 117113-22

The off cut to column base within wall cavity adj 0/029 (External) contains asbestos.

Any change in its appearance should be recorded and passed to Property Services.
