### ASBESTOS SURVEY REPORT FOR BARNWELL ACADEMY, PENSHAW

*Control of Asbestos  
Regulations 2012*

**BARNWELL ACADEMY,  
PENSHAW**

**Date: 14 May 2026**

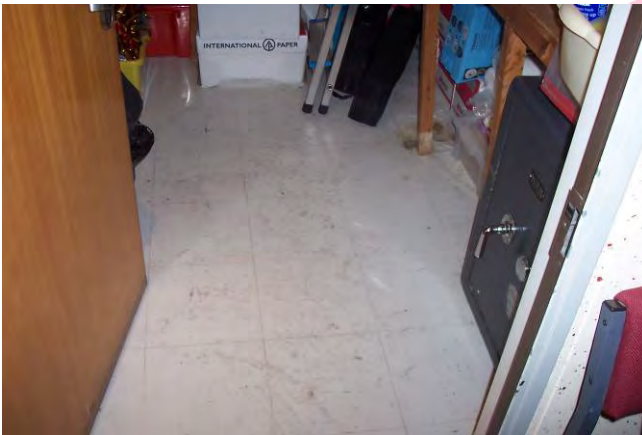
### **Item 2 - JL06/4153**

The white floor tiles and adhesive in room 1 (CB Office) contain asbestos. These floor tiles have been overlaid by carpet.

Any change in their appearance should be recorded, and passed to Property Services.

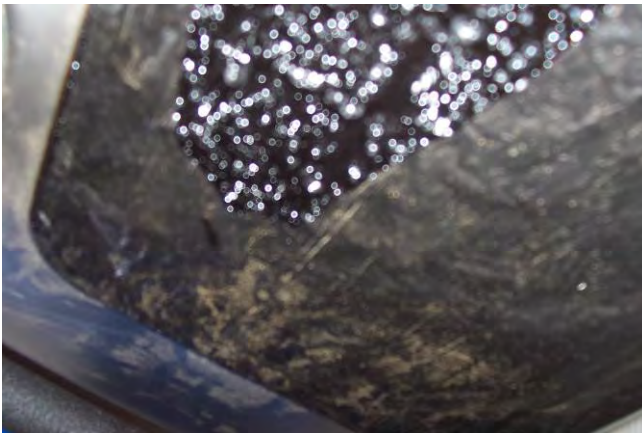
### **Item 3 - JL06/4154**

The sink pad in room 9 (staff room) does not contain asbestos.

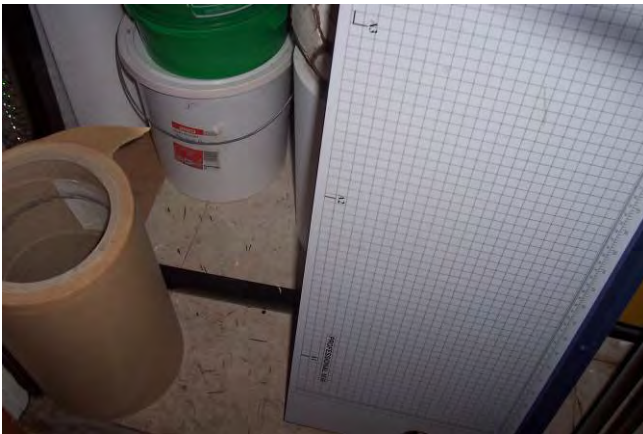
### **Item 5 – As JL06/4143**

The white floor tiles and adhesive in area 39 (store cupboard) contain asbestos.

Any change in its appearance should be recorded, and passed to Property Services.

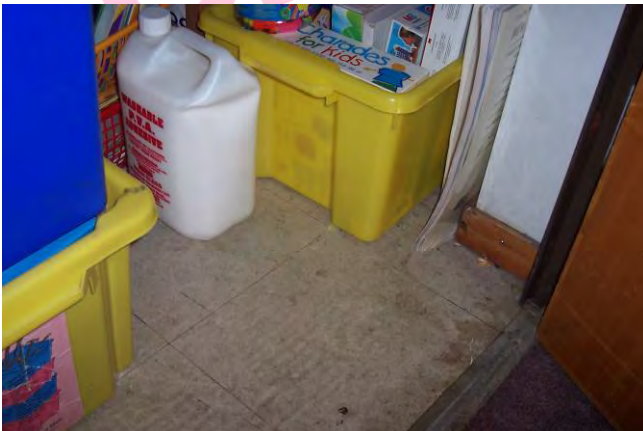
### **Item 6 – As JL06/4153**

The white floor tiles and adhesive in area 15 (store cupboard) contain asbestos.

Any change in their appearance should be recorded, and passed to Property Services.

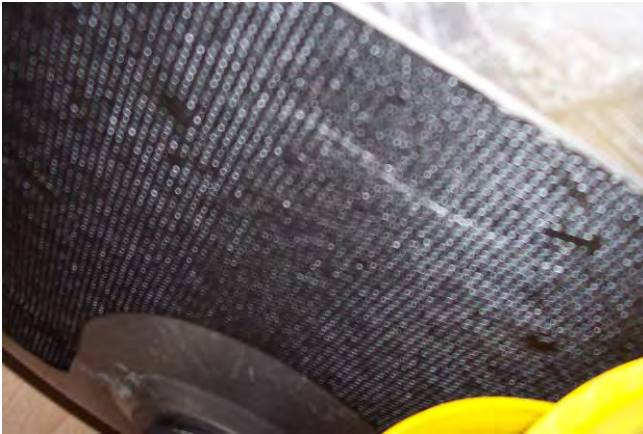
### **Item 7 – As JL06/4154**

The sink pads in areas 12, 13 & 14 (classroom) do not contain asbestos.

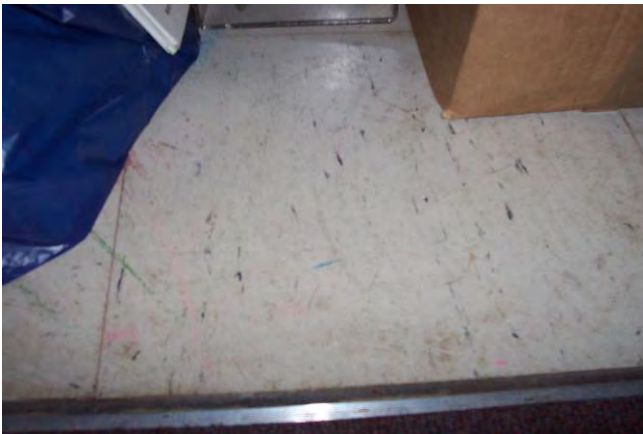
### **Item 8 – As JL06/4153**

The white floor tiles and adhesive in area 11 (store cupboard) contains asbestos.

Any change in their appearance should be recorded, and passed to Property Services.

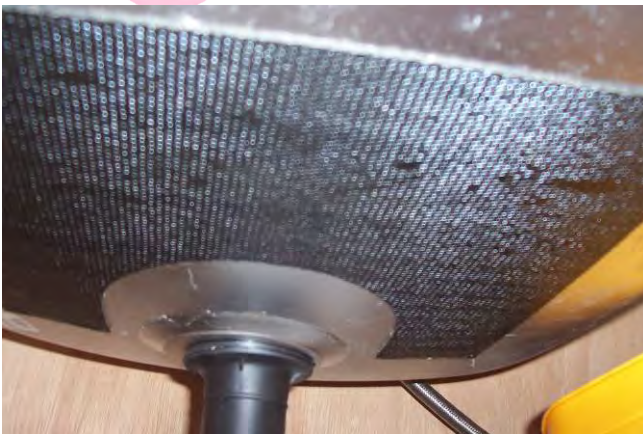
### **Item 9 – As JL06/4154**

The sink pad in area 26 (classroom) does not contain asbestos.

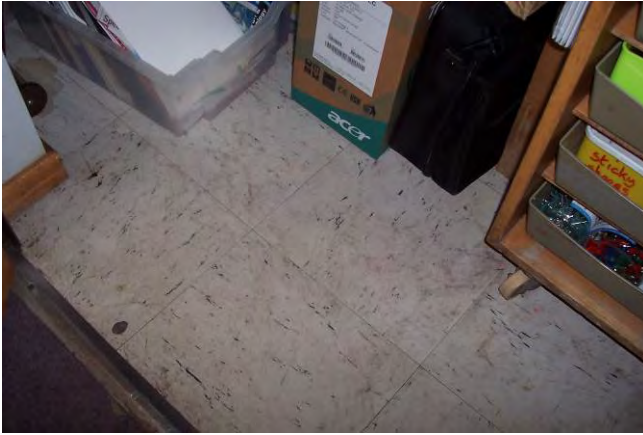
### **Item 10 – As JL06/4153**

The white floor tiles and adhesive in area 6 (store cupboard) contains asbestos.

Any change in their appearance should be recorded, and passed to Property Services.

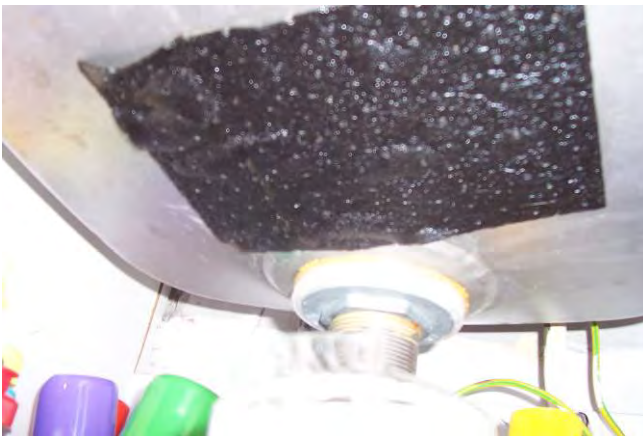
### **Item 11 – As JL06/4154**

The sink pad in area 25 (classroom) does not contain asbestos.

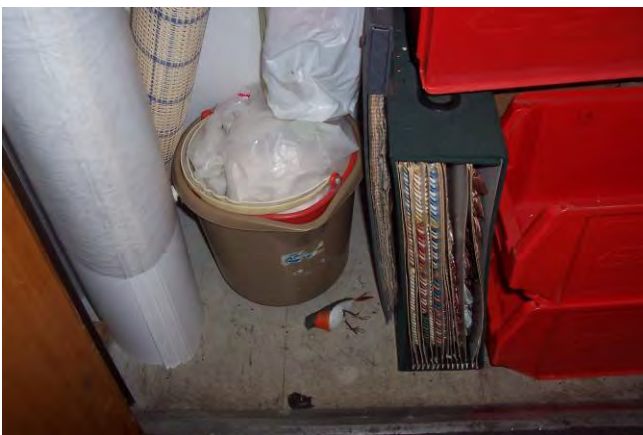
### **Item 12 – As JL06/4153**

The white floor tiles and adhesive in area 5 (store cupboard) contain asbestos.

Any change in their appearance should be recorded, and passed to Property Services.

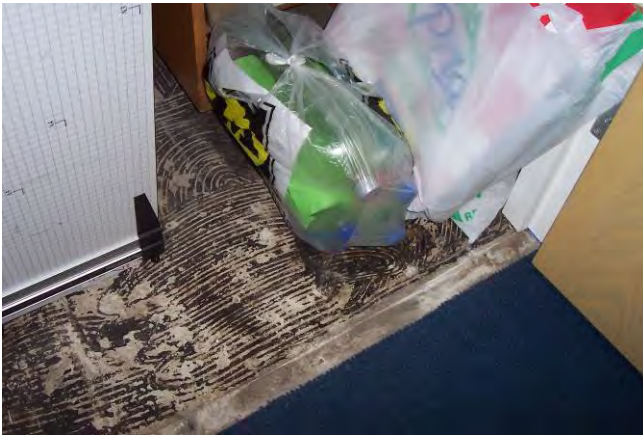
### **Item 13 – JL06/4155**

The floor tiles and adhesive in area 3 (store cupboard) contains asbestos.

Any change in their appearance should be recorded, and passed to Property Services.

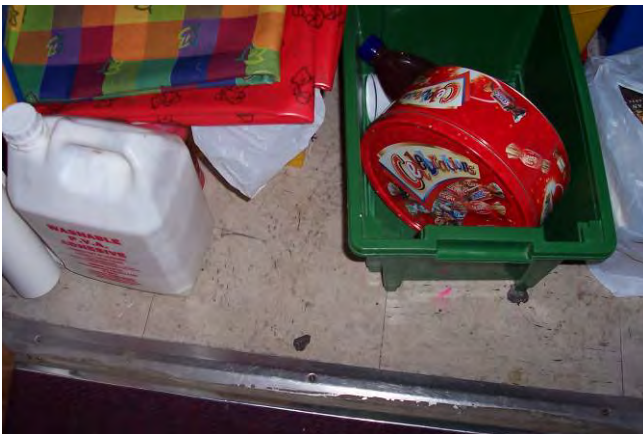
### **Item 14 – As JL06/4153**

The white floor tiles and adhesive in area 4 (store cupboard) contain asbestos.

Any change in their appearance should be recorded, and passed to Property Services.

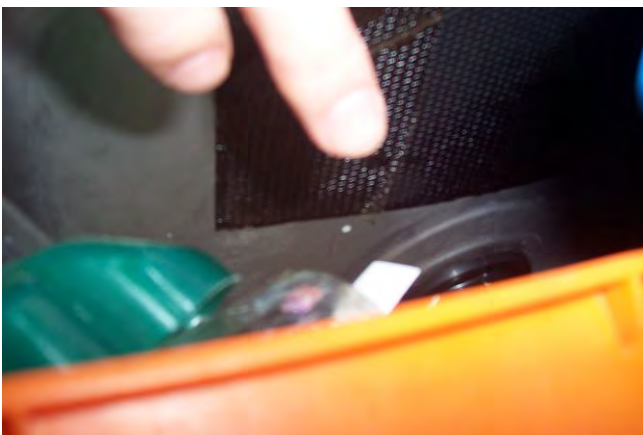
### **Item 15 – As JL06/4154**

The sink pad in area 31 (classroom) does not contain asbestos.

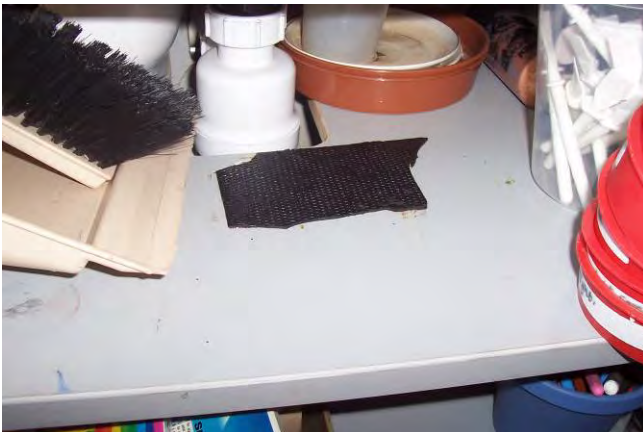
### **Item 18 – As JL06/4154**

The sink pad (fallen off sink – stuck on shelf) in area 34 (classroom) does not contain asbestos.

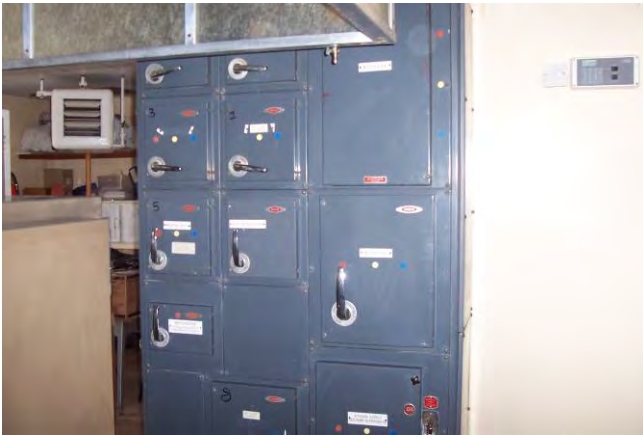
### **Item 19 – Presumed**

The flash guards to fuse box in area 19 (kitchen) contains asbestos.

Any change in its appearance should be recorded, and passed to Property Services.

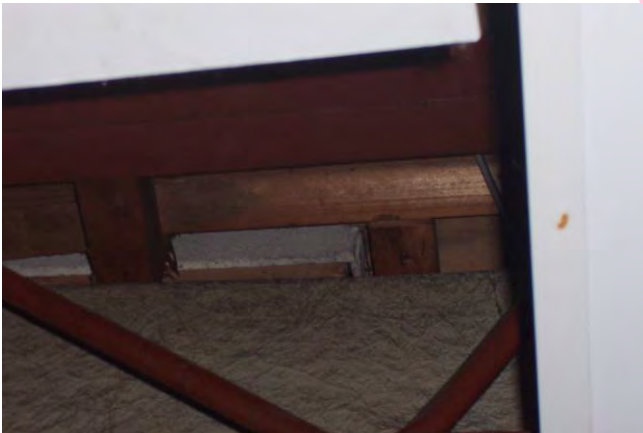
### **Item 20 – JL06/4156**

The boards to upstands in vent in ceiling void in area 19 (kitchen) contain asbestos.

Any change in its appearance should be recorded, and passed to Property Services.

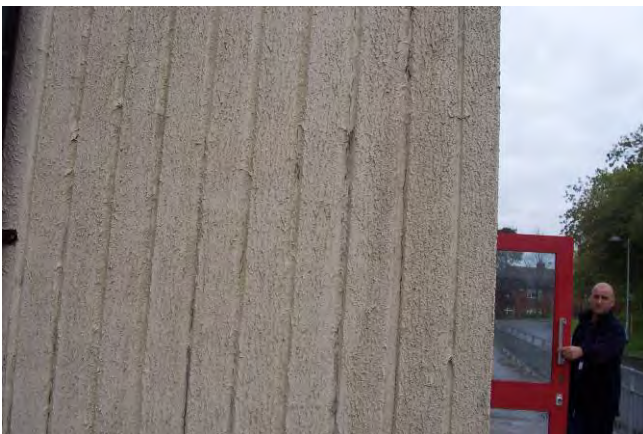
### **Item 21 – JL06/4157**

The textured coating to outside walls (exterior) does not contain asbestos.

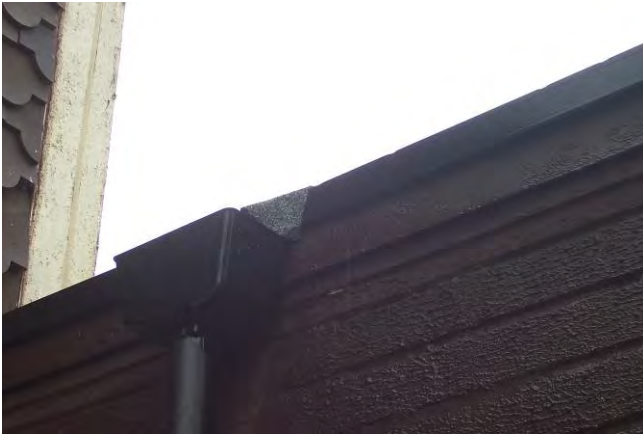
**Item 22 – JL06/4158**

The roofing felt to flat roofs (exterior) does not contain asbestos.

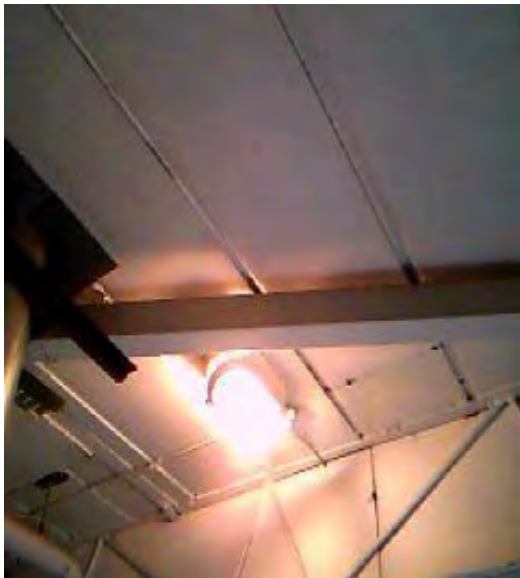
**Item 23 – AD000530**

The ceiling panels to the boiler room contain asbestos.

Any change in its appearance should be recorded, and passed to Property Services.

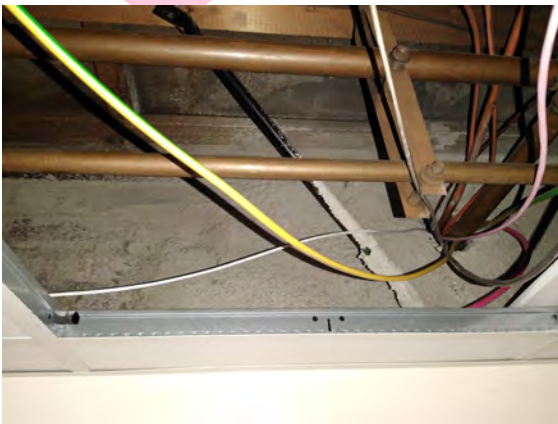
### **Item 26 Ref: 416936-1**

The firebreak in Kitchen void above/ 0/19 does not contain asbestos.

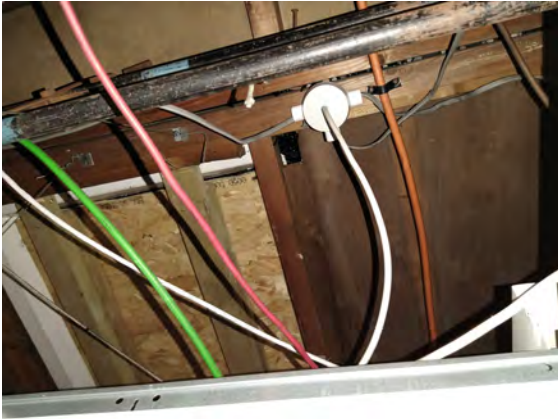
### **Item 27 Ref: 416936-2**

The roof adhesive residue to joists in Kitchen void above/ 0/19 does not contain asbestos.

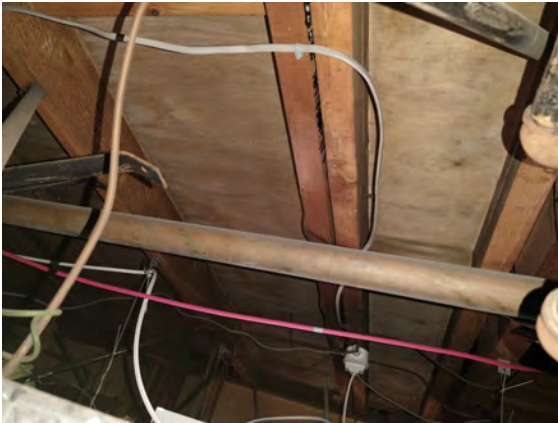
### **Item 28 Ref: As 416936-2**

The roof adhesive residue to joists in Kitchen void above/ 0/20 does not contain asbestos.

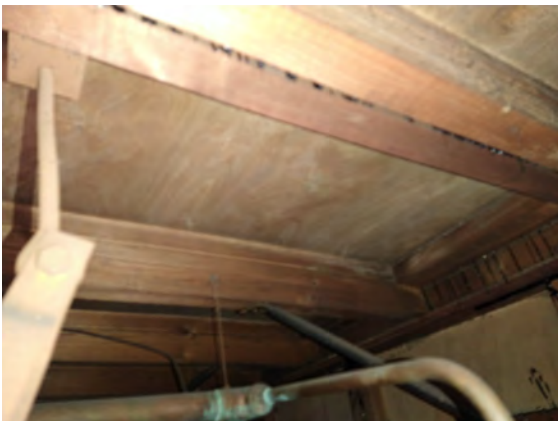
### **Item 29 Ref: As 416936-2**

The roof adhesive residue to joists in Kitchen locker room void above/ 0/21 does not contain asbestos.

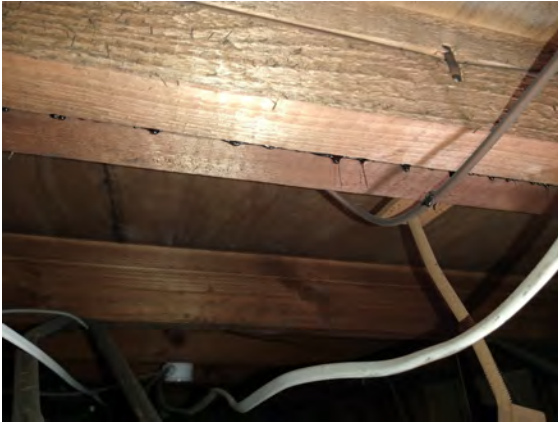
### **Item 30 Ref: As 416936-2**

The roof adhesive residue to joists in Kitchen void above/ 0/22 does not contain asbestos.

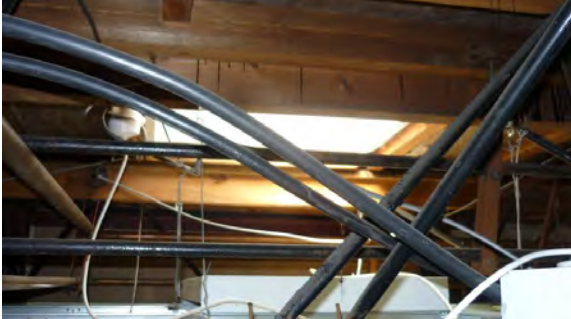
### **Item 34 Ref: As AW0703/11**

The skylight surrounds in 0/33 Kitchen Store void above contain asbestos.

Any change in its appearance should be recorded and passed to Property Services.

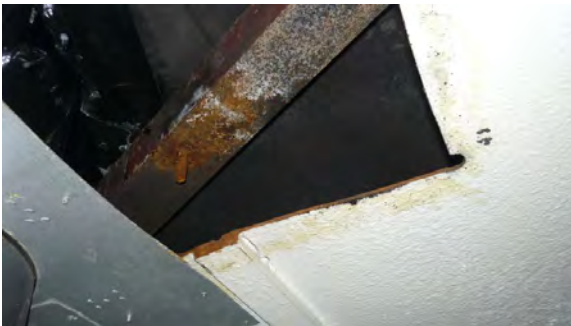
### **Item 35 Ref: Presumed**

The ceiling above within smaller section of 0/36 Boiler Room Ceiling Void is presumed to contain asbestos.

Any change in its appearance should be recorded and passed to Property Services.

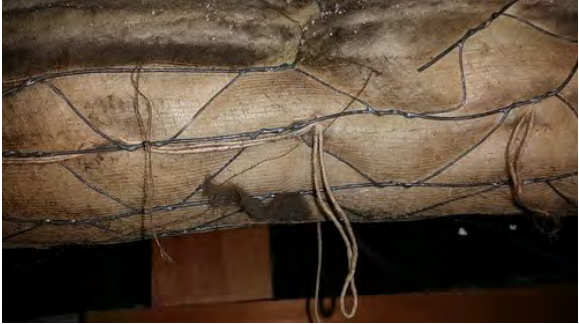
**Item 37 Ref: 80235-1**

The string to pipe lagging in 035/cupboard – void above does not contain asbestos.

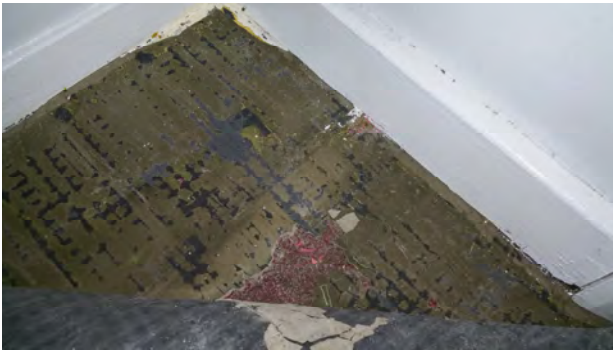
**Item 62 Ref: 117113-2**

The subfloor covering in 01/entrance lobby does not contain asbestos.

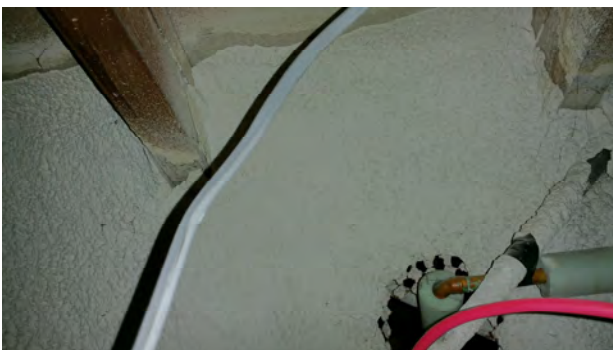
**Item 63 Ref: 117113-1**

The firebreak & associated debris in 01/entrance lobby-void above does not contain asbestos.

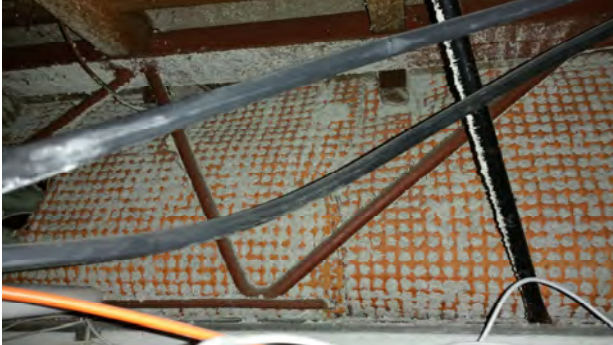
### **Item 64 Ref: As 117113-1**

The firebreak & associated debris in 02/headteachers office-void above does not contain asbestos.

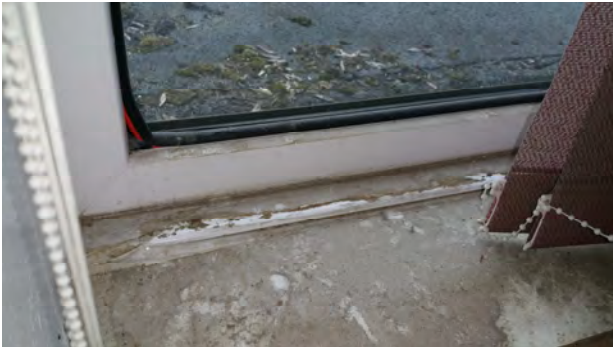
### **Item 65 Ref: 117113-3**

The membrane below high level window cill in 03/main hall contains asbestos.

Any change in its appearance should be recorded and passed to Property Services.

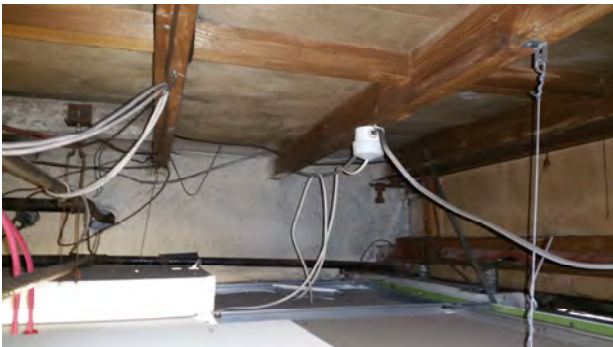
### **Item 66 Ref: As 117113-1**

The firebreak & associated debris in 04/kitchen -void above does not contain asbestos.

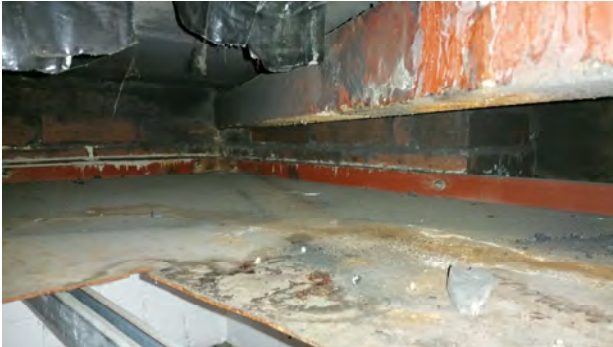
### **Item 67 Ref: 117113-6**

The debris to topside of lower wood ceiling in 06/boiler room contains asbestos.

Any change in its appearance should be recorded and passed to Property Services.

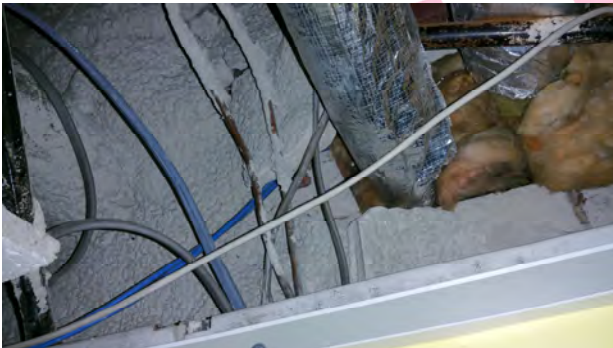
### **Item 68 Ref: As 117113-1**

The firebreak & associated debris in 07/classroom-void above does not contain asbestos.

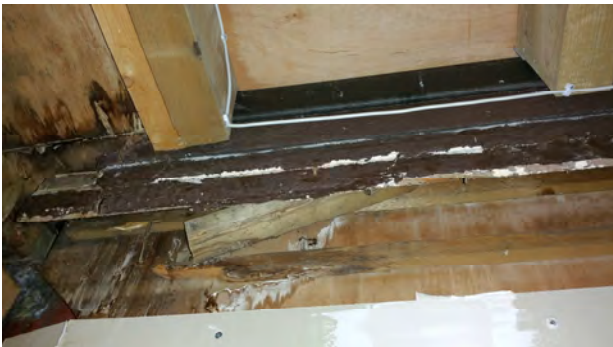
### **Item 69 Ref: 117113-8**

The render to original fascia in 017/cupboard-void above does not contain asbestos.

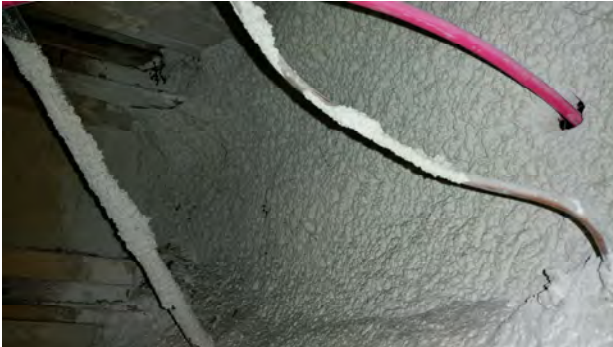
### **Item 70 Ref: 117113-10**

The firebreak & associated debris in 019/staffroom-void above does not contain asbestos.

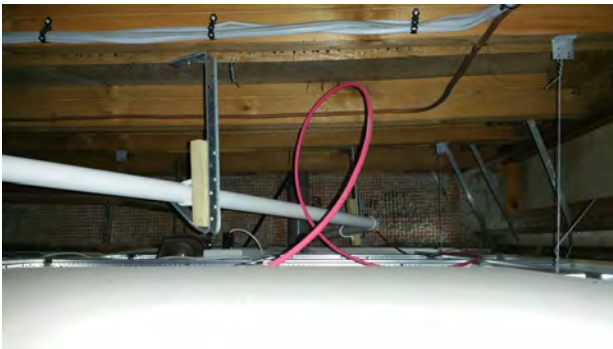
### **Item 71 Ref: As 117113-10**

The firebreak & associated debris in 021/boys wc-void above does not contain asbestos.

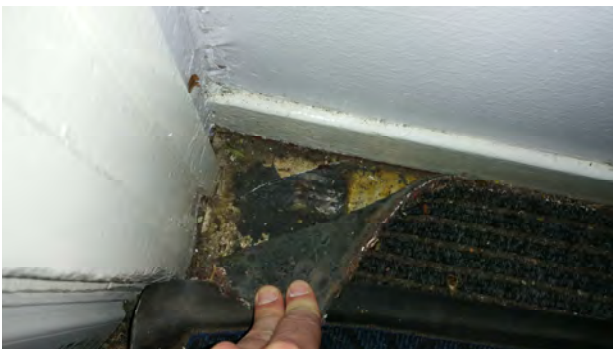
### **Item 72 Ref: 117113-11**

The subfloor covering in 022/corridor contains asbestos.

Any change in its appearance should be recorded and passed to Property Services.

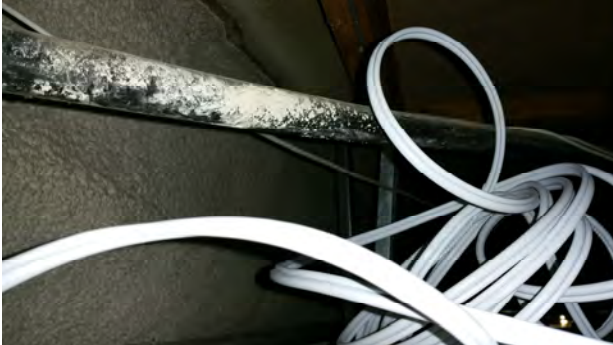
**Item 73 Ref: As 117113-10**

The firebreak & associated debris in 023/girls wc -void above does not contain asbestos.

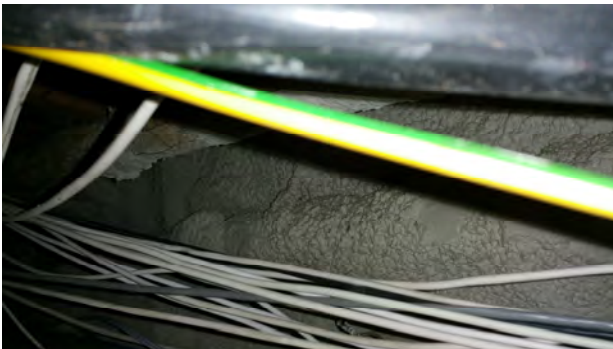
**Item 74 Ref: As 117113-10**

The firebreak & associated debris in 024/girls wc -void above does not contain asbestos.

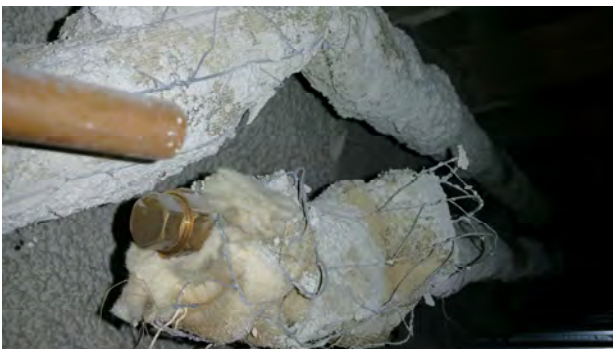
**Item 75 Ref: As 117113-10**

The firebreak & associated debris in 025/boys wc -void above does not contain asbestos.

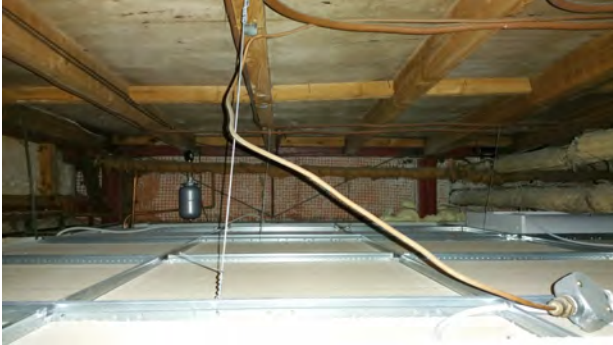
### **Item 76 Ref: As 117113-10**

The firebreak & associated debris in 026/staffroom -void above does not contain asbestos.

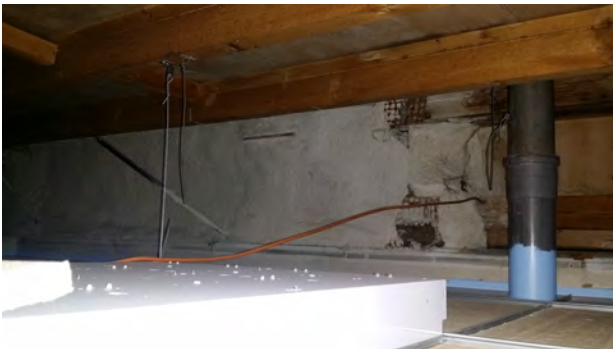
### **Item 77 Ref: As 117113-10**

The firebreak & associated debris in 027/boys wc -void above does not contain asbestos.

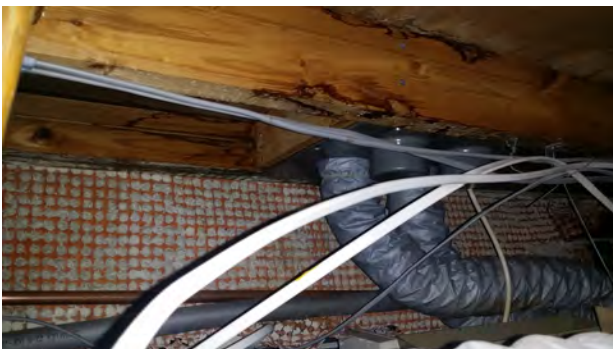
### **Item 78 Ref: As 117113-10**

The firebreak & associated debris in 029/reception -void above does not contain asbestos.

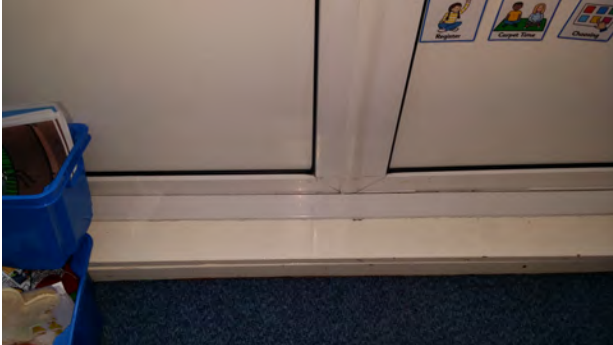
### **Item 79 Ref: 117113-14**

The remnant floor covering within wood boxing below windows in 033/classroom contains asbestos.

Any change in its appearance should be recorded and passed to Property Services.

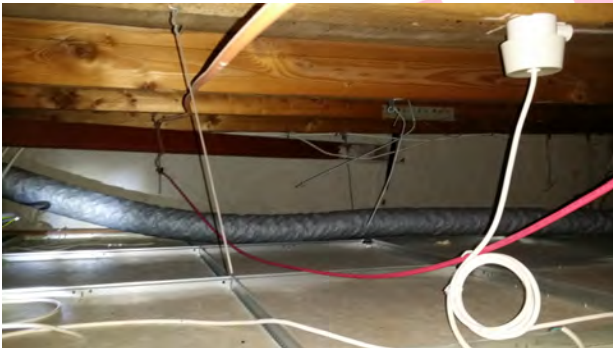
### **Item 80 Ref: As 117113-15**

The firebreak & associated debris in 033/classroom - void above does not contain asbestos.

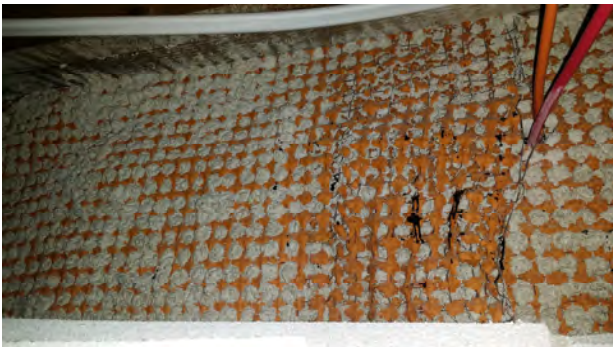
### **Item 81 Ref: 117113-15**

The firebreak & associated debris in 034/classroom - void above does not contain asbestos.

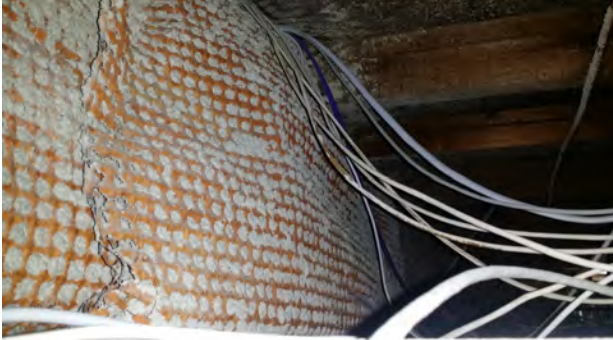
### **Item 82 Ref: As 117113-15**

The firebreak & associated debris in 035/office -void above does not contain asbestos.

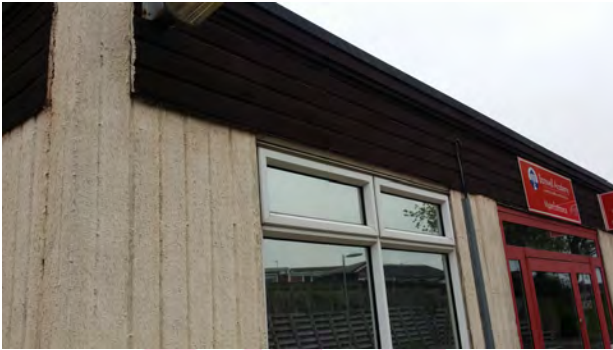
### **Item 83 Ref: 117113-17**

The render to walls & fascia (External) does not contain asbestos.

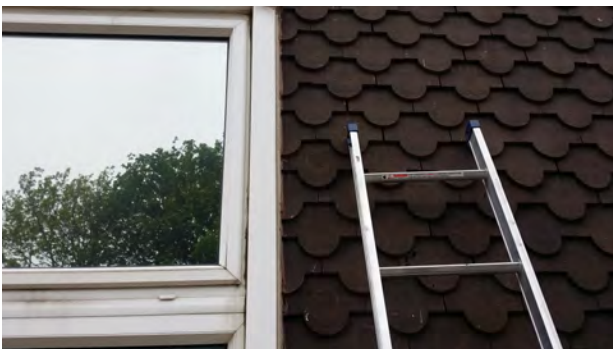
### **Item 84 Ref: 117113-18**

The brown sealant to clay tile wall cladding (External) does not contain asbestos.

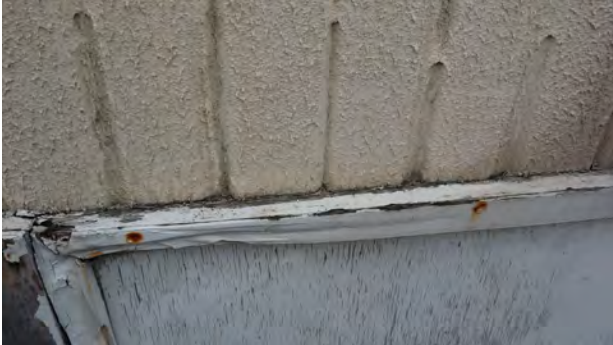
### **Item 85 Ref: 117113-19**

The sealant to wood cladding panels (External) does not contain asbestos.

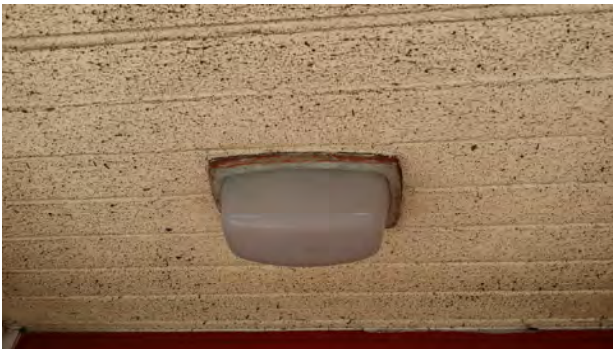
### **Item 86 Ref: 117113-21**

The sealant to glass of bulkhead light fitting (External) contains asbestos.

Any change in its appearance should be recorded and passed to Property Services.

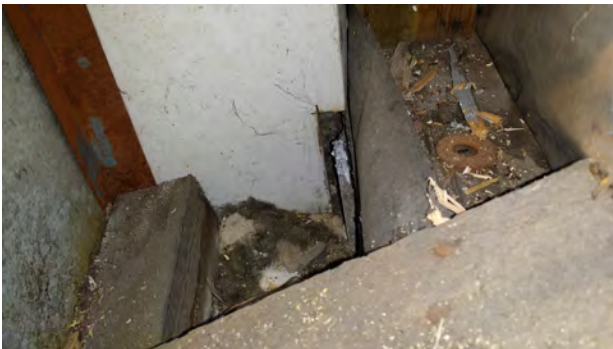
### **Item 87 Ref: 117113-22**

The off cut to column base within wall cavity adj 0/029 (External) contains asbestos.

Any change in its appearance should be recorded and passed to Property Services.

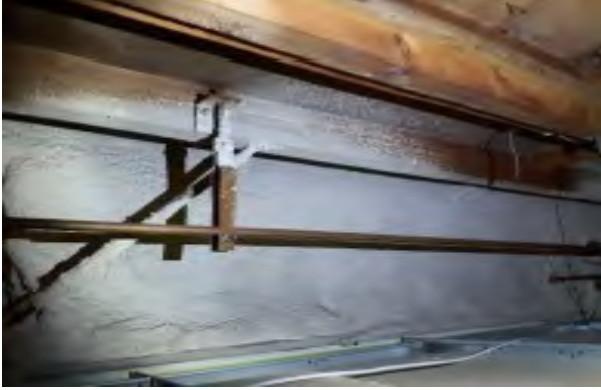
### **Item 88 Ref: RO001028**

The sprayed coating to the ceiling void in the Kitchen (G/001) does not contain asbestos.

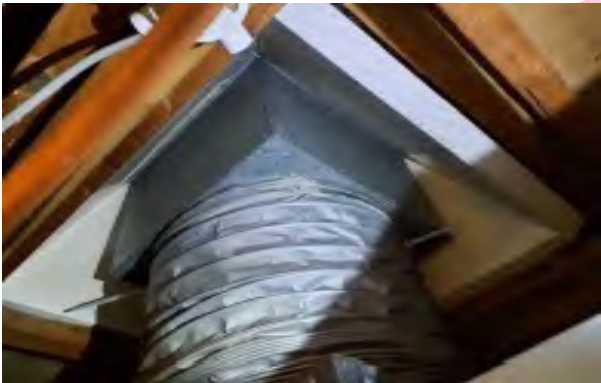
### **Item 89 Ref: RO001029**

The mastic ducting in the kitchen (G/001) does not contain asbestos.

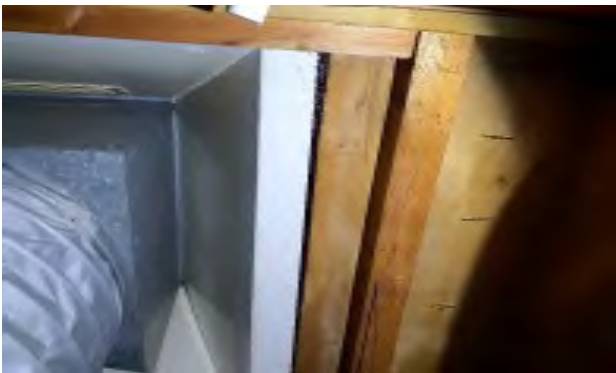
### **Item 90 Ref: RO001030**

The bitumen felt to the underside of the roof in the kitchen (G/001) does not contain asbestos.

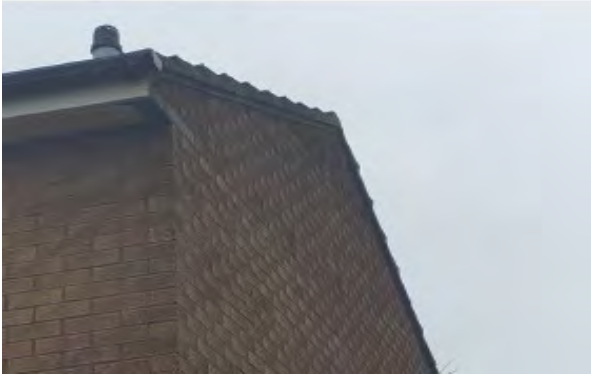
### **Item 91 Ref: SE000329**

The cement Undercloaking to the roof (External E/01) does not contain asbestos.

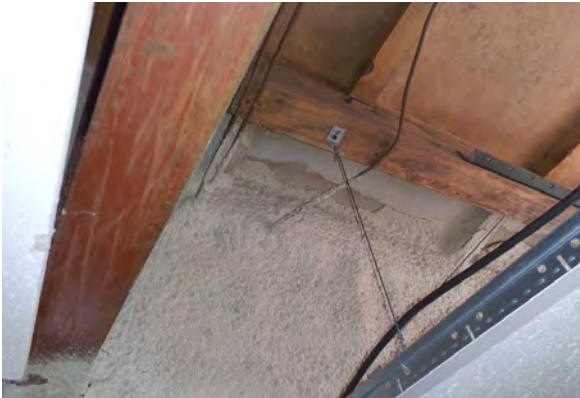
### **Item 92 Ref: HD000849**

The sprayed coating in the ceiling void (Meeting Rm G/001) does not contain asbestos.

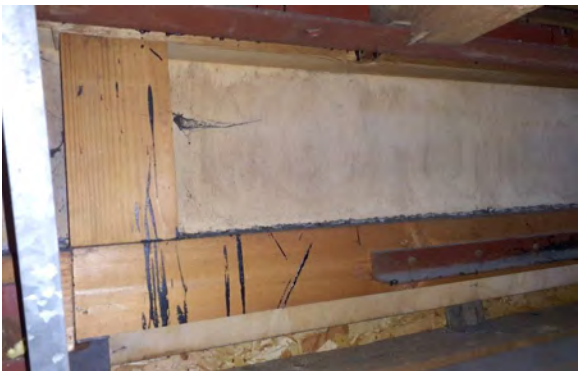
### **Item 93 Ref: HD000850**

The bitumen in the ceiling void (Meeting Rm G/001) does not contain asbestos.

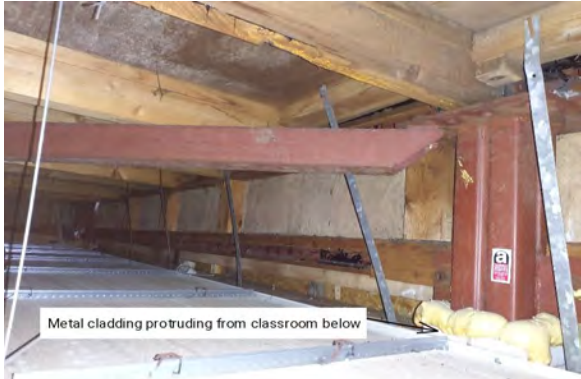
### **Item 94 Ref: Presumed**

The insulating board to walls (Meeting Rm G/001) is presumed to contain asbestos.

Any change in its appearance should be recorded and passed to Property Services.

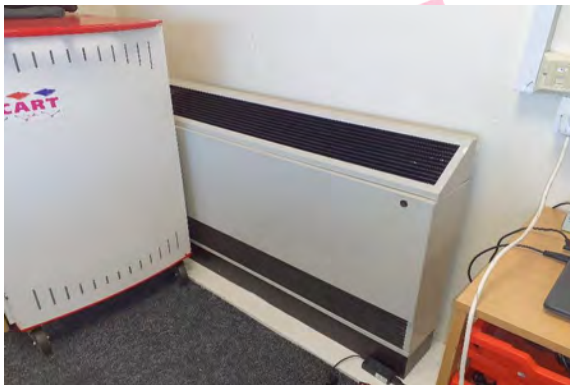
### **Item 95 Ref: Presumed**

The insulating board to heater (Meeting Rm G/001) is presumed to contain asbestos.
