### **ASBESTOS SURVEY REPORT FOR BARNWELL ACADEMY, PENSHAW**

### BARNWELL ACADEMY, PENSCHAW

**Date: 25 July 2025**

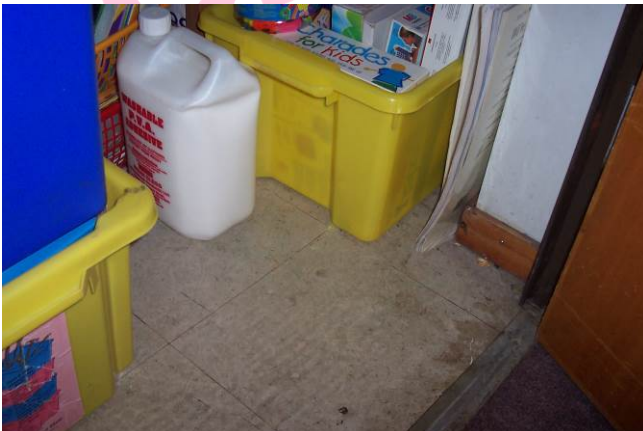
### **Item 6 – As JL06/4153**

The white floor tiles and adhesive in area 15 (store cupboard) contain asbestos.

Any change in their appearance should be recorded, and passed to Property Services.

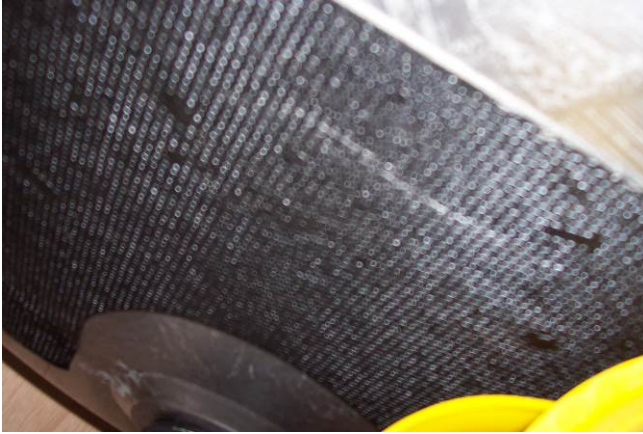
### **Item 7 – As JL06/4154**

The sink pads in areas 12, 13 & 14 (classroom) do not contain asbestos.

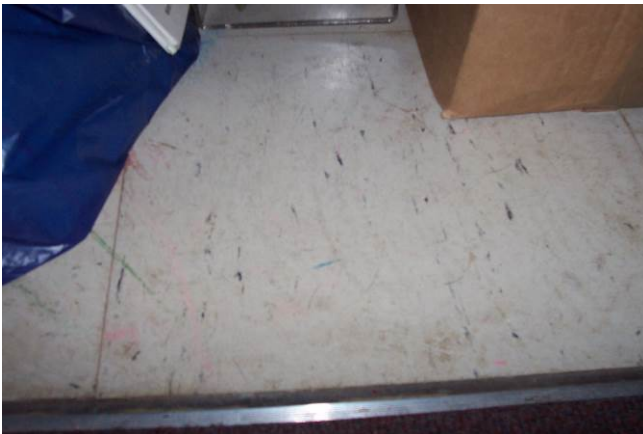
### **Item 8 – As JL06/4153**

The white floor tiles and adhesive in area 11 (store cupboard) contains asbestos.

Any change in their appearance should be recorded, and passed to Property Services.

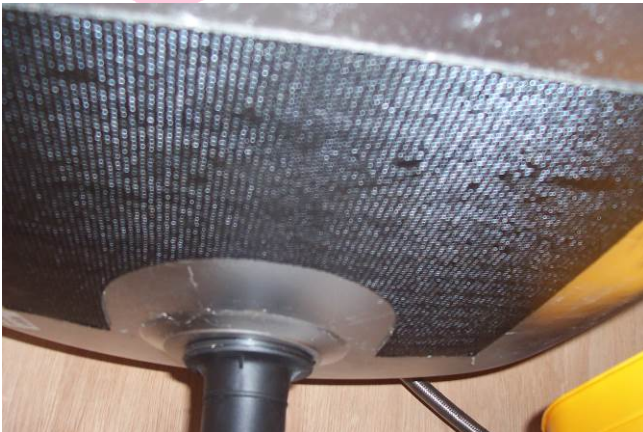
### **Item 9 – As JL06/4154**

The sink pad in area 26 (classroom) does not contain asbestos.

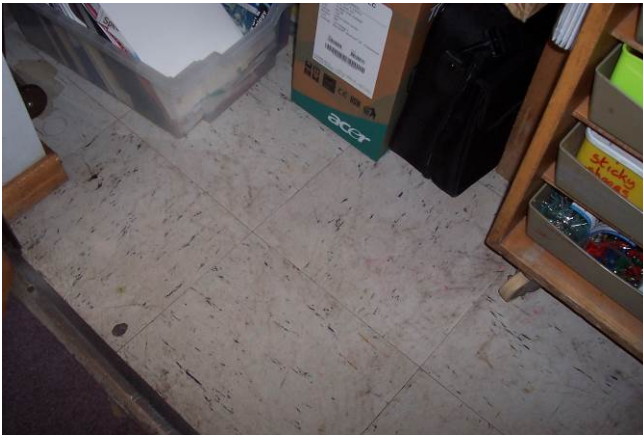
### **Item 10 – As JL06/4153**

The white floor tiles and adhesive in area 6 (store cupboard) contains asbestos.

Any change in their appearance should be recorded, and passed to Property Services.

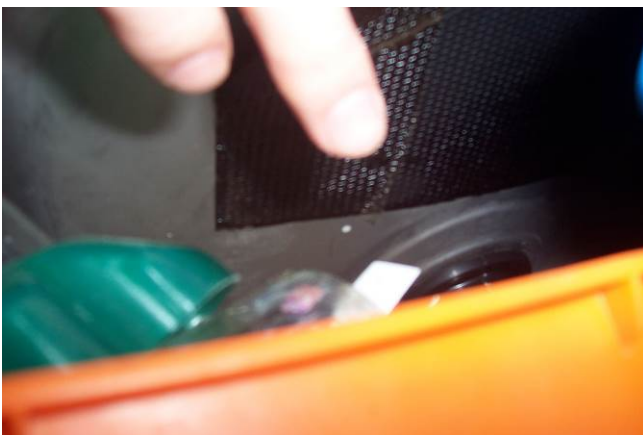
### **Item 15 – As JL06/4154**

The sink pad in area 31 (classroom) does not contain asbestos.

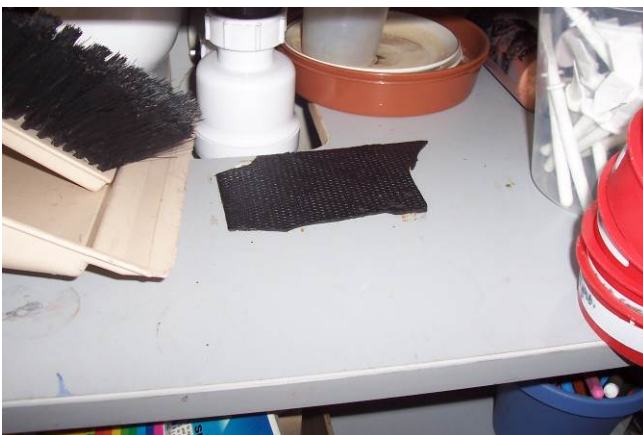
### **Item 18 – As JL06/4154**

The sink pad (fallen off sink – stuck on shelf) in area 34 (classroom) does not contain asbestos.

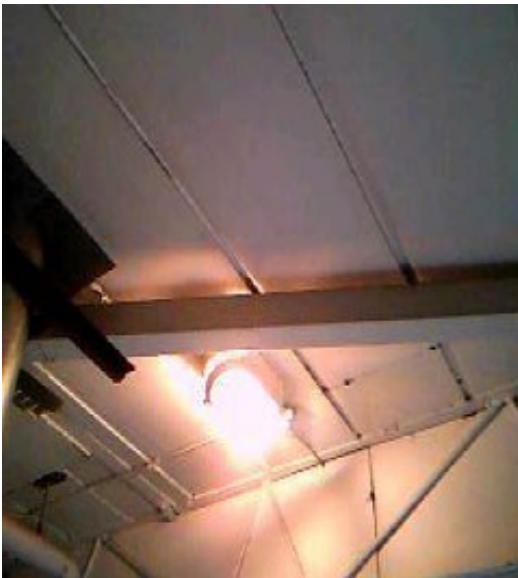
### **Item 23 – AD000530**

The ceiling panels to the boiler room contain asbestos.

Any change in its appearance should be recorded, and passed to Property Services.

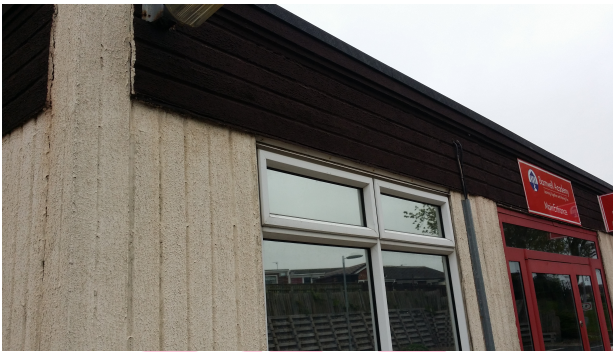
### **Item 83 Ref: 117113-17**

The render to walls & fascia (External) does not contain asbestos.
