ASBESTOS SURVEY REPORT FOR BENEDICT BISCOP, SUNDERLAND

Asbestos Register for BENEDICT BISCOP, SUNDERLAND

Date: 16 March 2026

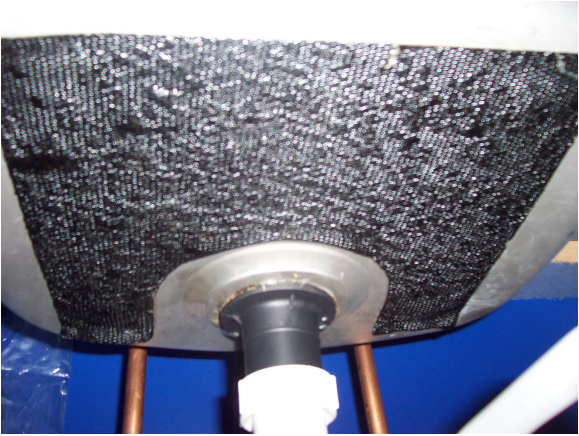
Item 1 Ref: NO06/02

The sink pads in the reception area do not contain asbestos.

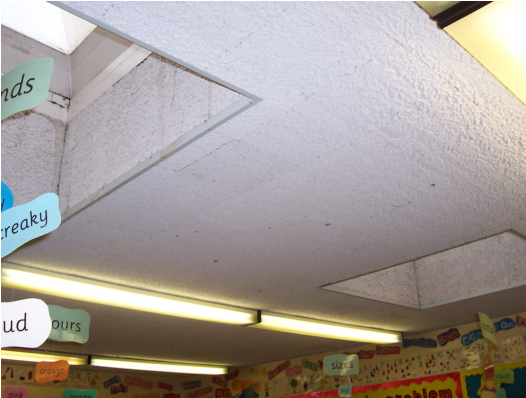
Item 2 - Ref: NO06/03

The ceiling tiles in year 2 class do not contain asbestos.

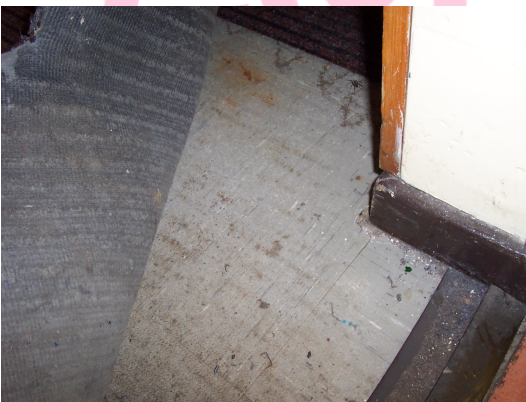
Item 3 - Ref: NO06/05

The floor tiles in year 5 & 6 classroom do not contain asbestos.

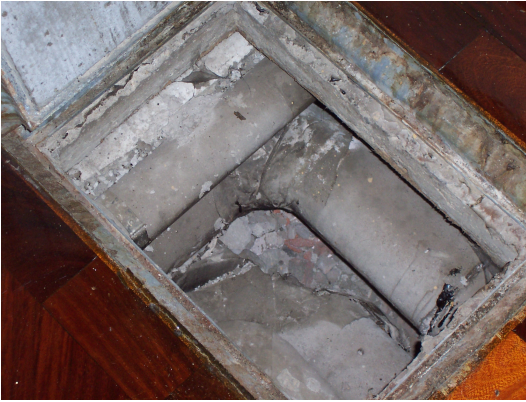
Item 4 - Ref: NO06/06

The pipe lagging throughout the school in the ducts does not contain asbestos.

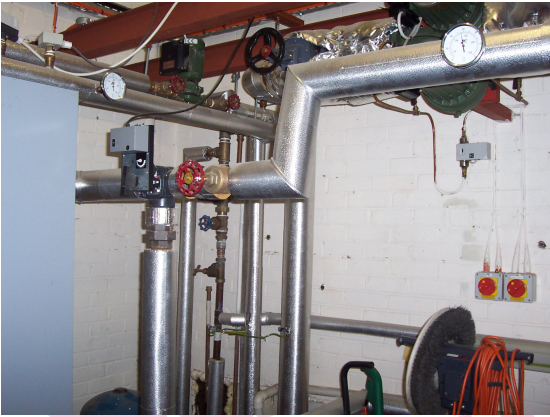
Item 5 - Ref:NO06/07

The pipe lagging in the boiler house does not contain asbestos.

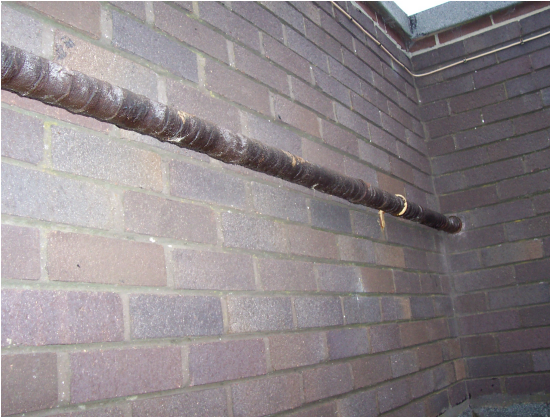
Item 7 - Ref: N006/09

The pipe insulation above the felt roof in the cleaner's store does not contain asbestos.

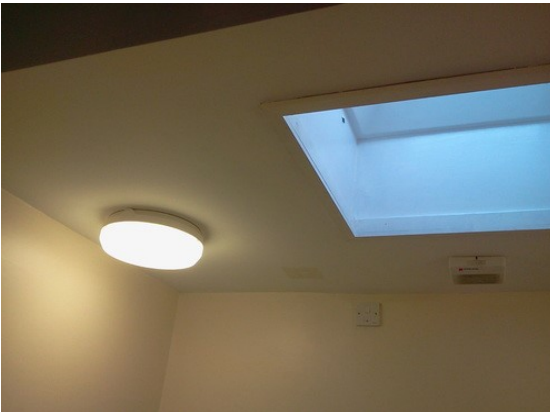
Item 15 - Ref: 43039-1

The fixed ceiling in the Disabled WC (Rm 0/003) does not contain asbestos.

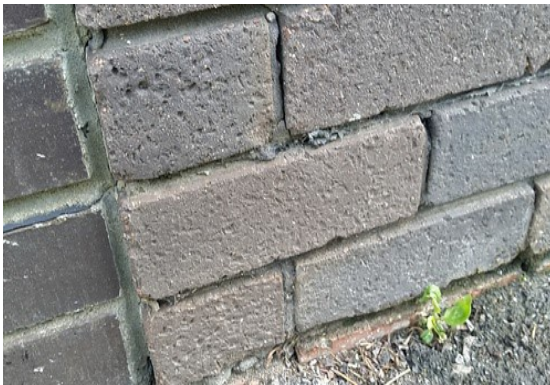
Item 18 - Ref: 87662-1

The damp proof course (External) does not contain asbestos.

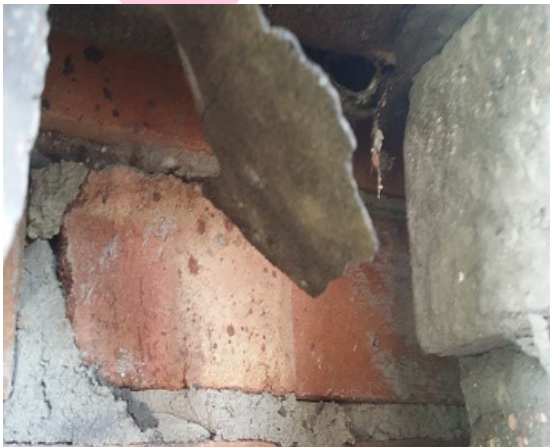
Item 19 - Ref: 87662-2

The membrane below windowsill (External) does not contain asbestos.

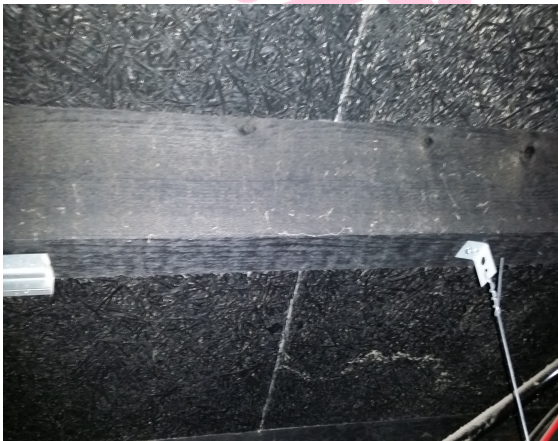
Items 22 - Ref: 117404-1

The underside of roof in Meeting Room (0/001) does not contain asbestos.

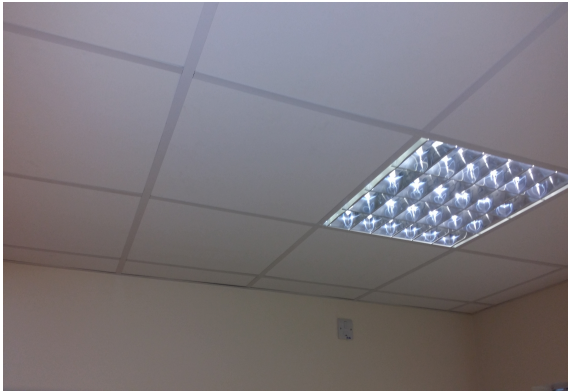
Items 23 - Ref: 117404-2

The suspended ceiling in Meeting Room (0/001) does not contain asbestos.

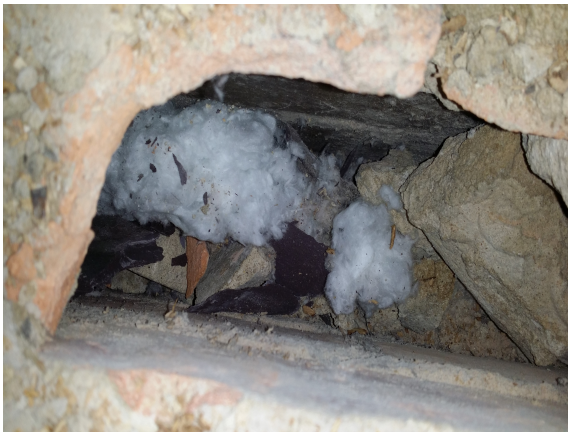
Items 24 - Ref: 117404-3

The cavity insulation in Meeting Room (0/001) does not contain asbestos.

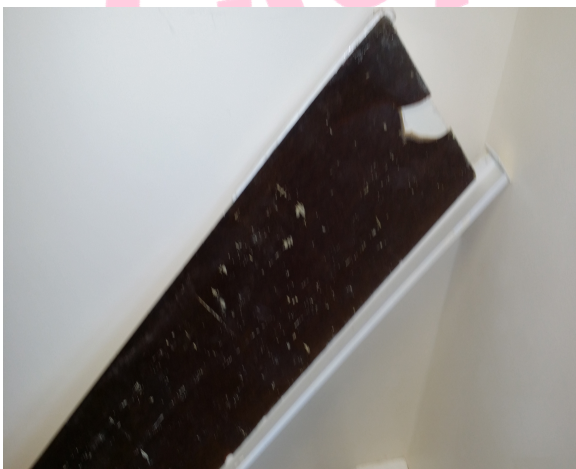
Items 25 - Ref: 117404-4

The lining to wood cill in Meeting Room (0/001) does not contain asbestos.

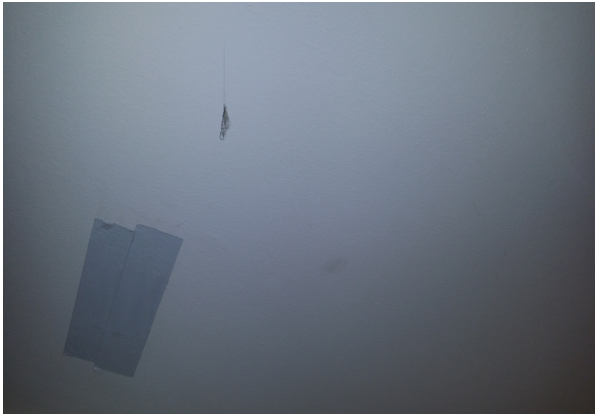
Items 26-Ref:As117404-1

The underside of roof in WC (0/002) does not contain asbestos.

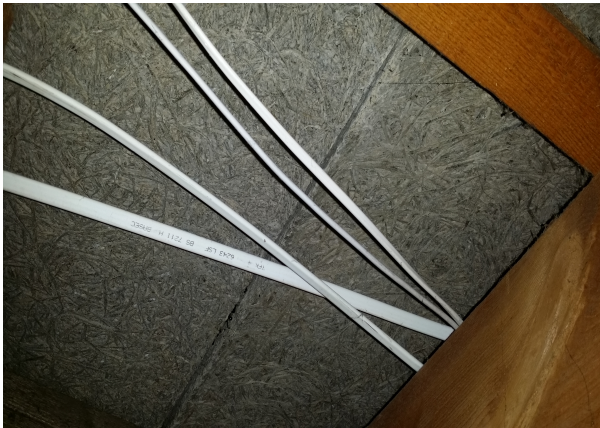
Items 27-Ref:As117404-1

The underside of roof in Reception Lobby ceiling void (0/003) does not contain asbestos.

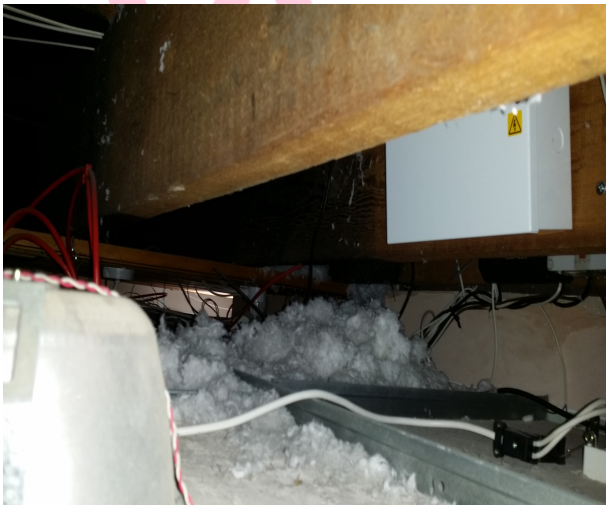
Items 28-Ref:As117404-3

The insulation in Reception Lobby ceiling void (0/003) does not contain asbestos.

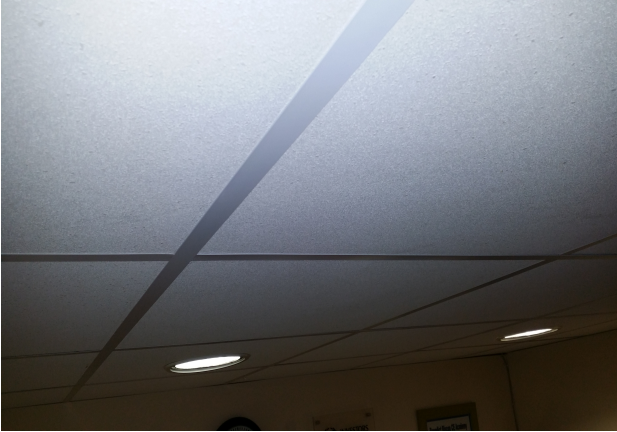
Items 29-Ref:As117404-2

The suspended ceiling in Reception Lobby (0/003) does not contain asbestos.

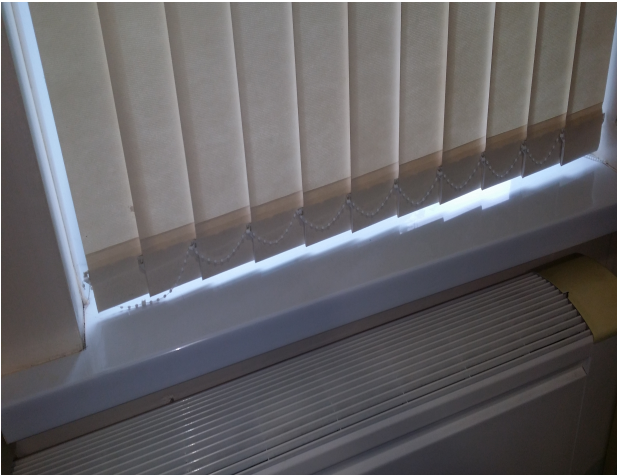
Items 30-Ref:As117404-4

The panel to original cill in Reception Lobby (0/003) does not contain asbestos.

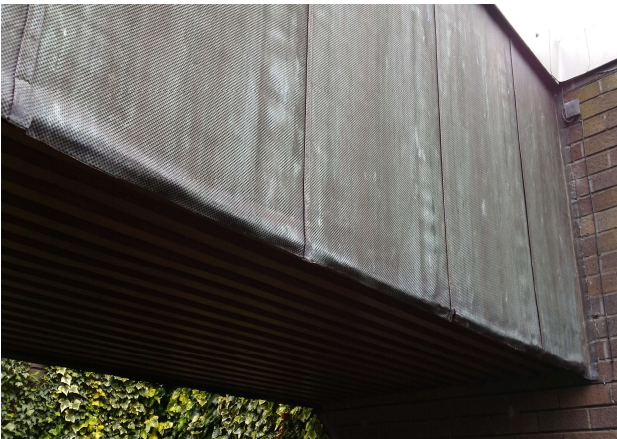
Items 31-Ref:As117404-1

The underside of roof canopy (External) does not contain asbestos.

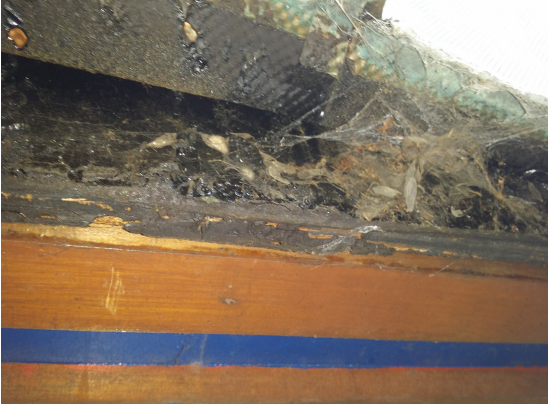
Items 32 - Ref: 117404-5

The felt to canopy walls
(External) does not contain
asbestos.

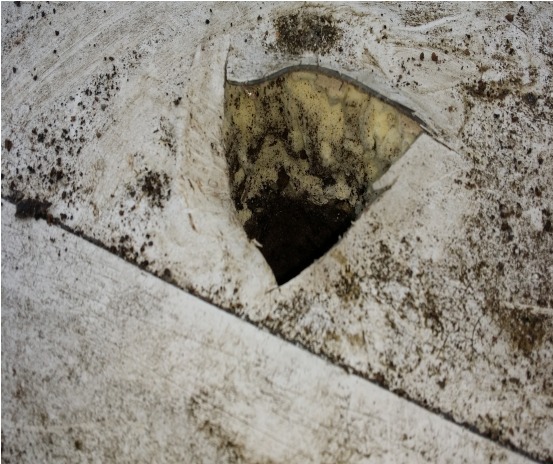
Items 33 - Ref: 117404-6

The original roof covering
(External) does not contain
asbestos.

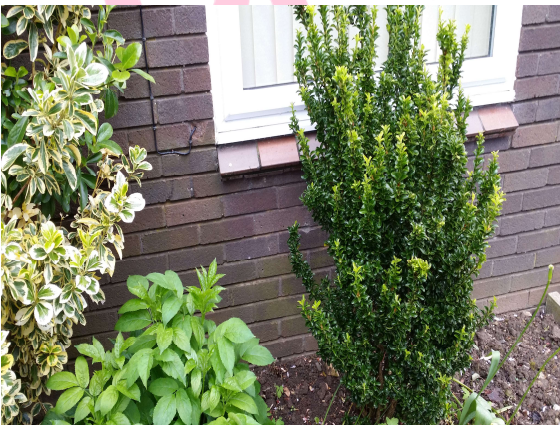
Items 34-Ref:As117404-3

The insulation to wall cavity
(External) does not contain
asbestos.

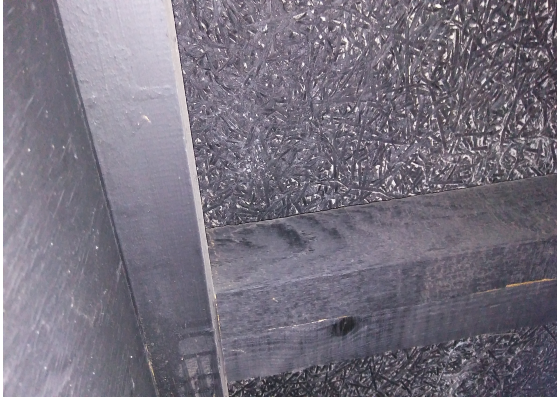
Items 35 - Ref: 376631-5

The underside of roof in Classroom (Rm 006) void above suspended ceiling does not contain asbestos.

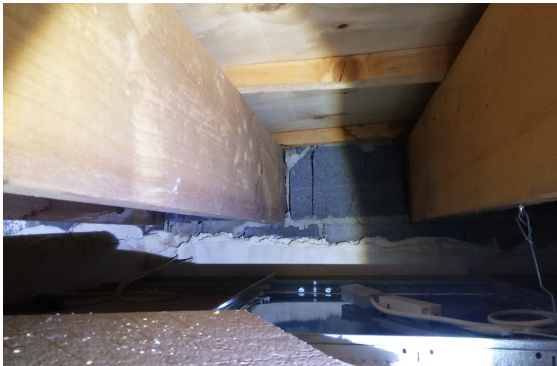
Items 36 - Ref: 376631-1

The remnant roof covering adhesive in classroom (Rm 007) void above suspended ceiling does not contain asbestos.

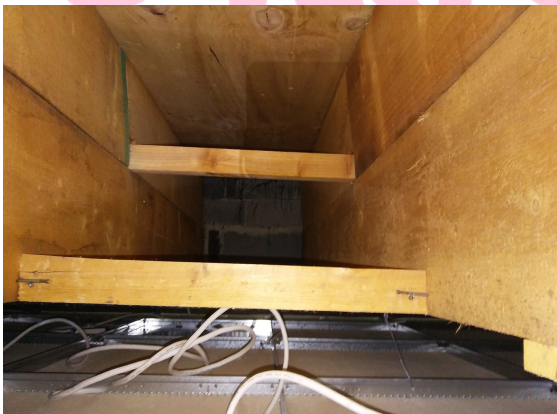
Items 37 - Ref: As 376631-1

The remnant roof covering adhesive in classroom (Rm 012) void above suspended ceiling does not contain asbestos.

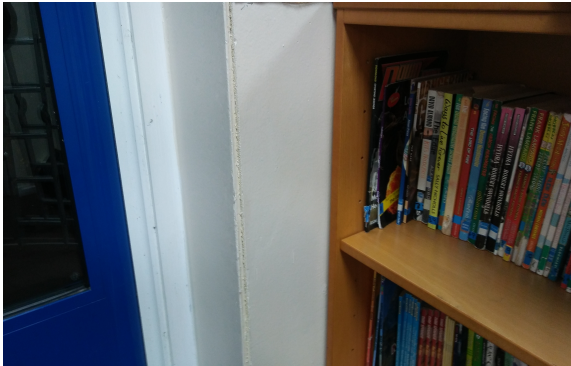
Items 38 - Ref: 376631-4

The cladding to wall in the corridor (Rm 013) does not contain asbestos.

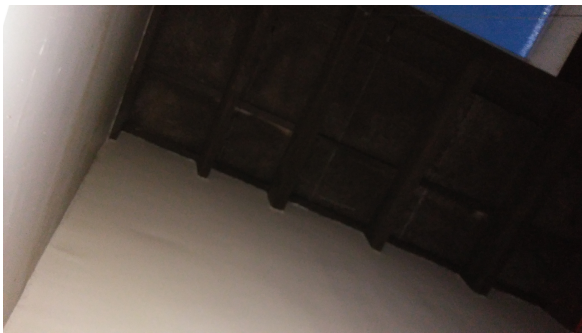
Items 39 - Ref: As 376631-5

The underside of roof in the corridor (Rm 013) void above suspended ceiling does not contain asbestos.

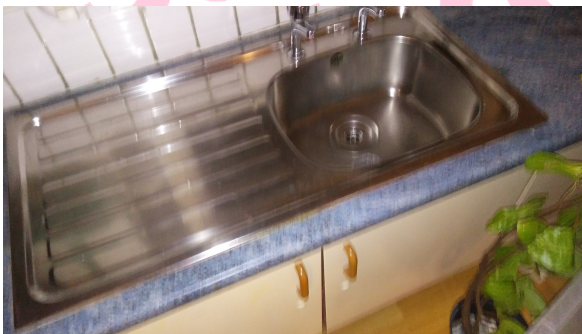
Items 40 - Ref: 376631-6

The acoustic sink pad in the nursery (Rm 014) does not contain asbestos.

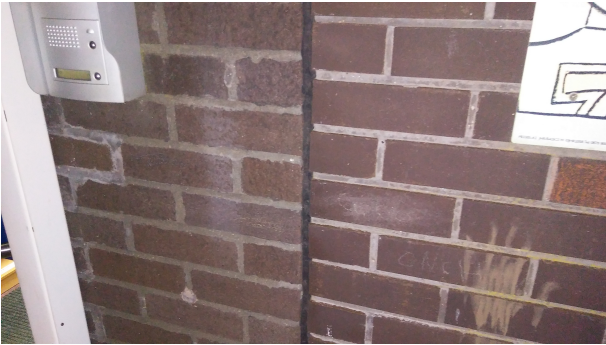
Items 41 - Ref: 376631-2

The expansion gap filler between newer extension and older building (External) does not contain asbestos.

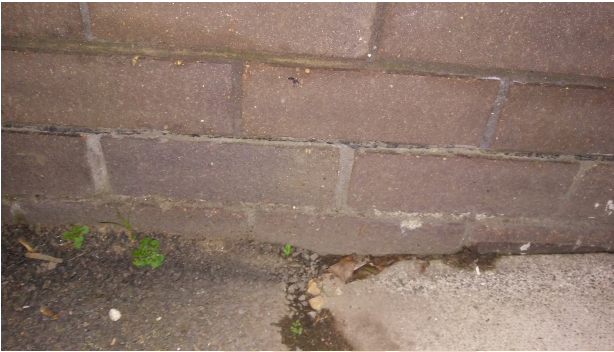
Items 42 - Ref: As 376631-3

The damp proof course (External) does not contain asbestos.

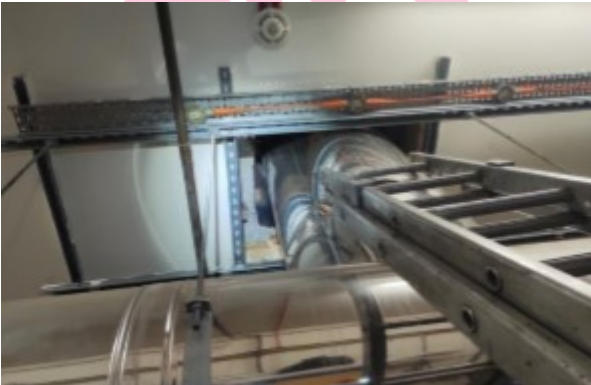
Items 43 - Ref: 21-30788-1

The ceiling in Area 1/Plant Room does not contain asbestos.

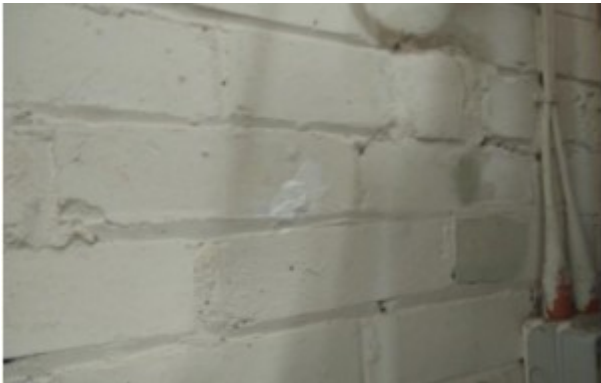
Items 44 - Ref: 21-30788-2

The residue to the walls in Area 1/Plant Room does not contain asbestos.

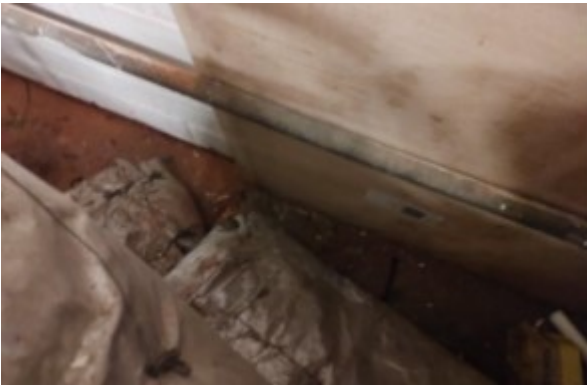
Items 45 - Ref: 21-30788-3

The debris to floor in Area 1/Plant Room does not contain asbestos.

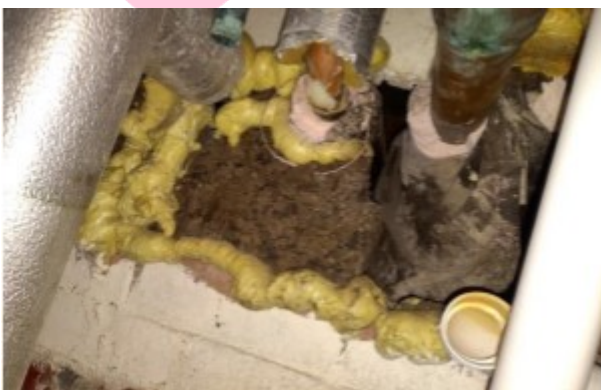
Items 46 - Ref: 21-30788-4

The pipes small bore penetration wall void in Area 1/Plant Room does not contain asbestos.

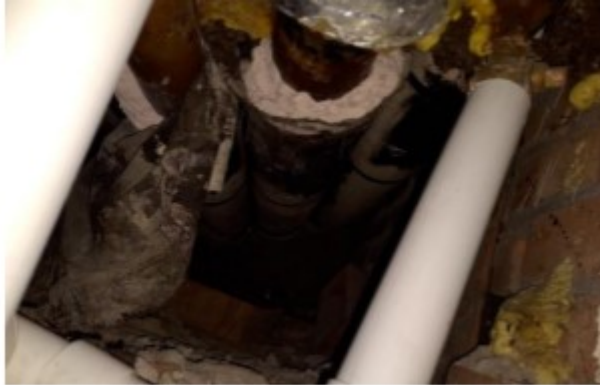
Items 47 - Ref: 21-30788-5

The pipes medium bore penetration wall in Area 1/Plant Room does not contain asbestos.

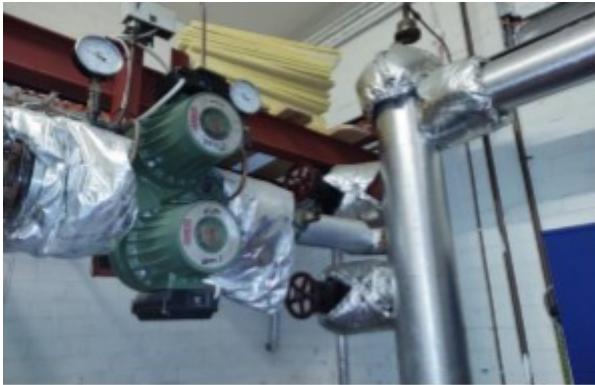
Items 48 - Ref: Presumed

Presumed – Gaskets (Area 1/Plant Room) (Item 48) – Removed by Building Maintenance no paperwork supplied

The gaskets in Area 1/Plant Room contain asbestos.

Removed by Building Maintenance no paperwork supplied

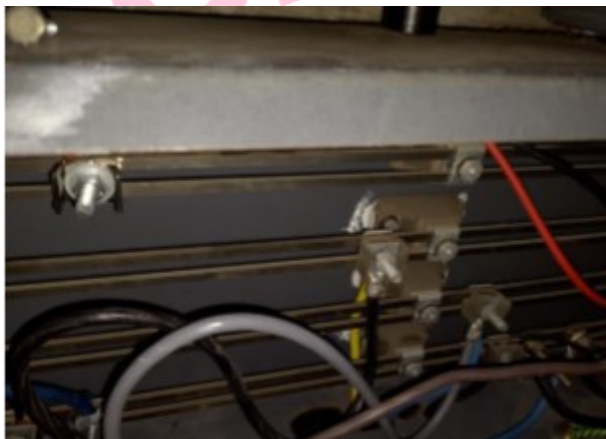
Items 49 - Ref: 21-30854-1

21-30854-1 – Insulators to electrical box (Area 2/Electrical Switch Room) (Item 49) – Low Risk

The insulators to electrical box in Area 2/Electrical Switch room does contain asbestos.

Any change in appearance should be reported to Property Services.

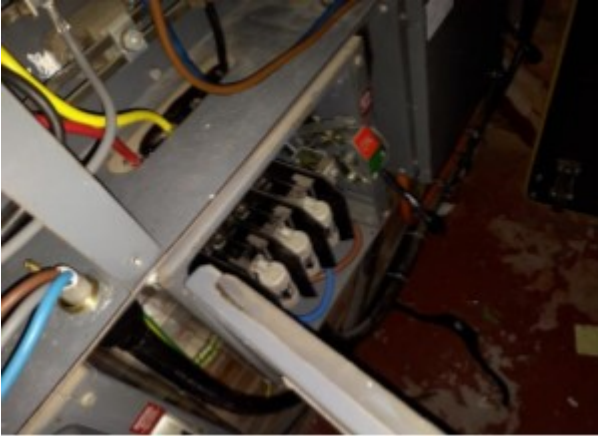
Items 50 - Ref: Presumed

Presumed – Barrel fuses (Area 2/Electrical Switch Room) (Item 50) – Low Risk

The barrel fuses in Area 2/Electrical Switch room does contain asbestos.

Any change in appearance should be reported to Property Services.

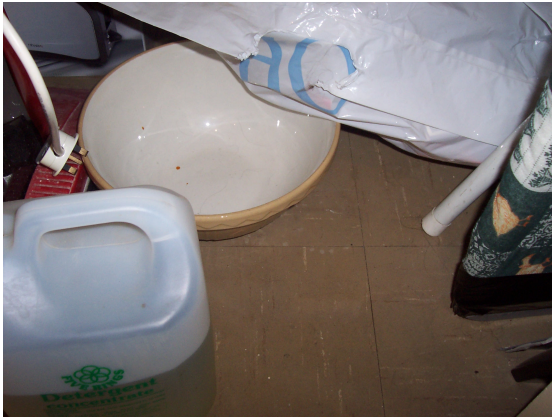
Items 8-14- Ref: NO06/10

The floor tiles to the pantry in the caretaker's house do not contain asbestos.

Similar flooring is located in bedrooms 1-3, hall, living room and corridor store.
