### **ASBESTOS SURVEY REPORT FOR CASTLEVIEW ACADEMY, SUNDERLAND**

## CASTLEVIEW SPORTS CENTRE, SUNDERLAND

**Date: 01 July 2025**

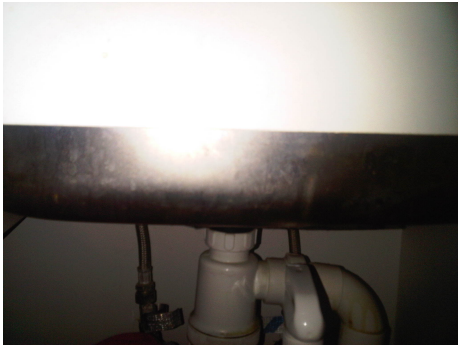
### **Item 1 Ref: MBA10/1787**

The sink pad to the kitchen (Room 6) does not contain asbestos.

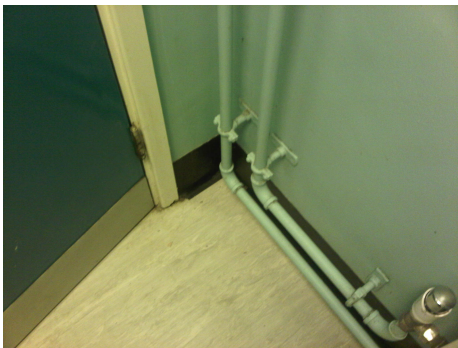
### **Item 2 - Ref: MBA10/1788**

The skirting board to the kitchen (Room 6) does not contain asbestos.

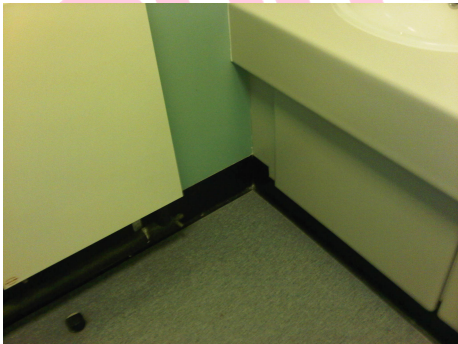
### **Item 3 - As MBA10/1788**

The skirting board to the staff WC (Room 7) does not contain asbestos.

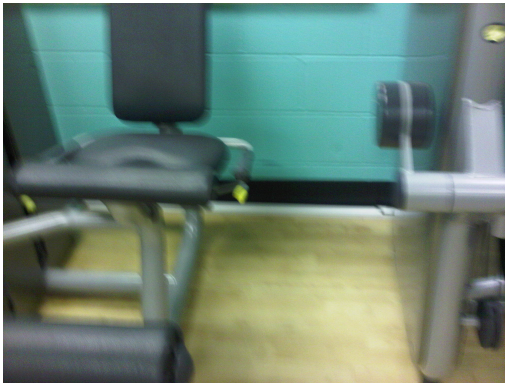
### **Item 4 – As MBA10/1788**

The skirting board to the Gym and electric cupboard (Room 8) does not contain asbestos.

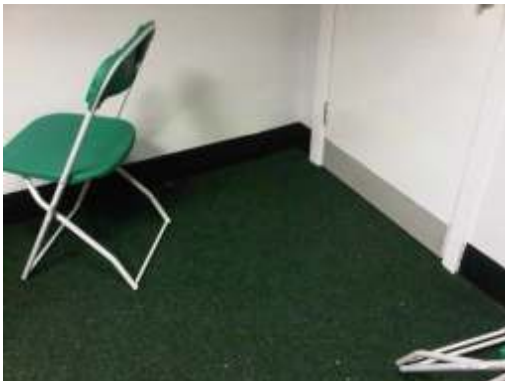
### **Item 5 – As MBA10/1788**

The skirting board to the community room (Room 9) does not contain asbestos.

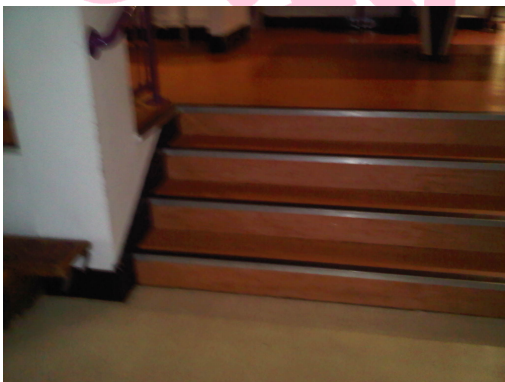
### **Item 6 - Ref: MBA101789**

The stair nosing to the main area community room (Room 9) does not contain asbestos.

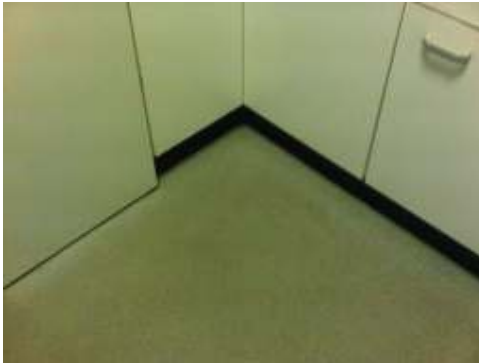
### **Item 7 – AS MBA10/1788**

The skirting board to the kitchen and cleaners cupboard (Room 10) does not contain asbestos.

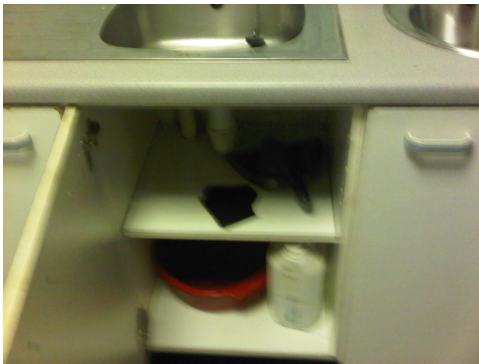
### **Item 8 - Ref: MBA10/1790**

The sink pad to the kitchen and cleaners cupboard (Room 10) does not contain asbestos.

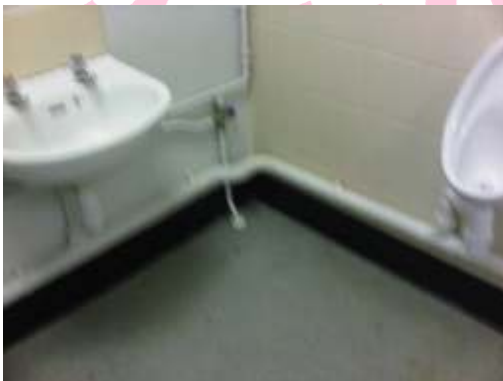
### **Item 9 – As MBA10/1788**

The skirting board to the male WC community Room (Room 11) does not contain asbestos.

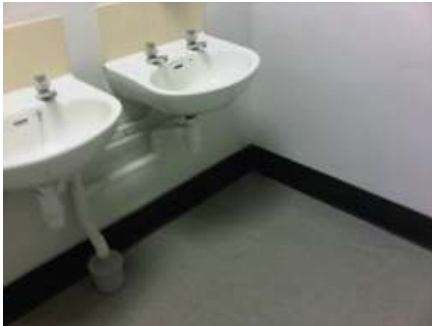
### **Item 10– As MBA10/1788**

The skirting boards to the female WC community room (Room 12) do not contain asbestos.

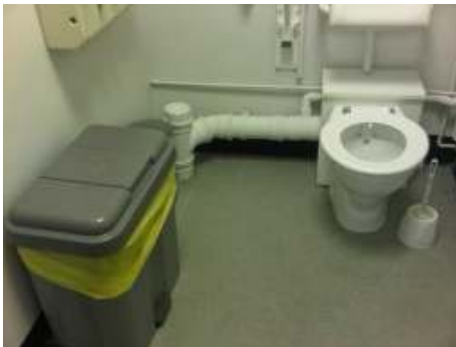
### **Item 11 –As MBA10/1788**

The skirting boards to the disabled WC in the community area (Room 13) do not contain asbestos.

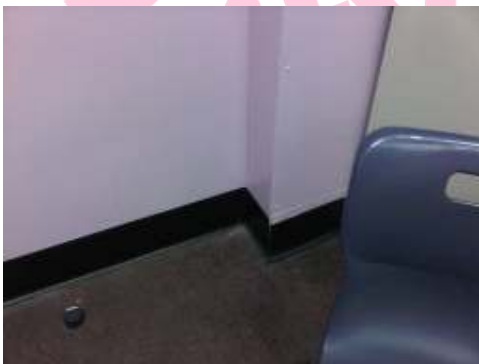
### **Item 12 –As MBA10/1788**

The skirting boards to the IEU off the Community Room (Room 16) do not contain asbestos.

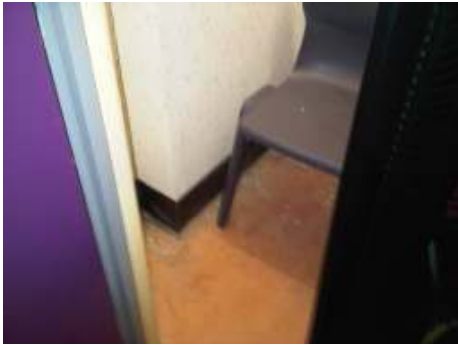
### **Item 13– As MBA10/1788**

The skirting boards to the office area (Room 17) do not contain asbestos.

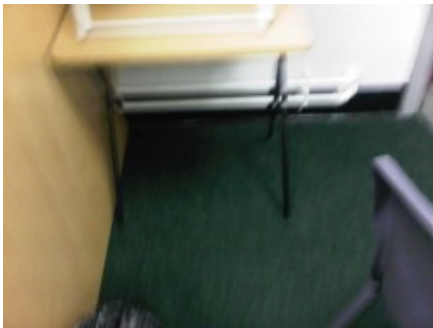
### **Item 14 –As MBA10/1788**

The skirting boards to the classroom off the community area (Room 18) do not contain asbestos.

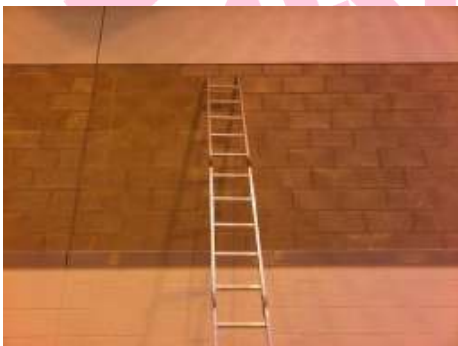
### **Item 15–Ref:MBA10/1791**

The high level boards to the main sports hall (Room 19) do not contain asbestos.

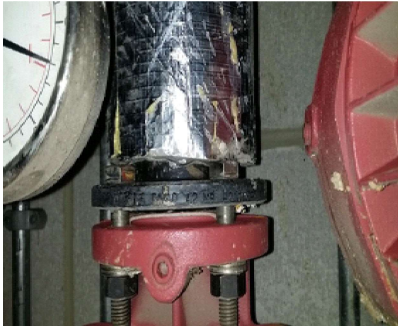
### **Item 17 Ref: 65006-1**

The pipework flange gaskets x 4 (wet) to the pipework in the pool boiler room contains asbestos. Any change in its appearance should be noted and reported to Property Services. *(Confirmed on survey J251522 only 4 present AW005652)*

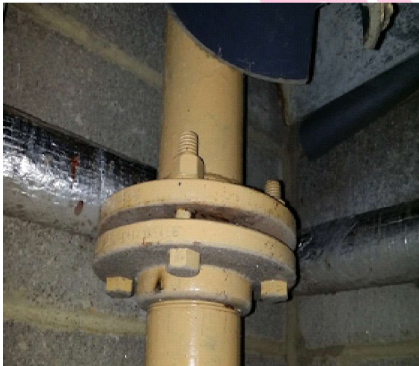
### **Item 18 Ref: 65006-2**

The pipework flange gaskets x 2 (gas) to the pipework in the pool boiler room contains asbestos. Any change in its appearance should be noted and reported to Property Services.

*Removed – no paperwork provided*

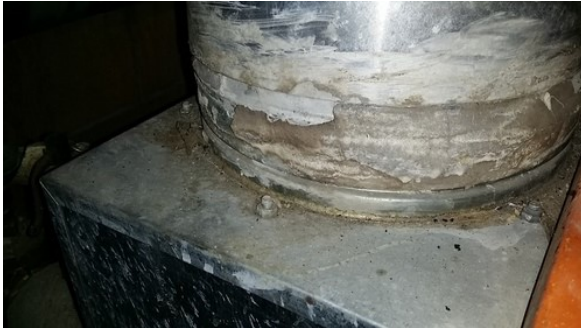
### **Item 19 Ref: 65006-3**

The boilers packing to joint at base of flue in the Pool Boiler Room does not contain asbestos.

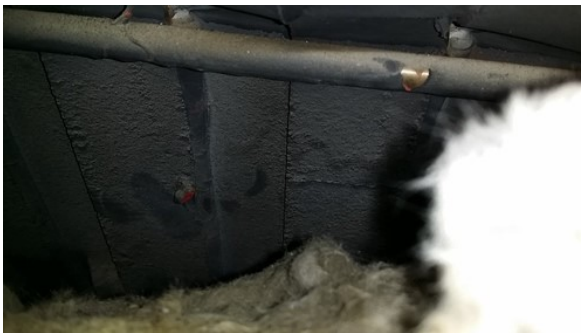
### **Item 20 Ref: 65006-4**

The boilers (boiler segment gasket) in the Pool Boiler Room does not contain asbestos.

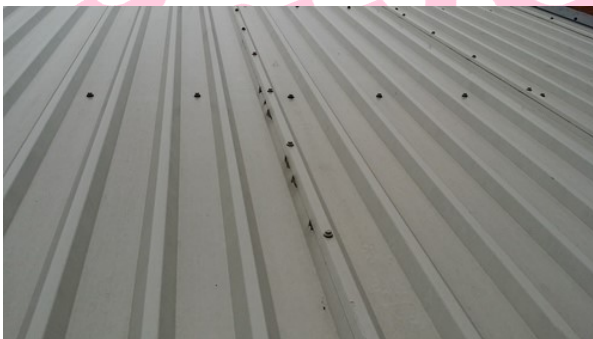
### **Item 21 Ref: 65006-5**

The sealant to roofing panel overlaps (external-localised to proposed solar panel mounting on sports hall roof) does not contain asbestos.

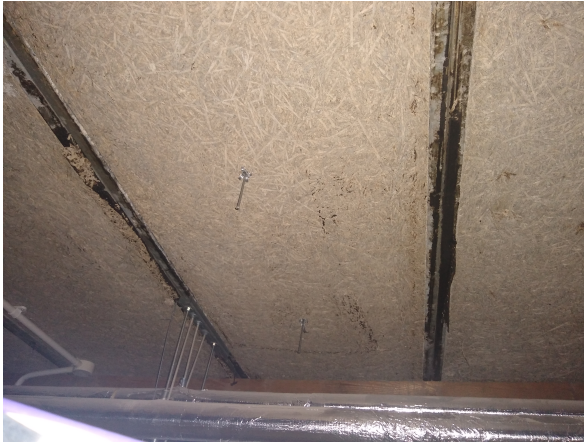
### **Item 22 Ref: 338853-1**

The protruding roof felt and residue to underside of roof to the void above the classroom (Room 001) contains asbestos.

Any works planned within this area should be reported to Property Services.

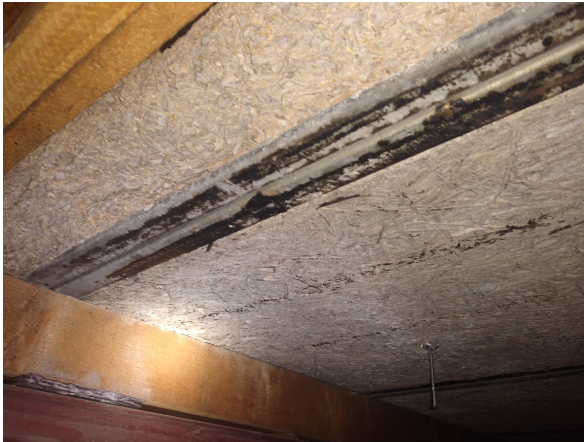
### **Item 23 Ref: 338853-2**

The roof felt to the void above the classroom (Room 001) contains asbestos.

Any works planned within this area should be reported to Property Services.

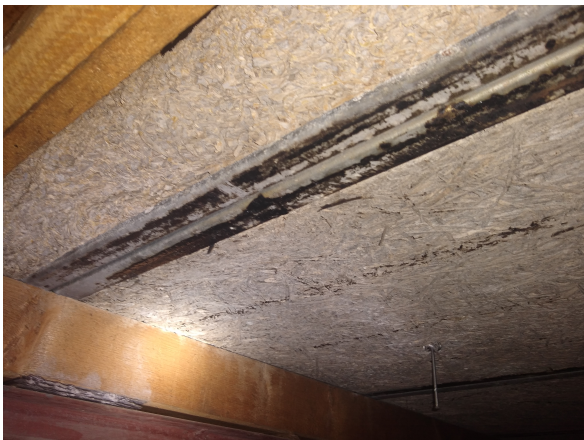
### **Item 24 Ref: As 338853-1**

The protruding roof felt and residue to underside of roof to the void above the classroom (Room 002) contains asbestos.

Any works planned within this area should be reported to Property Services.

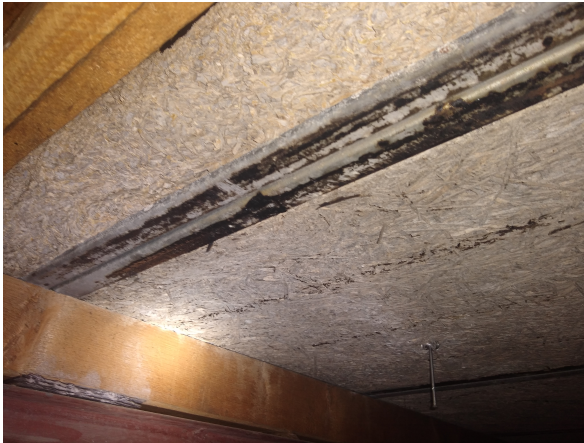
### **Item 25 Ref: As 338853-2**

The roof felt to the void above the classroom (Room 002) contains asbestos.

Any works planned within this area should be reported to Property Services.

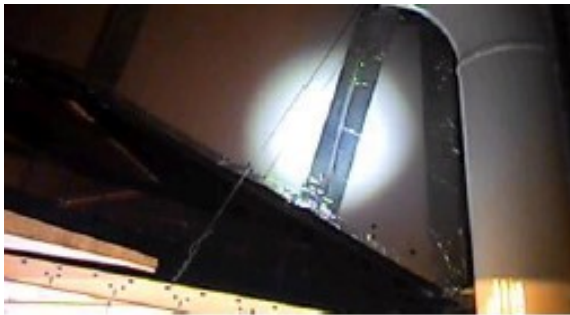
### **Item 26 Ref: EA000059**

The cladding to roof joists (Room 1 Swimming Pool) does not contain asbestos.

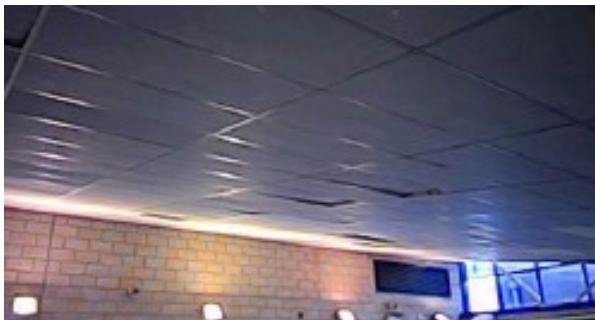
### **Item 27 Ref: EA000060**

The suspended ceiling tiles (Room 1 Swimming Pool) do not contain asbestos.

*Removed*

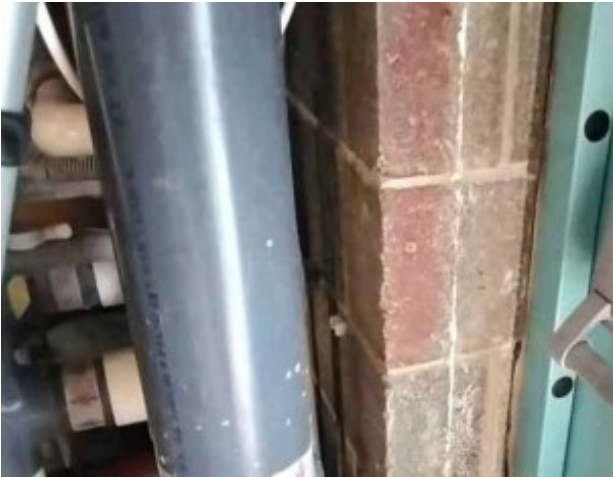
#### **Item 28 Ref: AW005653**

The wall cavity damp proof course in the pool tank room (G/001) does not contain asbestos.

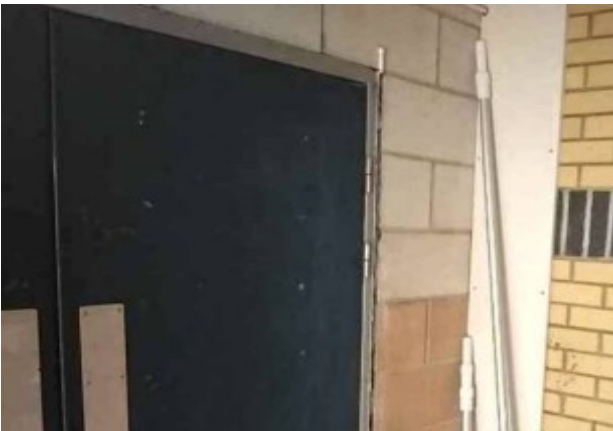
#### **Item 29 Ref: AW005654**

The column cladding in the pool tank room (G/001) does not contain asbestos.

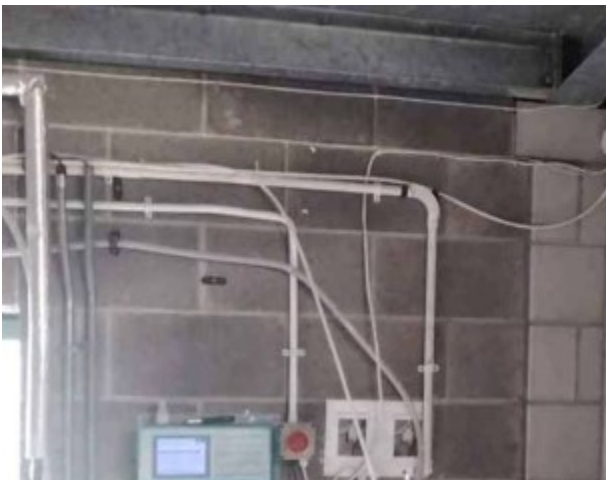
#### **Item 30 Ref: AW005655**

The wall joint sealant in the pool tank room (G/001) does not contain asbestos.

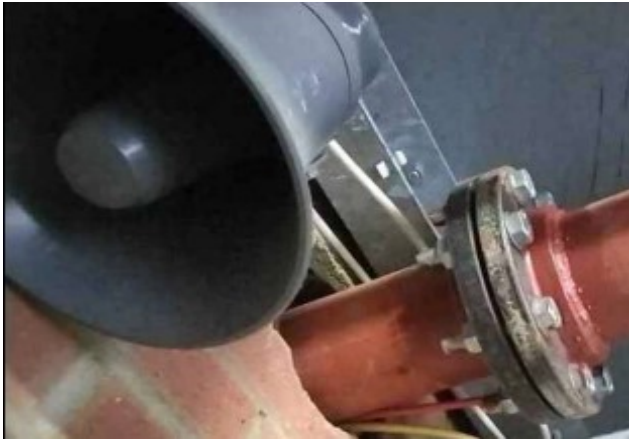
### **Item 31 Ref: AW005656**

The pipework gasket to gas main in the pool tank room (G/001) does not contain asbestos.

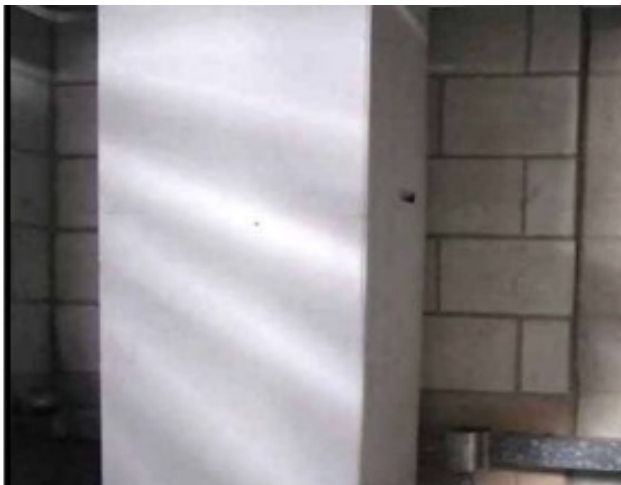
### **Item 32 Ref:As AW005655**

The wall joint sealant in the boiler room (G/002) does not contain asbestos.

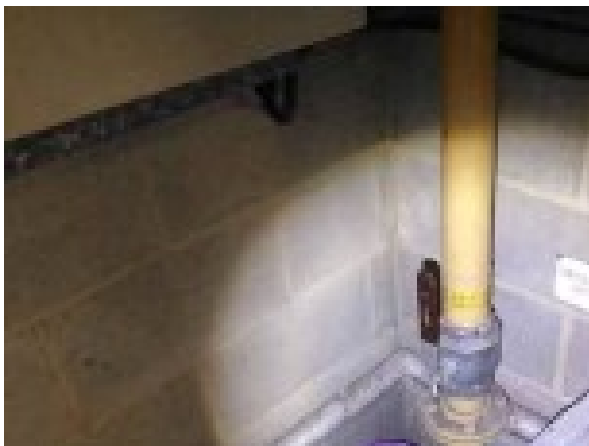
### **Item 33 Ref: AW005658**

The pipework gasket to gas main in the boiler room (G/002) does contain asbestos.

Any change in appearance should be reported to Property Services.

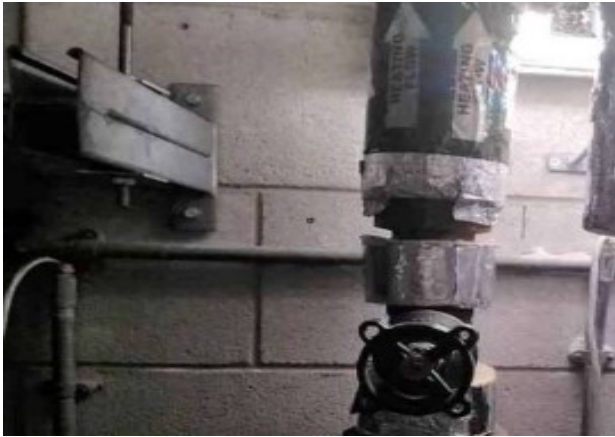
**Item 34 Ref: AW005657**

The wall joint sealant in the boiler room (G/002) does not contain asbestos.
