ASBESTOS SURVEY REPORT FOR CASTLEVIEW ACADEMY, SUNDERLAND

Castle View Academy – Version 2.0 - Last updated 27/11/2025

Asbestos Register for

CASTLEVIEW SPORTS CENTRE, SUNDERLAND

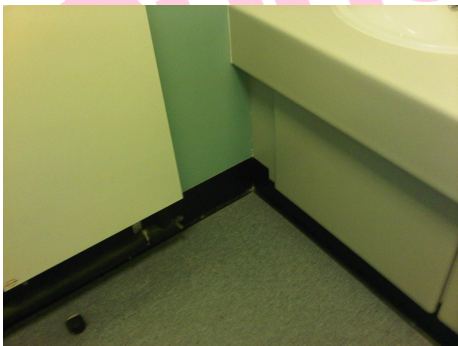
Item 3 - As MBA10/1788

The skirting board to the staff WC (Room 7) does not contain asbestos.

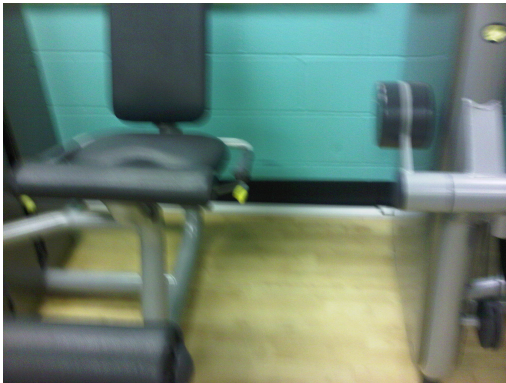
Item 4 – As MBA10/1788

The skirting board to the Gym and electric cupboard (Room 8) does not contain asbestos.

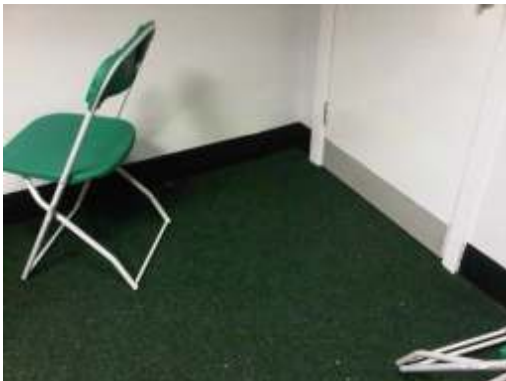
Item 5 – As MBA10/1788

The skirting board to the community room (Room 9) does not contain asbestos.

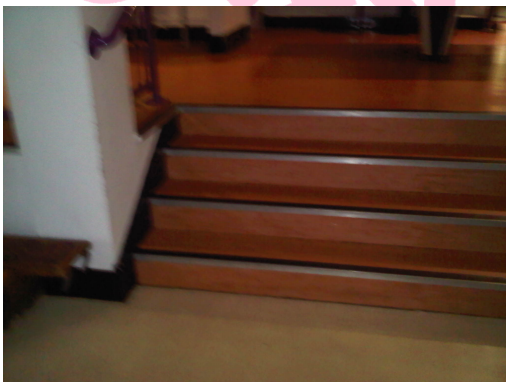
Item 6 - Ref: MBA101789

The stair nosing to the main area community room (Room 9) does not contain asbestos.

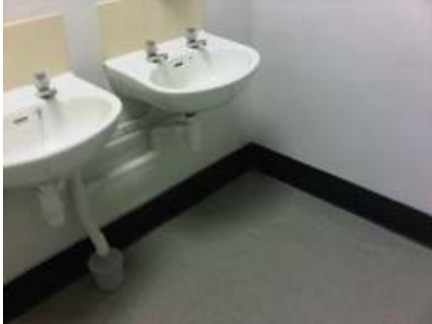
Item 10– As MBA10/1788

The skirting boards to the female WC community room (Room 12) do not contain asbestos.

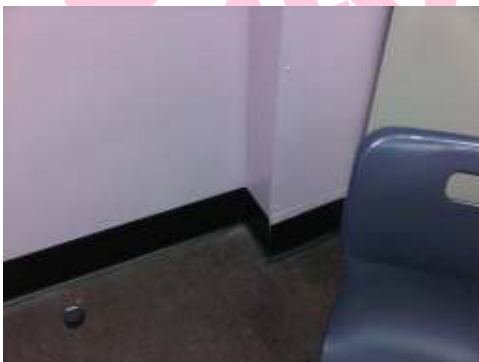
Item 12 –As MBA10/1788

The skirting boards to the IEU off the Community Room (Room 16) do not contain asbestos.

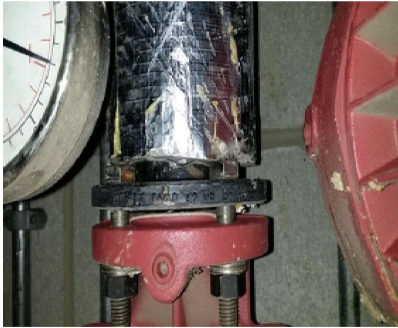
Item 17 Ref: 65006-1

The pipework flange gaskets x 4 (wet) to the pipework in the pool boiler room contains asbestos. Any change in its appearance should be noted and reported to Property Services. *(Confirmed on survey J251522 only 4 present AW005652)*

Item 17	Gaskets to pipework x 4 – Pool boiler room (confirmed on survey J251522 only 4 present AW005652	Very Low	12 monthly	03.12.2026
Item 18	Gaskets to pipework x 2 – Pool boiler room	Very Low	12 monthly	Removed – no waste certificates

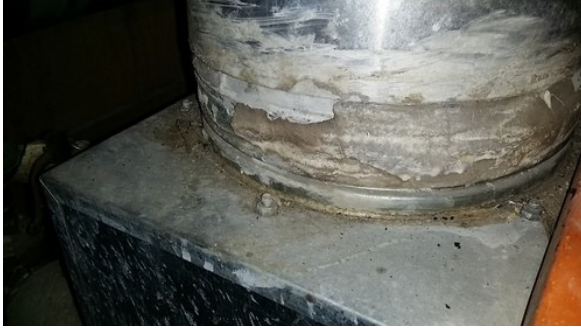
Item 19 Ref: 65006-3

The boilers packing to joint at base of flue in the Pool Boiler Room does not contain asbestos.

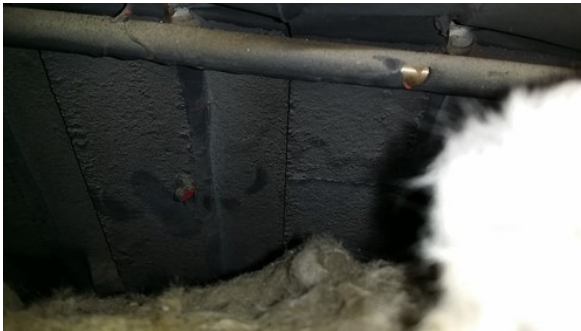
Item 20 Ref: 65006-4

The boilers (boiler segment gasket) in the Pool Boiler Room does not contain asbestos.

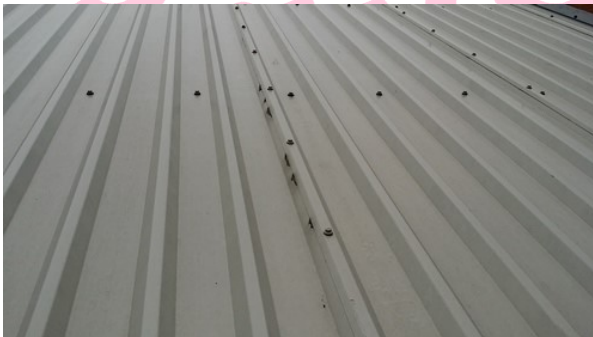
Item 21 Ref: 65006-5

The sealant to roofing panel overlaps (external-localised to proposed solar panel mounting on sports hall roof) does not contain asbestos.

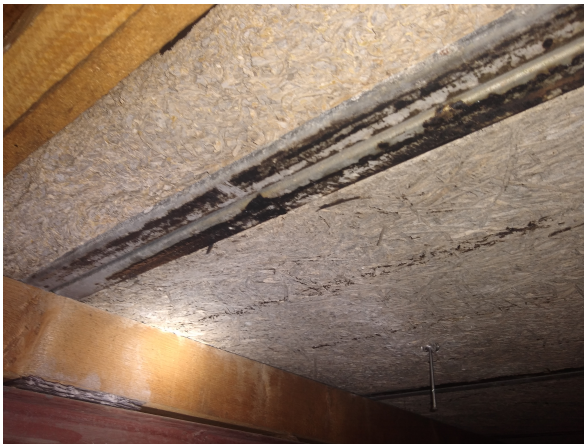
Item 23 Ref: 338853-2

The roof felt to the void above the classroom (Room 001) contains asbestos.

Item 23	Roof felt above – Room 001 void above	Very Low	12 monthly	Do not inspect
Item 24	Roof felt and residue - Room 002 void above	Very Low	12 monthly	Do not inspect

Any works planned within this area should be reported to Property Services.

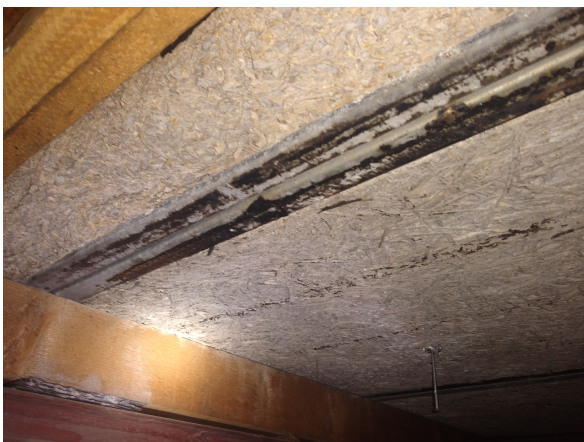
Item 24 Ref: As 338853-1

The protruding roof felt and residue to underside of roof to the void above the classroom (Room 002) contains asbestos.

Any works planned within this area should be reported to Property Services.

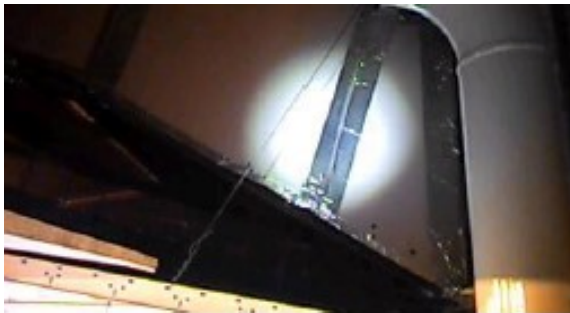
Item 26 Ref: EA000059

The cladding to roof joists (Room 1 Swimming Pool) does not contain asbestos.

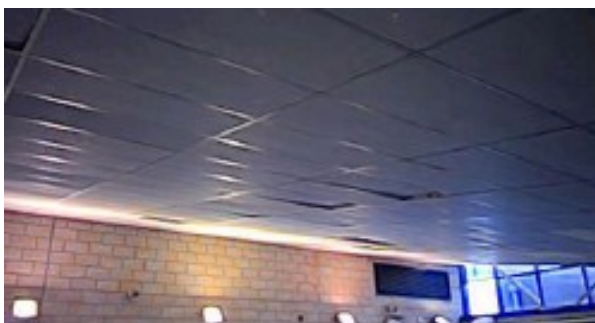
Item 27 Ref: EA000060

The suspended ceiling tiles (Room 1 Swimming Pool) do not contain asbestos.

Removed

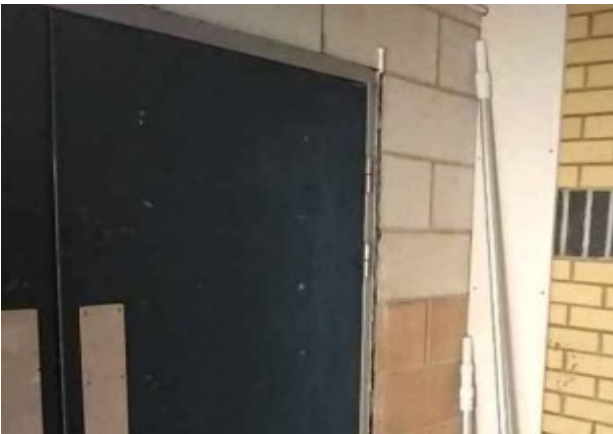
Item 29 Ref: AW005654

The column cladding in the pool tank room (G/001) does not contain asbestos.

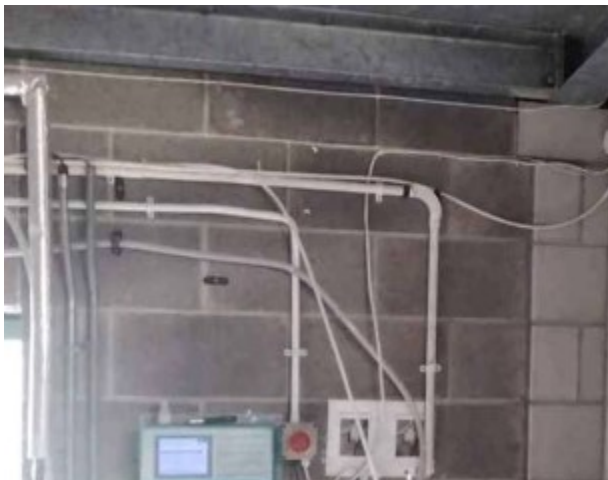
Item 30 Ref: AW005655

The wall joint sealant in the pool tank room (G/001) does not contain asbestos.

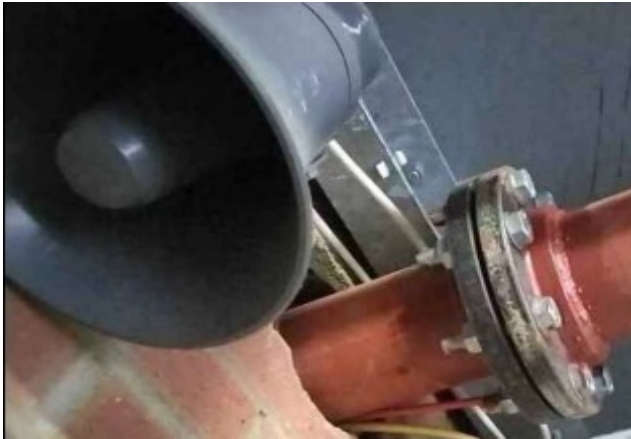
Item 31 Ref: AW005656

The pipework gasket to gas main in the pool tank room (G/001) does not contain asbestos.

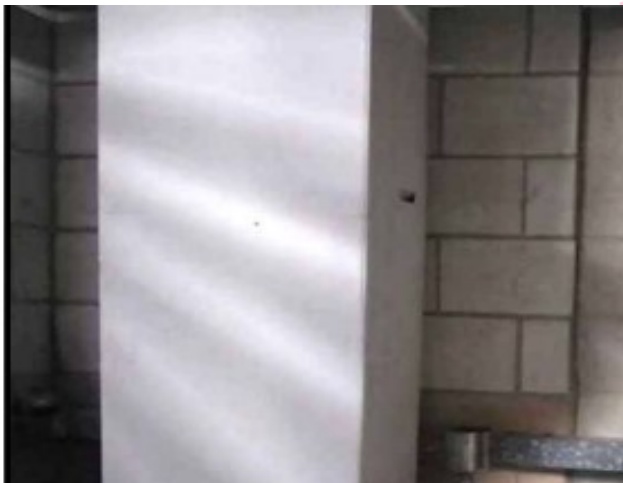
Item 32 Ref:As AW005655

The wall joint sealant in the boiler room (G/002) does not contain asbestos.

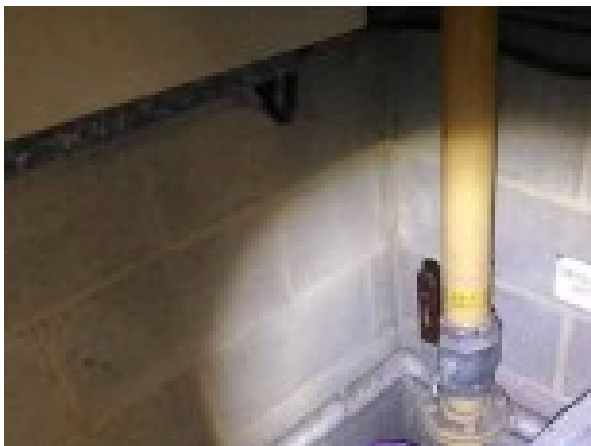
Item 33 Ref: AW005658

The pipework gasket to gas main in the boiler room (G/002) does contain asbestos.

Any change in appearance should be reported to Property Services.

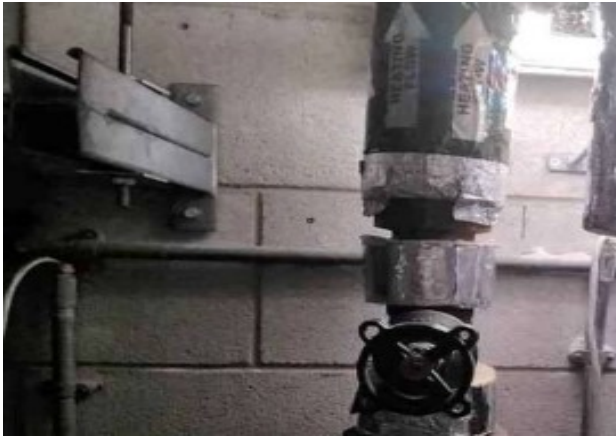
Item 34 Ref: AW005657

The wall joint sealant in the boiler room (G/002) does not contain asbestos.
