### ASBESTOS SURVEY REPORT FOR DIAMOND HALL INFANT SCHOOL, SUNDERLAND

### **Asbestos Register for DIAMOND HALL INFANT ACADEMY, SUNDERLAND**

**UPRN: - 131926**

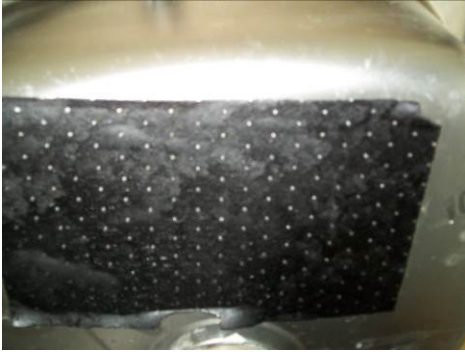
### **Item 1 Ref: YA0327/10**

The sink pad to the kitchen (Area 0/6) does not contain asbestos.

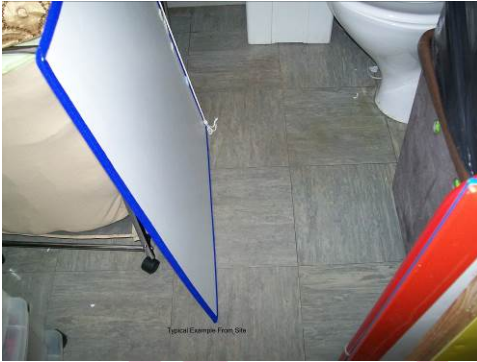
### **Item 2 - Ref: YA0328/10**

The grey floor tiles to the toilets (Area 0/7a) do not contain asbestos.

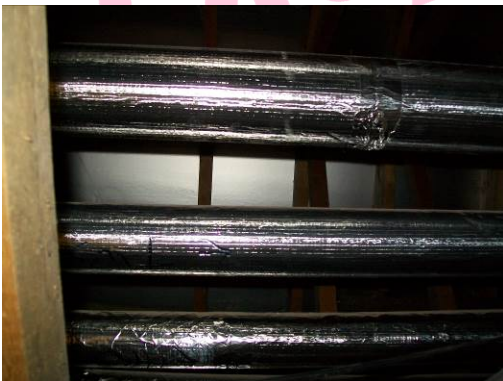
### **Item 3 - Ref: YA0329/10**

The pipe insulation on the pipework in the ceiling void of the toilets (Area 0/9) does not contain asbestos.

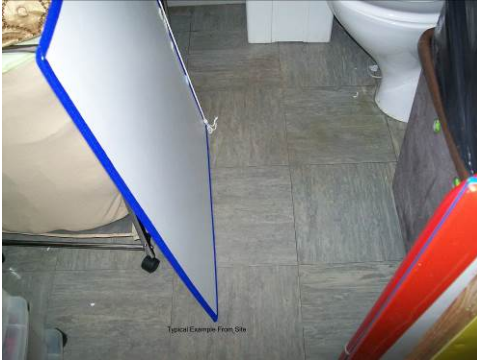
### **Item 4 - Ref: YA0330/10**

The floor tiles to the store room (Area 0/10) do not contain asbestos.

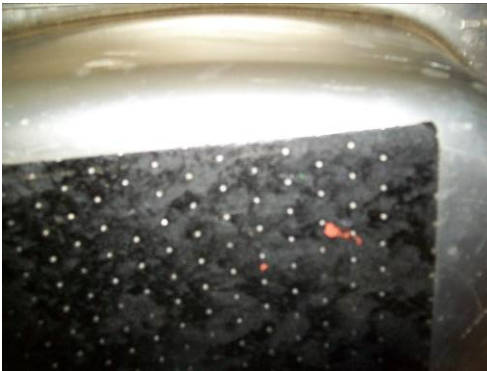
### **Item 5 - Ref: YA03331/10**

The sink pad to the classroom (Area 0/15) does not contain asbestos.

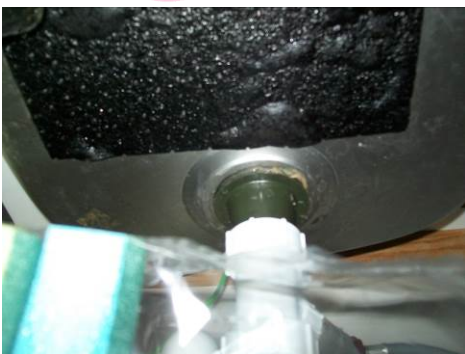
### **Item 6 - Ref: YA0344/10**

The sink pad to the Children's Centre (Area 0/16) does not contain asbestos.

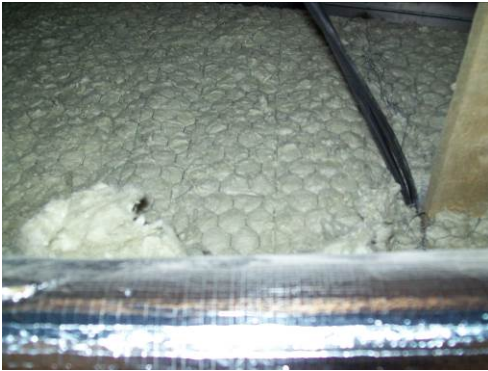
### **Item 7 - Ref: YA0332/10**

The firebreak to the ceiling void in the classroom (Area 0/23) does not contain asbestos.

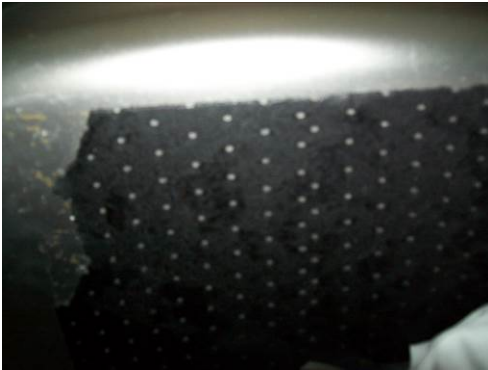
### **Item 8 - Ref: YA0334/10**

The sink pad to the classroom (Area 0/25) does not contain asbestos.

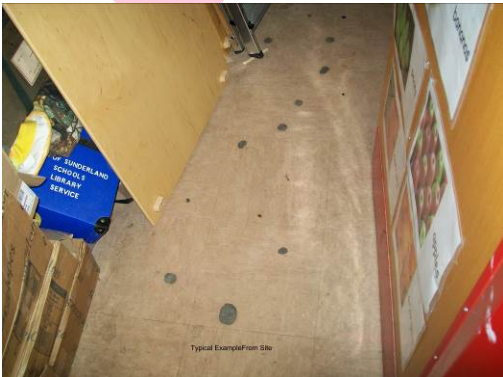
### **Item 9 - Ref: YA0333/10**

The beige floor tiles to the store cupboard – (Area 0/30) do not contain asbestos.

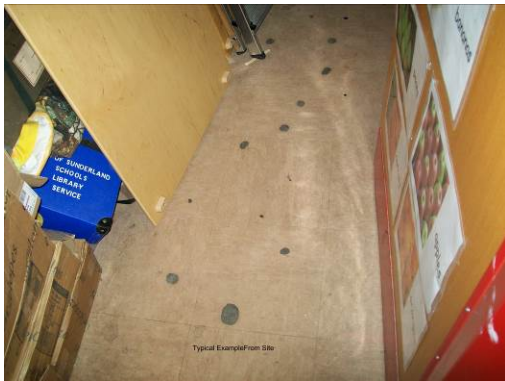
### **Item 10 - Ref: YA0335/10**

The beige floor tiles to the store cupboard Area 0/31a) do not contain asbestos.

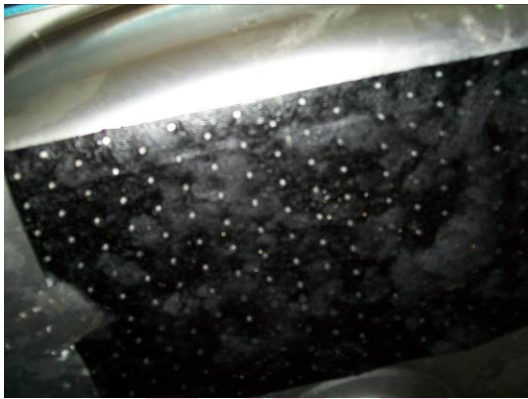
### **Item 11 - Ref: YA0337/10**

The sink pad to the classroom (Area 0/35) does not contain asbestos.

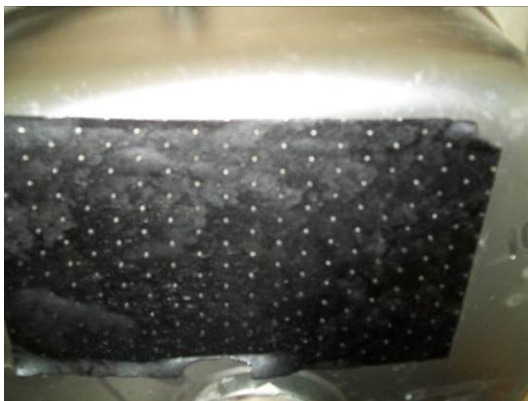
### **Item 12 - Ref: YA0336/10**

The sink pad to the classroom (Area 0/51) does not contain asbestos.

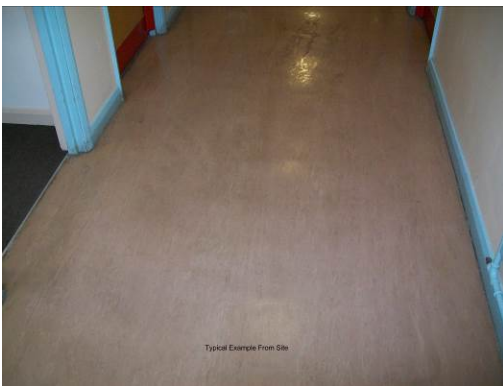
**Item 14 - Ref: YA0339/10**

The floor covering to the corridor (Area 0/53) does not contain asbestos.

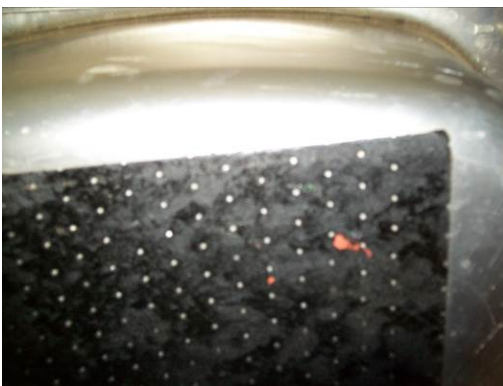
**Item 15 - Ref: YA0338/10**

The sink pad to the drama classroom (Area 0/56) does not contain asbestos.

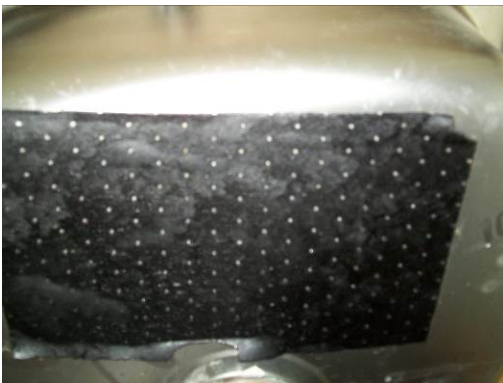
**Item 17 - Ref: YA0348/10**

The sink pad to the kitchen (Area 0/76) does not contain asbestos.

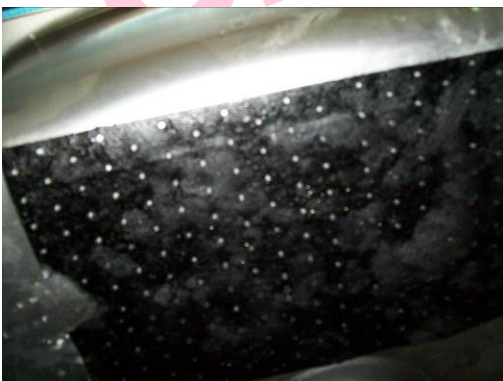
**Item 18 - Ref: YA0345/10**

The sink pad to the kitchen (Area 0/80) does not contain asbestos.

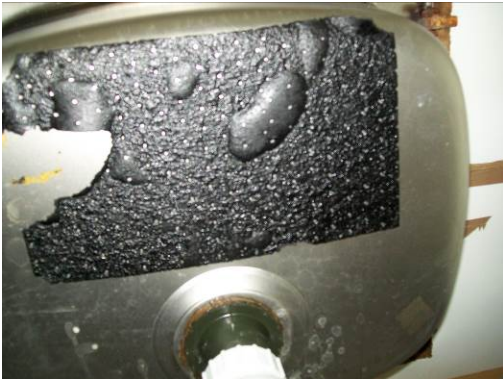
### **Item 19 - Ref: YA0342/10**

The sink pad to the photocopy room (Area 0/81) does not contain asbestos.

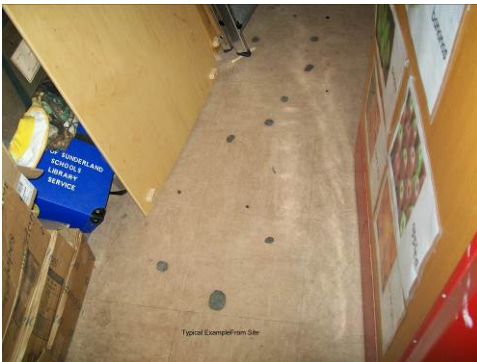
### **Item 20 - Ref: YA0343/10**

The floor covering to the corridor (Area 0/89) does not contain asbestos.

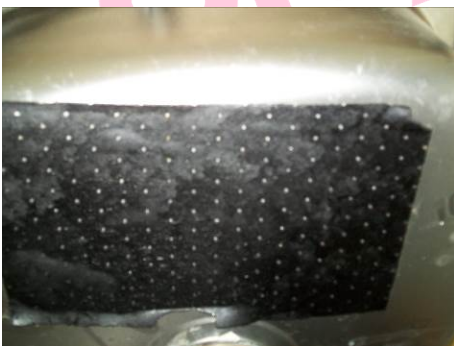
### **Item 21 - As YA0319/10**

The sink pad to the main school kitchen (Area 0/91) does not contain asbestos.

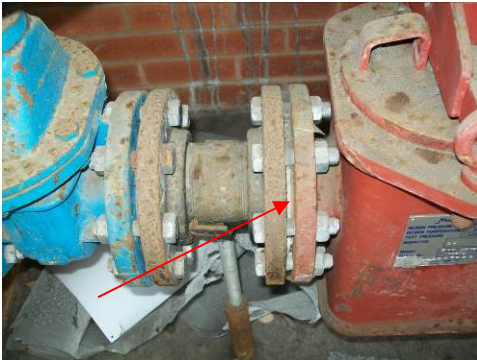
**Item 22 - Ref: YA0346/10**

The gaskets to the pipework in the gas meter cupboard (Area 0/90) contain asbestos.

***This was removed in September 2016.***

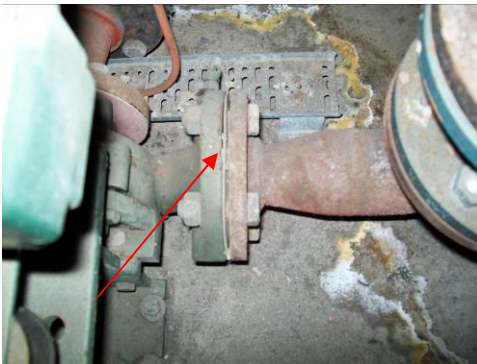
**Item 23 - Ref: Presumed**

The gaskets to the pipework in the boiler room (Area 0/99) contain asbestos.

Any change in its appearance should be recorded, and passed to Property Services.

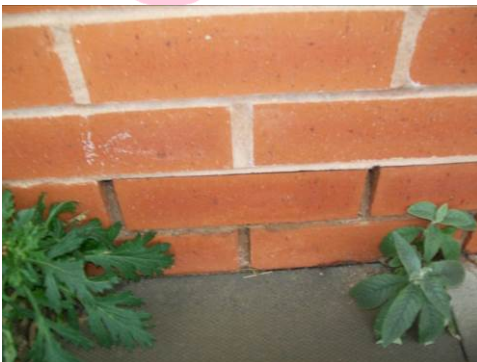
**Item 24 - Ref: YA0347/10**

The damp proof course to the external of the building (Area E/1) does not contain asbestos.

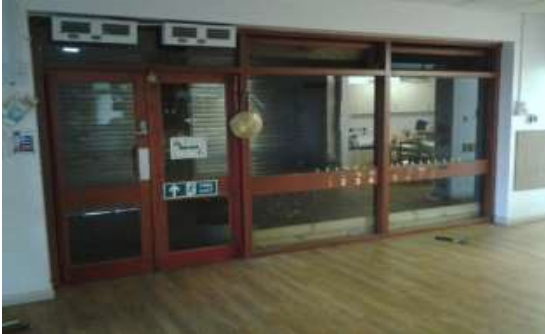
**Item 25 - Ref:16-24682-1**

The putty to the windows and doorway between the main nursery and the covered play area does not contain asbestos.

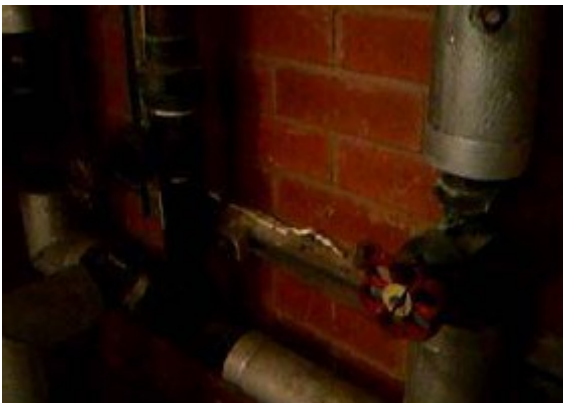
**Item 27 - Ref: AA002393**

The debris to pipework in Boiler Room does not contain asbestos.

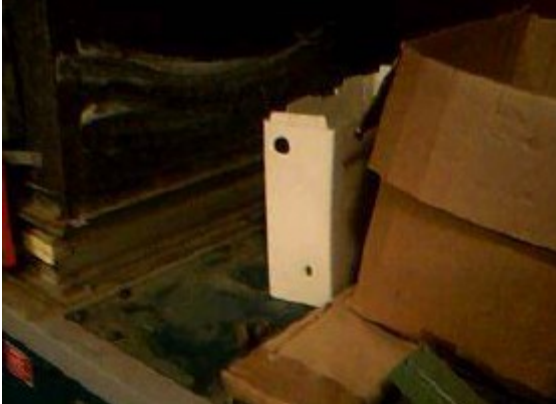
**Item 28 - Ref: AA002394**

The debris/dust to machinery in Boiler Room does not contain asbestos.

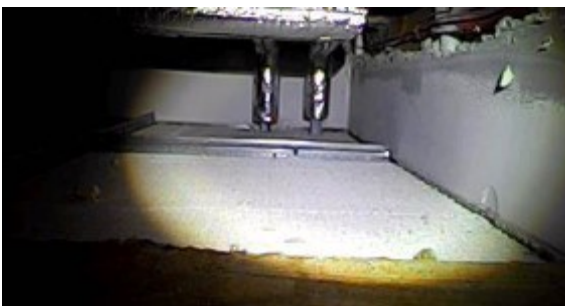
**Item 30 - Ref: EC000058**

The debris in the Staff Room ceiling void does not contain asbestos.

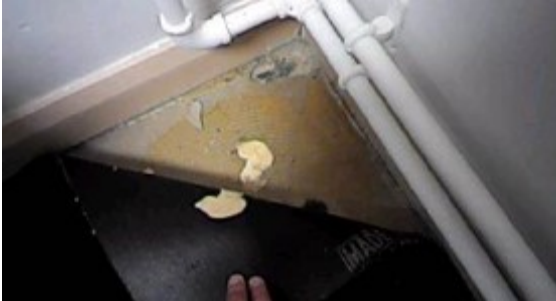
**Item 31 - Ref: EC000059**

The floor/screed in Staff Room does not contain asbestos.

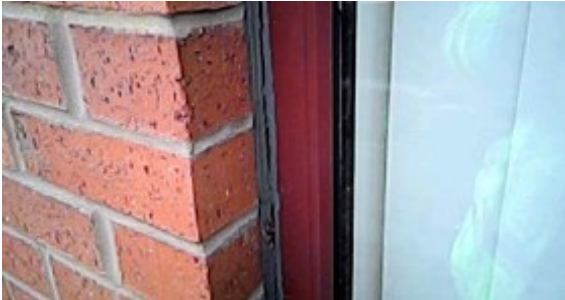
**Item 32 - Ref: EC000061**

The windows, composite putty sample (external) does not contain asbestos.
